7 October 2021

Project No. 21494739-001-L-Rev2

## **LETTER OF SUPPORT FOR THE SSD MODIFICATION OF THE MINTO WAREHOUSE AND LOGISTICS HUB TO RECONFIGURE THE LAYOUT OF THE WAREHOUSES**

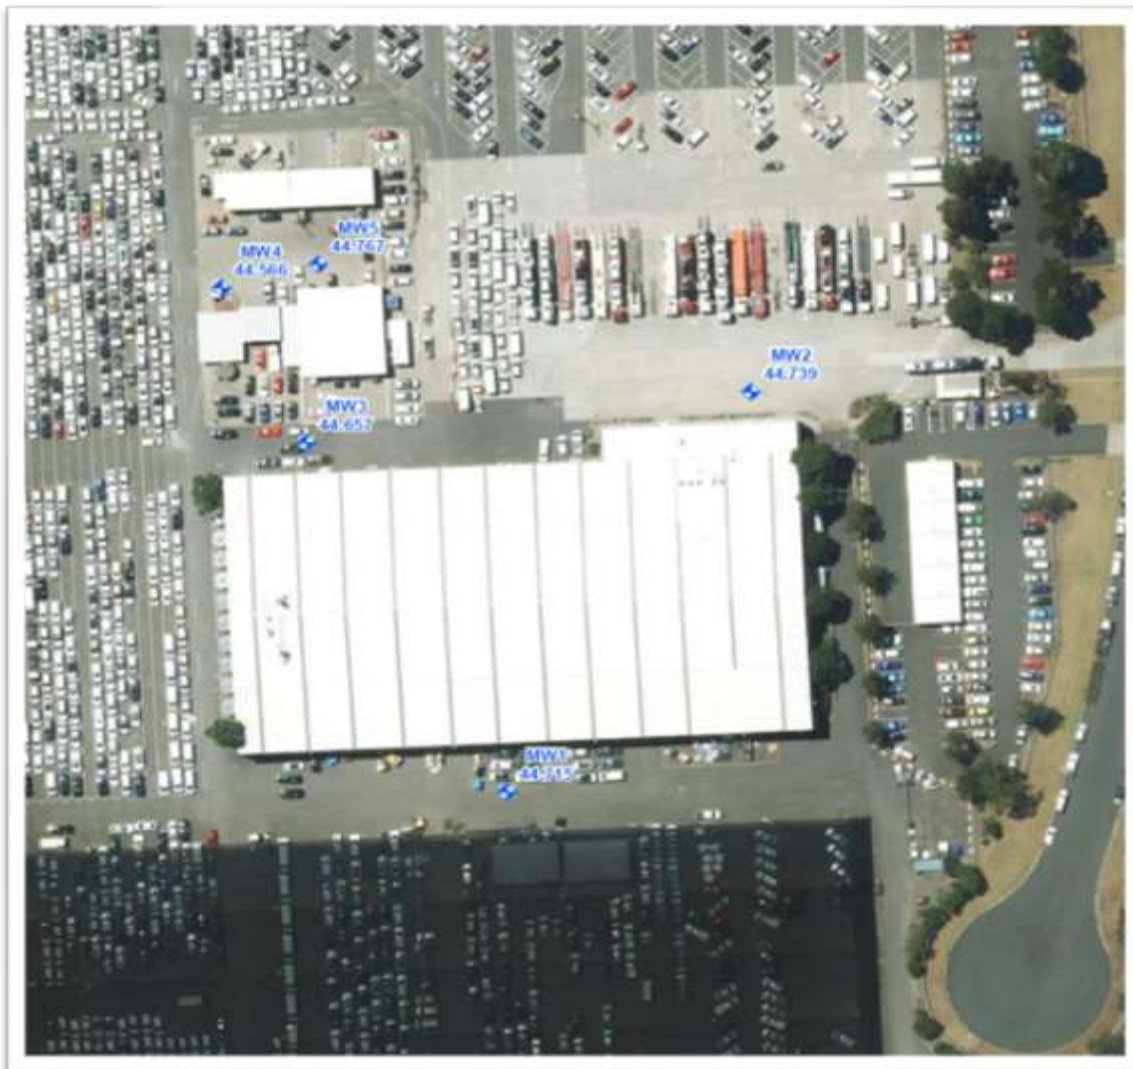
**Figure 3: MW01-MW05 Locations located adjacent to the fuel storage and dispensing area.**

Groundwater results at MW3 and MW4 in the central portion of the site reported concentrations of naphthalene exceeding the NEPM 2013 GIL for freshwater ecosystems. This is consistent with previous investigations (Golder, 2016b). No other concentrations of naphthalene were observed above the detection limit in the groundwater monitoring locations on the site boundaries, GA-BH02, GA-BH04, GA-BH05, GA-BH08 (Golder 2016a) and locations near the central area MW01, MW02 and MW05 (Golder 2016b, WSP 2020b). A summary of these groundwater results is presented in Table 2 below, with the groundwater monitoring locations presented on Figure 3 and Figure 4 below.

Total Petroleum Hydrocarbon (TPH) C6-C10 less BTEX (F1) concentrations in the central precinct of the site at monitoring location MW4 reported higher concentrations during the 2020 WSP investigation compared to the 2016 Golder investigation (320 ug/L compared to 110 ug/L). These concentrations do not exceed the adopted NEPM 2013 HSL (vapour intrusion).
