**PRELIMINARY ENVIRONMENTAL SITE ASSESSMENT**

**NEW ULTIMO PYRMONT PUBLIC SCHOOL**

**189 JONES STREET, ULTIMO**

**REF: E30361KHrpt-rev2**

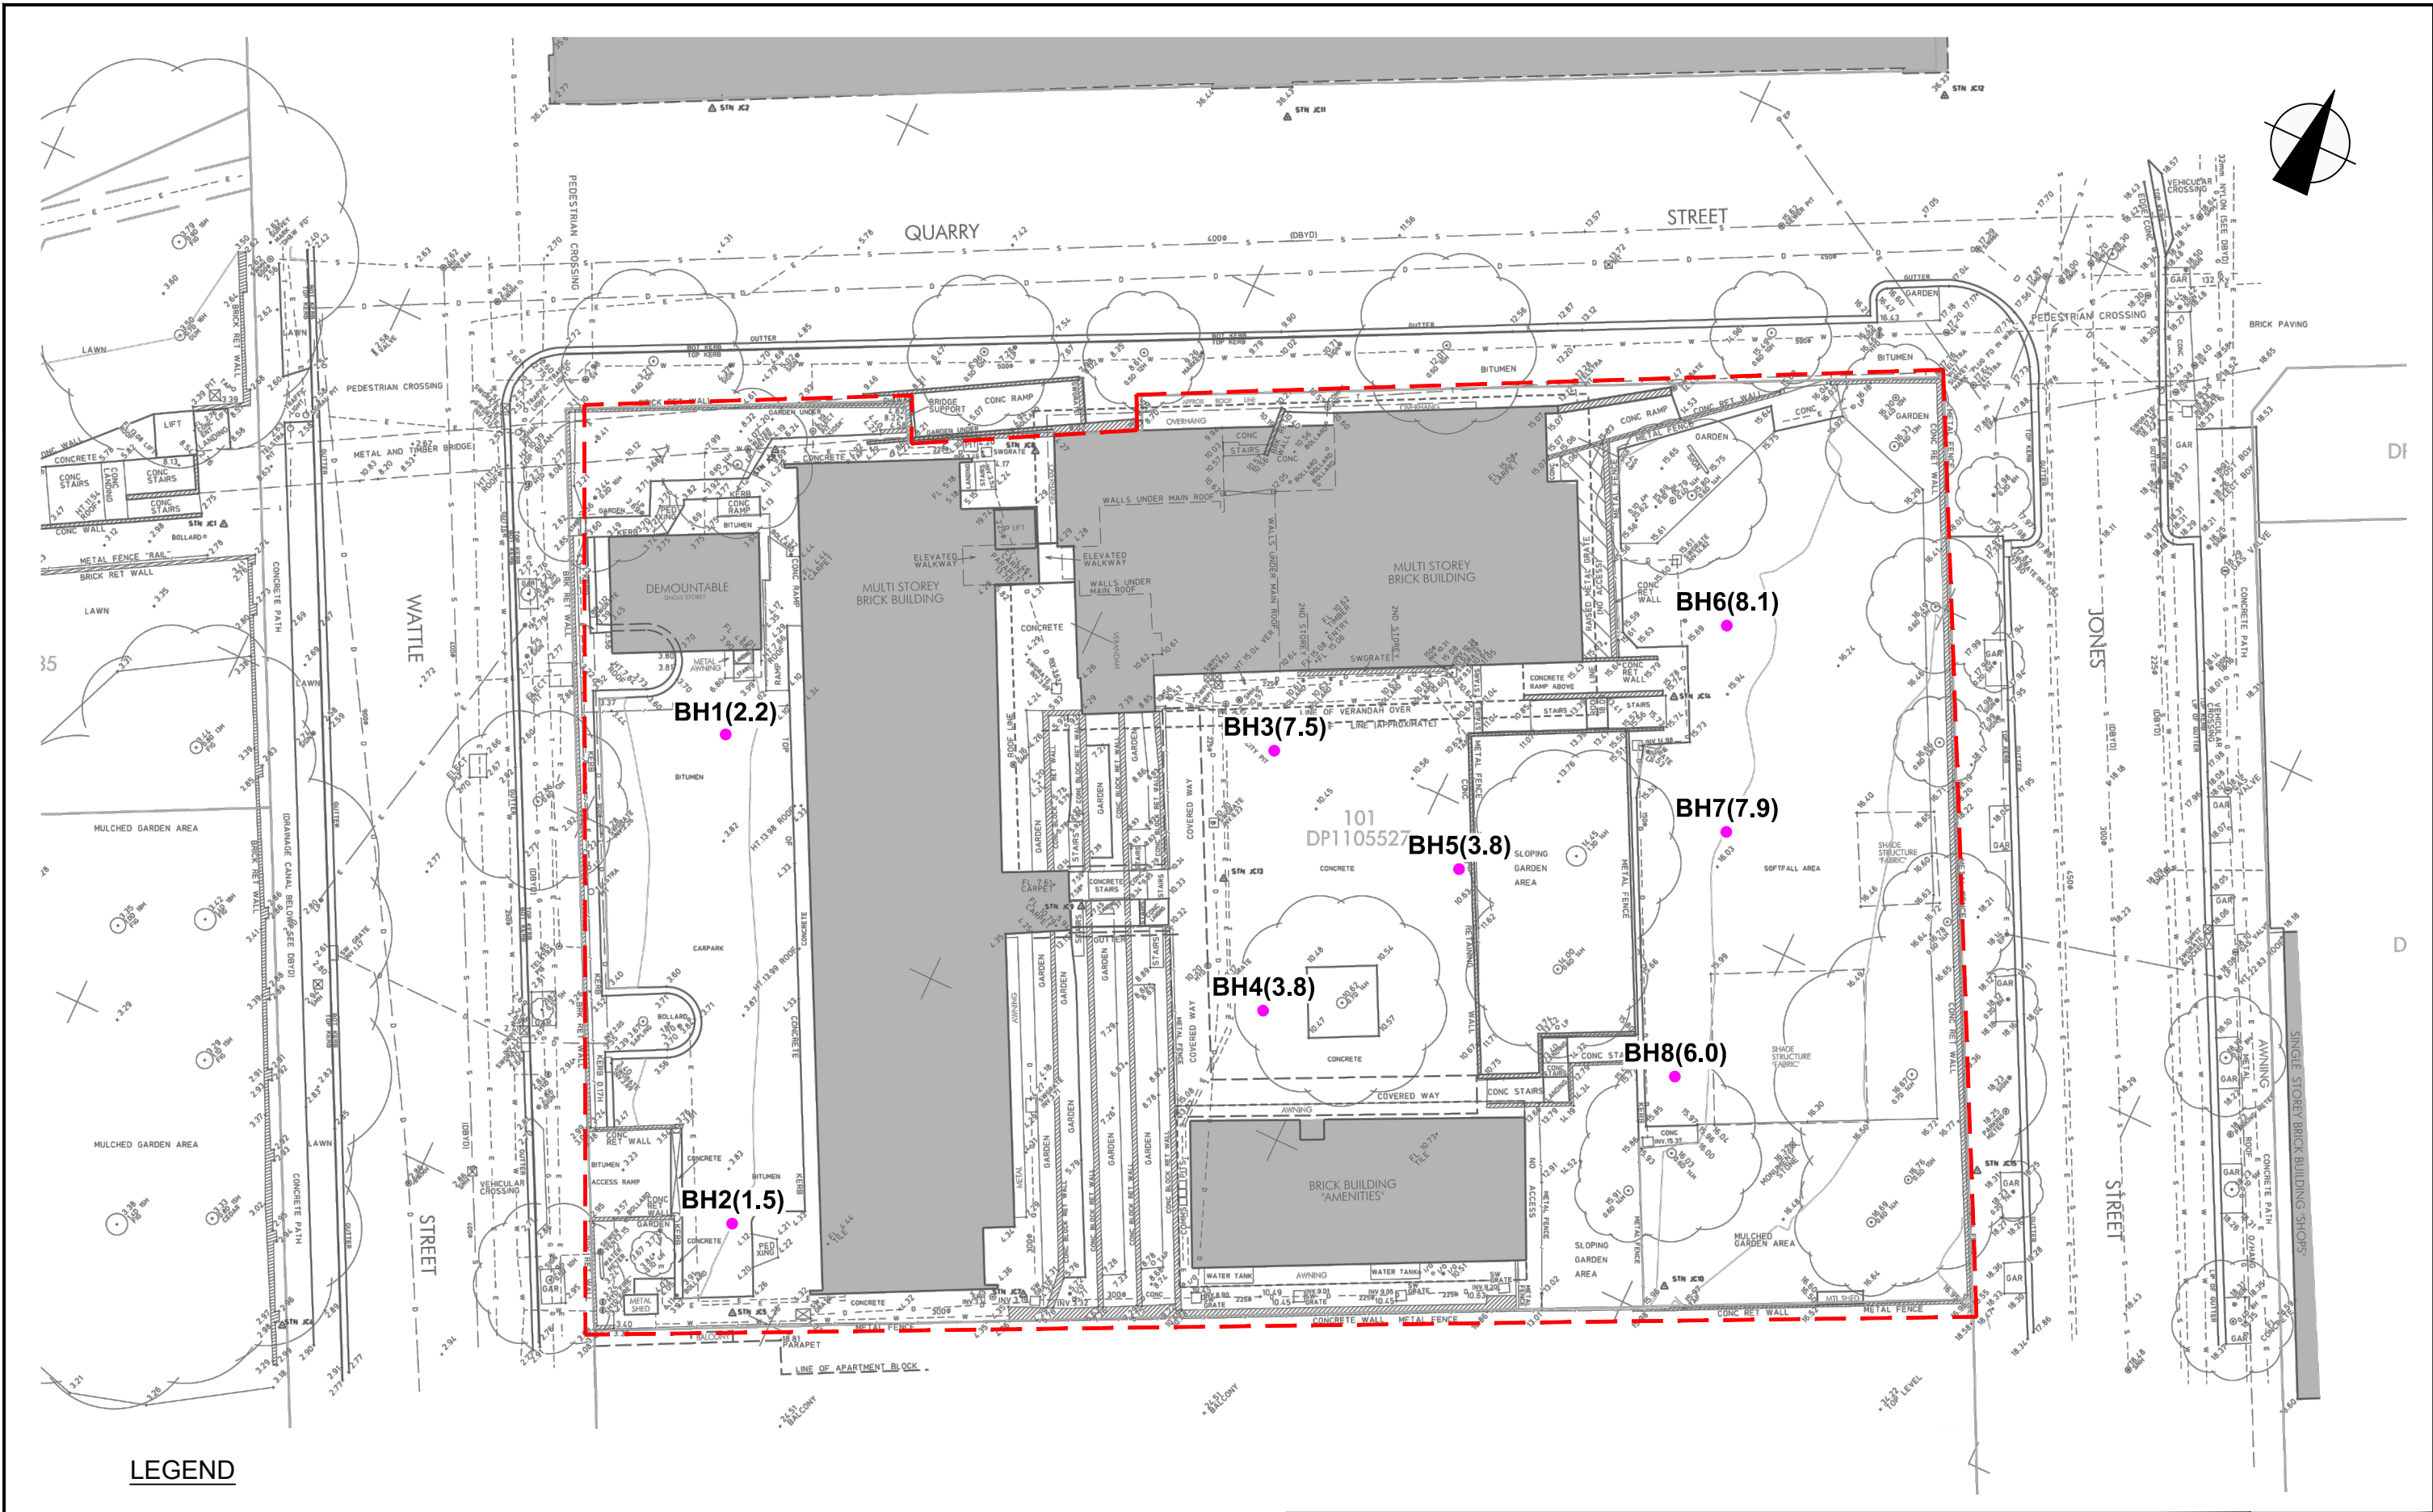
Figure 2: Sample Location Plan

- APPROXIMATE SITE BOUNDARY
- BH (Fill Depth) BOREHOLE LOCATION, NUMBER AND DEPTH OF FILL (m)
