### **Environmental Site Assessment**

Infrastructure NSW  
Environmental Site Assessment

Western Sydney Stadium  
O'Connell Street, Parramatta, NSW

12 July 2016  
51666/104304 (rev 1)  
JBS&G

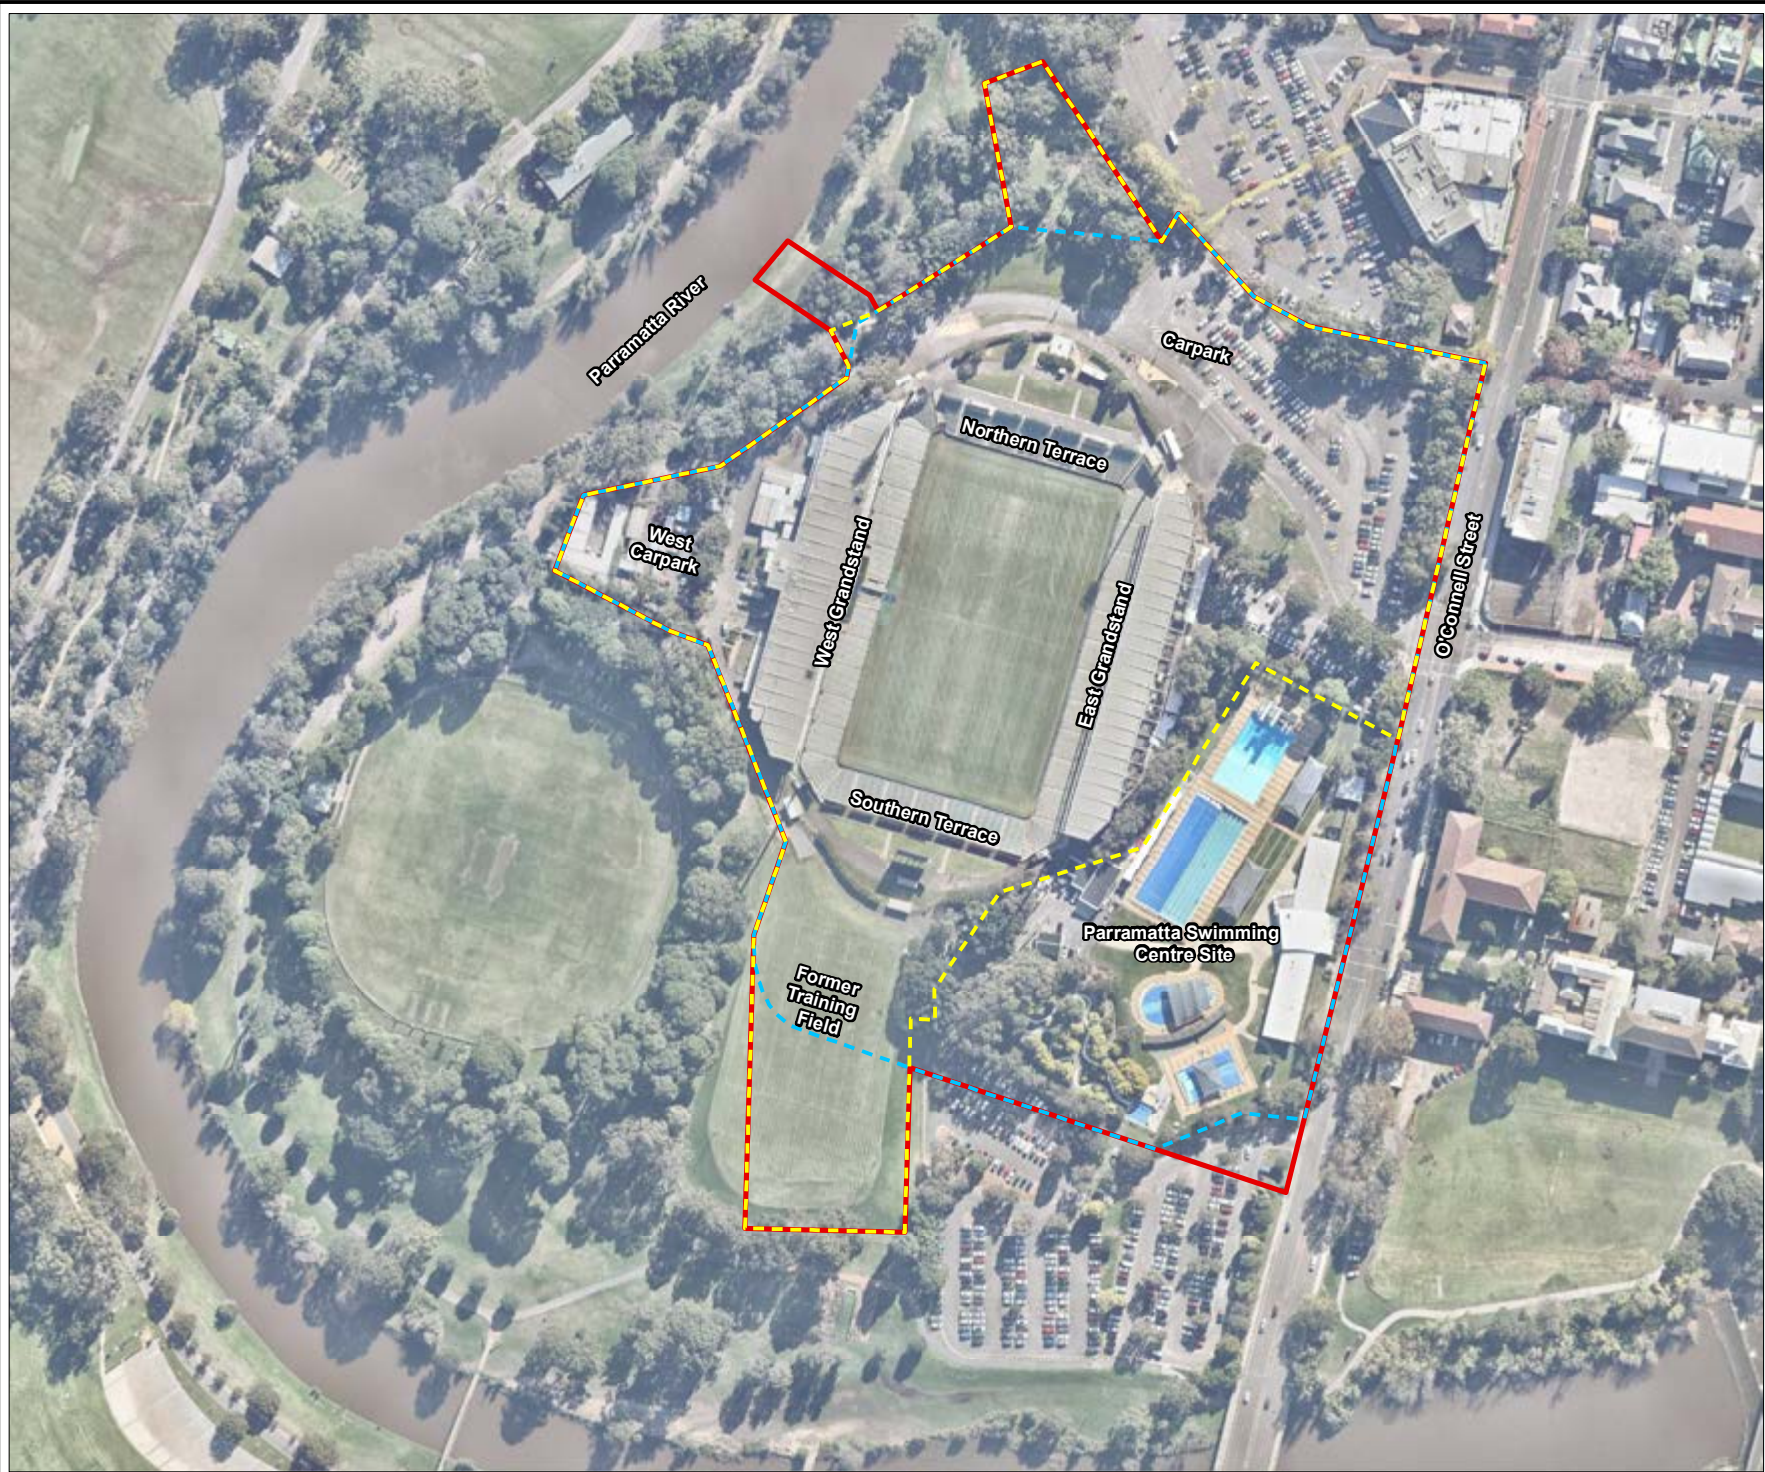
**FIGURE 2**

**SITE LAYOUT**

As noted in **Figure 2**, the south-east portion of the Site comprises the existing Parramatta Swimming Centre (PSC) Site. As a result of access constraints associated with the current facilities, whilst part of the Site, the PSC has been excluded from the site investigation Study Area as shown in **Figure 2**.

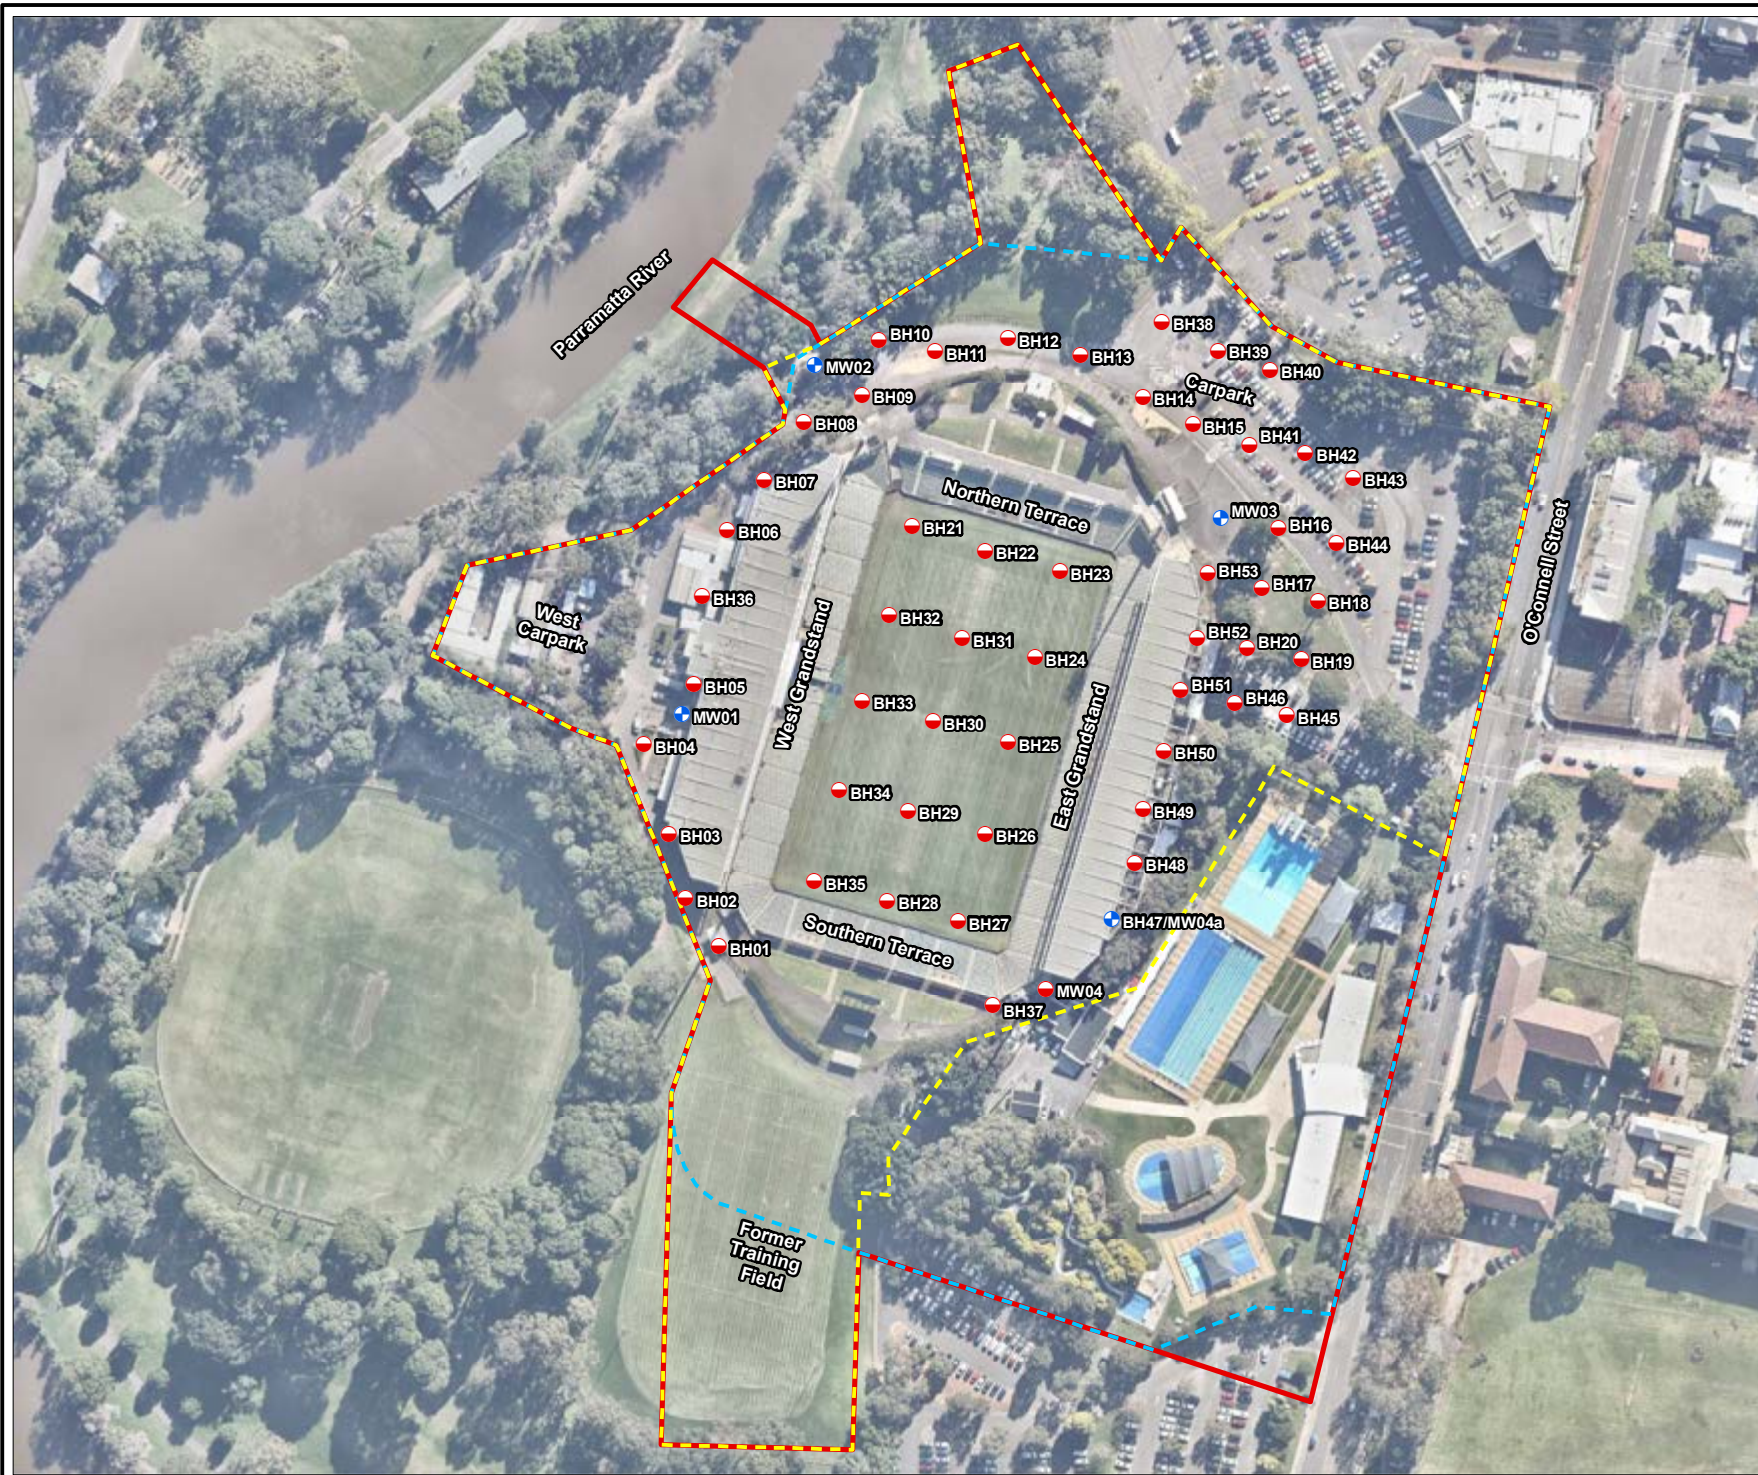
- Legend:**
- The Site
  - The Study Area
  - Demolition Works Area
  - Borehole Location
  - Groundwater Monitoring Well Location

As discussed in **Section 4**, 58 former site investigation locations have historically been advanced in targeted areas, typically in the central north and central south of the Study Area for assessment of soil conditions. To supplement the existing Site data, JBS&G completed subsurface investigation locations as shown in **Figure 4**, comprising the following:

- Forty-two boreholes (BH01 to BH20, BH36 to BH53 and MW01 to MW04) were advanced across the Study Area in areas external to the current stadium facilities on an approximately systematic spacing. Four sample locations were converted into groundwater monitoring wells (MW01, MW02, MW03 and BH47/MW04a). It is noted that MW04 was not converted in a groundwater well as a result of drilling refusal prior to groundwater; and
- Fifteen boreholes (BH21 to BH35) were advanced within the existing playing field footprint.
