CONSERVATION MANAGEMENT PLAN

Volume 1 Main Report

**104-119 DARLINGTON ROAD
121-123 DARLINGTON ROAD
DARLINGTON, SYDNEY**

PREPARED FOR
UNIVERSITY OF SYDNEY
DRAFT DECEMBER 2008
08 1205
TANNER ARCHITECTS
52 ALBION STREET SURRY HILLS NSW 2010

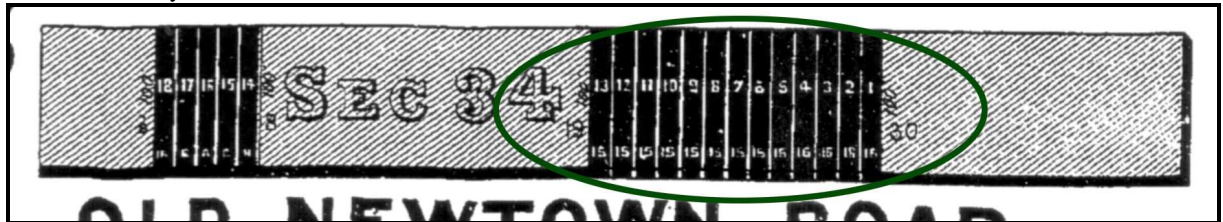
W. H. Paling's allotments of the Golden Grove subdivision. Image sourced from the Mitchell Library – Golden Grove Subdivision Plan G7/16

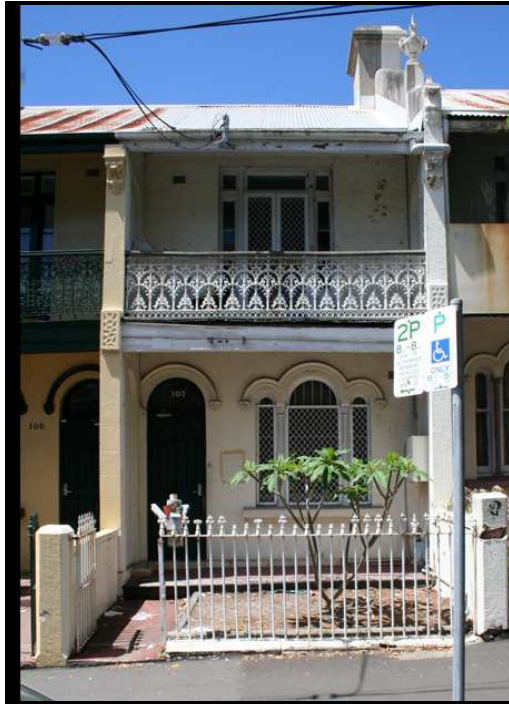
The front elevation of No. 107 Darlington Road.

Typically, each building has a brick masonry load bearing structure set on a sandstone basecourse/foundation. The front (north) elevation is cement rendered with decorative details in the Victorian Filigree architectural style.³⁰ The render is lined-out as ashlar stone masonry construction. The gable roof is sheeted in corrugated metal and projects over the first floor verandah, directly under which is the ground floor verandah. Rendered brick chimneys project above the fire separation/party walls and have a cement-moulded stringcourse, but no chimneypots. The chimneys service two adjoining buildings. The projecting walls above the roof plane retain in some instances pairs of decorative cast cement urns. The party walls on their street frontage are fitted with decorative precast cement panels and brackets.

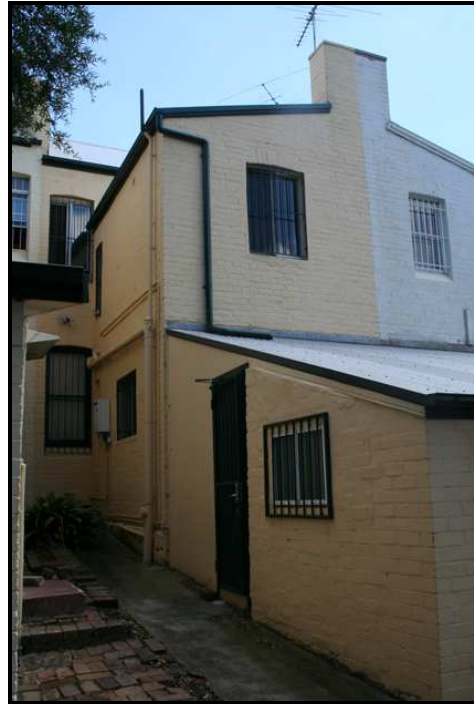
The rear breezeway and service wing of No. 113 Darlington Road.

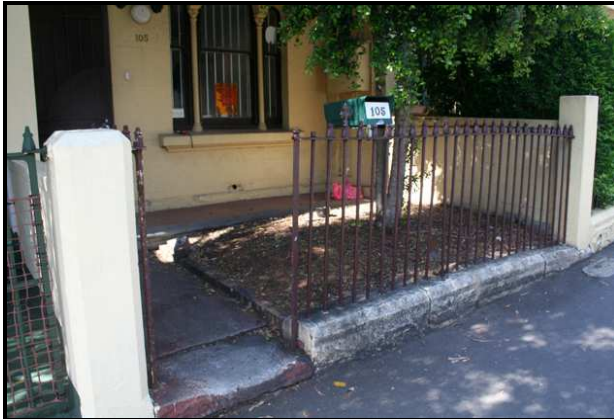
The front garden, fence and path of No. 105 Darlington Road.

Palisade fence The fence to the street boundary is an iron palisade that originally comprised a dressed sandstone plinth with a coping, iron posts with iron spearheads, a wrought iron top rail, stay, and latch keeper. The plinth blocks have a rusticated or rock faced finish with chamfered coping stones.

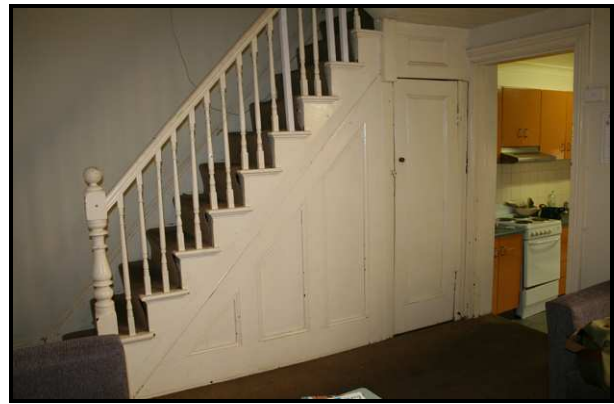
A complete staircase ensemble in the rear living room (102) of No. 109 Darlington Road.

Staircase The staircase is the most elaborate joinery item in the house and is represented in each house within the terrace. The staircase comprises an open string, treads and risers, skirting, turned balusters, newel posts surmounted with a ball motif, and handrails. The handrail has been replaced in 107/102, 113/102-200, 114/200, 116/102-200, 117/102-200, 118/102, 119/102 -200, 121/102-200, 122/102-200, and 123/102-200. Some balusters have also been replaced. The soffit is boarded with a beaded edge, in some instances now lined over in plasterboard. The area under the stairs was originally boxed-in and with a door opening providing a cupboard. There are a few examples of this enclosure, namely in No. 110, 111 and 113, and it is complete with its door in No. 104 and 109. The joinery has been painted and the species of timber and early finishes have not been determined.
