**Dexus Property Group Pty Ltd**

**North Shore Private Hospital, Stage 1 - East Tower**

Remedial Action Plan

26 July 2016

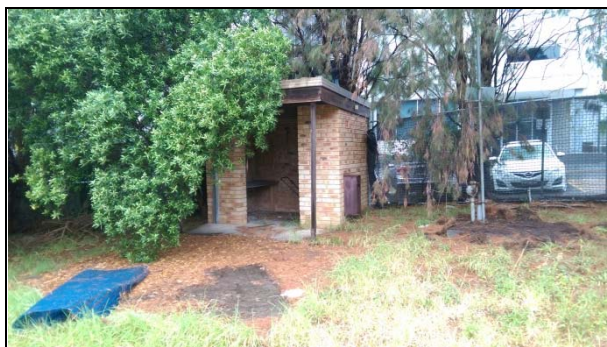
The southern-most part of the site is situated at the crest of the former quarry (approx. RL 98m) and is accessed via locked gates along Reserve Road boundary. This part of the site was reportedly used as a landing site for helicopters transporting patients to/from the adjoining North Shore Hospital site. This part of the site is currently vacant with the exception of a small brick structure and concrete pad adjacent to the Westbourne Street boundary (refer Photo 1). The use of this brick structure is not known. The adjoining concrete pad appears consistent with petroleum storage infrastructure, comprising a small underground storage tank (UST), hand pump and vent pipe. No UST dip/fill points were noted (refer Photo 2).

**Photo 1:** brick structure and underground petroleum storage infrastructure.

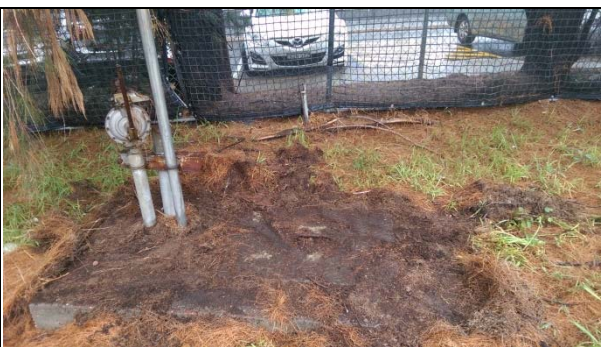
**Photo 2:** concrete slab with suspected hand pump and vent pipe.
