**Dexus Project Pty Ltd**

**North Shore Private Hospital, Stage 1 - East Tower**

**Geotechnical Investigation Report**

4 April 2016

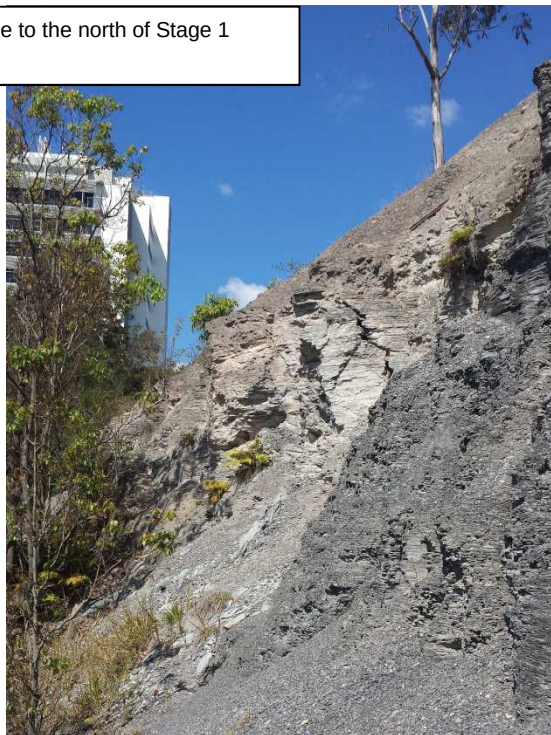
Plate 2 – Photo of exposed shale to the north of Stage 1 development

Former quarry walls are exposure to a depth of about 18 m below street level to the north of the Stage 1 site. These exposures indicate weathered Ashfield Shale bedrock, grading from residual soil at road level, to slightly weathered to fresh bedrock at the base of the excavation. The weathering due to exposure may disguise the true rock condition behind the faces. Plate 2 shows a typical rock excavation observable to the north of the Stage 1 development.

Our desktop study (GEOTLCOV25513AA-AC) identified the following possible members within the Ashfield Shale:

- The lower shale face that is cut more steeply represents the Rouse Hill Siltstone member, comprising dark grey to black siltstone/mudstone.
- The upper quarry wall faces are assessed as the Kellyville Laminite member which is a regularly laminated dark grey siltstone and fine-grained sandstone.
