## **Appendix A - Borelogs**

# Engineering Log - Borehole

project: **Forensic Pathology & Coroners Court**

location: **480 Weeroona Road, Lidcombe**

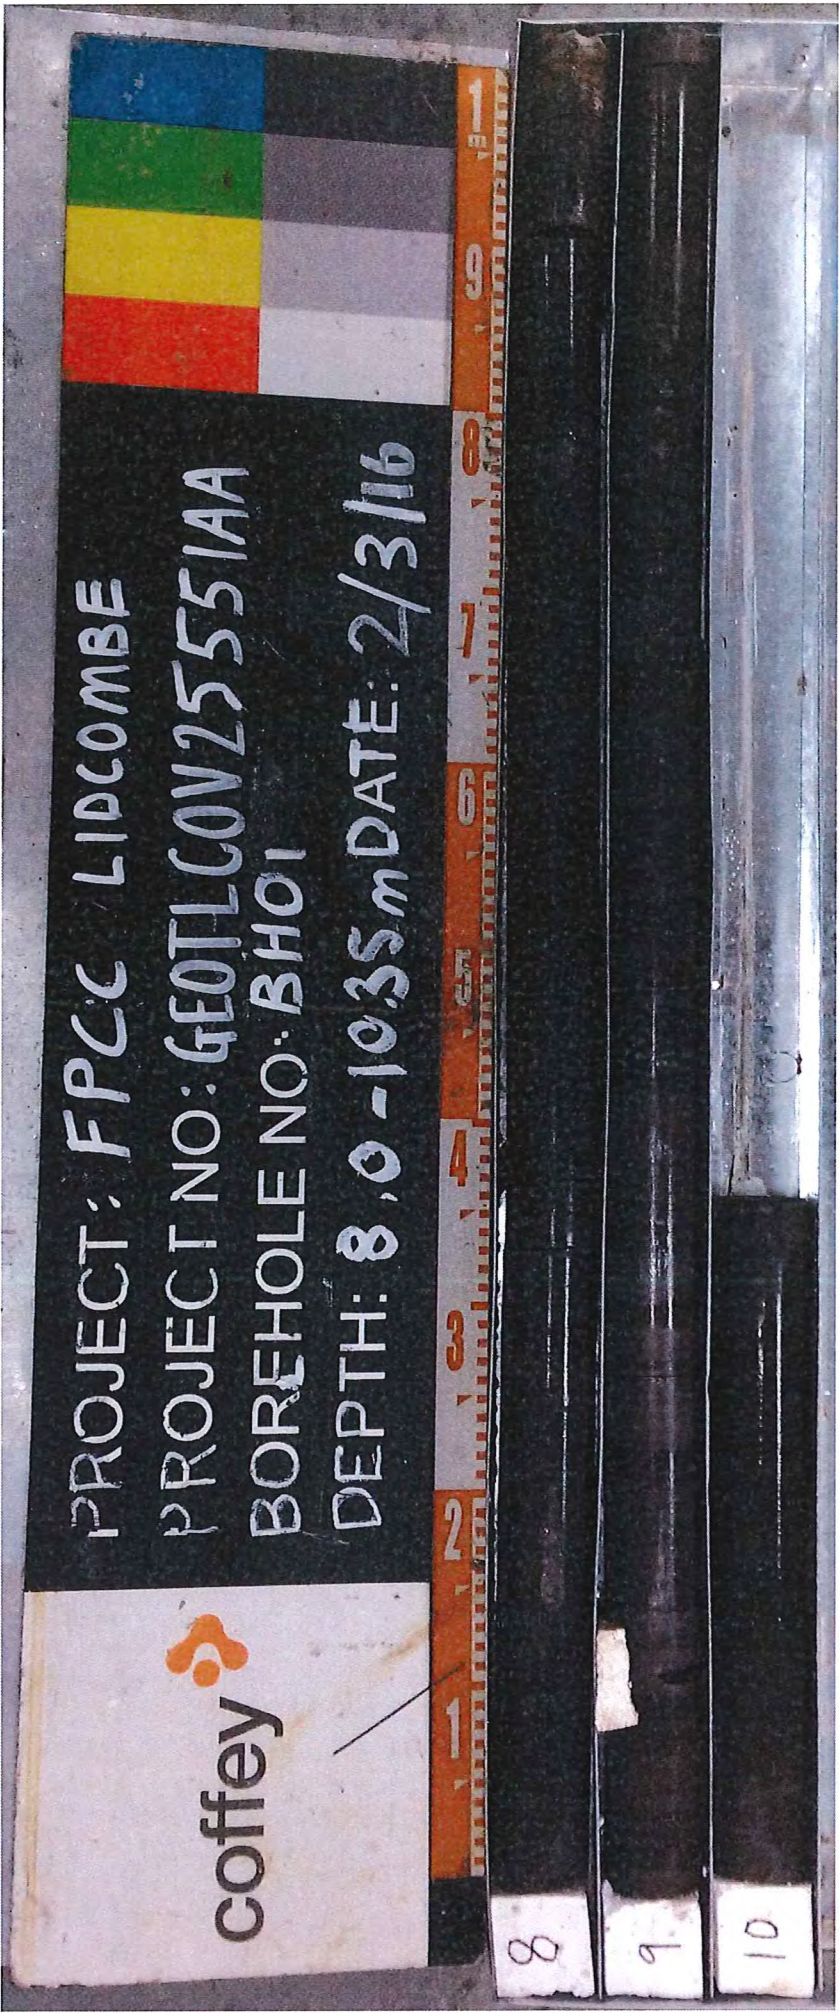
| | | project no: GEOTLCOV2551AA | fig no: <b>FIGURE 2</b> | rev: |

PointID : BH01 Depth Range: 8.00 - 10.35 m

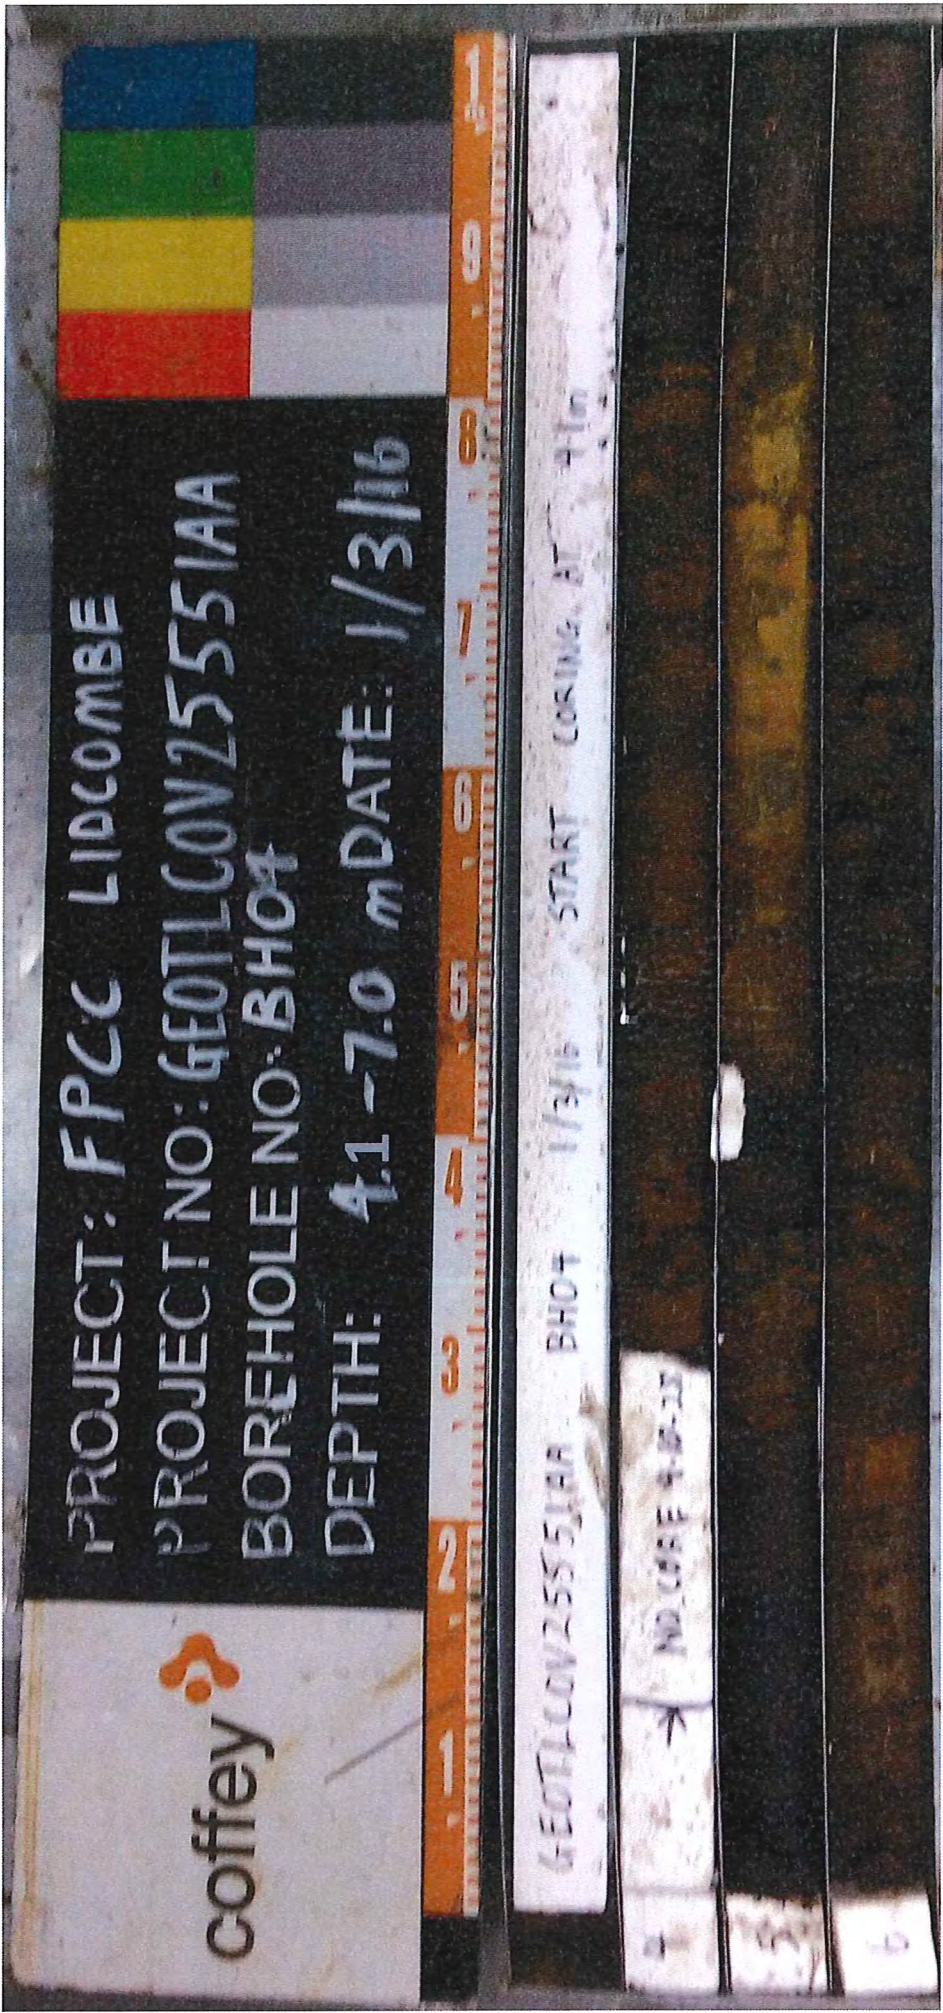
| original size | A4 | | fig no: | FIGURE 1 |

PointID : BH04 Depth Range: 4.10 - 7.00 m

| date | 15/03/2016 | | title: | CORE PHOTOGRAPH<br>BH04 |
