| project: | FORENSIC PATHOLOGY AND CORONERS COURT<br>480 WEEROONA ROAD, LIDCOMBE, NSW | | |
| title: | BOREHOLE LOCATION PLAN | | |
| project no: | GEOTLCOV25551AA-AJ | figure no: | FIGURE 1 |

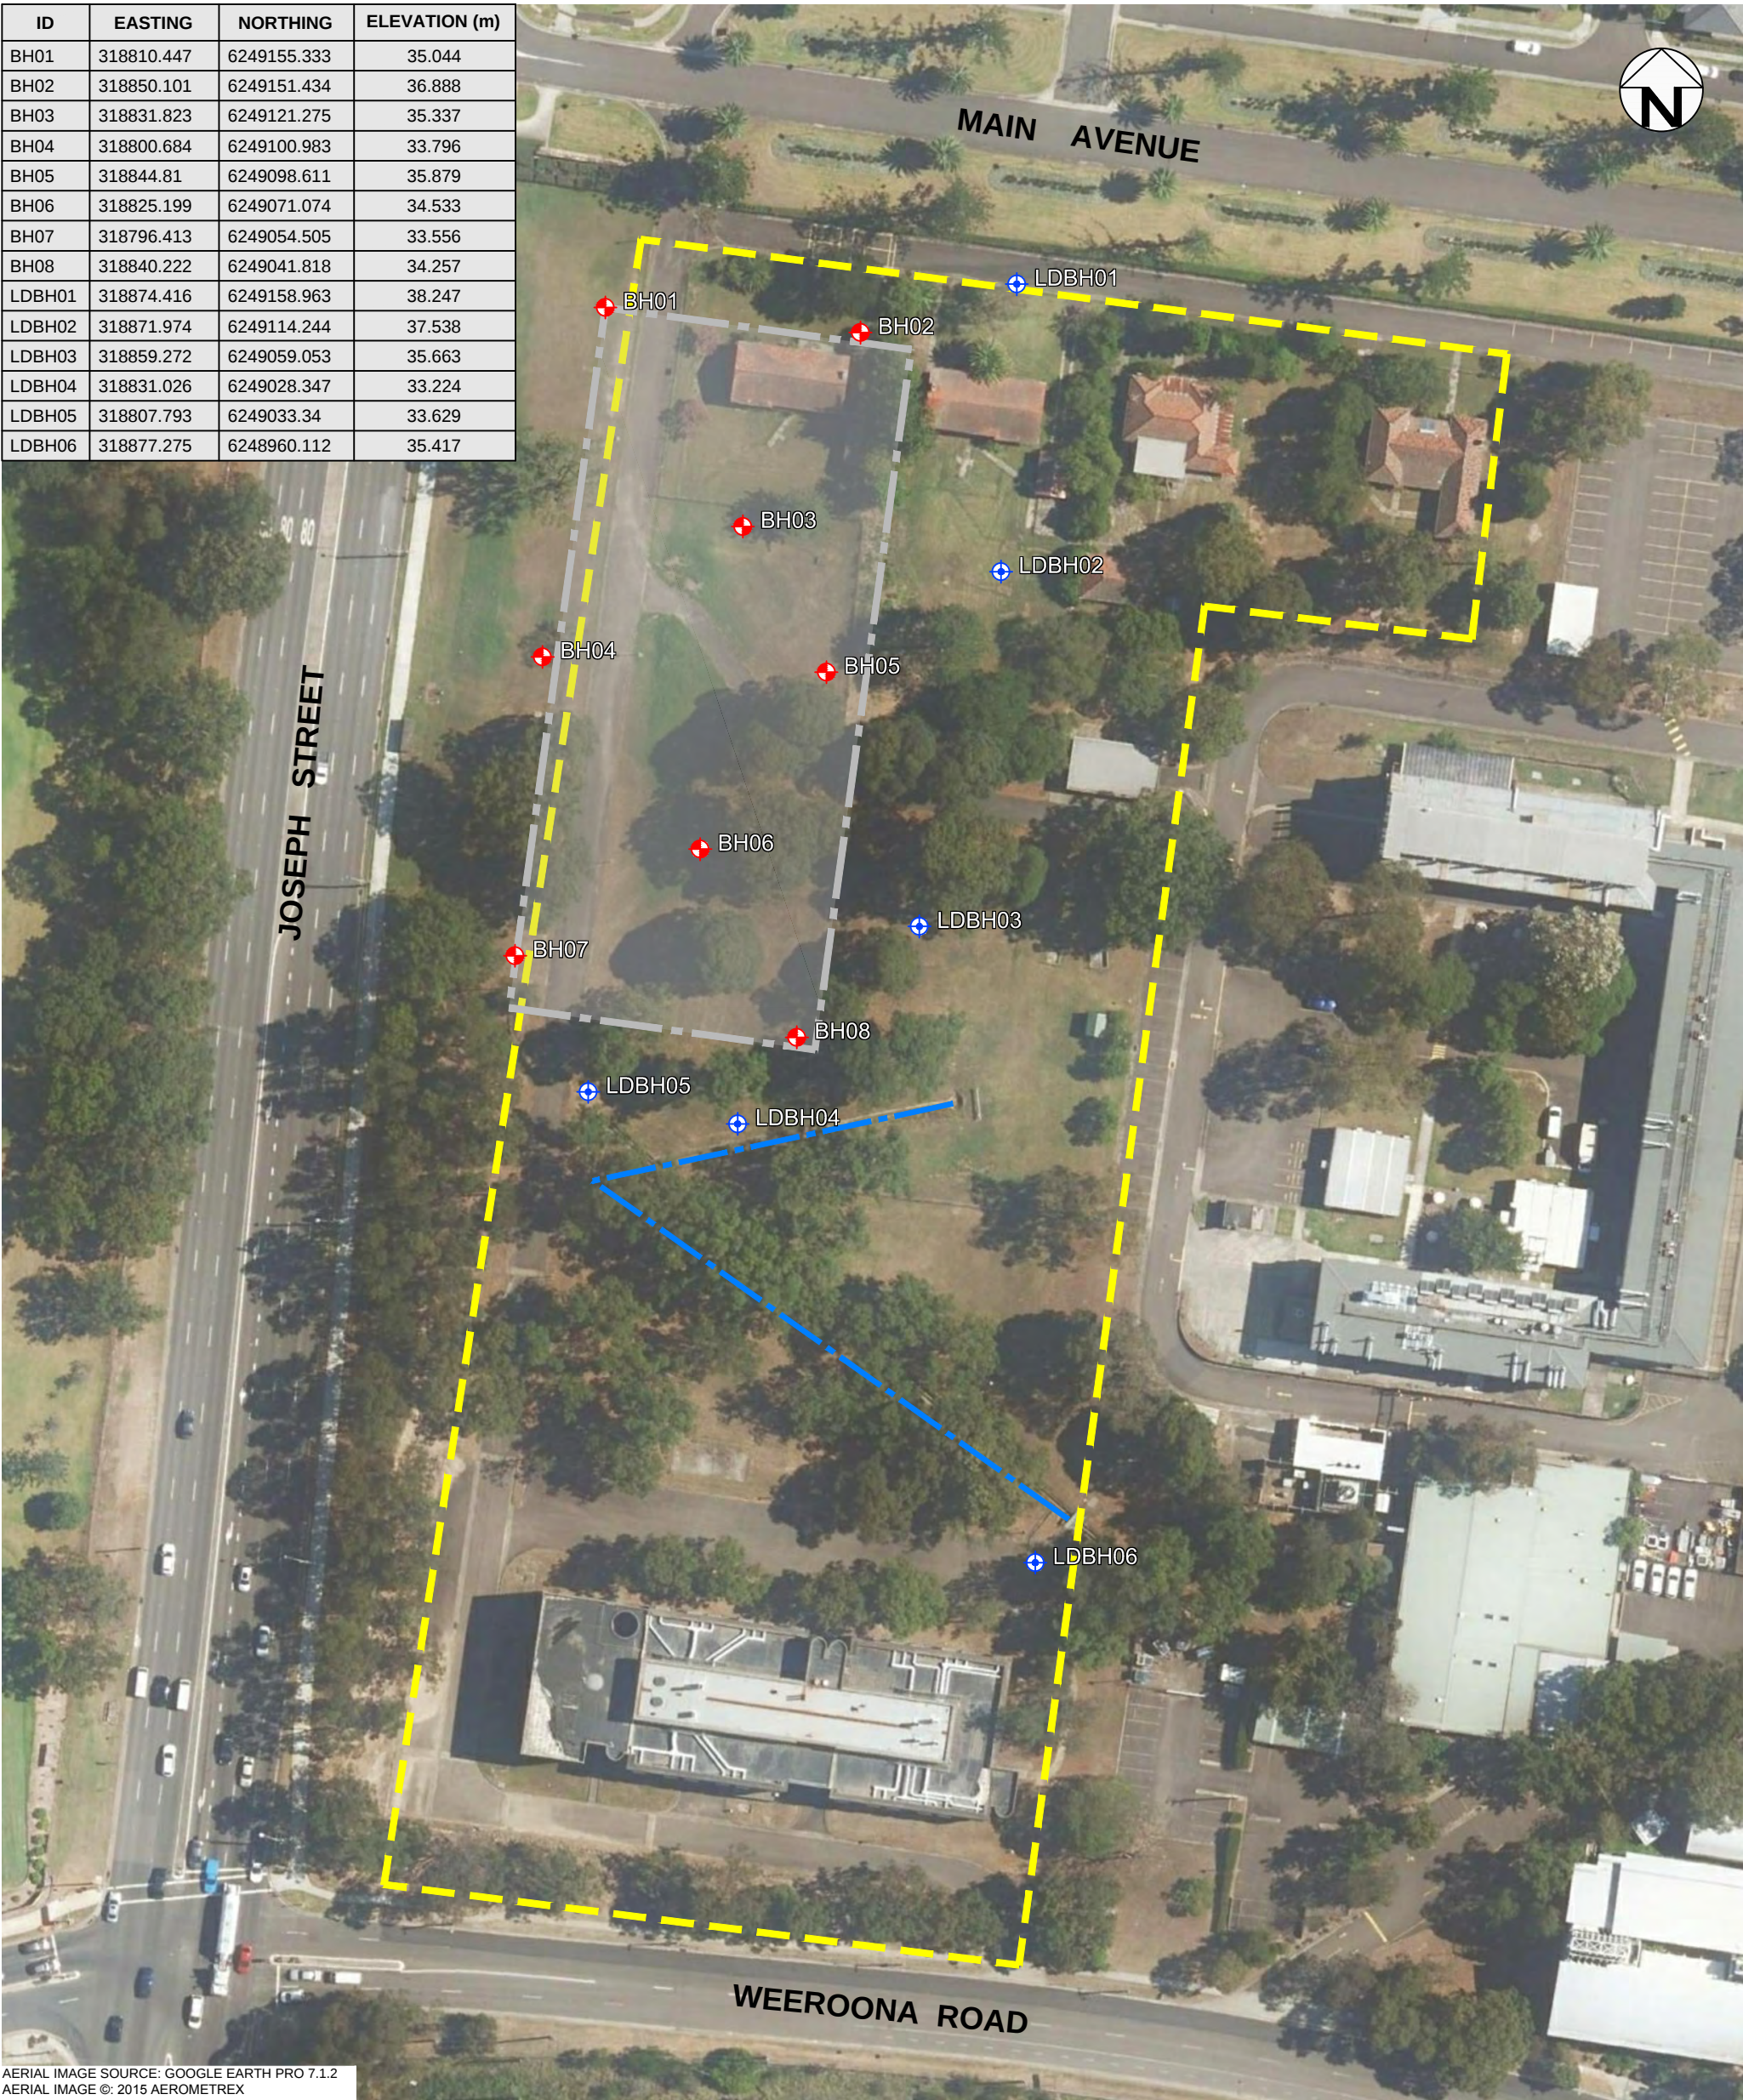
- BOREHOLE LOCATION
- LARGE DIAMETER BOREHOLE LOCATION
- SITE BOUNDARY
- INFERRED POSITION OF CONCRETE LINED DRAIN
- APPROXIMATE LOCATION OF FPCC BUILDING FOOTPRINT

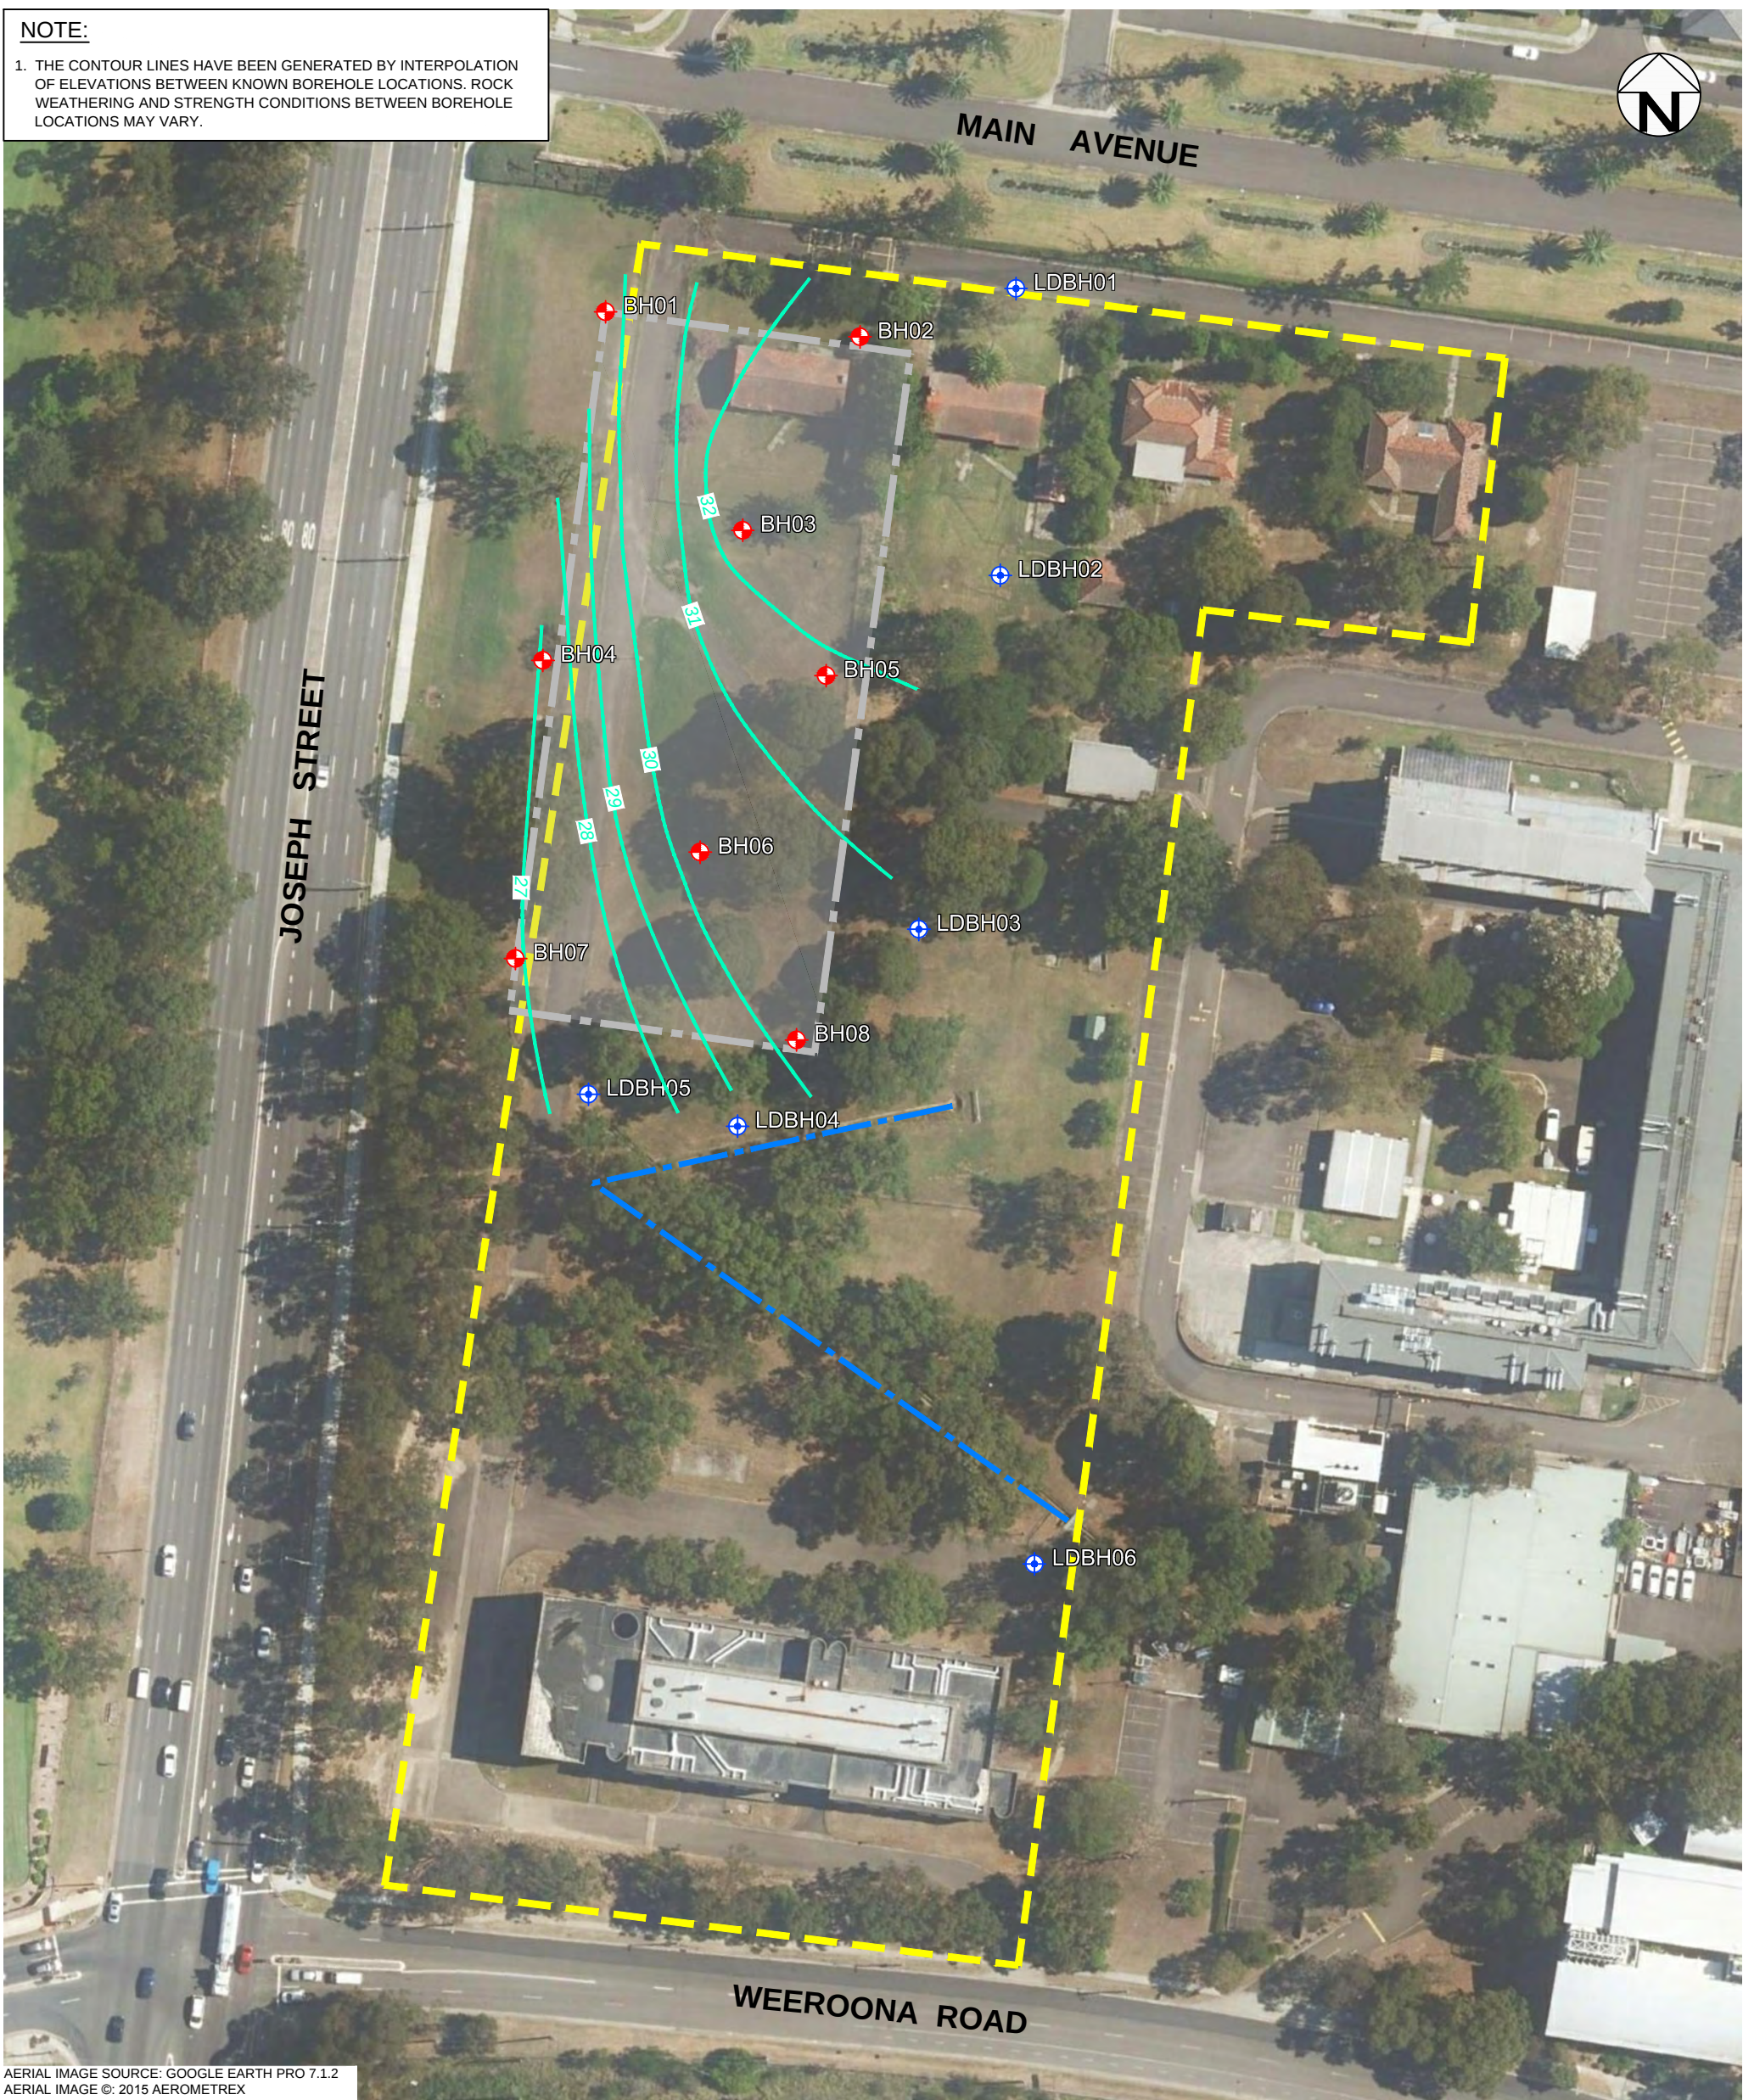
1. THE CONTOUR LINES HAVE BEEN GENERATED BY INTERPOLATION OF ELEVATIONS BETWEEN KNOWN BOREHOLE LOCATIONS. ROCK WEATHERING AND STRENGTH CONDITIONS BETWEEN BOREHOLE LOCATIONS MAY VARY.

| revision | no. | description | drawn | approved | date | LEGEND | | | | |
|---|---|---|---|---|---|---|---|---|---|--|
| | | | scale | AS SHOWN | | | title: TOP OF CLASS III CONTOUR MAP | | | |

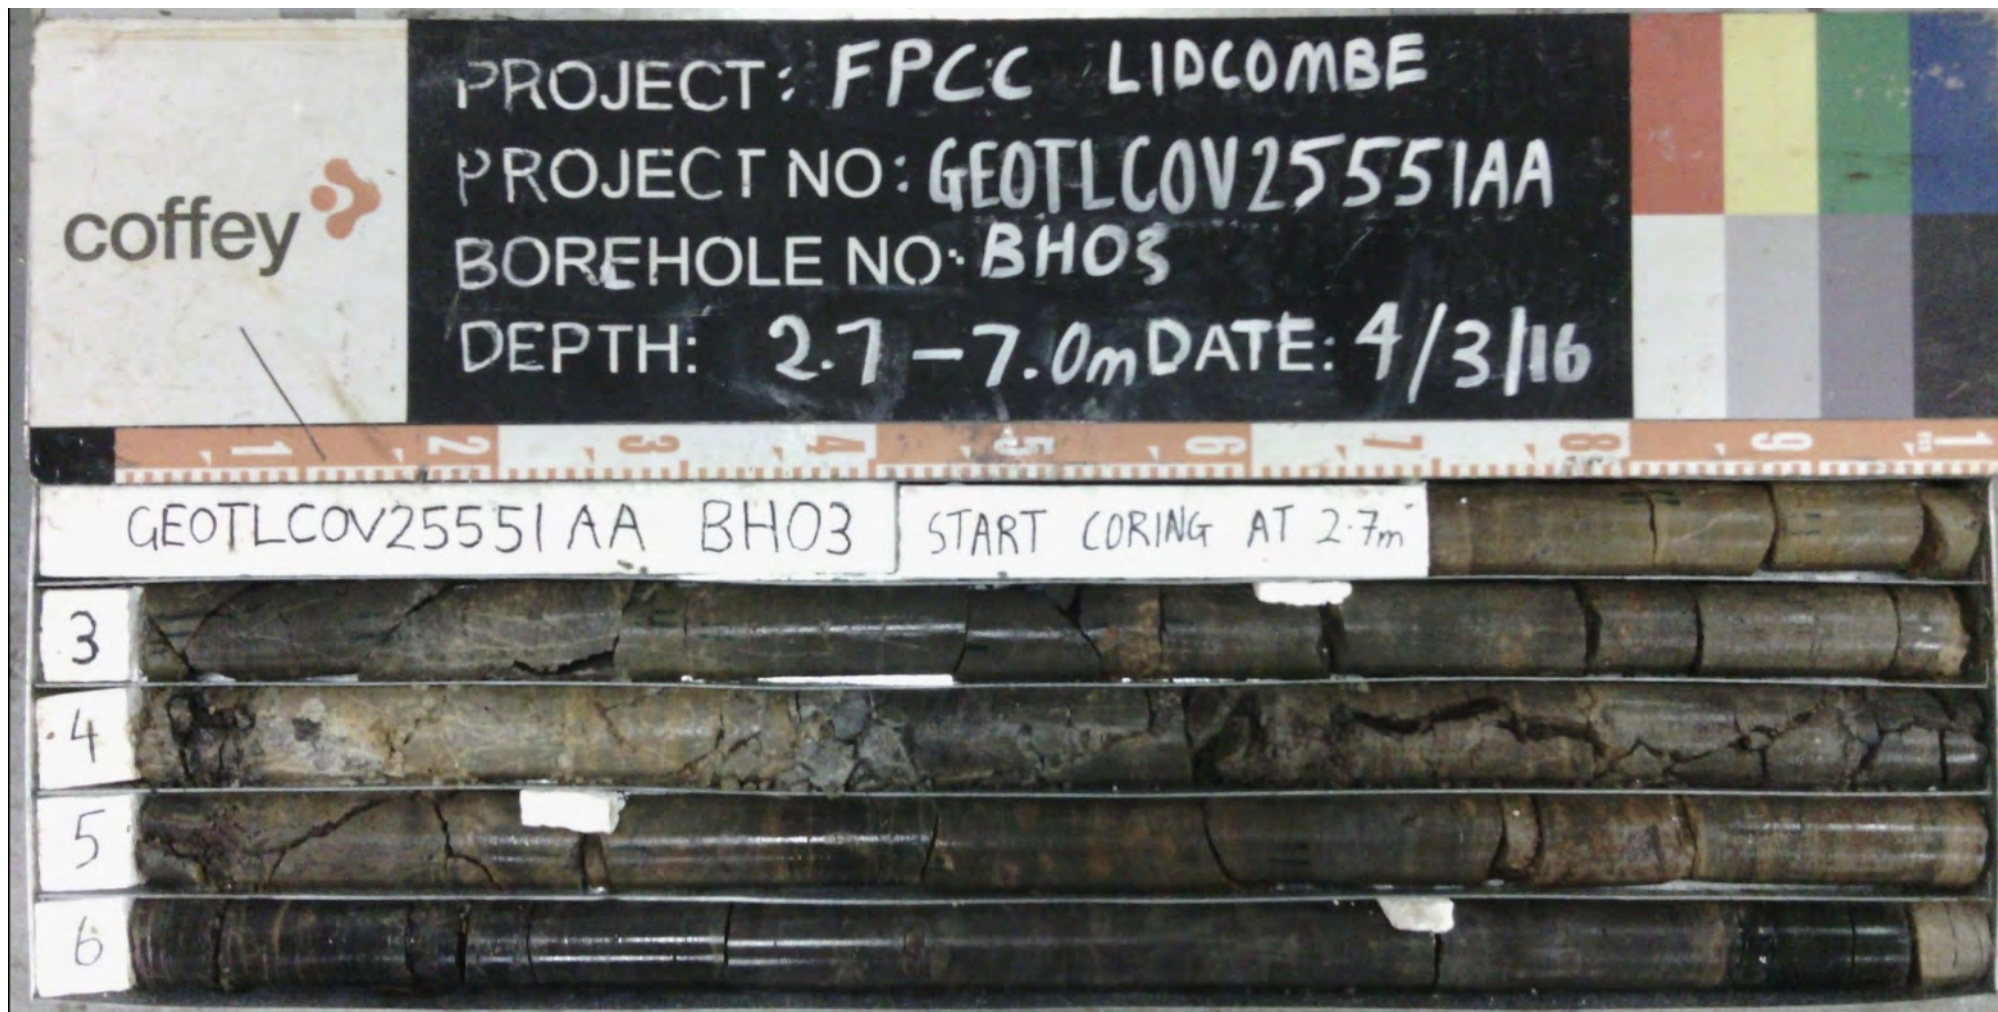
PointID : BH03 Depth Range: 2.70 - 7.00 m

| drilling information | | | | material substance | | | | rock mass defects | | | | |
|---|---|---|---|---|---|---|---|---|---|---|---|---|
| | | -32 | 3.0 | | start coring at 2.70m<br><br>SHALE: grey and dark grey, orange-brown staining, distinctly laminated at 0-5°. | SW | X | a=0.41<br>d=0.22 | 92% | | SM, 0 - 5°, IR, Clay filled<br>PT, 0 - 5°, PL - IR, RO, VN | |
