**Report on Geotechnical Investigation**

**Proposed Seniors Housing**

**2-32 Junction Street, Forest Lodge NSW**

**Project 229796.00**

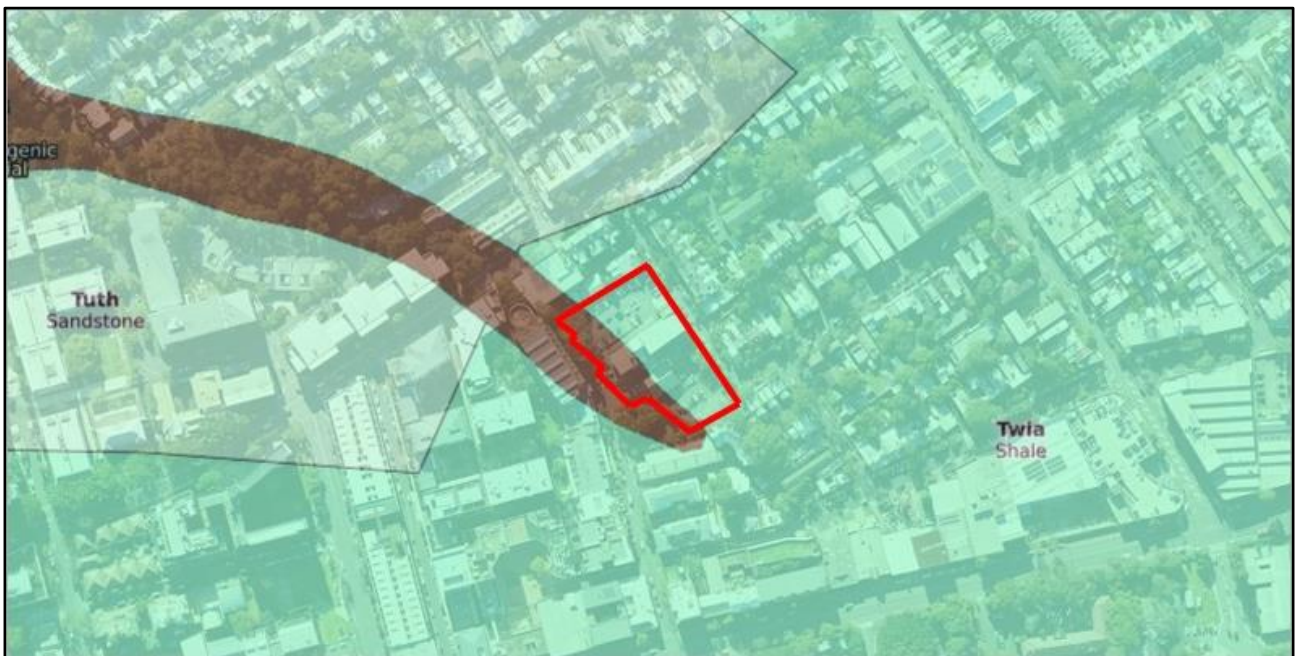
**Figure 1: NSW Seamless Geology map with site location.**

Reference to the NSW Seamless Geology Map indicates that the site is underlain Ashfield Shale, which generally comprises dark grey shale and laminite; but is also close to the border of the Hawkesbury Sandstone formation that underlies the Ashfield Shale formation, so either formation may be present at the surface. An extract of the NSW Seamless Geology Map is shown in Figure 1. The mapping also indicates the presence of anthropogenic (i.e., fill) material in the southwest of the site where the former creek extended.

The site investigations encountered residual clays and medium to coarse grained sandstone with minor laminite, from the Hawkesbury Sandstone formation, and also encountered deeper fill material in the southwest of the site. The investigation results are consistent with the site context and geological mapping, although noting that Ashfield Shale was not encountered.

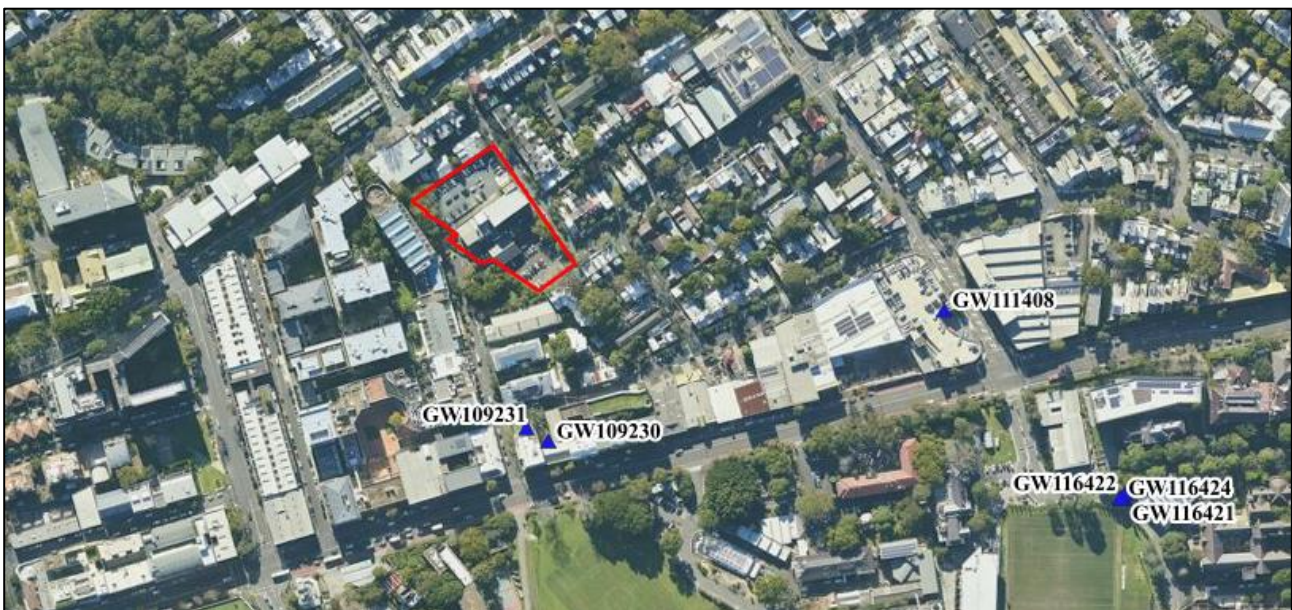
**Figure 2: Nearby registered groundwater wells with site location**

Water levels are noted on four of the six well records. The standing water level depths noted on the well records, where present, are summarised in Table 1. Elevation survey data is not available for the wells.

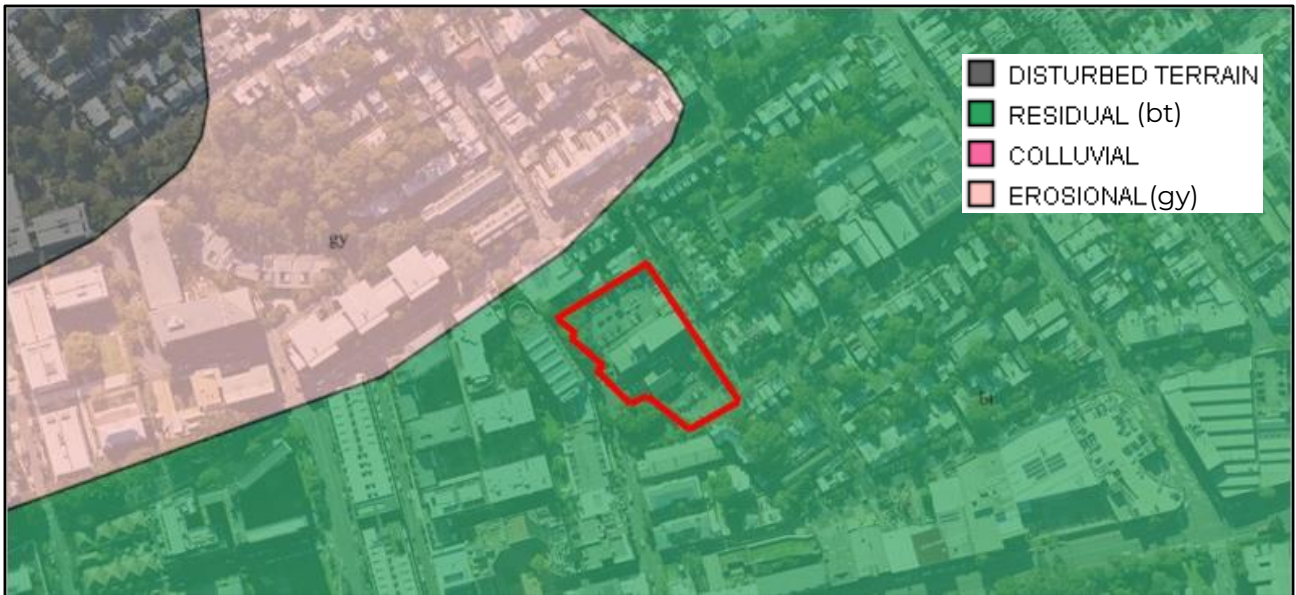
**Figure 3: Soil landscape mapping with site location**

Reference to the 1:100 000 Sydney Soils Landscape Sheet indicates that the Blacktown Residual Soil Landscape (bt) is mapped over the site with the Gynea Erosional Soil Landscape mapped to the north of the site. The Blacktown residual landscape is characterised by undulating rises on Wianamatta Group Shales, with local relief of 30 m, and slopes usually >5%. This soil landscape is shallow to moderately deep (>100cm) hard-setting mottled texture contrast soils, red and brown podzolic soils on crests grading to yellow podzolic soils on lower slopes and in drainage lines. The Gynea landscape to the north of the site is characterized by undulating to rolling rises and low hills with rock outcrops and shallow, highly permeable sands. An extract of the soil landscape map is shown in Figure 3.

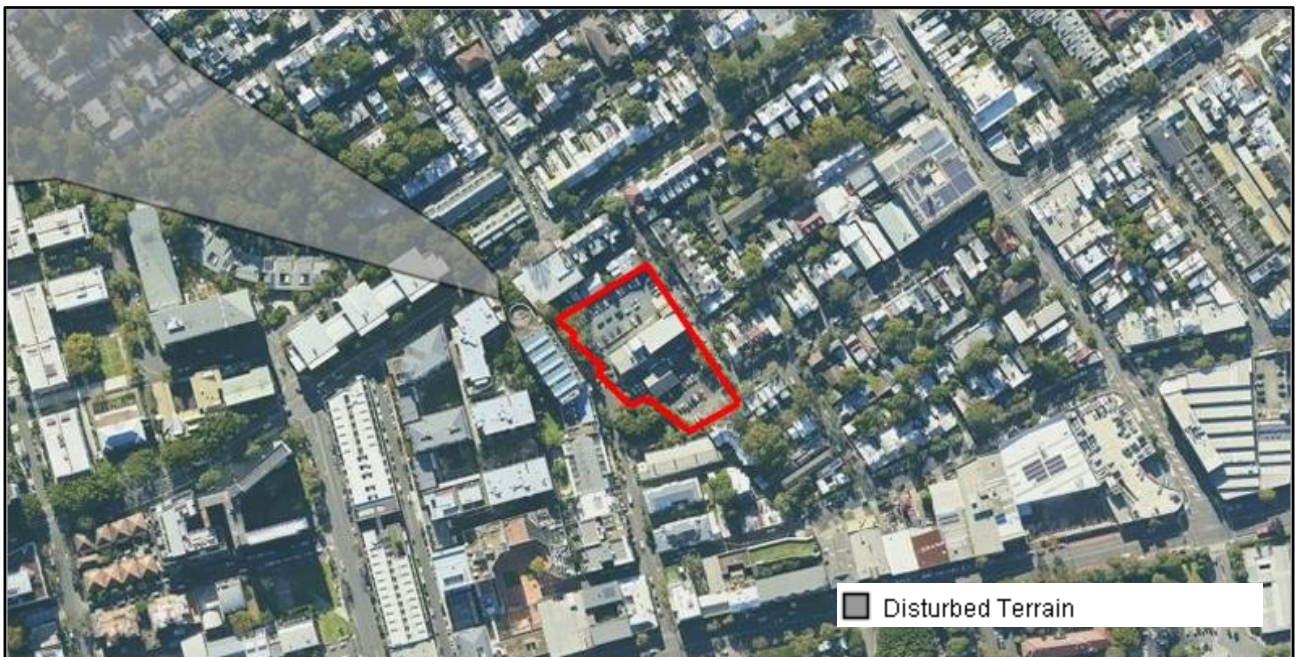
**Figure 4: Acid sulfate soil mapping with approximate site location**

Reference to the NSW Acid Sulfate Soils Risk Mapping indicate that the site is near to an area mapped as disturbed terrain, elevation >4 m AHD. This layer follows Orphan School Creek to the north-west of the site, along the same alignment as the backfilled historical drainage line on the south-western boundary of the site. An extract of the Acid Sulfate Soil map is shown in Figure 4.
