# REMEDIATION ACTION PLAN

10 HERBERT STREET, ST LEONARDS, NSW

**Ramsay Health Care Limited**

Project no: 2268308A  
Date: November 2015

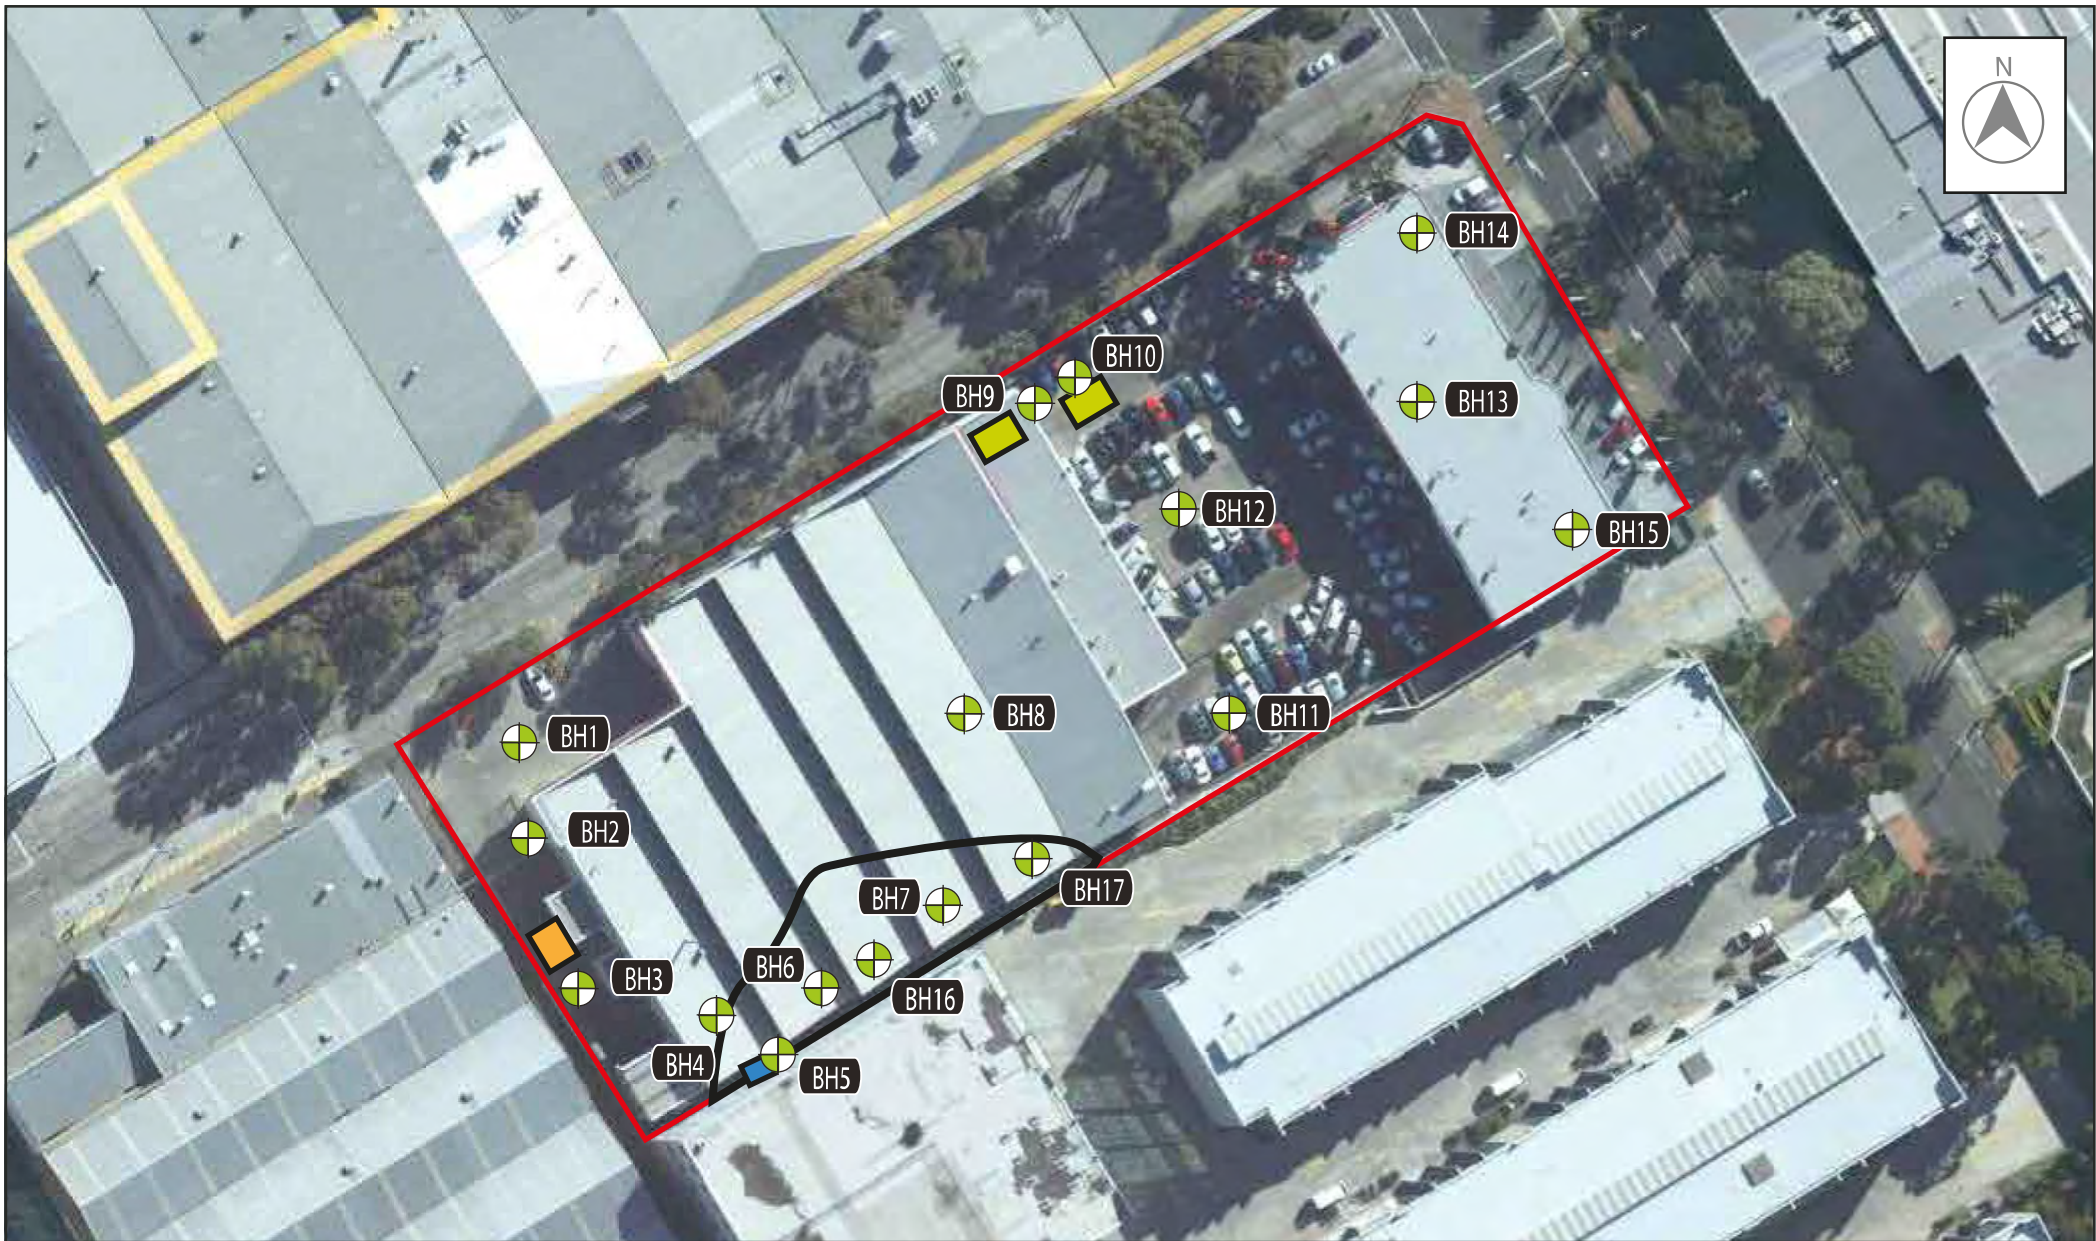
**FIGURE 3**

- Site Boundary
- Operational UST
- Non-Operational UST
- Oil / Water Separator
- Approximate Lateral Extent of Former Quarry Area on Property
- BH1
Borehole Location

Investigation Locations  
10 Herbert Street, St Leonards, NSW  
00040387

- Evidence of two non-operational USTs was identified in the northern portion of the Site, adjacent Frederick Street. The location of one potential UST was identified by visual evidence of concrete cutting and replacement, in addition to a ground penetrating radar (GPR) confirmed a sub-surface anomaly indicative of back-fill material. No fill or dip points were observed. The second potential UST was identified by the observation of a potential fill/dip point that had been concreted shut. A GPR scan confirmed a sub-surface anomaly which may indicate the UST was decommissioned in-situ or historically removed and back-filled.

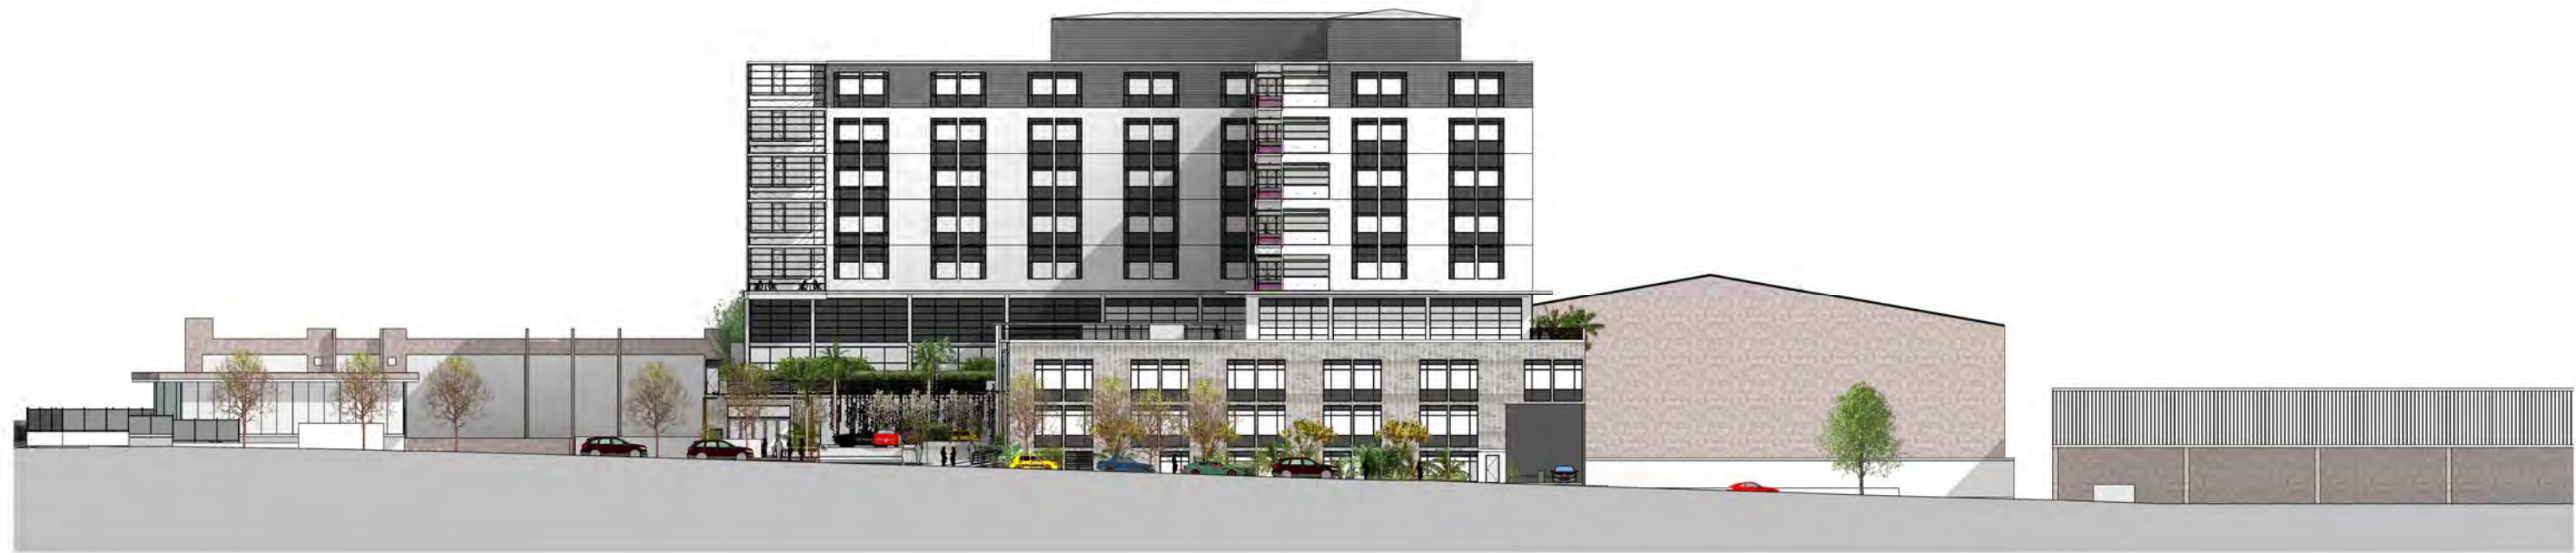
2 Proposed Street Elevation  
1 : 500

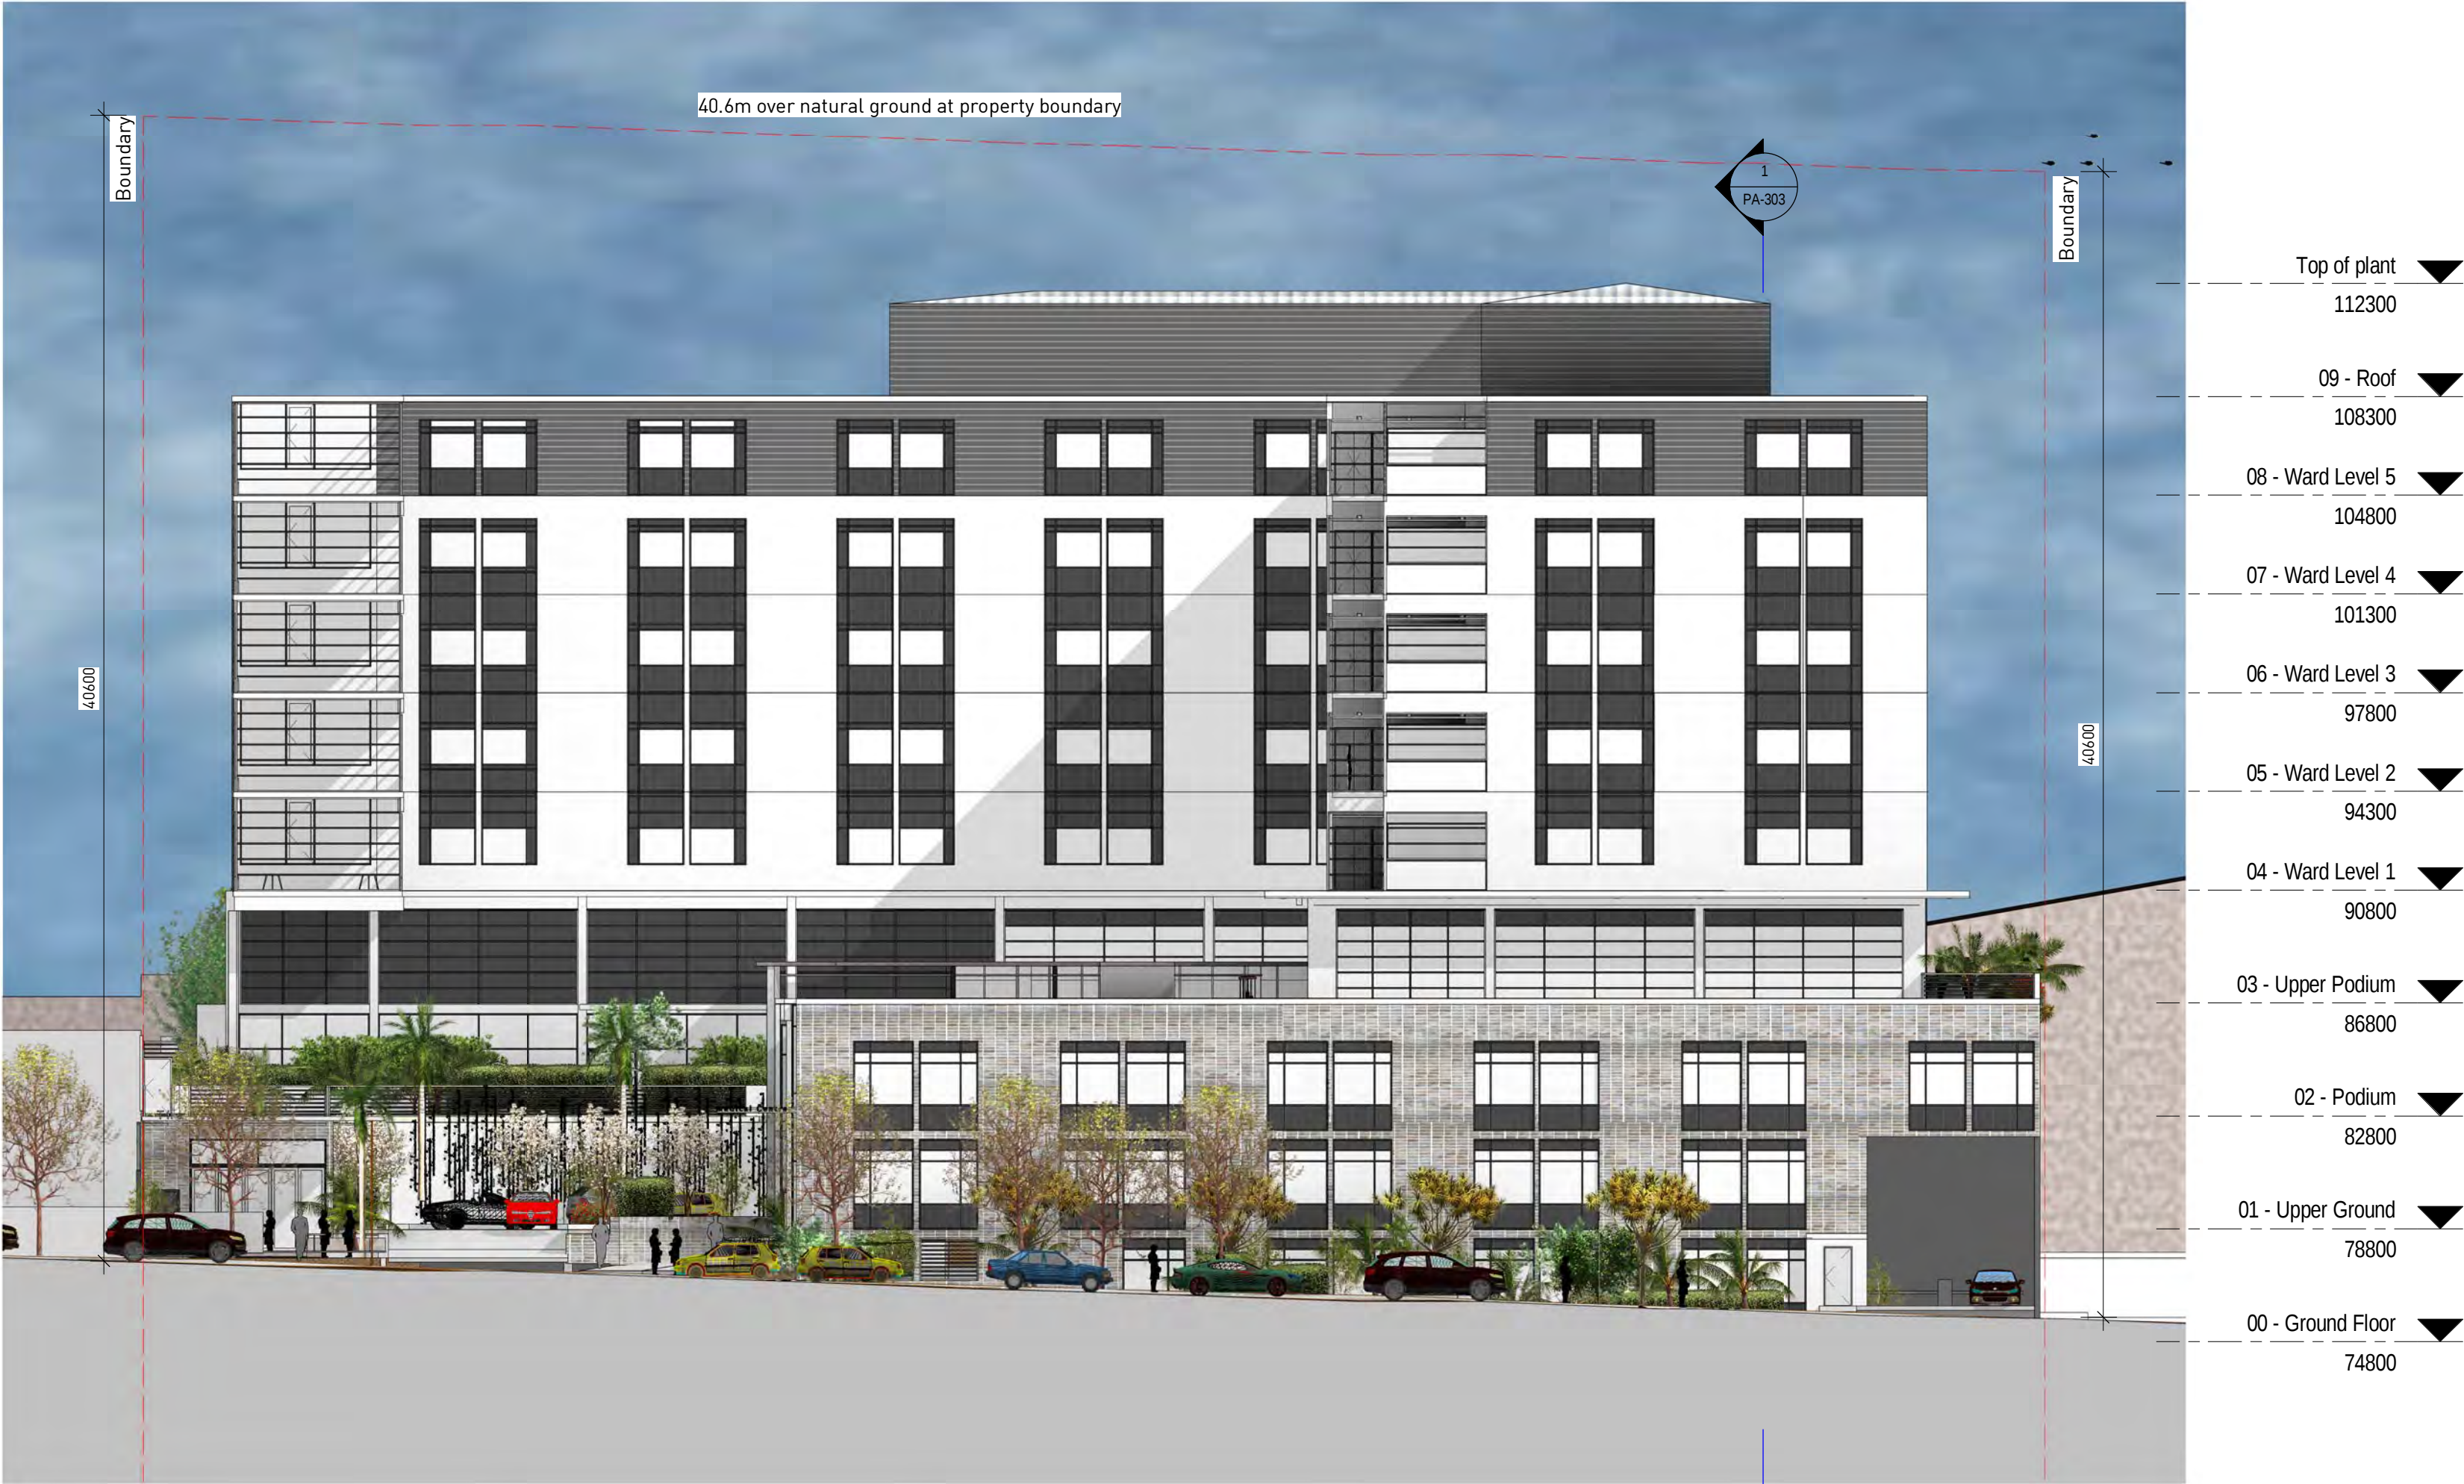
1 North Elevation  
1 : 200

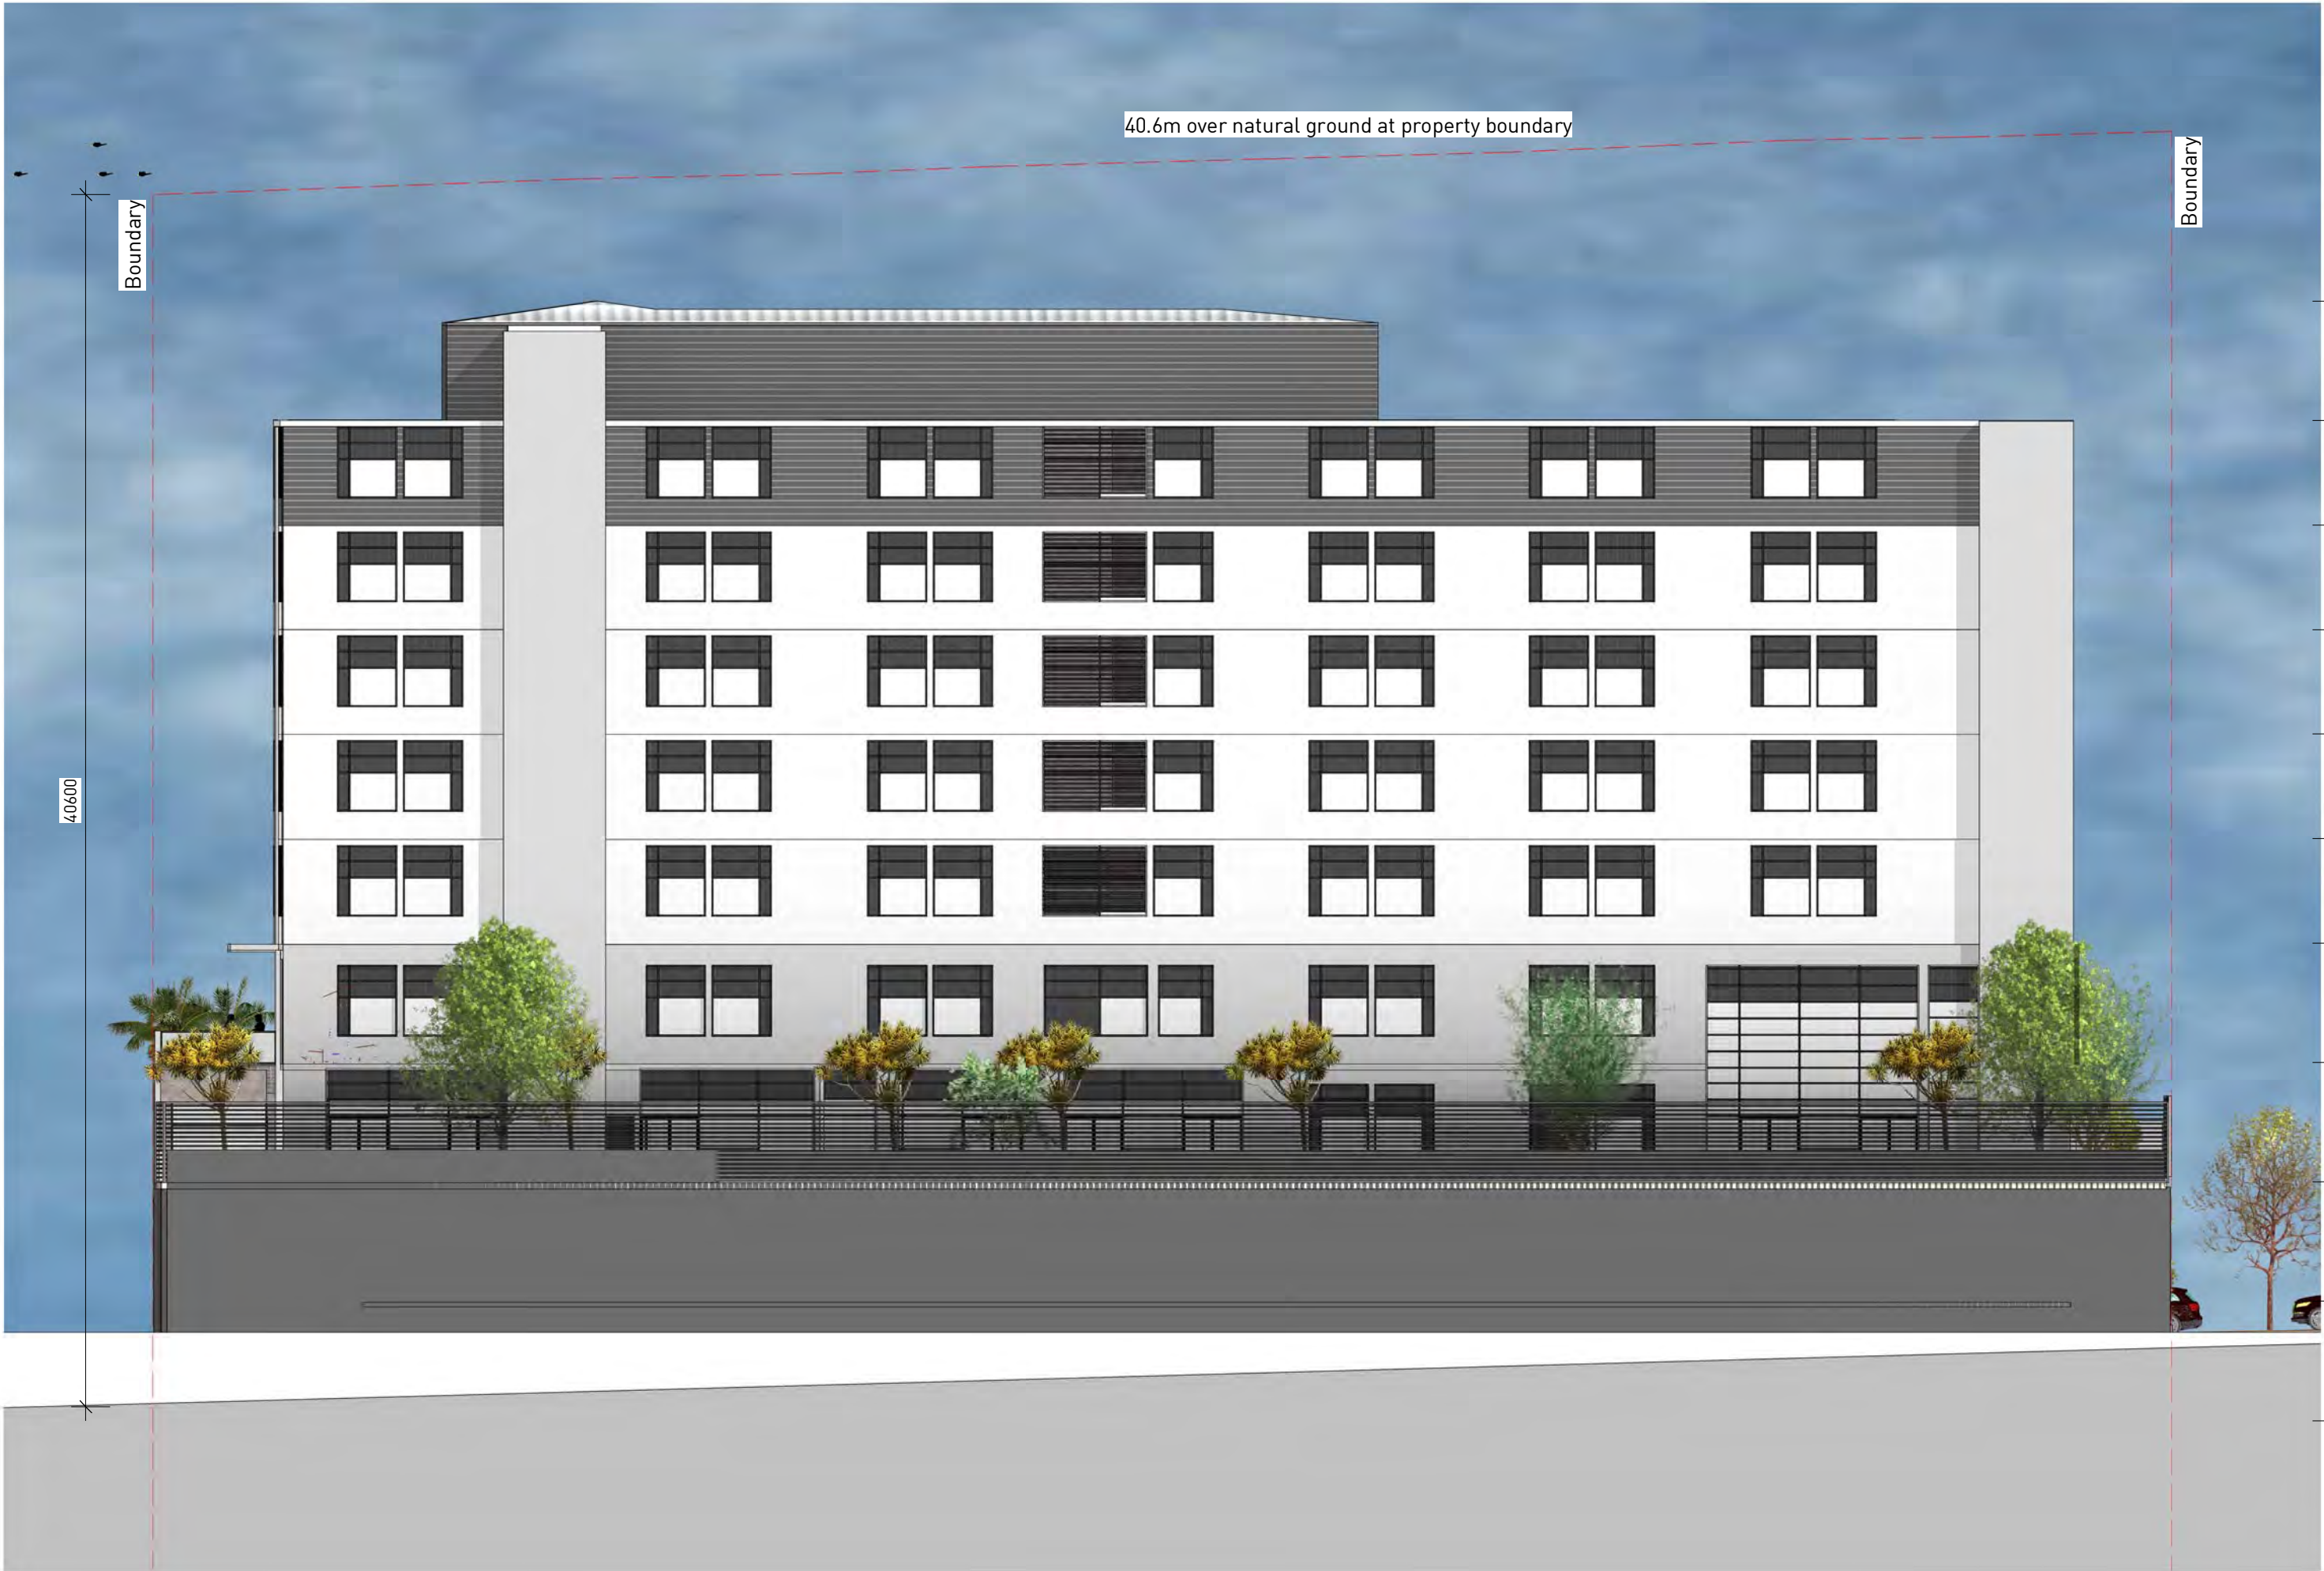
1 South Elevation  
1 : 200

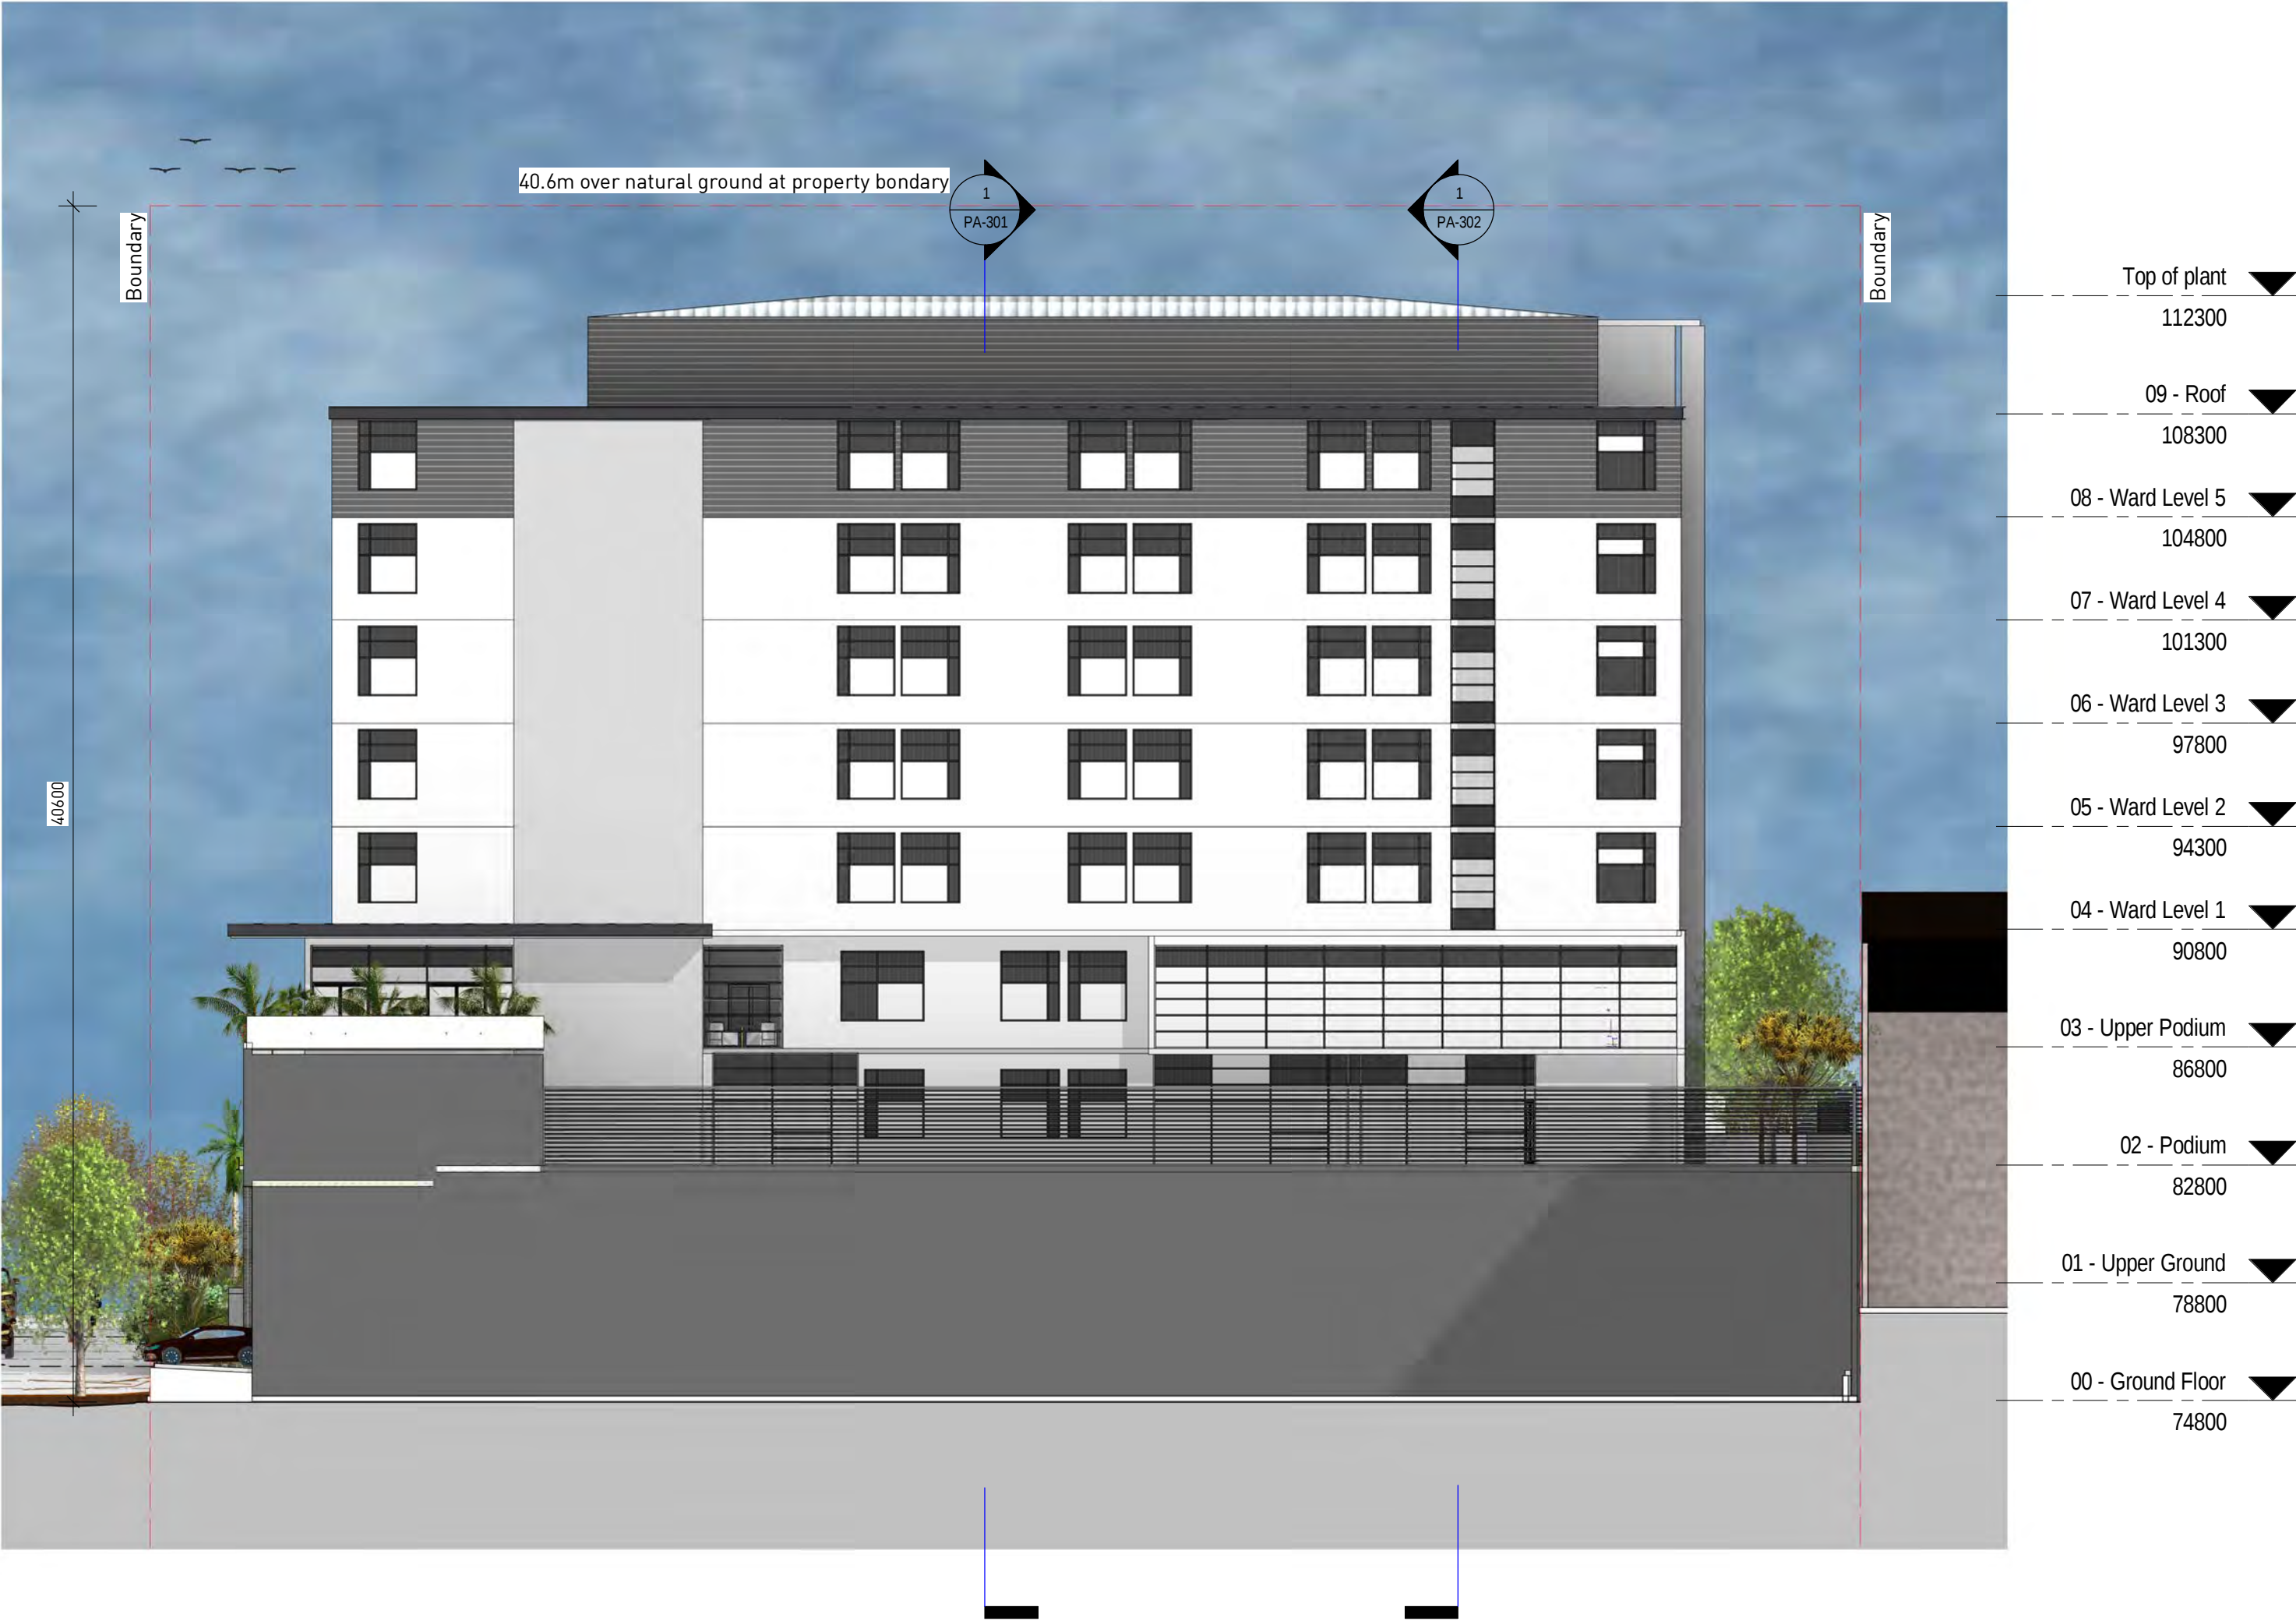
1 West Elevation  
1 : 200
