# Springvale Water Treatment Project

State Significant Development 7592  
Environmental Impact Statement  
Volume 2 - Appendix H2

## **6. Existing environment – aquatic ecology**

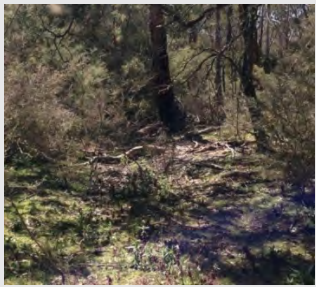
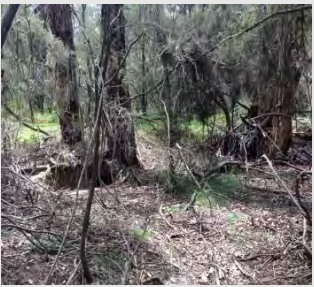
**Table 6-2 Representative photographs of site NCup**

During the 2013 and the 2014 surveys (GHD, 2014b), the site was dry. The channel is small and undefined and it is likely this site only holds water during periods of rain. Large amounts of leaf litter were observed in the channel. Native open forest, including large snow gum (*Eucalyptus pauciflora*) surround the site.

| Site | September 2013 | May 2014 | October 2014 |
|---|---|---|---|
| NCup facing upstream showing the dry undefined channel | | | |

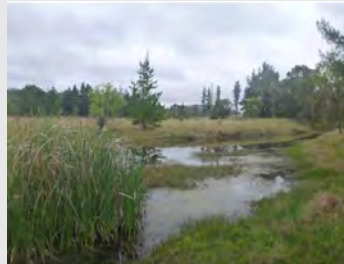
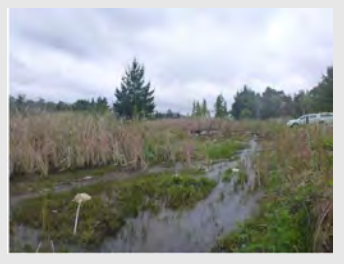
**Table 6-11 Representative photographs of site CR3 (MPR, 2014b, 2015a, b, d 2016b, c)**

Surveys undertaken by MPR indicated that the monitoring site has a consistent condition during both autumn and spring monitoring rounds. MPR indicated that water is clear and flowing through site length with a maximum depth to 0.7 m and average depth 0.2 m. The types of edge habitat that observed by MPR during monitoring included trailing bank vegetation, macrophytes (rush (*Baumea rubiginosa*), jointed rush and cumbungi), *charophytes* and detritus.

| Site | Autumn 2014 | Spring 2014 | Spring 2015 |
|---|---|---|---|
| CR3 facing upstream | | | |
| CR3 facing downstream | | | |

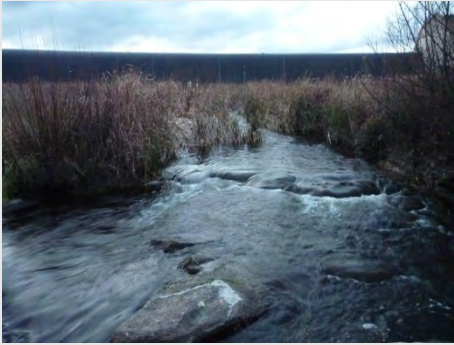
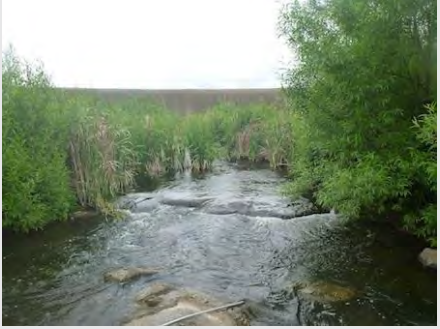
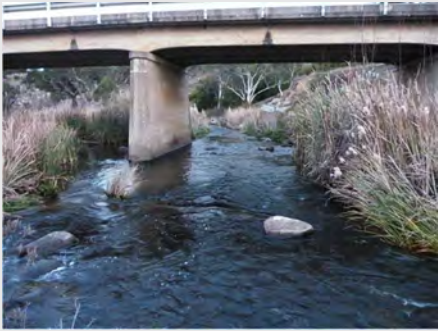
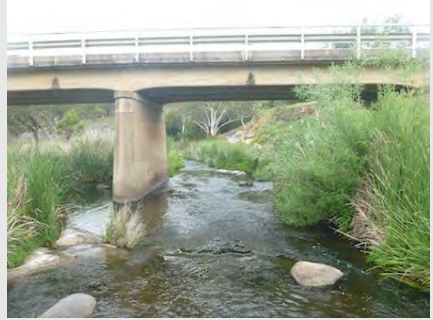
**Table 6-14 Representative photographs of site CR6**

MPR (2016) reported that the substrate at this site dominated by bedrock and boulders, with a smaller proportion of cobbles and sand. Both riffle and pool habitat was observed at this site. The banks supported trailing vegetation/grasses, providing stabilisation. Detritus and the emergent macrophyte Water Cress (*Nasturtium officinale*) and undercut banks provided instream habitat. Abundant filamentous algae were observed during the 2015 surveys (MPR, 2016), smothering rocky surfaces.

| Site | May 2015 | November 2015 |
|---|---|---|
| CR6 facing upstream | | |
| CR6 facing downstream | | |

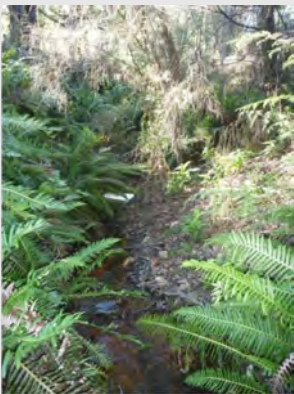
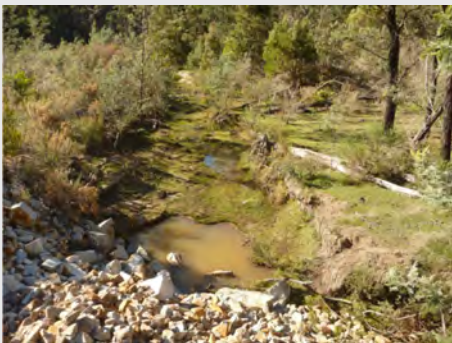
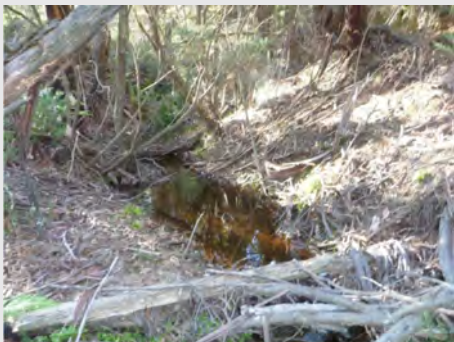
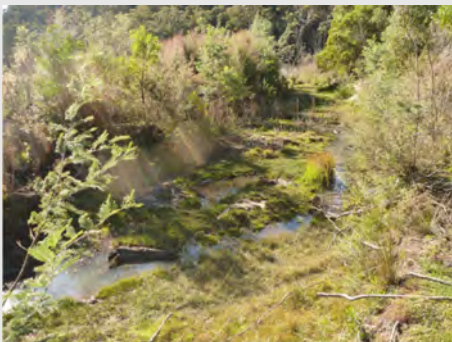
**Table 6-15 Representative photographs of sites SSWdn/SSCup**

Site SSWdn is located on a first order stream with maximum depths of 0.6 m and average depths of 0.2 m (MPR (2013a)). Channel substrate was dominated by sand with some boulder outcrops. Orange precipitate blanketed much of the reach and filamentous algae was abundant. No macrophytes were observed.

Site SSCup was surveyed in 2014 by MPR (MPR, 2014a). The reach surveyed was described as being artificial – composed of a series of pools with no flow. Maximum stream width was 2 m and averaged 0.8 m. Maximum depth was 0.5 m, with an average of 0.2 m. Macrophytes present included Jointed Rush and Swamp Clubrush. Substrate was composed of muddy sand and gravel/pebble. Small amounts of filamentous algae were observed.

| Site | May 2013 (SSWdn) | May 2014 (SScup) |
|---|---|---|
| SSWdn/SSCup<br>facing upstream | | |
| SSWdn/SSCup<br>facing<br>downstream | | |

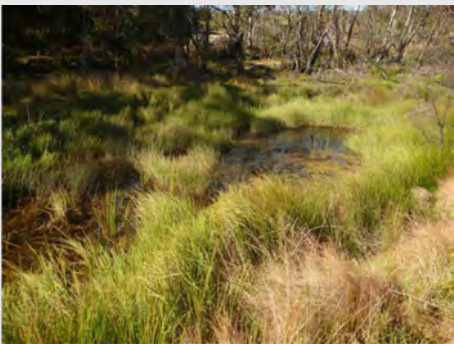
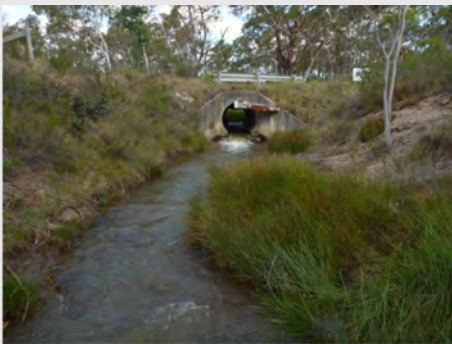
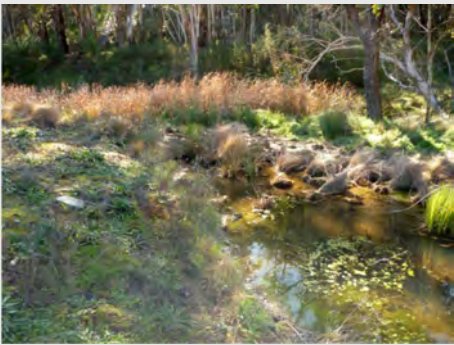
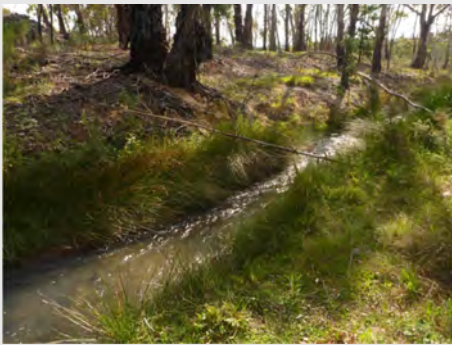
**Table 6-16 Representative photographs of site DP9dn**

| Site | May 2014 | November 2014 |
|---|---|---|
| DP9dn facing upstream | | |
| DP9dn facing downstream | | |
