Geotechnical Investigation Report

Proposed Redevelopment ISHS – Inner City High School
200 Chalmers Street, Surry Hills NSW

Project Number: 2187

Report Number: 2187-GR-1-1

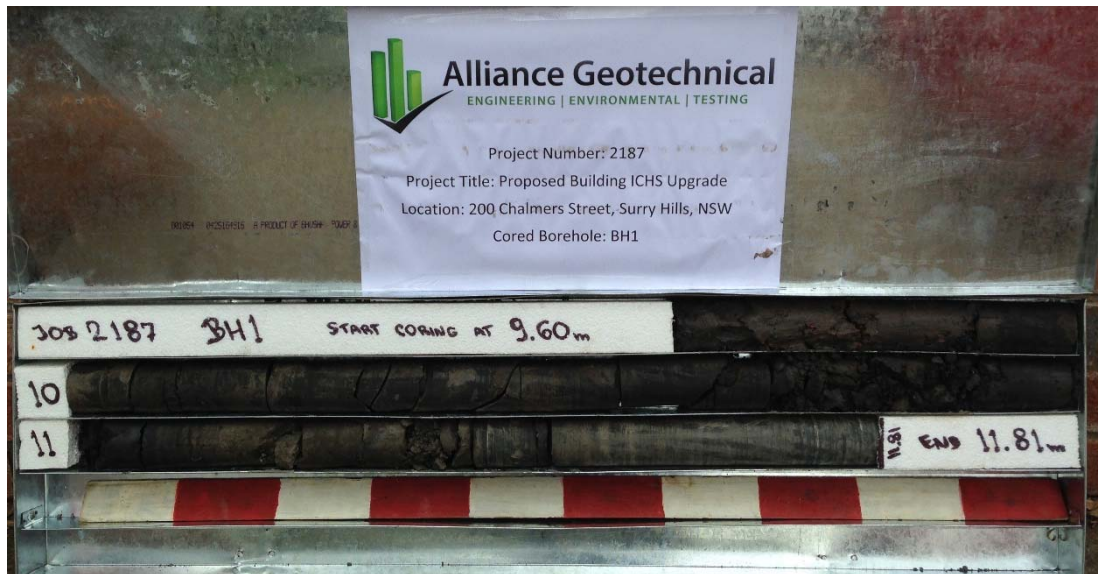
Figure 2 – BH1 Core Photo

- Shale - Highly weathered, dark grey with grey laminations, progressed with NMLC rock coring within the bedrock profile from 9.6m to the maximum depth of 11.81m in BH1. Shale bedrock was tested and assessed low to medium strength, Class IV from 9.6m to 10.2m, and Class IV/III from 10.2m to 11.81m.

Borehole	Depth (m)	I_{s50} Axial (MPa)	I_{s50} Diametric (MPa)	Material Types
BH1	9.95	0.21	-	Shale, highly weathered, dark grey and grey
BH1	10.16	0.39	0.37	Shale, highly weathered, dark grey and grey
BH1	10.93	0.24	-	Shale, highly weathered, dark grey and grey
BH1	11.43	0.18	0.21	Shale, highly weathered, dark grey and grey
BH1	11.71	0.46	0.39	Shale, highly weathered, dark grey and grey

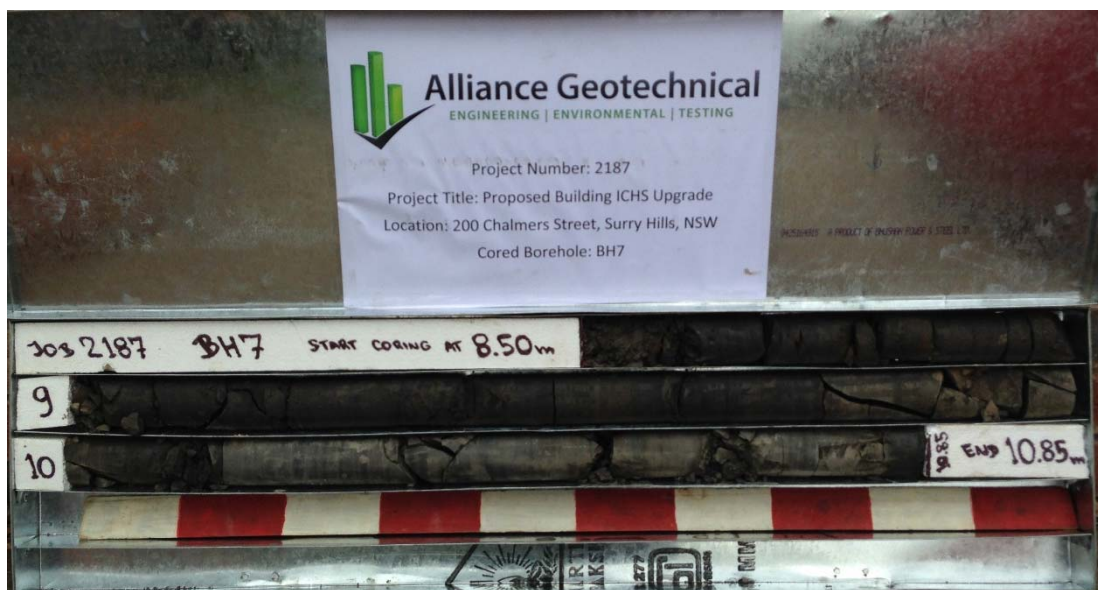
Figure 3 – BH7 Core Photo

- Shale - Highly weathered, dark grey with grey laminations, progressed with NMLC rock coring within the bedrock profile from 8.5m to the maximum depth of 10.85m in BH7. Shale bedrock was tested and assessed low to medium strength, Class IV from 8.5m to 9.8m, and Class IV/III from 9.8m to 10.85m.

Borehole	Depth (m)	I_{s50} Axial (MPa)	I_{s50} Diametric (MPa)	Material Types
BH7	8.85	0.13	-	Shale, highly weathered, dark grey and grey
BH7	9.21	0.13	0.27	Shale, highly weathered, dark grey and grey
BH7	9.48	0.23	0.35	Shale, highly weathered, dark grey and grey
BH7	9.65	0.22	0.28	Shale, highly weathered, dark grey and grey
BH7	10.15	0.50	0.52	Shale, highly weathered, dark grey and grey
