Circulation

Boundary Condition

Wind Mitigation

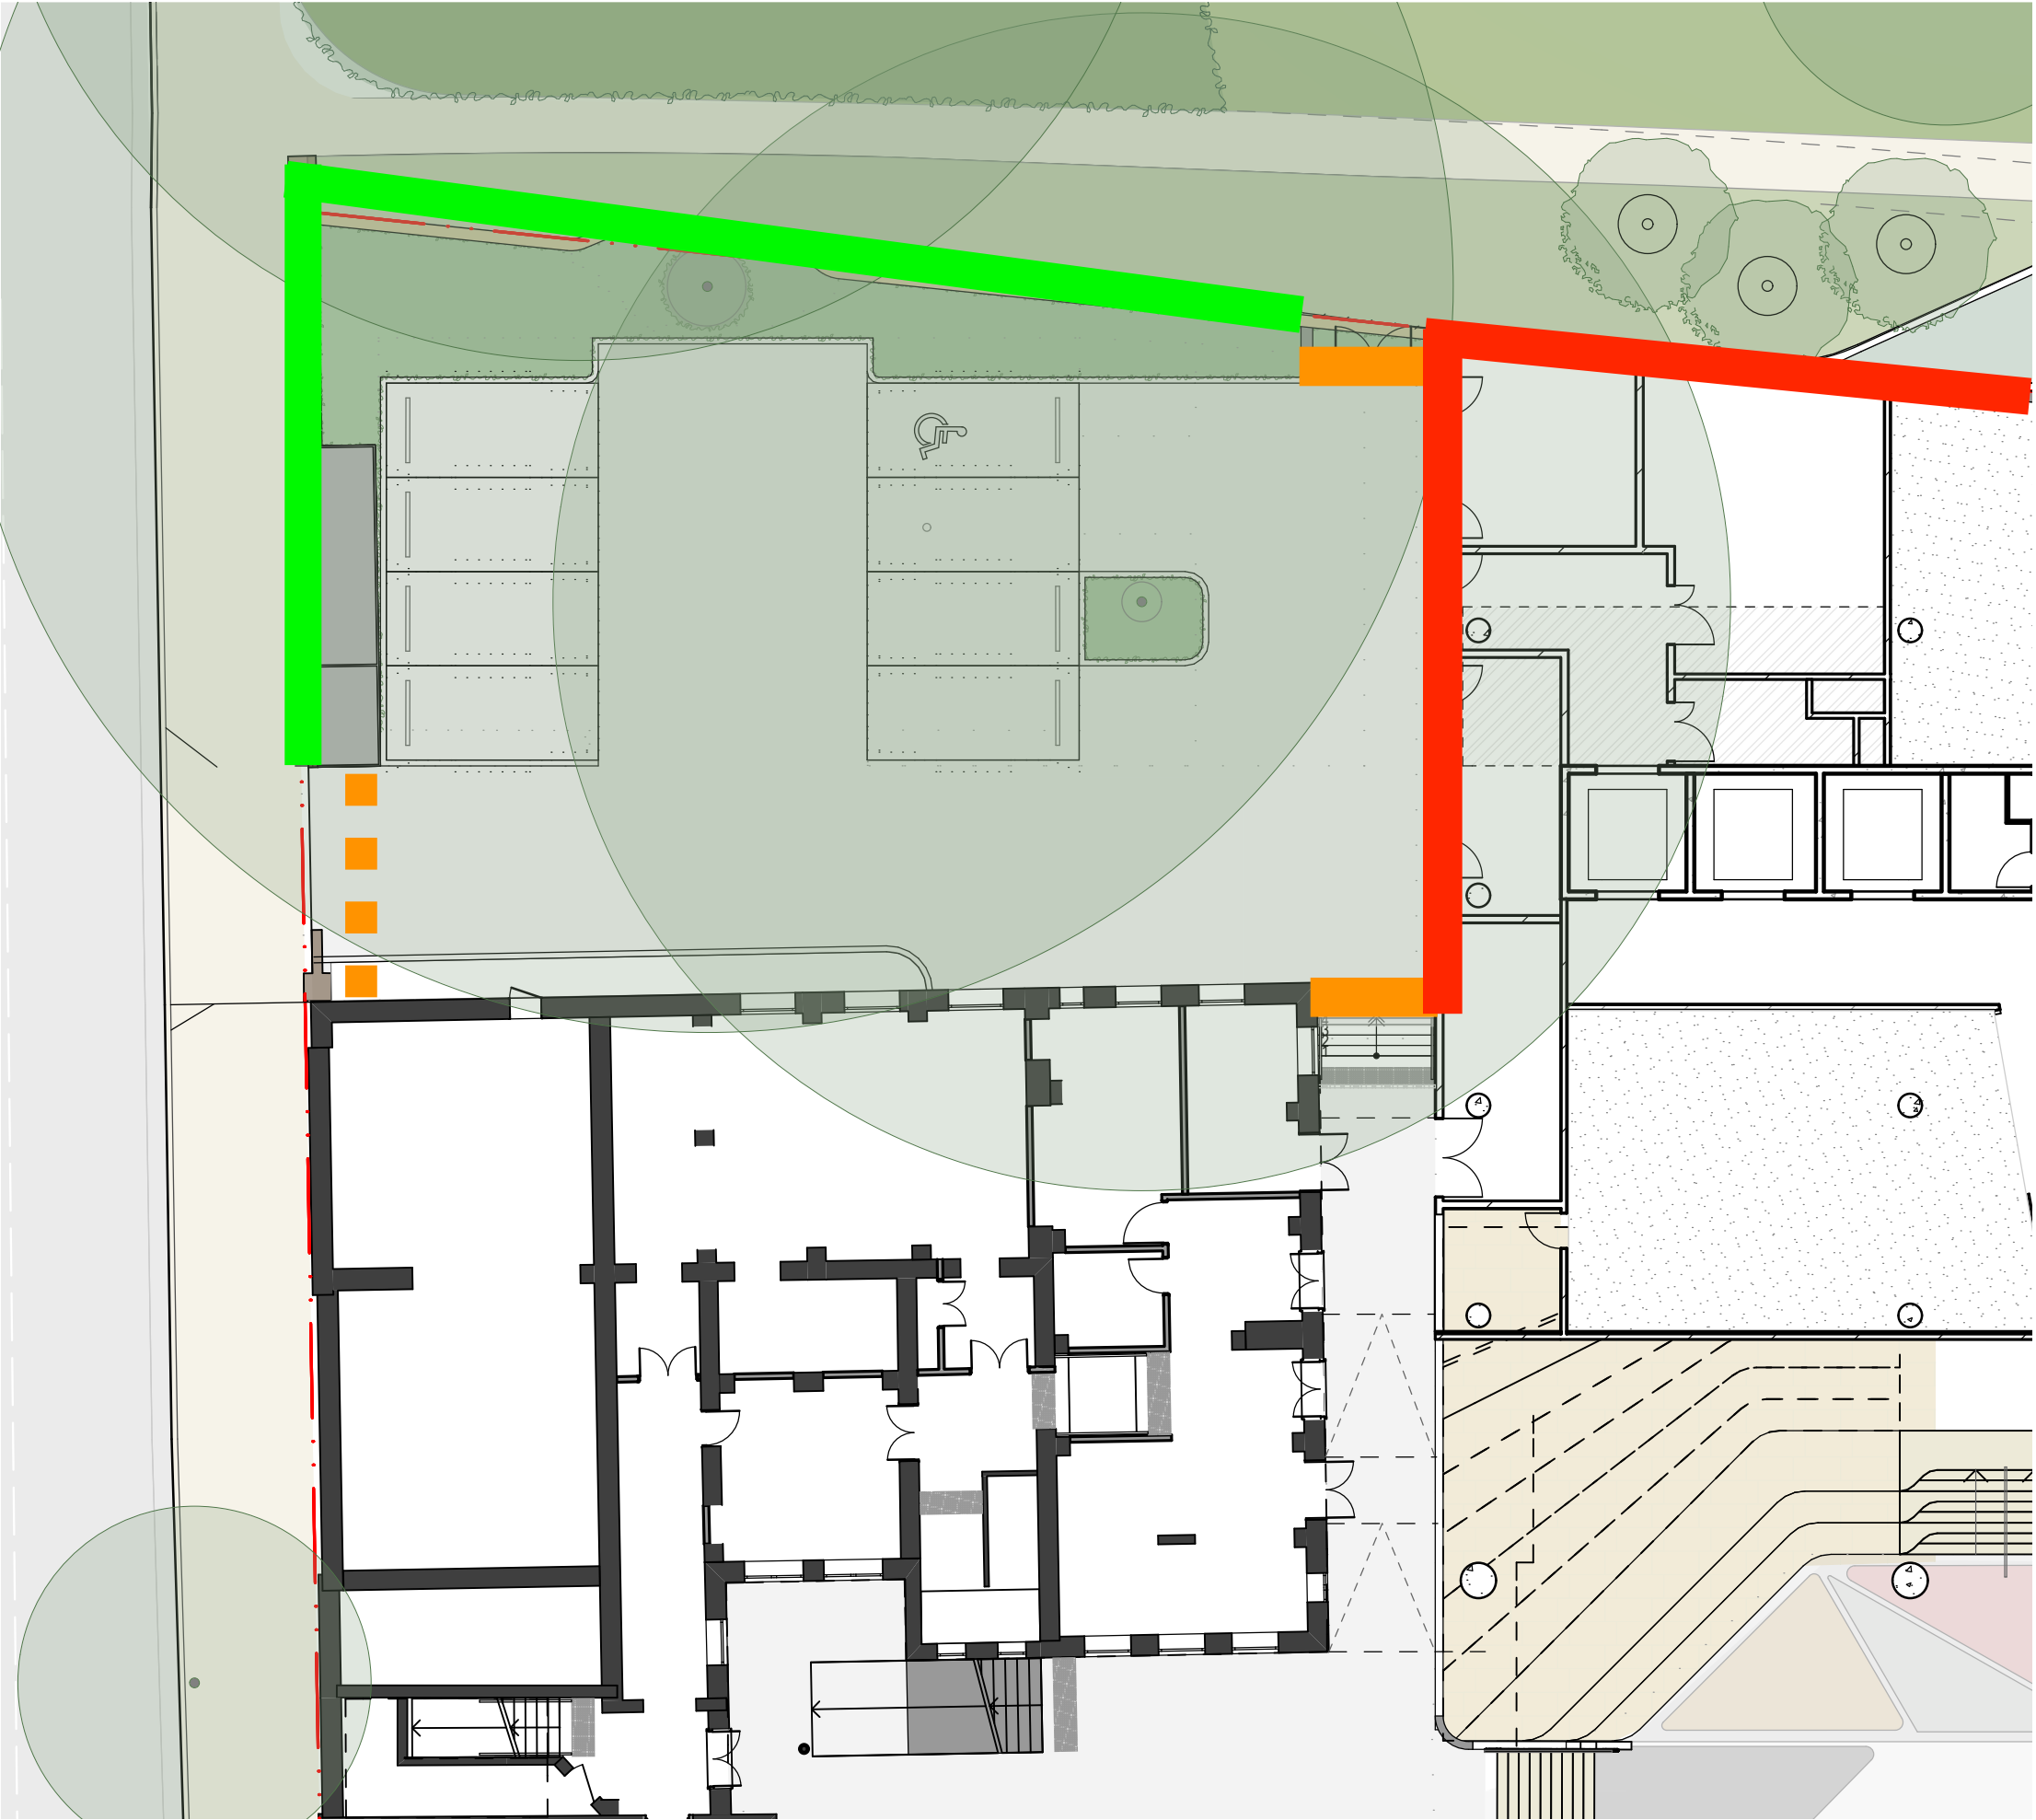
Boundary Condition Lower Ground

Painted, rendered masonry with graffiti protection
-

Security gate (Keypad)
Potential public secure access
-

Full height automated glazed louvres with protective stainless steel mesh to outside

- Painted, rendered masonry with graffiti protection
- Security gate
Emergency egress
- Existing palisade fencing
- Sliding security gate. This gate will be open during extended school hours and closed after hours.
Access after hours to be by keypad

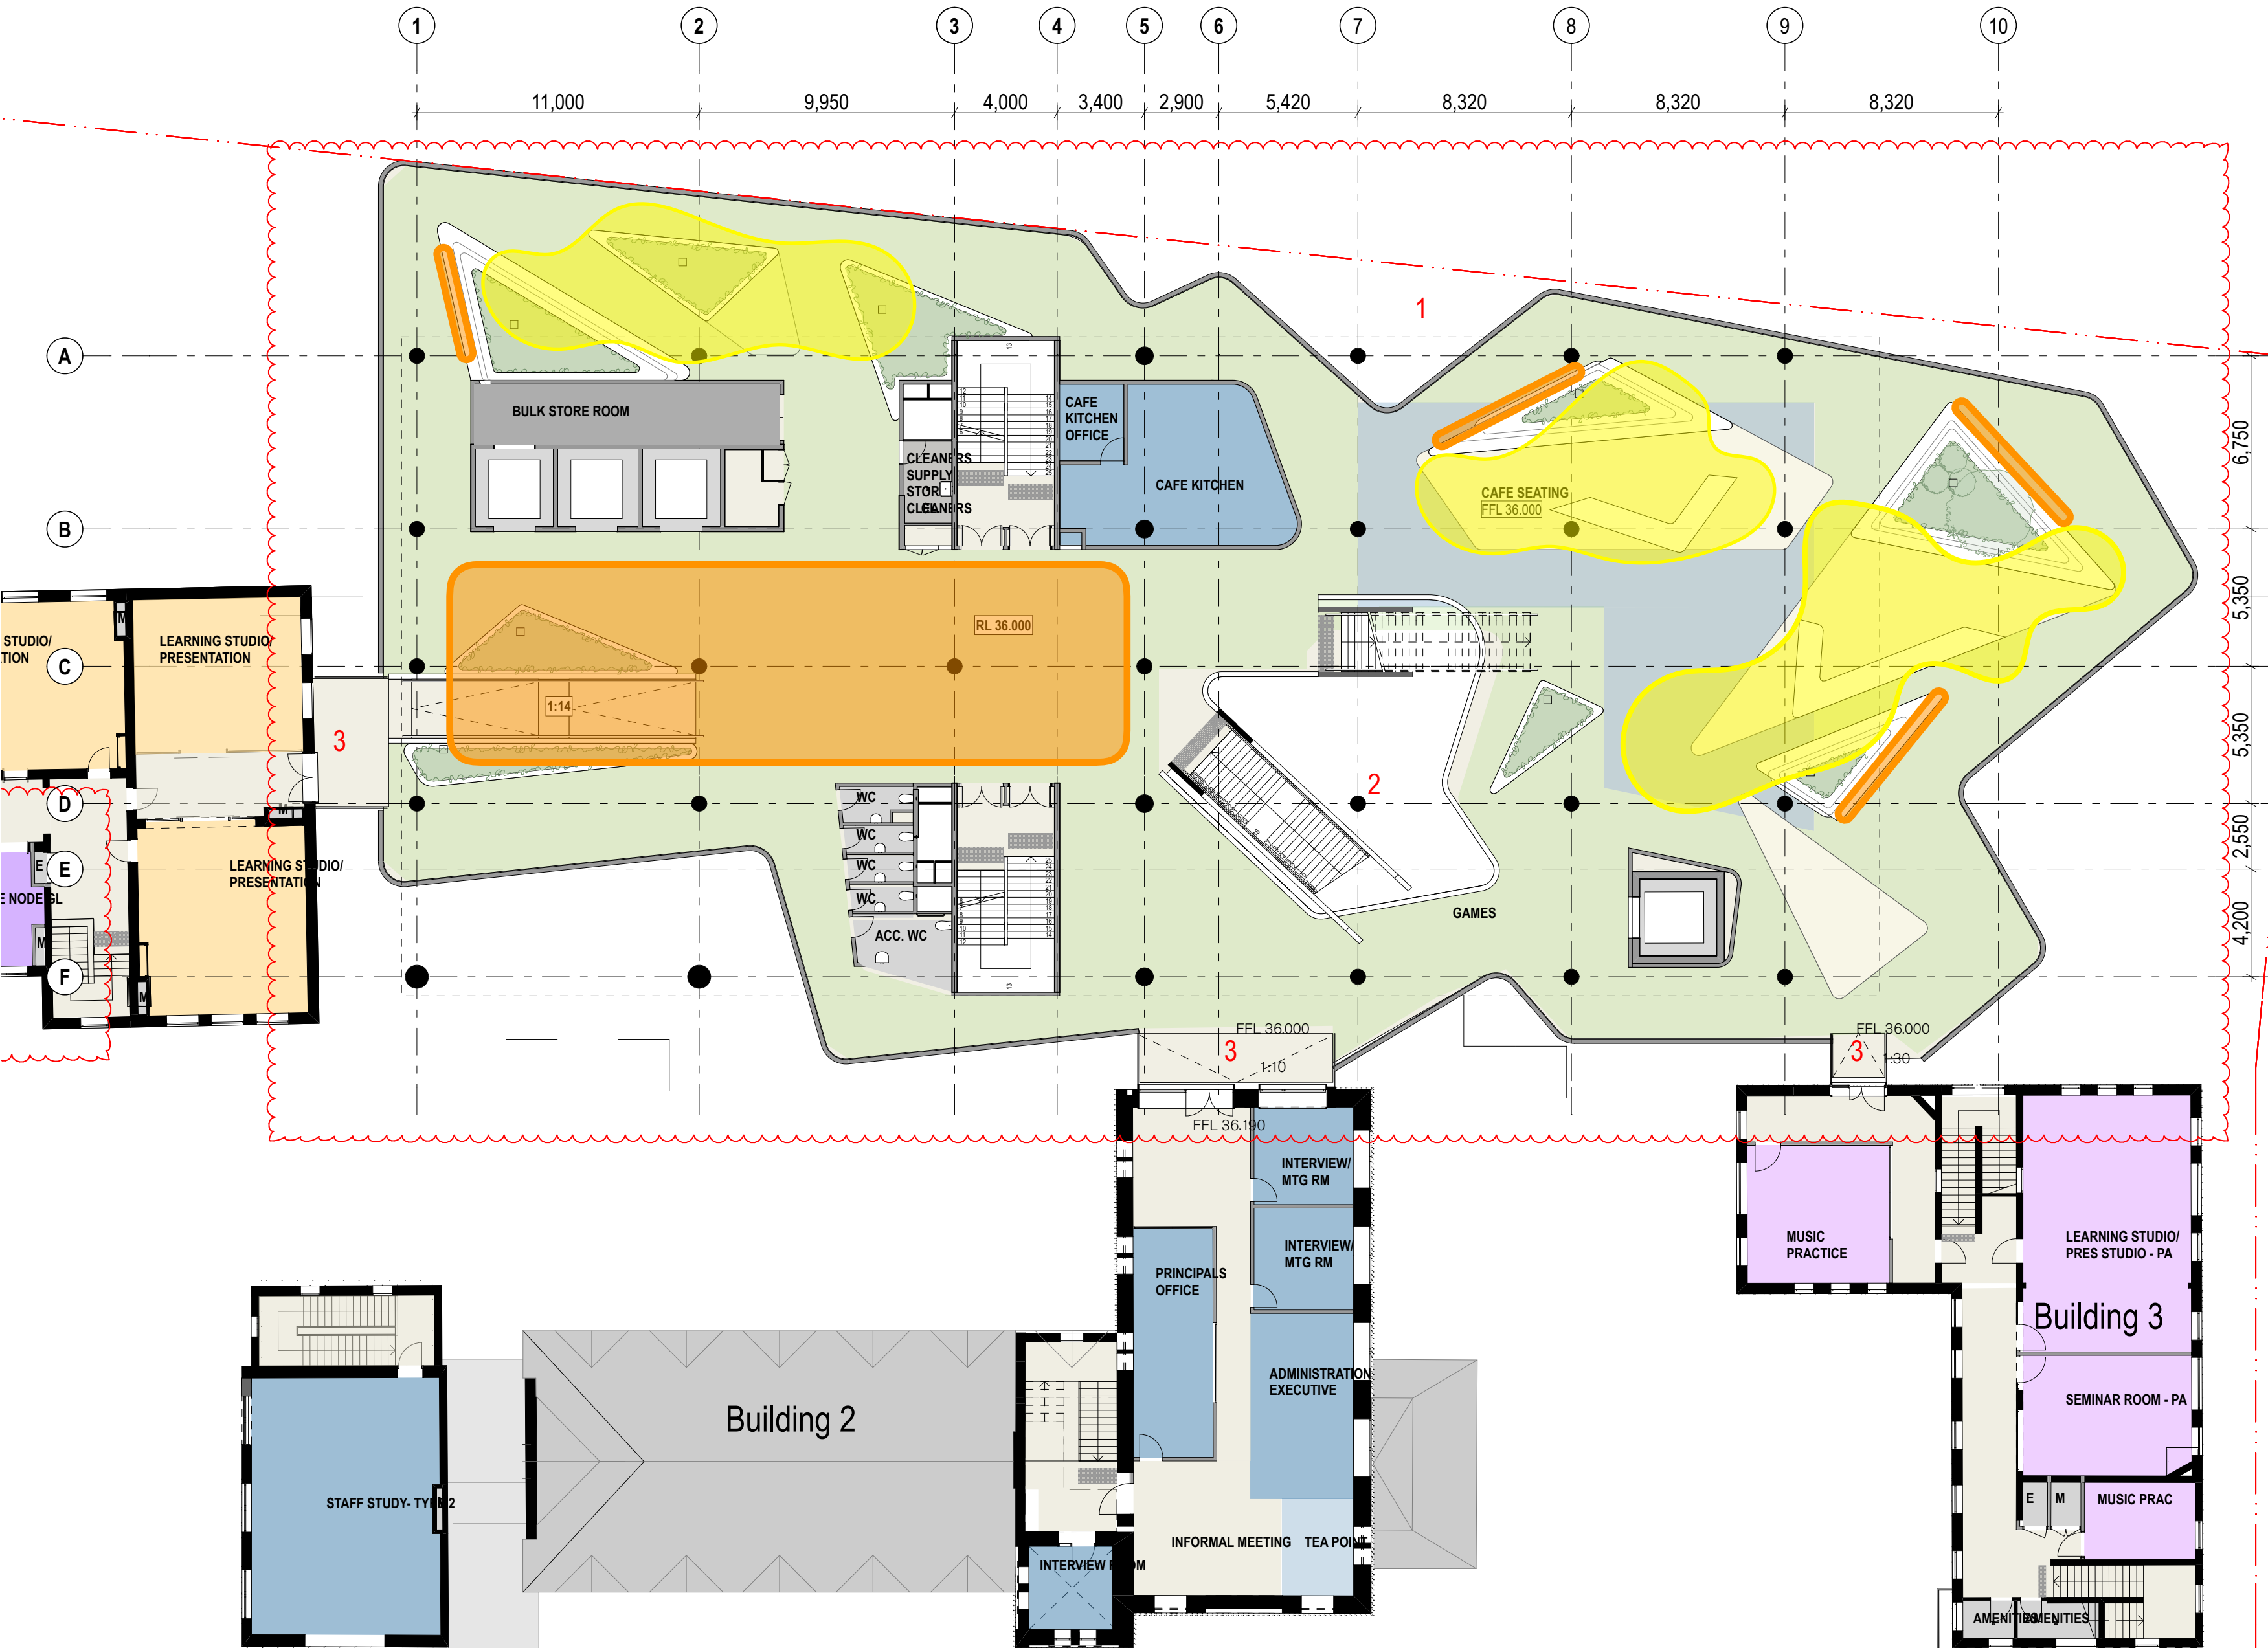
Wind Mitigation Level 1

Local conditions ameliorated in casual seating areas.

Signage blades providing localised calm areas

Transient zone therefore any potential increase in conditions here is acceptable.

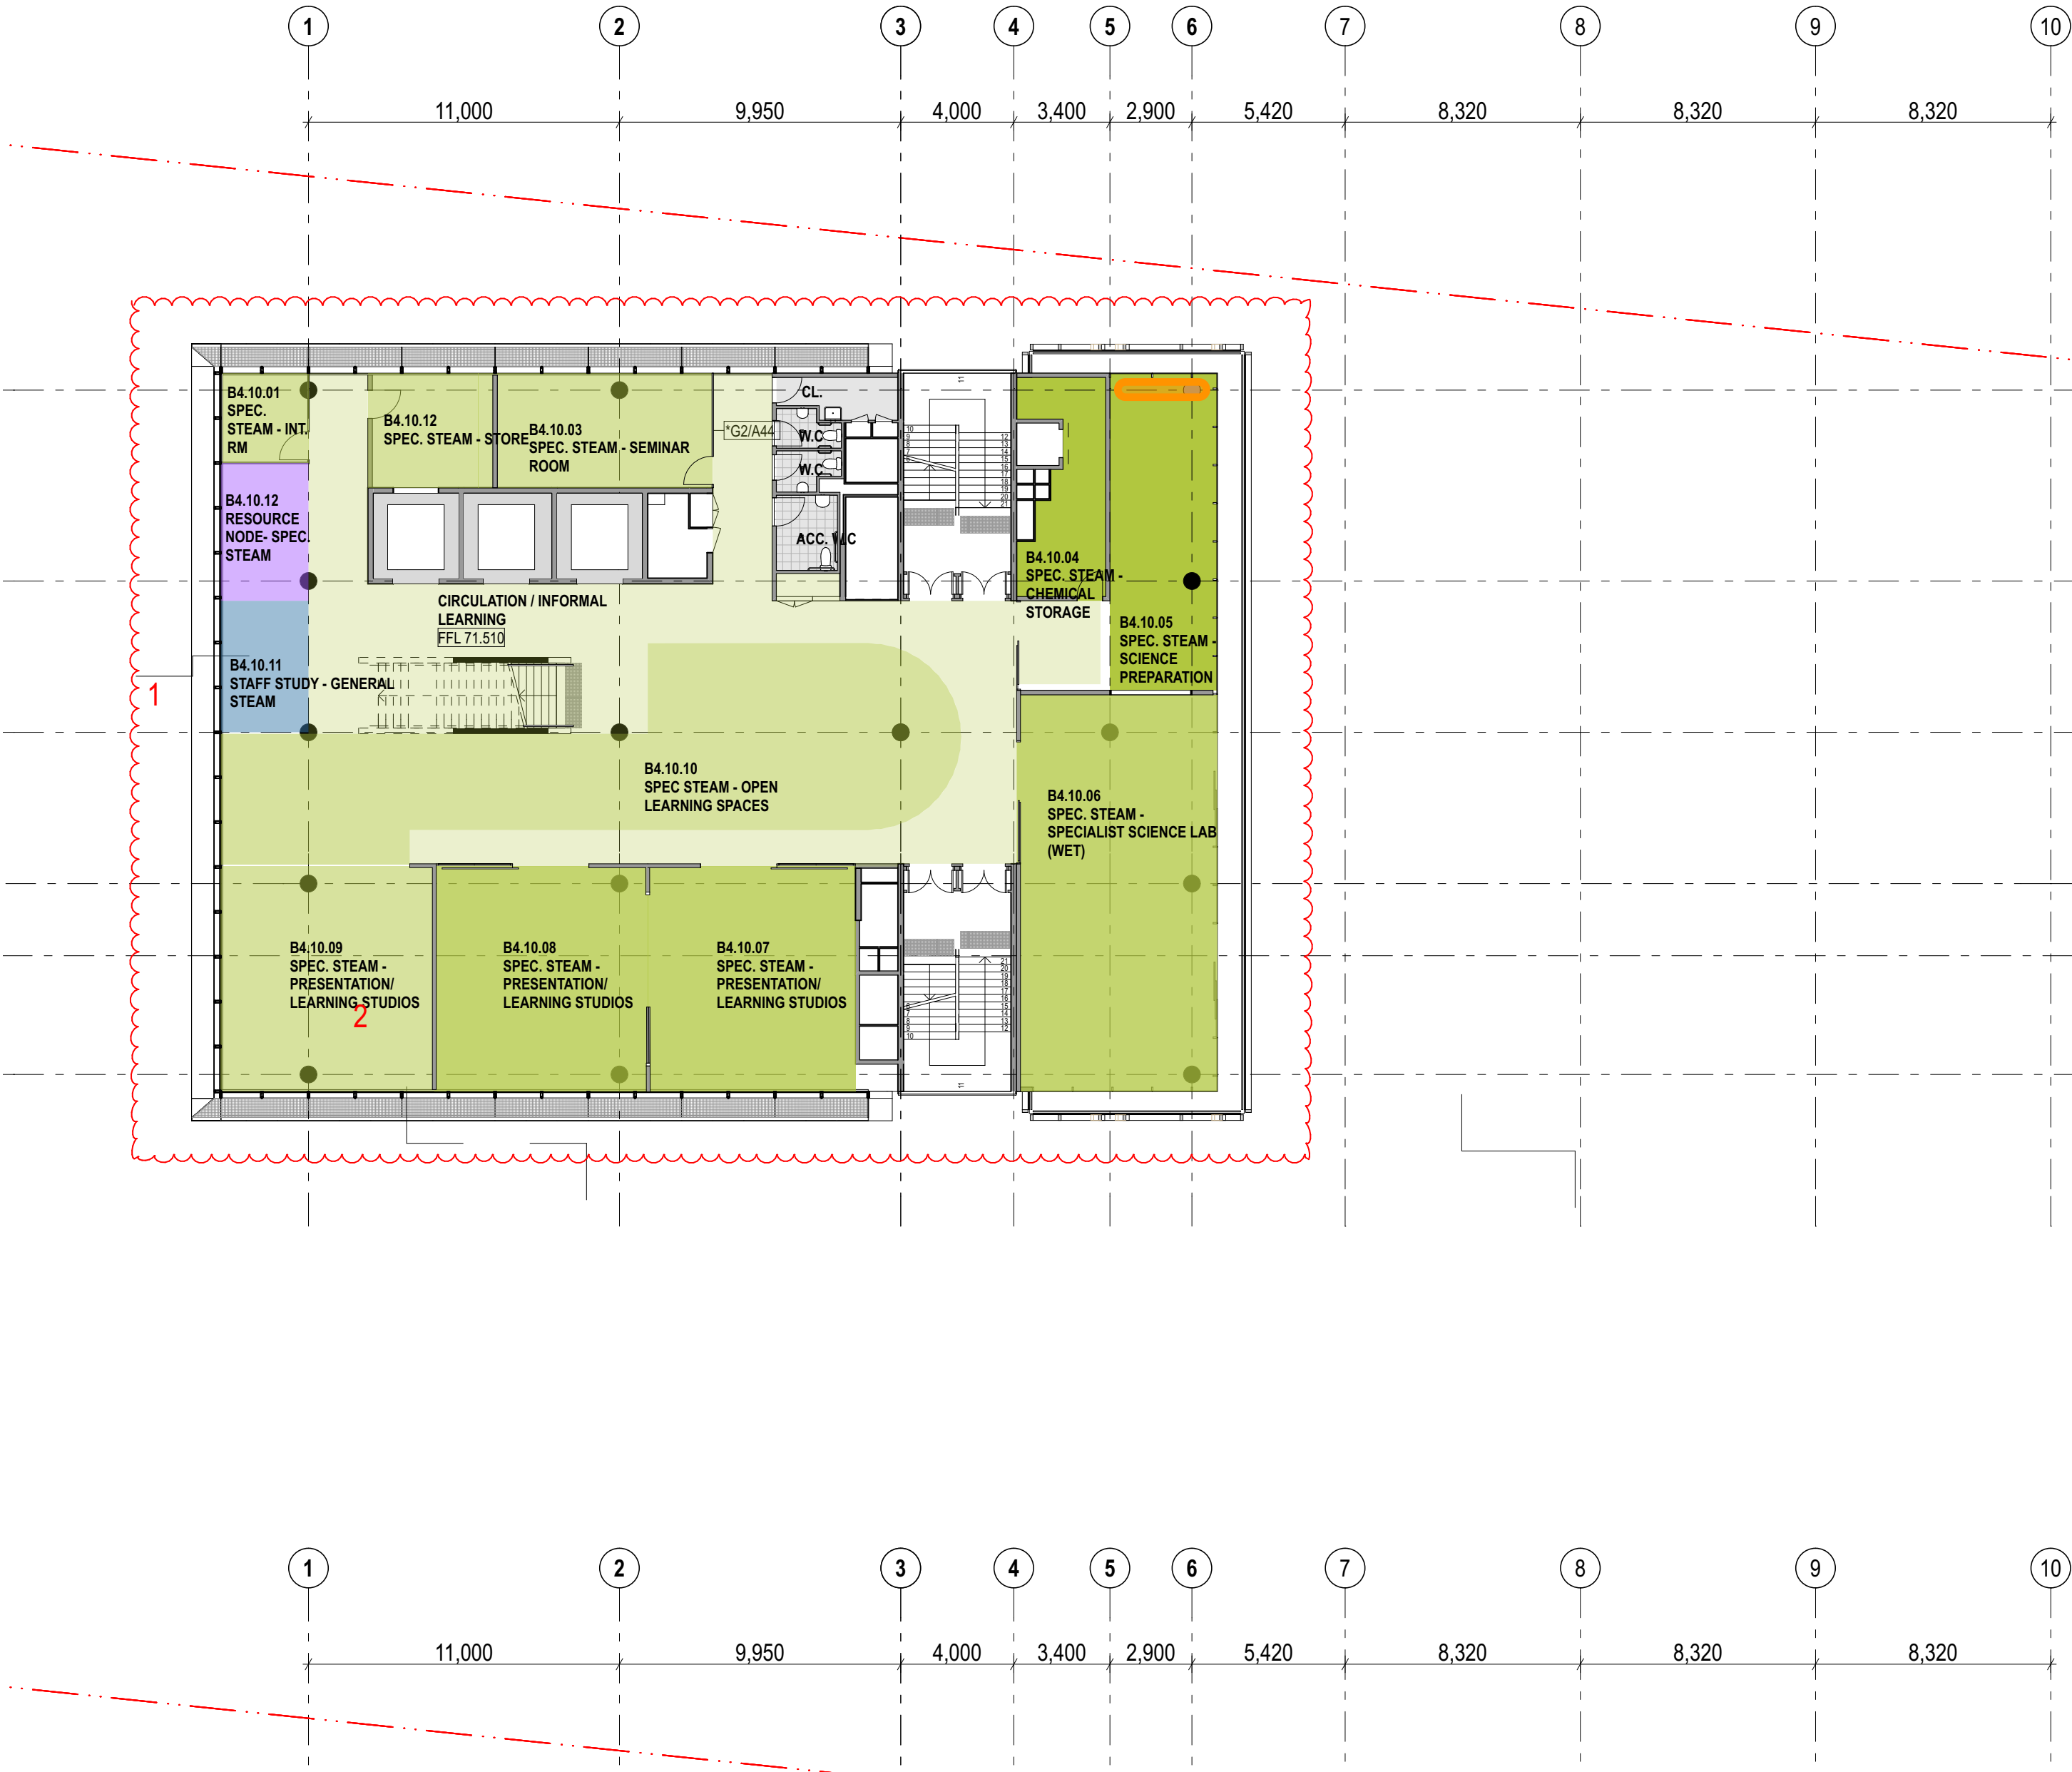
Potential signage blade to ameliorate conditions.
