Preliminary Hydrogeological Assessment

2-30 Tempus Street, Rouse Hill, NSW

Final Report

P2410429JR02V03

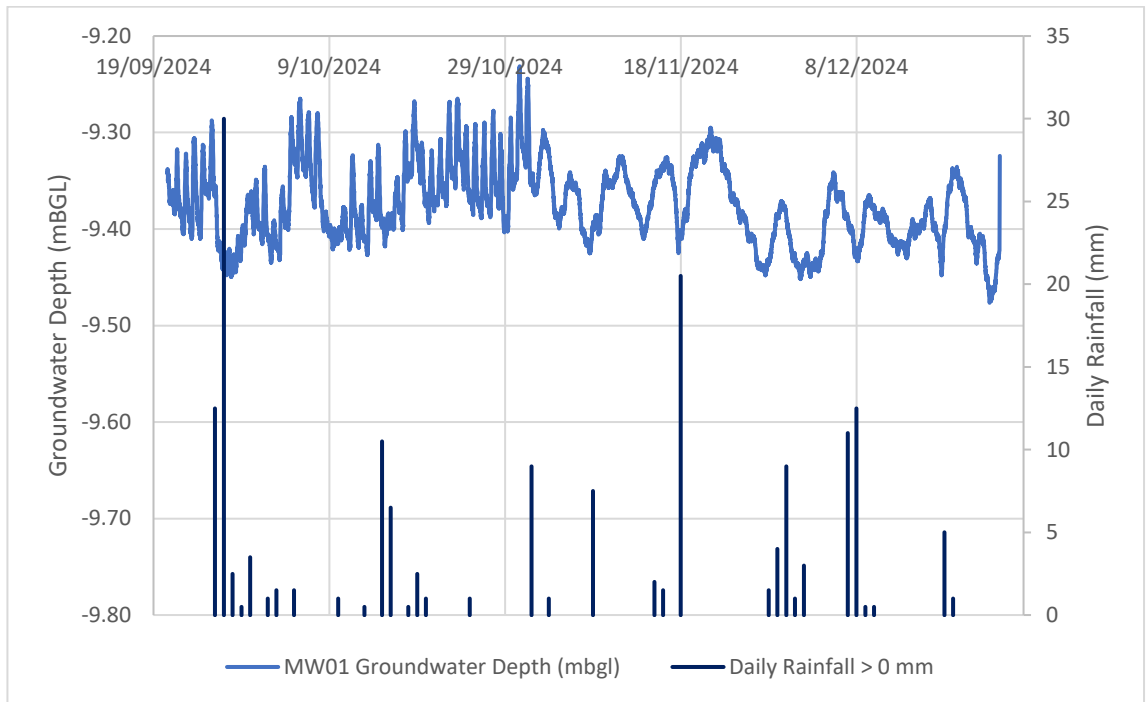
Figure 2: Plot of groundwater depths (mbgl) and daily rainfall (mm).

Dip meter measurements and continuous data logger recordings are summarised in Table 4 and Table 5, and graphical plot of collected groundwater level data is provided in Figure 2 and Figure 3.

In summary groundwater level at the Site is relatively consistent with a range of 0.18 m. Comparison of monitoring data with daily rainfall data suggests that incident rainfall does not significantly increase groundwater level at the Site. We note that extreme and prolonged rainfall or drought can induce peaks and troughs with future data. The aquifer

is predominantly located in the weathered shale rock mass underlying the placed fill material.

- Groundwater monitoring data indicated that the groundwater level at the Site is relatively consistent with reported levels between 39.05 mAHD and 39.24 mAHD during the monitoring period.

- Comparison of monitoring data to daily rainfall data indicates rainfall does not significantly increase groundwater level at the Site.
- Based on site plans, excavation required for basement construction is expected to be approximately 10.01 – 5.98 m across the Site, assuming for a 200 mm slab.

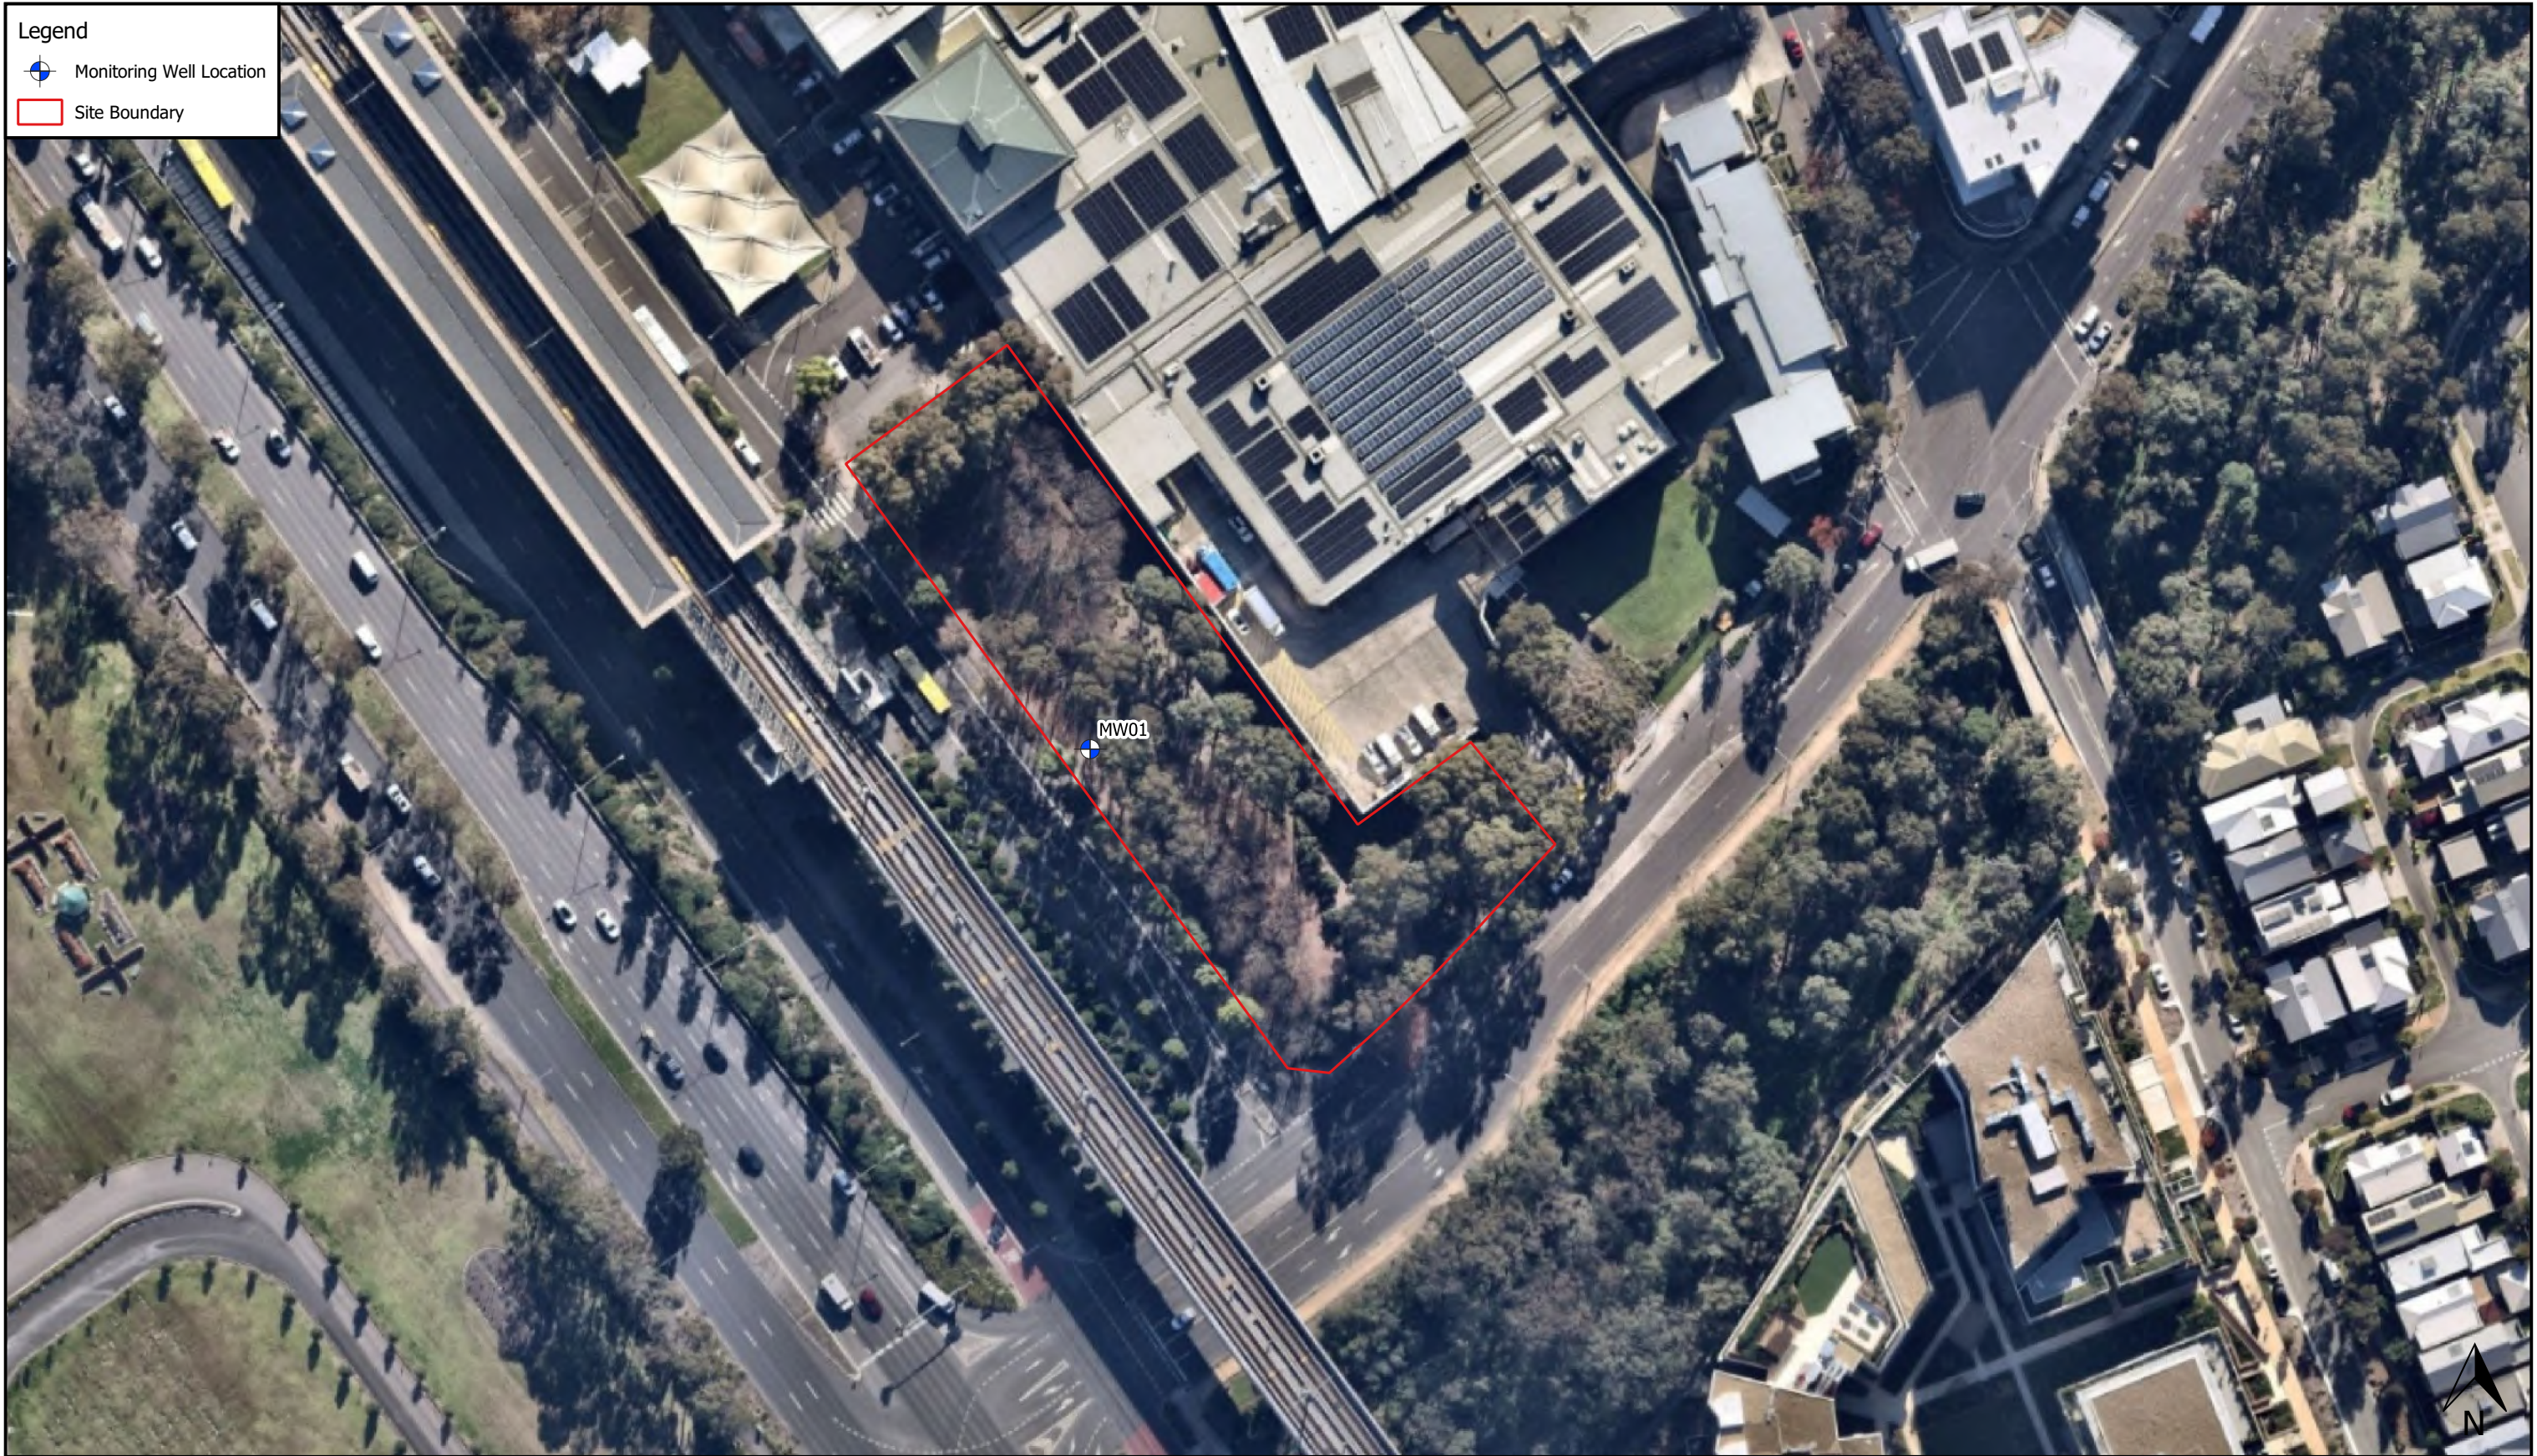
Map Title / Figure:
Monitoring Well Locations

Monitoring Well Location
-

MW01 was installed on 19 September 2024 in conjunction with borehole investigations completed as part of geotechnical investigation at the Site. A summary of well construction is provided in Table 3.

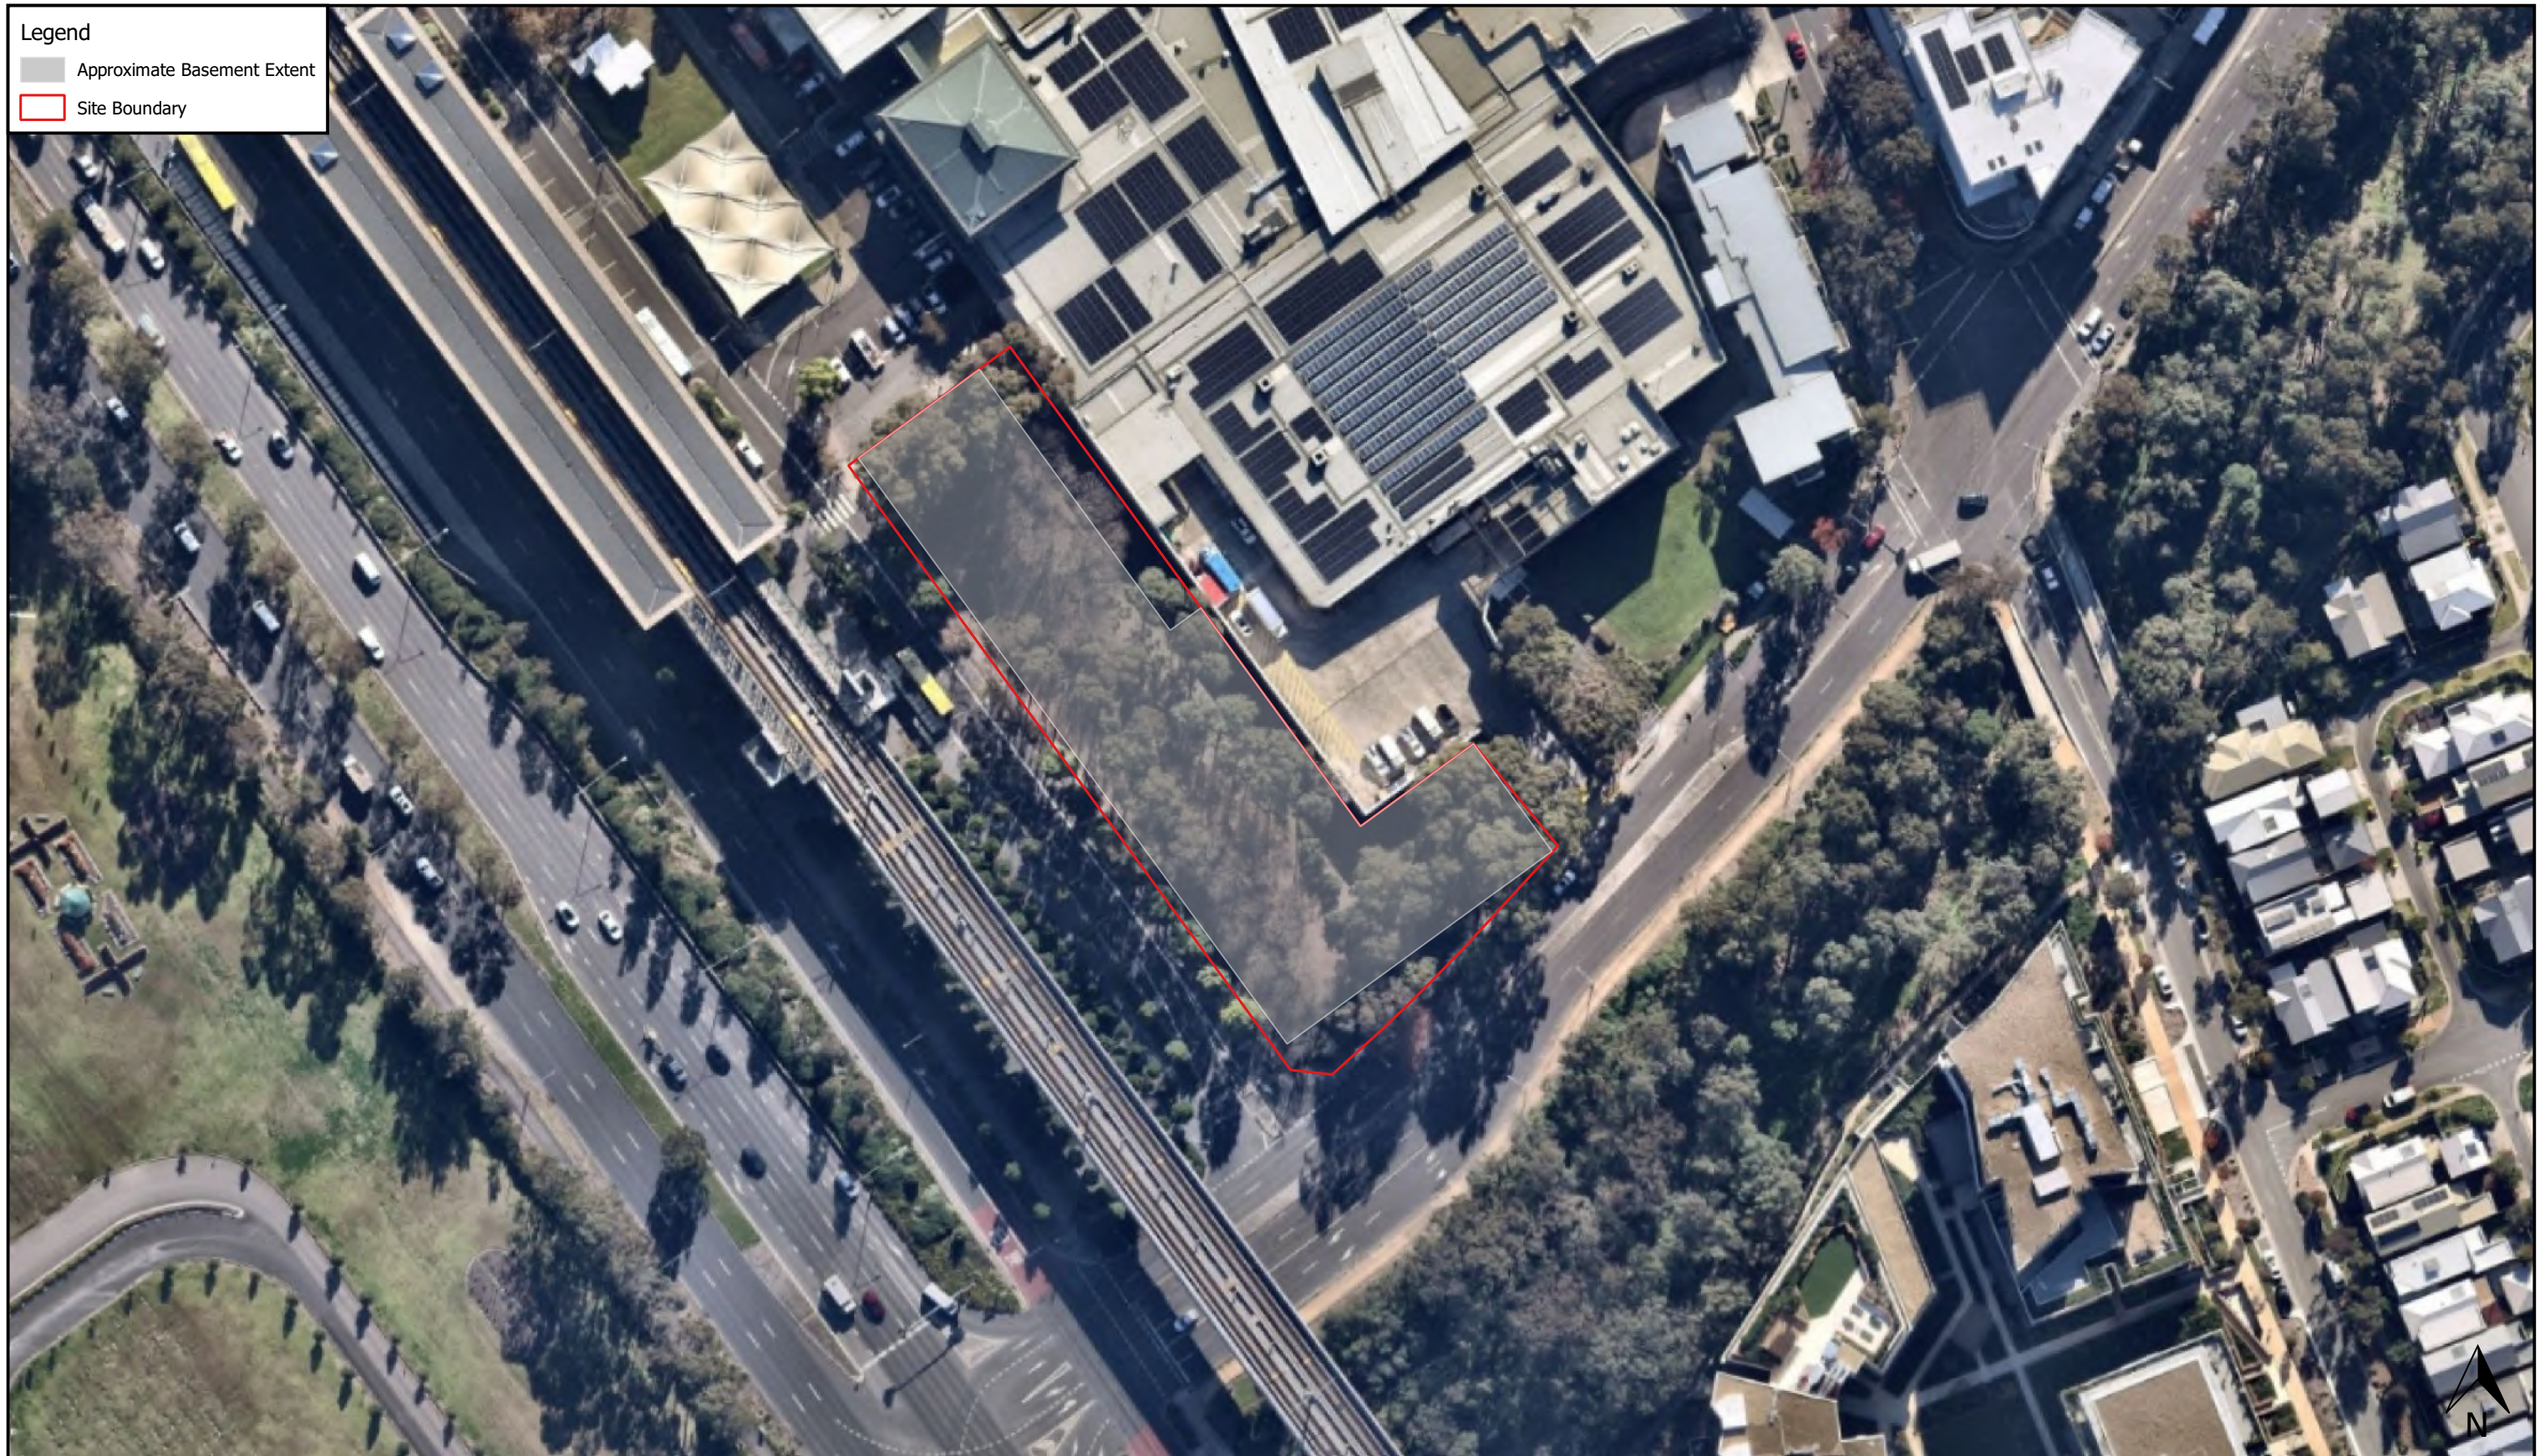
- Approximate Basement Extent
- Site Boundary

Latest architectural plans (Architectus, 2025) show the proposal will include a two level basement with a finished floor level (**FFL**) of 40.584 mAHD, equivalent to an estimated bulk excavation ranging from approximately 10.01 – 5.98 metres below ground level (**mbgl**) allowing for a 200 mm slab to be constructed.

Approximate basement extent is shown in Map 03, Appendix A.
