# Preliminary Geotechnical Assessment

2-30 Tempus Street, Rouse Hill, NSW

P2410429JR03V02

Prepared for Freecity Rouse Hill Development Pty Ltd

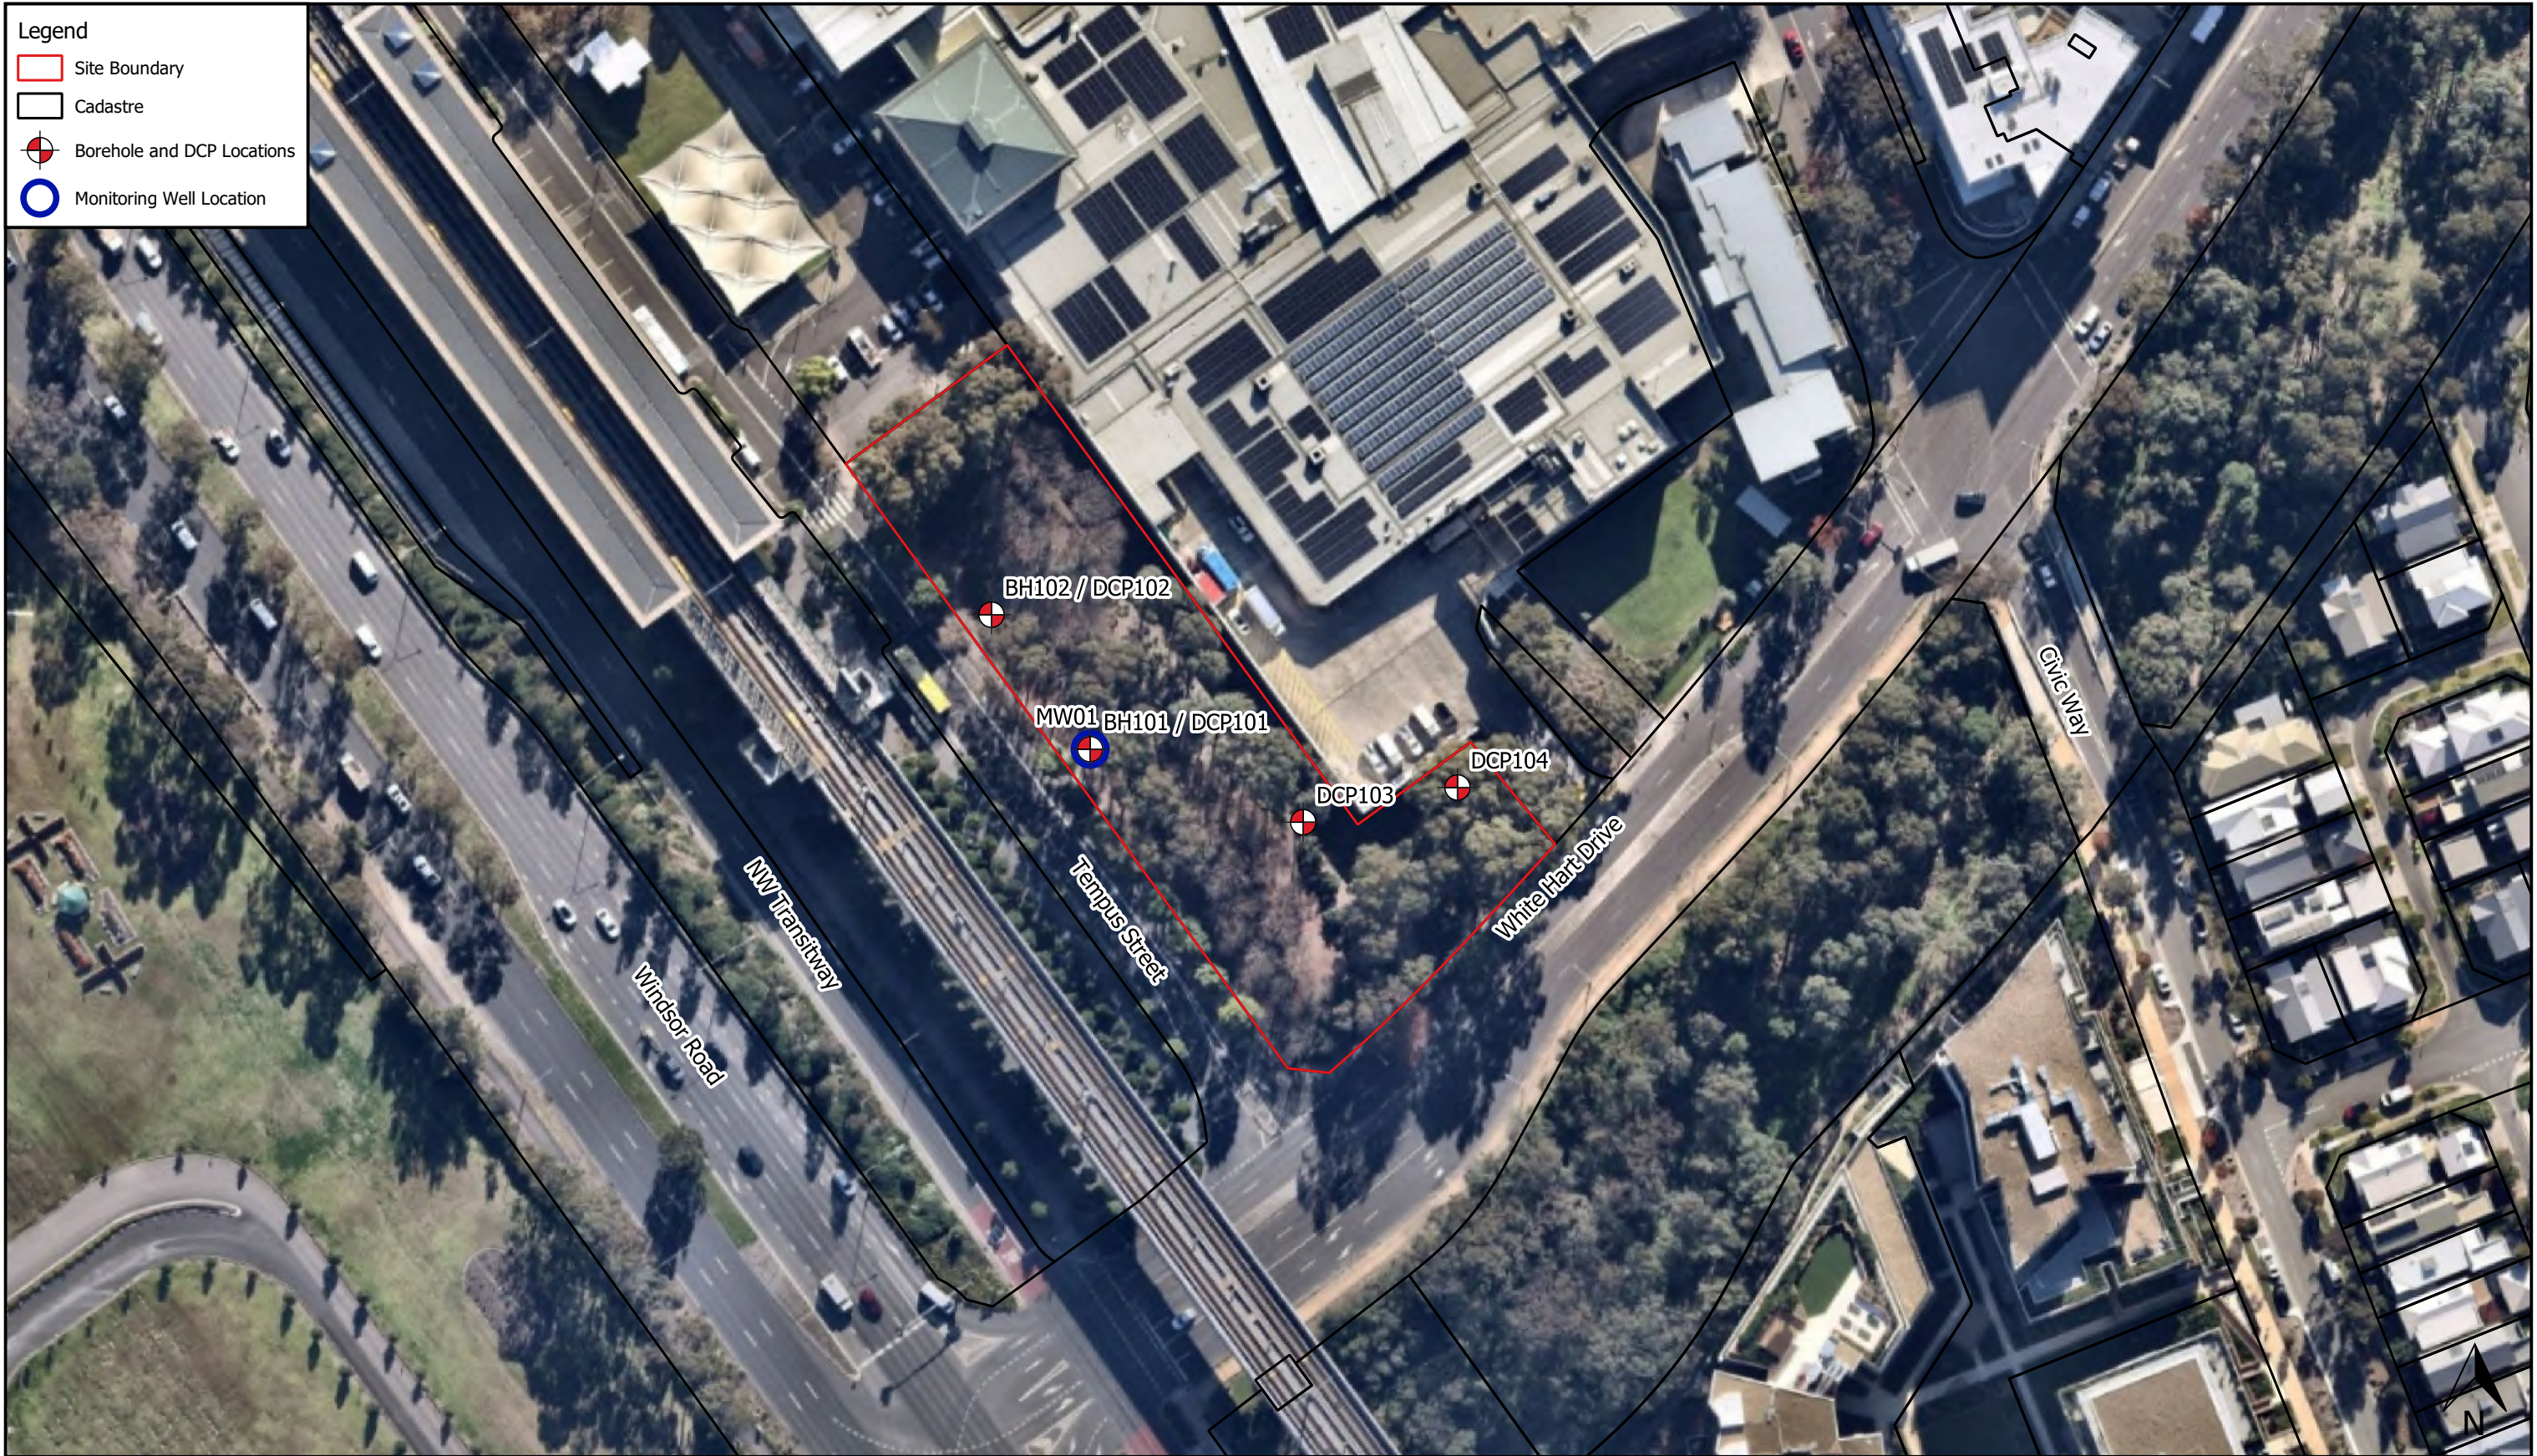
- Site Boundary
- Cadastre
- ⊕ Borehole and DCP Locations
- ⊕ Monitoring Well Location

Encountered conditions are described in more detail in the borehole logs in Appendix B and associated explanatory notes in Appendix F. For DCP test results refer to Appendix C.
