# Resource Feasibility Assessment

Proposed Bluestone Hardrock Quarry - Springvale Road, Elderslie, NSW &  
Blind Creek Road, Glendon Brook, NSW

Final Report

Prepared for Bluestone Hardrock Pty Ltd

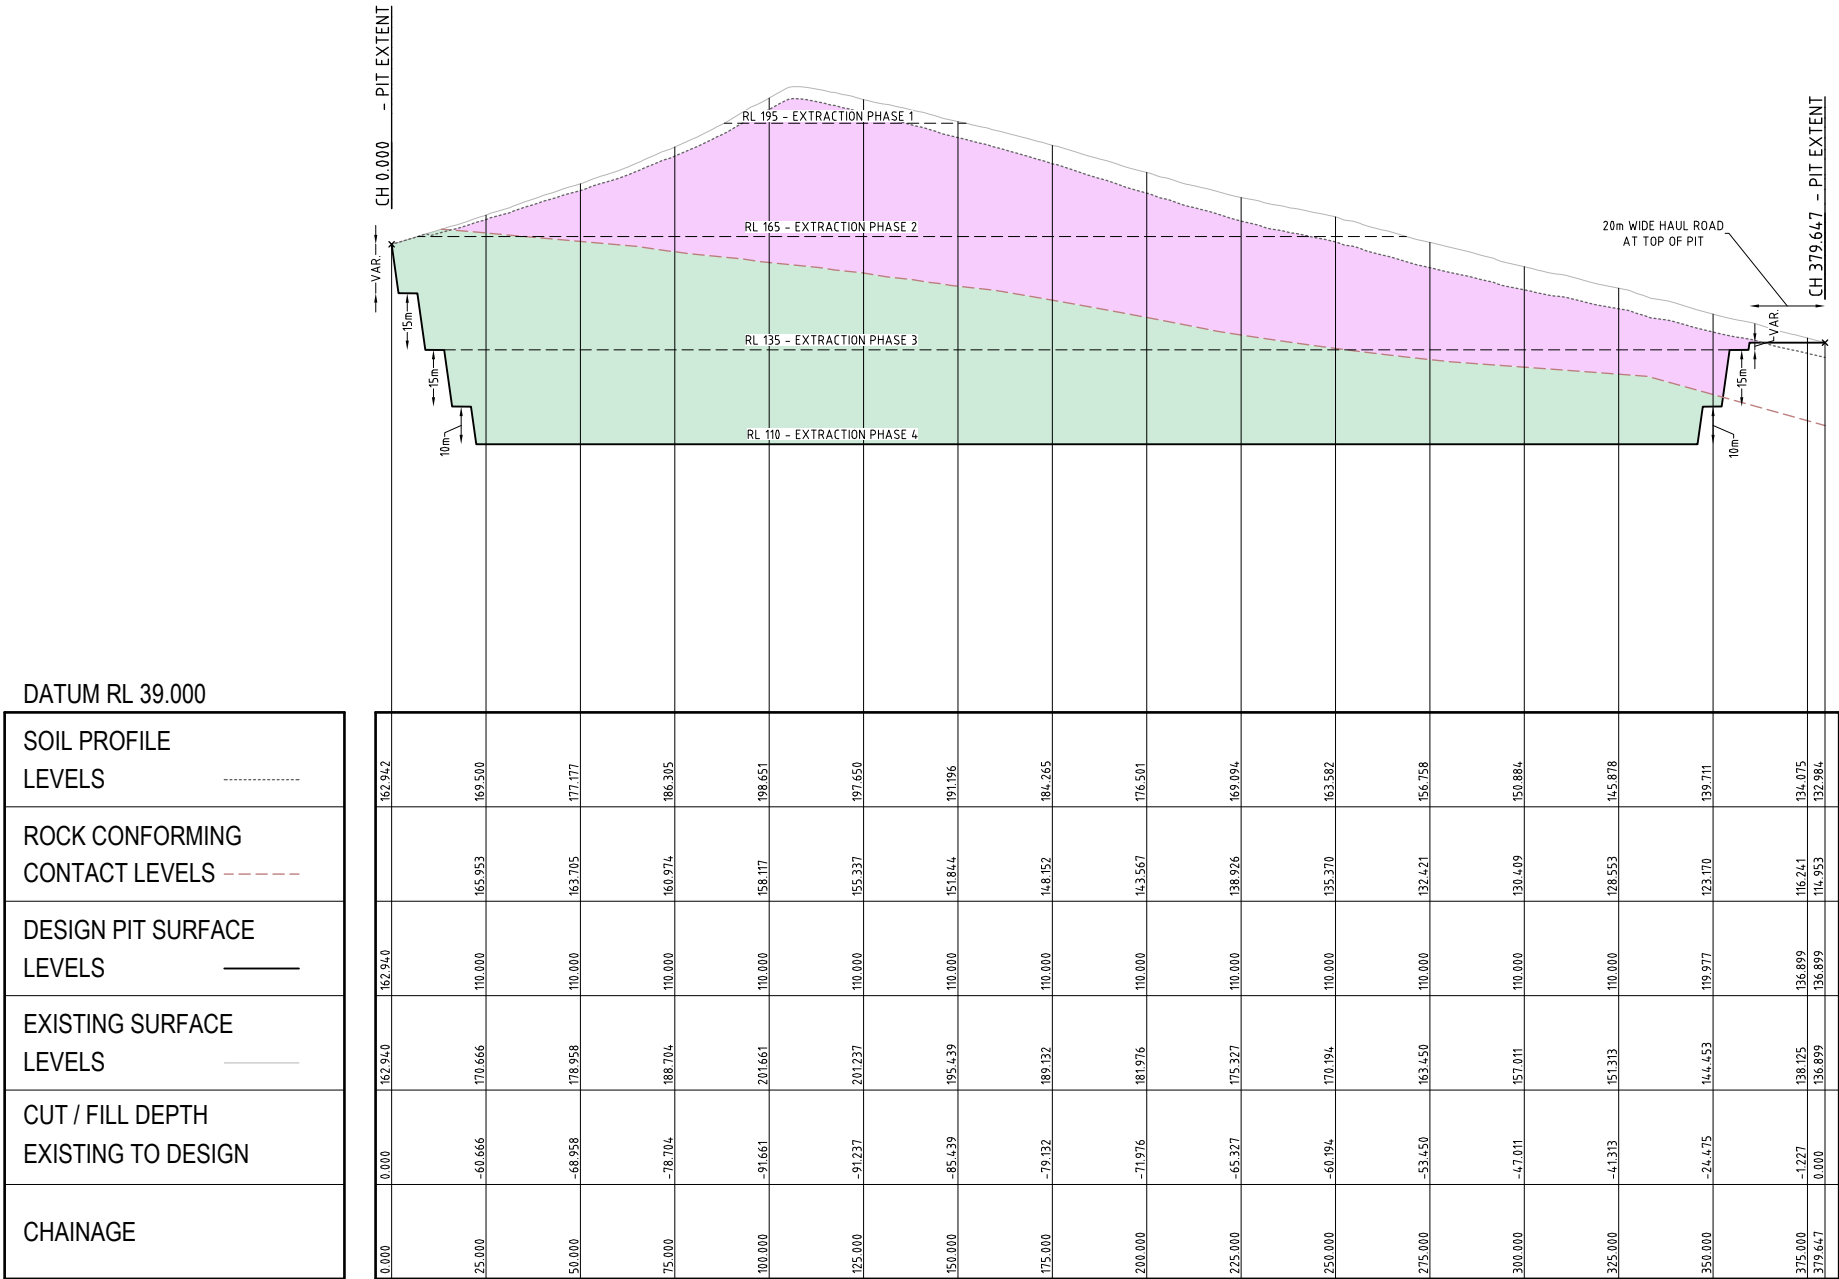
SECTION B

NOTES:  
1. CONFORMING CONTACT BETWEEN TUFF AND AGGLOMERATE AND SOIL PROFILE LEVELS HAVE BEEN APPROXIMATED BASED ON FIELD MAPPING. REFER TO GEOTECHNICAL AND PIT STAGING ASSESSMENT BY MARTENS AND ASSOCIATES (P2410628)R03V01.  
2. THE PRELIMINARY DESIGN CONSIDERS 20m HAUL ROAD AT THE TOP OF THE PIT AS SHOWN ON THE DRAWINGS AS A SIMPLE WORSE CASE SCENARIO, WHICH CONSERVATIVELY ESTIMATES THE VOLUMES (LOWER THAN ACTUAL). THE HAUL ROAD TO BE DESIGNED AT DETAILED DESIGN STAGE.

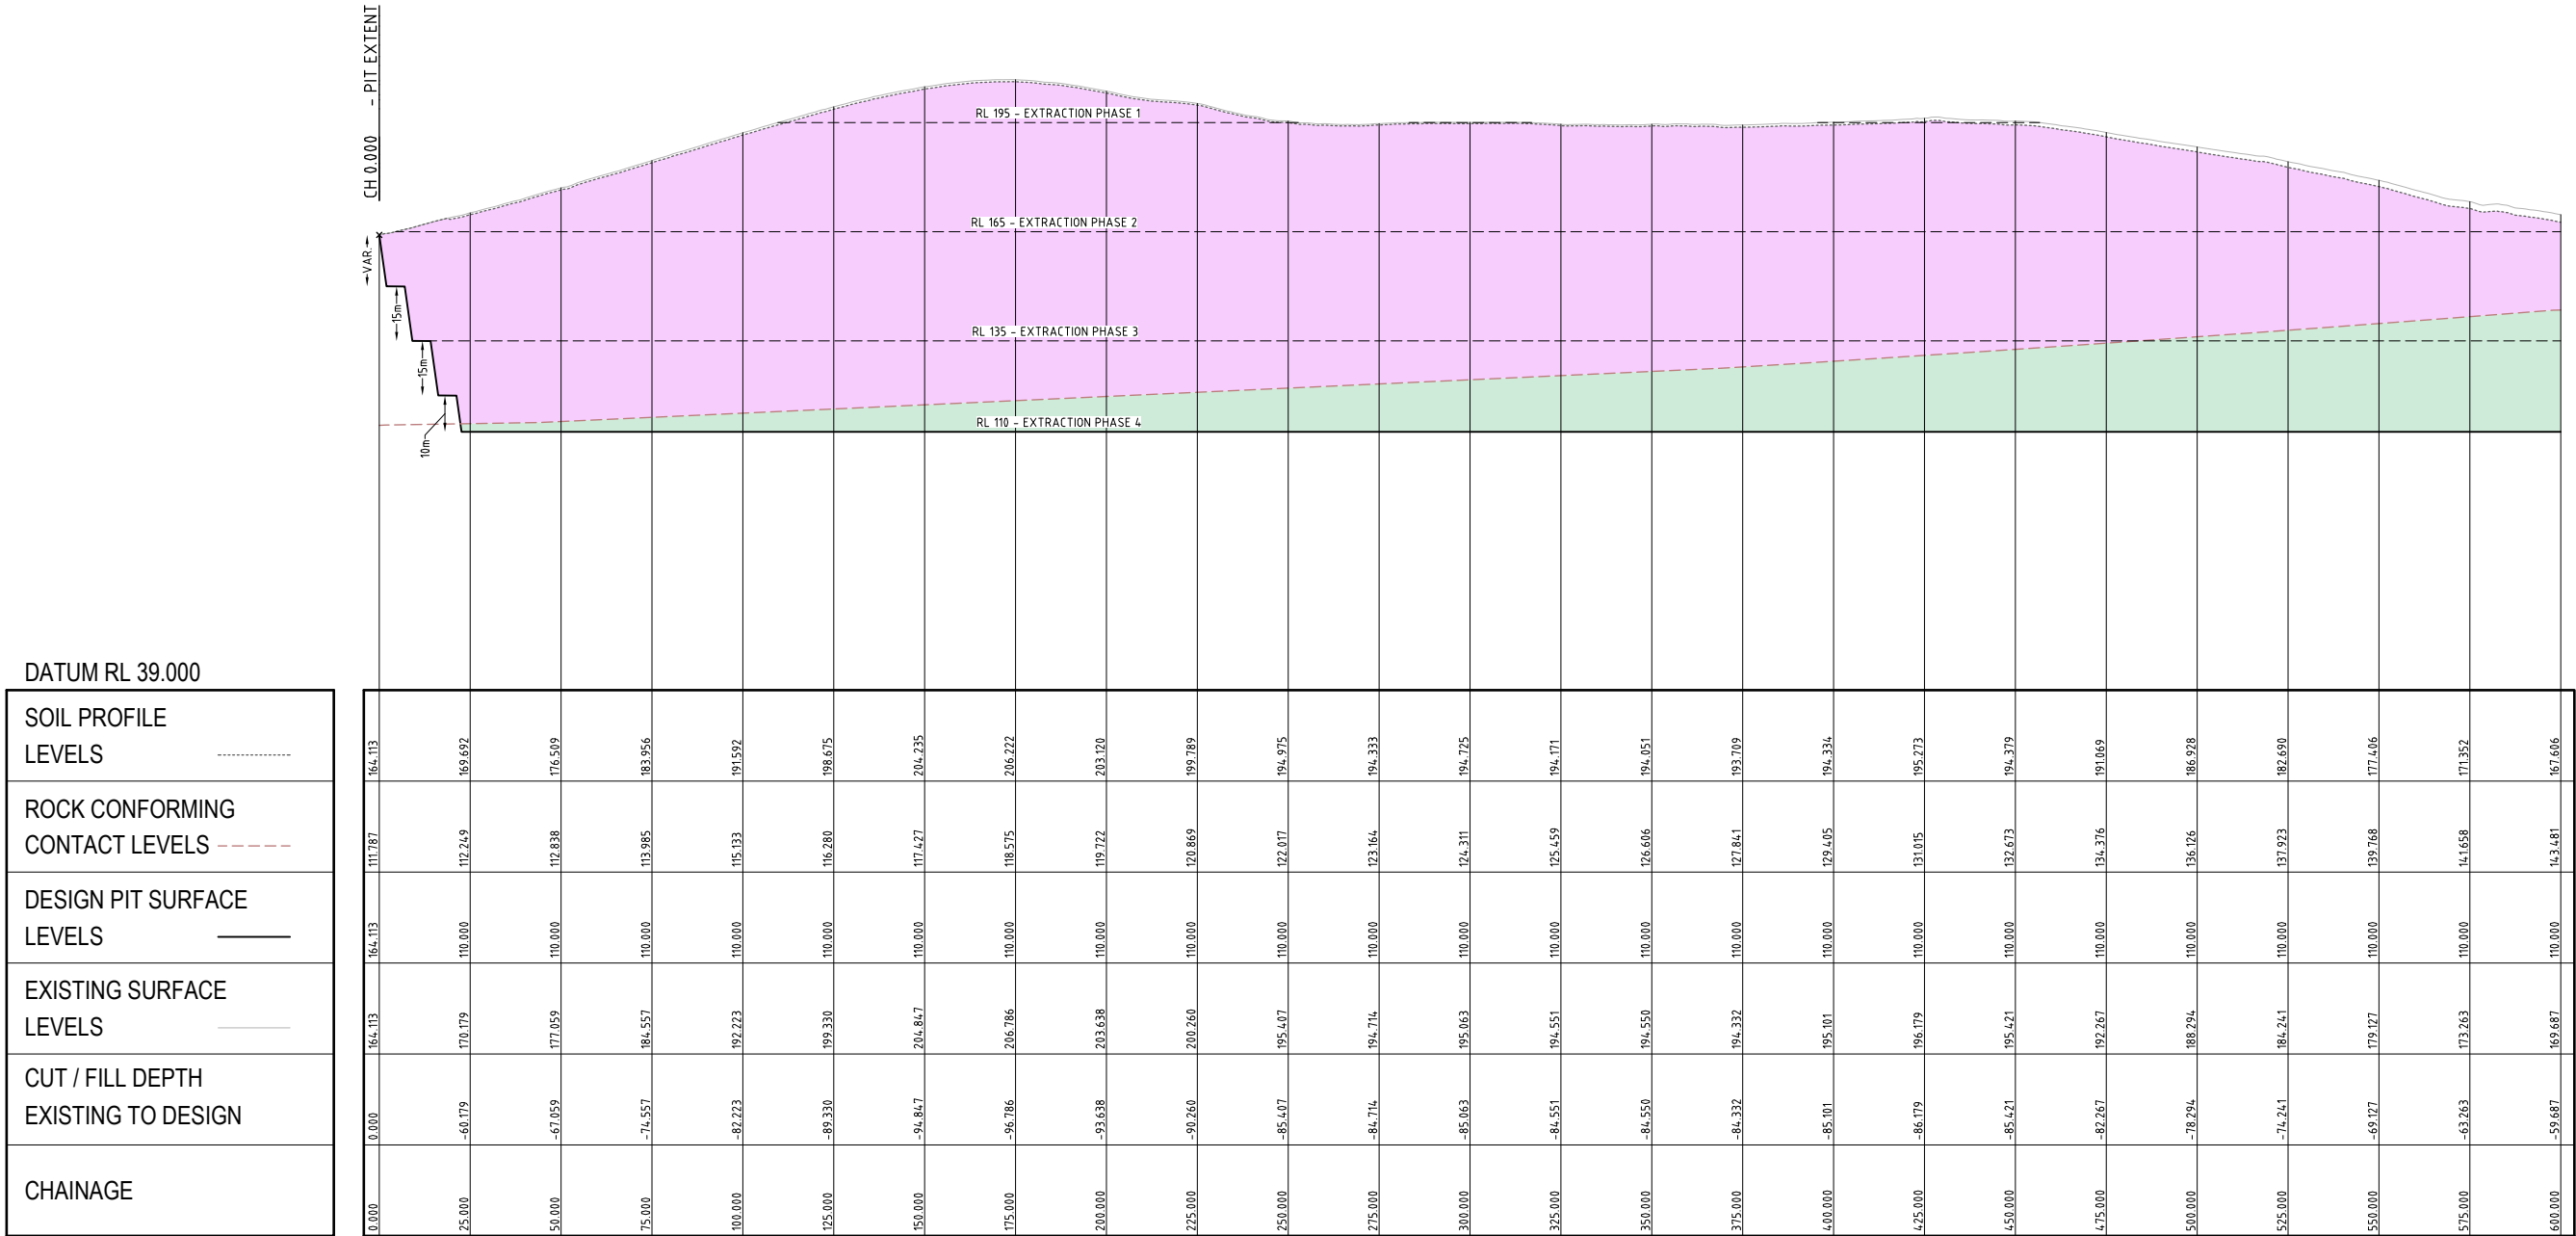
SECTION C

NOTES:  
1. CONFORMING CONTACT BETWEEN TUFF AND AGGLOMERATE AND SOIL PROFILE LEVELS HAVE BEEN APPROXIMATED BASED ON FIELD MAPPING. REFER TO GEOTECHNICAL AND PIT STAGING ASSESSMENT BY MARTENS AND ASSOCIATES (P2410628)R03V01.  
2. THE PRELIMINARY DESIGN CONSIDERS 20m HAUL ROAD AT THE TOP OF THE PIT AS SHOWN ON THE DRAWINGS AS A SIMPLE WORSE CASE SCENARIO, WHICH CONSERVATIVELY ESTIMATES THE VOLUMES (LOWER THAN ACTUAL). THE HAUL ROAD TO BE DESIGNED AT DETAILED DESIGN STAGE.

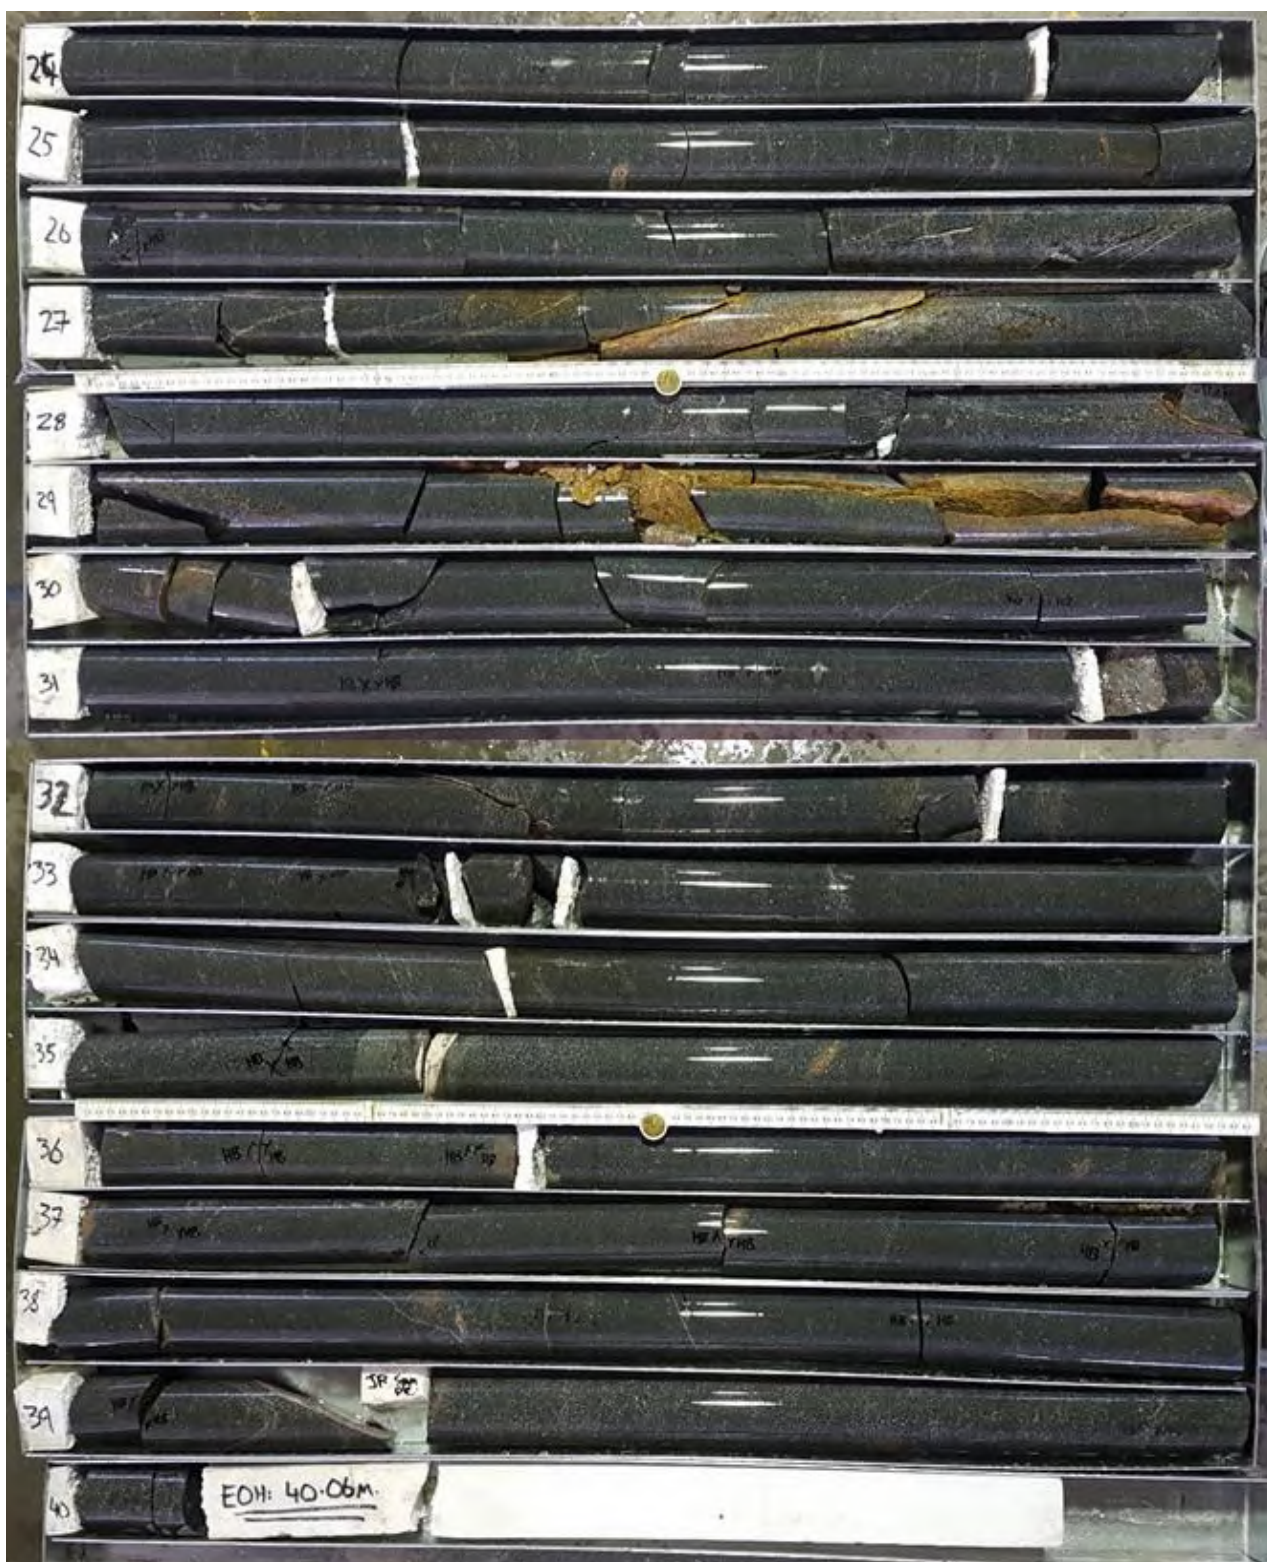
| Martens & Associates Pty Ltd ABN 85 070 240 890 | | Environment Water Wastewater Geotechnical Civil Management | |
|---|---|---|---|
| Drawn: | AM | Photo of Rock Core<br>BH102: 24.0 m – 40.06 m (Wet)<br>Lot 904 DP 1061259, Elderslie, NSW | Drawing No: |

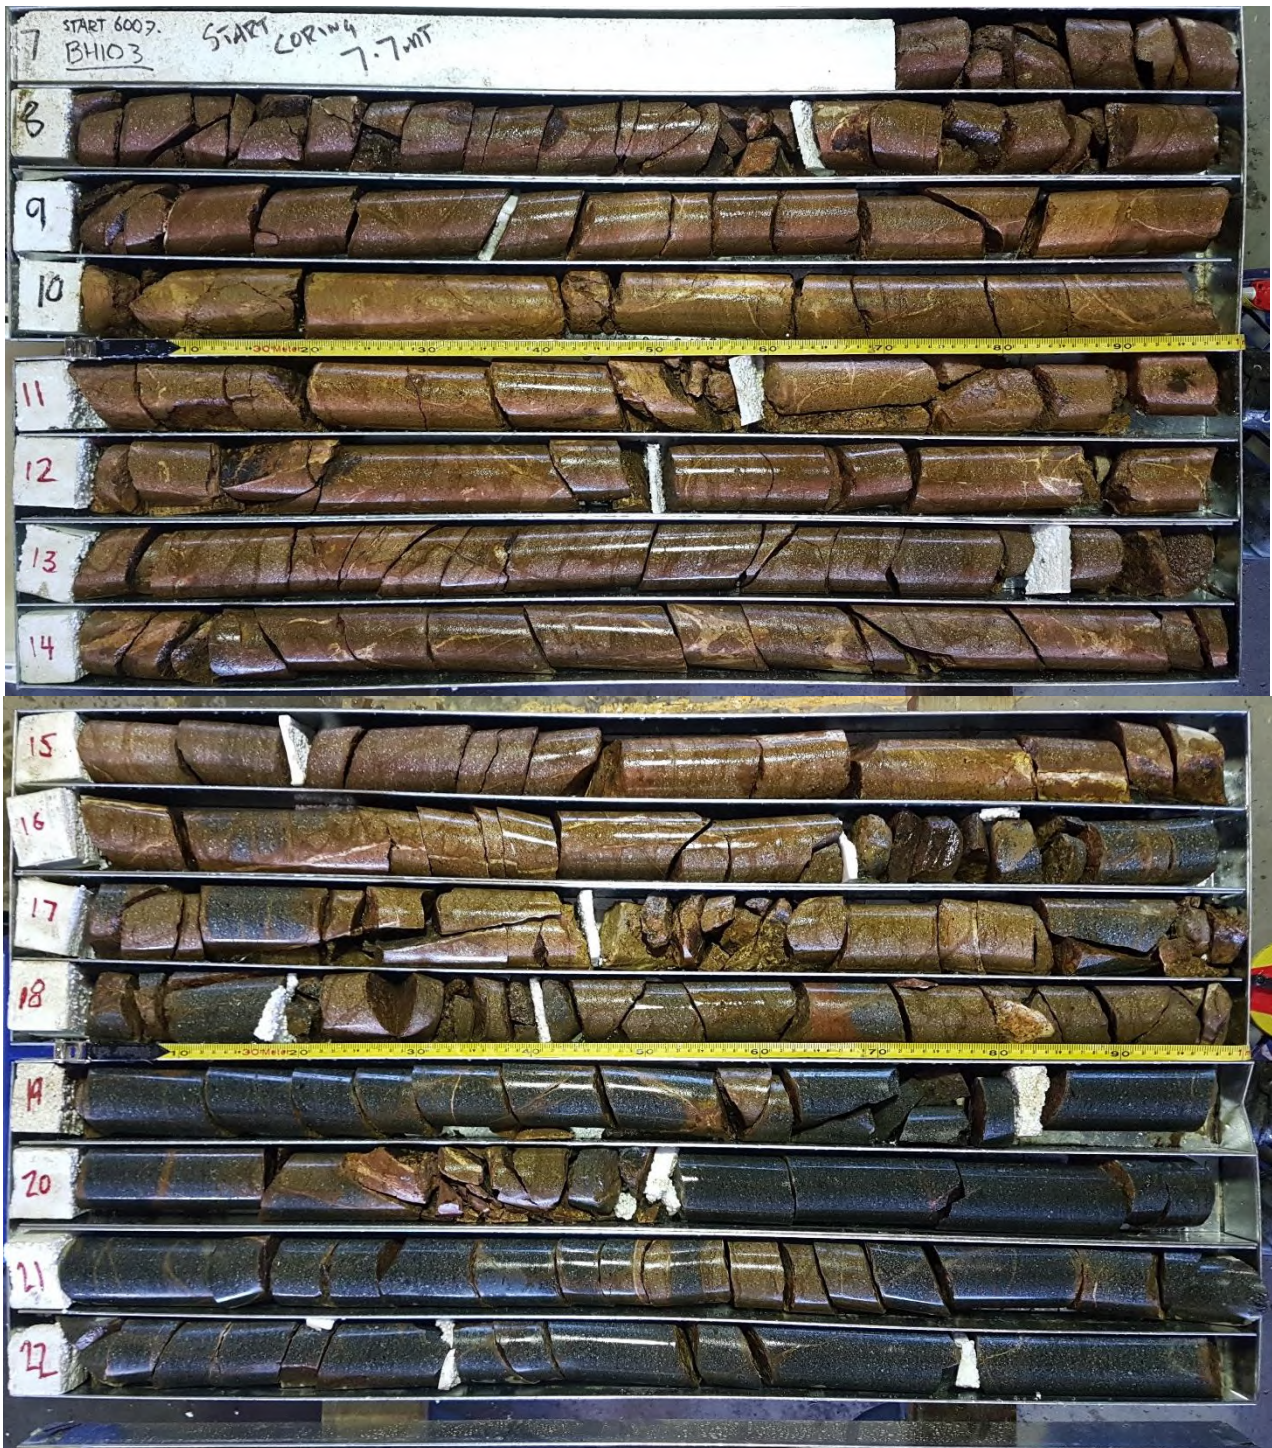
| Drawn: | AM | Photo of Rock Core<br>BH103: 7.7 m – 23.0 m (Wet)<br>Lot 904 DP 1061259, Elderslie, NSW | Drawing No: |

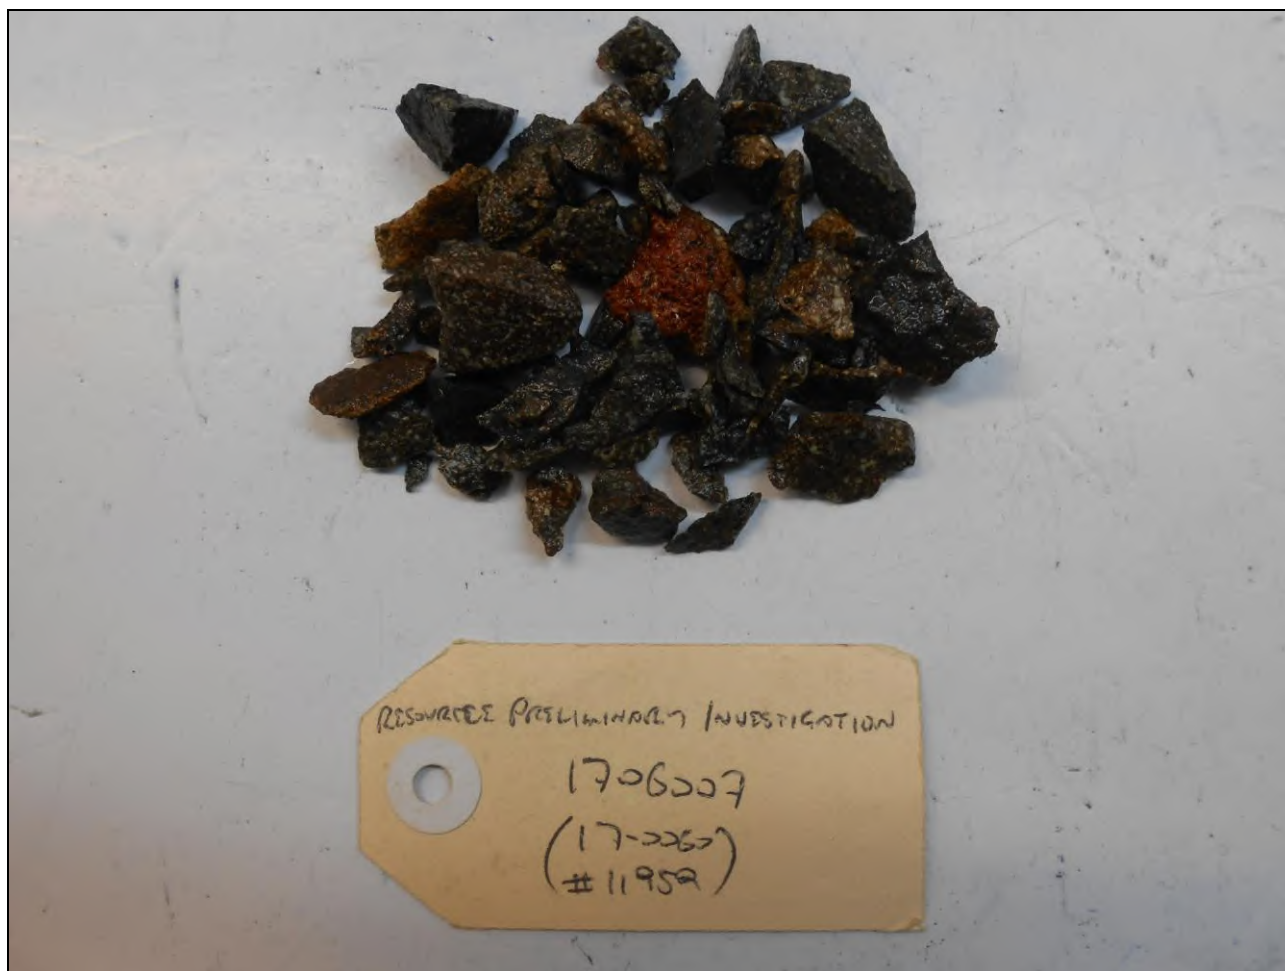
**Plate 1:** Photograph of supplied crushed aggregate sample.

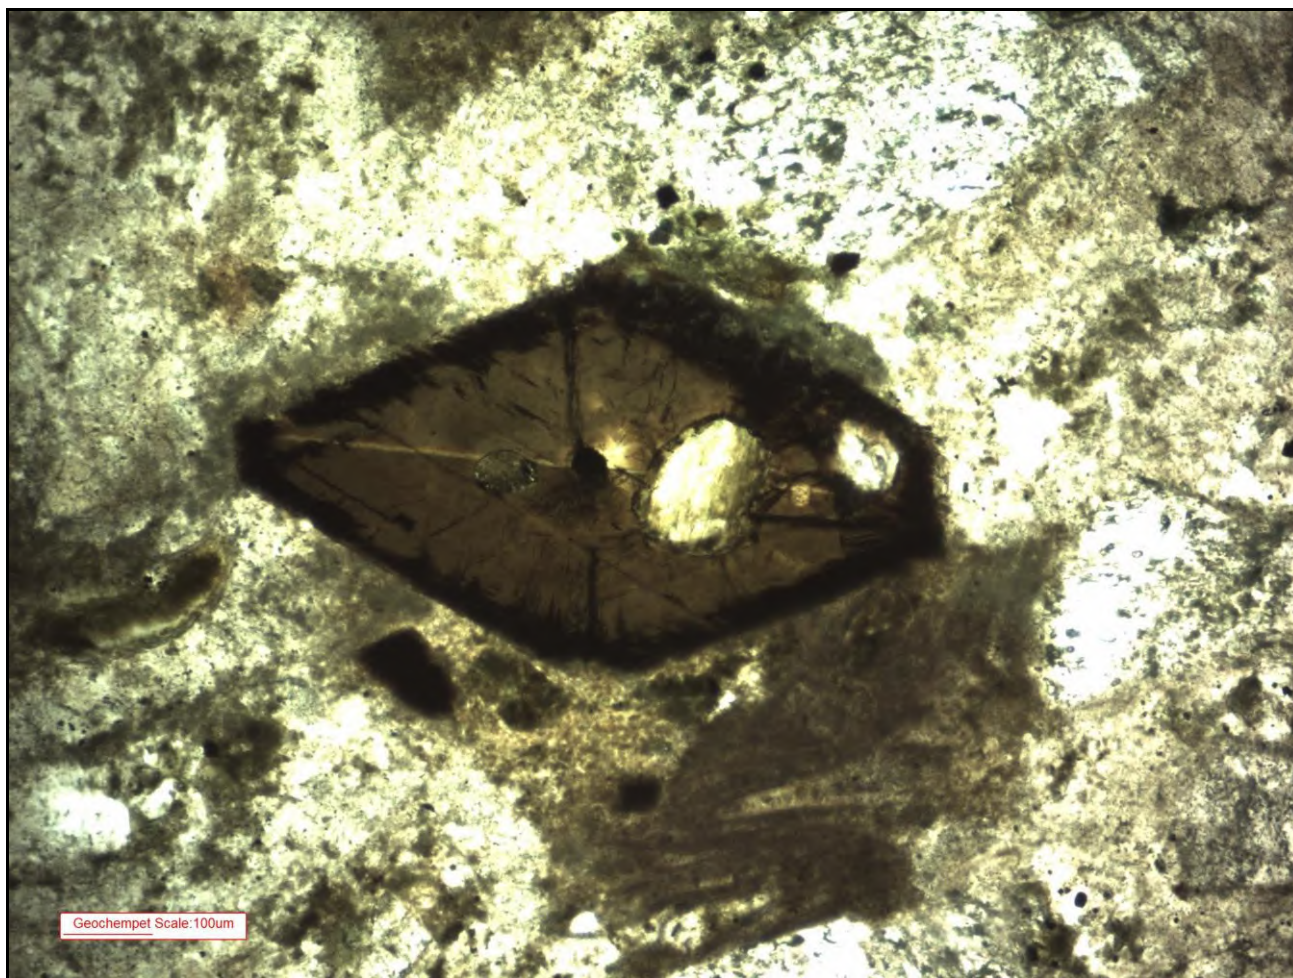
**Plate 2:** Micrograph taken at medium magnification in transmitted plane polarised light. The image shows a fragment with finely crystalline quartzofeldspathic groundmass (ghosted former glassy shards are still preserved) with a hornblende phenocryst outline by an opacite rim.

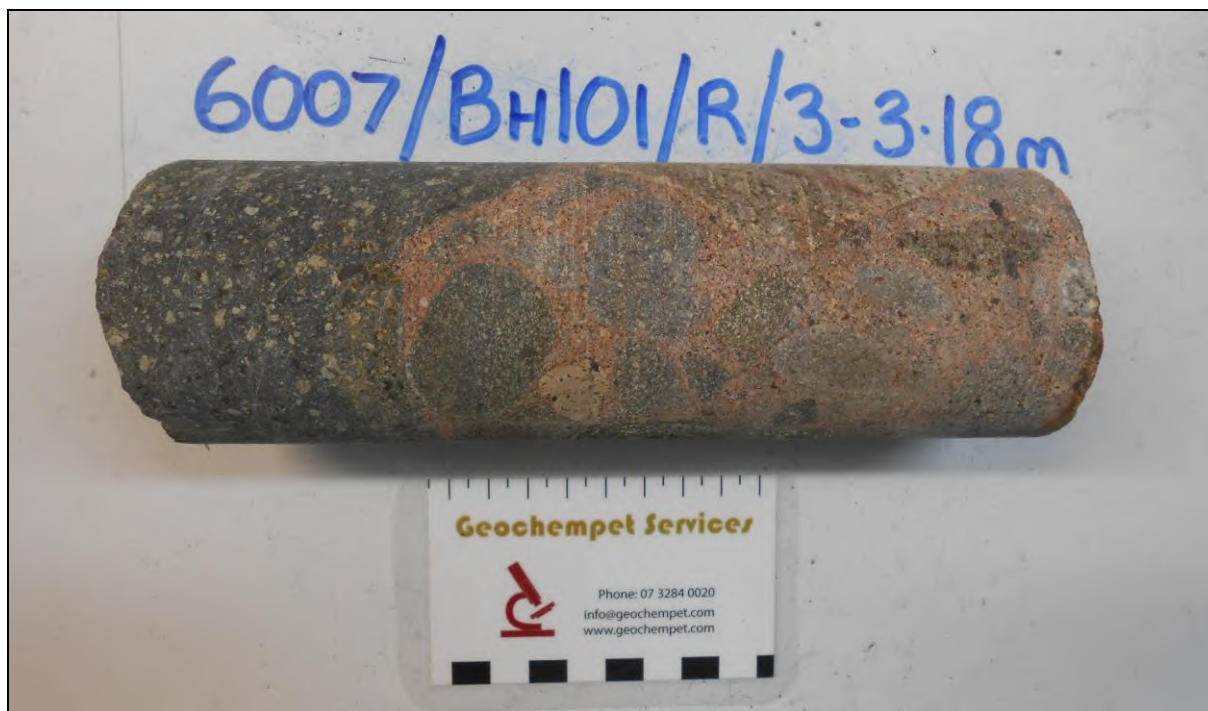
**Plate 1.** Photograph of supplied drill core sample.

The supplied sample consists of a 60 mm diameter drill core which displays apparently hard, robust, variously medium grey and light red, intermediate volcanic rock containing sub-rounded medium-grey clasts (speckled white) from a fraction of a millimetre up to 30 mm and less commonly to at least 60 mm in size dispersed through an interstitial hematite-stained (composed of fine, reddish hematite and pinkish, calcite) and brecciated matrix.

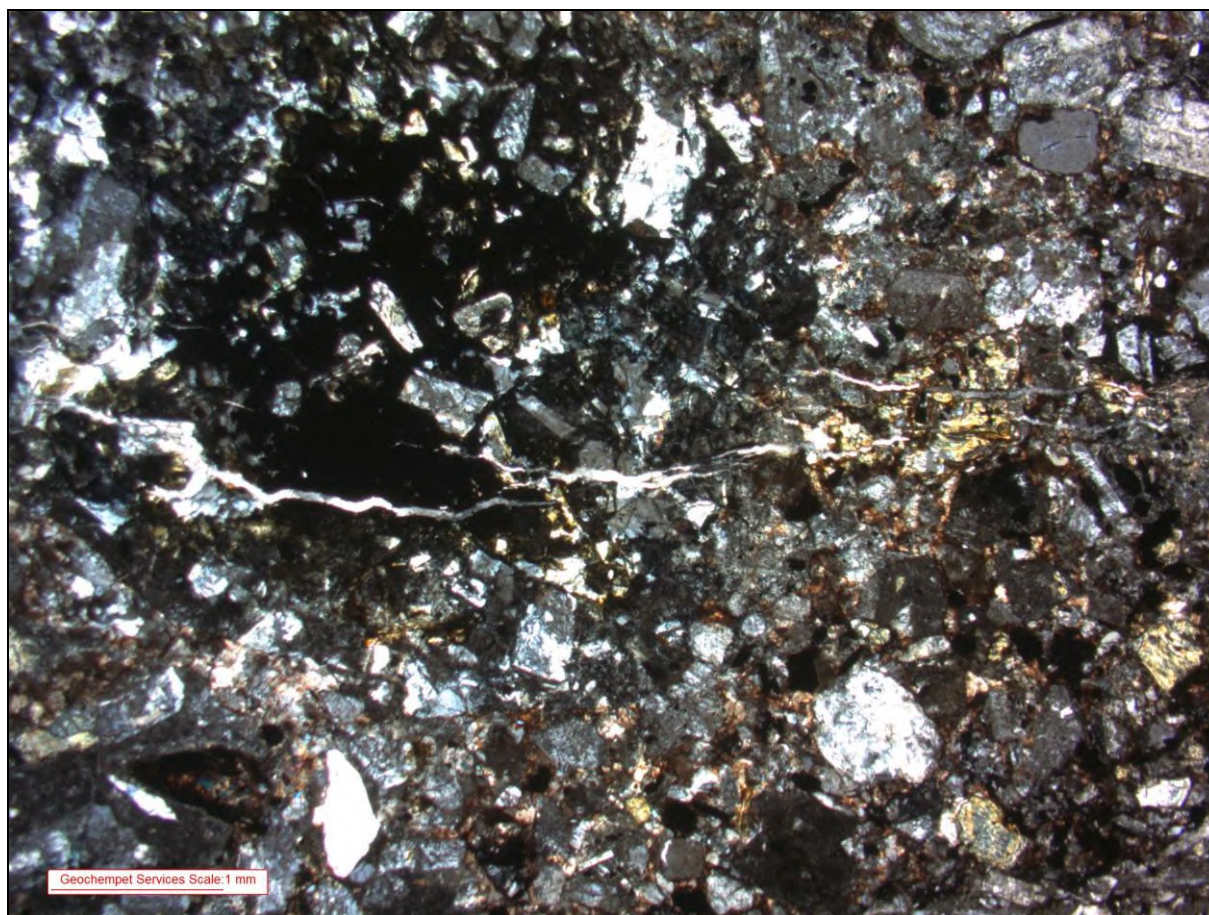
**Plate 2.** Low magnification, crossed polarised, transmitted light image of latite agglomerate. Note the variations in lithic clasts due to hematite replacement and patches of reddened anisotropic zeolite and green smectite clay. Note the calcite in fracture veins cutting across clasts.

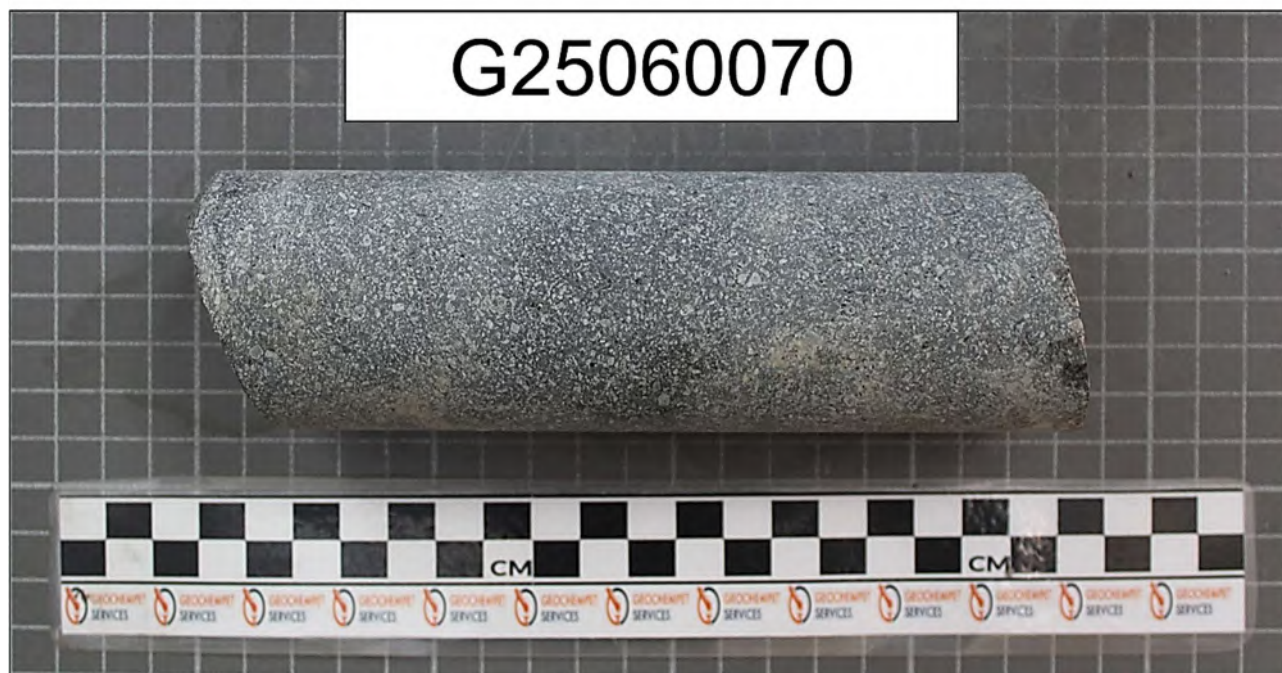
**Figure 1:** Photograph of the supplied core. Grid spacing is 1 cm.

The supplied rock appears to have an igneous origin. It comprises an andesite composition volcanic rock with a porphyritic texture. Very light grey to white and greyish black (Munsell Colour Chart 2009 N8 to N9 and N2) phenocrysts about 1 mm to 3 mm in size are present in a fine-grained, medium dark grey (Munsell Colour Chart 2009 N4) groundmass that is less than about 1 mm in size (Figure 1). The sample is hard and unweathered.

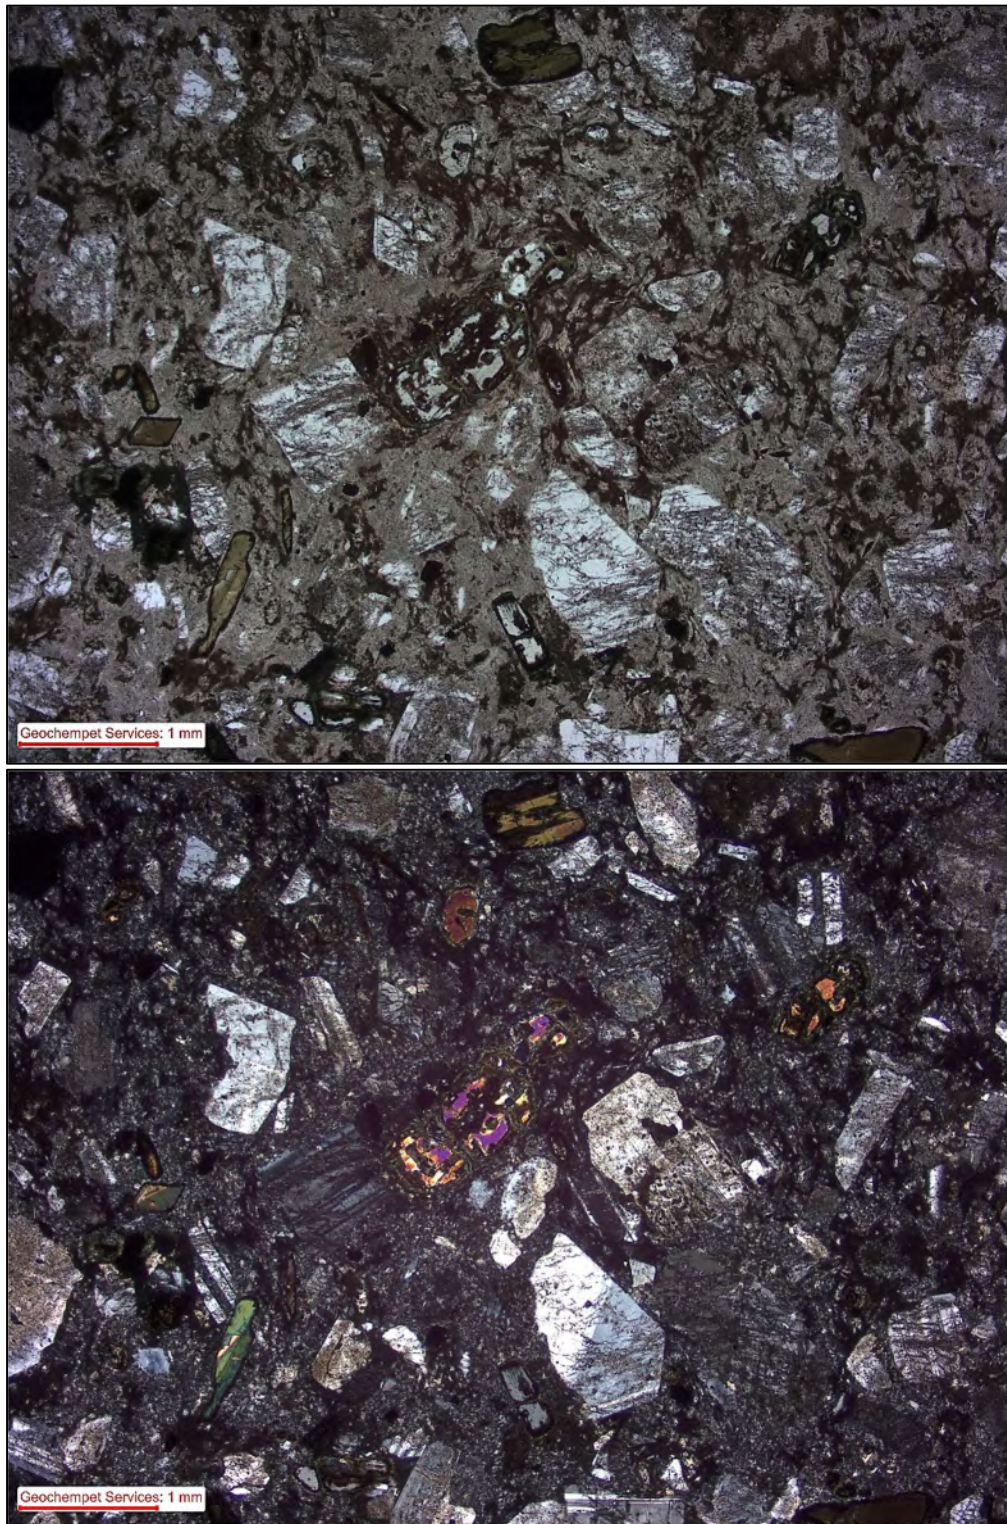
**Figure 2:** Photomicrograph of the sample taken at low magnification (2× objective) using plane-polarised (upper) and cross-polarised (lower) transmitted light. The image shows phenocrysts of variably sericite/illite altered feldspar, chlorite altered pyroxene and iron oxide rimmed amphibole in a microcrystalline groundmass of quartz and feldspar.

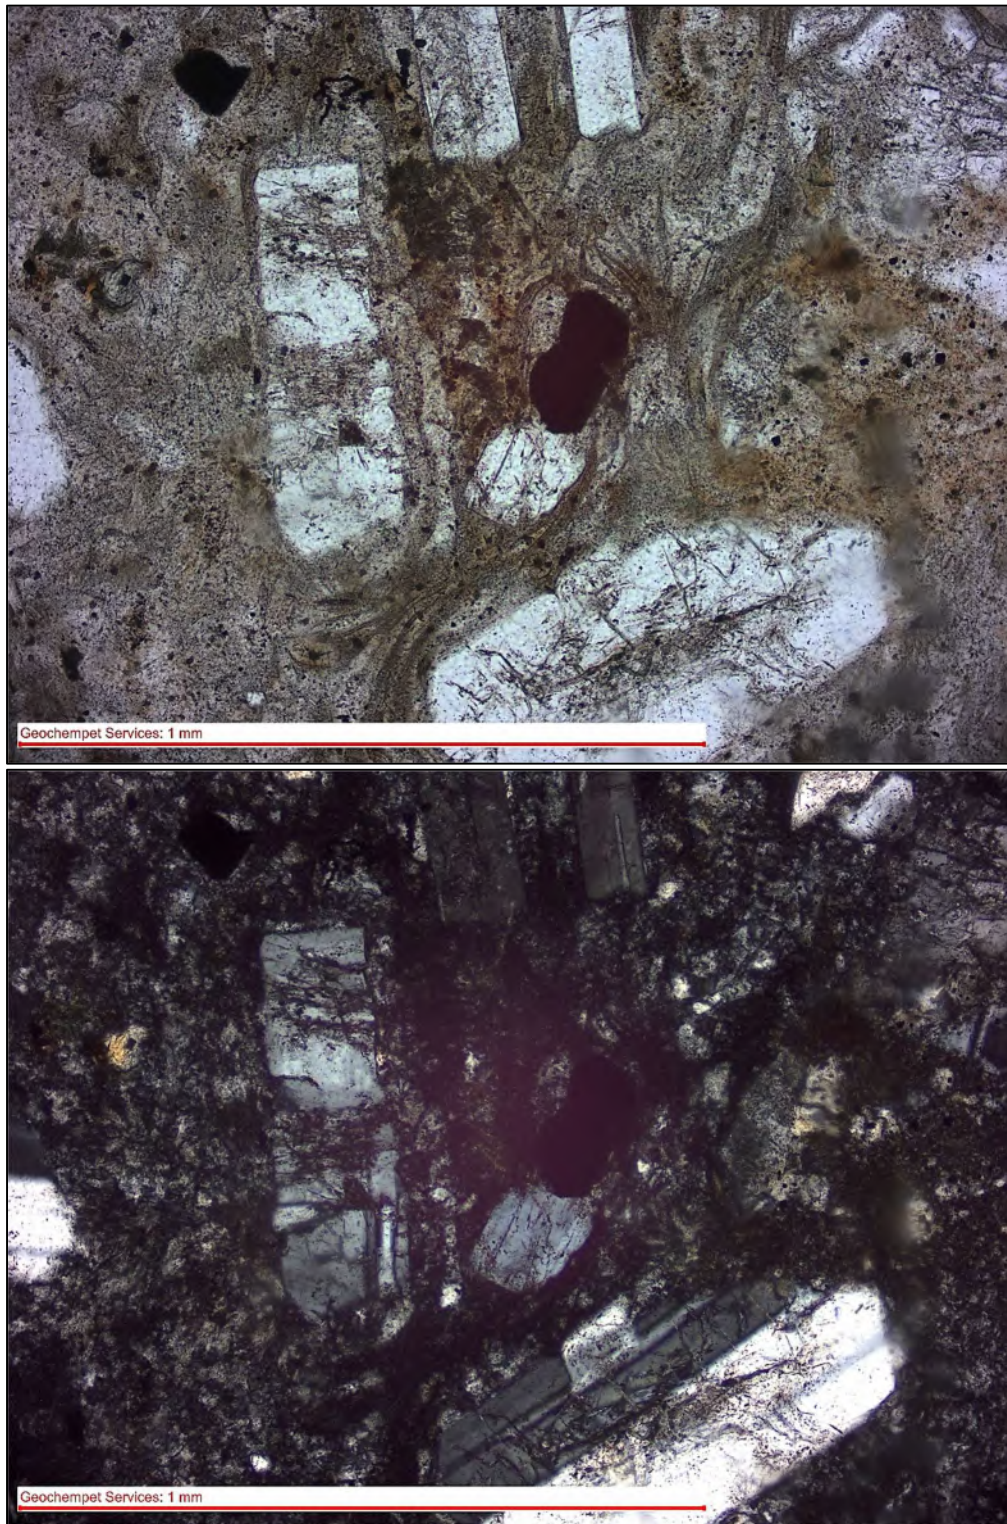
**Figure 3:** Photomicrograph of the sample taken at high magnification (10× objective) using plane-polarised (upper) and cross-polarised (lower) transmitted light. The image shows a pocket of remnant eutaxitic banding in the microcrystalline groundmass.

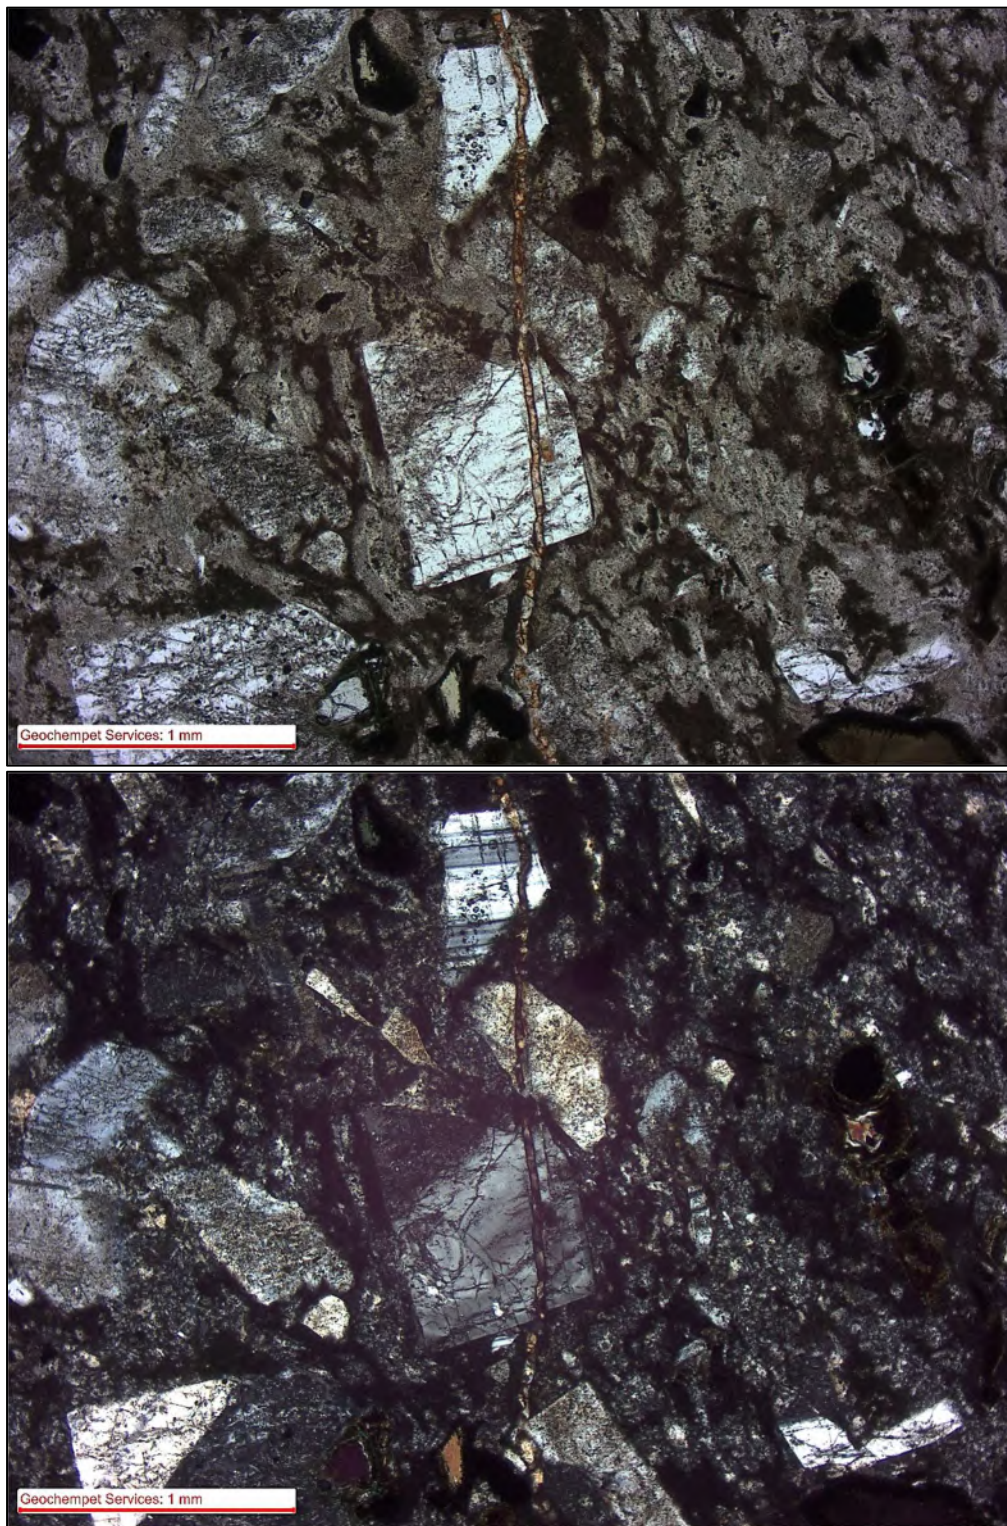
**Figure 4:** Photomicrograph of the sample taken at medium magnification (4× objective) using plane-polarised (upper) and cross-polarised (lower) transmitted light. The image shows a late fracture cutting across feldspar phenocrysts and the groundmass mineralogy.

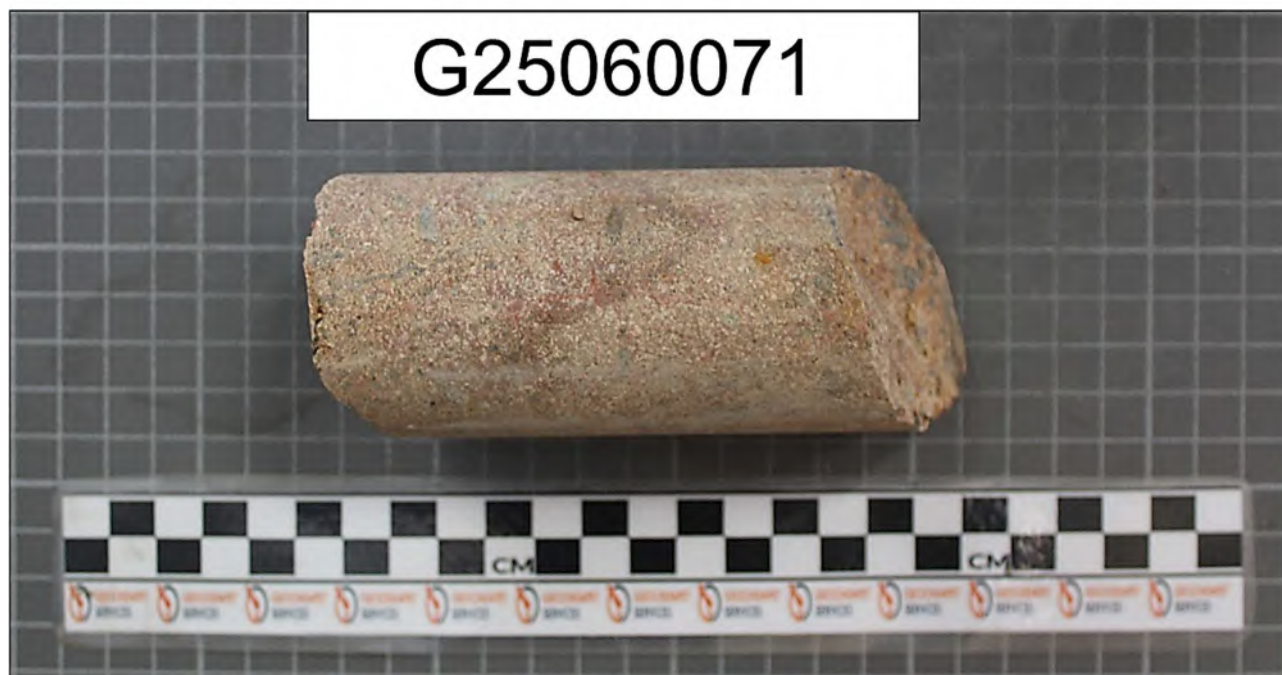
**Figure 1:** Photograph of the supplied core. Grid spacing is 1 cm.

The rock has minor amounts of fracturing less than 1 mm in thickness. The fracturing appears to be randomly oriented throughout the sample and contains moderate reddish brown to dark reddish brown (Munsell Colour Chart 2009 10R 4/6 to 10R 3/4) secondary iron oxide mineral fill.

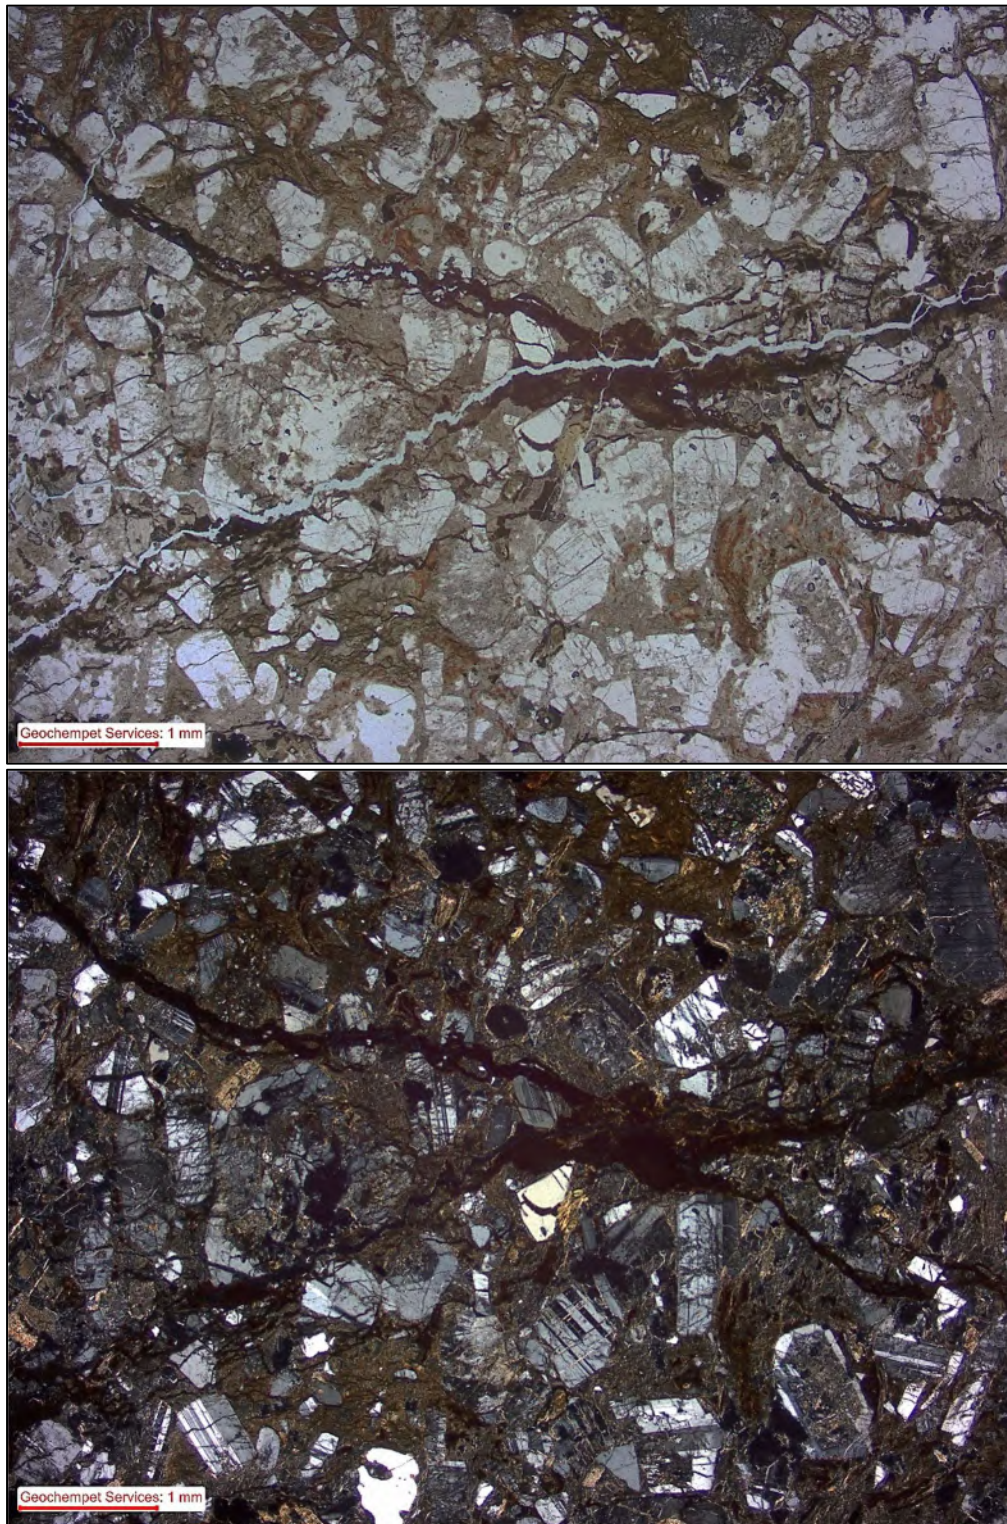
**Figure 2:** Photomicrograph of the sample taken at low magnification (2× objective) using plane-polarised (upper) and cross-polarised (lower) transmitted light. The image shows variably strained quartz phenocrysts and variably sericite/illite altered feldspar phenocrysts in the altered groundmass. Also shown are several randomly oriented late fractures that are variably filled with iron oxides.
