# Resource Feasibility Assessment

Proposed Bluestone Hardrock Quarry - Springvale Road, Elderslie, NSW &  
Blind Creek Road, Glendon Brook, NSW

Final Report

Prepared for Bluestone Hardrock Pty Ltd

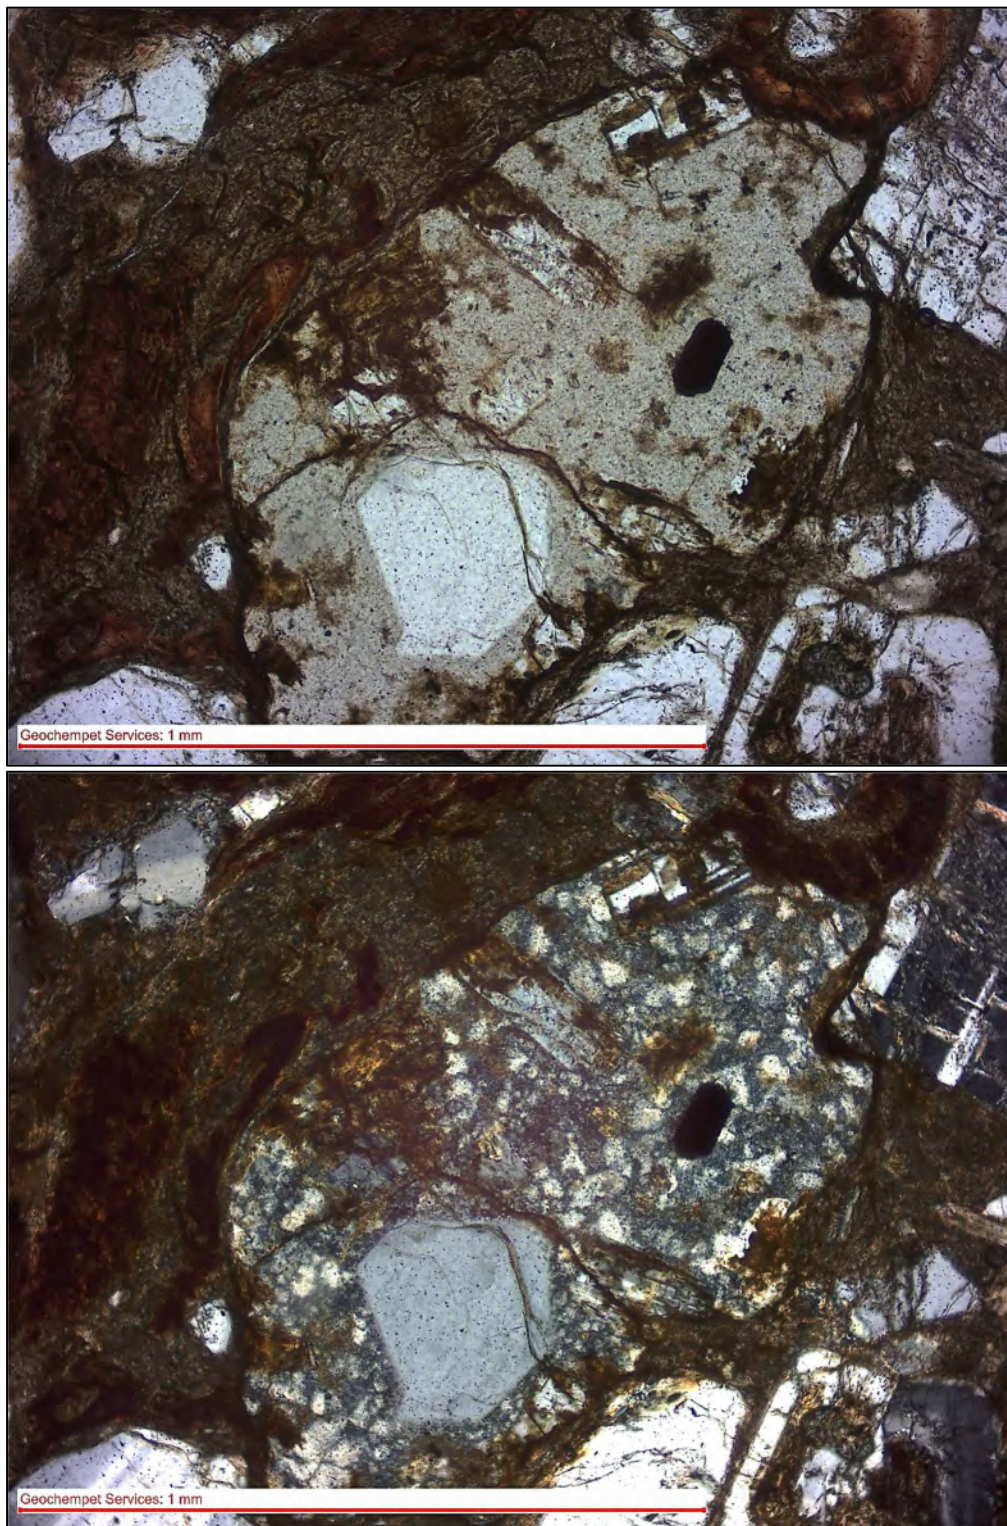
**Figure 3:** Photomicrograph of the sample taken at high magnification (10× objective) using plane-polarised (upper) and cross-polarised (lower) transmitted light. The image shows a lithic fragment of felsic volcanic rock within the altered groundmass of the rhyodacite tuff.

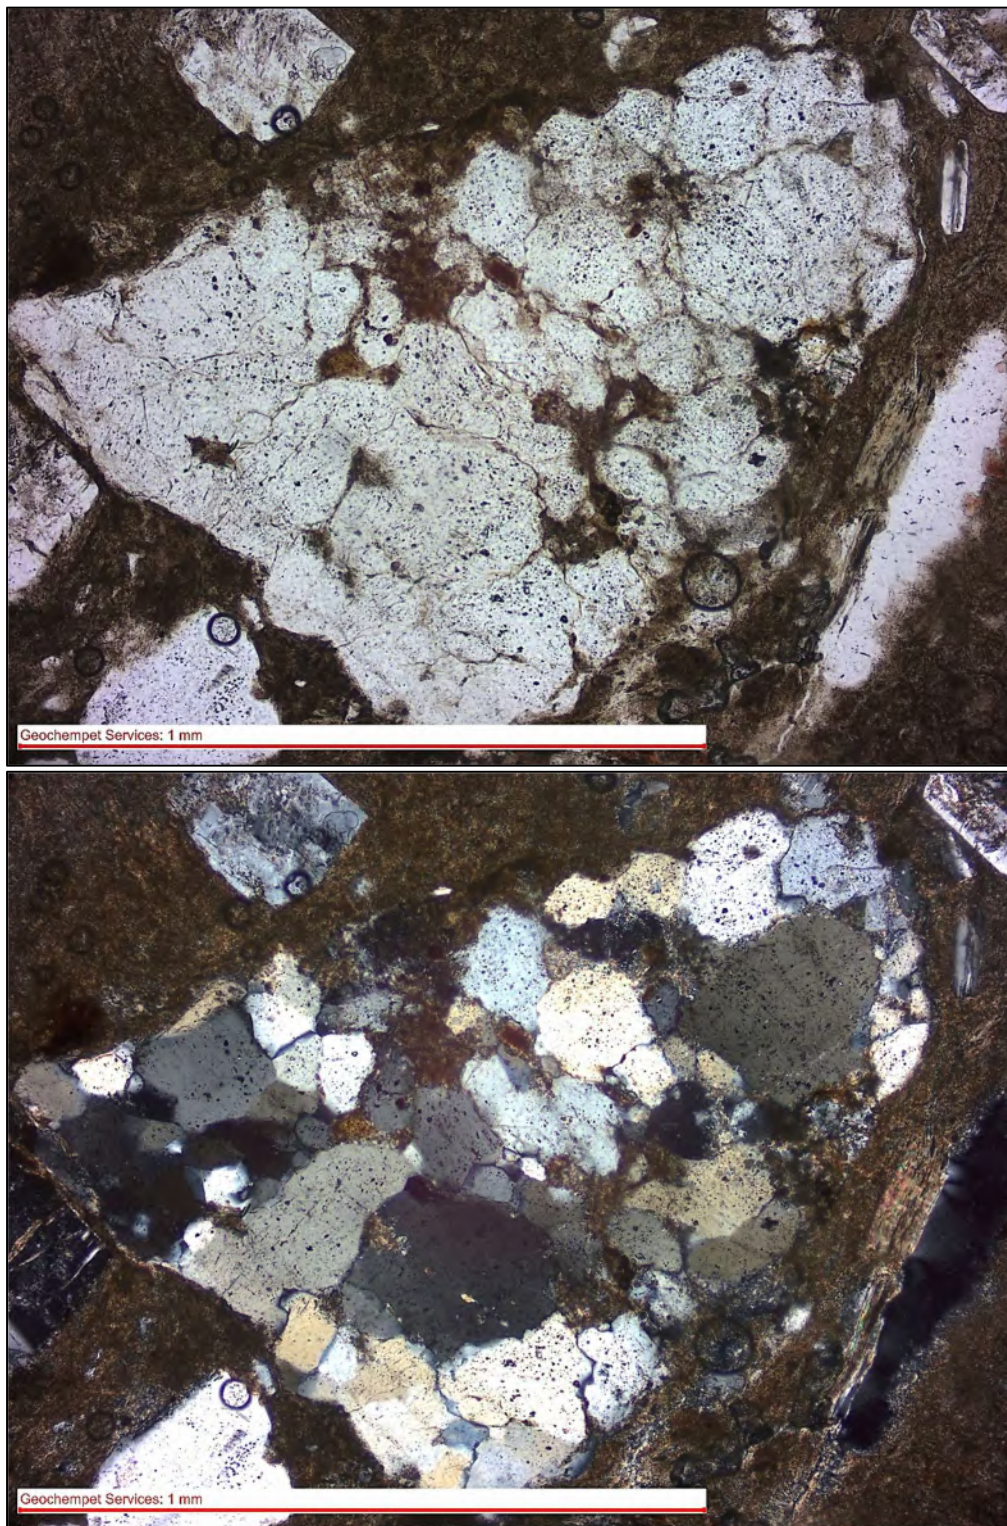
**Figure 4:** Photomicrograph of the sample taken at high magnification (10× objective) using plane-polarised (upper) and cross-polarised (lower) transmitted light. The image shows a lithic fragment of quartzite within the altered groundmass of the rhyodacite tuff.

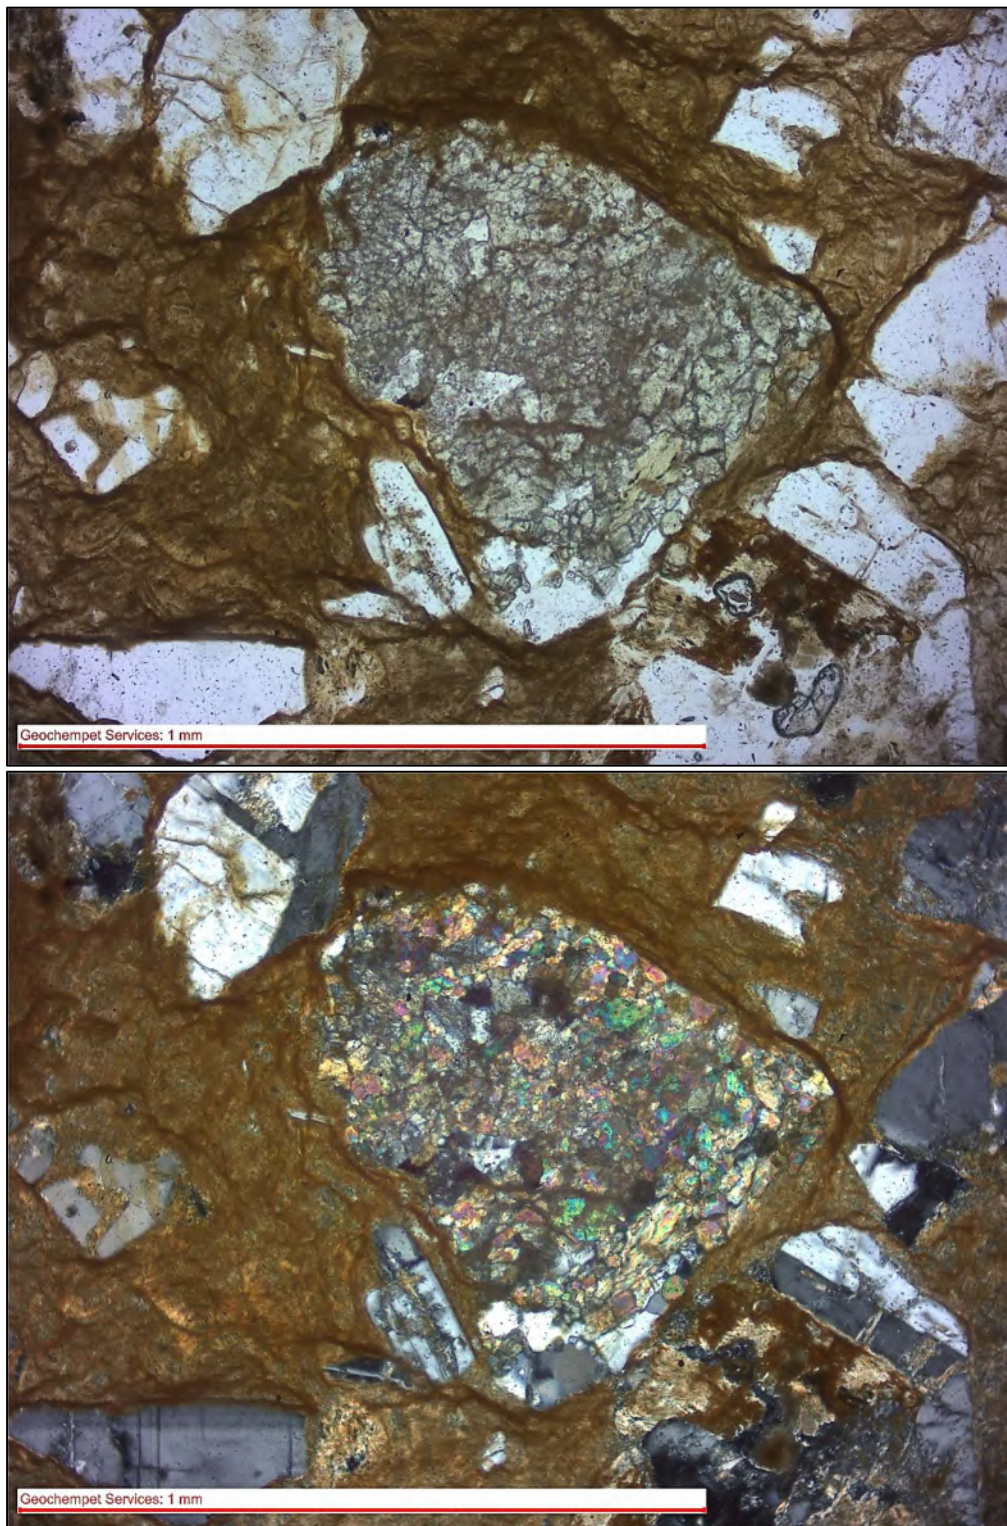
**Figure 5:** Photomicrograph of the sample taken at high magnification (10× objective) using plane-polarised (upper) and cross-polarised (lower) transmitted light. The image shows a lithic fragment of epidosite (epidote and quartz rock) within the altered groundmass of the rhyodacite tuff.
