**MOOREBANK PRECINCT EAST STAGE 2:
BIODIVERSITY MONITORING IN ANZAC CREEK
AUTUMN 2022 SURVEY**

**Report Prepared for
ARCADIS**

6 July 2022

**BIO-ANALYSIS Pty Ltd**
Marine, Estuarine & Freshwater Ecology
2/1 Botham Close, Charmhaven, NSW 2263
(Mobile) 0414 477 066; (Email) info@bioanalysis.com.au

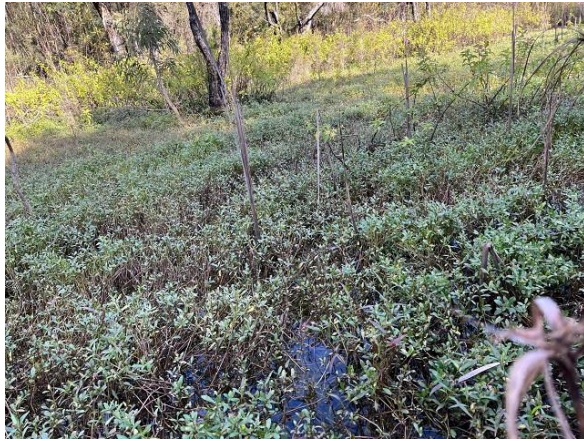
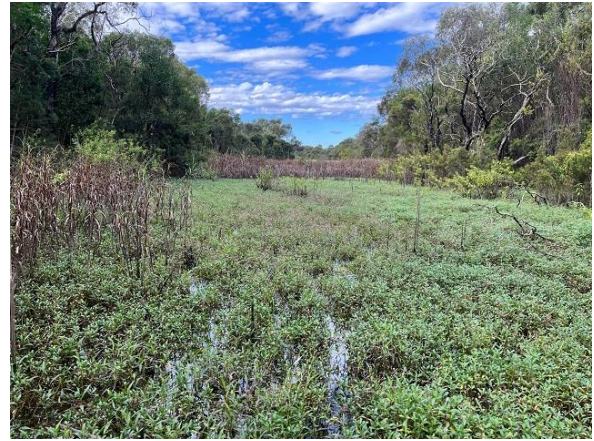
Flow was apparent at the time of the autumn 2022 surveys and the channel was almost full-to-bank (up to approximately 0.4 m deep) (Plates 1&2). The active channel zone at this site (up to approximately 5 m wide) remains stable (i.e. no signs of active erosion), mostly due to dense cover of the shallow, relatively narrow stream channel by emergent macrophytes and the relatively intact woody riparian vegetation (Appendix 2). The channel consisted of fine sediment.

The stream channel at Site AQ1 is mostly colonised by the noxious plant, Alligator Weed (*Alternanthera philoxeroides*), and the native species, Slender knotweed (*Persicaria decipiens*) (Plates 1&2). Other species of aquatic plant observed at Site AQ1 included Marsh Club-rush (*Bolboschoenus fluviatilis*) and Typha (*Typha* sp.). The tree canopy was mostly comprised by *Melaleuca* spp. and *Eucalyptus* spp. (Plates 1&2).

Plate 1: AQ1 – View across-stream (31/05/22)

Plate 2: AQ1 – View downstream (5/05/22)

It is recommended that Land managers focus on containment and on-going suppression of the Alligator Weed infestation at Site AQ1. Signage and public information at popular points of entry by the public to the creek and other local waterways may reduce the chance of unintentional human-assisted introductions (e.g. by using live bait, or by being released by aquaria).

Also of relevance to Site AQ1 is the continued infestation of the stream channel by Alligator Weed (*Alternanthera philoxeroides*). Due to its highly invasive nature, Alligator weed is listed as a noxious plant and considered a threat to waterways, wetlands, floodplains and irrigation systems in Australia. The “Regional Recommended Measure” applicable to the area

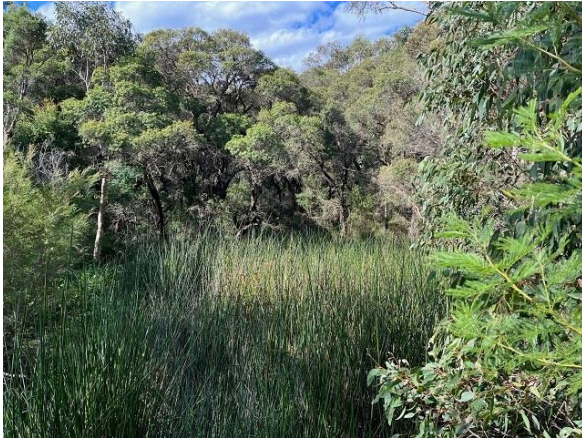
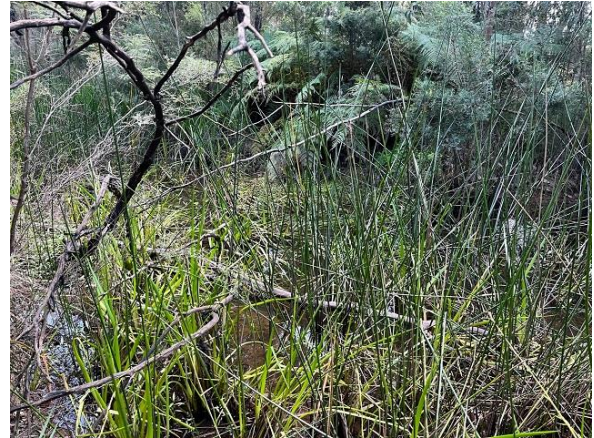
The stream channel at Site AQ4 has occasionally been dry, including at the time of the Baseline survey (i.e. autumn 2018). Since the autumn 2020 surveys, surface water has been observed along the study reach (up to approximately 0.4 m deep), including in autumn 2022 (Plates 3&4). Water clarity was considered good at the time of the autumn 2022 surveys (Plate 3).

Since the baseline survey, stands of the emergent macrophyte, Jointed Twig Rush (*Baumea articulata*) and Twig Rush (*Baumea rubiginosa*) have formed across the downstream reaches of stream channel (Plate 4). Jointed Twig Rush, Slender Knotweed and Frog's Mouth (*Philydrum lanuginosum*) are common in the upstream reaches (Plate 4).

The active channel zone, composed of fine sediments, was up to approximately 4 m wide (Plates 3&4). No indicators of significant erosion were observed suggesting that Anzac Creek continues to be relatively stable at this site, particularly since colonisation of the stream channel by emergent macrophytes (Plate 3&4, Appendix 2).

Plate 3: AQ4 – View downstream (5/05/22)

Plate 4: AQ4 – View upstream (5/05/22)

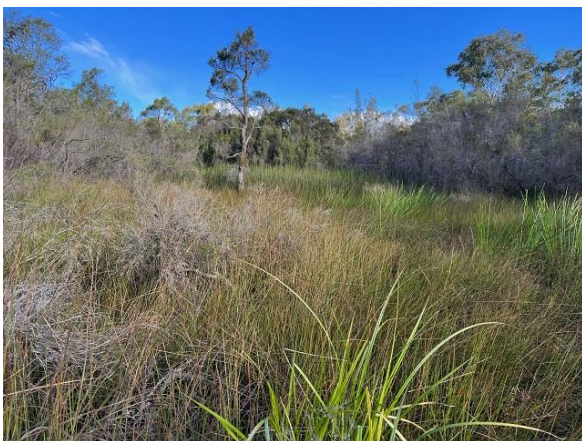
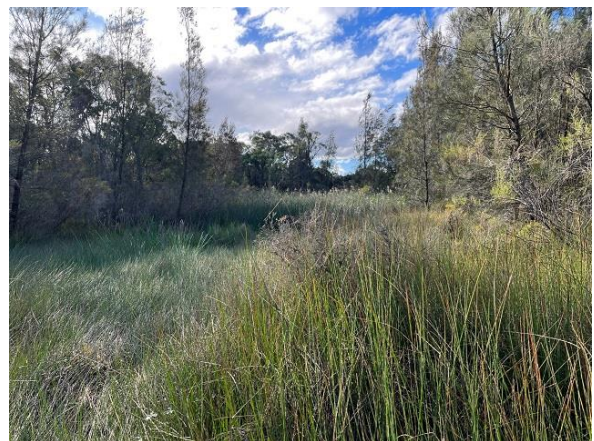
Similar to previous surveys, the study reach was mostly colonised by Heron Bristle Sedge (*Chorizandra cymbaria*), Jointed Twig Rush and Tall Spikerush (*Eleocharis sphacelata*), with occasional Frogmouth (*Philydrum lanuginosum*), Slender Knotweed and the introduced species, Umbrella Sedge (*Cyperus eragrostis*), present throughout (Plates 5&6). Riparian vegetation was dominated by *Casuarina* trees. Common Reed/Phragmites (*Phragmites australis*) was present at the downstream end of the site (Plate 6).

The stream channel at Site AQ8 (up to approximately 20 m wide) continues to be classified as stable, mostly due to dense cover by emergent macrophytes in addition to a relatively intact, woody riparian zone (Appendix 2).

Plate 5: Site AQ8 – view upstream (31/05/22)

Plate 6: Site AQ8 – view downstream (31/05/22)

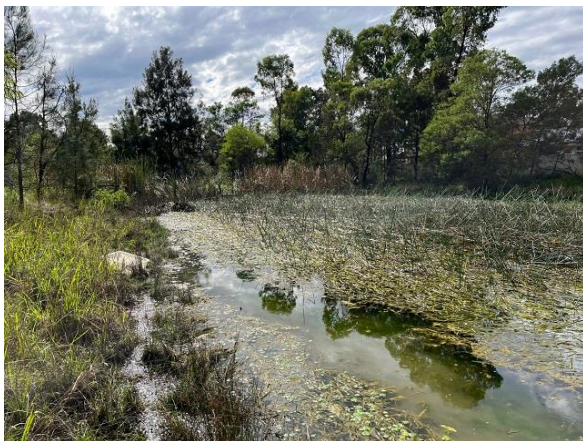
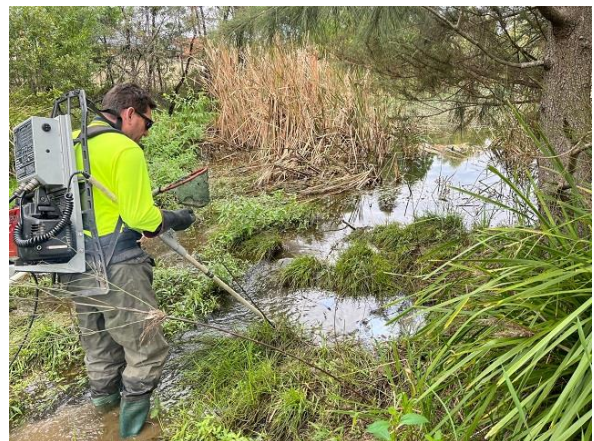
The submerged macrophyte species, Ribbonweed (*Vallisneria* sp.) and *Potamogeton ochreatus* were common, in addition to Slender Knotweed and dense stands of Typha, Phragmites and Tall Spike Rush (Plate 7). *Nymphoides geminata* (Entire Marshwort), with mostly floating leaves, was common close to the shore. Accumulations of green filamentous algae were apparent in areas close to the shore (Plates 7&8). *Egeria* (*Egeria densa*), which was collected close to the left-bank (facing downstream) of the pool in spring 2020, has not been collected subsequently.

Riparian vegetation included Casuarina, Eucalyptus and Melaleuca trees and Spiny-head Mat-rush/Basket Grass (*Lomdandra longifolia*) (Plates 7&8).

Plate 7: Site AQ12 – view downstream (5/05/22)

Plate 8: Site AQ12 – view upstream (5/05/22)

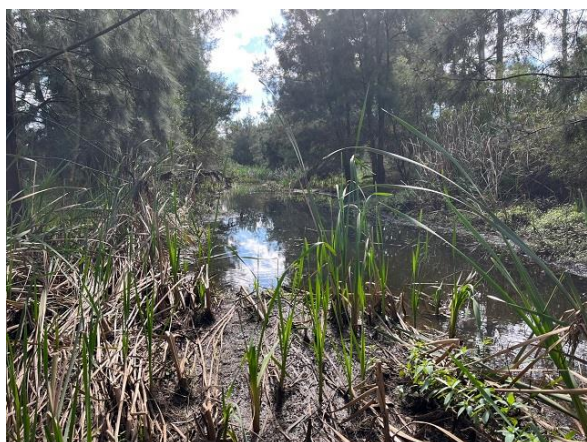
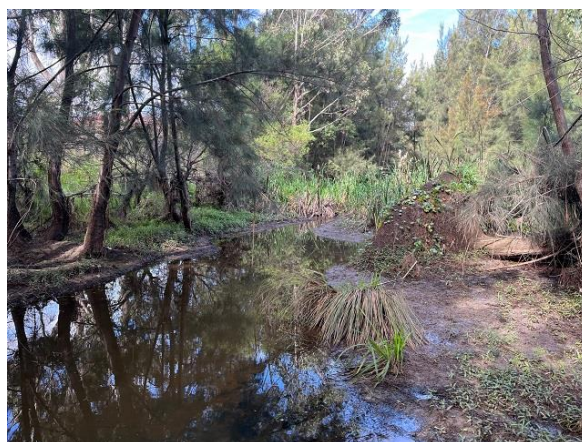
Water to a depth of approximately 0.8 m was present at Site AQ13 at the time of both surveys, and flow was apparent (Plates 9&10). Unlike the findings of previous surveys, there was no apparent iron floc or anoxic layer covering the stream substratum and visibility was good.

A large proportion of the stream channel and edges were colonised by Typha and Slender Knotweed. River Clubrush (*Schoenoplectus validus*) and Whorled Pennywort/Shield Pennywort (*Hydrocotyle cf verticillata*) were also common. The stream channel appeared stable (Appendix 2).

Plate 9: Site AQ13 – view downstream (5/05/22)

Plate 10: Site AQ13 – view upstream (5/05/22)

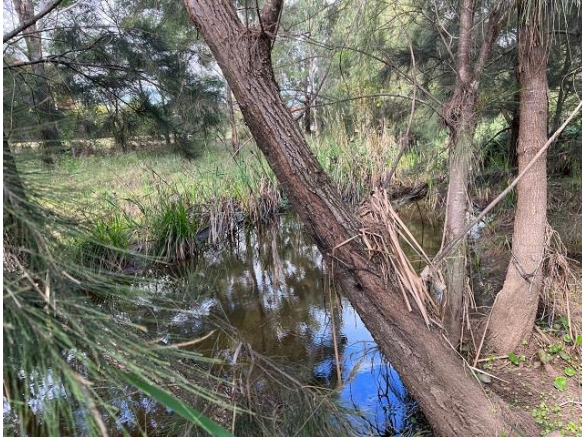
Site AQ14 is situated approximately 150 m downstream of Site AQ13 and immediately downstream of the culvert that links the dam within Commonwealth Department of Defence Lands to Anzac Creek (Figure 1). Flow was apparent at the time of both autumn 2022 surveys and water clarity was good (Plates 11&12).

Typha, Slender Knotweed, River Clubrush and Whorled Pennywort/Shield Pennywort were common (Plates 11&12). This section of Anzac Creek remains mostly stable due to dense instream vegetation and vegetated banks (Appendix 2).

Plate 11: Site AQ14 – view upstream (5/05/22)

Plate 12: Site AQ14 – view across-stream (5/05/22)

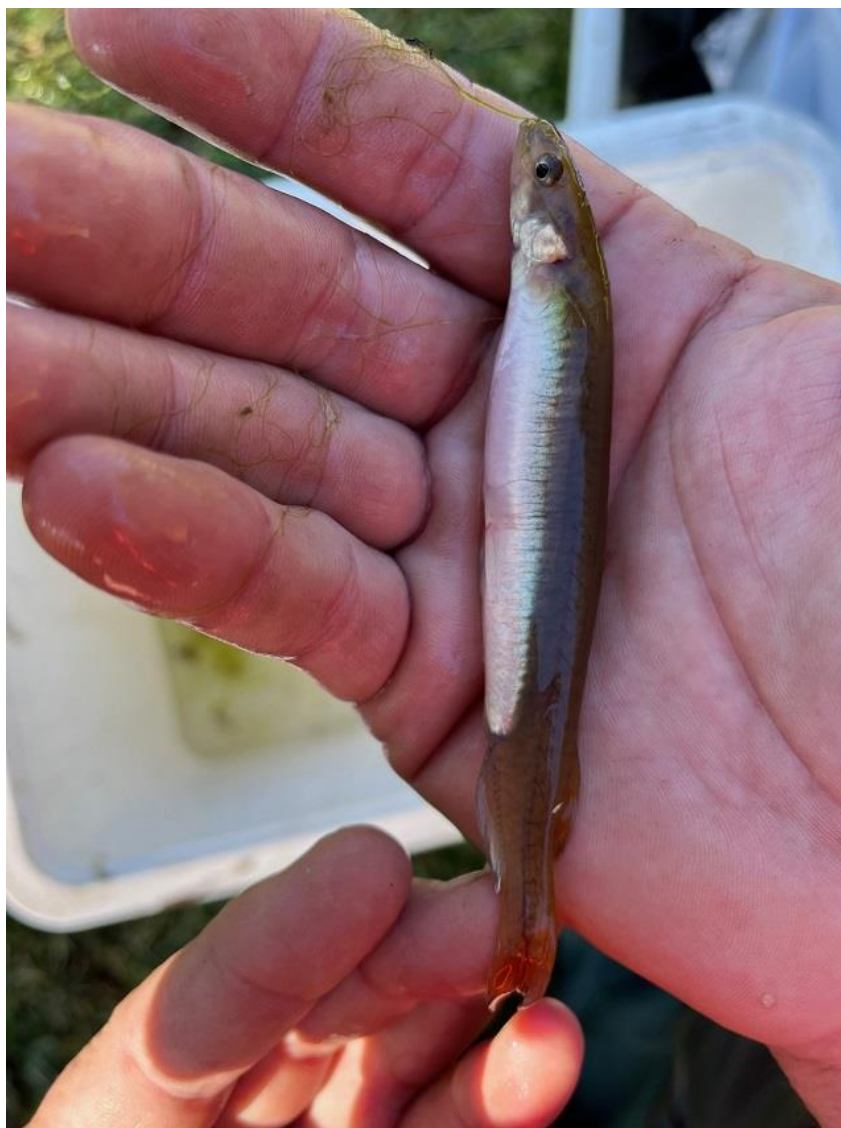
Plate 13: Common galaxias collected at Site AQ12 (31/05/2022).

Six species of fish were observed while electro-fishing at Site AQ12 in autumn 2022 (Table 10). *Gambusia* (*Gambusia holbrooki*) were common and were also caught in dip nets used to sample aquatic macroinvertebrates in autumn 2022 (Table 6). Other species collected during autumn 2022 included Short-finned (*Anguilla australis*) and Long-finned eels (*Anguilla reinhardtii*) (<30cm in length), small numbers of Common galaxias (*Galaxias maculatus*) and Striped gudgeon (*Gobiomorphus australis*) and the introduced species, Oriental waterloach (*Misgurnus anguillicaudatus*) (Table 10).
