Report on  
Preliminary (Subsurface) Contaminated Land  
Investigation

Proposed Mixed Use Development  
WIN Grand  
Crown Street, Wollongong

Prepared for  
Birketu Pty Ltd

Project 89584.01  
June 2022

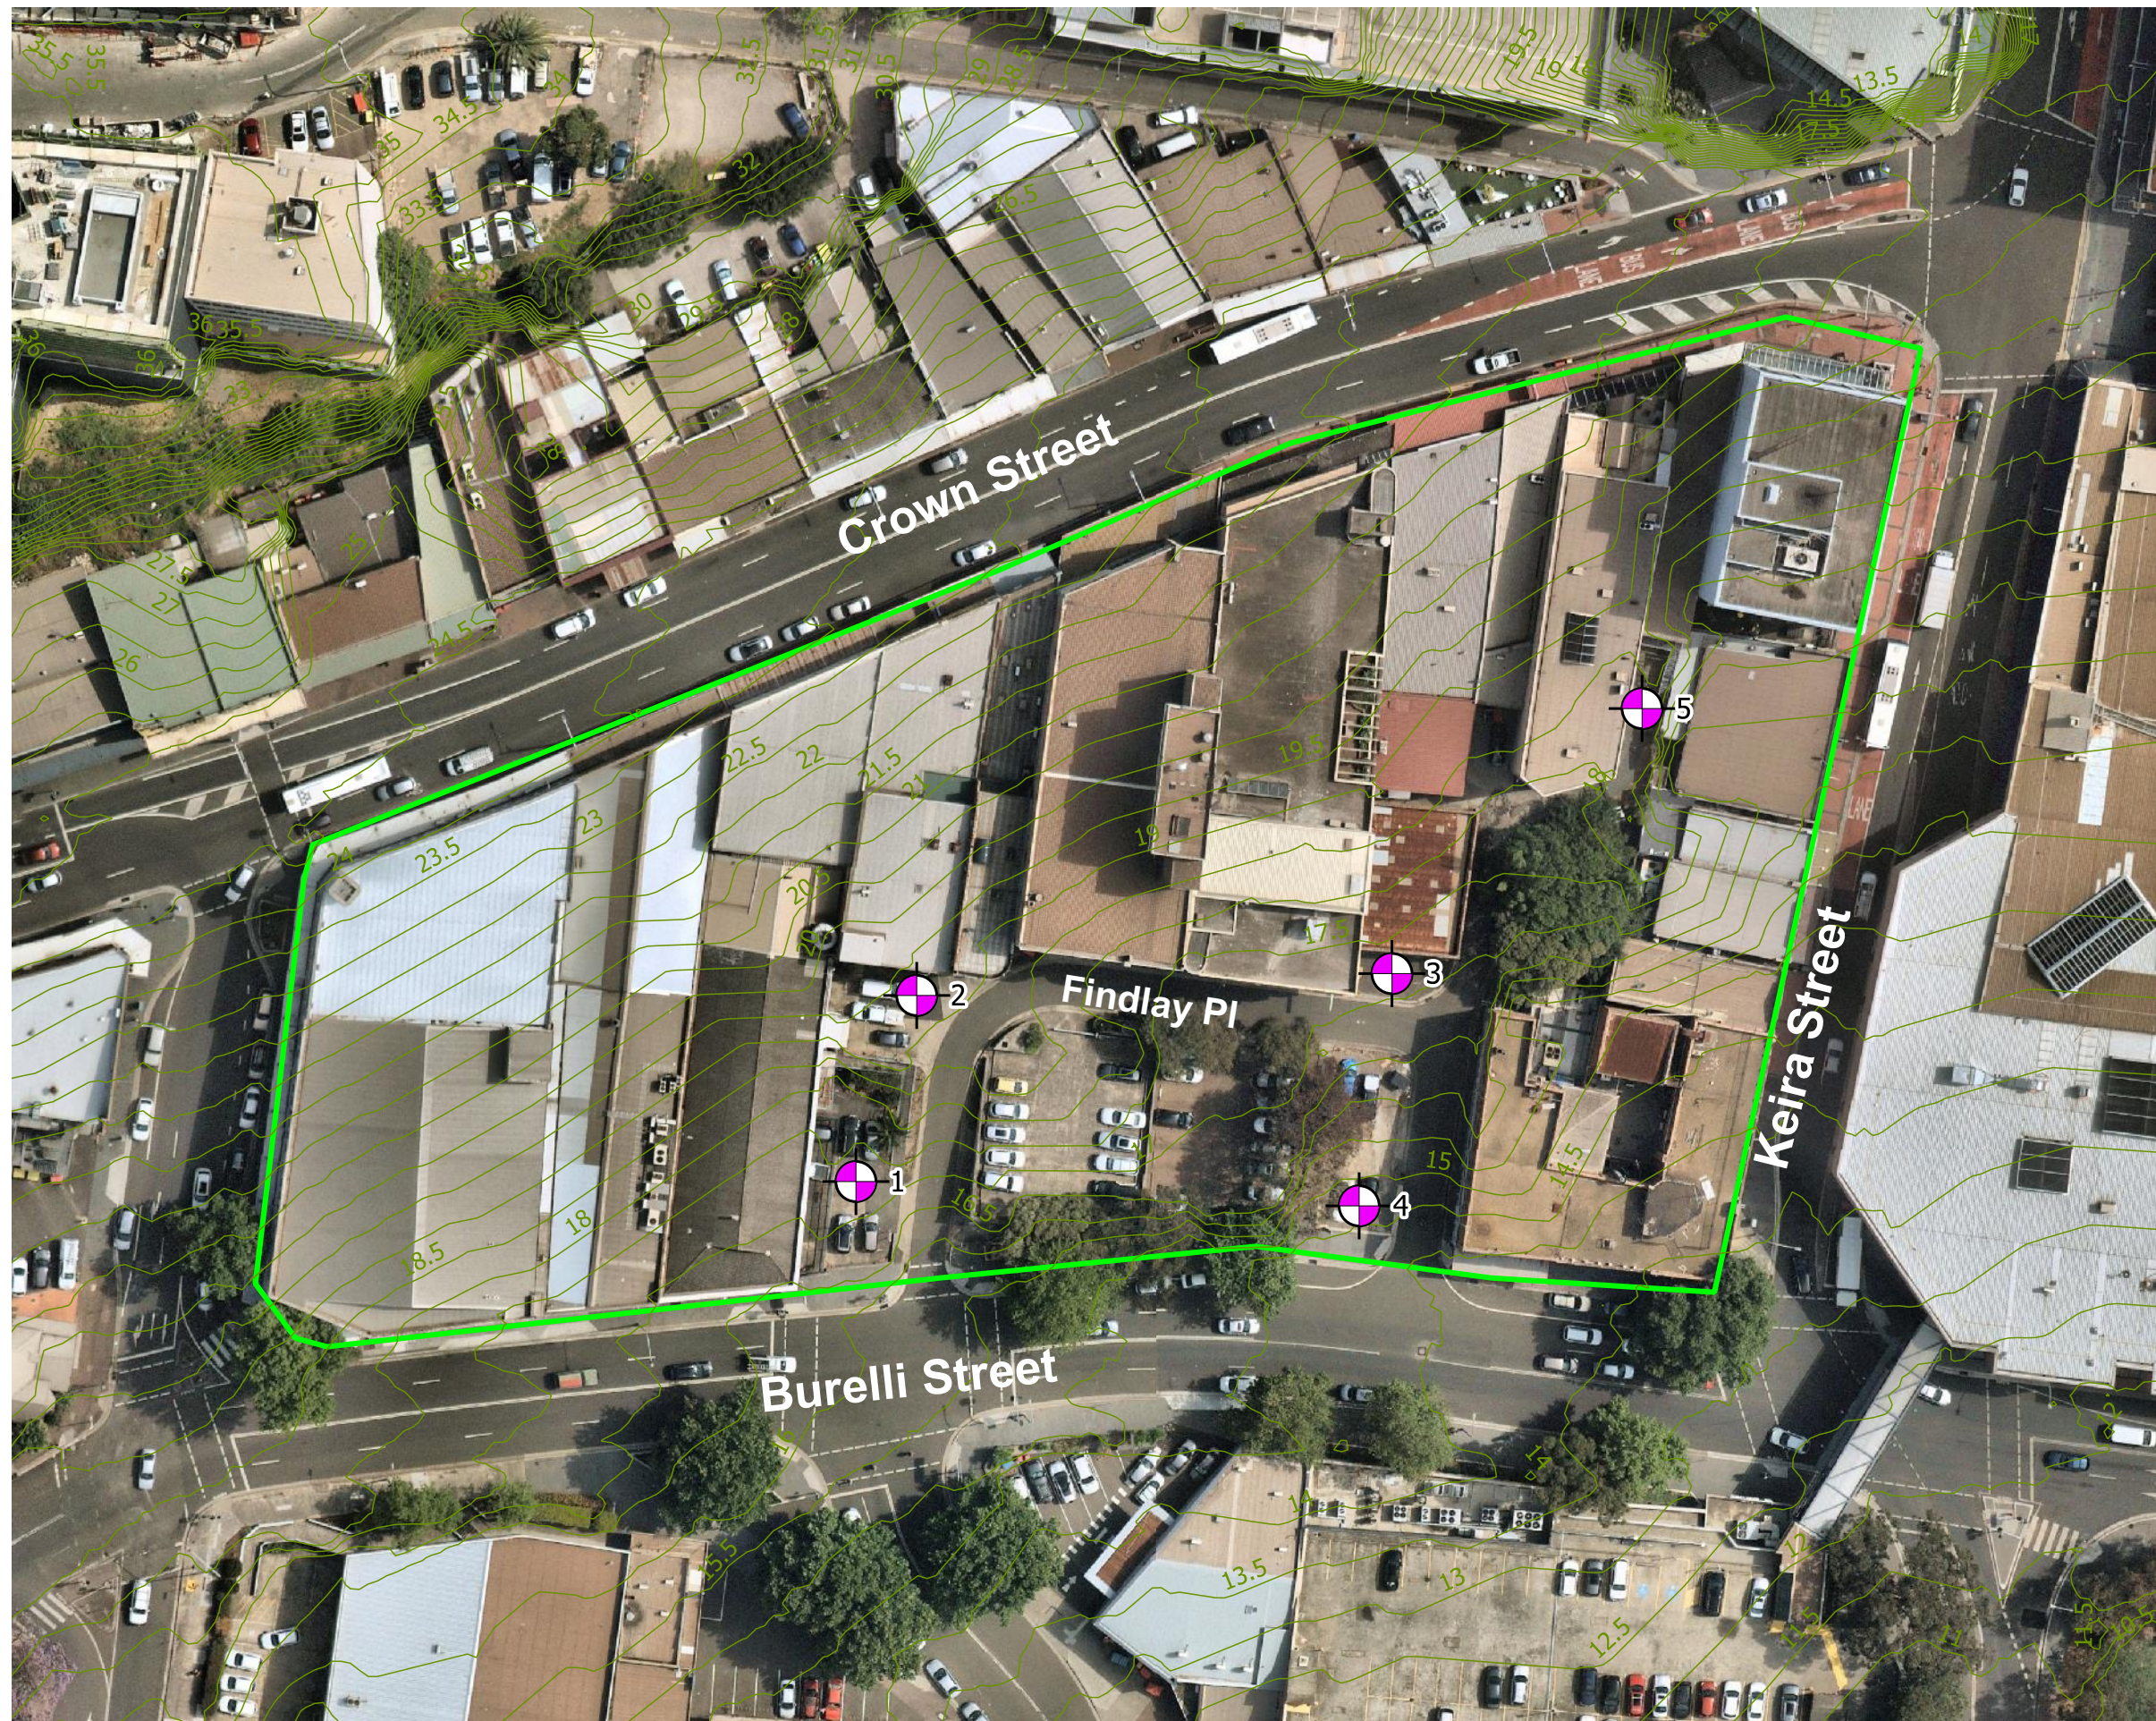
Drawing 1

Locality Plan

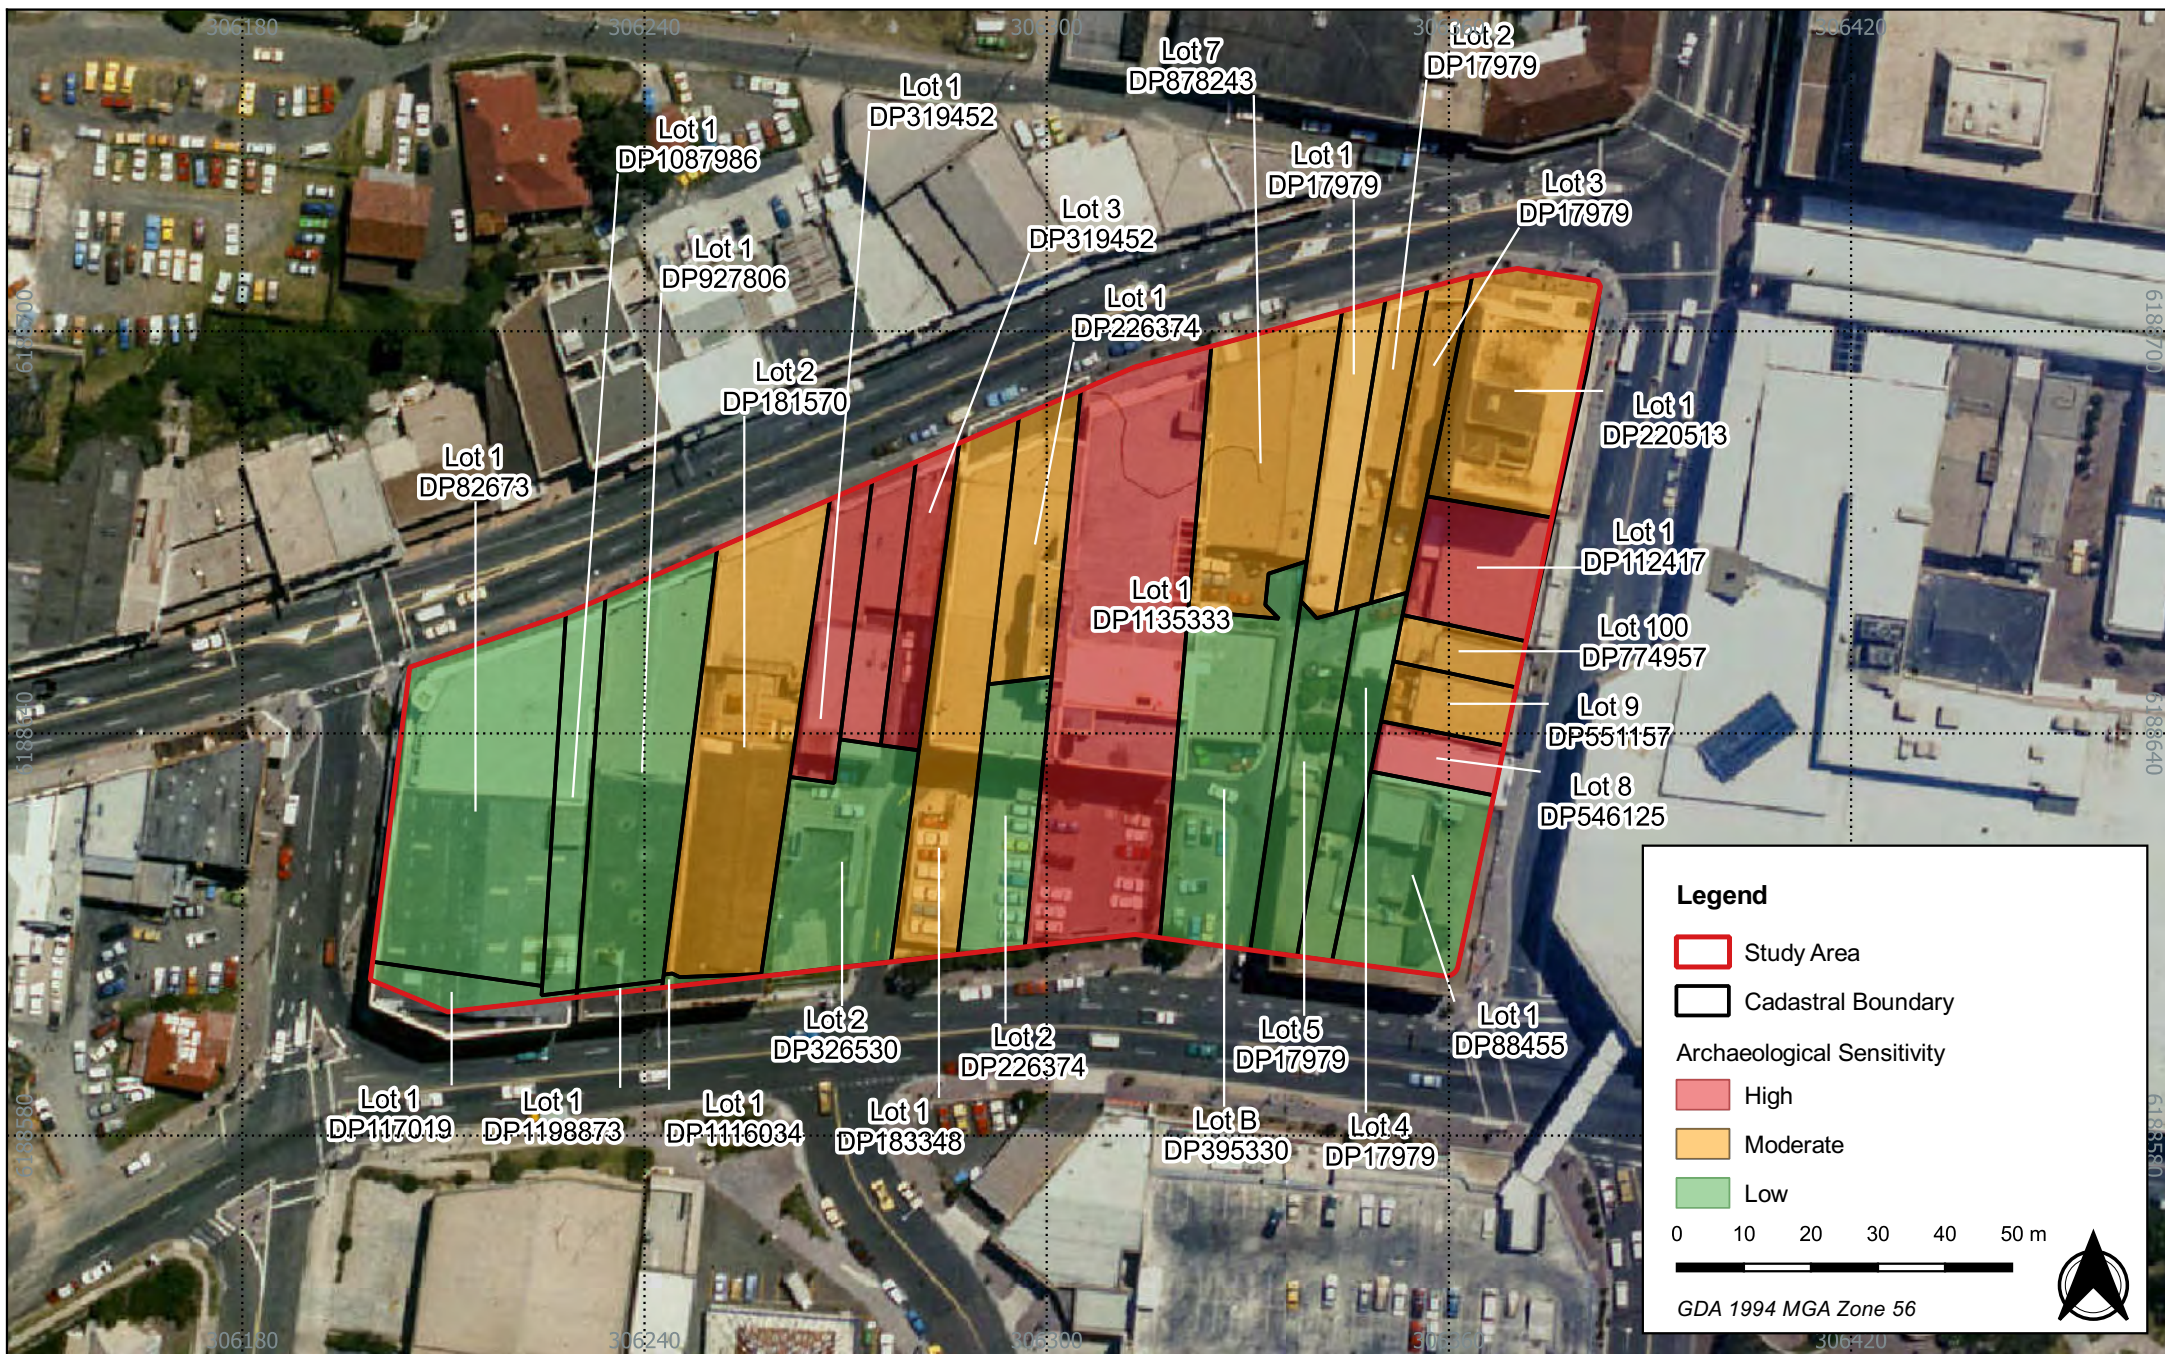
**Figure 5.1 - Summary of land-use / archaeological sensitivity**
