# STATEMENT OF HERITAGE IMPACT

*State Significant Development Application SSD-76440958*

221-291 Crown Street, 216-238 Keira Street and Nos 86-90

July 2025 | J4205\_05

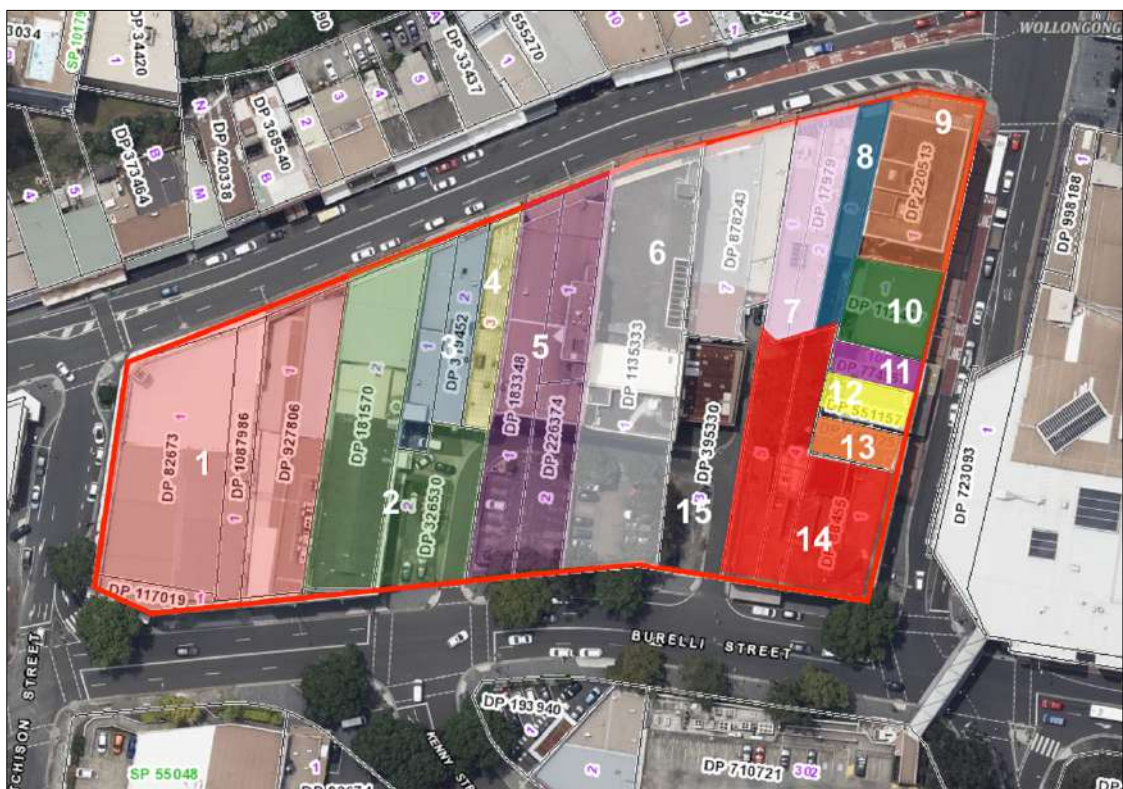
**Figure 3: Aerial Photograph over the Site. The solid red line defines the site boundary. The colours and numbers relate to Table 3 below.**

The buildings on the site range in date and style from the Late Federation/Interwar period to the present day. These buildings and the lots they stand on, are briefly identified in Table 3.

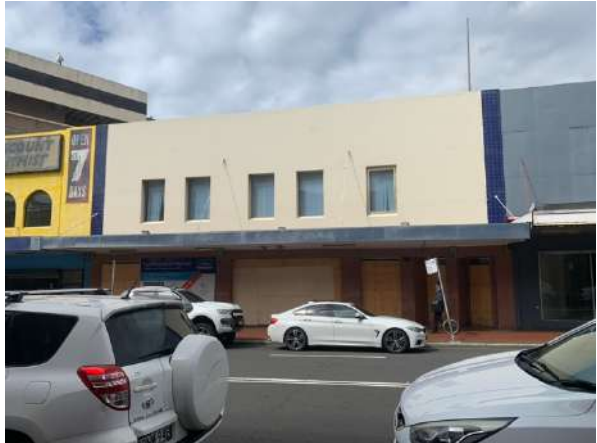
| Address | Brief Description | Image |
|---|---|---|
| <p>No. 273-279 Crown Street (Lot 2 D.P. 181570; Lot 1 D.P. 1116034; and Lot 2 D.P.326530).</p> | <p>This building fronts Crown Street and presents to the street as a storey Post World War II commercial building with a fixed windows and a high largely un-ornamented parapet. This building is shaded green and marked '2' in Figure 3 above.</p> | |

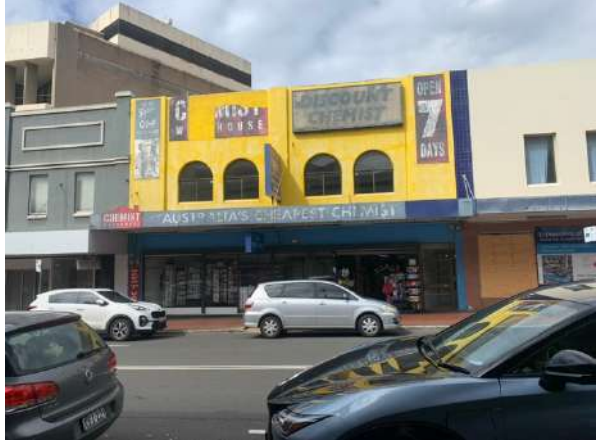
| Address | Brief Description | Image |
|---|---|---|
| <p>No. 269-271 Crown Street (Lots 1 and 2 D.P. 319452).</p> | <p>This building fronts Crown Street. It presents to the street as a much-altered two storey Federation/Interwar period commercial building with modern shop fronts and large arched openings fitted with metal framed glazing at first floor level. This building is shaded light blue and marked '3' in Figure 3.</p> | |

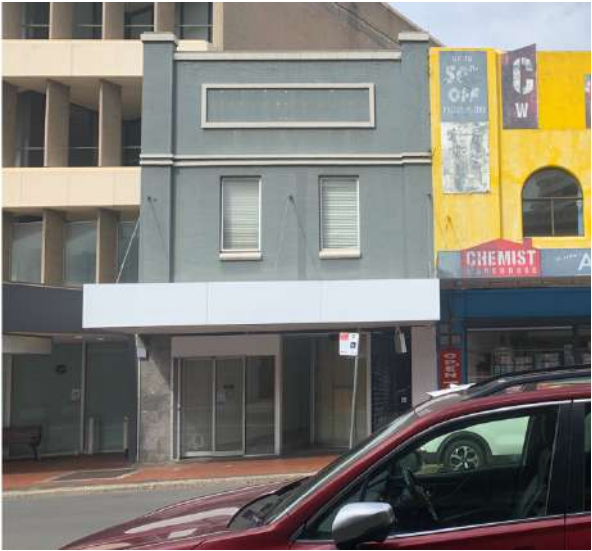
| Address | Brief Description | Image |
|---|---|---|
| No. 261 Crown Street (Lot 3 D.P. 319452). | This building fronts Crown Street. It presents to the street as a late Federation/early Interwar period two storey commercial building. The shop fronts, awning and first floor windows have been replaced. The parapet is simply detailed. This building is shaded yellow and marked '4' in Figure 3 above. | |

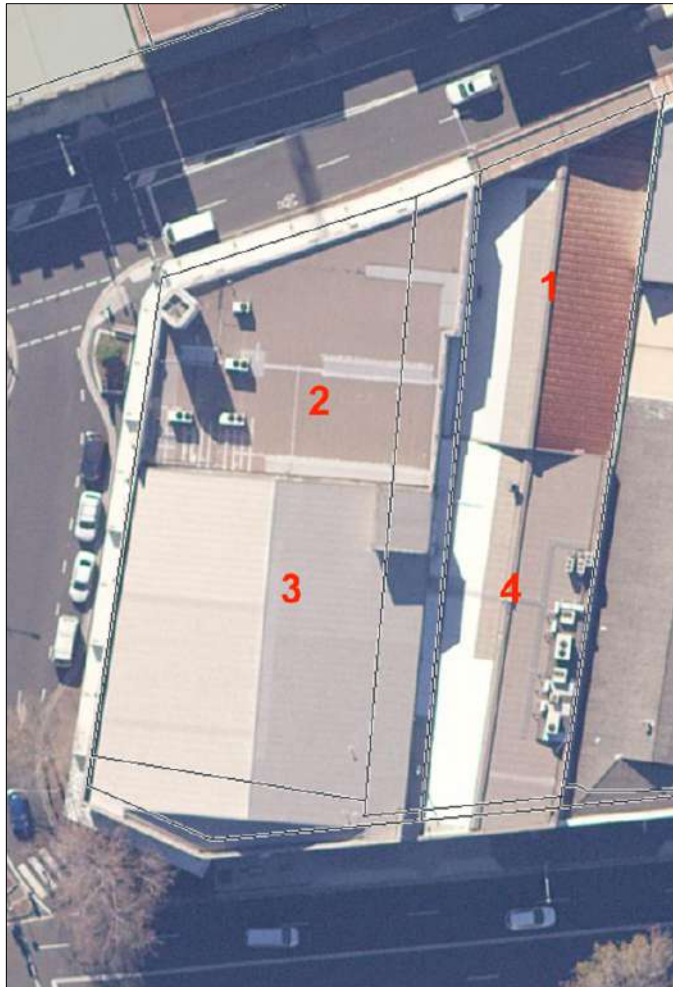
The building(s) on the lots part of the heritage curtilage of the Former Marcus Clark Building can be divided into number of distinct sections, which are identified in Figure 4.

**Figure 4:**  
**Sections of the heritage listed building(s) referred to below.**

As demonstrated by the aerial photograph, Figure 4, the building(s) has various roof forms. Roof forms are skillion roof forms or low-pitched roof forms, clad in corrugated metal sheet.

The interior of that part of the building occupied by Spotlight was photographed in 2021. No major changes have occurred since this time. This tenancy comprises the areas marked '2' and '3' in Figure 4 above. No access was provided to the remainder of the interior. The existing DA approval provides for the removal of these interiors.

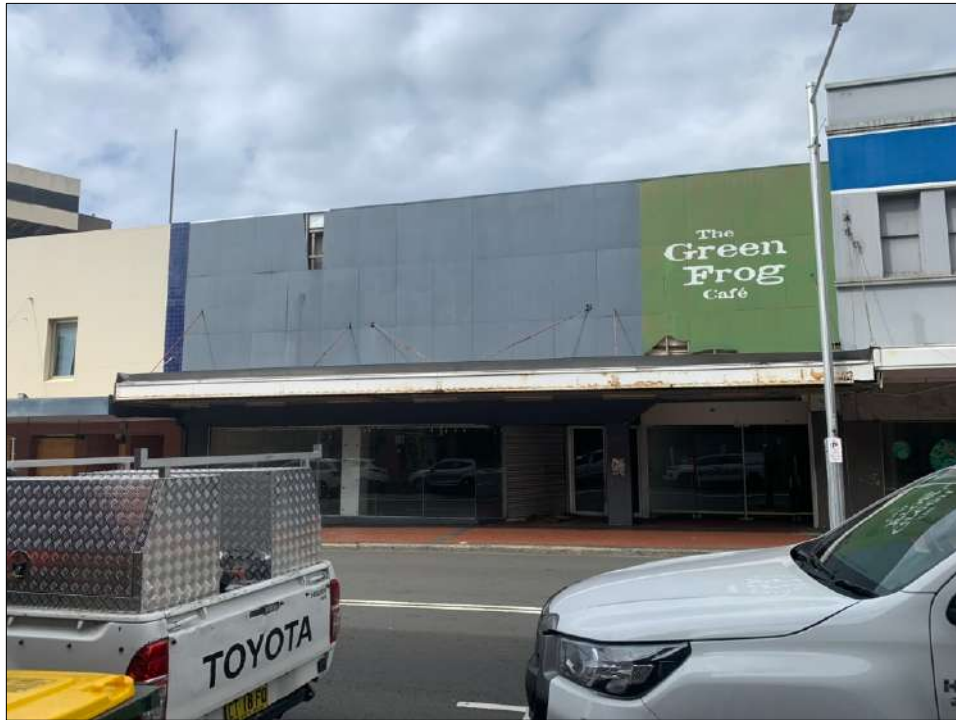
The eastern-most section of the Crown Street elevation (associated with the roof form marked '1' in Figure 4 above) is two storeys in height to Crown Street. At ground floor level, the walls are rendered and painted. There are large metal framed shop windows. There is a suspended awning, separate from the awning of the western end of the building. The first floor elevation is blind and rises seamlessly into the parapet, which is lower than the western section of the elevation. This part of the elevation is clad in metal sheeting and has no architectural detailing. This is the only elevation of this part of the building that is visible. Refer to Figure 5.

**Figure 5: Eastern most end of the building on the heritage listed site, Crown Street elevation.**

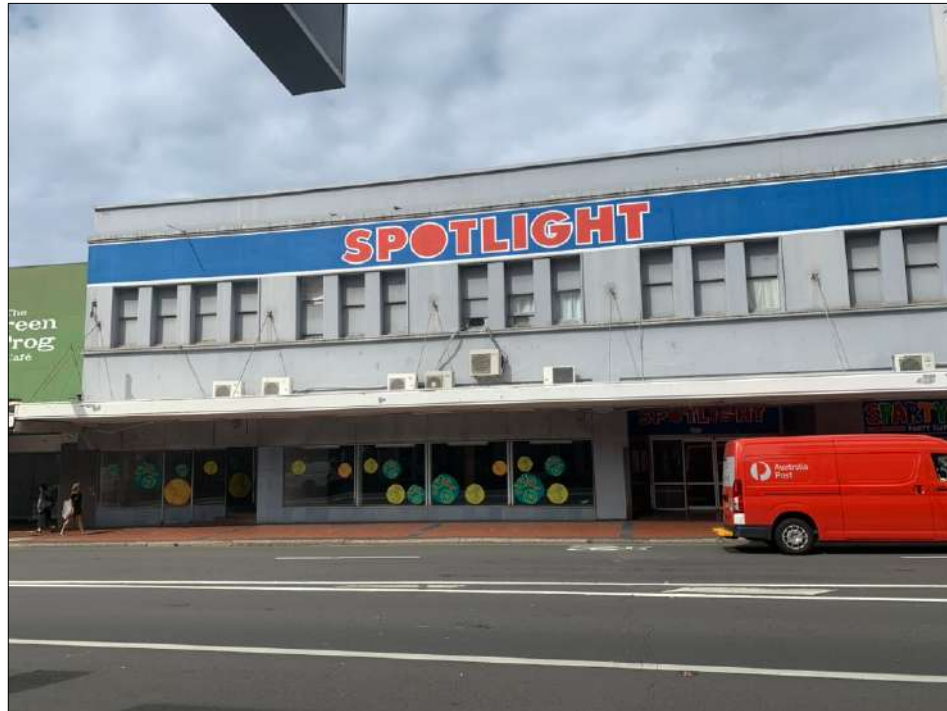
The above detailing continues around the **north western corner elevation**. There are no openings at first floor level in this elevation. A square clock tower (with clock hands removed) rises above the parapet.

**Figure 6: Northern elevation of the western building.**

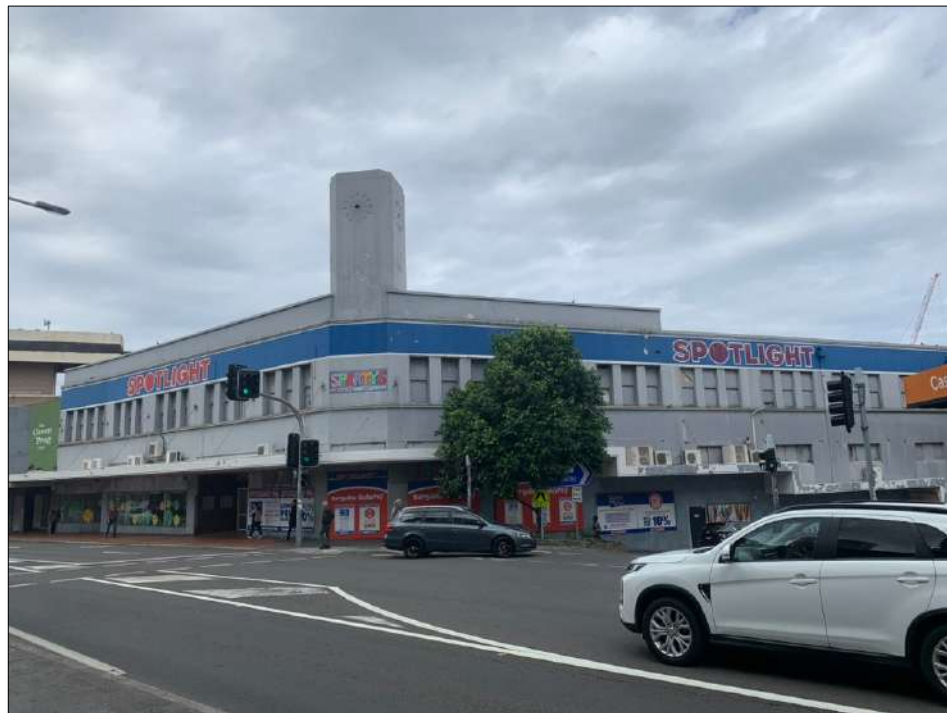
**Figure 7: The north western corner of the building.**

**Figure 59: Aerial Photograph over the site in 1938. The building has two distinct roof forms and does not extend as far as Burelli Street. At this time, the Company did not own the small lot on the corner with Burelli Street. Note the distinct roof form of the building on Lot 1 D.P. 927806. This building- single storey with a high parapet- is just visible in Figure 7 above.**

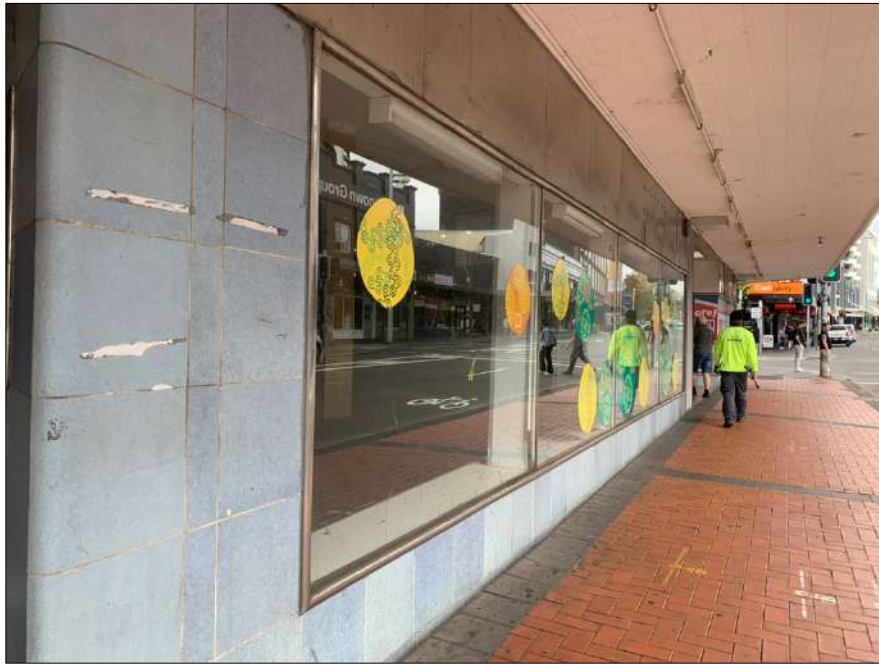
The western section of the Crown Street elevation (associated with the roof form marked '2' in Figure 4 above) is constructed of rendered and painted masonry. At ground floor level there are large metal framed shop windows surrounded by glazed blue square tiles at ground floor level. Entrances are recessed and lined in red granite. The ground floor is divided from the first floor by a suspended metal awning, the underside of which is lined with asbestos 'tile' sheeting.

**Figure 8:**  
Looking along the  
Crown Street  
elevation, showing  
the large metal  
framed shop  
windows.

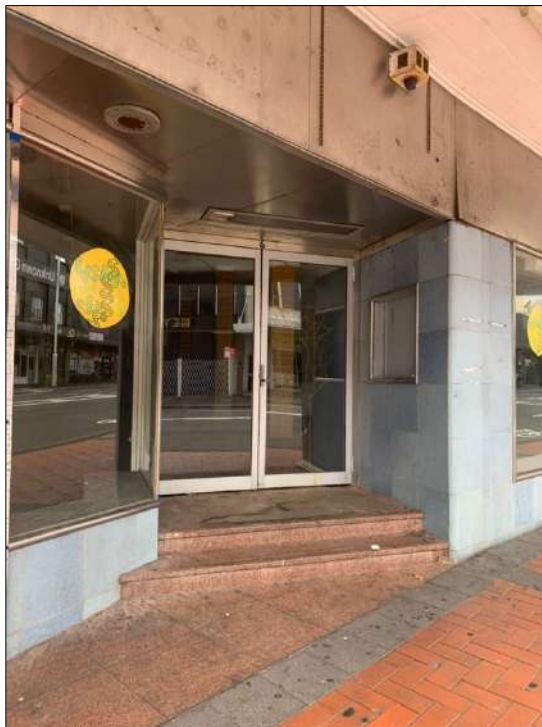
**Figure 9: Detail of one of the Crown Street entrances with red granite.**

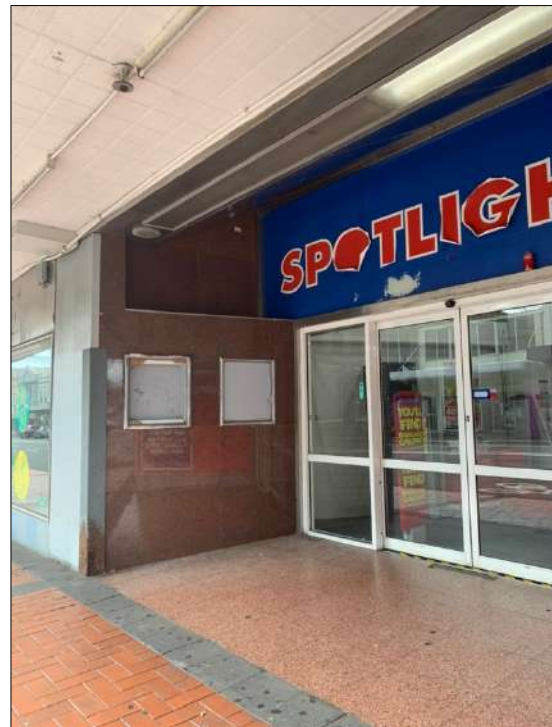
**Figure 10: Detail of one of the Crown Street entrances with red granite.**

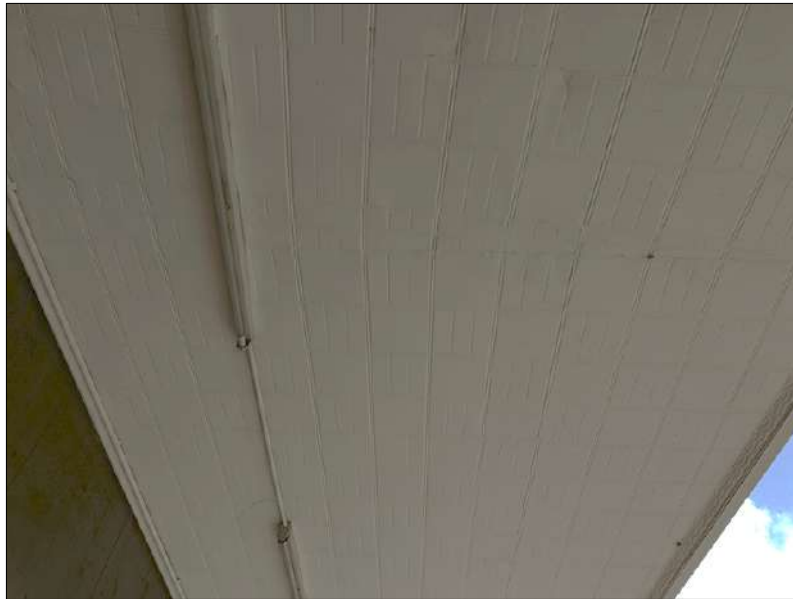
**Figure 11:**  
Detail of the  
asbestos tile  
sheeting to the  
underside of the  
awning.

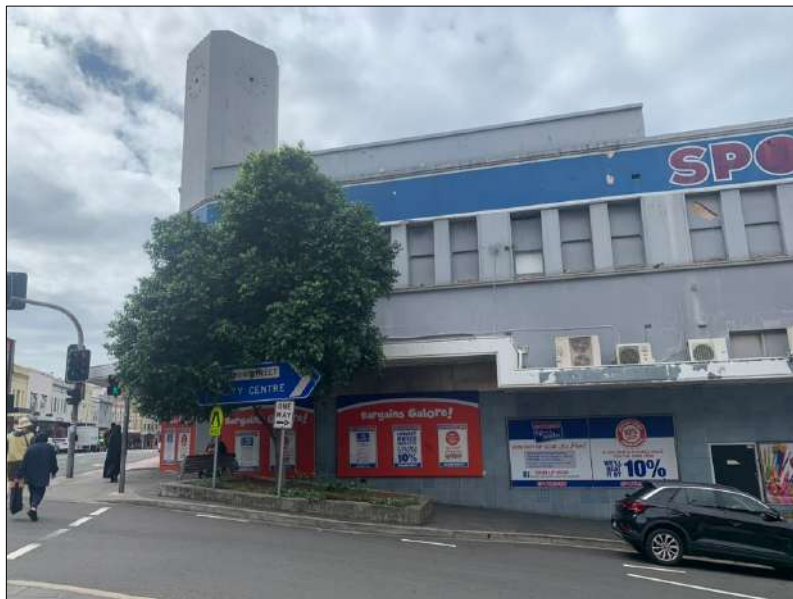
The **Atchison Street, western, elevation** of the 1921/1957 is similarly detailed to the Crown Street elevation. The parapet steps down in height. As the site falls, the double hung windows of the first floor of the Crown Street elevation correspond to the second floor level of this elevation. Below these windows, there are horizontal openings. The suspended awning steps down in line with the fall of the street. Refer to Figure 12 and 15

**Figure 12:**  
Western  
elevation.  
This section  
lies under the  
roof forms  
marked '2'  
and '3' in  
Figure 4.

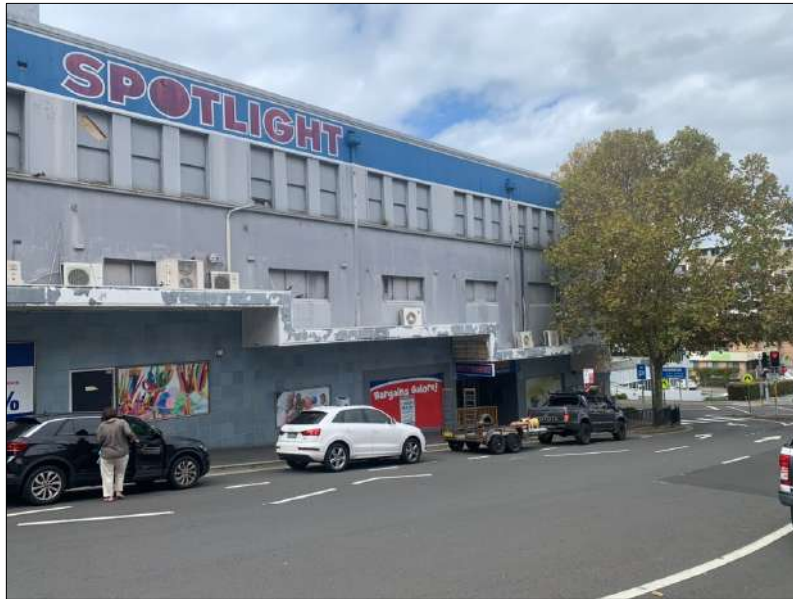
**Figure 13:**  
Continuing  
south along  
the western  
elevation.  
This section  
lies under  
the roof  
form  
marked '3'  
in Figure 4.

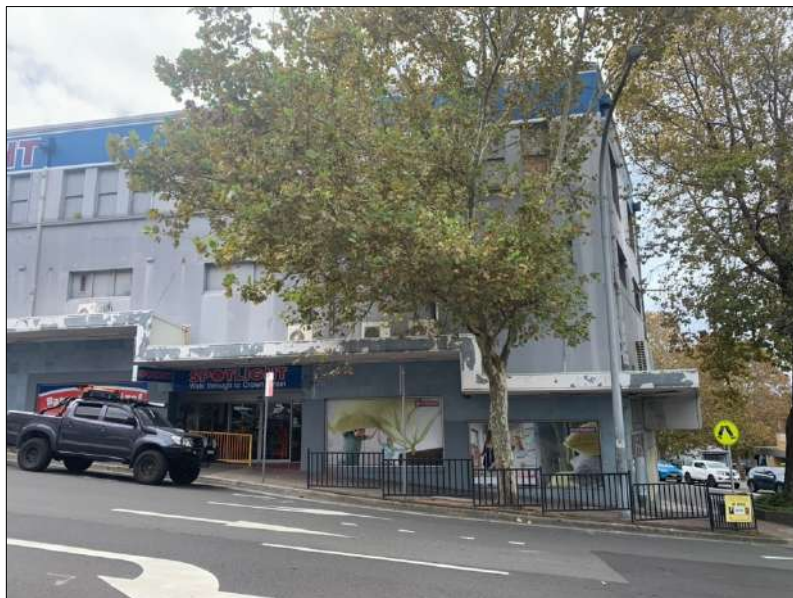
**Figure 14:**  
Continuing  
south along  
the western  
elevation.  
This section  
lies under  
the roof  
form  
marked '3'  
in Figure 4.

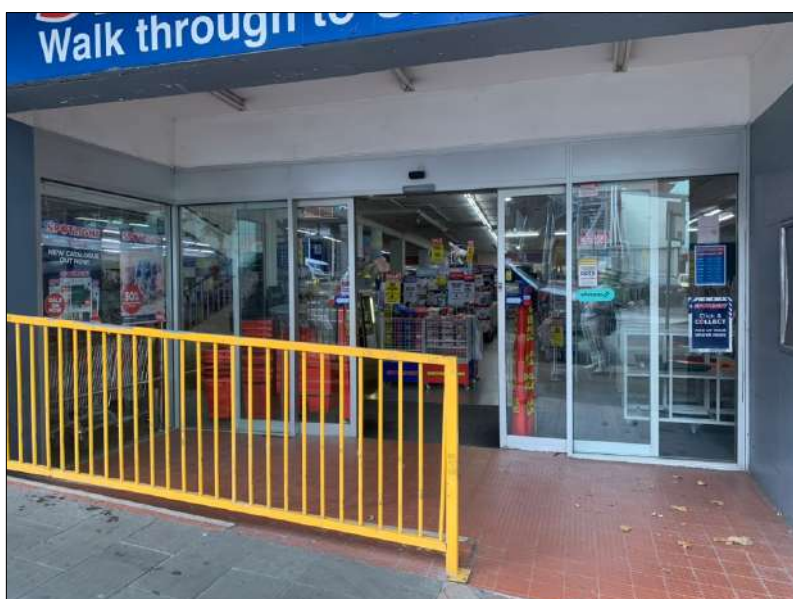
**Figure 15:**  
Detail of the  
main  
entrance in  
the western  
elevation.

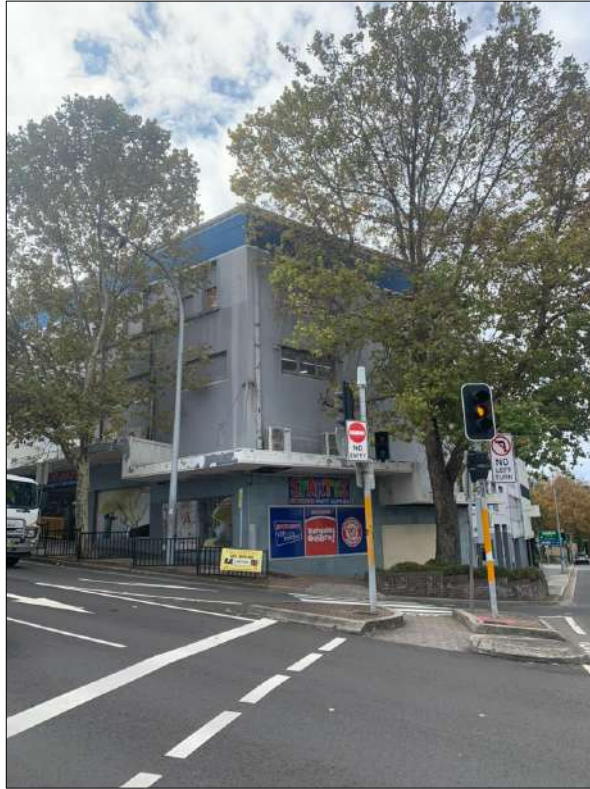
Figure 16 illustrates the **south western corner** of the building. The awning continues around this corner, as does the blue tiling and large shop windows at ground floor level. At first floor level there are two horizontal openings fitted with timber framed windows. At second floor level, there are two large openings fitted with three timber framed double hung windows.

**Figure 16:**  
**South western corner. This section lies under the roof form marked '3' in Figure 4.**

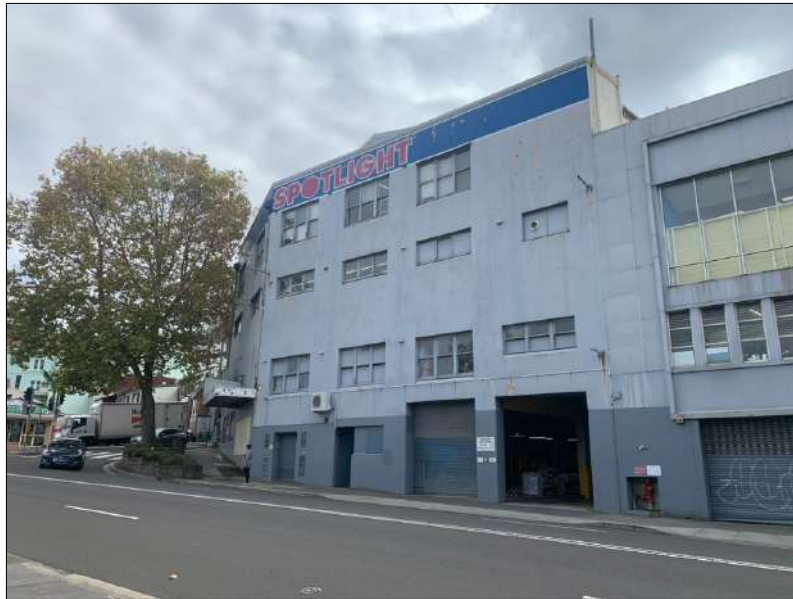
Figures 17 and 18 illustrate the southern, **Burelli Street elevation**, which comprises three distinct parts, reflecting the three separate roof forms that lie above. This elevation extends beyond the boundaries of the heritage listing. The western-most end (under the roof form marked '3' in Figure 17) reads as being four storeys in height and constructed of rendered and painted masonry. There are large openings at ground floor level fitted with roller doors and metal framed and glazed doors. At first floor level, there are openings (of two sizes) fitted with timber framed double hung windows (with a single pane to each sash). This level corresponds with ground floor level on Crown Street. At second floor level there are horizontal highlight openings fitted with timber framed windows. The upper most level has large openings fitted with fitted with timber framed double hung windows (with a single pane to each sash).

The central part of this elevation (under the roof form marked '4' in Figure 17 above) steps down in height. This part of the elevation is clad. There is a roller door at ground floor level and metal framed and glazed doors. At first and second floor level there are metal framed windows of various sizes. Refer to Figure 17.

**Figure 17:**  
Western end of  
the southern  
elevation.

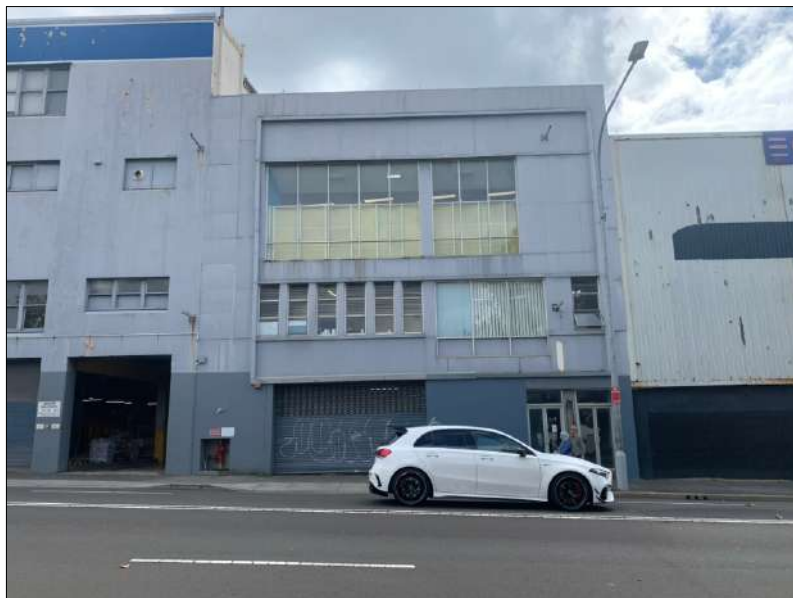
The south eastern corner of the building (outside of the boundaries of the heritage listing) is constructed of masonry at ground floor level and is clad in corrugated metal sheeting at first and second floor levels. It has metal framed windows. There is carparking under the building at ground level. Refer to Figures 18 and 19.

**Figure 18:**  
Eastern end of  
the southern  
elevation.

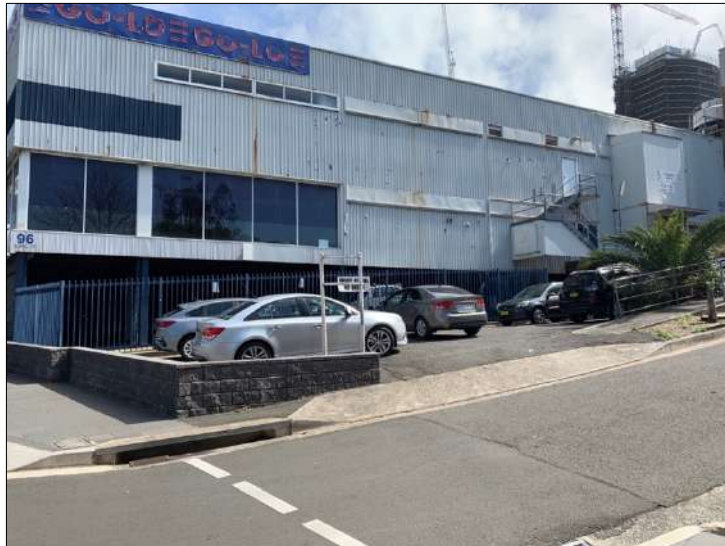
**Figure 20:**  
**Eastern elevation of**  
**the later addition.**

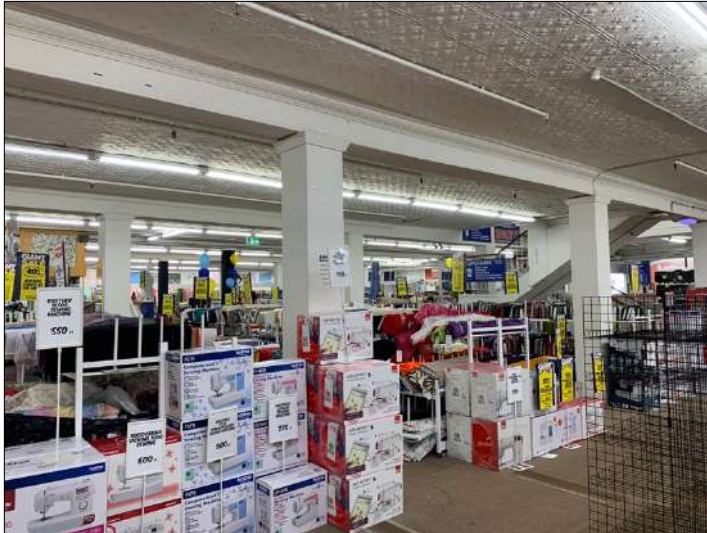
**Figure 21:**  
**Basement level.**  
WP Heritage, 2021.

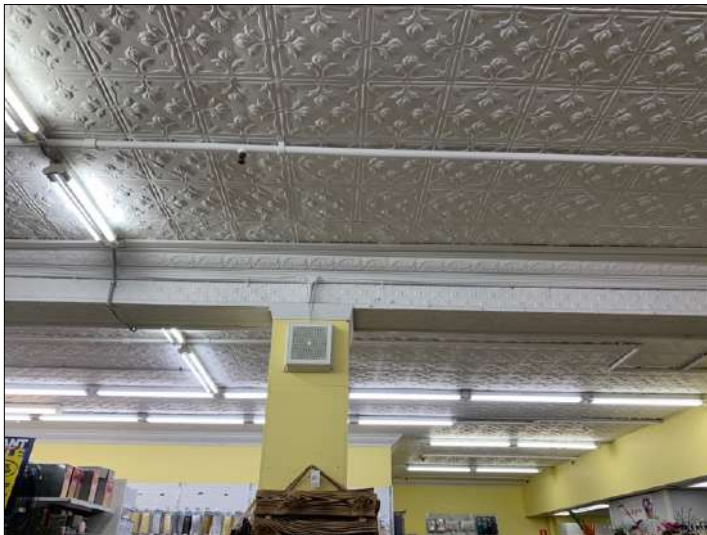
**Figure 22:**  
**Detail of the pressed metal ceiling at basement level.**  
WP Heritage, 2021.

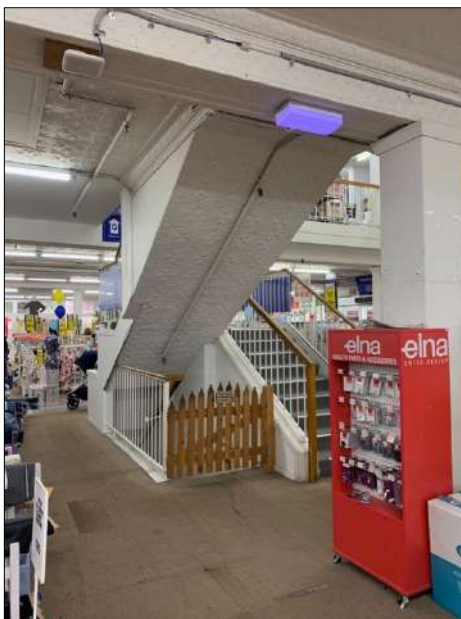
**Figure 23:**  
**Detail of the pressed metal beneath the staircases and the pressed metal cornice to beams.**  
WP Heritage, 2021.

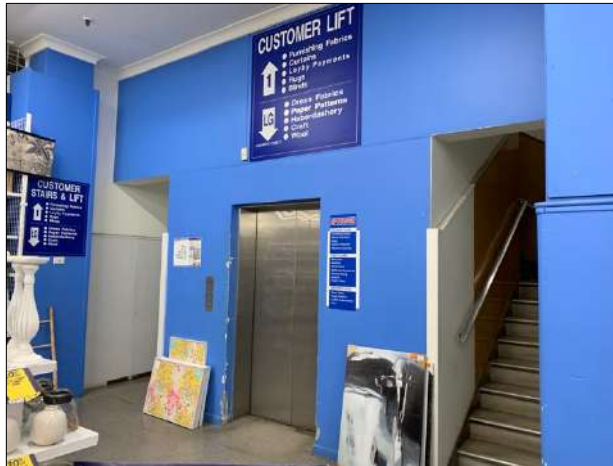
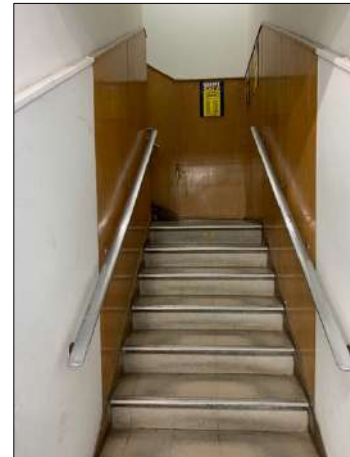
**Figure 24: Lift on the eastern edge of the 1921 building.**  
**Figure 25: Staircase on the southern side of the lift.**  
 WP Heritage, 2021.

As part of the works, interior fit outs were replaced. The State Heritage Inventory (SHI) listing sheet for the item states that the original staircase and lift well in the eastern part of the building were retained and an additional staircase was built (located in the

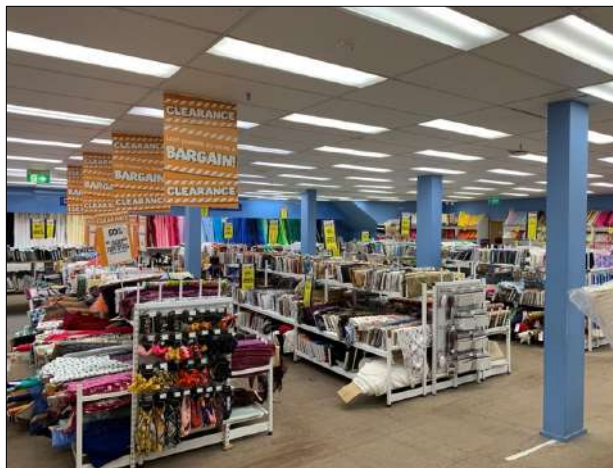
**Figure 26:**  
**Basement level of the extension.**  
 WP Heritage, 2021.

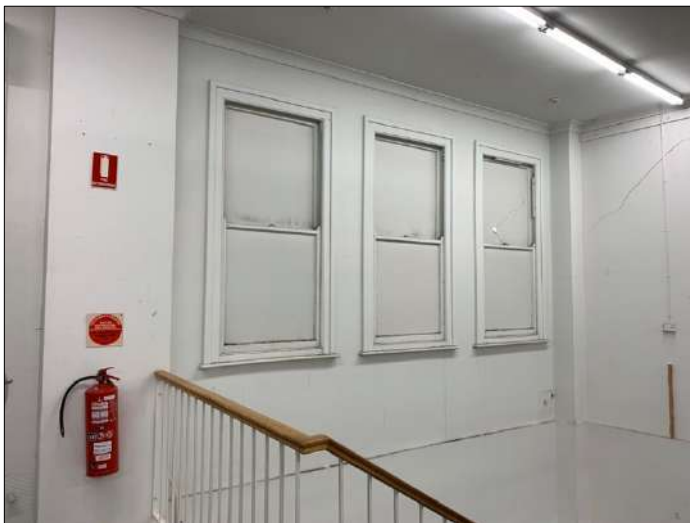
**Figure 30:**  
**Typical window joinery**  
**at first floor level.**  
WP Heritage, 2021.

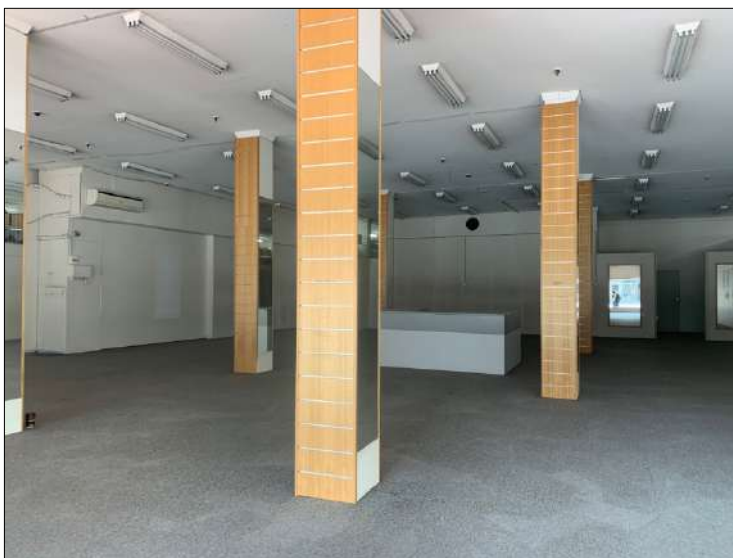
The unoccupied ground floor of the 1959 extension was viewed through the Crown Street windows. The floor plate is similarly open. The supporting pillars have modern cladding. Refer to Figure 41.

**Figure 31:**  
**Ground floor of the**  
**1959 extension.**  
WP Heritage, 2021.

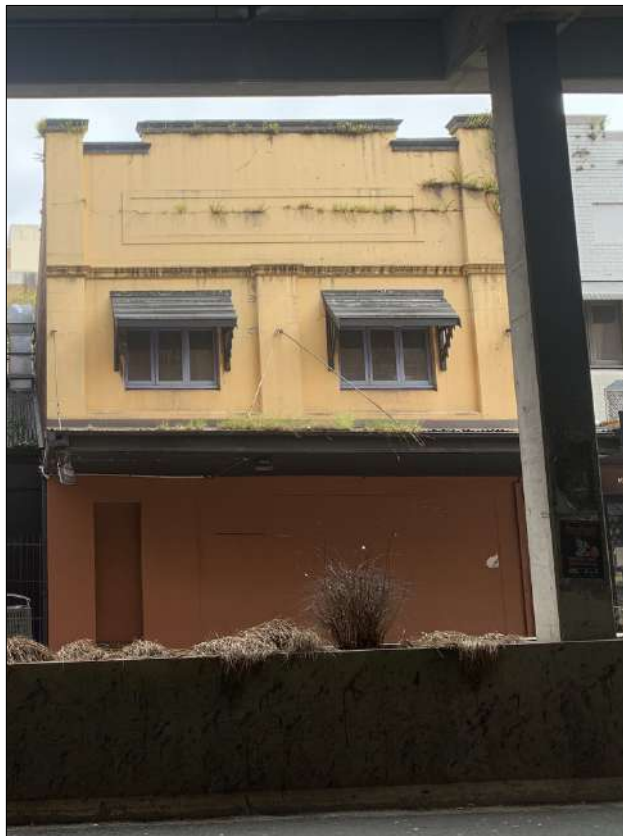
**Figure 33:**  
**No. 232-234 Keira Street.**

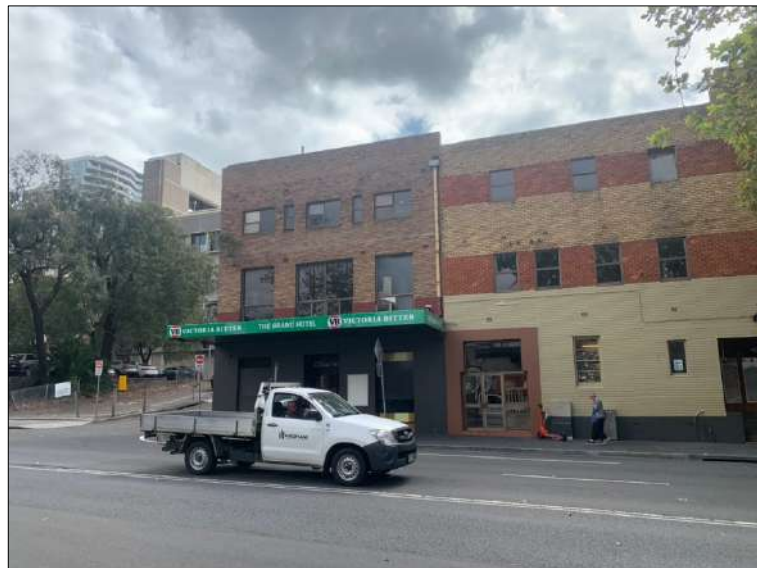
The 1956 addition at the western end is built to its Burelli Street frontage. It has a face brick and painted brick elevation. There is a suspended steel awning; a parapet conceals the roof form. All the windows and doors are metal framed.

**Figure 38:**  
Western end of  
the Burelli  
Street  
elevation,  
showing the  
1956 addition.

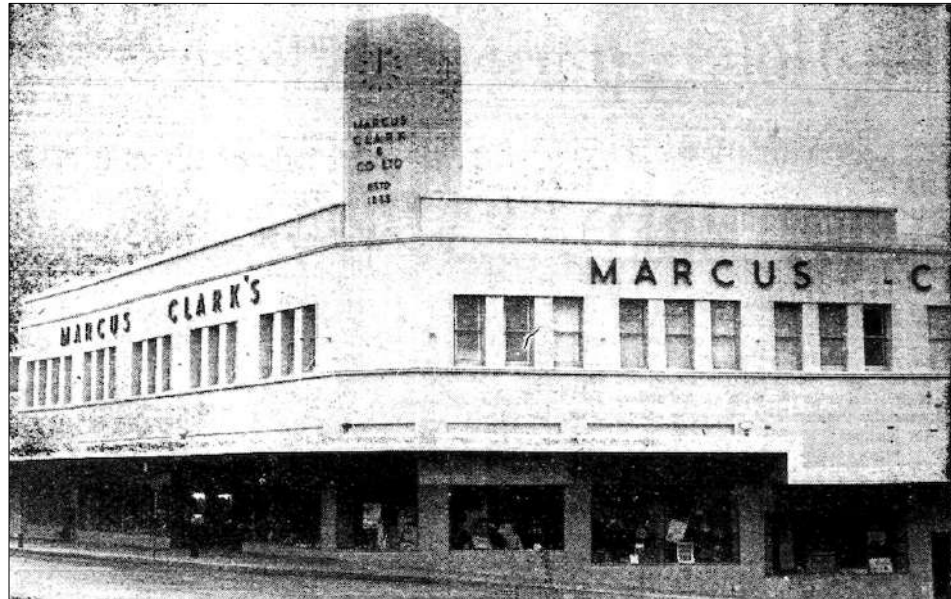
The building was expanded to incorporate No. 287-291 Crown Street, thereby increasing the floor space to 51,000 sq. ft and the Crown Street frontage to 100 ft. According to the paper, almost all the old building was demolished and rebuilt 'piece by piece' so that trading could continue during construction. The only part of the old store said to have remain untouched were the foundations under the front portion. A new awning was erected and the building extended through to Burelli Street, where it became four storeys high. The main entrance from Crown Street was finished in polished red Swedish marble; pale blue terracotta tile framed the windows. The Company evidently foresaw a bright future; the foundations were made deep enough to carry additional storeys for future expansion. <sup>45</sup>

**Figure 62: A 'pleasing design,' 1957.**  
*Daily Mercury*, 12 August, 1957.

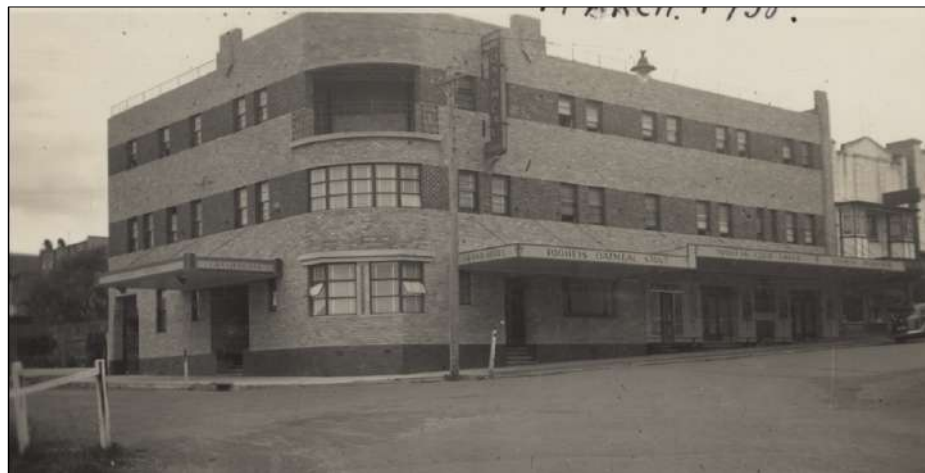
'The Grand Hotel is one of Wollongong's new hotels, and the horizontality of its design definitely marks it as a building of recent date. The effect is achieved by the utilisation of alternating bands of light and dark brickwork...'<sup>61</sup>

**Figure 66: Grand Hotel, Wollongong in 1938 (Detail).**

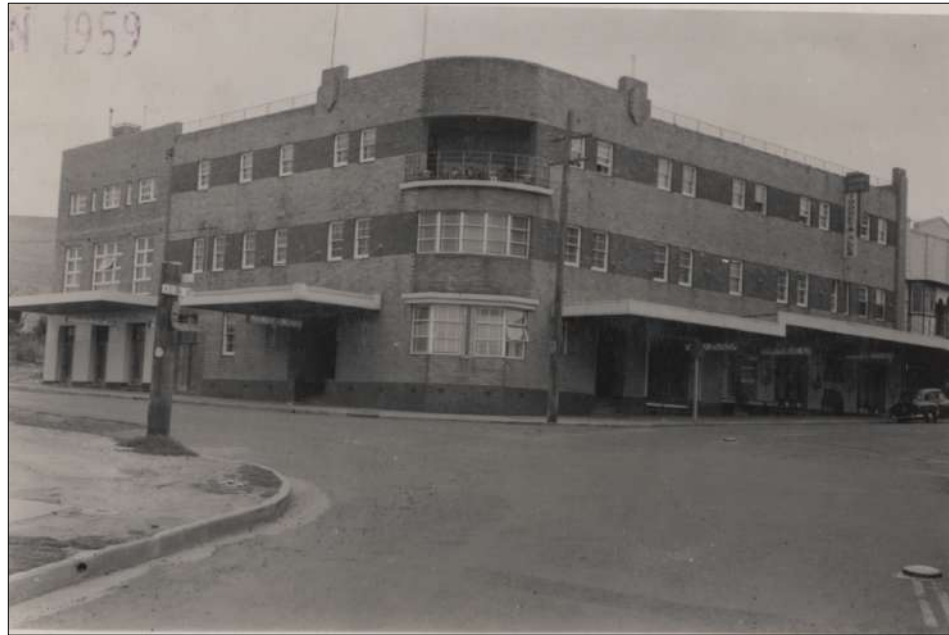
The building underwent a significant refurbishment in 1956, including an addition on the western side.<sup>62</sup> This addition is noted in the Tooth & Co. Yellow Cards as a new wing comprising three floors of nine suites with bathrooms and a new lounge, to be constructed at a cost of £150,000.<sup>63</sup> Figure 67 provides a photograph of the hotel after these works were executed. The hotel appears to have been owned by Tooth & Co. by this time.<sup>64</sup>

**Figure 67: Grand Hotel, Wollongong in 1959.**

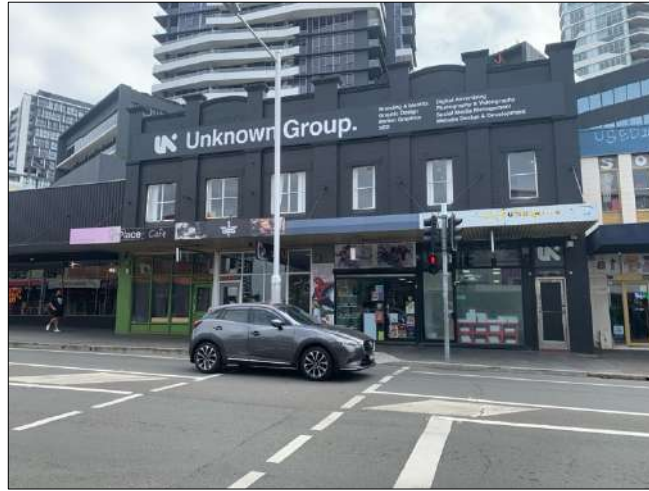
The building presents to Crown Street (and the site) are a two storey Interwar period shop-residence. The elevation to Crown Street is simply detailed and is constructed of rendered and painted masonry. The elevation is divided into two by a suspended awning. The detailing of the ground floor shop fronts vary. The elevation above the awning is divided by engaged piers that rise above the parapet. The straight line of the parapet is broken by low curved pediments above the second and fifth bays. There is a single or double window within each bay.

**Figure 69:**  
The heritage item from Crown Street. This photograph was taken from outside of the former Marcus Clark Building.

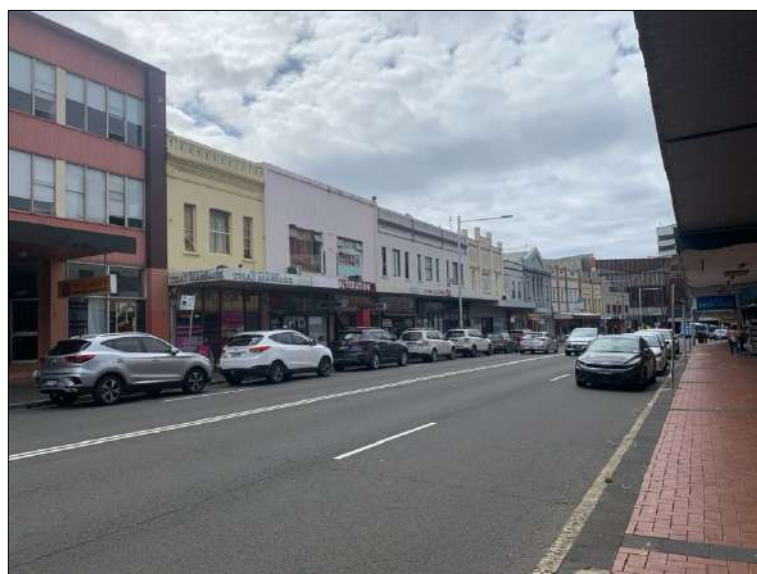
**Figure 70:**  
Looking east  
towards the row  
of heritage  
listed  
properties. This  
photograph  
shows the  
relationship of  
the site to these  
items.

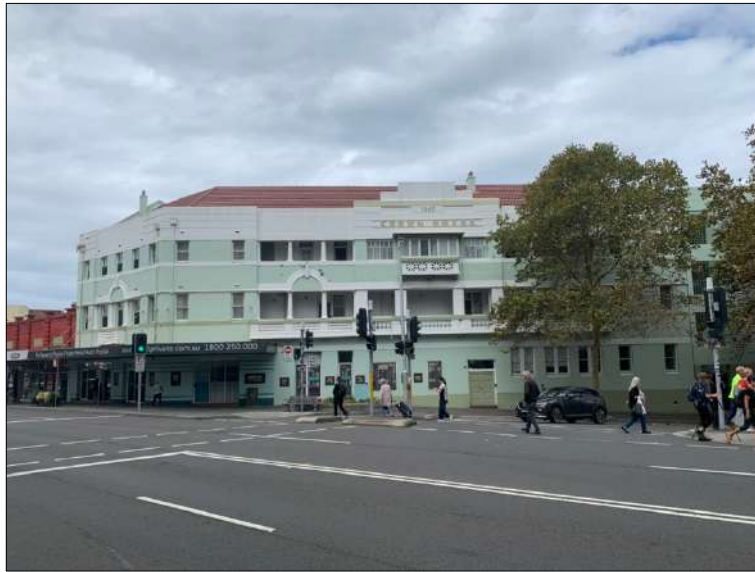
‘The current three storey building has a symmetrical façade that was originally face brick with cement-rendered details. The façade features a central arched pediment with recessed balconies below. Overall, it has mixed features of Inter-war Art Deco and Inter-war Free Classical architectural styles. The additional c. 1940 level included a similar façade detail with rendered horizontal banding. The façade was later painted. The façade was repainted in light green and white in 2019.’<sup>72</sup>

**Figure 72:**  
No. 309 Crown  
Street from  
Crown Street.

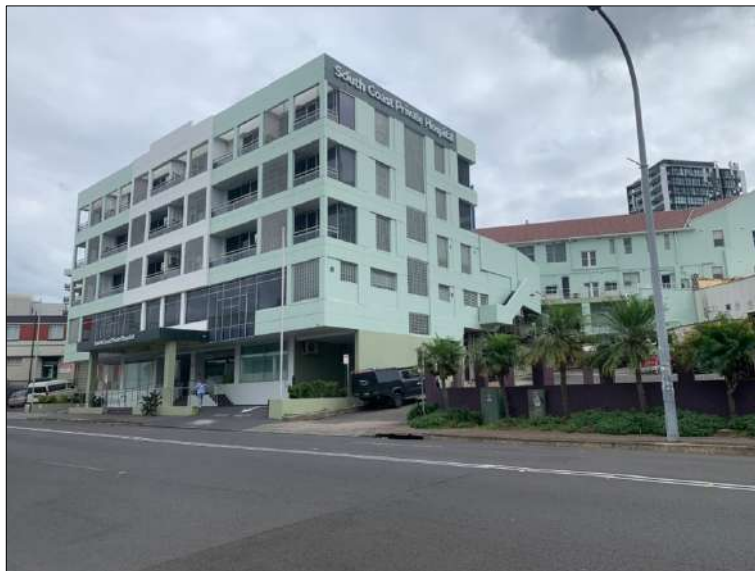
**Figure 73:**  
NO. 309 Crown  
Street from  
Burelli Street.

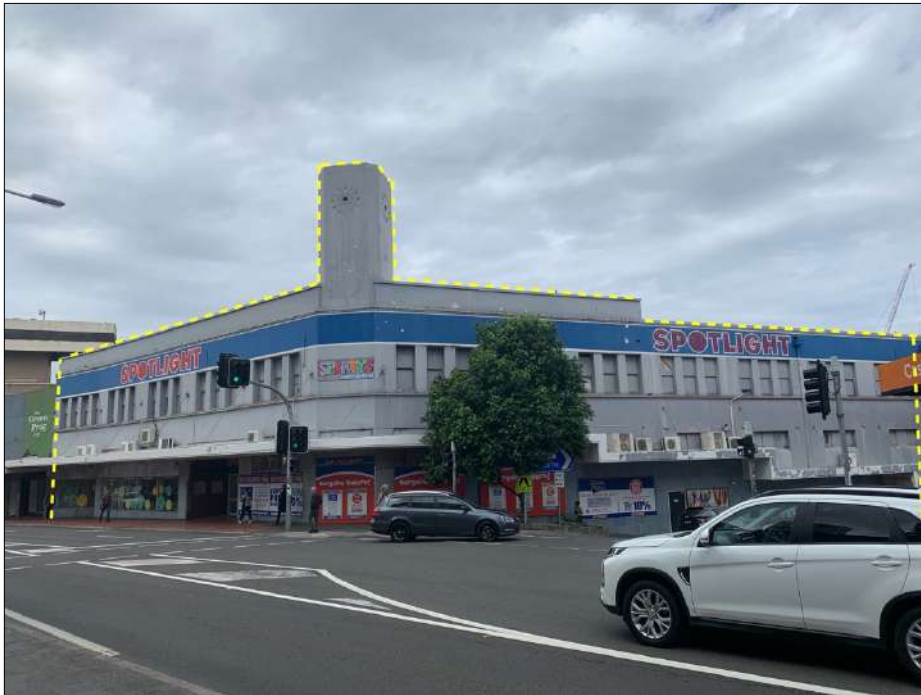
**Figure 86: Significant section of elevation of the Former Marcus Clark building elevations.**

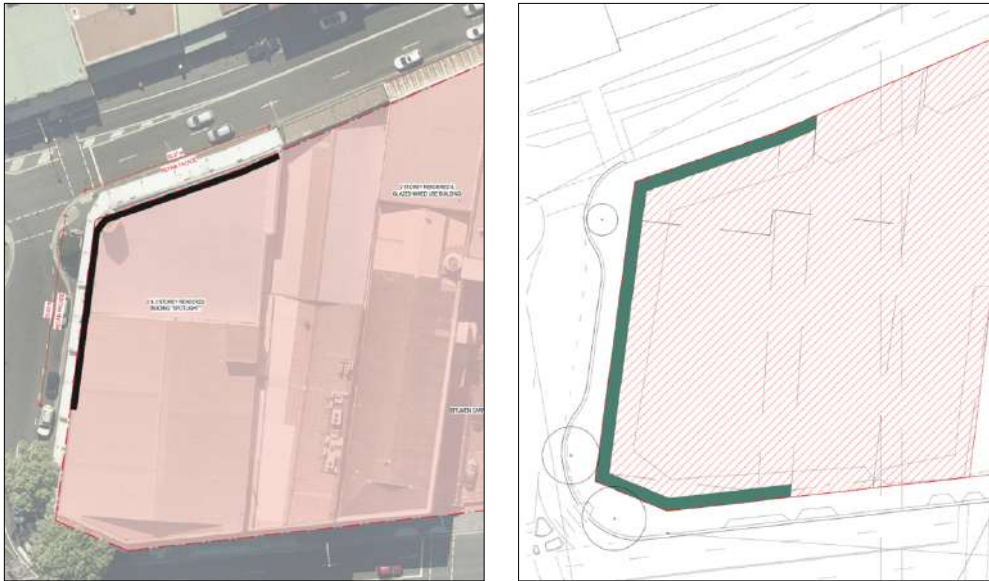
**Figure 87: Detail from the approved architectural plan set for DA-2021/957 showing the extent of demolition approved for the Former Marcus Clark Building (shaded red). The retained section of façade is outlined in black.**

DA-2021/957 approved the removal of the majority of the Former Marcus Clark Building to the extent illustrated by Figure 87 below. Restoration works were approved to the retained section of the façade and awning. Refer to the Schedule of Conservation Works in Appendix 1.

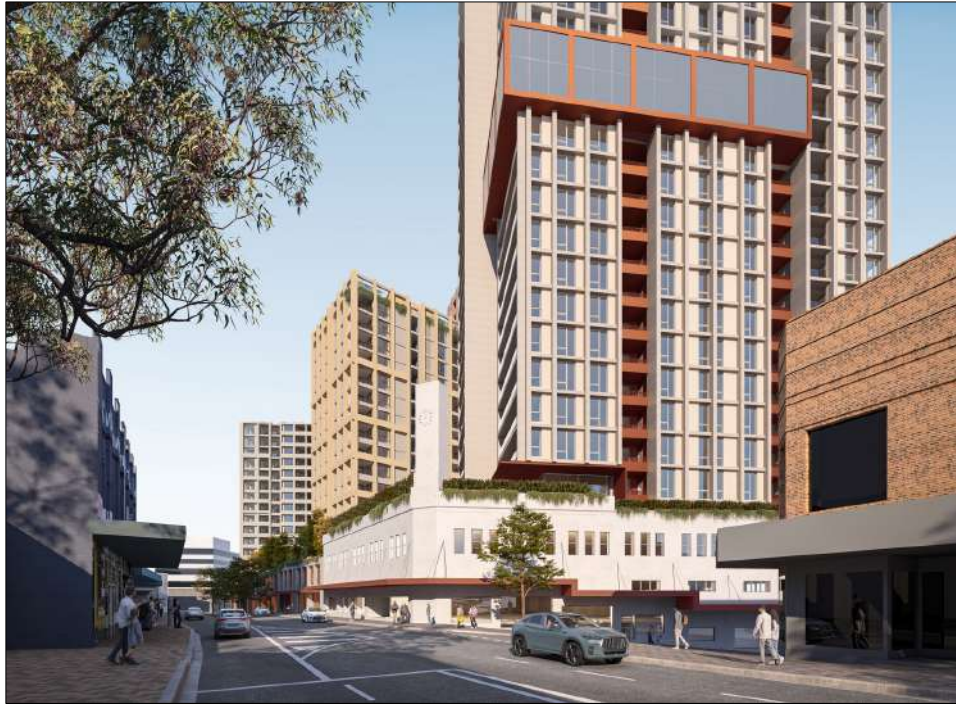
**Figure 89: Photomontage of the proposed view towards the site on approach along Crown Street from the west.**

Refer to Figure 89. These photomontage demonstrates that while the new towers will be visible in view corridors that include the Former Marcus Clark Building tower, the view line on approach along is preserved. As the area is redeveloped in line with the desired future character for it as expressed by Council controls, the proposed new towers will no longer read in isolation. The restoration of the Former Marcus Clark Building façade will help reinforce its presence at streetscape level.
