# STATEMENT OF HERITAGE IMPACT

*State Significant Development Application SSD-76440958*

221-291 Crown Street, 216-238 Keira Street and Nos 86-90

July 2025 | J4205\_05

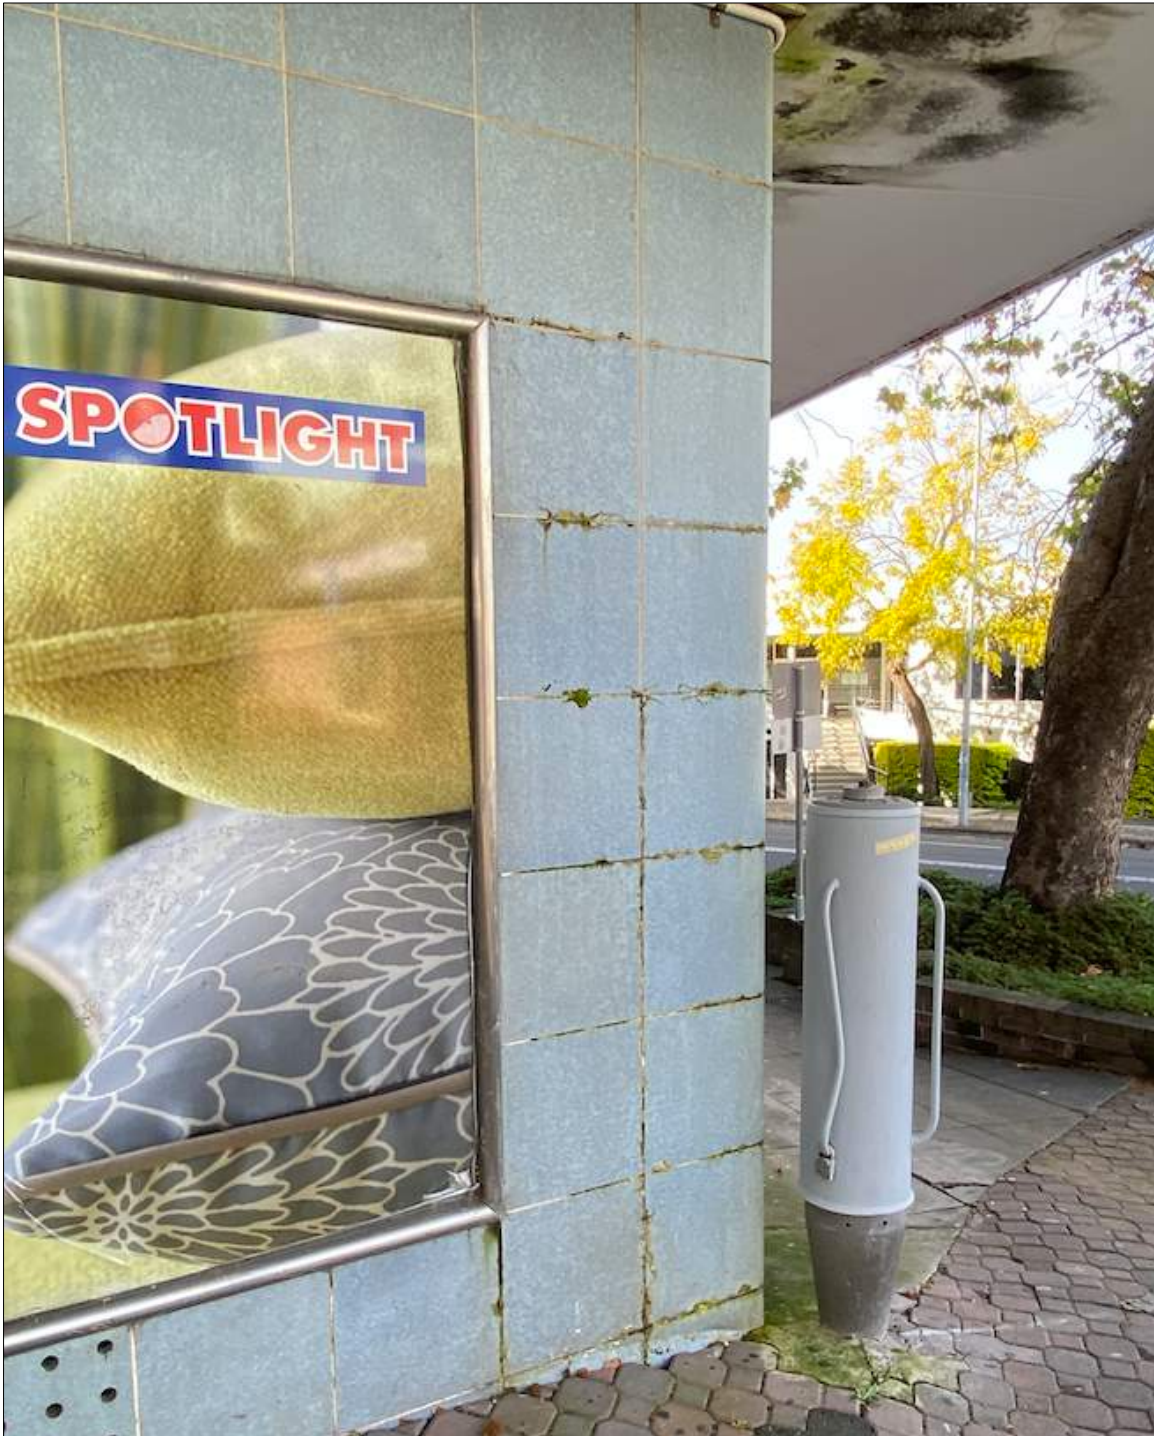
**Fig. 4.** The façade wall tiling is to be cleaned. The curved stainless steel shopfront glazing trim is to be retained and protected from damage for the duration of any and all approved building works.

| | | <b>LOCATION:</b> Façade – Ground Floor<br><br><b>WORK REQUIRED:</b><br>The façade wall tiling is to be cleaned. The curved stainless steel shopfront glazing and signage trim is to be retained, protected from damage for the duration of any and all approved building works.<br><br>This work is to be executed by a licensed contractor with a proven record of satisfactory work to heritage buildings. | |

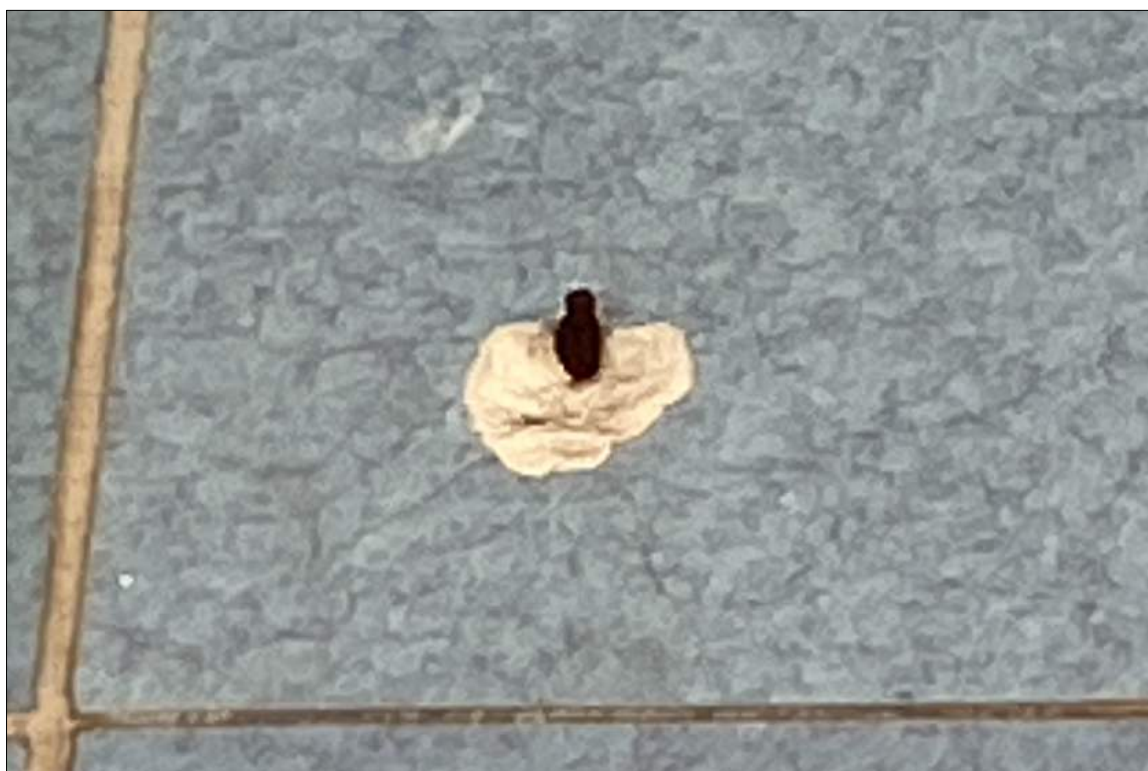
**Fig. 6. Broken tiles are to be replaced with matching tiles or repaired if no suitable tile is available. Rusting fixing are to be removed from the tiles and the holes repaired.**

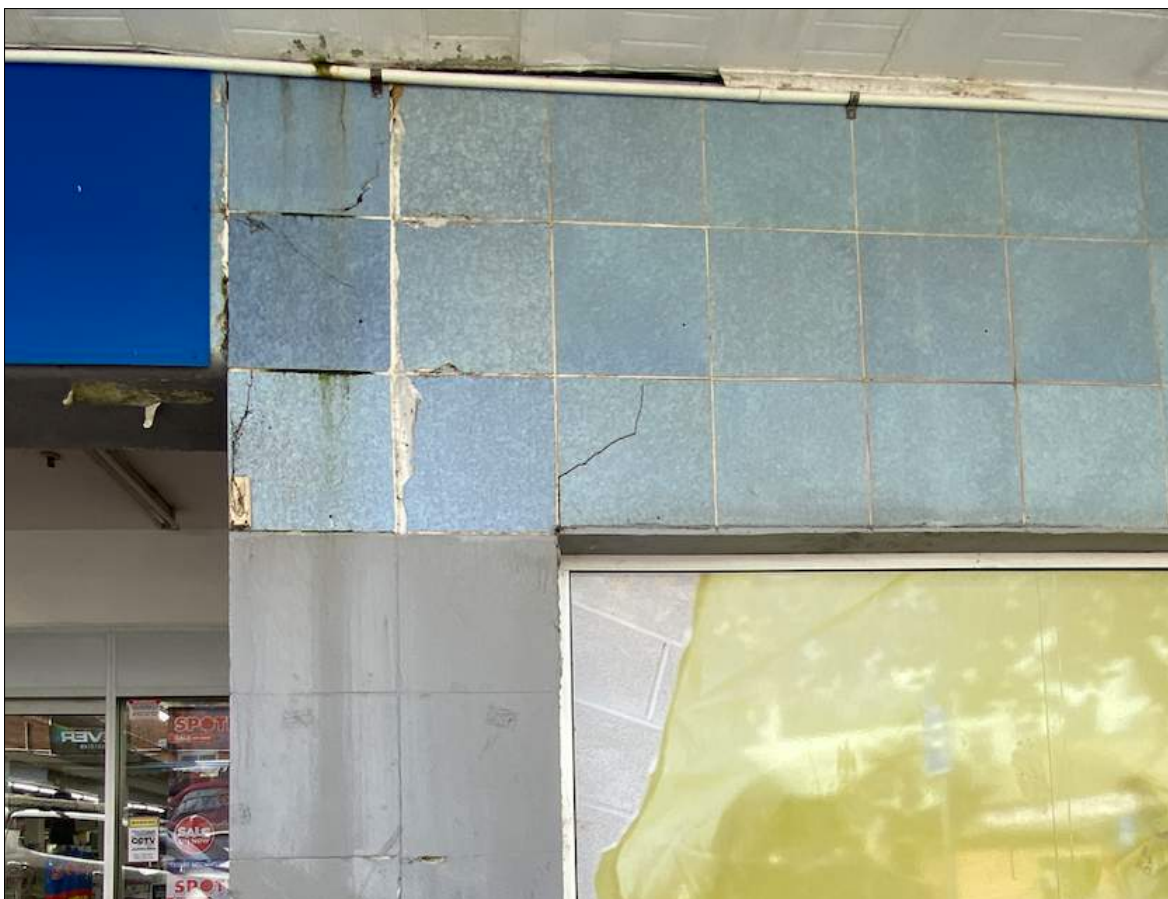
**Fig. 7. Broken tiles are to be replaced with matching tiles or repaired if no suitable tile is available. Surface conduits are to be removed from façade and the damage made good.**

| | | <b>LOCATION:</b> Western Façade – Ground Floor<br><br><b>WORK REQUIRED:</b><br>Broken tiles are to be replace with matching tiles or repaired if no suitable tile is available. Surface conduits are to be removed from façade.<br><br>This work is to be executed by a licensed contractor with a proven record of satisfactory work to heritage buildings.<br><br><b>Standards:</b> AS 3958.1-2007 installation of tiles and AS/NZS 3000:2018, Electrical installations. | |

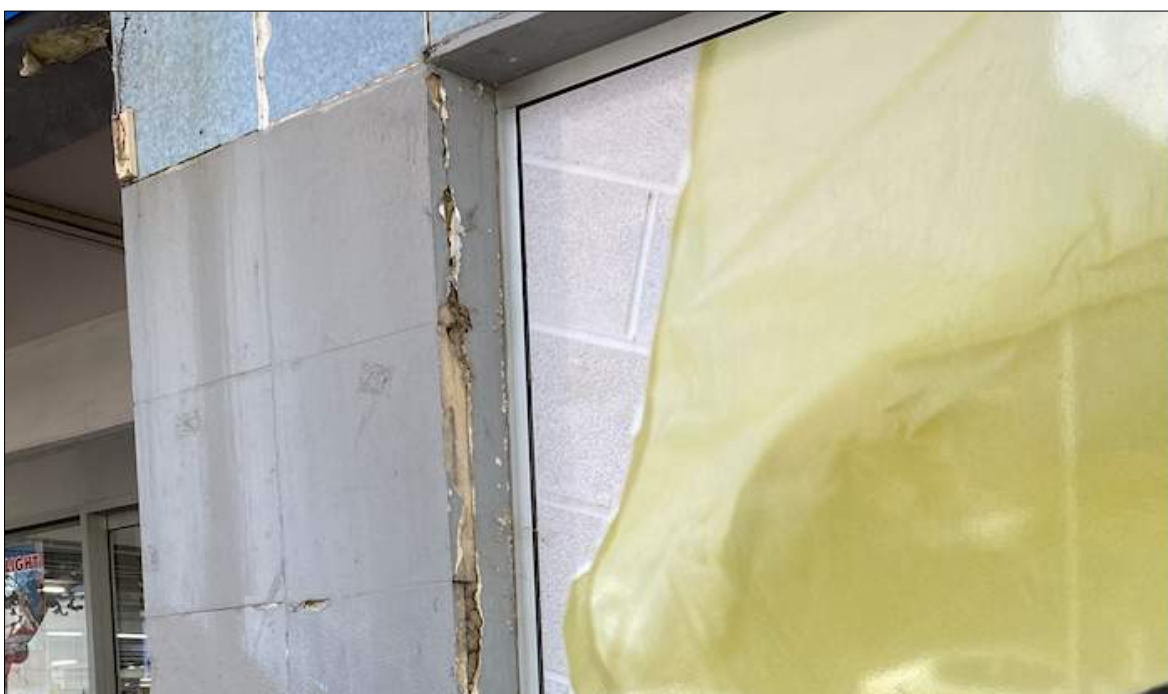
**Fig. 8. Damaged painted render to shop fronts in Atchison Street.**

| | | <b>LOCATION:</b> Western Façade – Ground Floor<br><br><b>WORK REQUIRED:</b><br>Damaged painted render to shop fronts in Atchison Street.<br><br>This work is to be executed by a licensed contractor with a proven record of satisfactory work to heritage buildings.<br><br><b>Standards:</b> AS 3972-2010 General purpose and blended cements, AS/NZS 2311-2017 Guide to Painting of Buildings and protection, and AS 4361.2-1998 Guide to lead paint management - Residential and commercial buildings. | |

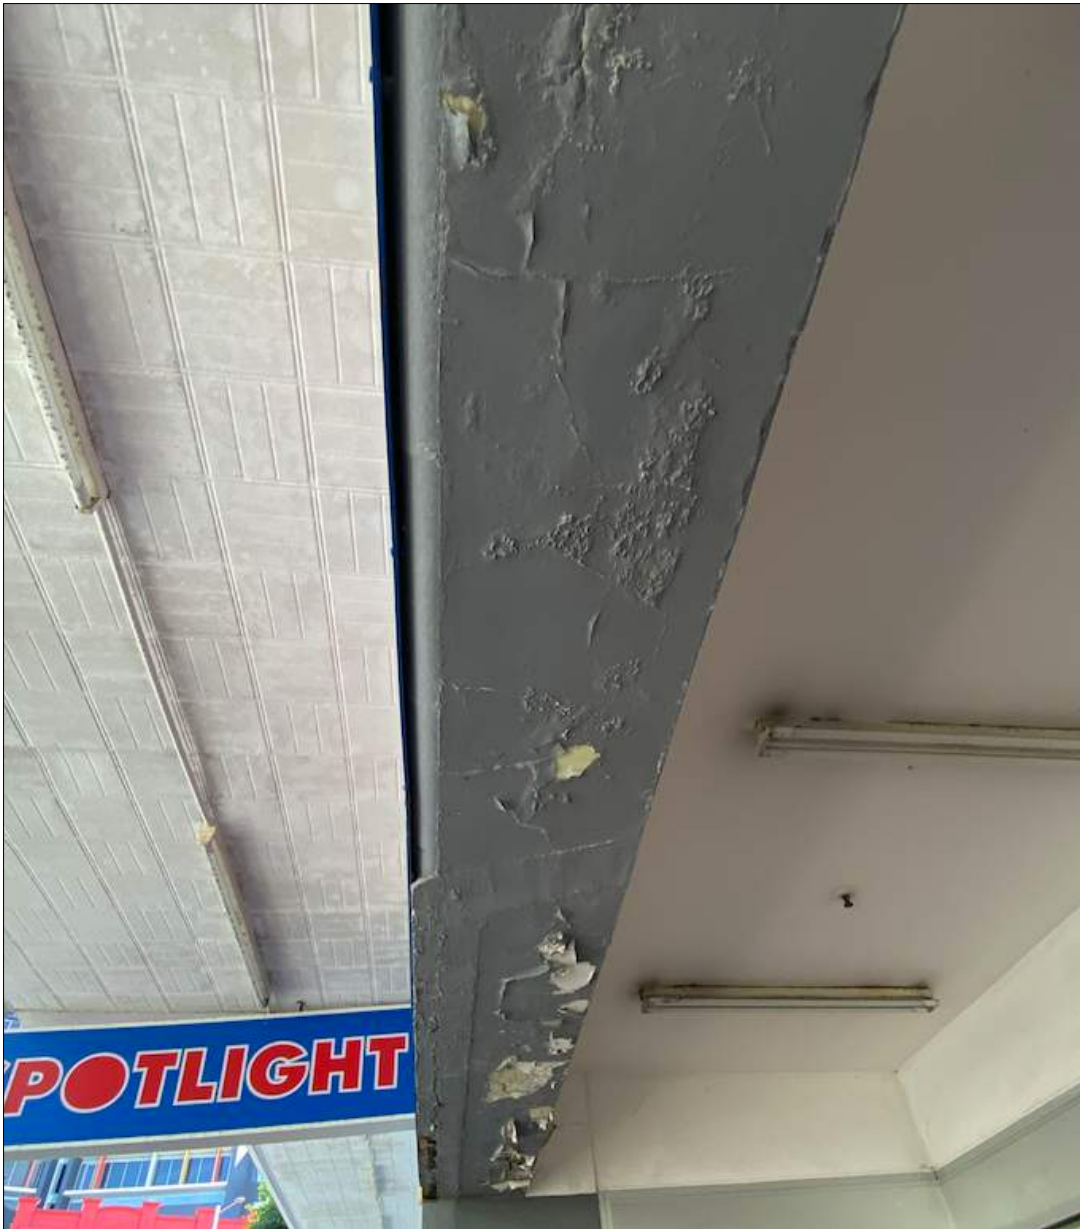
**Fig. 9. Awning water penetration of the concrete beam over the Atchison Street entry.**

| | | <b>LOCATION:</b> Western Façade – Ground Floor<br><br><b>WORK REQUIRED:</b><br>Provide repair to overhead concrete beam (spalling repairs in required) at the Atchison Street entry.<br>This work is to be executed by an experienced contractor with a proven record of satisfactory repairs to heritage building.<br><br><b>Standards:</b> SA HB 84:2018 Guide to concrete repair and protection, AS 1478.2-2005 Chemical admixtures for concrete, mortar and grout, AS/NZS 2311-2017 Guide to Painting of Buildings and protection, AS 4361.2-1998 Guide to lead paint management - Residential and commercial buildings and AS 2312.1:2014 Guide to the protection of structural steel against atmospheric corrosion by the use of protective coatings Paint coatings. | |

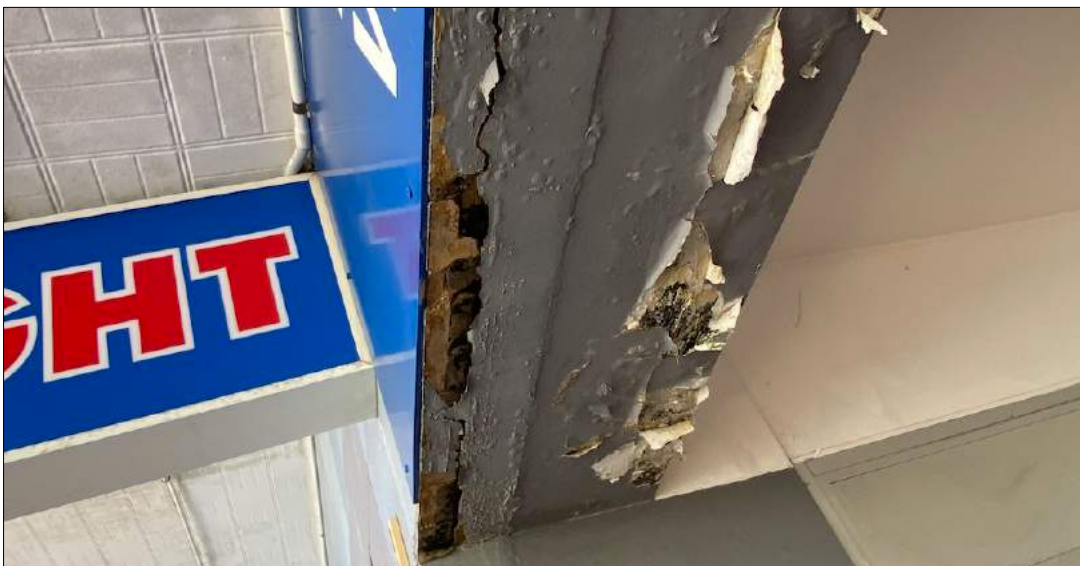
**Fig. 10. Awning water penetration of the concrete beam over the Atchison Street entry.**

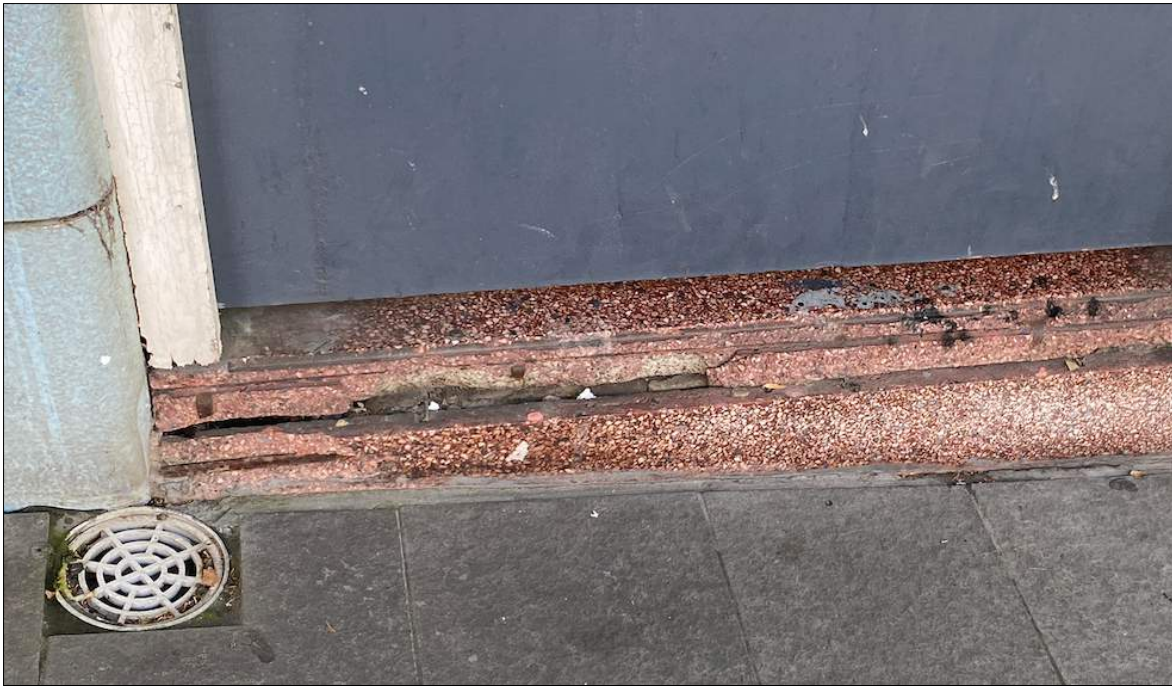
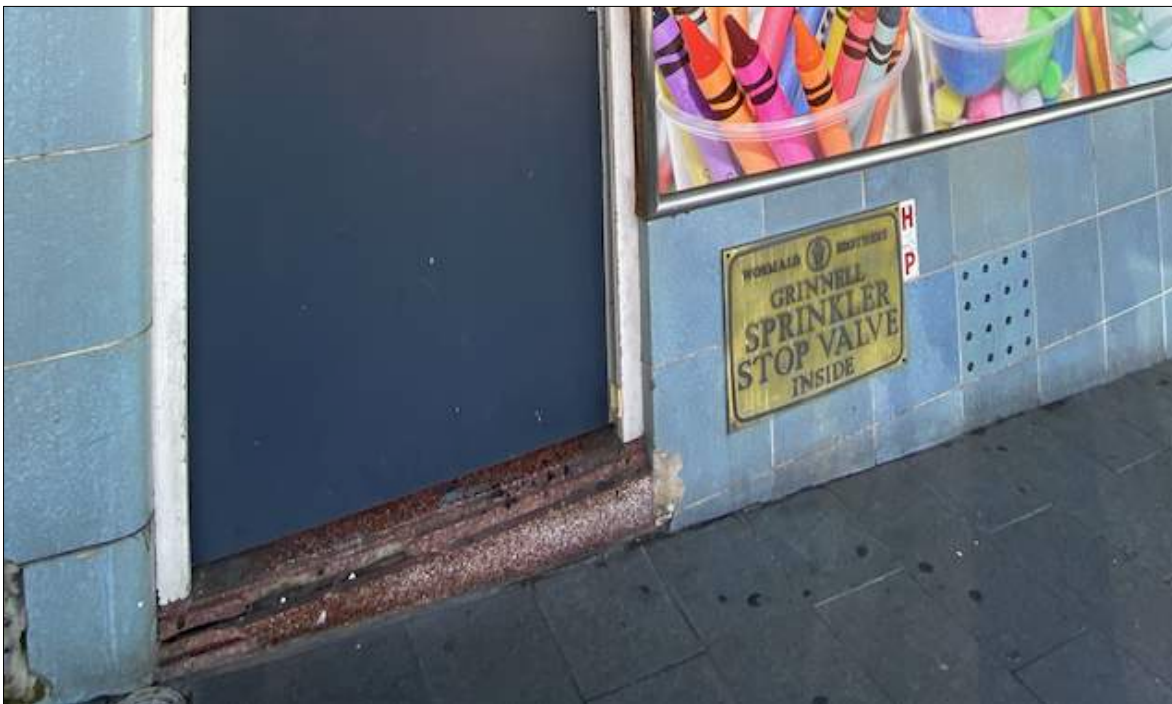
**Fig. 11. Damaged door threshold in Atchison Street.**

**Fig. 12. Damaged door threshold in Atchison Street.**

| | | <b>LOCATION:</b> Western Façade – Ground Floor<br><br><b>WORK REQUIRED:</b><br>Provide repairs to damaged door threshold in Atchison Street.<br><br>This work is to be executed by an experienced terrazzo contractor with a proven record of satisfactory repairs to heritage building.<br><br><b>Standards:</b> SA HB 84:2018 Guide to concrete repair and protection and AS 1478.2-2005 Chemical admixtures for concrete, mortar and grout. | |

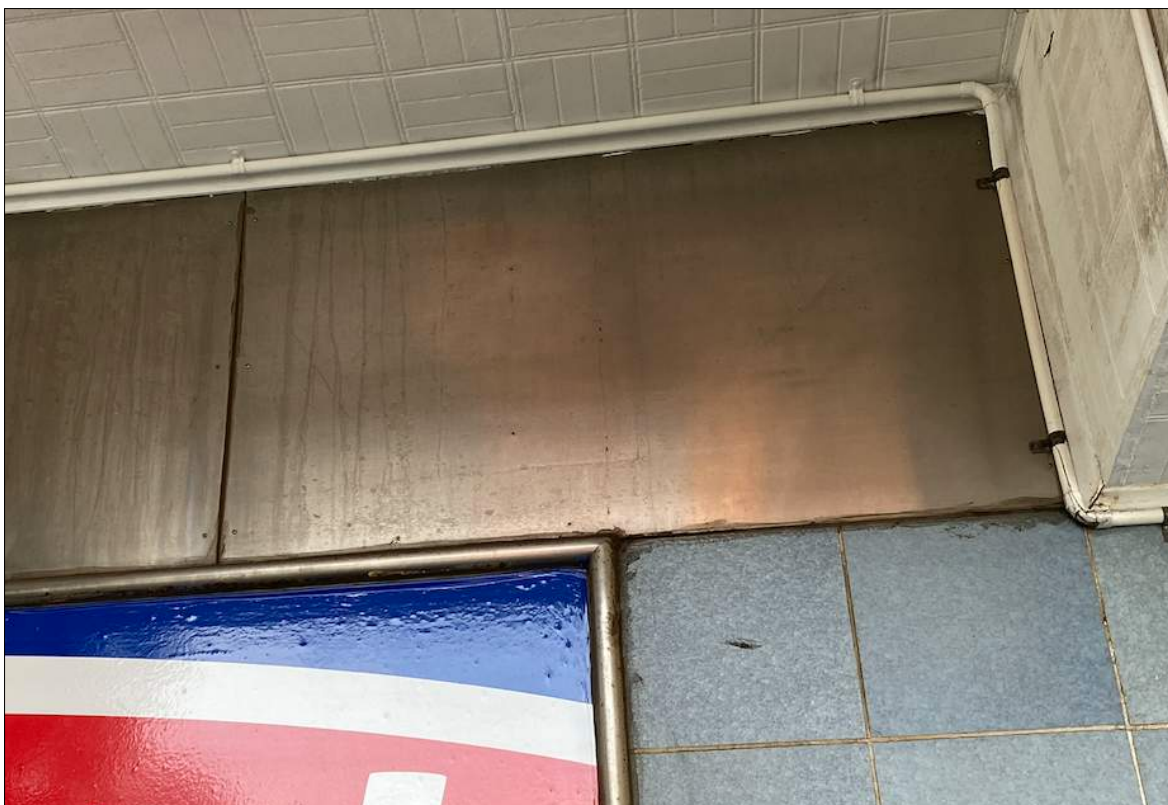
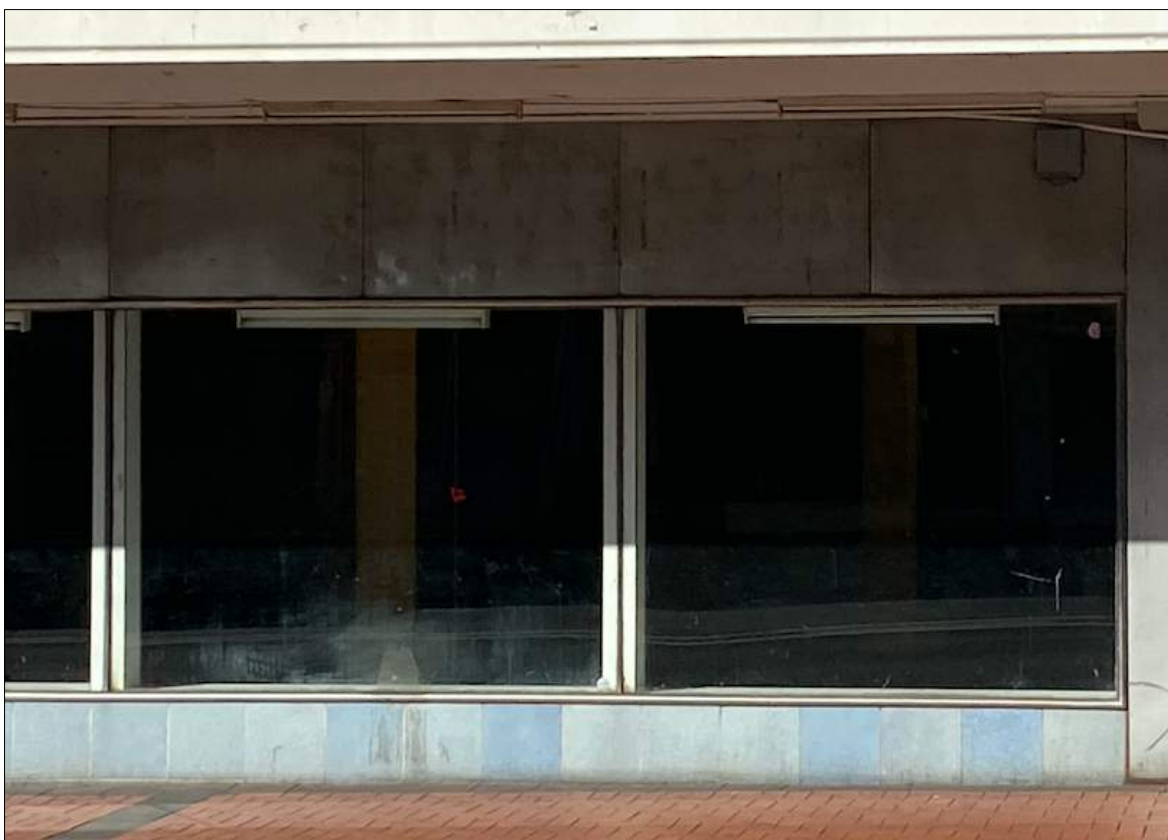
**Fig. 13. Curved stainless steel frame to glass shopfronts and signage is to be retained and protected from damage during all approved building works.**

**Fig. 14. Curved stainless steel frame to glass shopfronts and signage is to be retained and protected from damage during all approved building works.**

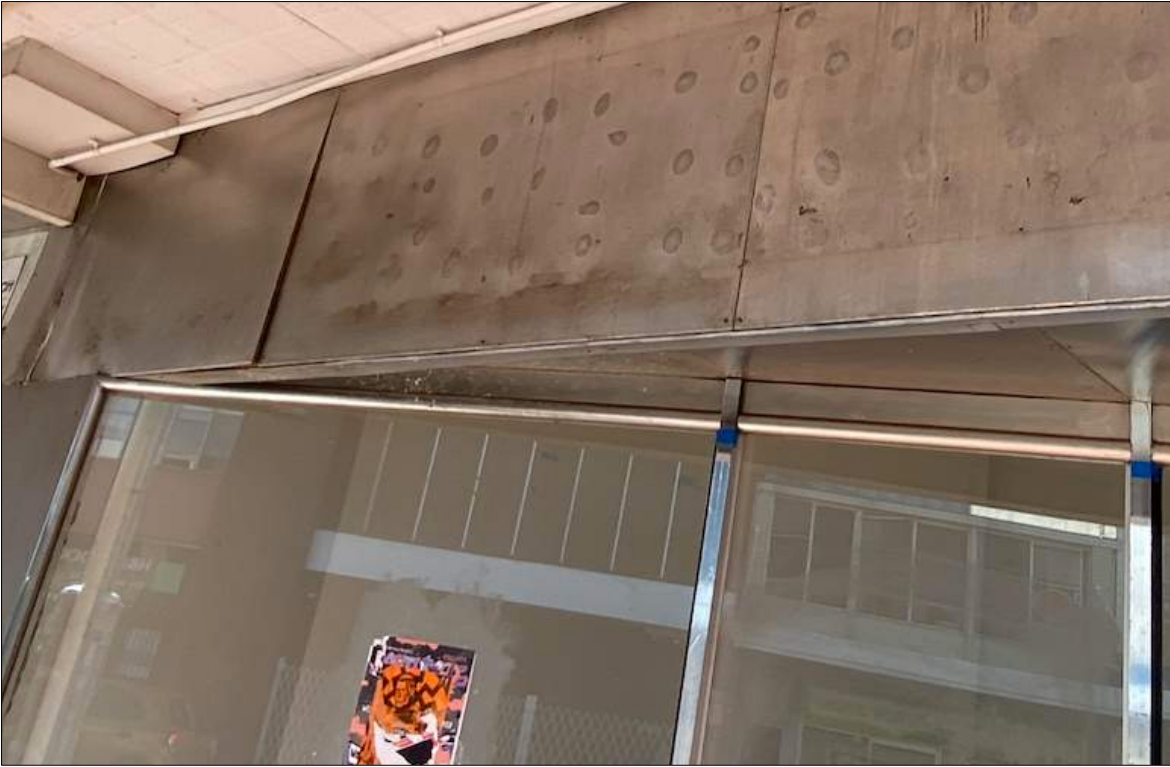
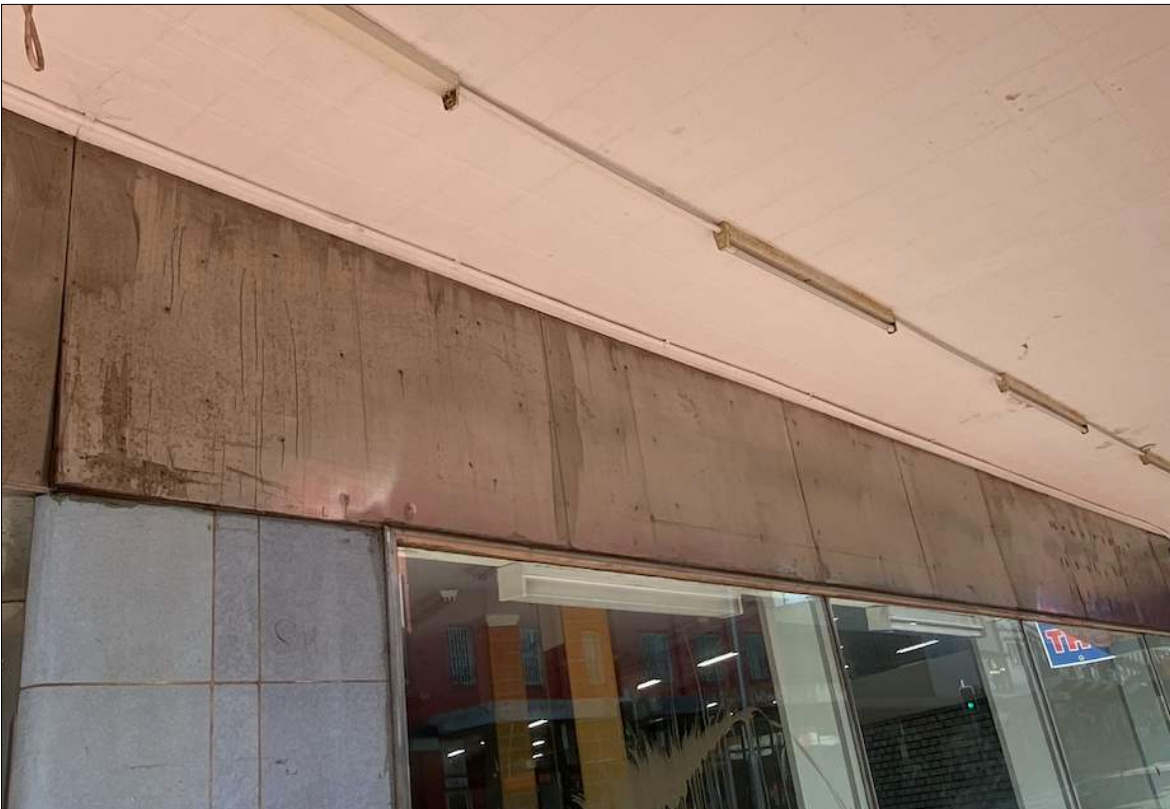
**Fig. 15.** Sections of the stainless steel cladding above the shopfront glazing are to be removed to reveal the underlying surface, Guidance from the nominated heritage consultant is to be sort on how these areas are to be treated.

**Fig. 16.** Sections of the stainless steel cladding above the shopfront glazing are to be removed to reveal the underlying surface, Guidance from the nominated heritage consultant is to be sort on how these areas are to be treated.

| | | <b>LOCATION:</b> Northern Façade – Ground Floor<br><br><b>WORK REQUIRED:</b><br>Sections of the stainless steel cladding above the shopfront glazing are to be removed to reveal the underlying surface, Guidance from the nominated heritage consultant is to be sort on how these areas are to be treated once the underlying surface is exposed.<br><br>This work is to be executed by an experienced contractor with a proven record of satisfactory work to heritage buildings. | |

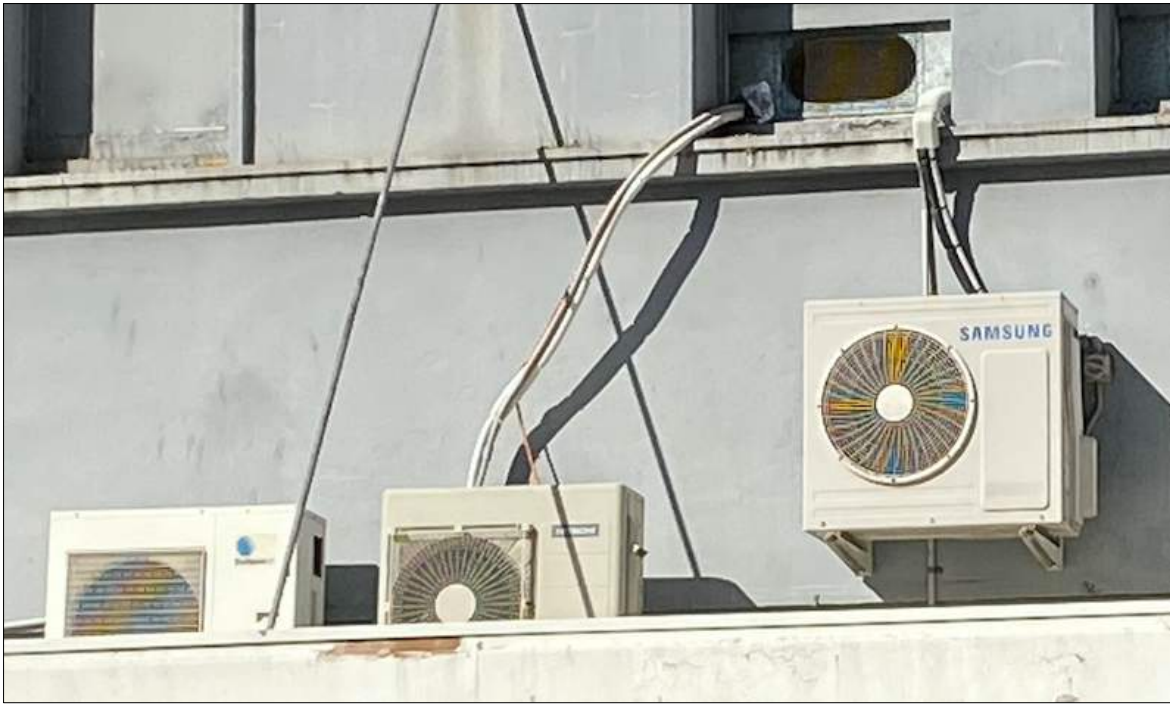
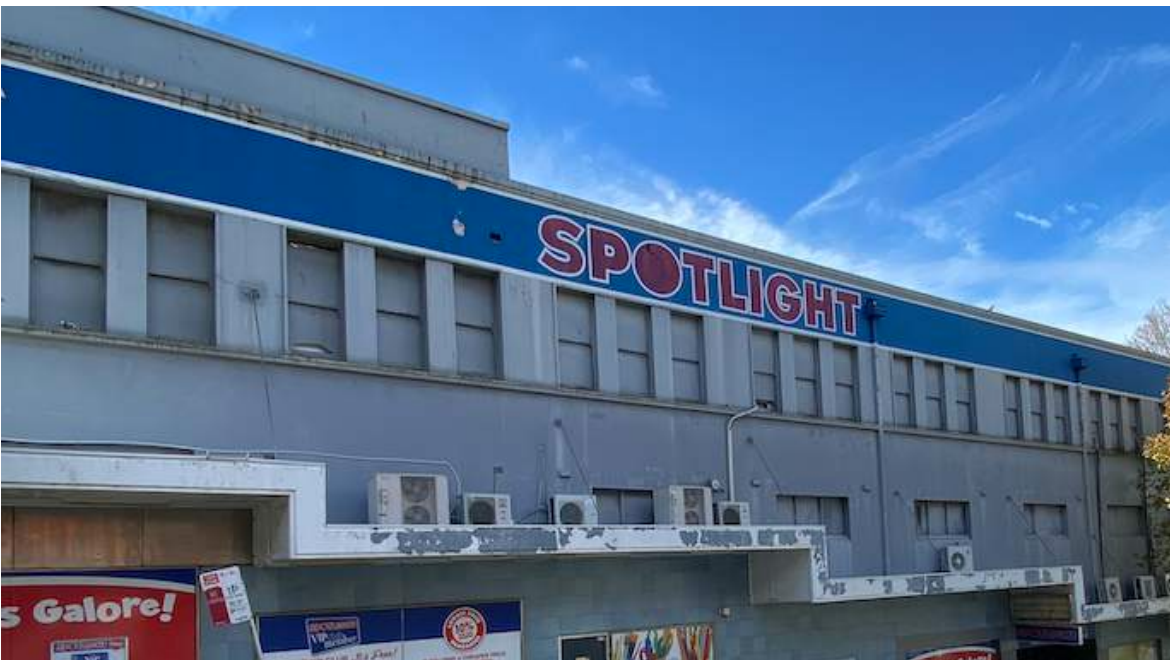
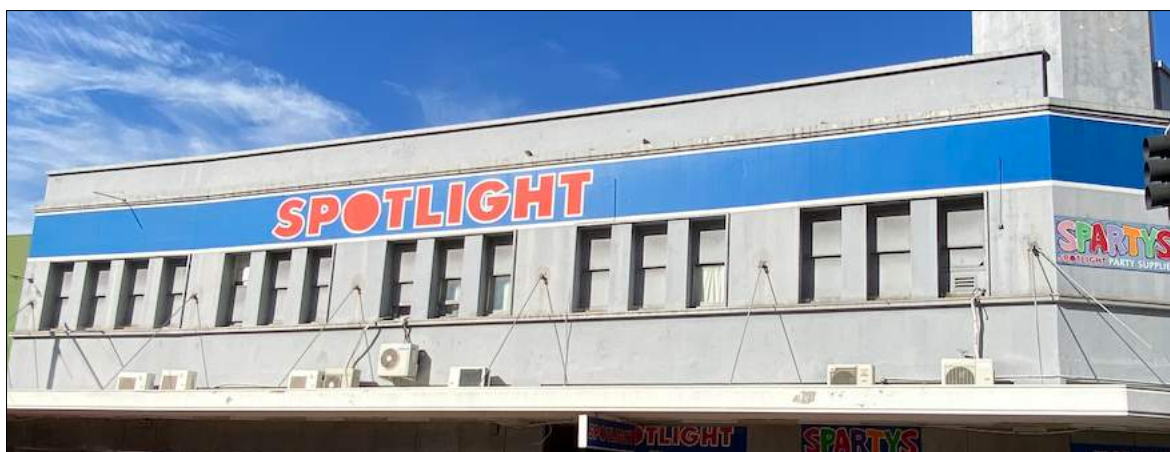
**Fig. 17.** All air-conditioning compressors, conduits, air-conditioning pipework, redundant brackets and fixings are to be removed from the facade on both Atchison and Crown Street.

**Fig. 18.** All air-conditioning compressors, conduits, air-conditioning pipework, redundant brackets and fixings are to be removed from the facade on both Atchison and Crown Street.

**Fig. 19. All air-conditioning compressors, conduits, air-conditioning pipework, redundant brackets and fixings are to be removed from the facade on both Atchison and Crown Street.**

| | | <b>LOCATION:</b> Northern and Western Façade<br><br><b>WORK REQUIRED:</b><br>All air-conditioning compressors, conduits, air-conditioning pipework, redundant brackets and fixings are to be removed from the facade on both Atchison and Crown Street.<br><br>This work is to be executed by an experienced contractor with a proven record of satisfactory work to heritage buildings.<br><br><b>Standard:</b> AS/NZS 3000:2018 Electrical installations. | |

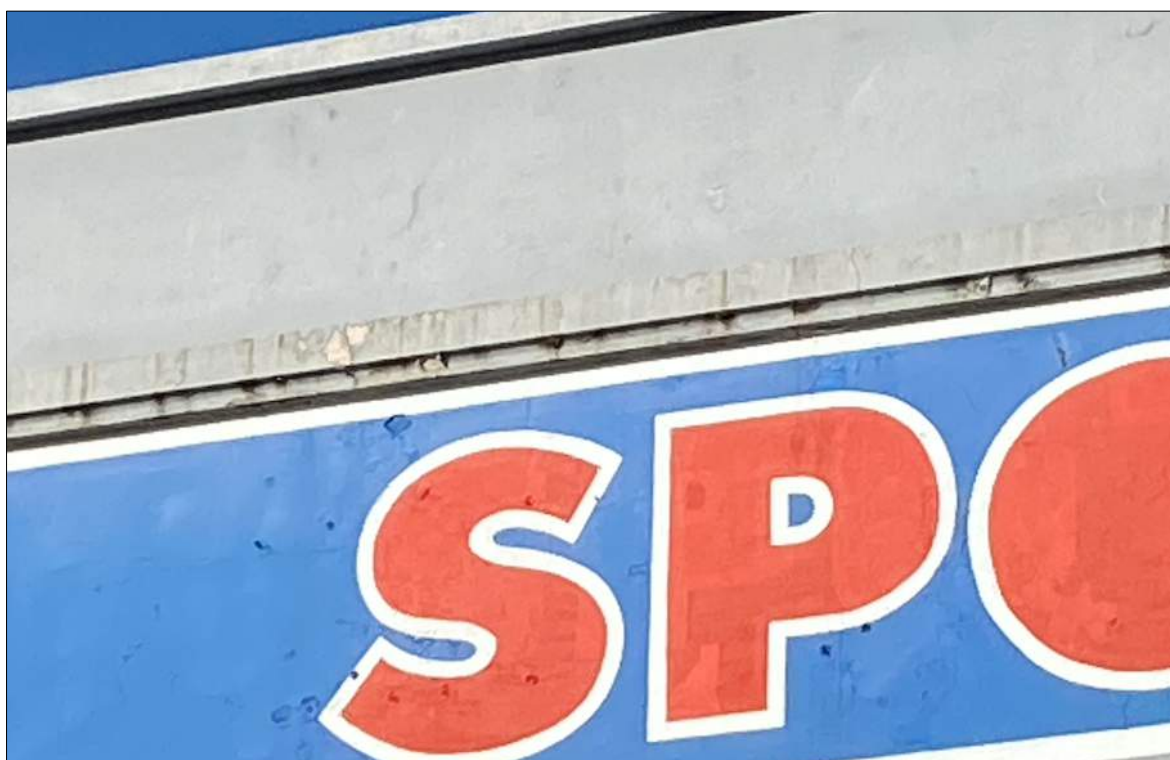
**Fig. 20. All rusting remnants of redundant masonry anchors are to be removed from the facade on both Atchison and Crown Street.**

| | | <b>LOCATION:</b> Northern and Western Façade<br><br><b>WORK REQUIRED:</b><br>All rusting remnants of redundant masonry anchors are to be removed from the facade on both Atchison and Crown Street and the fixing's hole repaired.<br><br>This work is to be executed by an experienced contractor with a proven record of satisfactory work to heritage buildings.<br><br><b>Standards:</b> AS 3972-2010 General purpose and blended cements. | |

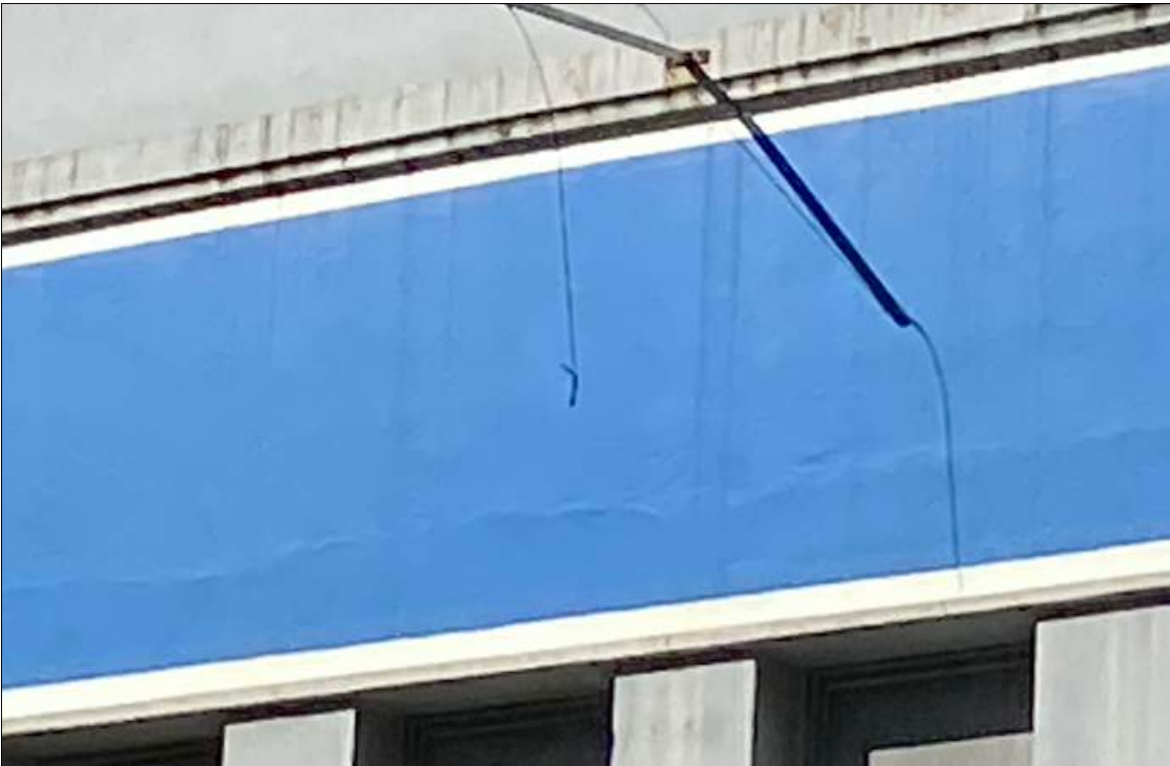
**Fig. 21. The deformity in the painted render on eastern end on the Crown Street façade is to be investigated and findings reported to the nominated heritage consultant and guidance sort on any required remediation.**

| | <p><b>LOCATION:</b> Northern Façade</p> <p><b>WORK REQUIRED:</b><br/>The deformity in the painted render on eastern end on the Crown Street façade is to be investigated and findings reported to the nominated heritage consultant and guidance sort on any required remediation.</p> <p>This work is to be executed by an experienced contractor with a proven record of satisfactory work to heritage buildings.</p> |

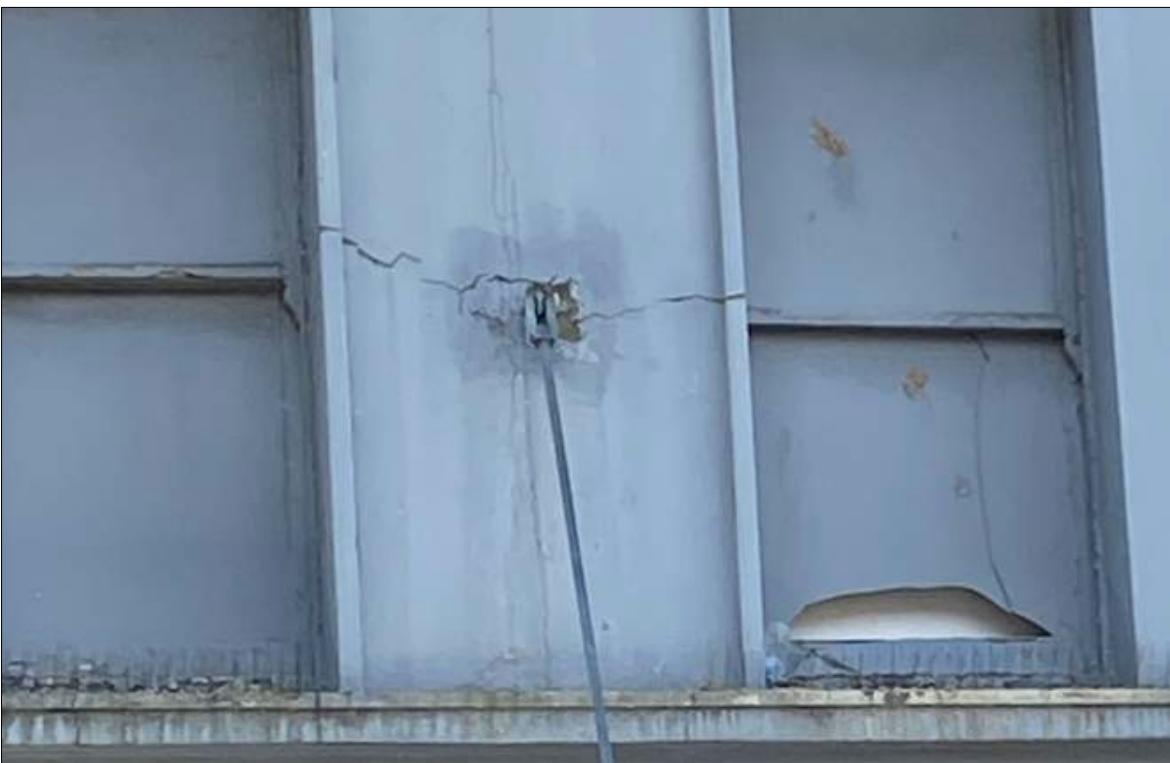
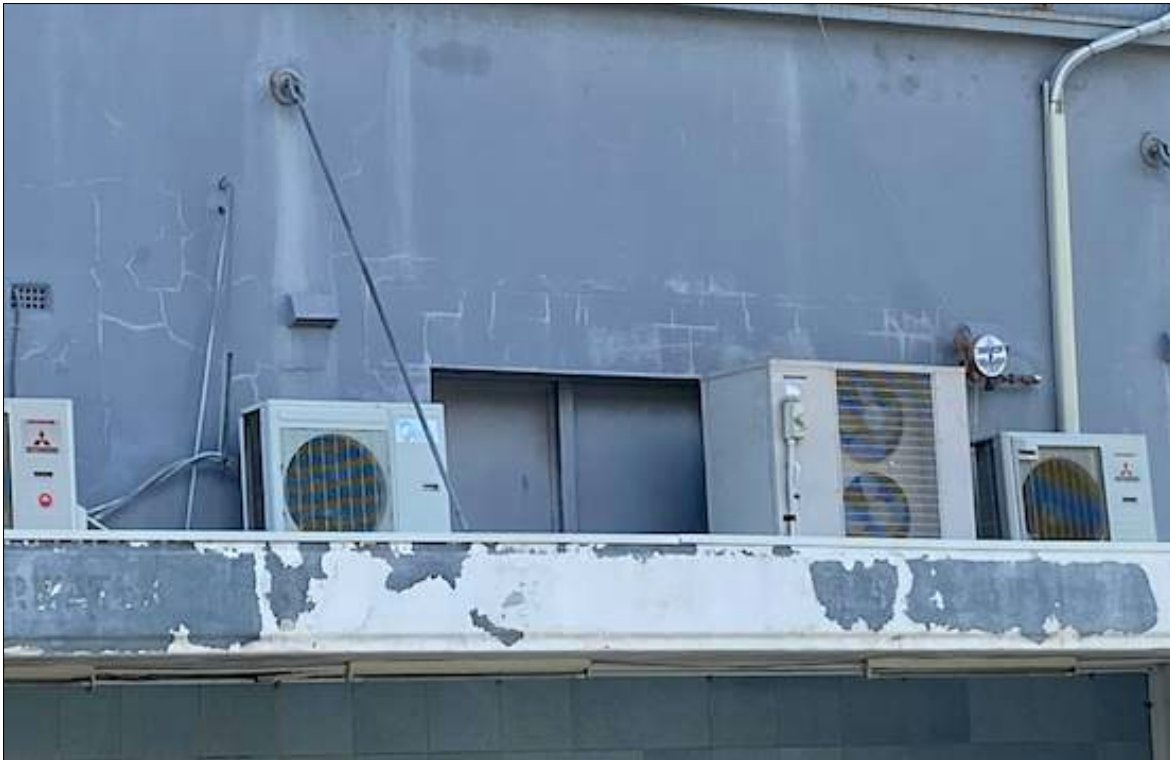
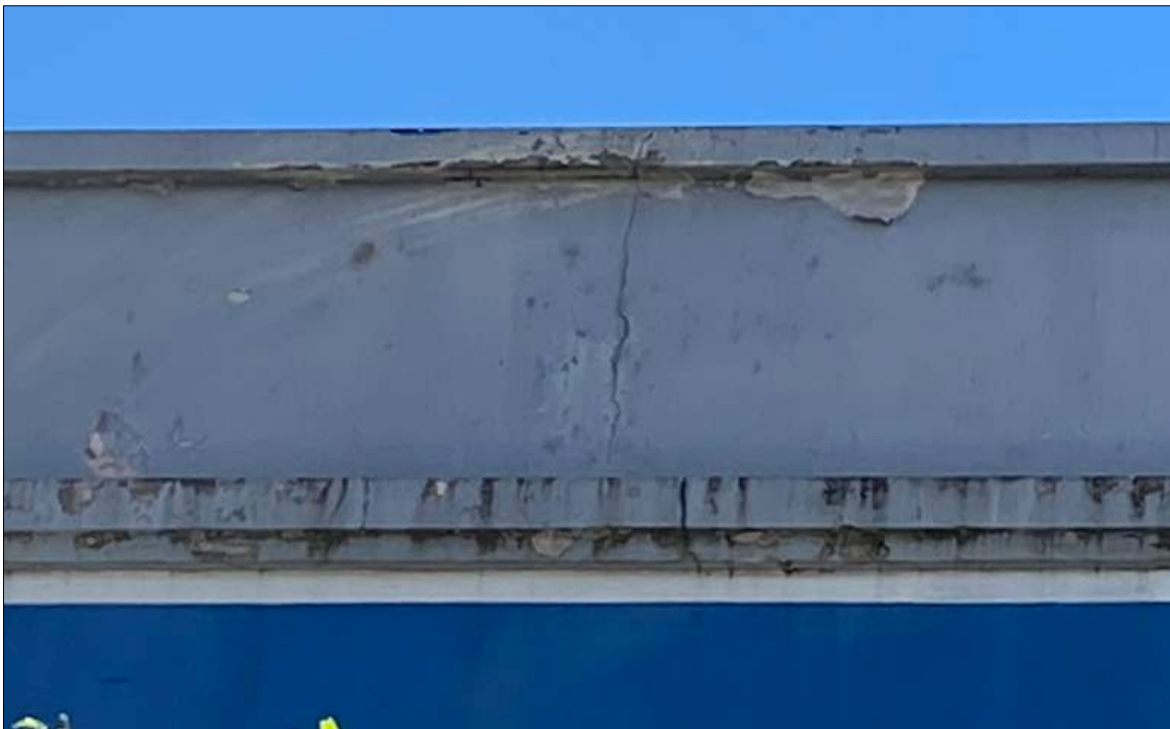
**Fig. 22. Cracked, crazed and damaged rendered masonry is to be repaired.**

**Fig. 23. Cracked, crazed and damaged rendered masonry is to be repaired.**

**Fig. 24. Cracked, crazed and damaged rendered masonry is to be repaired.**

| | | <b>LOCATION:</b> Northern and Western Façade<br><br><b>WORK REQUIRED:</b><br>All cracked, crazed and damaged rendered and underlying masonry is to be repaired.<br><br>This work is to be executed by an experienced contractor with a proven record of satisfactory work to heritage buildings.<br><br><b>Standards:</b> AS 3972-2010 General purpose and blended cements, SA HB 84:2018 Guide to concrete repair and protection, and AS 1478.2-2005 Chemical admixtures for concrete, mortar and grout. | |

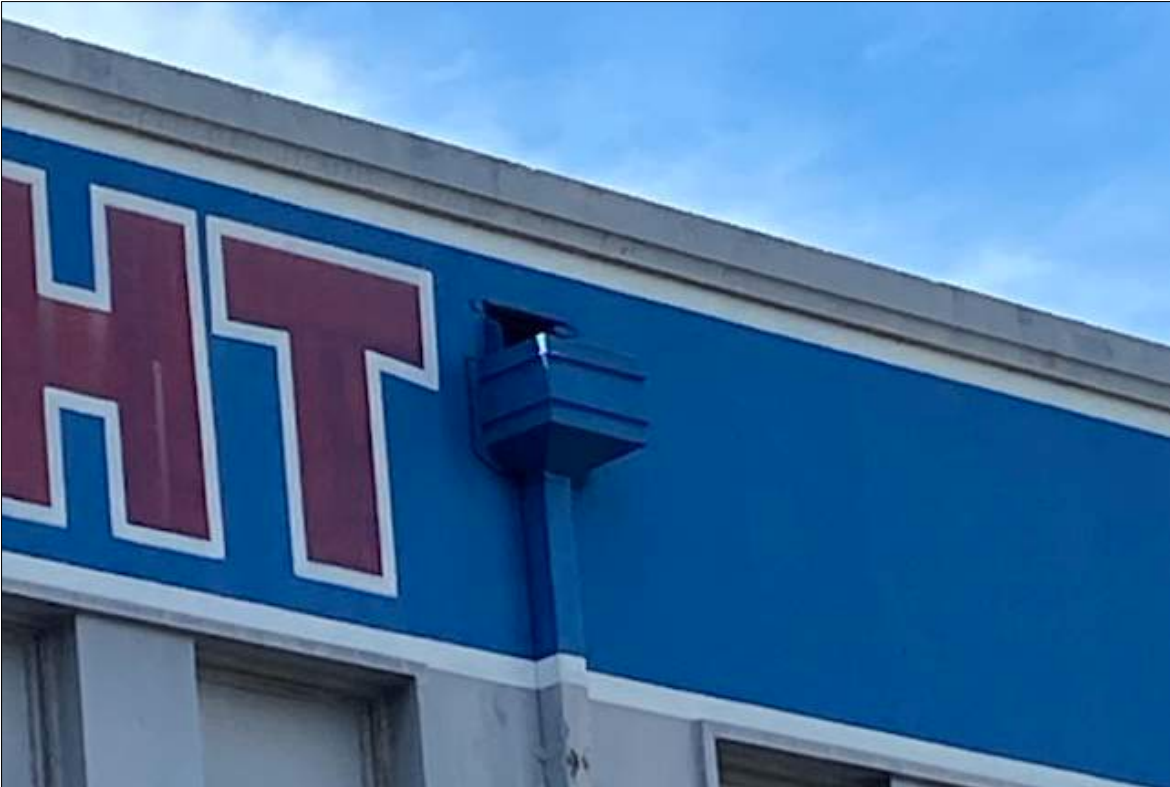
**Fig. 25.** The rain-heads and down-pipes on the Atchison Street façade are to be retained or replaced with 'like-for-like' rain-heads and down-pipes if corroded beyond repair.

| | | <b>LOCATION:</b> Western Façade<br><br><b>WORK REQUIRED:</b><br>The rain-heads and down-pipes on the Atchison Street façade are to be retained or replaced with 'like-for-like' rain-heads and down-pipes if corroded beyond repair.<br><br>This work is to be executed by an experienced contractor with a proven record of satisfactory work to heritage buildings.<br><br><b>Standards:</b> AS/NZS 2179.1-1994 Metal Rainwater and AS/NZS 3500.3.2003. Stormwater Drainage. | |
