# STATEMENT OF HERITAGE IMPACT

*State Significant Development Application SSD-76440958*

221-291 Crown Street, 216-238 Keira Street and Nos 86-90

July 2025 | J4205\_05

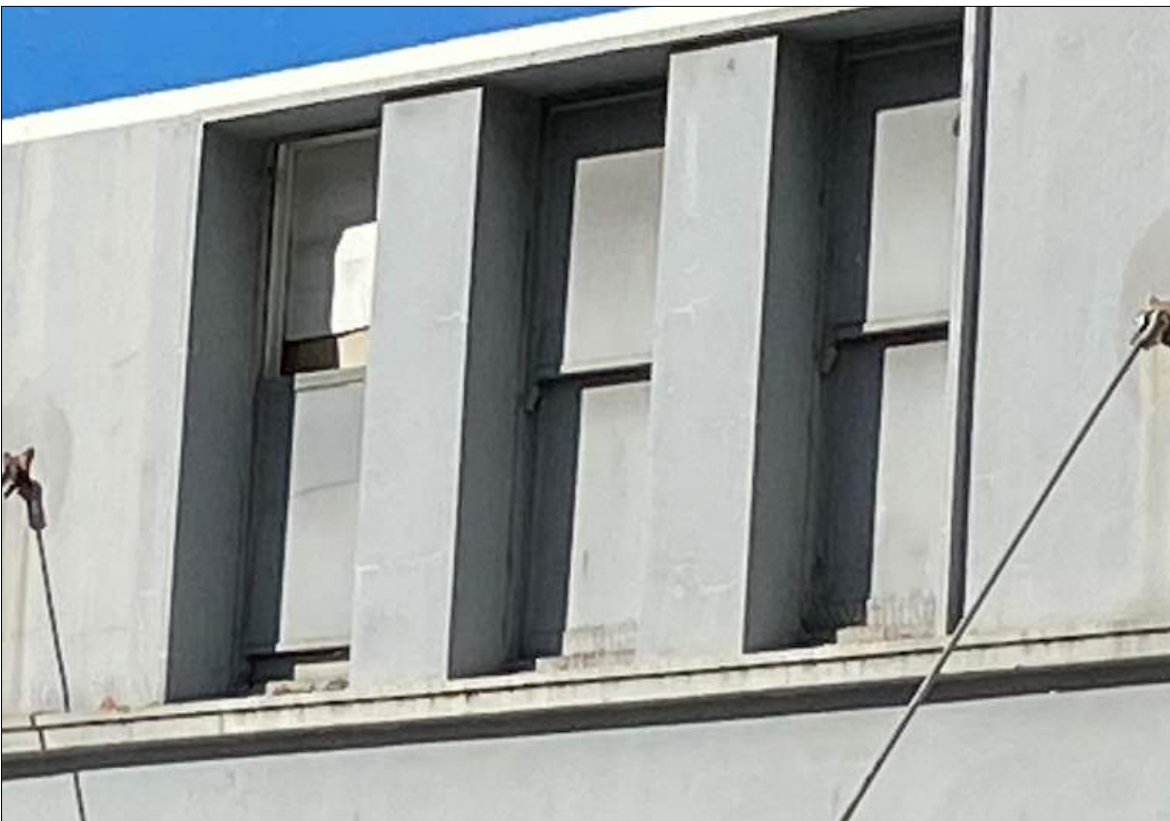
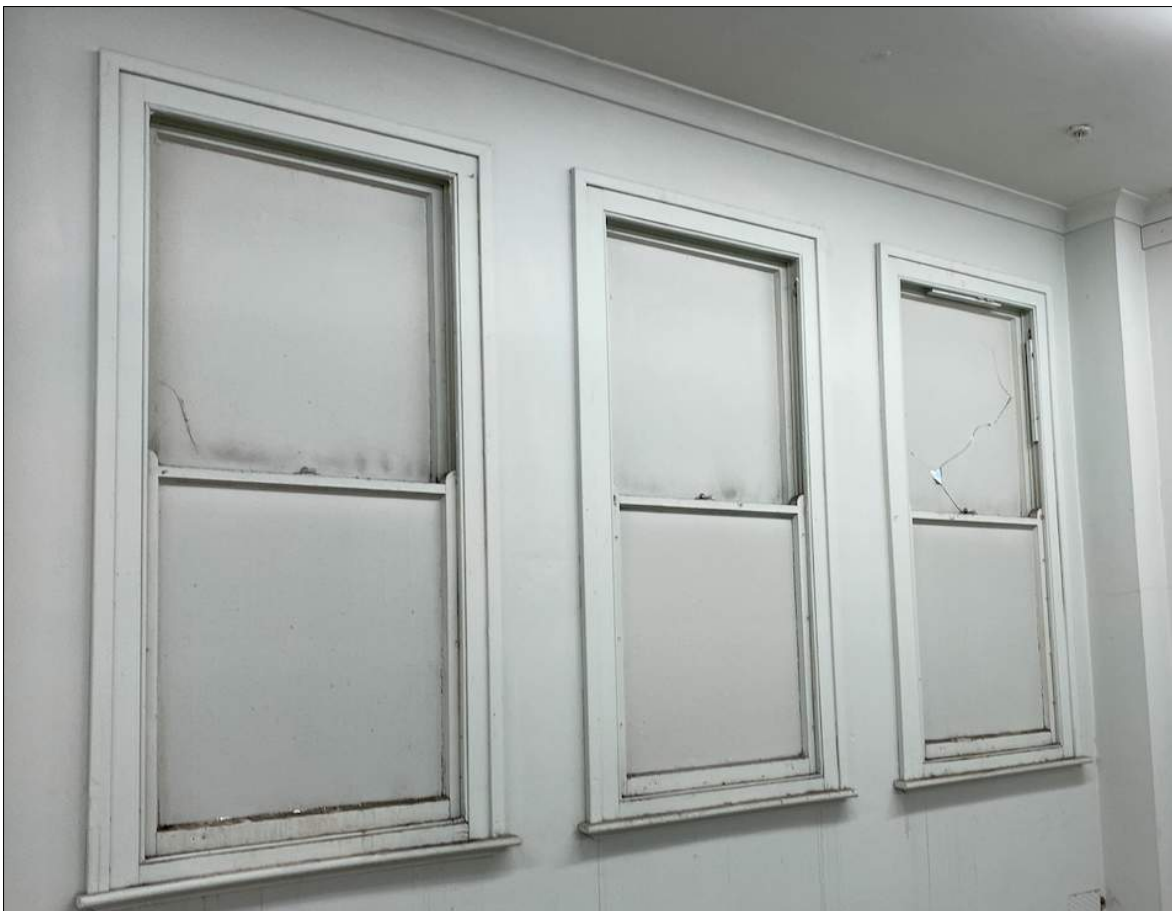
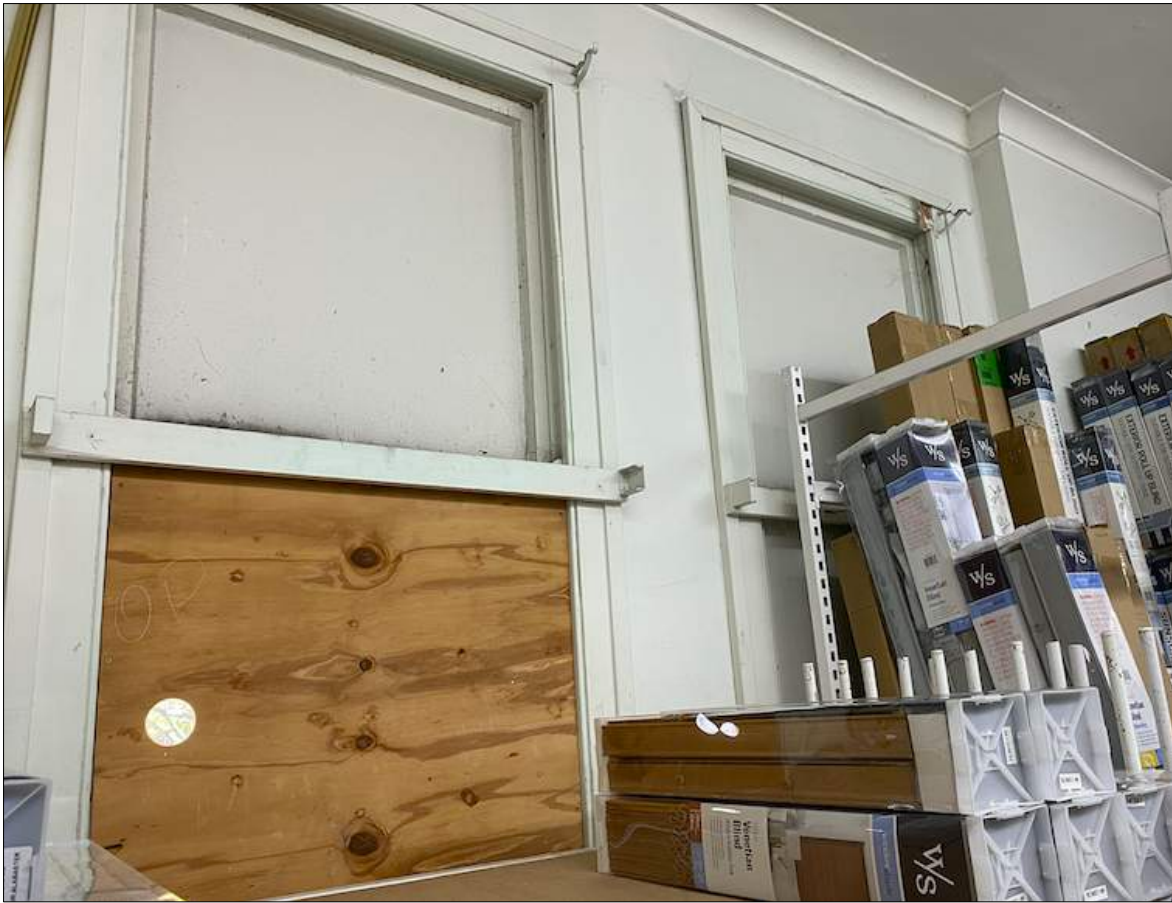
**Fig. 26.** All the double hung timber windows in the façade in both Atchison and Crown Street are to be restored.

**Fig. 30.** All the double hung timber windows in the façade in both Atchison and Crown Street are to be restored.

**Fig. 31. All the double hung timber windows in the façade in both Atchison and Crown Street are to be restored.**

| | | <b>LOCATION:</b> Northern and Western Façade<br><br><b>WORK REQUIRED:</b><br>All the double hung timber windows in the façade in both Atchison and Crown Street are to be restored, Window frames and sill are to be repaired where required, window sashes are to be repaired where required or replaced with 'like-for-like window sashes where sash is missing or damage beyond repair. Glass is to be replaced and the windows are to be properly prepared and painted to paint manufactures specification in approved colour<br><br>This work is to be executed by an experienced contractor with a proven record of satisfactory work to heritage buildings.<br><br><b>Standards:</b> AS 1684.2—2006 Timber framing, AS/NZS 2311-2017 Guide to Painting of Buildings and protection, and AS 4361.2-1998 Guide to lead paint management - Residential and commercial buildings. | |

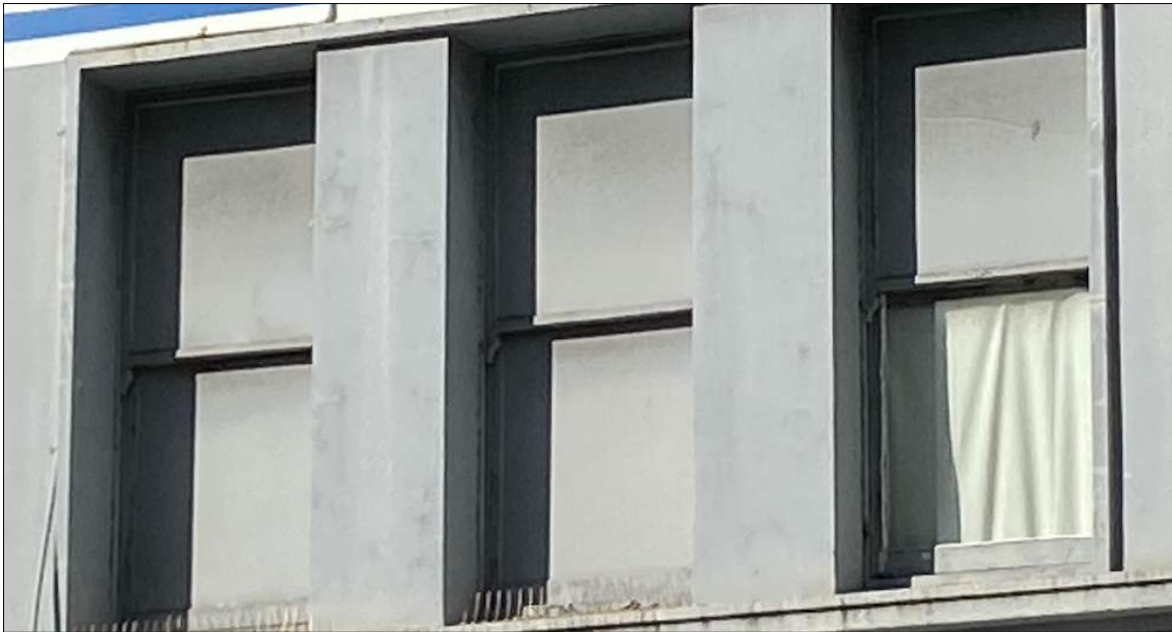
**Fig. 27.** All the double hung timber windows in the façade in both Atchison and Crown Street are to be restored.

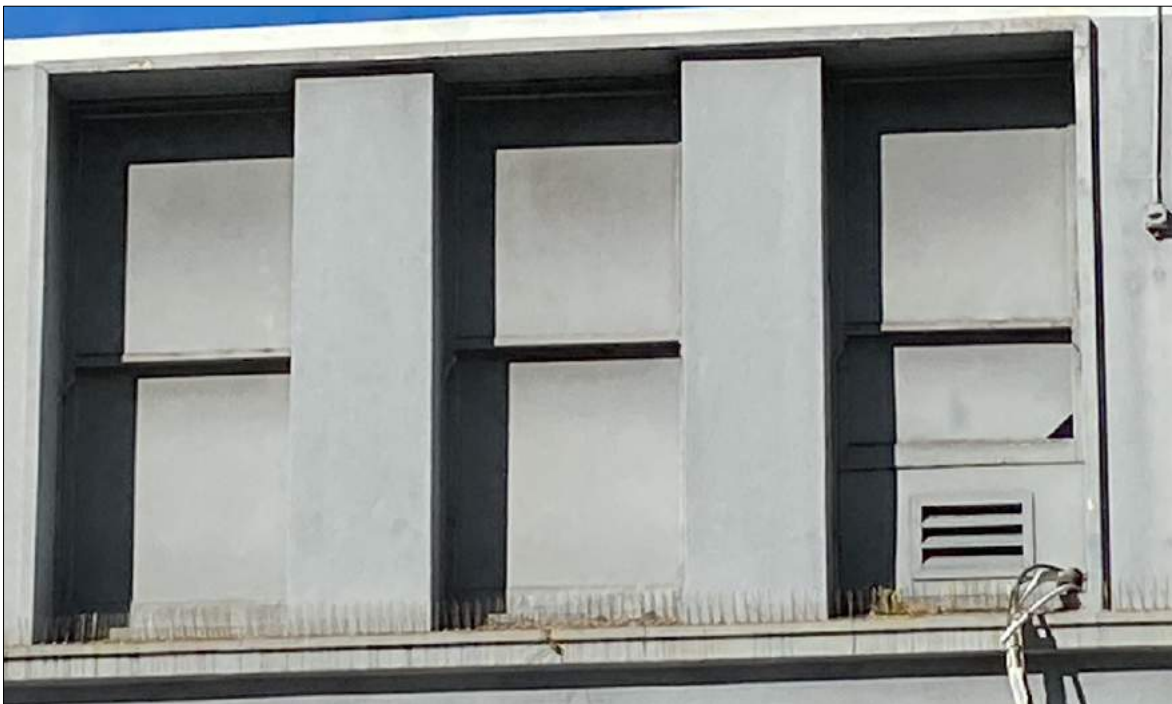
**Fig. 28.** All the double hung timber windows in the façade in both Atchison and Crown Street are to be restored.

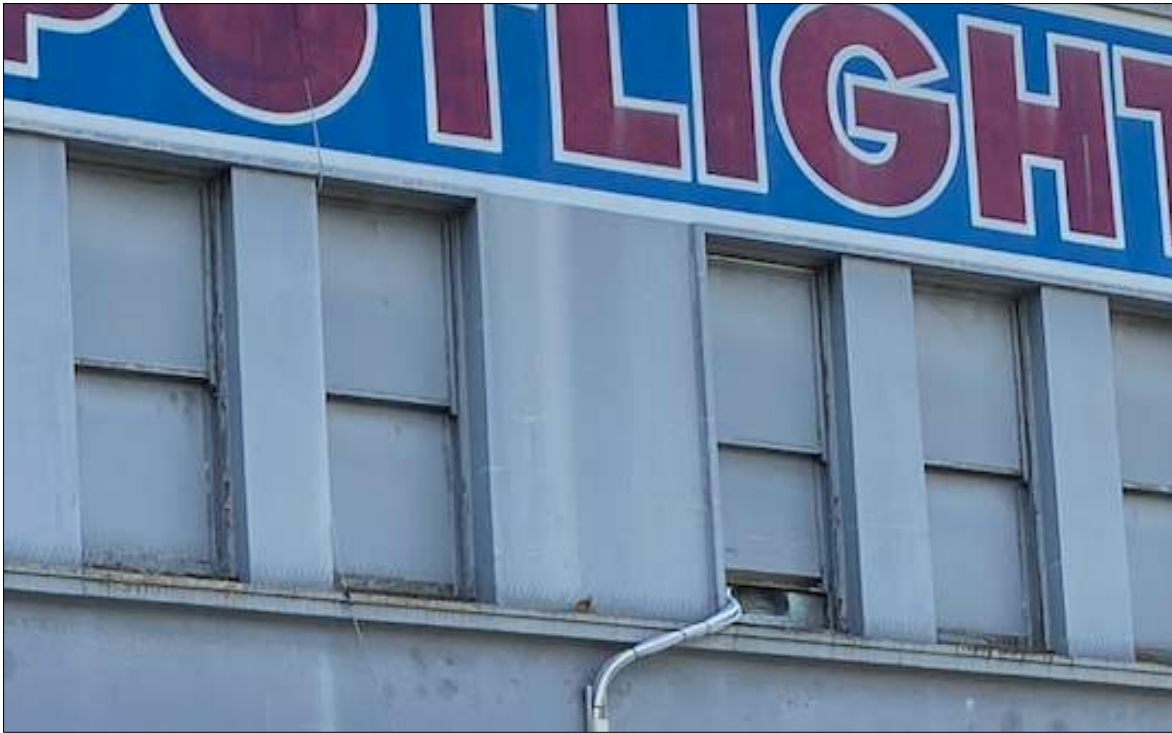
**Fig. 29.** All the double hung timber windows in the façade in both Atchison and Crown Street are to be restored.

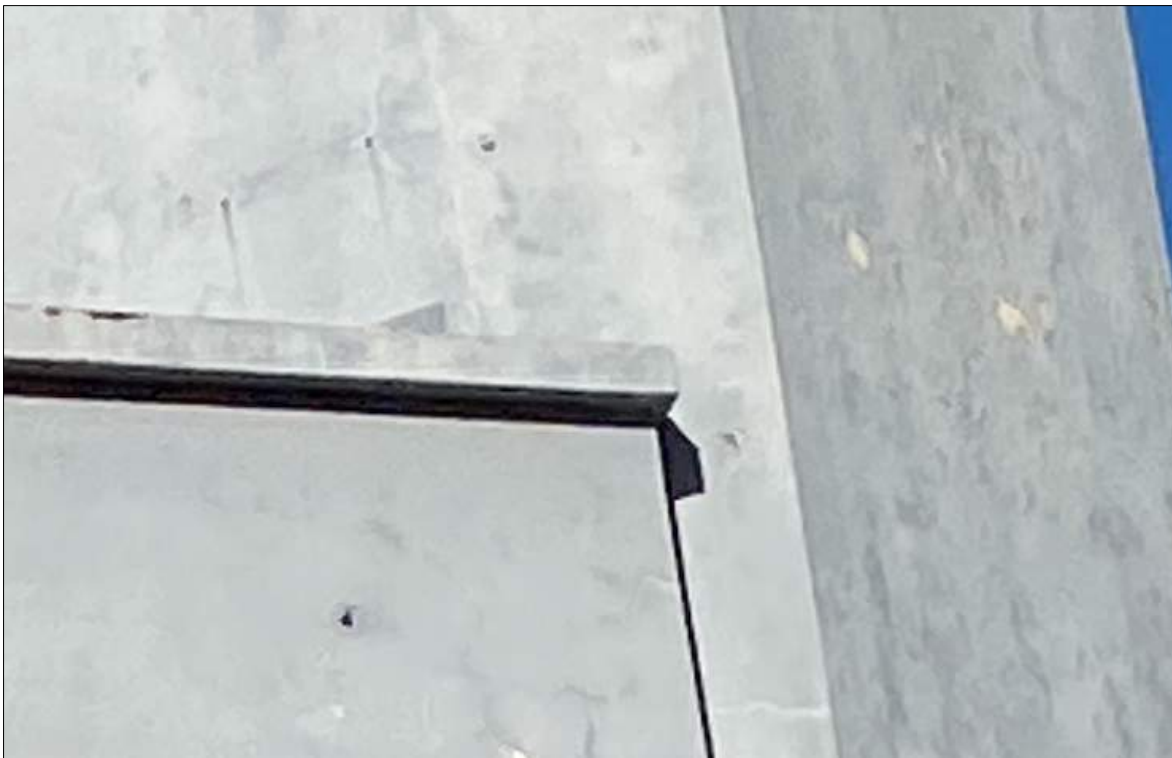
**Fig. 32. All rusting remnants of redundant masonry anchors are to be removed from the clock tower.**

| | | <b>LOCATION:</b> Clock Tower<br><br><b>WORK REQUIRED:</b><br>All remnants of redundant masonry anchors are to be removed from the clock tower. The pigeons are to be removed from inside the clock tower and damaged concrete is to be repaired. The clocks on all three faces are to be reinstated with functioning mechanism.<br><br>The clock tower is to be restored and protected from damage during the course of approved works.<br><br>This work is to be executed by an experienced contractors with proven records of satisfactory work to heritage buildings.<br><br><b>Standard:</b> SA HB 84:2018 Guide to concrete repair and protection, AS 1478.2-2005 Chemical admixtures for concrete, mortar and grout and AS/NZS 3000:2018 Electrical installations. | |

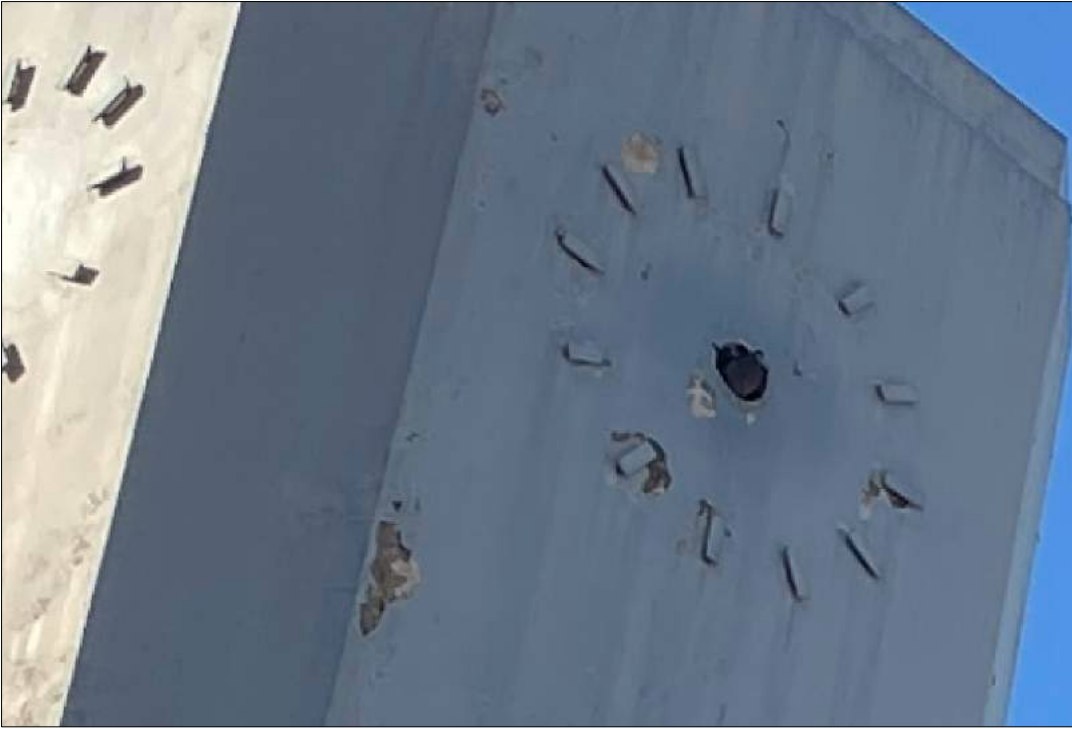
**Fig. 33. The pigeons are to be removed from inside the clock tower and damaged concrete is to be repaired.**

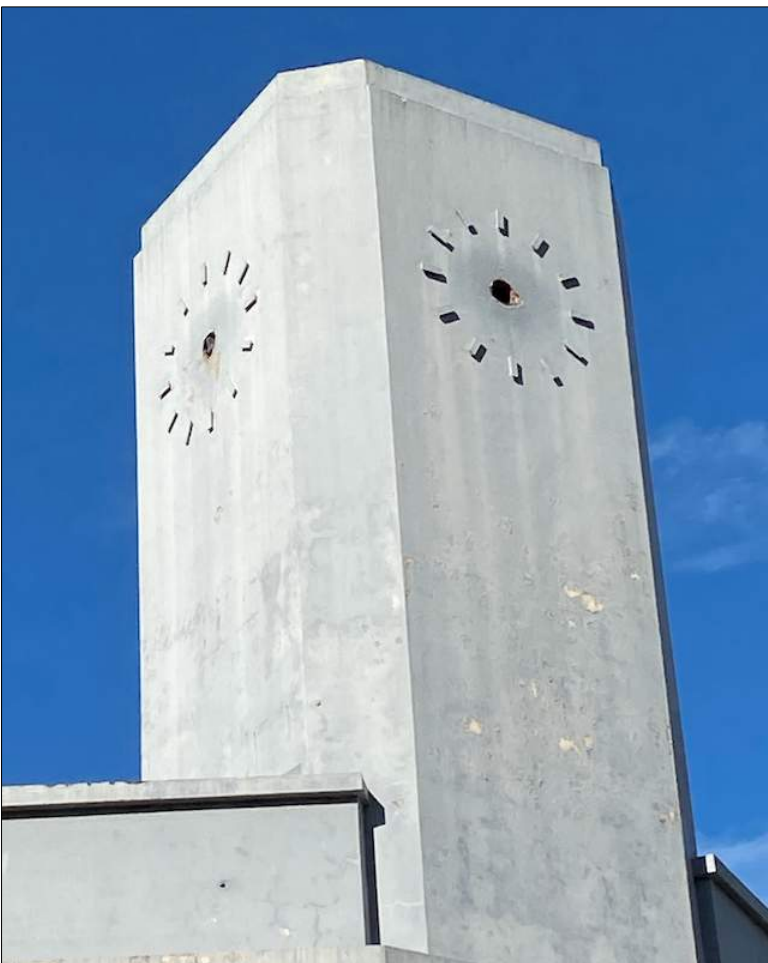
**Fig. 34. The clock tower is to be restored and protected from damage during the course of approved works. The clocks on all three faces are to be reinstated with functioning mechanism. The historic wording is to be reinstated on the corner façade below the clock face.**

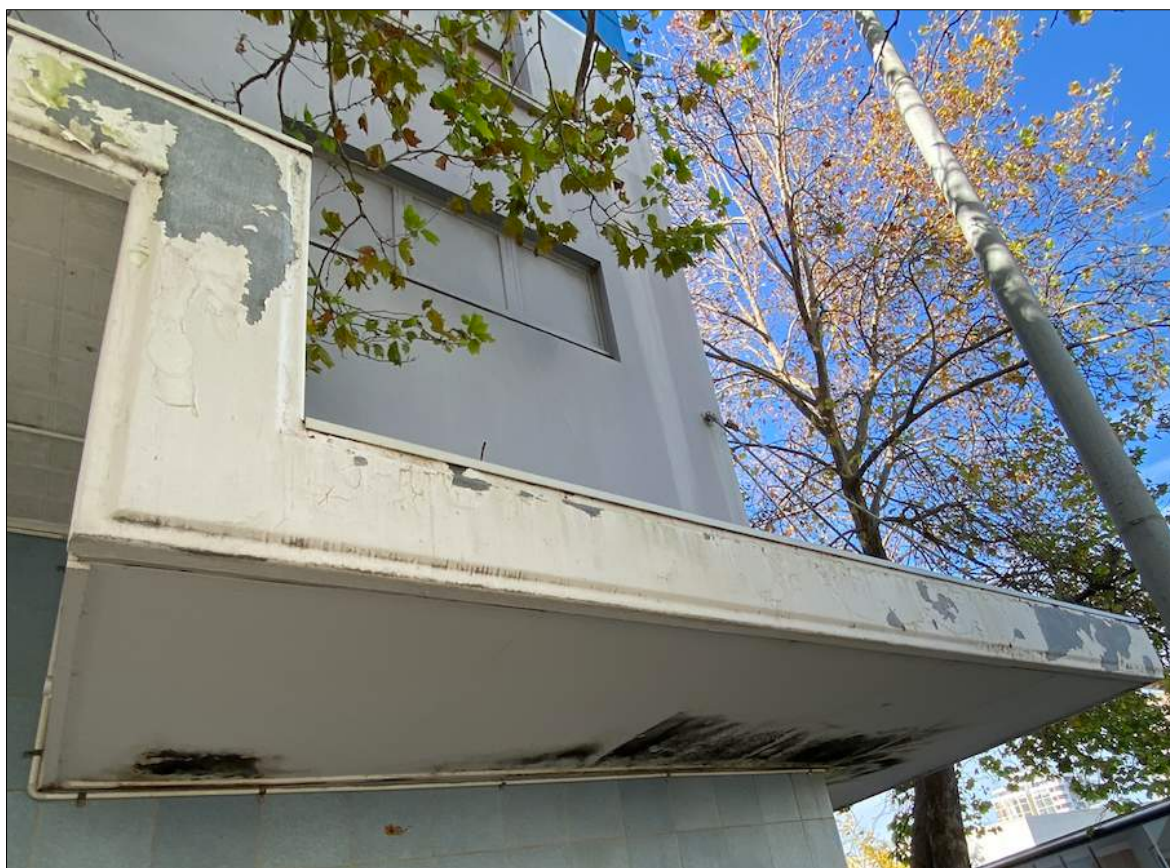
**Fig. 35. Evidence on numerous areas on the underside of the shop awning suggests that the awning roof and guttering has rusted out and needs to be replaced.**

| | | <b>LOCATION:</b> Northern and Western Shop Awnings<br><br><b>WORK REQUIRED:</b><br>Evidence on numerous areas on the underside of the shop awning suggests that the awning roof and guttering has rusted out and needs to be replaced.<br>The drainage system for the shop awning appears to be concealed. This draining system (down-pipes) from the awning is to be thoroughly investigated by an experience roof plumbing contractor with a history of satisfactory work on heritage buildings. If found to be deteriorated the system is to be replaced.<br>This work is to be executed by an experienced contractors with proven records of satisfactory work to heritage buildings.<br><br><b>Standards:</b> AS 1562.1 2018 and SA HB 3850.1-2015 Metal Roofing , AS/NZS 2179.1-1994 Metal Rainwater and AS/NZS 3500.3.2003. Stormwater Drainage. | |

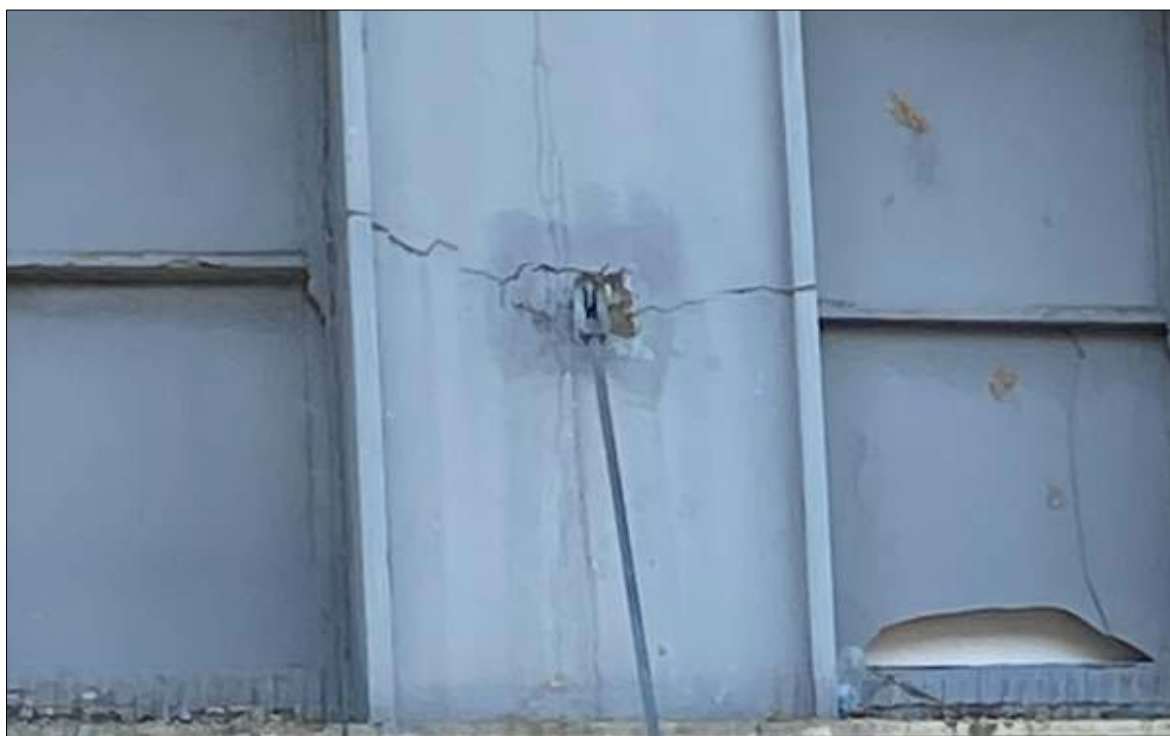
**Fig. 36. All Support suspension anchors and suspension elements are to be properly inspected by an experienced awning installation contractor with a history of satisfactory work on heritage buildings.**

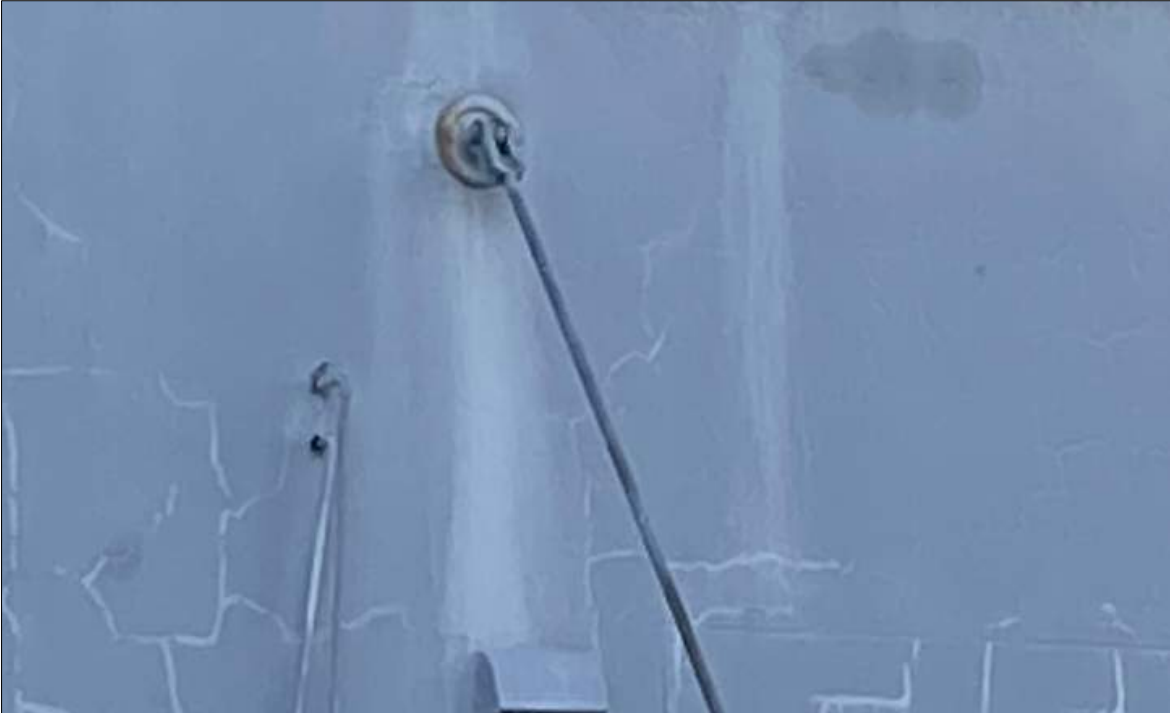
**Fig. 37. All Support suspension anchors and suspension elements are to be properly inspected by an experienced awning installation contractor with a history of satisfactory work on heritage buildings.**

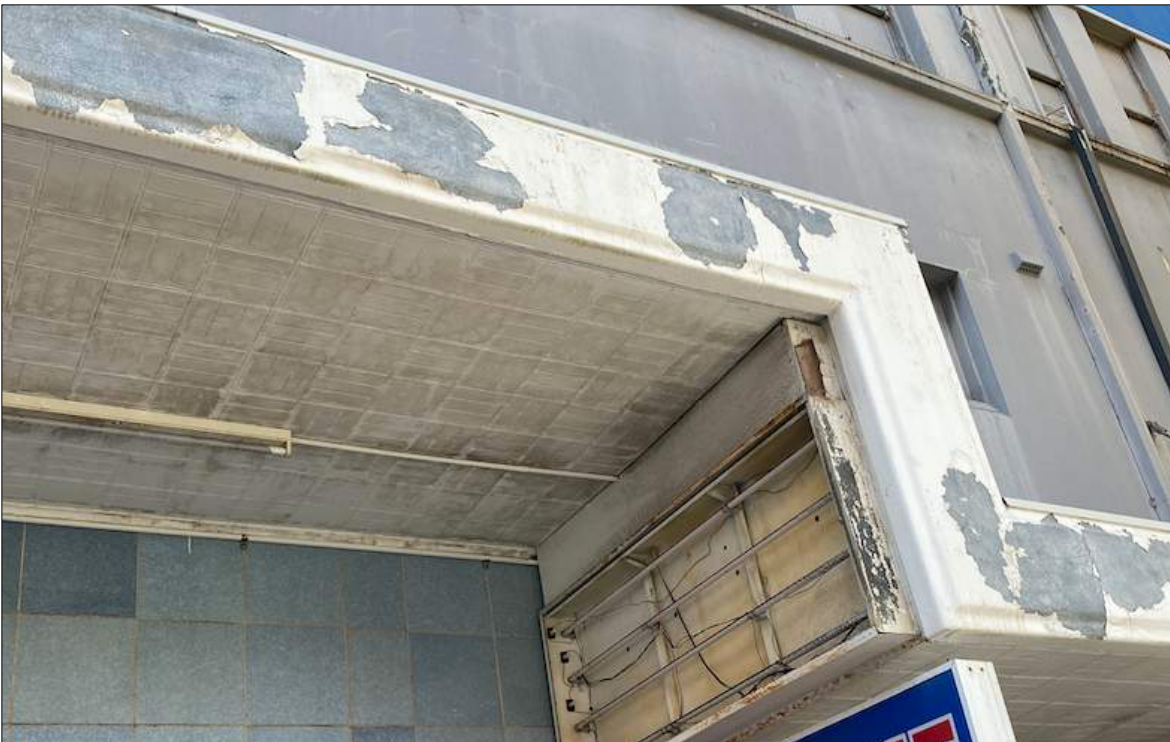
**Fig. 38. Awning fascia is to be repaired prior to proper preparation and repainting. Redundant signage is to be removed or reinstated.**

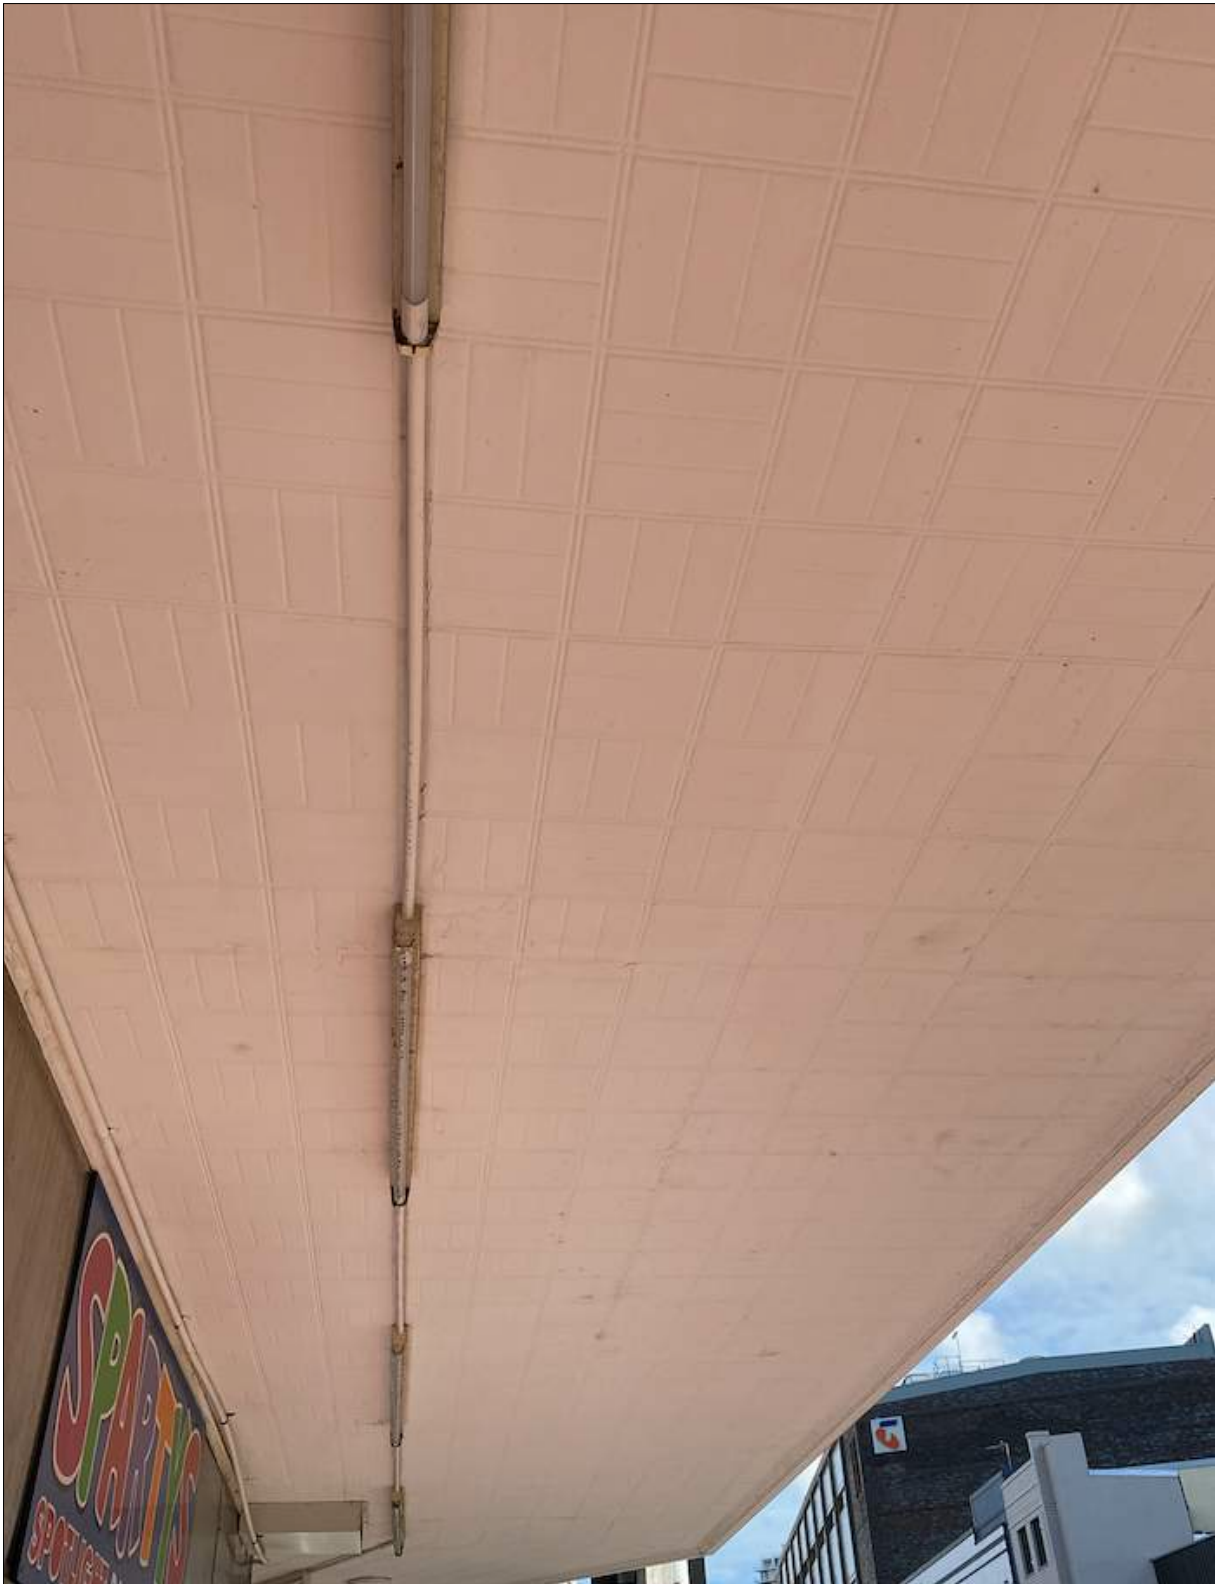
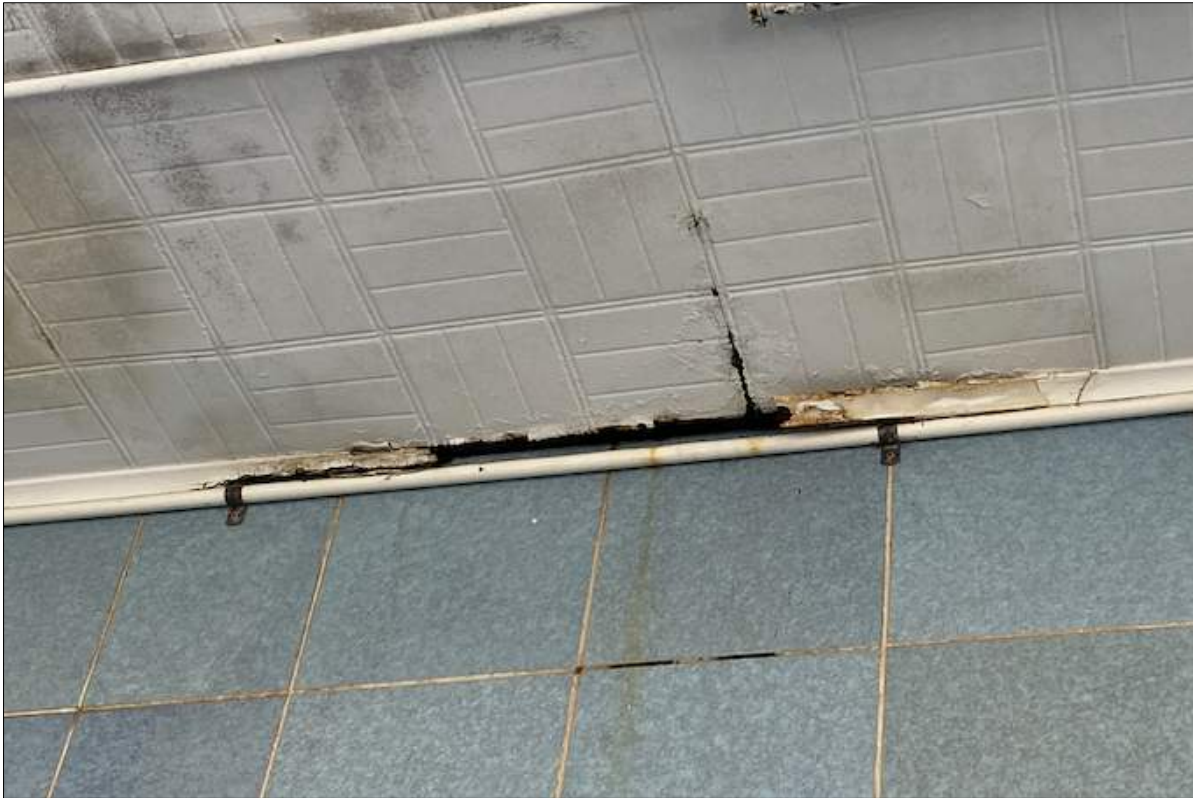
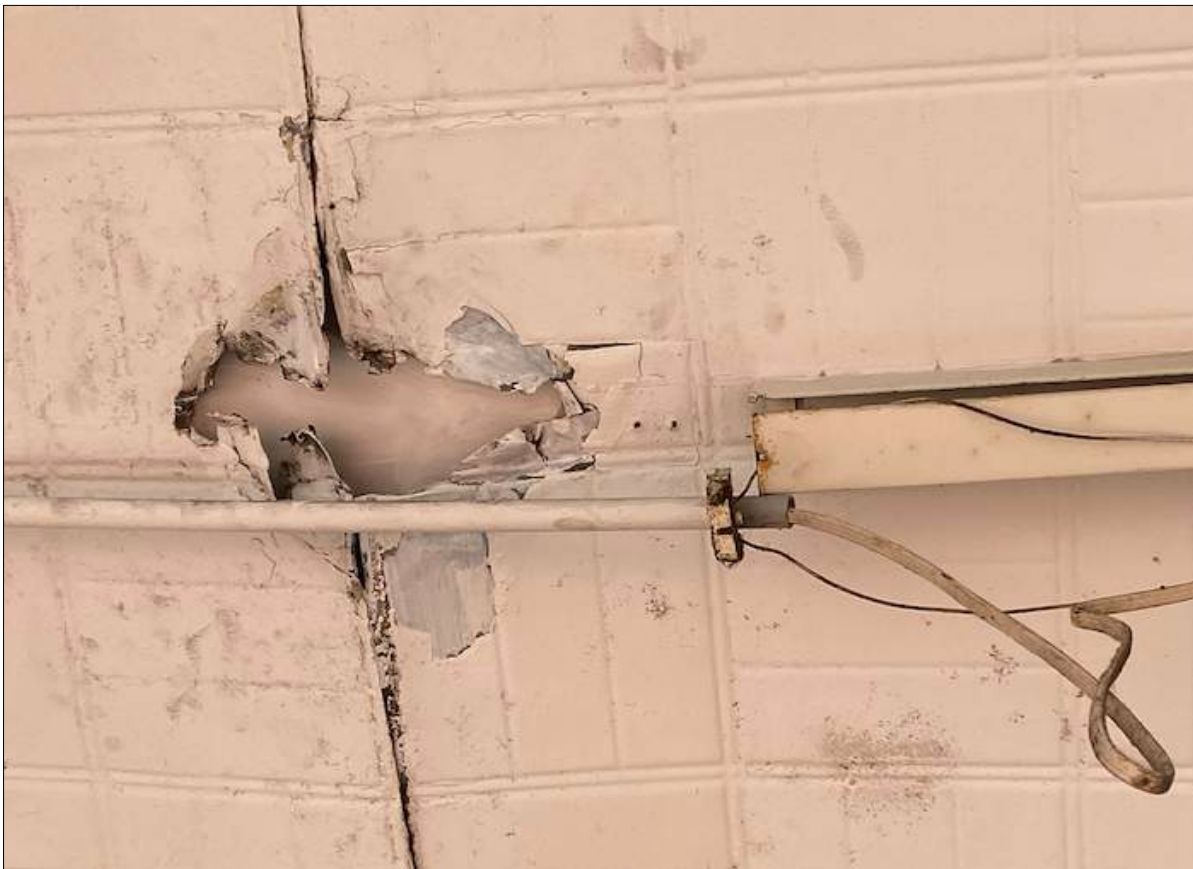
**Fig. 39. Awning soffits (pressed metal ceilings) are to be retained, repaired prior to proper preparation and repainting.**

**Fig. 40. Awning soffits (pressed metal ceilings) are to be retained, repaired prior to proper preparation and repainting.**

**Fig. 41. Awning soffits (pressed metal ceilings) are to be retained, repaired prior to proper preparation and repainting.**

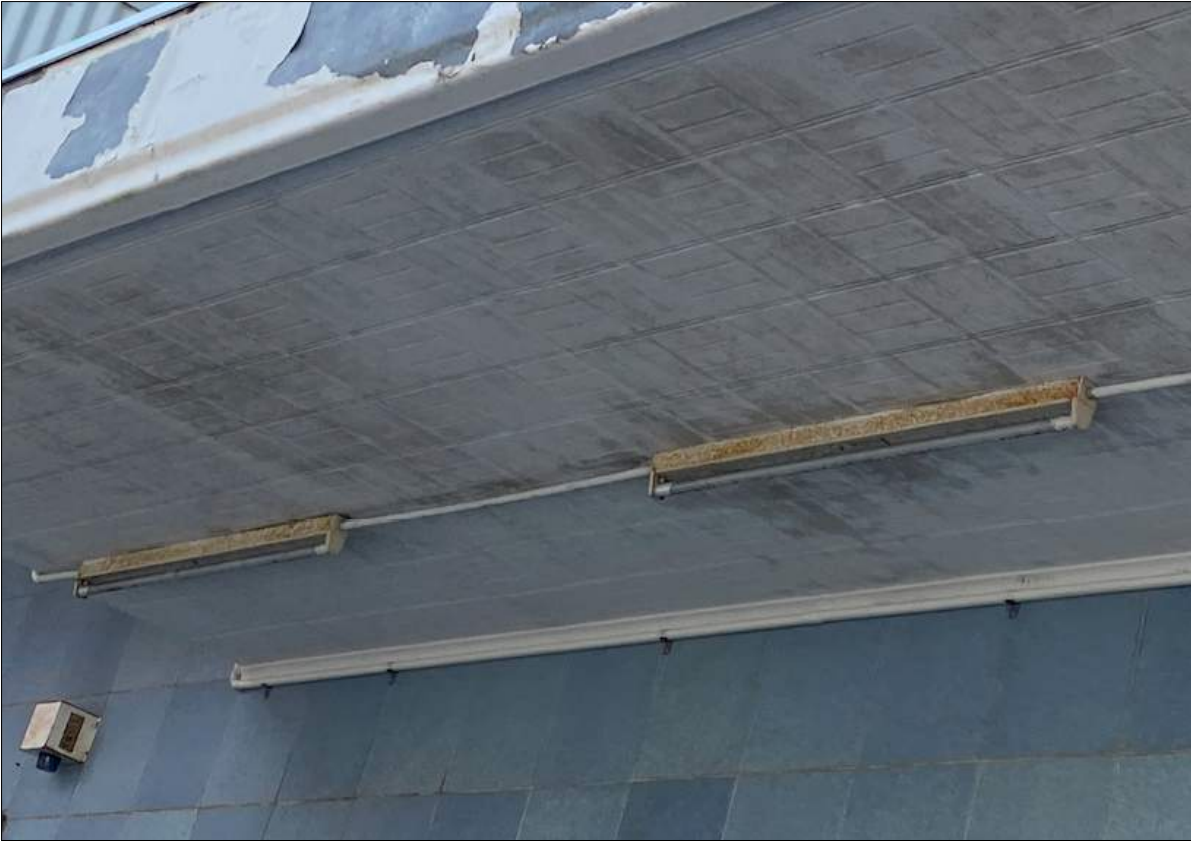
**Fig. 42. Rusting and damaged awning soffits lighting is to be replaced. Guidance from the nominated heritage consultant is to be sort on what replacement lighting is appropriate.**

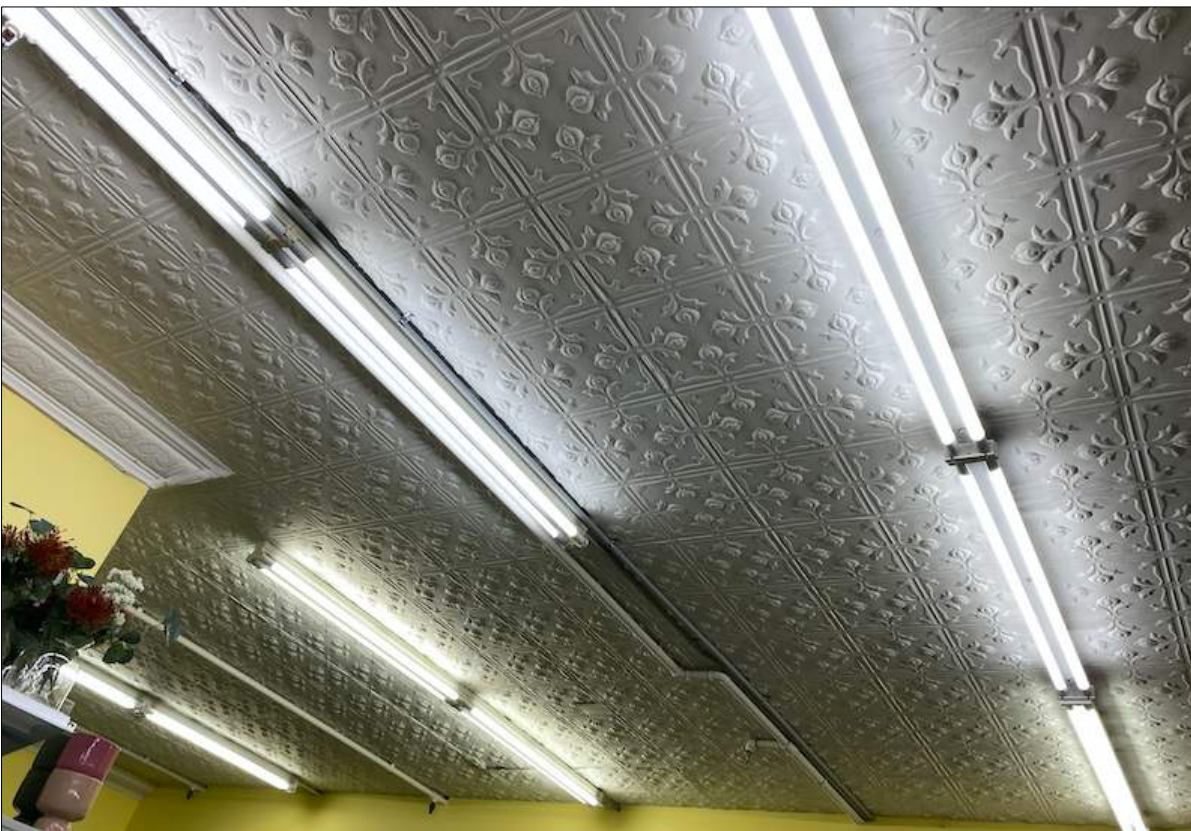
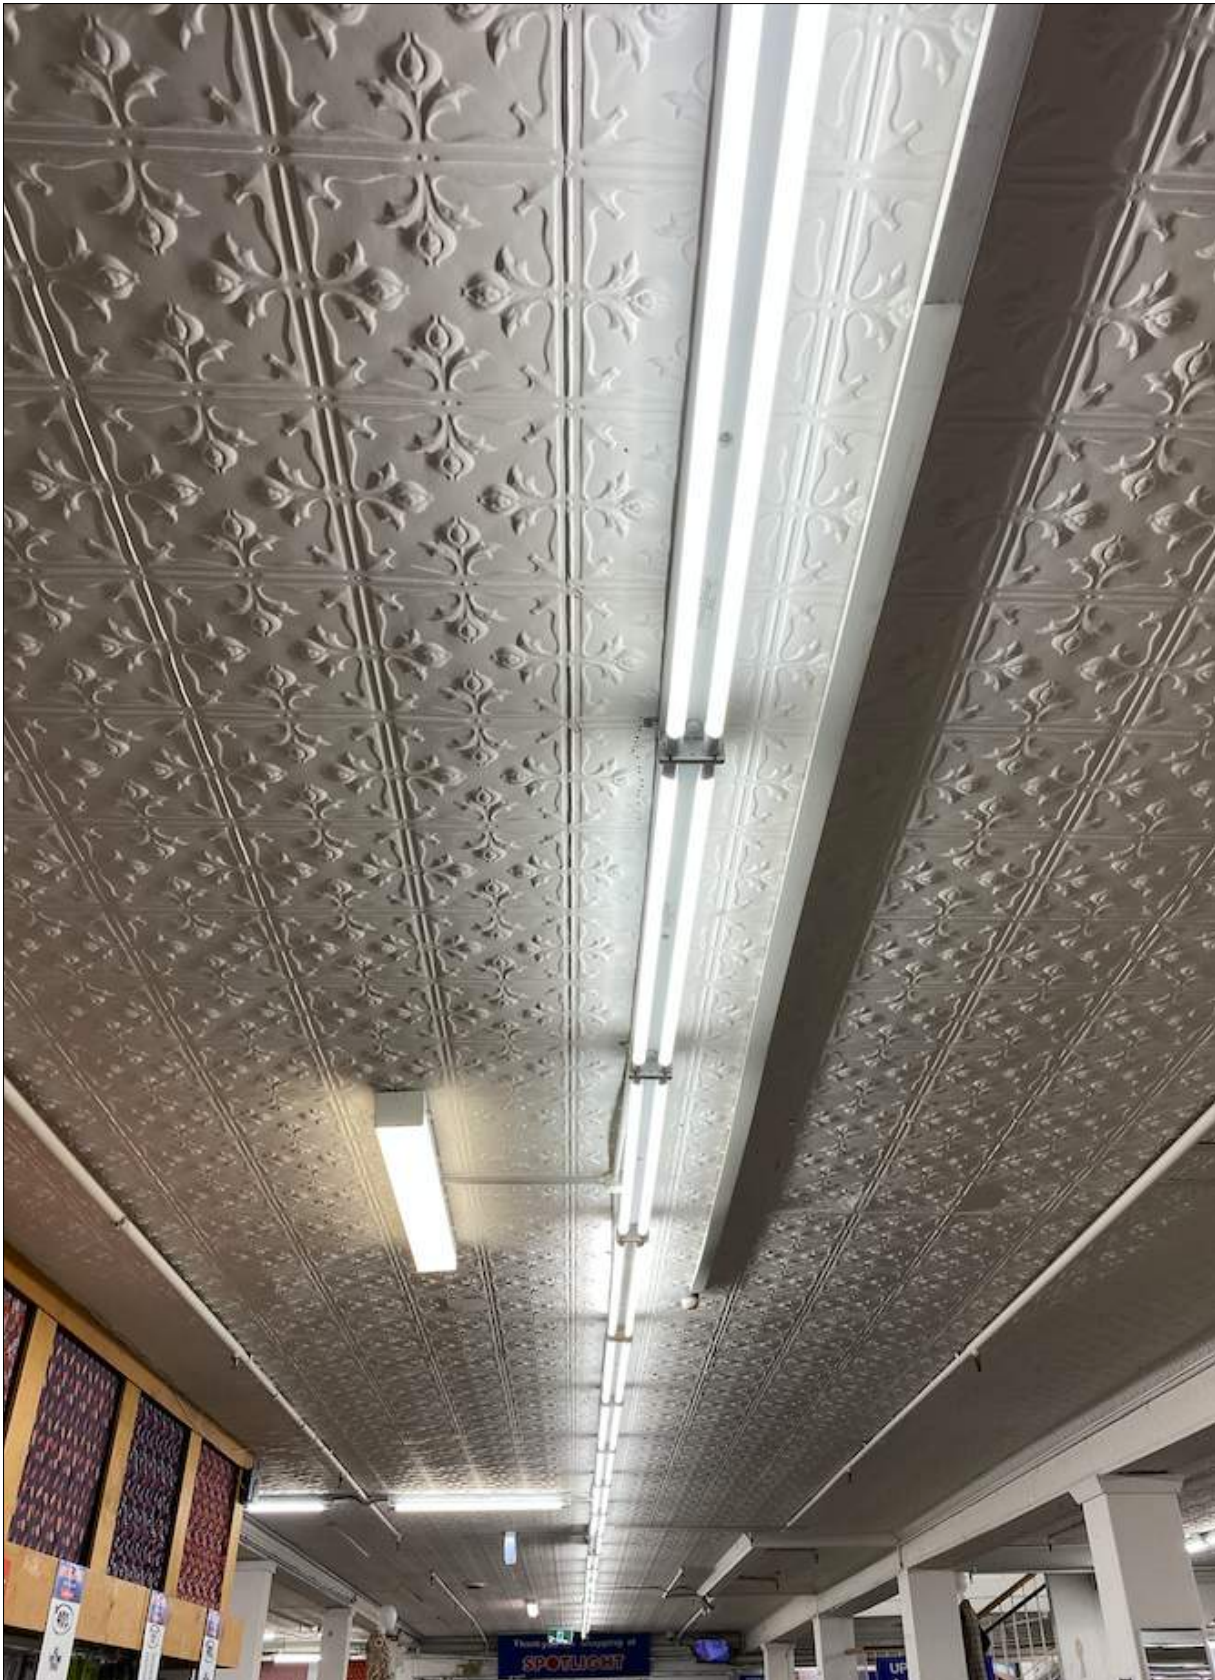
**Fig. 43. The pressed metal ceilings of the lower ground floor are to be salvaged where ever possible, protected from damaged and recycled either in the new construction in a nominated area and/or offered to a heritage building centre.**

**Fig. 44. The pressed metal ceilings of the lower ground floor are to be salvaged where ever possible, protected from damaged and recycled either in the new construction in a nominated area or delivered to a heritage building centre.**

| | | <p><b>LOCATION:</b> Pressed Metal Ceilings</p> <p><b>WORK REQUIRED:</b><br/> The pressed metal ceilings of the lower ground floor are to be salvaged where ever possible, protected from damaged and recycled either in the new construction in a nominated area or delivered to a heritage building recycling centre.</p> | |

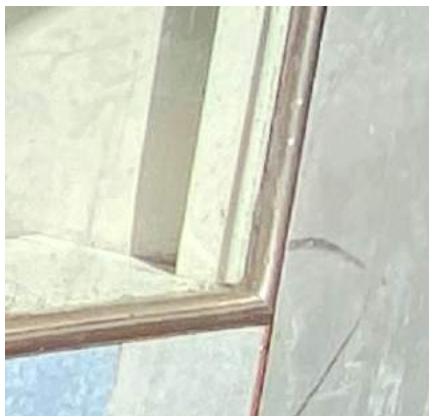
| | | <b>LOCATION:</b> Façade – Ground Floor<br><br><b>WORK REQUIRED:</b><br>The façade wall tiling is to be cleaned. The curved stainless steel shopfront glazing and signage trim is to be retained, protected from damage for the duration of any and all approved building works.<br><br>This work is to be executed by a licensed contractor with a proven record of satisfactory work to heritage buildings. | |

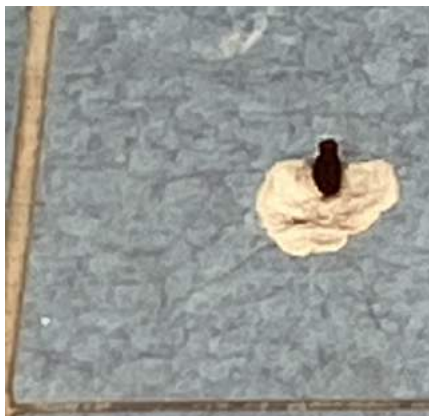
| | | <b>LOCATION:</b> Western Façade – Ground Floor<br><br><b>WORK REQUIRED:</b><br>Broken tiles are to be replaced with matching tiles or repaired if no suitable tile is available. Rusting fixing are to be removed from the tiles and the holes repaired.<br><br>This work is to be executed by a licensed contractor with a proven record of satisfactory work to heritage buildings<br><br><b>Standard:</b> AS 3958.1-2007 installation of tiles. | |

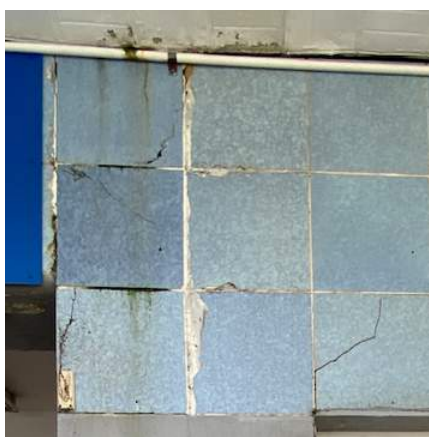
| | | <b>LOCATION:</b> Western Façade – Ground Floor<br><br><b>WORK REQUIRED:</b><br>Broken tiles are to be replace with matching tiles or repaired if no suitable tile is available. Surface conduits are to be removed from façade.<br><br>This work is to be executed by a licensed contractor with a proven record of satisfactory work to heritage buildings.<br><br><b>Standards:</b> AS 3958.1-2007 installation of tiles and AS/NZS 3000:2018, Electrical installations. | |

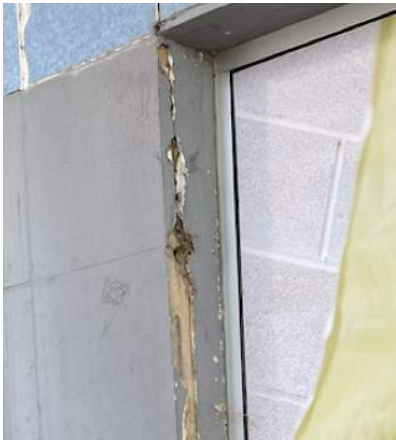
| | | <b>LOCATION:</b> Western Façade – Ground Floor<br><br><b>WORK REQUIRED:</b><br>Damaged painted render to shop fronts in Atchison Street.<br><br>This work is to be executed by a licensed contractor with a proven record of satisfactory work to heritage buildings.<br><br><b>Standards:</b> AS 3972-2010 General purpose and blended cements, AS/NZS 2311-2017 Guide to Painting of Buildings and protection, and AS 4361.2-1998 Guide to lead paint management - Residential and commercial buildings. | |

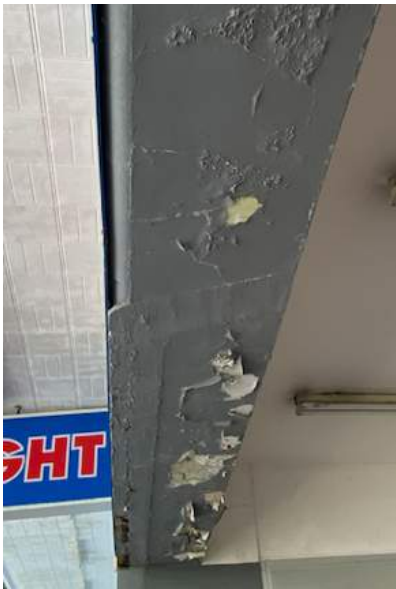
| | | <b>LOCATION:</b> Western Façade – Ground Floor<br><br><b>WORK REQUIRED:</b><br>Provide repair to overhead concrete beam (spalling repairs in required) at the Atchison Street entry.<br>This work is to be executed by an experienced contractor with a proven record of satisfactory repairs to heritage building.<br><br><b>Standards:</b> SA HB 84:2018 Guide to concrete repair and protection, AS 1478.2-2005 Chemical admixtures for concrete, mortar and grout, AS/NZS 2311-2017 Guide to Painting of Buildings and protection, AS 4361.2-1998 Guide to lead paint management - Residential and commercial buildings and AS 2312.1:2014 Guide to the protection of structural steel against atmospheric corrosion by the use of protective coatings Paint coatings. | |

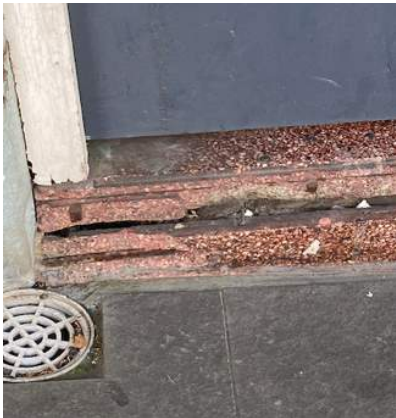
**Fig. 11. Damaged door threshold in Atchison Street.**

**Fig. 12. Damaged door threshold in Atchison Street.**

| | | <b>LOCATION:</b> Western Façade – Ground Floor<br><br><b>WORK REQUIRED:</b><br>Provide repairs to damaged door threshold in Atchison Street.<br><br>This work is to be executed by an experienced terrazzo contractor with a proven record of satisfactory repairs to heritage building.<br><br><b>Standards:</b> SA HB 84:2018 Guide to concrete repair and protection and AS 1478.2-2005 Chemical admixtures for concrete, mortar and grout. | |
