# STATEMENT OF HERITAGE IMPACT

*State Significant Development Application SSD-76440958*

221-291 Crown Street, 216-238 Keira Street and Nos 86-90

July 2025 | J4205\_05

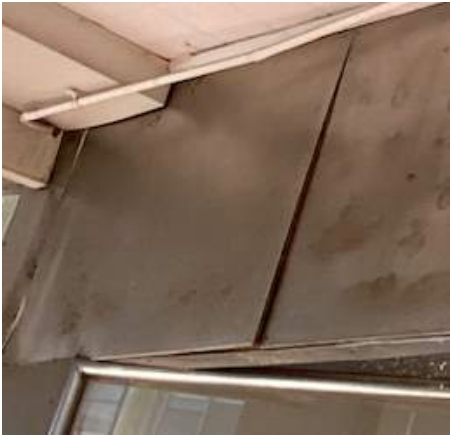
**Fig. 15.** Sections of the stainless steel cladding above the shopfront glazing are to be removed to reveal the underlying surface, Guidance from the nominated heritage consultant is to be sort on how these areas are to be treated.

**Fig. 16.** Sections of the stainless steel cladding above the shopfront glazing are to be removed to reveal the underlying surface, Guidance from the nominated heritage consultant is to be sort on how these areas are to be treated.

| | | <b>LOCATION:</b> Northern Façade – Ground Floor<br><br><b>WORK REQUIRED:</b><br>Sections of the stainless steel cladding above the shopfront glazing are to be removed to reveal the underlying surface, Guidance from the nominated heritage consultant is to be sort on how these areas are to be treated once the underlying surface is exposed.<br><br>This work is to be executed by an experienced contractor with a proven record of satisfactory work to heritage buildings. | |

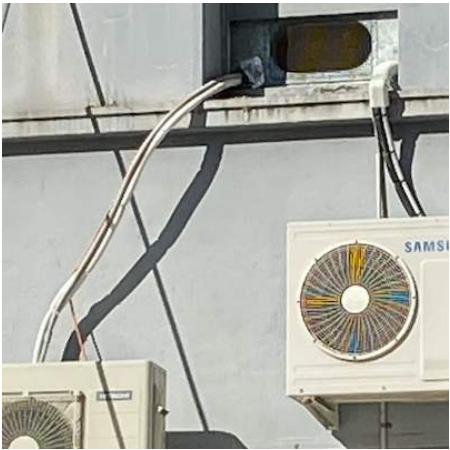
**Fig. 17.** All air-conditioning compressors, conduits, air-conditioning pipework, redundant brackets and fixings are to be removed from the facade on both Atchison and Crown Street.

**Fig. 18.** All air-conditioning compressors, conduits, air-conditioning pipework, redundant brackets and fixings are to be removed from the facade on both Atchison and Crown Street.

**Fig. 19. All air-conditioning compressors, conduits, air-conditioning pipework, redundant brackets and fixings are to be removed from the facade on both Atchison and Crown Street.**

| | | <b>LOCATION:</b> Northern and Western Façade<br><br><b>WORK REQUIRED:</b><br>All air-conditioning compressors, conduits, air-conditioning pipework, redundant brackets and fixings are to be removed from the facade on both Atchison and Crown Street.<br><br>This work is to be executed by an experienced contractor with a proven record of satisfactory work to heritage buildings.<br><br><b>Standard:</b> AS/NZS 3000:2018 Electrical installations. | |

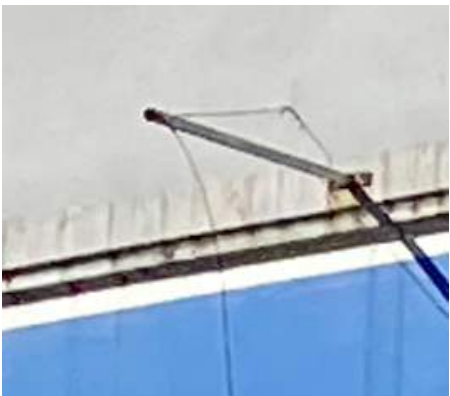
**Fig. 20. All rusting remnants of redundant masonry anchors are to be removed from the facade on both Atchison and Crown Street.**

| | | <b>LOCATION:</b> Northern and Western Façade<br><br><b>WORK REQUIRED:</b><br>All rusting remnants of redundant masonry anchors are to be removed from the facade on both Atchison and Crown Street and the fixing's hole repaired.<br><br>This work is to be executed by an experienced contractor with a proven record of satisfactory work to heritage buildings.<br><br><b>Standards:</b> AS 3972-2010 General purpose and blended cements. | |

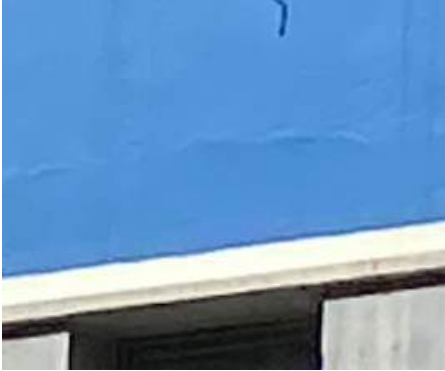
| | <p><b>LOCATION:</b> Northern Façade</p> <p><b>WORK REQUIRED:</b><br/>The deformity in the painted render on eastern end on the Crown Street façade is to be investigated and findings reported to the nominated heritage consultant and guidance sort on any required remediation.</p> <p>This work is to be executed by an experienced contractor with a proven record of satisfactory work to heritage buildings.</p> |

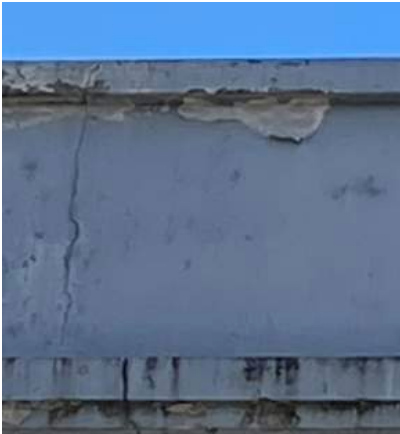
**Fig. 22. Cracked, crazed and damaged rendered masonry is to be repaired.**

**Fig. 23. Cracked, crazed and damaged rendered masonry is to be repaired.**

**Fig. 24. Cracked, crazed and damaged rendered masonry is to be repaired.**

| | | <b>LOCATION:</b> Northern and Western Façade<br><br><b>WORK REQUIRED:</b><br>All cracked, crazed and damaged rendered and underlying masonry is to be repaired.<br><br>This work is to be executed by an experienced contractor with a proven record of satisfactory work to heritage buildings.<br><br><b>Standards:</b> AS 3972-2010 General purpose and blended cements, SA HB 84:2018 Guide to concrete repair and protection, and AS 1478.2-2005 Chemical admixtures for concrete, mortar and grout. | |

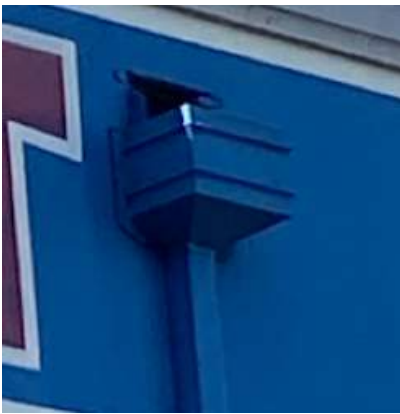
**Fig. 25.** The rain-heads and down-pipes on the Atchison Street façade are to be retained or replaced with 'like-for-like' rain-heads and down-pipes if corroded beyond repair.

| | | <b>LOCATION:</b> Western Façade<br><br><b>WORK REQUIRED:</b><br>The rain-heads and down-pipes on the Atchison Street façade are to be retained or replaced with 'like-for-like' rain-heads and down-pipes if corroded beyond repair.<br><br>This work is to be executed by an experienced contractor with a proven record of satisfactory work to heritage buildings.<br><br><b>Standards:</b> AS/NZS 2179.1-1994 Metal Rainwater and AS/NZS 3500.3.2003. Stormwater Drainage. | |

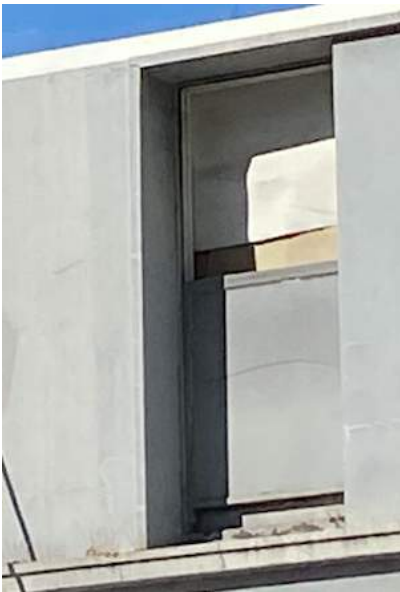
| | | <b>LOCATION:</b> Northern and Western Façade<br><br><b>WORK REQUIRED:</b><br>All the double hung timber windows in the façade in both Atchison and Crown Street are to be restored, Window frames and sill are to be repaired where required, window sashes are to be repaired where required or replaced with 'like-for-like window sashes where sash is missing or damage beyond repair. Glass is to be replaced and the windows are to be properly prepared and painted to paint manufactures specification in approved colour<br><br>This work is to be executed by an experienced contractor with a proven record of satisfactory work to heritage buildings.<br><br><b>Standards:</b> AS 1684.2—2006 Timber framing, AS/NZS 2311-2017 Guide to Painting of Buildings and protection, and AS 4361.2-1998 Guide to lead paint management - Residential and commercial buildings. | |

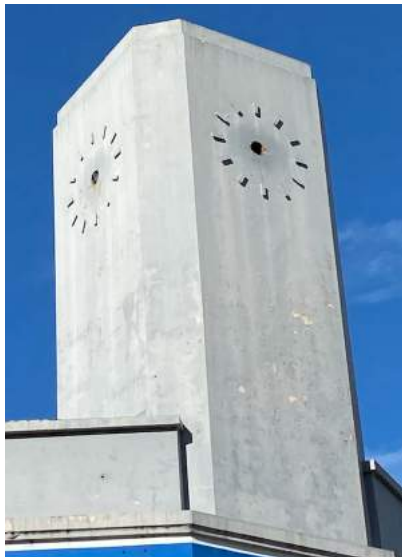
**Fig. 32. All rusting remnants of redundant masonry anchors are to be removed from the clock tower.**

**Fig. 33. The pigeons are to be removed from inside the clock tower and damaged concrete is to be repaired.**

**Fig. 34. The clock tower is to be restored and protected from damage during the course of approved works. The clocks on all three faces are to be reinstated with functioning mechanism. The historic wording is to be reinstated on the corner façade below the clock face.**

| | | <b>LOCATION:</b> Clock Tower<br><br><b>WORK REQUIRED:</b><br>All remnants of redundant masonry anchors are to be removed from the clock tower. The pigeons are to be removed from inside the clock tower and damaged concrete is to be repaired. The clocks on all three faces are to be reinstated with functioning mechanism.<br><br>The clock tower is to be restored and protected from damage during the course of approved works.<br><br>This work is to be executed by an experienced contractors with proven records of satisfactory work to heritage buildings.<br><br><b>Standard:</b> SA HB 84:2018 Guide to concrete repair and protection, AS 1478.2-2005 Chemical admixtures for concrete, mortar and grout and AS/NZS 3000:2018 Electrical installations. | |

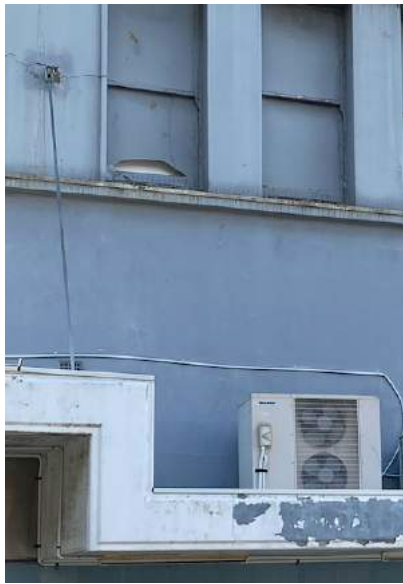
**Fig. 35. Evidence on numerous areas on the underside of the shop awning suggests that the awning roof and guttering has rusted out and needs to be replaced.**

| | | <b>LOCATION:</b> Northern and Western Shop Awnings<br><br><b>WORK REQUIRED:</b><br>Evidence on numerous areas on the underside of the shop awning suggests that the awning roof and guttering has rusted out and needs to be replaced.<br>The drainage system for the shop awning appears to be concealed. This draining system (down-pipes) from the awning is to be thoroughly investigated by an experience roof plumbing contractor with a history of satisfactory work on heritage buildings. If found to be deteriorated the system is to be replaced.<br>This work is to be executed by an experienced contractors with proven records of satisfactory work to heritage buildings.<br><br><b>Standards:</b> AS 1562.1 2018 and SA HB 3850.1-2015 Metal Roofing , AS/NZS 2179.1-1994 Metal Rainwater and AS/NZS 3500.3.2003. Stormwater Drainage. | |

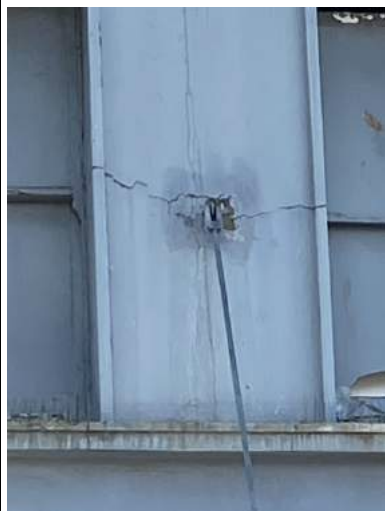
Sheet No: **CM-07**

**LOCATION:** Northern and Western Shop Awnings

While work to the roof of the awning is being undertaken, the structure of the awning that that penetrate the masonry wall is to be properly inspected by an experienced awning installation contractor with a history of satisfactory work on heritage buildings.

**Standards:** AS/NZS 5131:2016 Structural steelwork – Fabrication and erection and AS/NZS 1554.1:2014 Structural steel welding - Welding of steel structures.

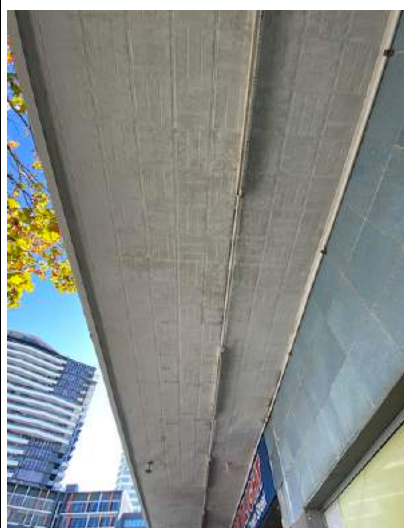
**LOCATION:** Northern and Western Façade

Awning soffits (pressed metal ceilings) are to be retained, repaired prior to proper preparation and repainting.

Awning fascia is to be repaired prior to proper preparation and repainting. Redundant signage is to be removed or reinstated.

Rusting and damaged awning soffits lighting is to be replaced. Guidance from the nominated heritage consultant is to be sort on what replacement lighting is appropriate.

This work is to be executed by an experienced contractor with a proven record of satisfactory work to heritage buildings.

**Standard:** AS/NZS 3000:2018 Electrical installations and AS 1562.1-1992 Design and installation of sheet roof and wall cladding Metal

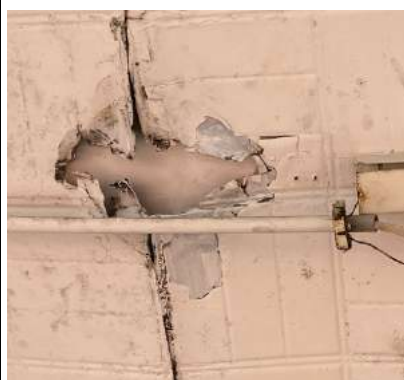
**LOCATION:** Northern and Western Façade

Awning soffits (pressed metal ceilings) are to be retained, repaired prior to proper preparation and repainting.

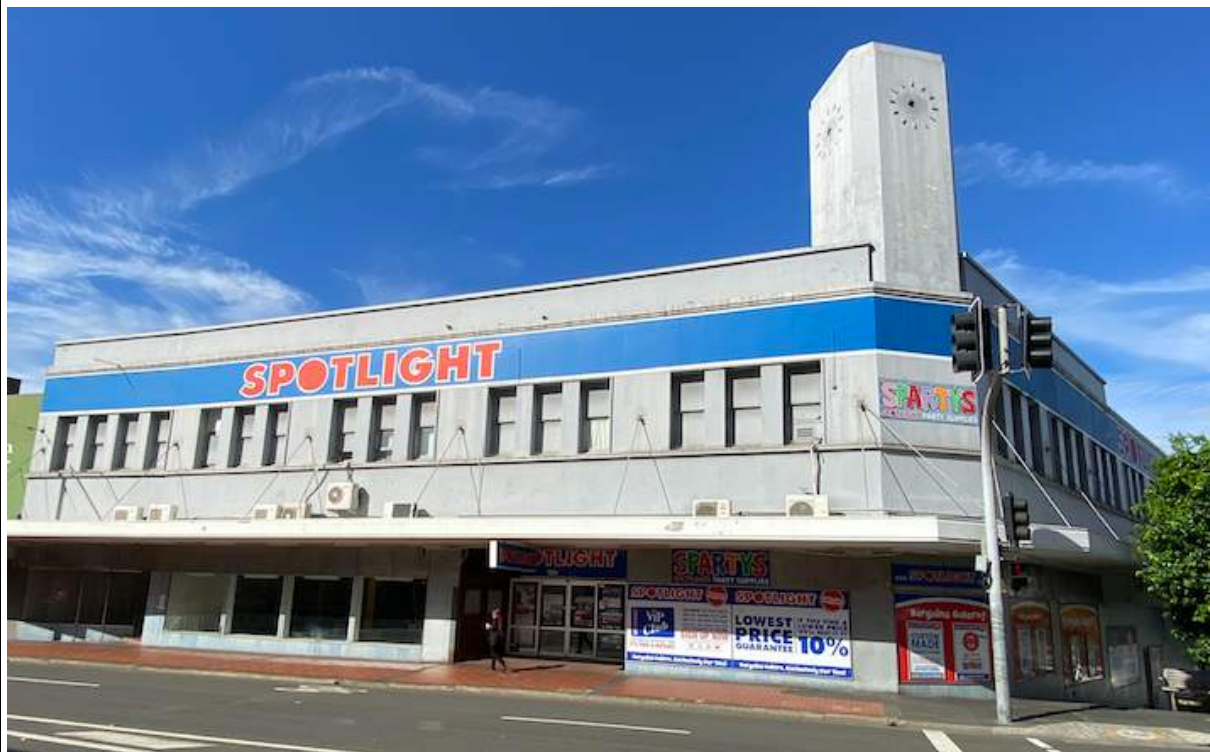
**LOCATION:** Northern and Western Façade

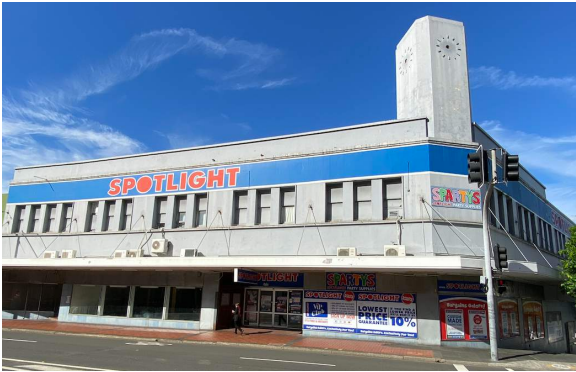
| Sheet No: | <b>PCM-01</b> | Space No: | Façade |

| Location:<br><br>Entire Façade in both Atchison and Crown Streets. | | | |
| Exterior concrete walls | Inspect for deterioration. Repair as required.<br>Replace any rusting fixings, remove all redundant masonry anchor remnants. | | |
| Clock tower | Inspect for deterioration. Repair as required. Inspect clocks to ensure they are functioning correctly. Repair or replace as required. | | |
