To	Loftex Chatswood Pty Ltd	From	Namal Yapage (Stantec) Senior Principal Geotechnical Engineer Yasmin Chen (Stantec) Geotechnical Engineer
CC		Date	11/02/2025
Project	301351072	Location	3-5 Help Street, Chatswood
Subject	Groundwater inflow estimates and drainage advice for the proposed residential building		
Report Status	Final Rev4	Attachments	Calculation sheet and groundwater measured records

1 Introduction

This report presents an assessment and recommendations by Stantec Australia Pty Ltd (formerly Cardno) for Loftex Chatswood (the Client) regarding the groundwater inflow estimates and drainage advice for the proposed residential building at 3-5 Help Street, Chatswood (the Site).

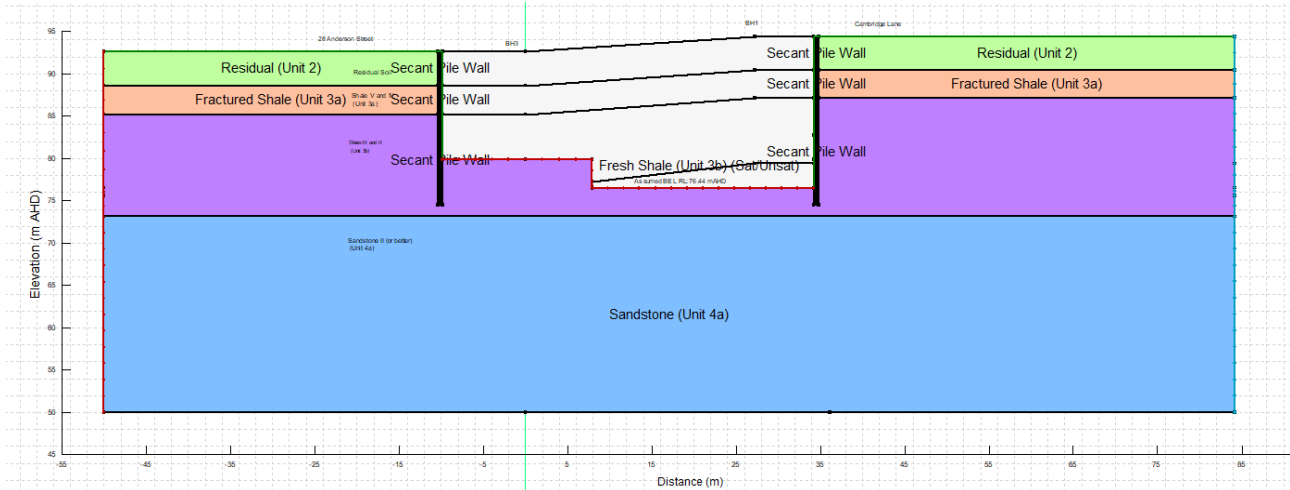
Figure 2 – Model Geometry of Analysed Section A (Top) and B (Bottom)

The ground surrounding the proposed development was simulated as being a multi-layered numerical model to represent the subsurface conditions surrounding the site and to allow the vertical flow components to be simulated more accurately. Details of the layering for analysed Sections is provided in Figure 2. The model boundaries were extended approximately 50 m from each excavation boundaries.

On the basis that groundwater monitoring data, for Section A and Section B, the design ground water is conservatively adopted at RL 84.5m across the whole site, approximately 2.0 m higher than the recorded highest groundwater standing level. Groundwater also runs from north-western corner towards south-eastern corner.

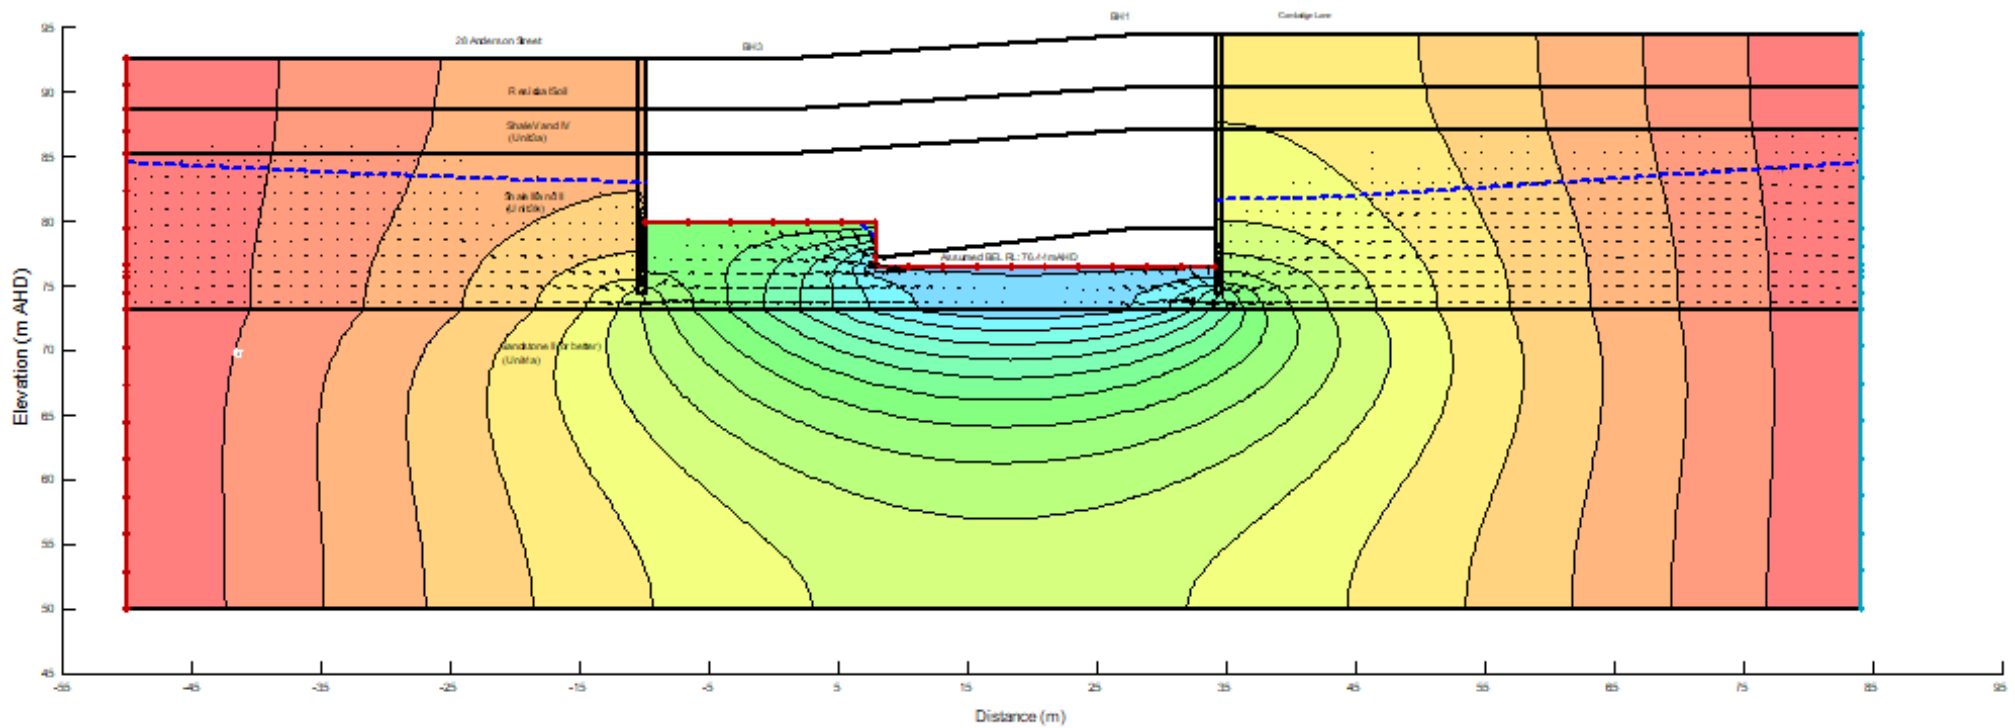
Section B - When the secant pile wall is slightly permeable

Color	Name	Category	W.H.	Parameters
Red	Left Side Pie Soil	Hydrolic	30 days 300 Head	0.5m
Blue	Right Side Pie Soil	Hydrolic	30 days 300 Head	0.5m
Orange	200 Permeable	Hydrolic	30 days 3000 Head	7m

Color	Name	Hydraulic Material (k)	Soil Permeability	Unit S.C. Function	W.P. Function	Ky/Kx Ratio	Flowline (?)	Velocity (m/day)	Compressibility (MPa)
Orange	Permeable Soil (S1-S3)	Soilbed/Unsoilbed	Permeable Soilbed	Permeable Soilbed	0.2	0			
Purple	Permeable Soil (S4-S6)	Soilbed/Unsoilbed	Permeable Soilbed	Permeable Soilbed	0.2	0			
Green	Permeable Soil (S7)	Soilbed/Unsoilbed	Permeable Soilbed	Permeable Soilbed	0.2	0			
Blue	Secant Pile (S8)	Soilbed/Unsoilbed	Soilbed	Soilbed	0.2	0	0.10	0.07	
Black	Secant Pile (S9)	Soilbed/Unsoilbed	Concrete wall	Concrete wall	1	0
