Report on  
Supplementary Geotechnical Investigation

Proposed Site 53 Redevelopment  
2 Figtree Drive, Sydney Olympic Park

Prepared for  
Mirvac Projects Pty Ltd

Project 73946.02  
September 2016

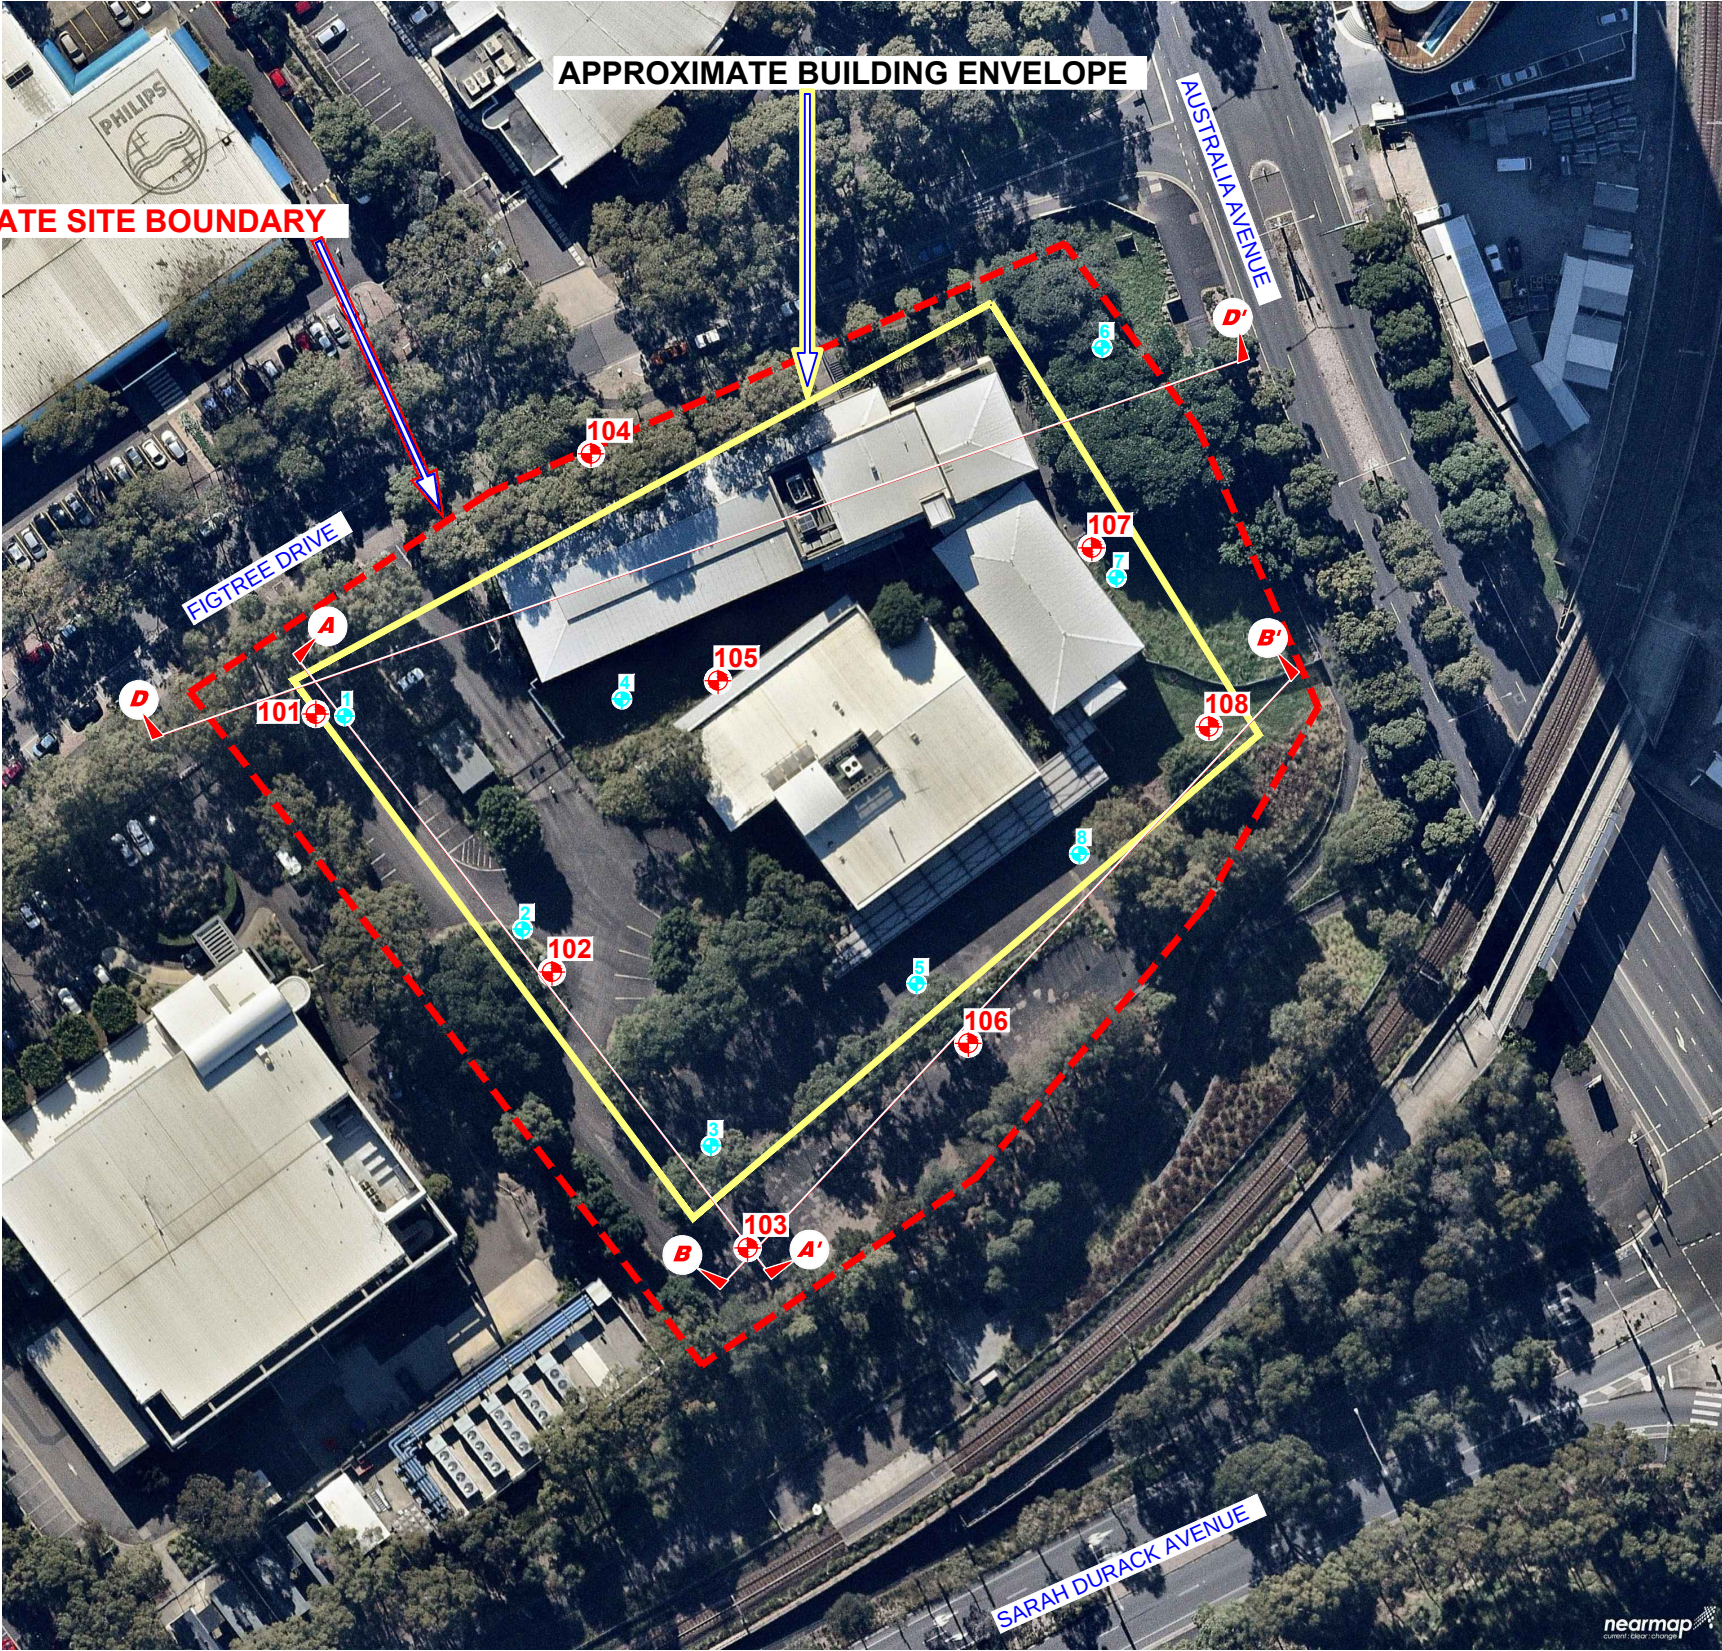
Locality Plan

NOTE:  
1: Base image from Nearmap.com  
2: Test locations are approximate only and are shown with reference to existing features.

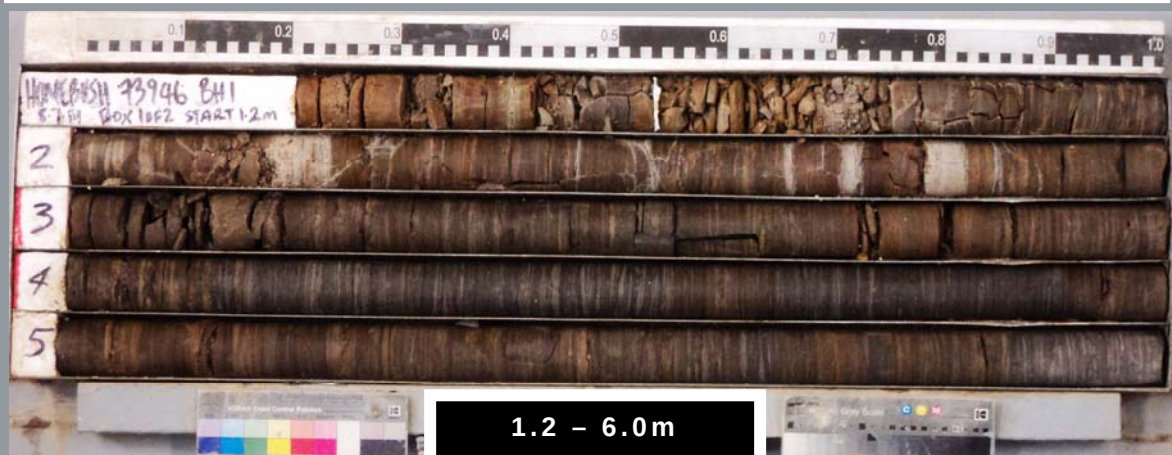
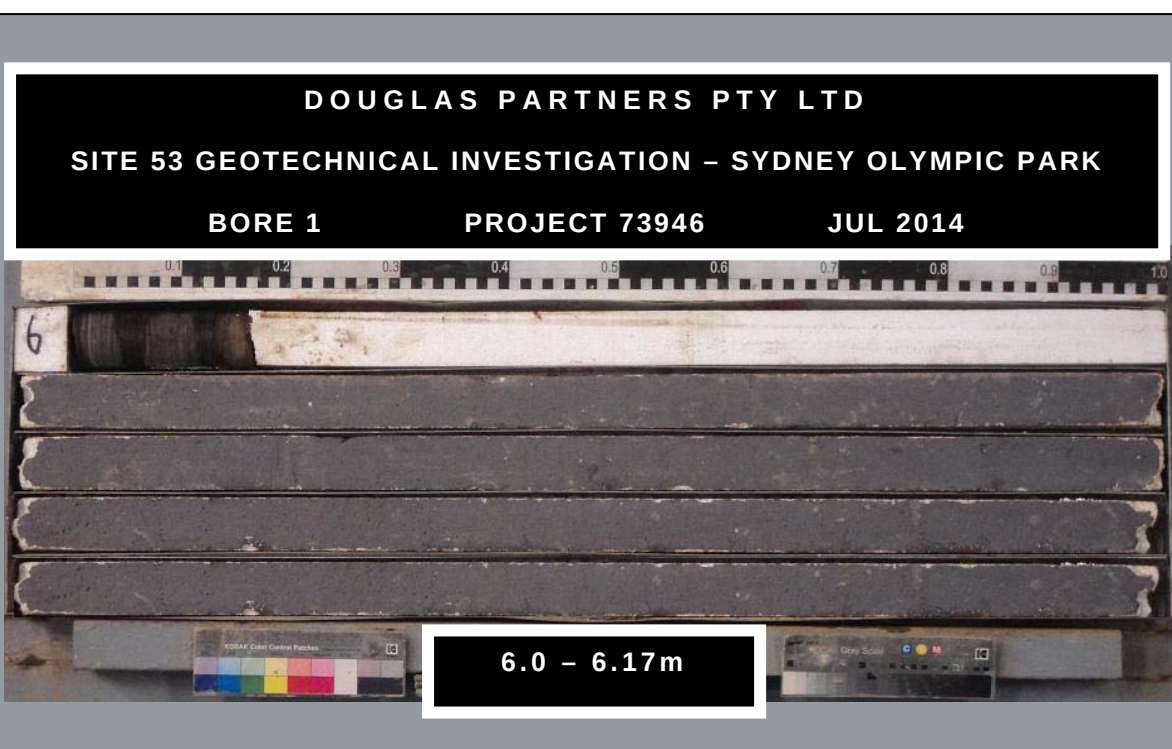
DOUGLAS PARTNERS PTY LTD  
SITE 53 GEOTECHNICAL INVESTIGATION – SYDNEY OLYMPIC PARK  
BORE 1 PROJECT 73946 JUL 2014

| RL | Depth (m) | Description of Strata | Degree of Weathering | | | | | Graphic Log | Rock Strength | | | | | Water | Fracture Spacing (m) | | | | Discontinuities | | Sampling & In Situ Testing | | | | |
|---|---|---|---|---|---|---|---|---|---|---|---|---|---|---|---|---|---|---|---|---|---|---|---|---|---|
| | 0.2 | FILLING - grey, fine to coarse gravelly silty sand filling, humid | | | | | | | | | | | | | | | | | | | | A/E | | | |
| | 0.7 | FILLING - orange-brown, fine to medium sand filling with some silt (rippled sandstone), humid | | | | | | | | | | | | | | | | | | | | A/E | | | |
| | 1.8 | LAMINITE - medium strength, highly to moderately then moderately weathered, fragmented to fractured, grey-brown laminite with approximately 20% fine sandstone laminations and some clay bands | | | | | | | | | | | | | | | | | | | | C | 100 | 0 | PL(A) = 0.7 |
| | 3.15 | LAMINITE - medium then high strength, moderately then slightly weathered, slightly fractured, brown then grey-brown, laminite with approximately 25% fine sandstone laminations | | | | | | | | | | | | | | | | | | | | | | | PL(A) = 0.5 |

**WATER OBSERVATIONS:** No free groundwater observed whilst augering
