## Overseas Passenger Terminal - Tenancy 5

### Contamination Preliminary Investigation

Prepared for Jimmys on the Mall Pty Ltd | 7 November 2016

Report J16111RP1 | Prepared for Jimmys on the Mall Pty Ltd | 7 November 2016

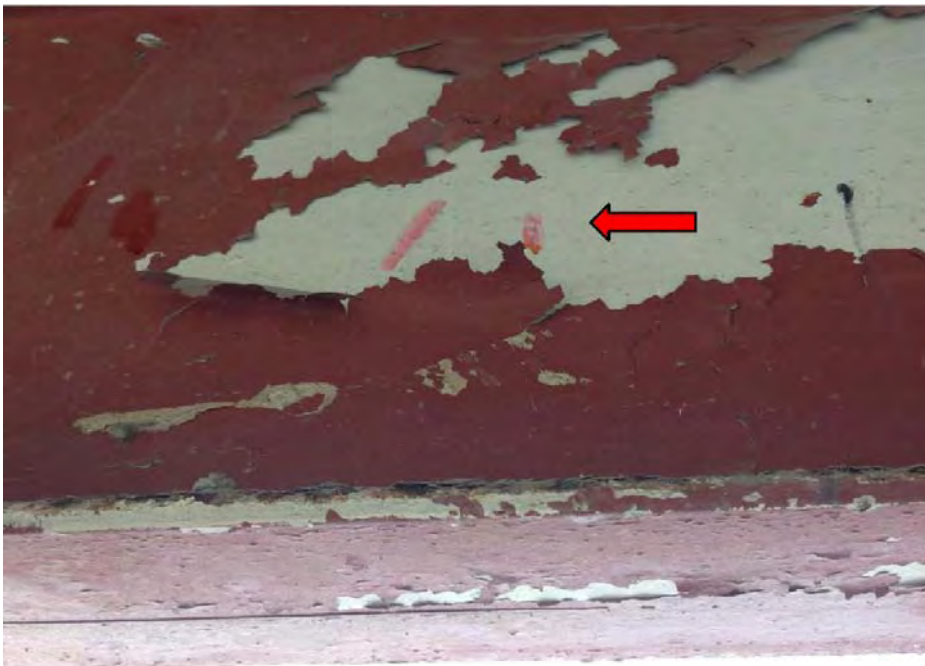
- interior, eastern side, southern end, midway north-south running ceiling horizontal support beam—red upper paint system (Photograph 5.1);
- interior, south-west area, north-east of former kitchen range-hoods, east-west running horizontal steel support beam—red upper paint system; and
- interior, south side, west end, within the eastern wing of the former female toilets, adjacent north wall, and east-west running horizontal support beams—red upper paint system.

The steel supports run to the external walls of the building some could be disturbed during work on these walls.

The condition of the paint was either poor (major flaking) or fair (minor flaking) which indicates that it is unstable and could pose a threat to human and environmental health.

**Photograph 5.1** Interior, eastern side, southern end, midway north-south running ceiling horizontal support beam—red upper paint system (Finka 2015)

The following is recommended to manage the lead-based paint found in the tenancy:
