Cockle Bay Park

Historical Archaeological Assessment

Report prepared for DPT and DPPT

August 2017

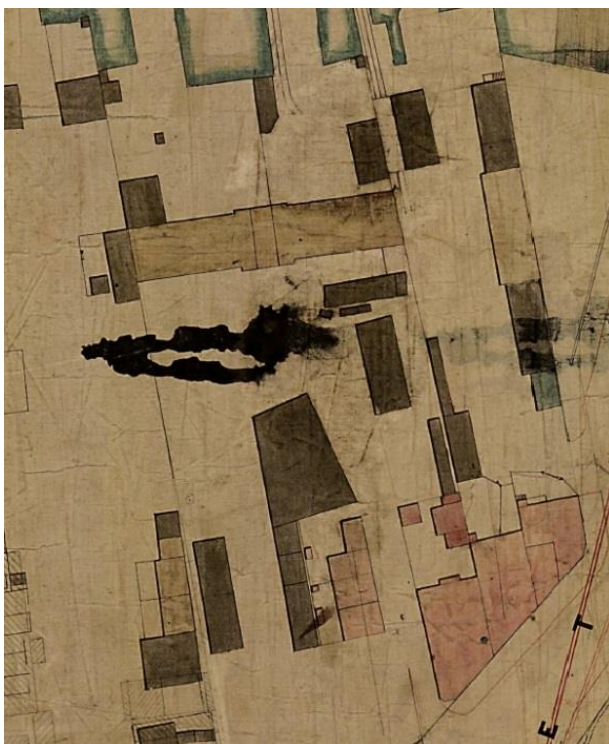
Other buildings surveyed in the Trigonometry Survey are also still standing, including an unattached timber shed in Miller and Harrison’s Timber Yard and the four one-storey buildings made of stone, iron and wood located southeast of the timber shed and connected shed complex (see Figure 2.5 and Figure 2.6).

Figure 2.5 A section of the Trigonometry Survey, 1855–1865. (Source: City of Sydney Archives)

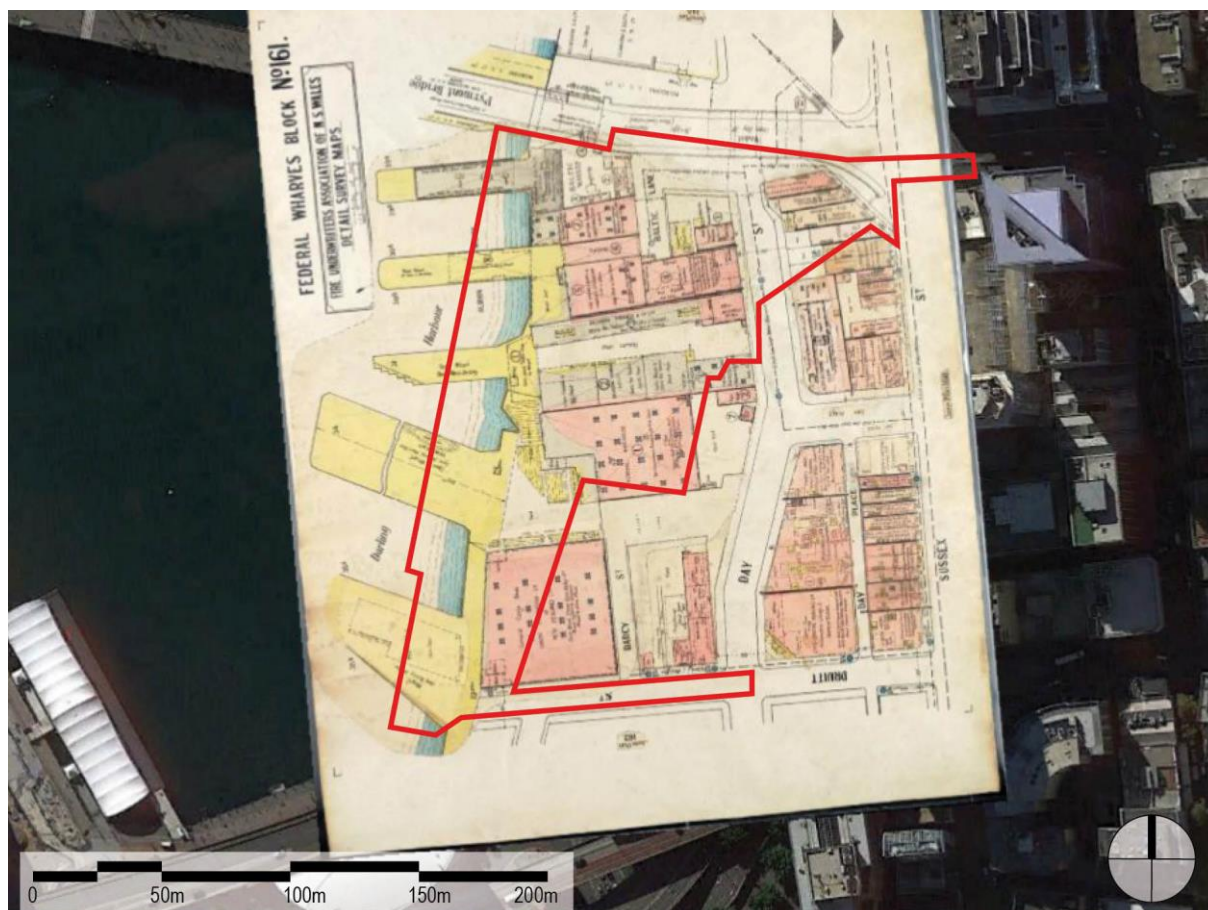
Figure 2.9 Fire Underwriters' Survey Map, 1923. (Source: City of Sydney Archives with Google Earth baseplan and GML overlays 2017)

The Fire Underwriters Association of NSW Detail Survey Map of Federal Wharves Block No. 161 states that the survey was created in 1923 (Figure 2.9). By now, the Sydney Harbour Trust (the Trust) had embarked on modernising the land the government had reclaimed. The Trust replaced privately-owned wharves with new finger wharfs from Darling Harbour to Millers Point. Work on replacing the old Pyrmont Bridge had begun in 1899, and the new steel bridge, with a swing span section, was opened in 1902.²⁰ Hickson Road was completed in 1923 and construction on the Sydney Harbour Bridge would commence the following year.²¹

Considerable road development had also occurred within the subject site. Along with parts of Sussex, Market and Druitt Streets, Day Street, Baltic Lane, part of the new Pyrmont Bridge, and the bridge's approach all fall within the site boundary. The Fire Underwriters' Survey Map of the site shows how the old wharves had been replaced with five new wharves, numbered from 29A to 35B. The wharves have been extended further into the harbour on reclaimed land, and extend well beyond the subject area's harbour-side boundary. Albion Wharf had kept its name and the wharf between Albion and Pyrmont Bridge appears to be named Baltic Wharf. The map indicates the rest of the wharves were unnamed at

this time. Wharf 34 extends the furthest into the Harbour and is labelled as being 325 feet long. Two of the wharves are labelled as open wharves. Coal, decking and wood piles were located on the wharves and many had offices, or wharf or timber sheds on the land alongside each wharf finger. Some of the wharf fingers also had buildings on them: an iron weathered wharf shed with concrete floor and an iron gable end stood on wharf 35, an open sided shed stood on Albion Wharf (30), and a structure with iron walls, and wood and glass sashes stood on Baltic Wharf (29).

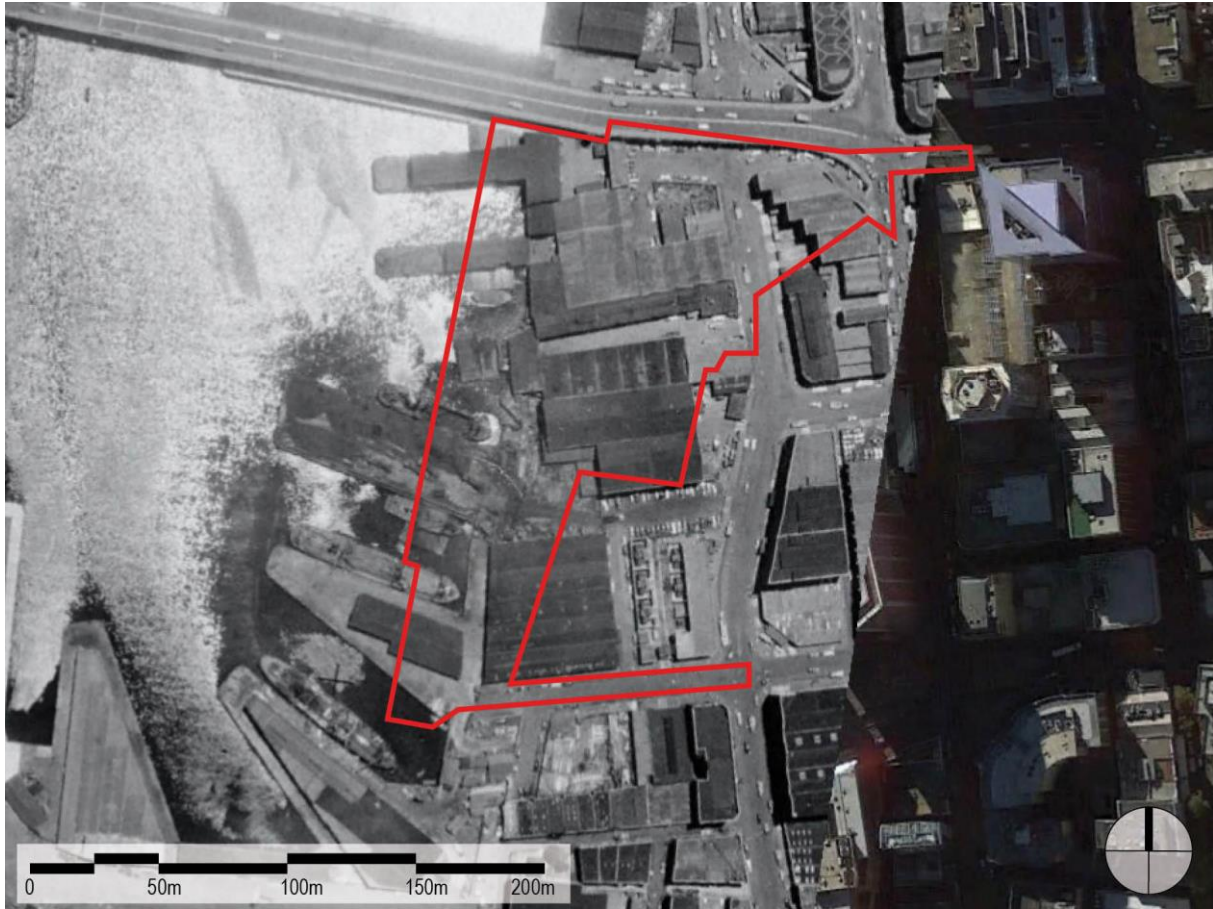
Figure 2.12 Historic aerial, 1948. (Source: City of Sydney Archives with Google Earth baseplan and GML overlays, 2017)

The third of the five wharves in the subject site (identified as wharf 31 in the 1948 Civic Survey) is not clearly visible in the aerial. The photographic image reveals large vessels alongside two of the wharves' fingers that partly feature in the subject area. The aerial also depicts the area's road transport links with Pymont Street and surrounding streets and cartways.

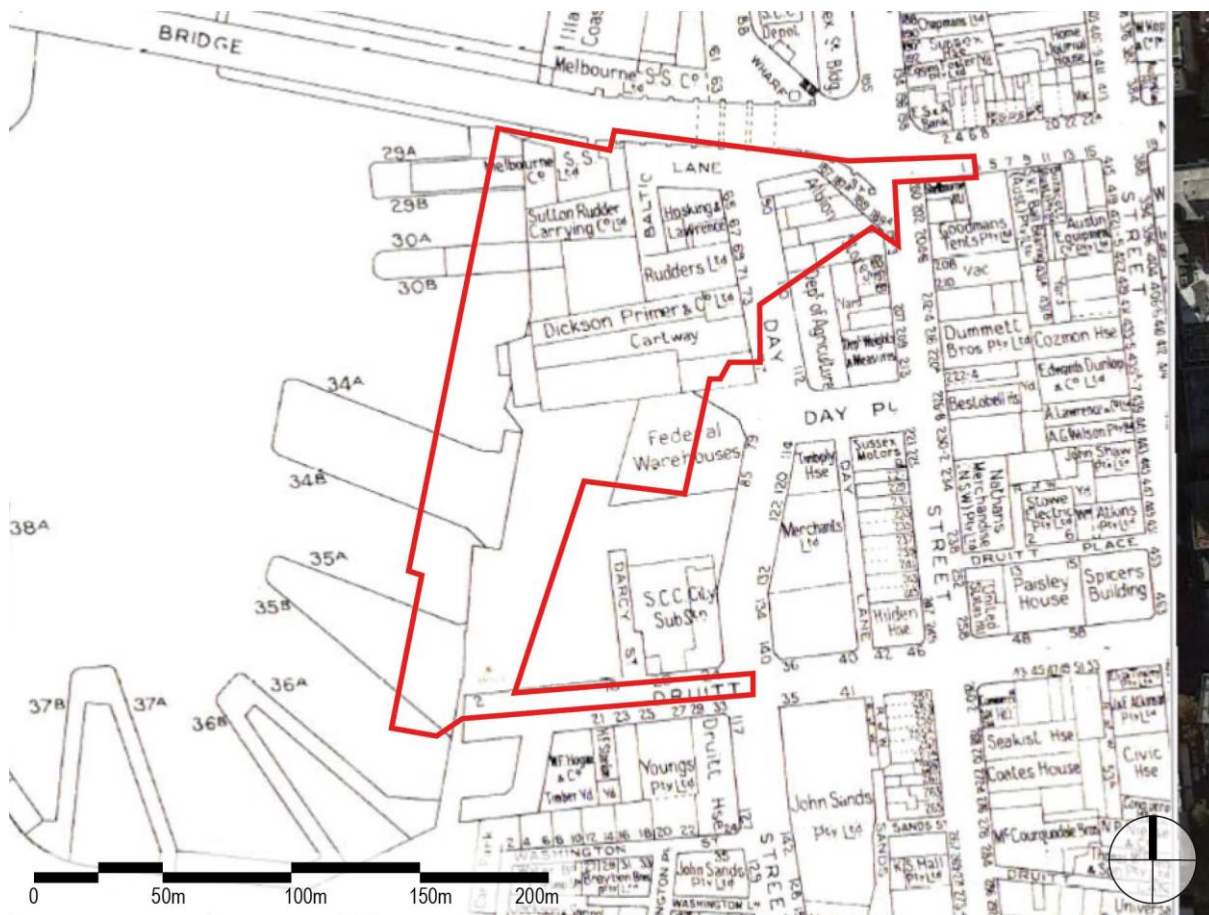
Figure 2.13 1956 Building Surveyors Plan. (Source: City of Sydney Archives with Google Earth baseplan and GML overlays, 2017)

Around 1956, the City of Sydney Building Surveyor's department undertook a survey (Figure 2.13). This occurred after the city's boundaries had been extended in 1948, and the city had been given new town planning responsibilities following World War II.²⁶ The section of the survey featuring the subject site indicates that the shed utilised by Union Steamship Co of New Zealand Ltd has been demolished, and that much of the land along the harbour shore directly behind wharves 34 and 35 is vacant. The building marked Federal Warehouse may be a new structure or an extension of previous smaller structures evident in the 1948 survey.

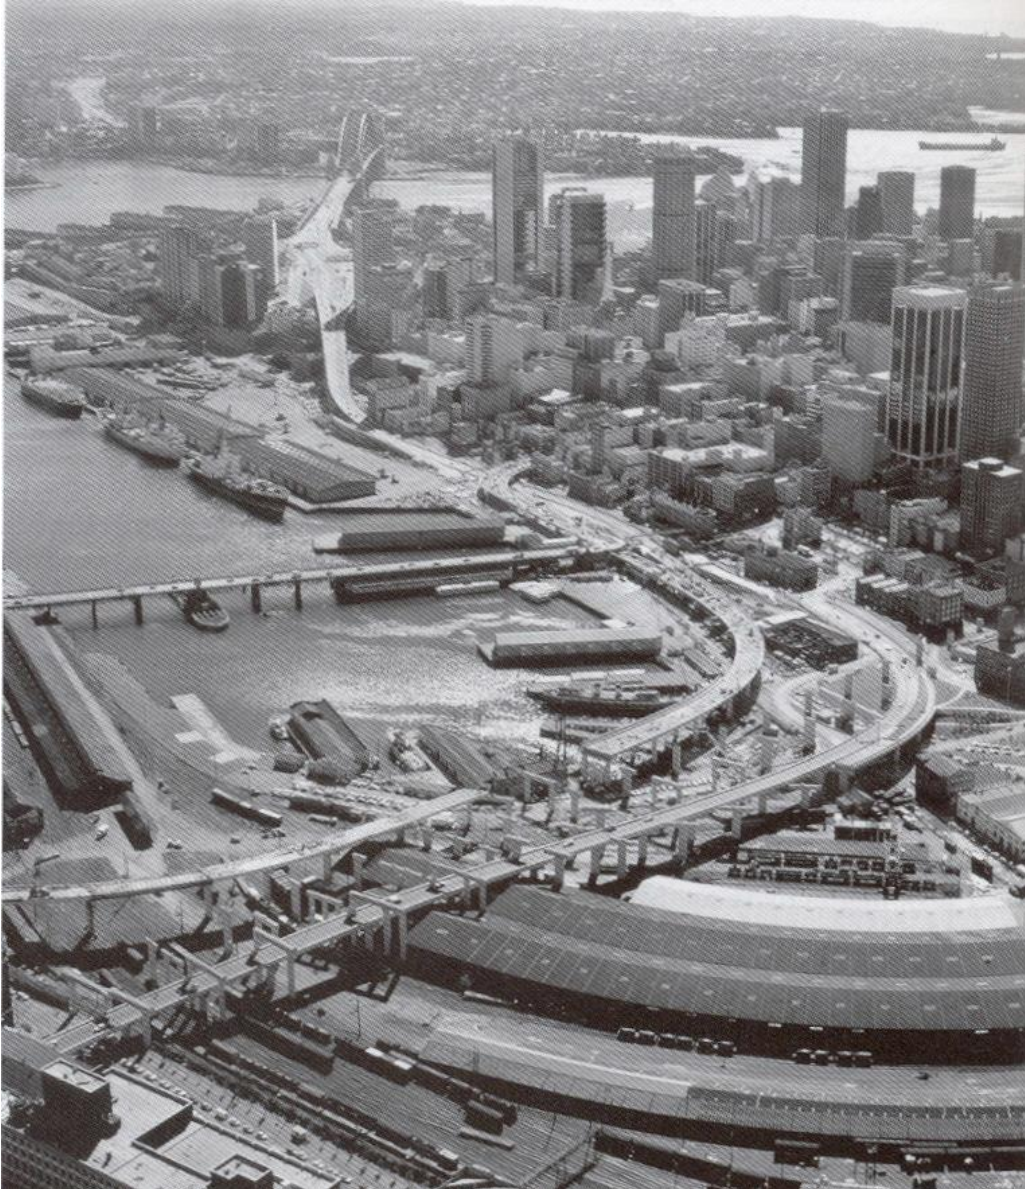
Figure 2.14 Construction of the Western Distributor through subject site, 1980. (Source: Oz Roads website, viewed August 2017)

Work on the Western Distributor began in the 1970s, and the new roadway opened in stages from 1972 onwards. The aerial photographs below show the construction of the Western Distributor through the subject site (Figure 2.14 and Figure 2.15). The first section of the planned North Western Freeway—which was later cancelled—across Darling Harbour opened on 24 May 1980.²⁹ Traffic flows on Sussex Street, amongst other roads, was altered to assist in managing the new traffic changes.³⁰ Sussex Street between King Street and Day Place became one-way southbound.³¹

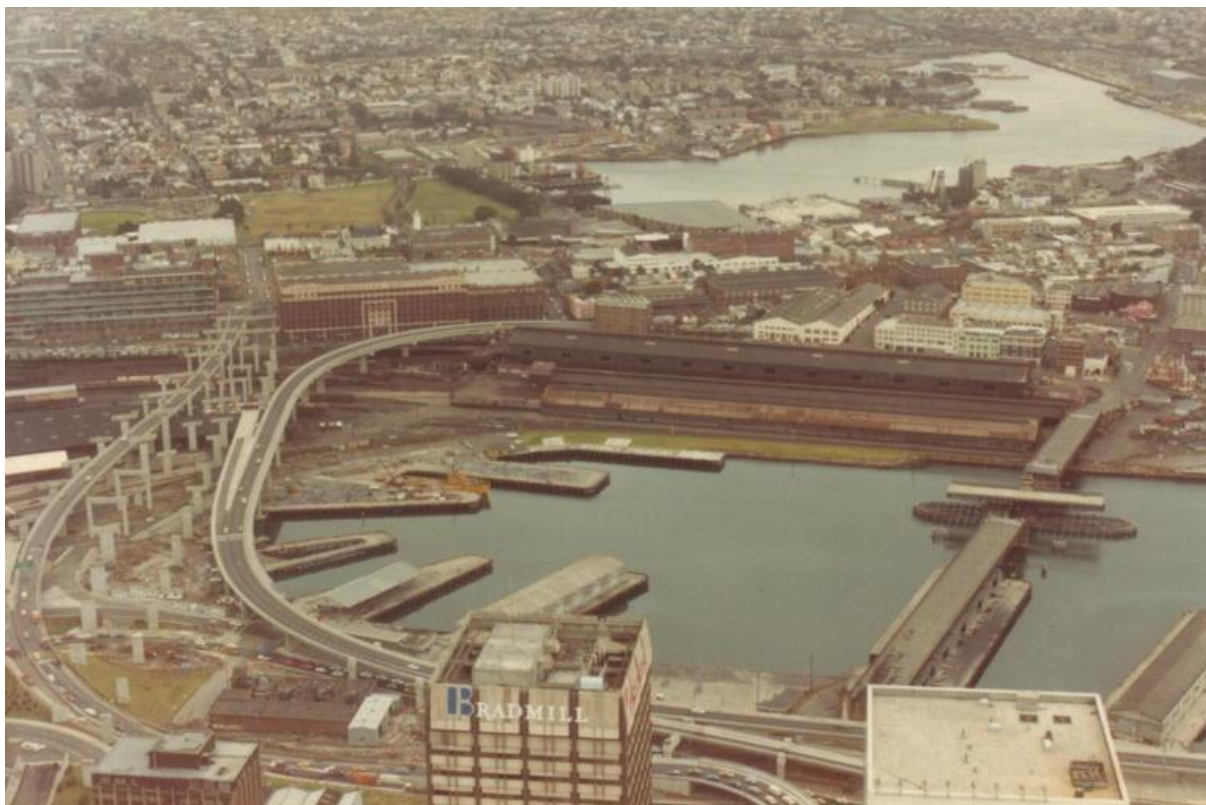
Figure 2.15 The Western Distributor, showing subject site, 1982. (Source: City of Sydney Archives 071/071490, SRC 23033, photographer: Helen Grant)

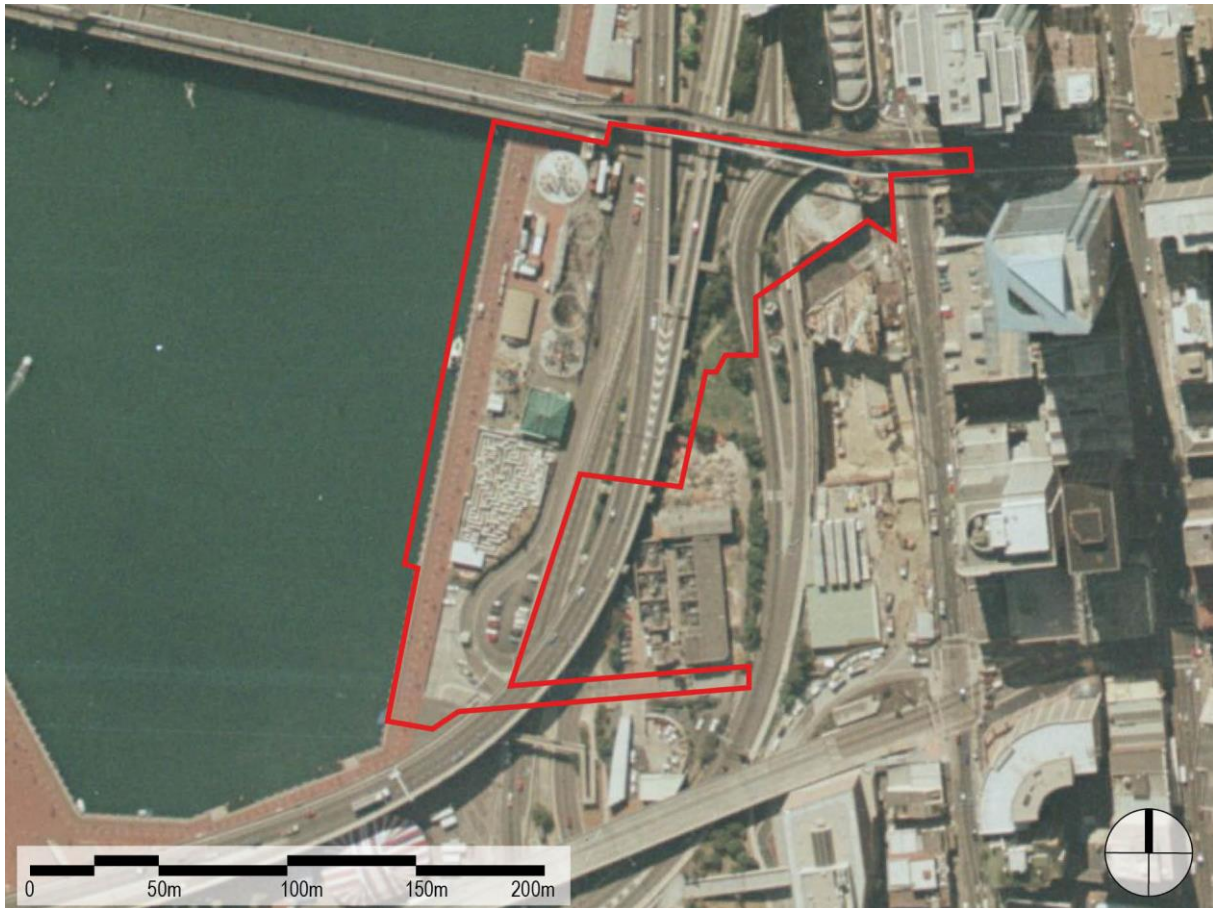
Figure 2.16 1991 aerial of the subject site. (Source: Land and Property Information NSW with GML overlays 2017)

A 1991 aerial of the subject site (Figure 2.16) displays how the Western Distributor and surrounding roads transformed the area. The wharves that once characterised the site have been removed and the site abuts the water's edge. There are a number of built structures within the site, near the approach to Pymont Bridge. By 1994, many of these structures appear to have been removed (as can be seen in the aerial below—Figure 2.17). By now, the first of the Darling Park towers has been constructed just outside the subject site, and an elevated pedestrian walkway connecting Market Street to Pymont Bridge, now known as Cockle Bay Bridge, is also evident at the northern end of the site. Structures related to the monorail can also be seen.

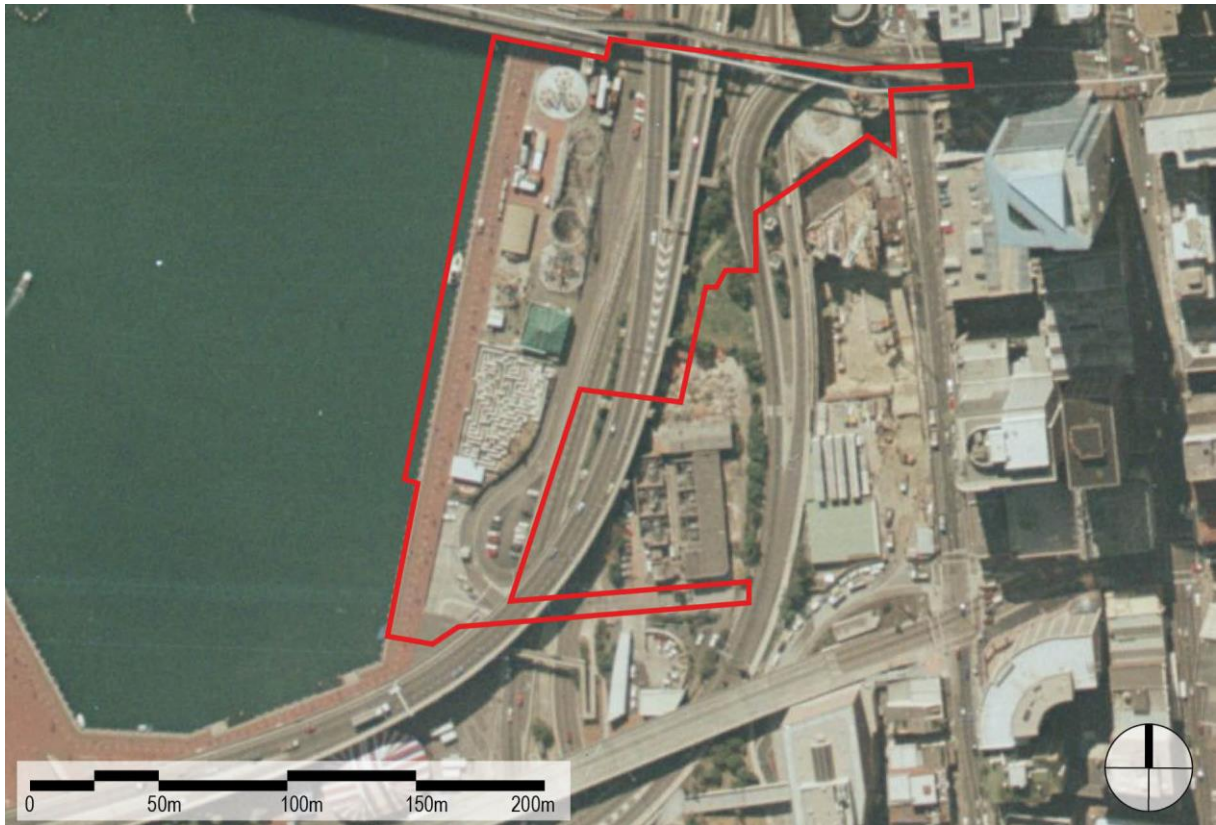
Figure 3.2 1991 aerial photograph. (Source: NSW LPI with GML overlay 2017)

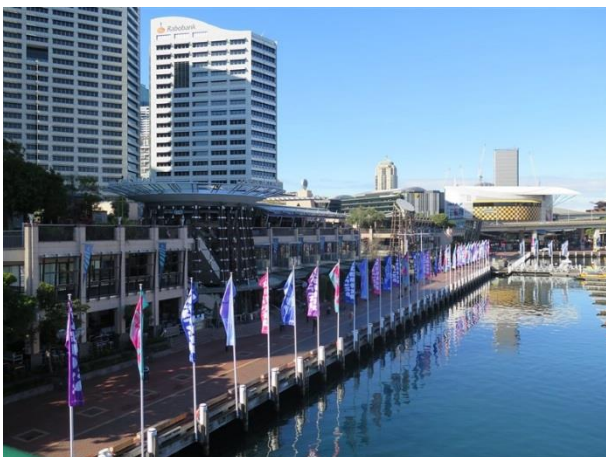
The study area extends over the water of Darling Harbour (Figure 3.4). The entire study area has been developed with buildings, roads, hard landscaping and public amenities (Figure 3.5). There are no exposed natural surfaces within the study area, trees and plants have all be grown in prepared garden boxes (Figure 3.6).

Figure 3.4 Looking southeast towards the site from Pymont Bridge. (Source: GML, 2016)

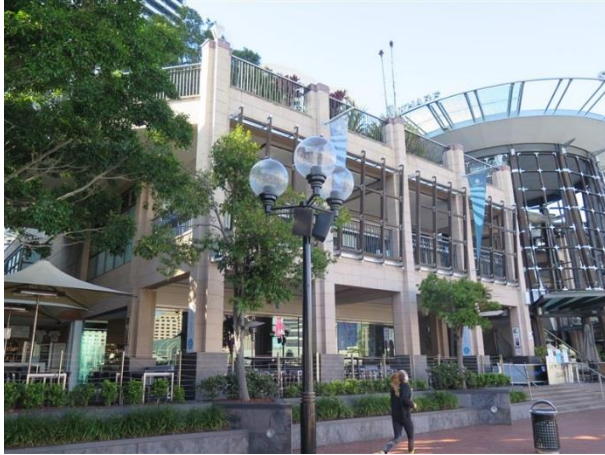
Figure 3.6 Looking southeast at the northern end of the existing Cockle Bay Wharf. (Source: GML, 2016)

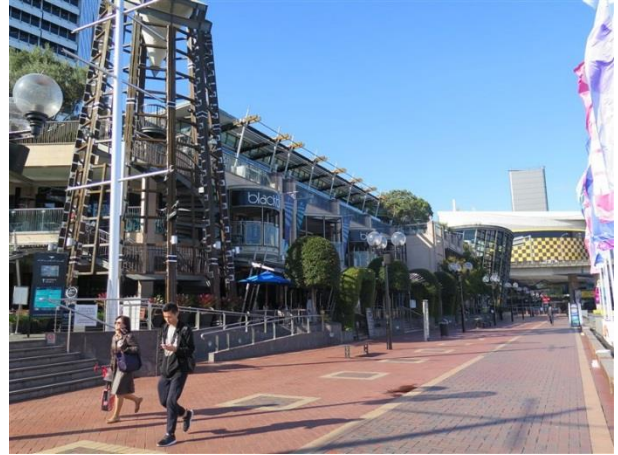
The western side of the study area, along Cockle Bay Wharf, is the main public thoroughfare (Figure 3.7, Figure 3.8, Figure 3.9). It provides access to the commercial building and views across Darling Harbour (Figure 3.10). Commercial buildings line the wharf, including cafes and restaurants. The northern section of the study area contains public access from the wharf to Sussex and Market Streets and towards Town Hall (Figure 3.11).

Figure 3.7 Looking southeast towards the southern half of the existing Cockle Bay Wharf. (Source: GML, 2016)

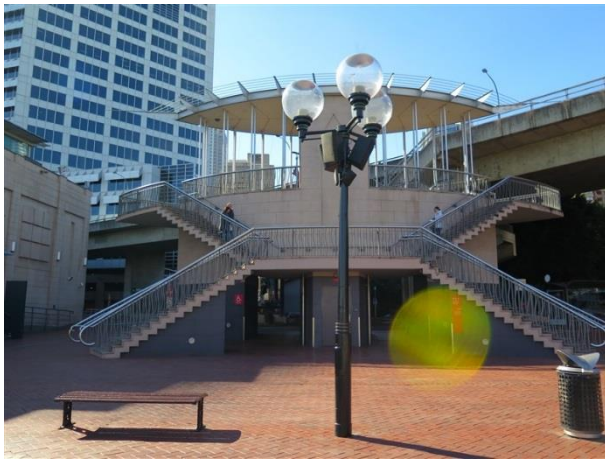
Figure 3.8 Looking east at the staircase in the southern part of the site; the stairs link to a public footpath. (Source: GML, 2016)

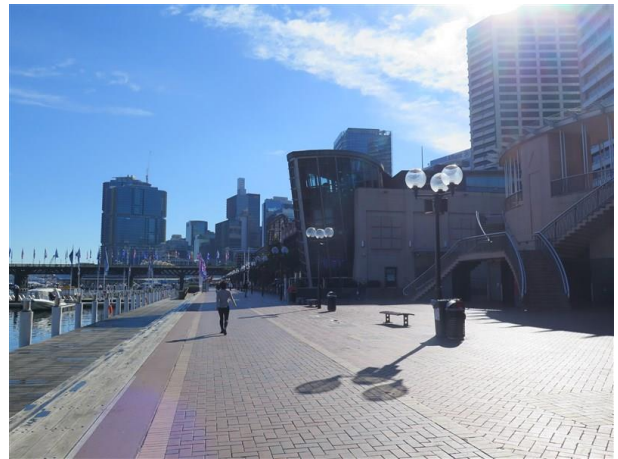
Figure 3.9 Looking north along the public domain space on the western edge of the site; the staircase and Cockle Bay Wharf are visible on the right-hand side of the image. (Source: GML, 2016)

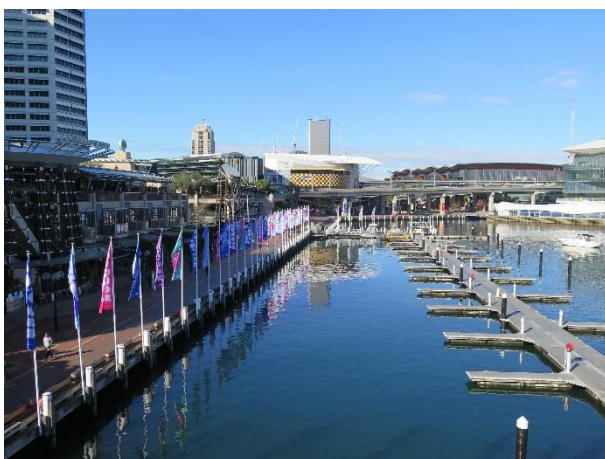
Figure 3.10 Looking south down Darling Harbour, from the Pyrmont Bridge. Cockle Bay Wharf is on the left. (Source: GML, 2016)

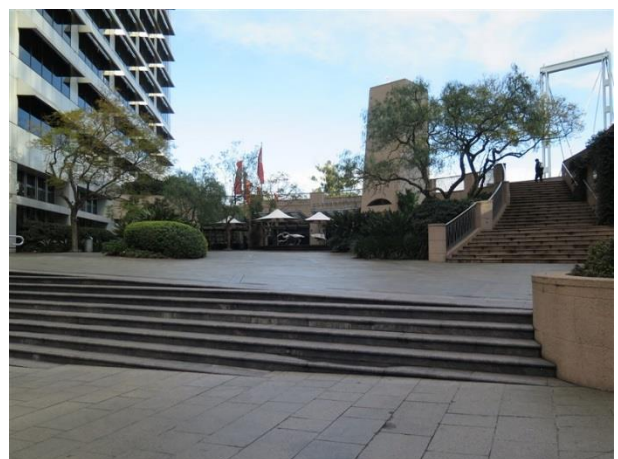
Figure 3.11 Looking west across the public domain space in the northeast of the site. (Source: GML, 2016)

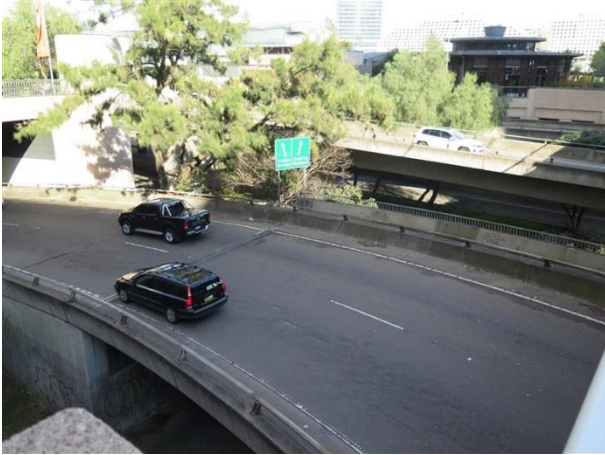
The eastern side of the study area, behind the wharf, is primarily road infrastructure, including the Western Distributor (Figure 3.12 to Figure 3.16). The majority of the Western Distributor is a flyover within the study area, therefore ground disturbance during construction would have been centred around the supporting pylons (Figure 3.13). Other roads within the study area include Wheat Road and Harbour Street, which provide access to the commercial buildings and Cockle Bay Wharf (Figure 3.17 and Figure 3.18). Both of these roads are on the current ground surface and therefore have a different impact area to the Western Distributor.

Figure 3.12 Looking southwest across the Western Distributor flyovers located in the northern part of the site. Cockle Bay Wharf is visible in the background of the image. (Source: GML, 2016)

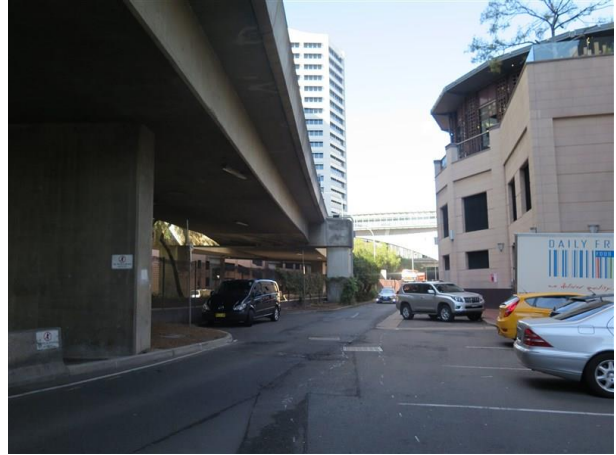
Figure 3.13 Looking south along Wheat Road in the northern part of the site. Cockle Bay Wharf is visible on the right and the Western Distributor northbound flyover is on the left. (Source: GML, 2016)

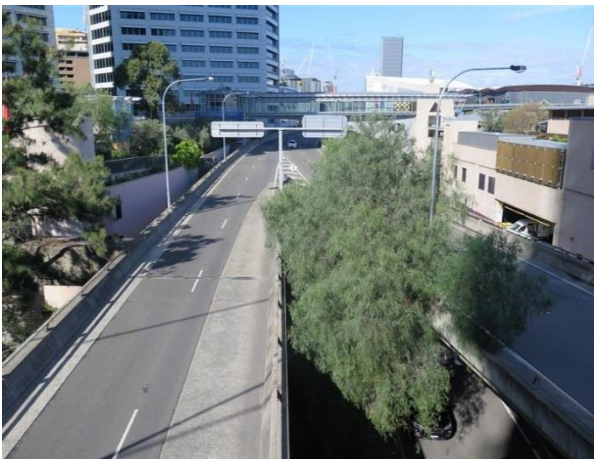
Figure 3.14 Looking south across the Western Distributor northbound flyover lanes in the northern part of the site. (Source: GML, 2016)

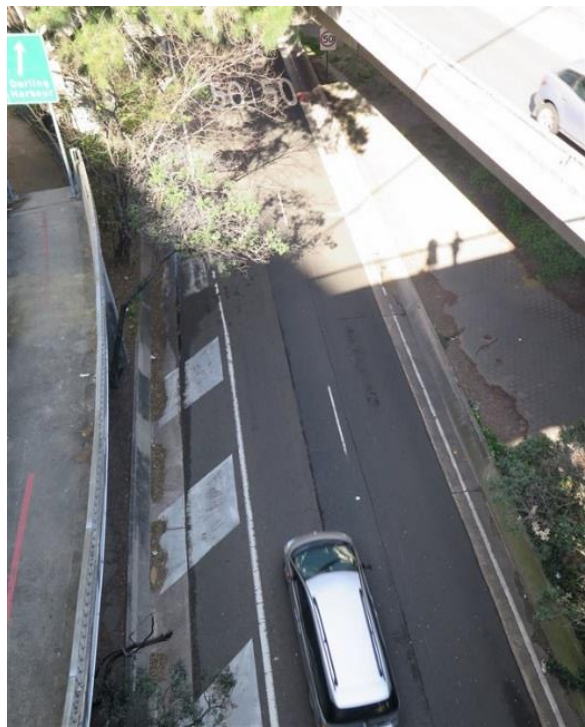
Figure 3.15 Looking down on the Western Distributor southbound lane from the pedestrian footbridge on the northern edge of the site. The northbound flyover is visible in the top right corner of the image. (Source: GML, 2016)

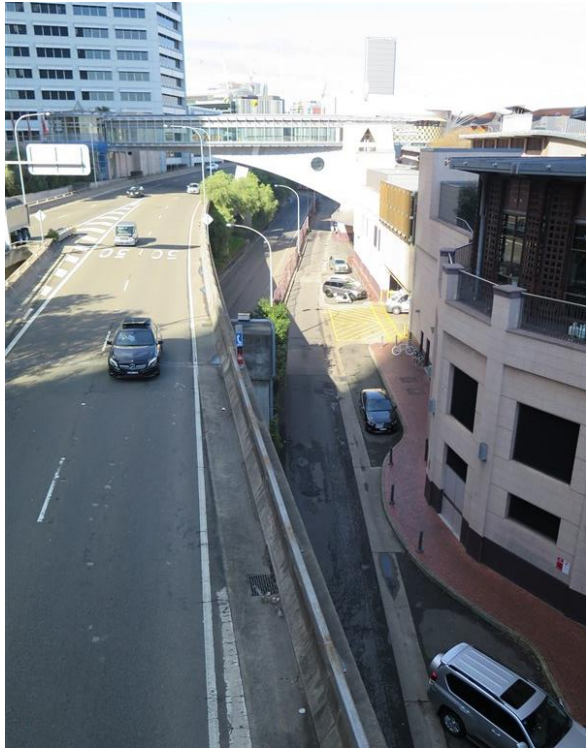
Figure 3.16 Looking south across the Western Distributor northbound flyover lane, Wheat Road, and the eastern façade of Cockle Bay Wharf from the pedestrian footbridge on the northern edge of the site. (Source: GML, 2016)

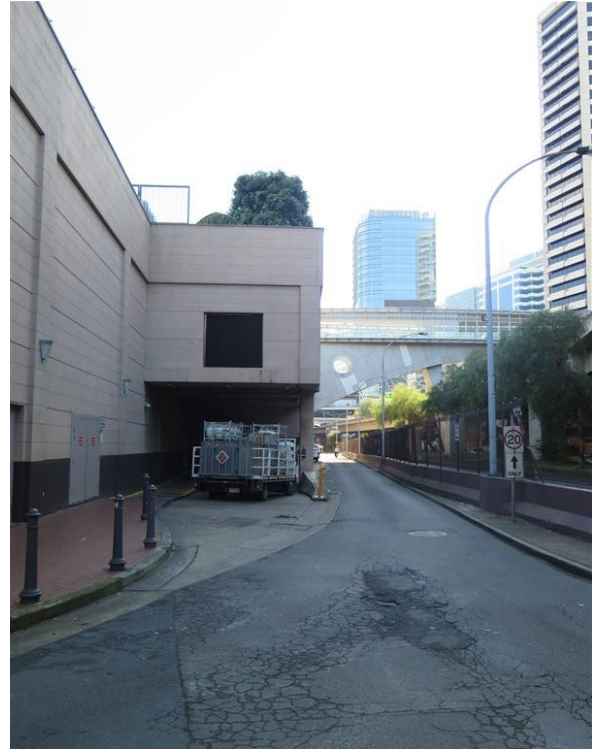
Figure 3.17 Looking north along Wheat Road; the eastern façade of Cockle Bay Wharf is visible on the left-hand side. (Source: GML, 2016)

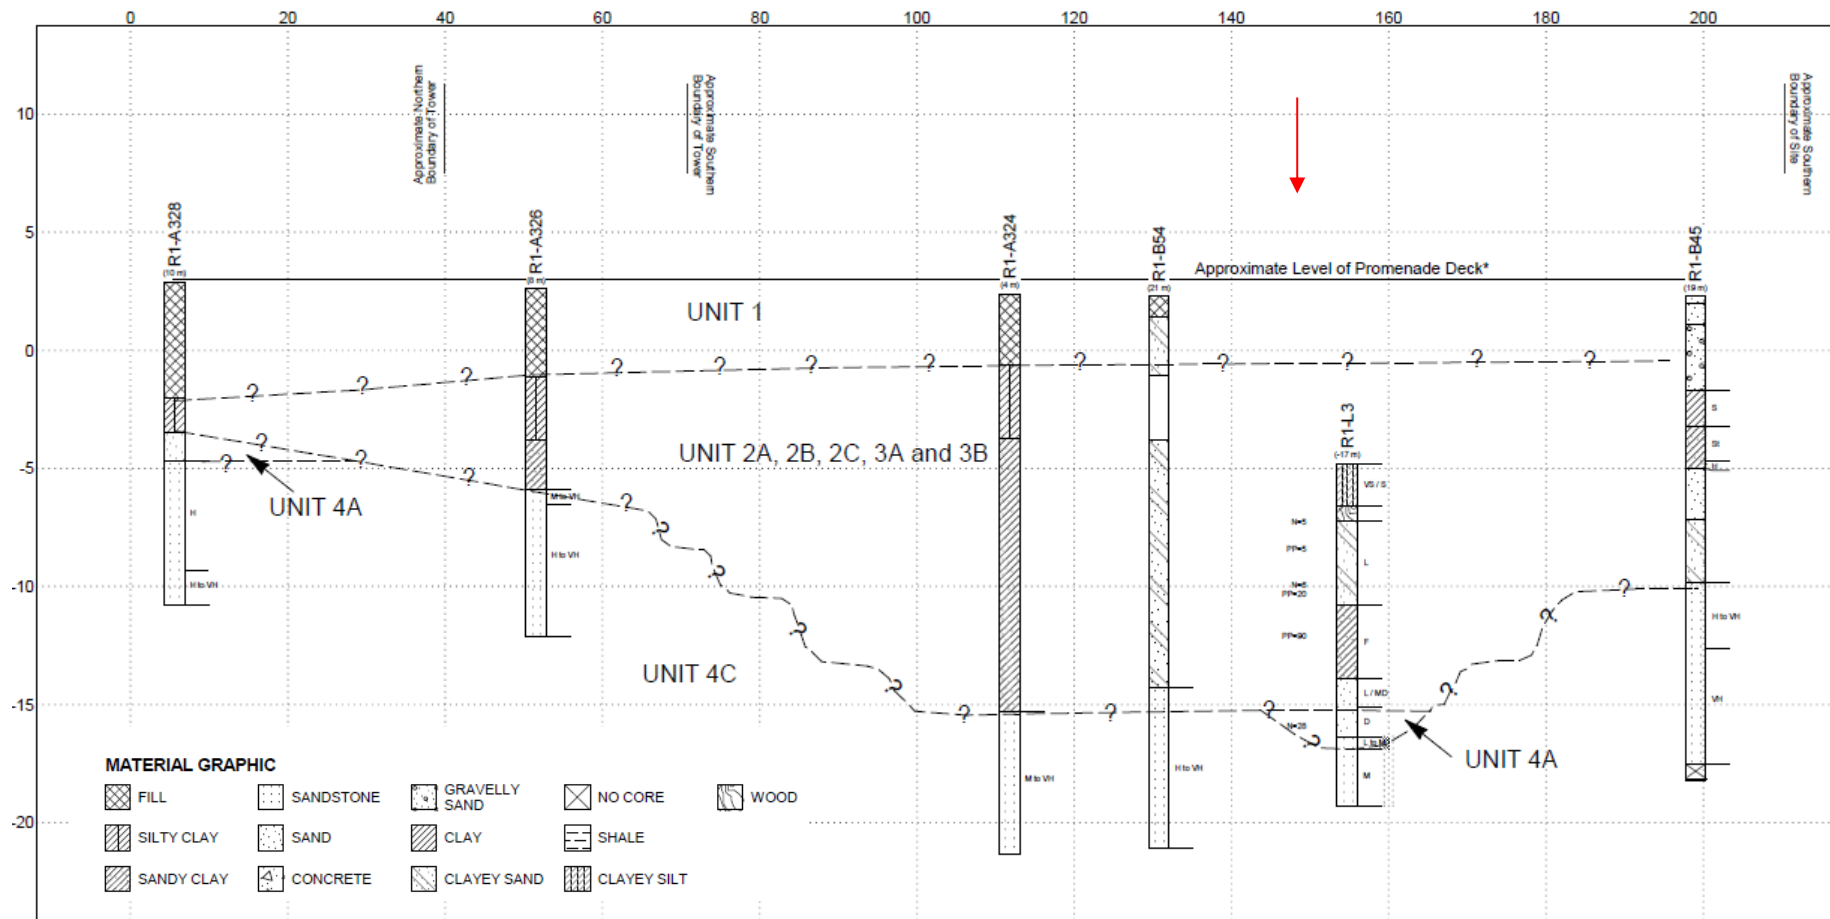
Figure 3.19 North-south borehole transect—the arrow indicates the location of the deeper alluvial deposits. (Source: Coffey Corporate 2016¹⁰)

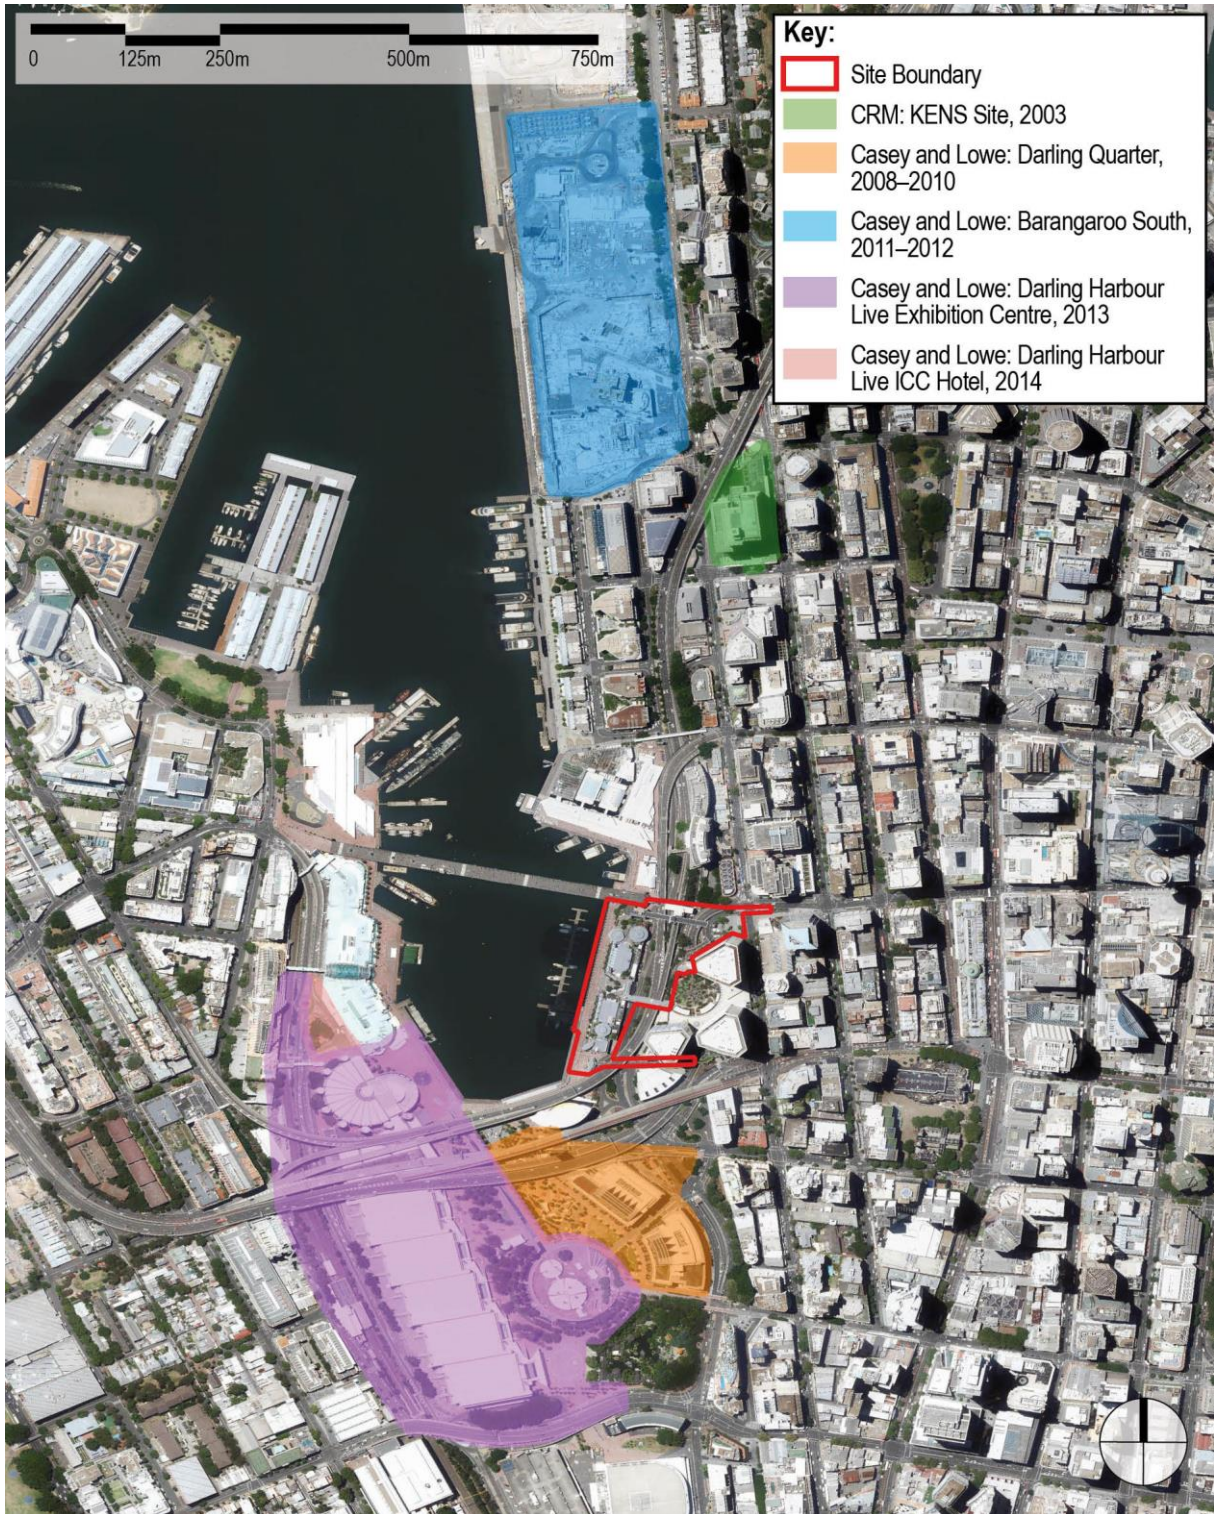
Figure 4.1 Location of previous archaeological investigations within the vicinity of the subject site. (Source: NSW LPI with GML overlay)

In the centre of the site, remains of seven terraced houses were recorded, comprising sandstone footings, yard surfaces, cess pits and external laneways, dating to c1840–1860s.⁷ Substantial underfloor deposits provided ample evidence of the living conditions of the properties' occupants, in particular casting light on potential differentiations between owner/occupiers and renters in terms of material possessions.⁸

Evidence for the industrial developments included remains of timber wharves, a sawmill, goods yard, and foundry containing evidence for the weighbridge and internal rail system.⁹ Other artefactual remains indicated a range of trades operating within the site during the nineteenth century, such as a mill, slaughterhouses/abattoirs, tanneries, soap and candle manufactories, dairy factory, foundries, and wharves, as well as areas of residential occupation. The results of the excavation also indicate the high levels of preservation within the site both in terms of organic remains, such as timber wharves and sheds, as well as due to the processes of historic development which was a continuous process of land consolidation resulting in the burial of earlier remains under layers of bulk fill deposited throughout the nineteenth and twentieth centuries.

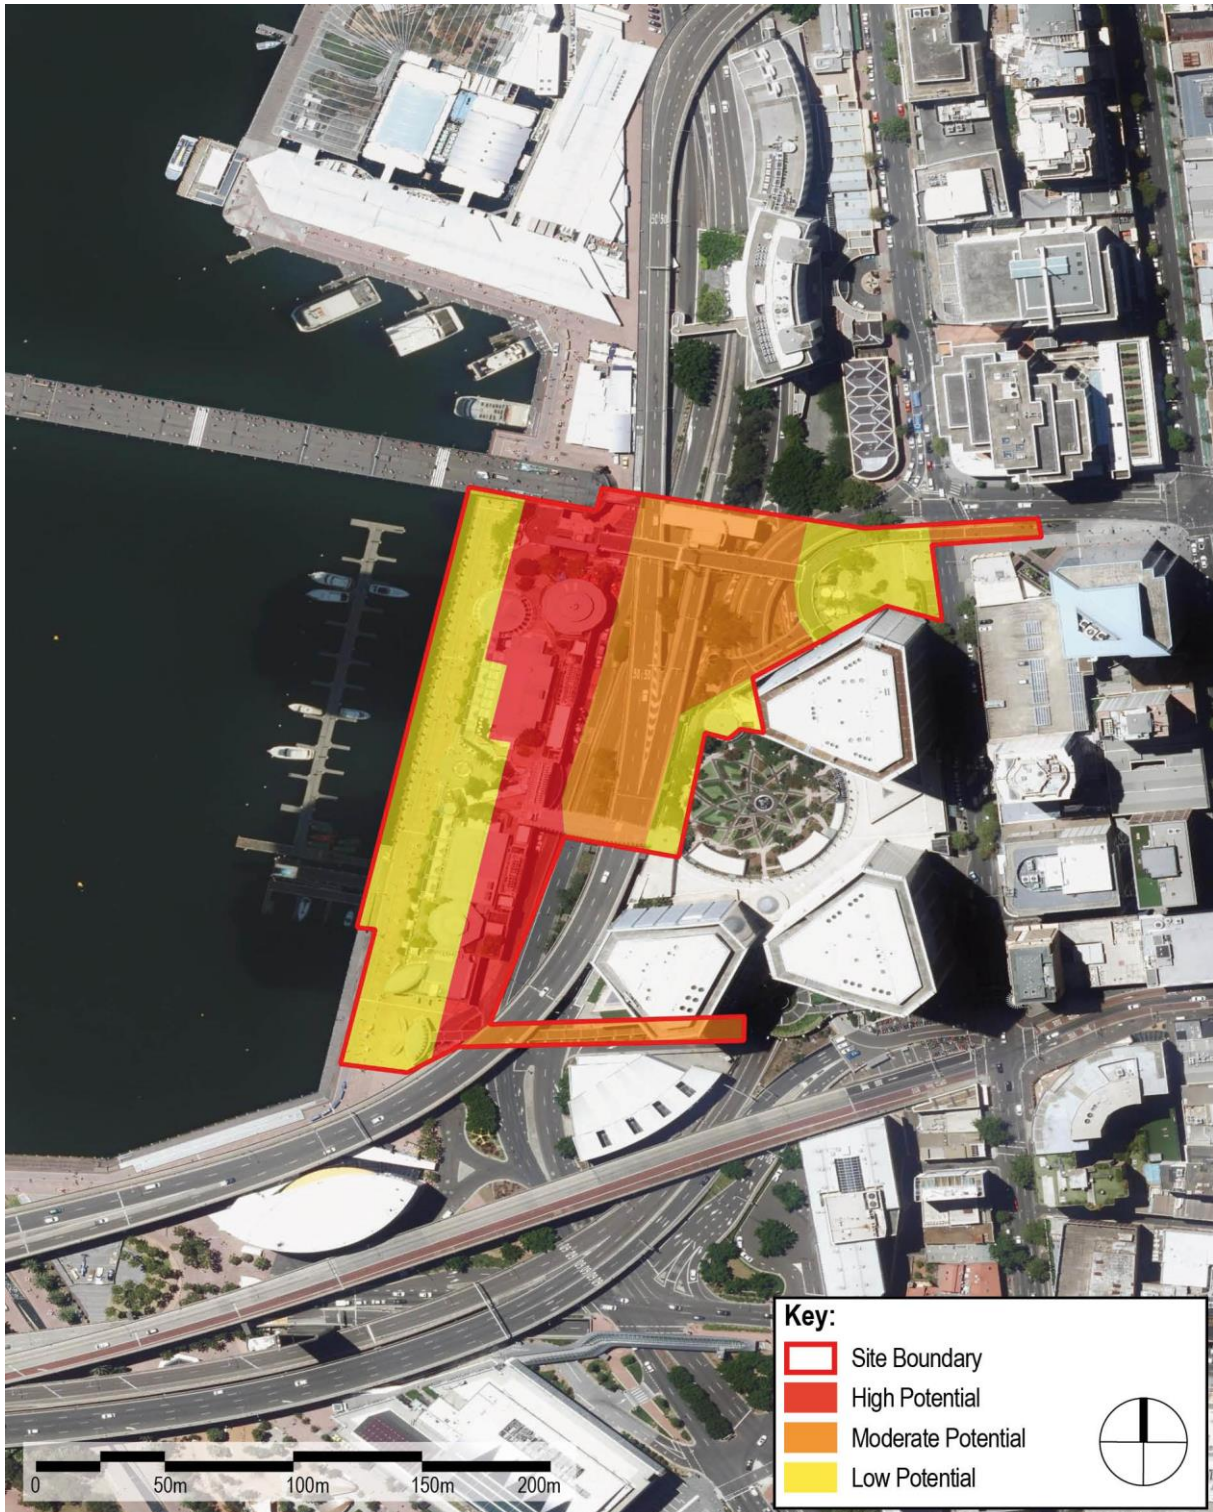
Figure 4.2 Plan of the subject site showing assessed archaeological potential. (Source: NSW LPI with GML overlay)

Wharves	Remains of 1830s timber wharfs or jetties—timber piles, complete structures.	Structural remains may survive within the western half of site beneath Cockle Bay Wharf and Wheat Road.	High
	Remains of 1860s timber wharfs or jetties.	Structural remains may survive within the western half of site beneath Cockle Bay Wharf and Wheat Road.	High
	Remains of early-twentieth century finger wharves.	Structural remains may survive within the western half of the site beneath Cockle Bay Wharf.	Moderate
