Sydney 46 Gale Road
Maroubra, NSW, 2035

Northern 2 Queen St
NSW Murwillumbah, NSW
P.O. Box 42 Condong, 2484

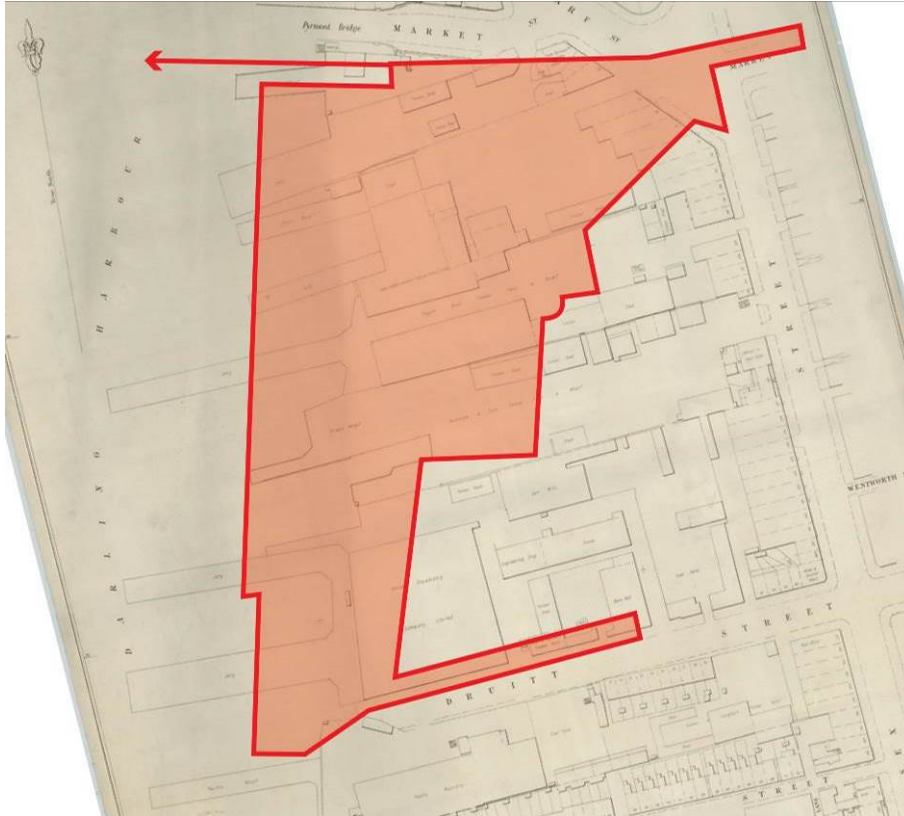
Figure 14: 1895 surveyors plans of Darling Harbour showing detail of wharves within the study area. Study area of Cockle Bay Park shown in red.²⁹

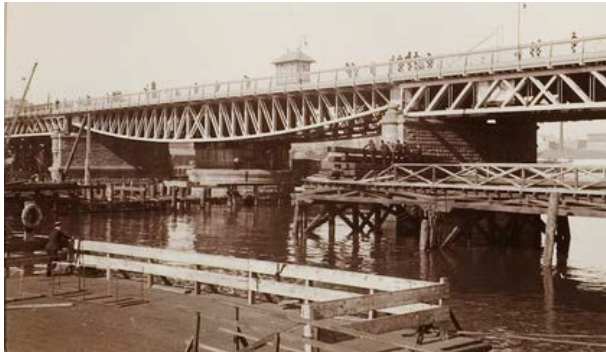
Figure 16: Pyrmont Bridge just after completion, with remnants of original bridge in foreground, 1902.³¹

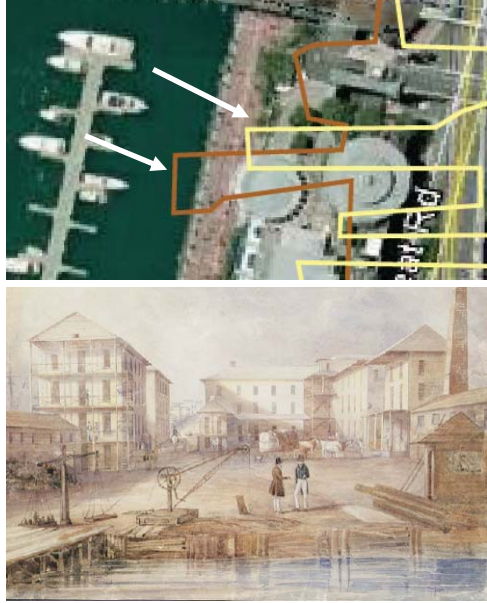
Wharf No.	History and Description	Outline Overlay and Historic Images
<p>Wharf 31 ca. 1956/1958 – 1963</p>	<p>Wharf 31 was constructed ca. 1956-1958 by the Maritime Services Board as part of improvement works to Darling Harbour. The wharf either replaced or involved the reconstruction of an earlier Wharf 31, and seems to represent a short lived attempt to improve wharfage by changing the alignment of Wharf 31 to match that of the larger Wharf 34 to the south. Wharf 31 is likely to have been built of timber piles and decking, and was demolished altogether by 1963. Previous structures in the footprint of Wharf 31 include part of the former Wharf 31, the northern wharf of Federal Wharves, the earlier pair of Fagans Wharves and the former Streets Wharf.</p>

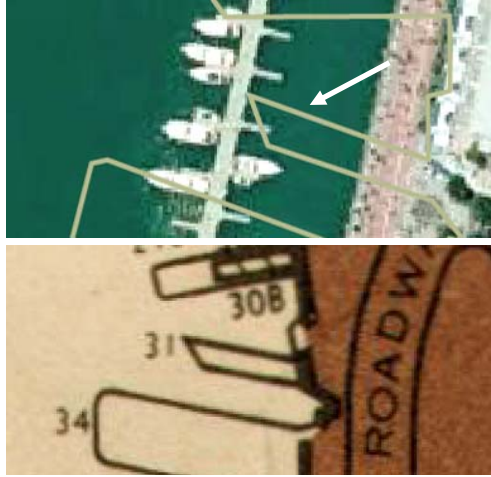
<p>Former Wharf 31 ca. late 1920s – late 1940s/early 1950s</p>	<p>Wharf 31 was constructed in this configuration in the late 1920s as part of the Sydney Harbour Trust improvements to Darling Harbour. The alignment of Wharf 31 perfectly matches that of the previous Wharf 31 / northern of the former pair of Federal Wharves, and it is most likely that this Wharf 31 was a reconstructed / cut-down version of the former structure rather than an entirely new wharf. Wharf 31 was an open wharf, constructed of timber piles and decking. It was demolished by the Maritime Services Board sometime in the late 1940s – early 1950s. Previous structures identified within the footprint of Wharf 31 include the former Wharf 31 / northern of pair of Federal Wharves, the pair of earlier Fagans Wharves and the former Streets Wharf.</p>

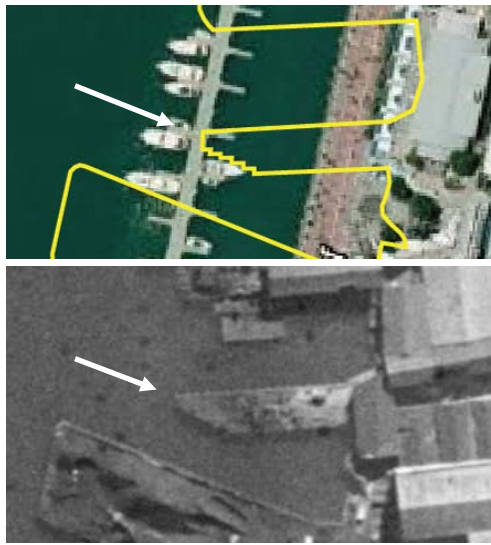
<p>Federal Wharf (north) ca. late 1880s/early 1890s – late 1920s Also "Wharf 31," "Fagans Bros Wharf", Huddart Parker & Co. Wharf", "Burns Philp & Co. Wharf."</p>	<p>The northern Federal Wharf was constructed ca. late 1880s to early 1890s; consisting of an open wharf built of timber piles and decking. The northern side of this Federal Wharf was repaired or rebuilt in ca. 1907 as part of the Sydney Harbour Trust improvements of Darling Harbour and was later rebuilt or cut-down by the Trust in the late 1920s to form the former Wharf 31 (see above). Previous structures within the footprint of the northern Federal Wharf include Fagans Wharves and the former Streets Wharf.</p>

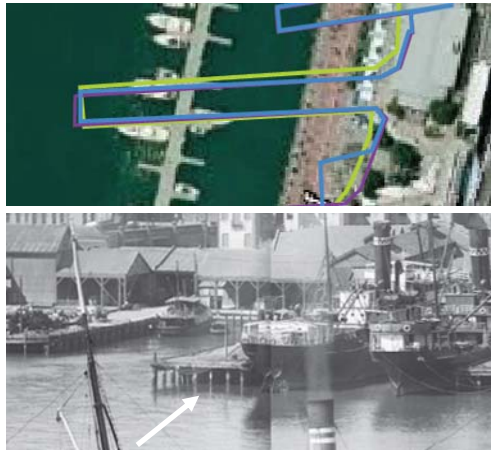
Wharf No.	History and Description	Outline Overlay and Historic Images
<p>Fagans Wharves (pair) ca. late 1850s/early 1860s – late 1880s/early 1890s</p>	<p>Fagans Wharves were constructed ca. late 1850s – early 1860s; comprising a pair of open wharves with timber piles and decking. There is a slight change in alignment and length of the wharves between and plans from 1865-1880 (light blue and burgundy outline) and an 1887 plan (green outline); possibly indicating that the wharves were partially rebuilt and lengthened during the early to mid-1880s. However, it is also quite likely just a case of the plans not quite matching up. Fagans Wharves were demolished ca. late 1880s-early 1890s. Previous structures in the footprint of Fagans Wharves include the former Streets Wharf.</p>

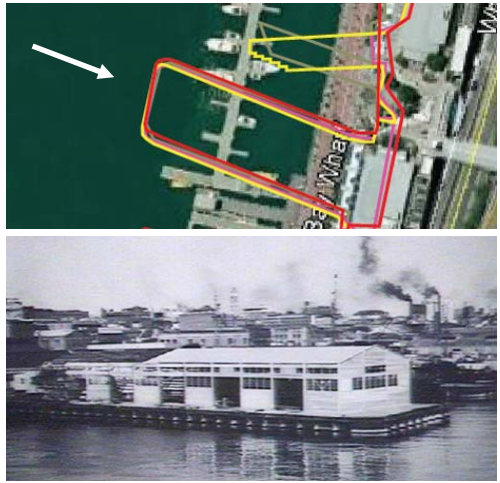
Wharf No.	History and Description	Outline Overlay and Historic Images
<p>Federal Wharf (south) ca. late 1890s – mid 1920s Also “Wharf 32,” “Burns Philp & Co. Wharf.”</p>	<p>The southern Federal Wharf was constructed ca. late 1890s; consisting of an open wharf built of timber piles and decking. This wharf was demolished ca. mid 1920s as part of the Sydney Harbour Trust improvements of Darling Harbour. Previous structures within the footprint of the southern Federal Wharf include Streets Wharf.</p>

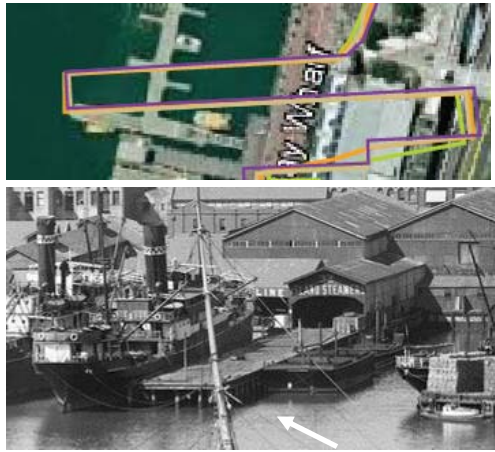
<p>Streets Wharf ca. late 1830s/early 1840s – late 1890s Also “Taylors Wharf”</p>	<p>This Streets Wharf was constructed on the frontage of reclamation in the late 1830s-early 1840s. It appears to correspond with the second, southernmost property of Thomas Street on Sussex Street between Market and Druitt Streets. Streets Wharf comprised an open wharf built of timber piles and decking with a narrow gauge rail / trolley track situated along the northern edge. This wharf was either demolished or rebuilt and extended in the late 1890s to form the southern Federal Wharf. No previous structures have been identified within the footprint of Streets Wharf.</p>

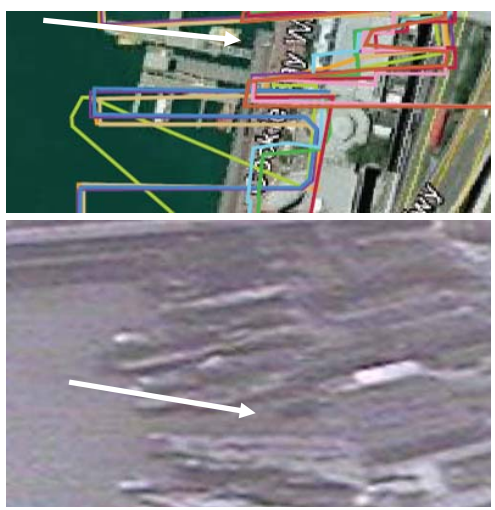
Wharf No.	History and Description	Outline Overlay and Historic Images
<p>Wharf 35 ca. 1918-1919 – mid 1980s</p>	<p>Wharf 35 was constructed in 1918-1919 as part of the Sydney Harbour Trust improvements of Darling Harbour. Wharf 35 was an open wharf, comprising timber piles and decking. It was demolished during the mid-1980s redevelopment of Cockle Bay by the Darling Harbour Authority, with the landward end of the wharf buried in reclamation. Previous structures identified within the footprint of Wharf 35 include the pair of Union SS Co. Wharves (former Wharves 34 and 35) and the earlier Hyndes Wharf and Wentworth Wharves.</p>

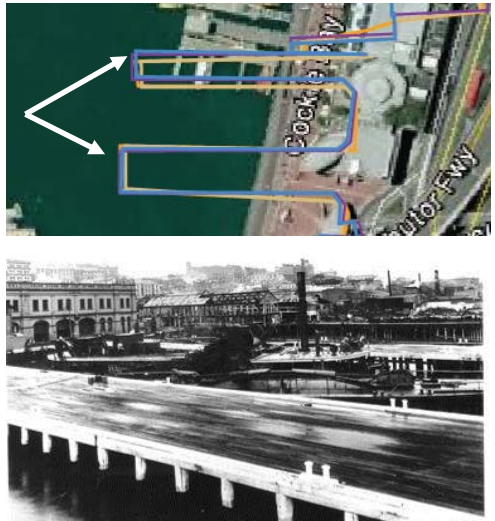
<p>Wentworth Wharves (pair) ca. late 1830s/early 1840s – late 1880s/early 1890s (south) and 1927/1928 (north)</p> <p>Also "Morrissett Coal Co. Wharf", and "Jaques Wharf" (the northern wharf) and "Burns Wharf" (the southern wharf).</p>	<p>The northern Wentworth Wharf was constructed in the late 1830s to early 1840s, forming the earliest version of the former Wharf 33 (see above). The southern Wentworth Wharf was constructed ca. late 1860s to 1870s on the frontage of late 1850s-early 1860s reclamation. The wharf was a wide, open wharf, built of timber piles and decking. The southern wharf was demolished in the late 1880s – early 1890s during the construction of the southern Union SS Co. Wharf; the northern one remained until 1927/1928 (see former Wharf 33 above). No earlier structures were identified in the footprint of either of the Wentworth Wharves.</p>

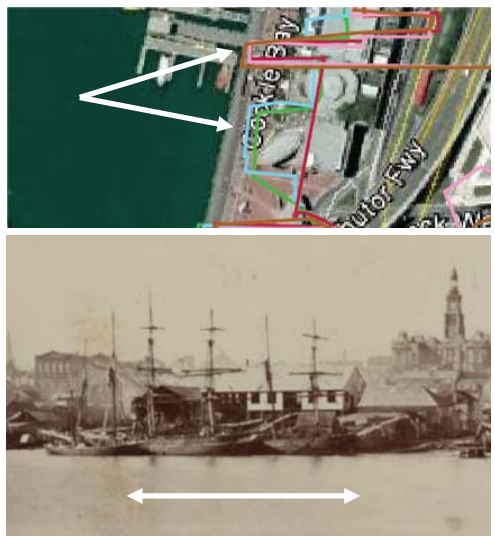
Wharf No.	History and Description	Outline Overlay and Historic Images
<p>Hyndes Wharf ca. late 1830s/early 1840s – late 1880s Also “Dearins Wharf.”</p>	<p>Hyndes Wharf was constructed on the frontage of reclamation ca. late 1830s-early 1840s. Hyndes Wharf was an open wharf, built of timber piles and decking. It was demolished ca. late 1880s – early 1890s. It appears that the earlier reclamation was determined to be unauthorised and a Department of Lands inquiry was made into the matter of illegal occupation of the site in the late 1880s; it is possible that the demolition of the wharf was associated with this inquiry. No earlier structures have been identified within the footprint of Hyndes Wharf.</p>

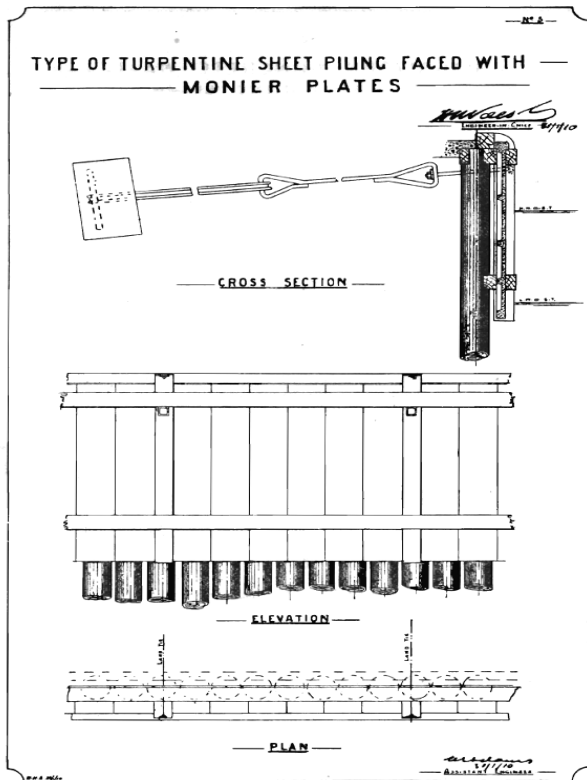
Figure 37: Design of timber sheet piling seawall faced with Monier concrete plates.⁴⁹

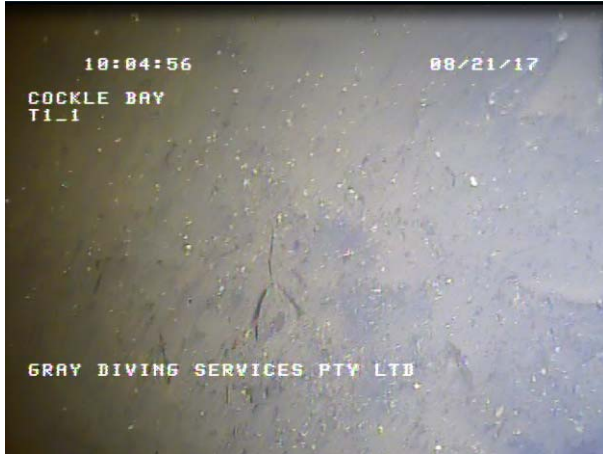
Figure 50: Example of seabed type. (Cockle Bay 170821 T1_2, 3:39)

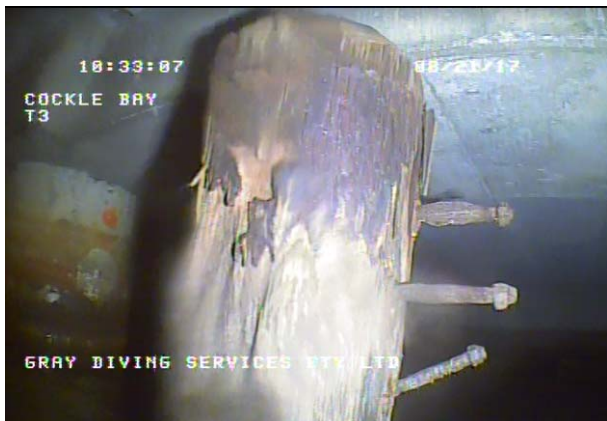
Figure 60: Top of the timber pile forming part of the diffuser. (Cockle Bay 170821 T3, 5:59)

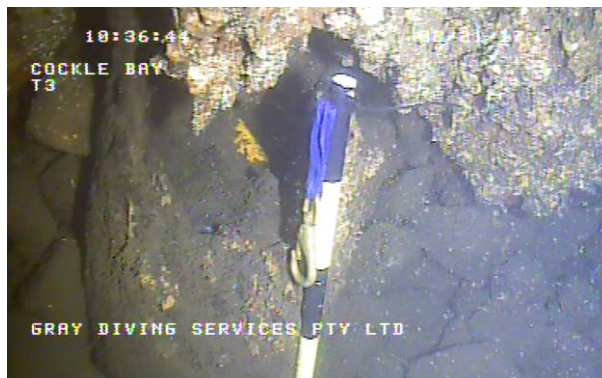
Figure 64: Degraded timber pile stump below concrete pour, against southern wall of storm water drain. Scale in 100 mm increments. (Cockle Bay 170821 T3, 9:19)

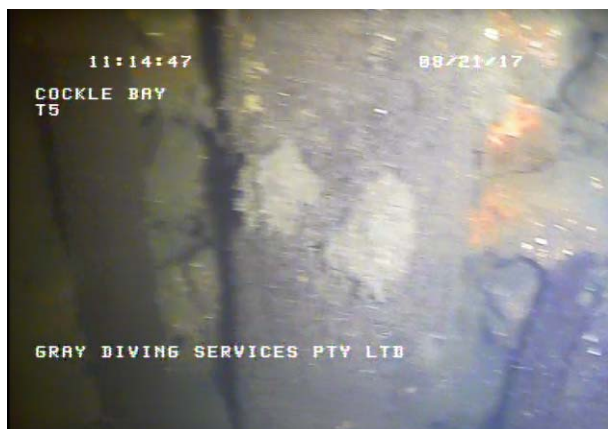
Figure 66: Northern group of three timber piles. (Cockle Bay 170821 T5, 6:27)

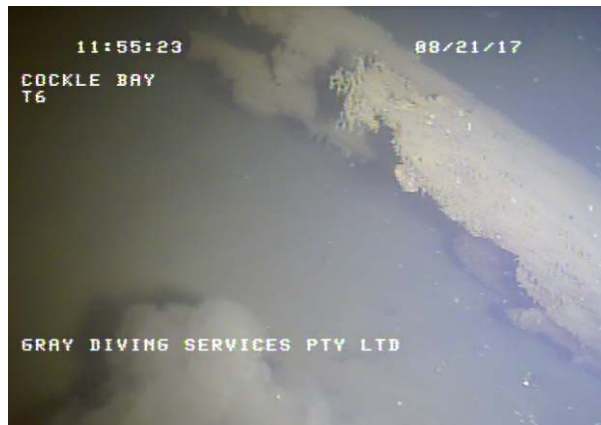
Figure 72: Single timber pile protruding north-east. (Cockle Bay 170821 T6, 3:06)

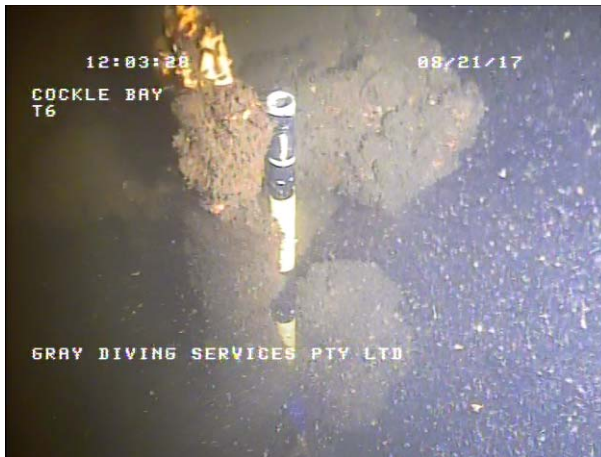
Figure 73: Vertical timber pile, being the most southern in the group of three with possible concrete plating behind. Scale in 100 mm increments. (Cockle Bay 170821 T6, 10:33)

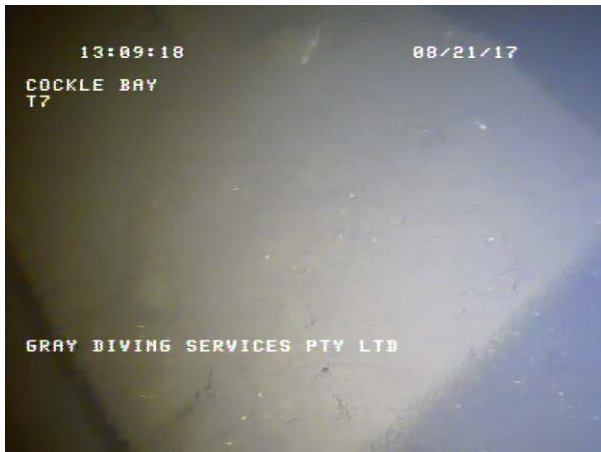
Figure 80: Modern mooring block. (Cockle Bay 170821 T7, 1:10)

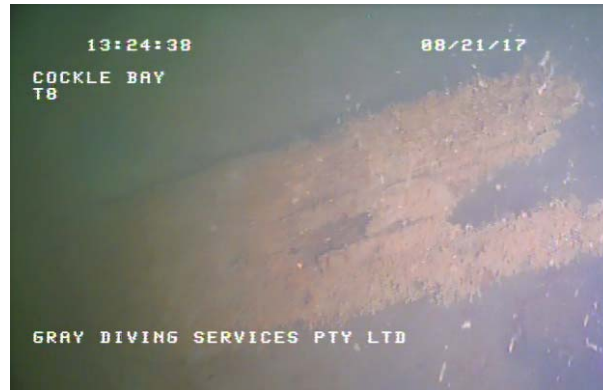
Figure 84: Timber pile on Transect 8. (Cockle Bay 170821 T8, 0:40)

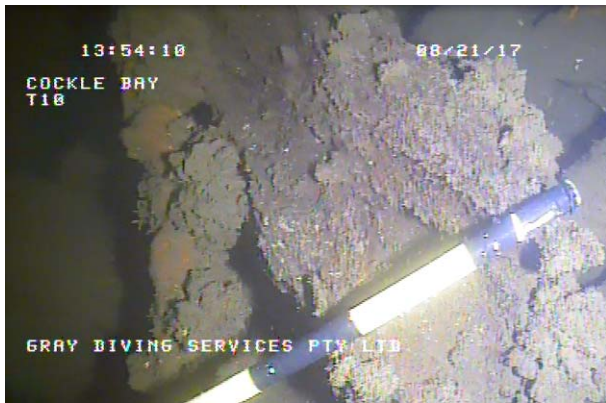
Figure 93: Sample of steel debris and loose timber pile. Scale is in 100 mm increments. (Cockle Bay 170821 T10, 2:19)

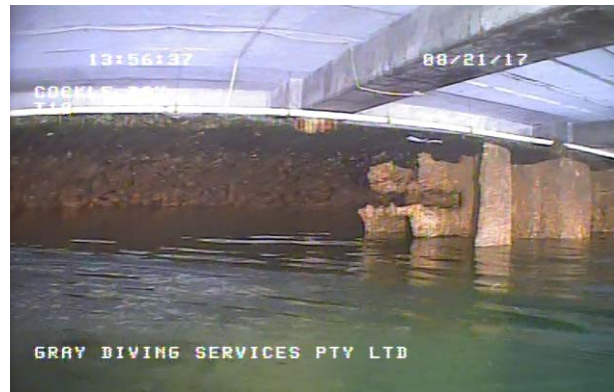
Figure 94: Visible end of sheet piling above water, with shadow of continued sheet piling below water level. Rock embankment and concrete seawall in background around the C steel pier. (Cockle Bay 170821 T10, 4:34)

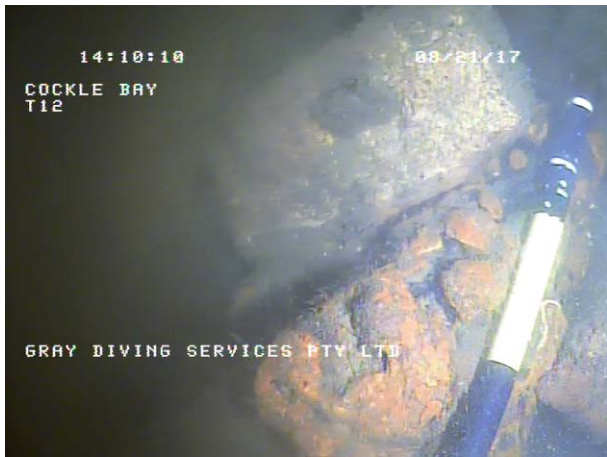
Figure 99: Ferrous toe on the tapered end of the long pile. Scale in 100 mm increments. (Cockle Bay 170821 T12, 2:49)

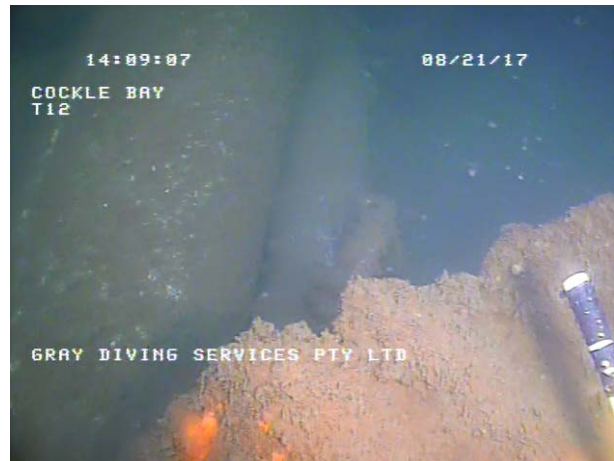
Figure 100: Pile (centre) with steel pipe (left) and sheet piling (foreground). (Cockle Bay 170821 T12, 1:52)

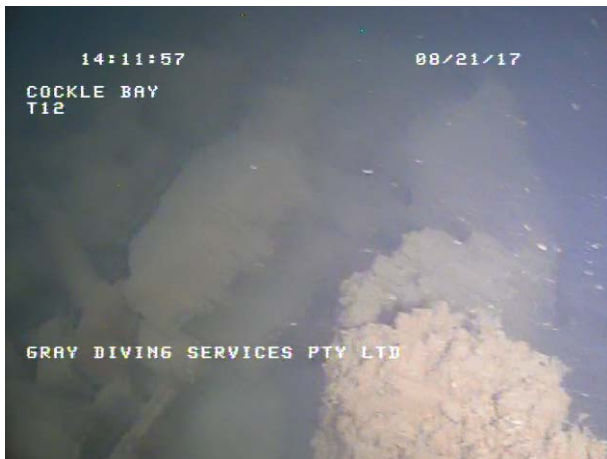
Figure 101: Corner of the sheet piling where it turns east, with debris. (Cockle Bay 170821 T12, 4:28)

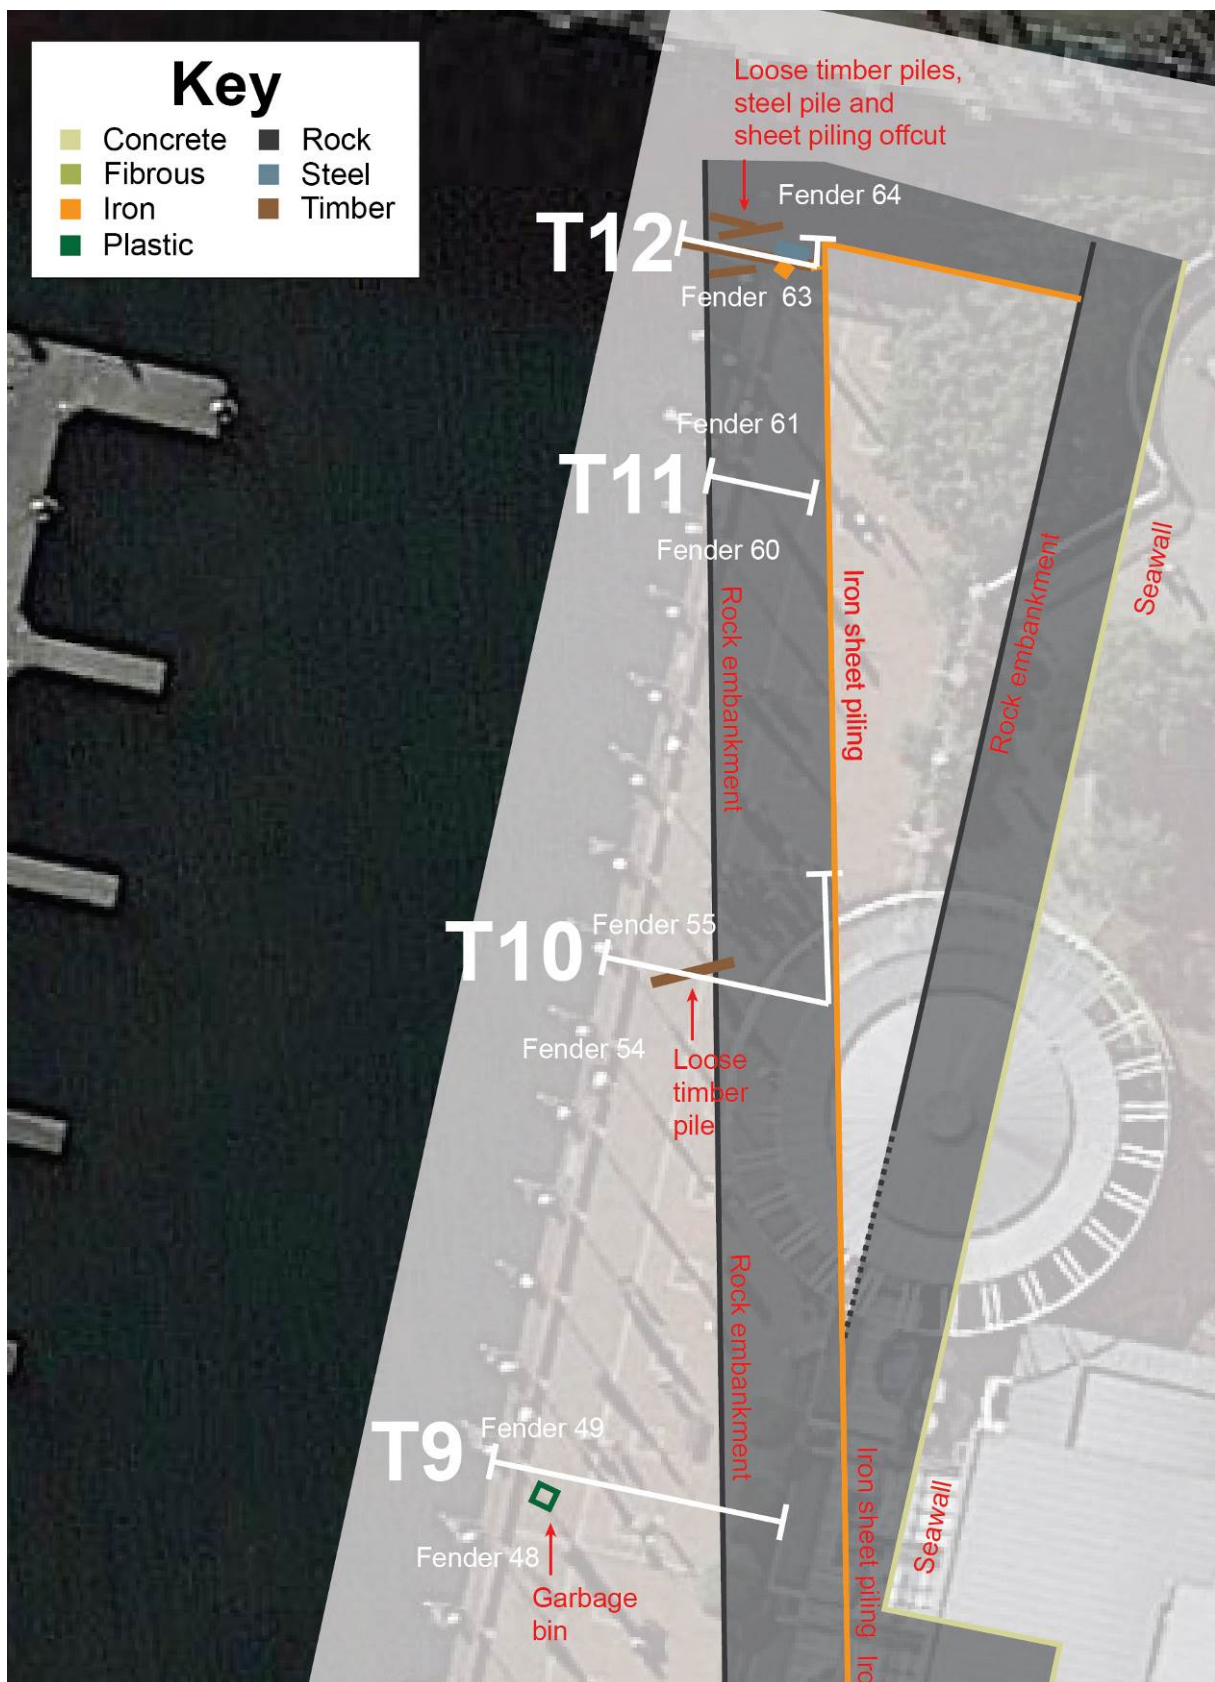
Figure 103: Overlay of site inspection findings for northern part of the site.
