## Walsh Bay Arts Precinct

## Maritime Archaeological Assessment and Management Plan

Walsh Bay  
Dawes Point  
NEW SOUTH WALES

**Walsh Bay Arts Precinct  
Maritime Archaeological Assessment  
and Management Plan**

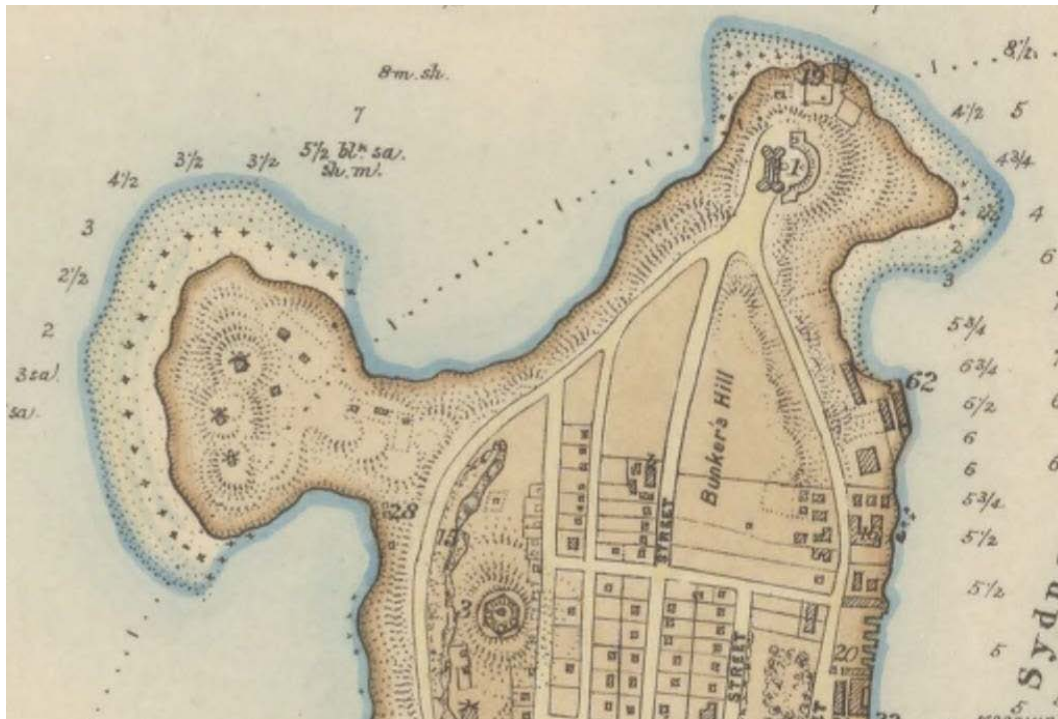
Figure 4: 1822 map of Walsh Bay and surrounds.<sup>5</sup>

As can be seen in Figure 4, a number of buildings were located in the area. The western most structures were the three mills owned by John Leighton, otherwise known as ‘Jack the Miller’.<sup>4</sup> Leighton produced flour for Sydney Town. As can be seen in 1822, there is no formal road between the Town and Miller’s Point. Although no jetties are present on the plan it would be reasonable to assume that Leighton would have shipped his finished produce via some informal landing close to the western end of Walsh Bay.

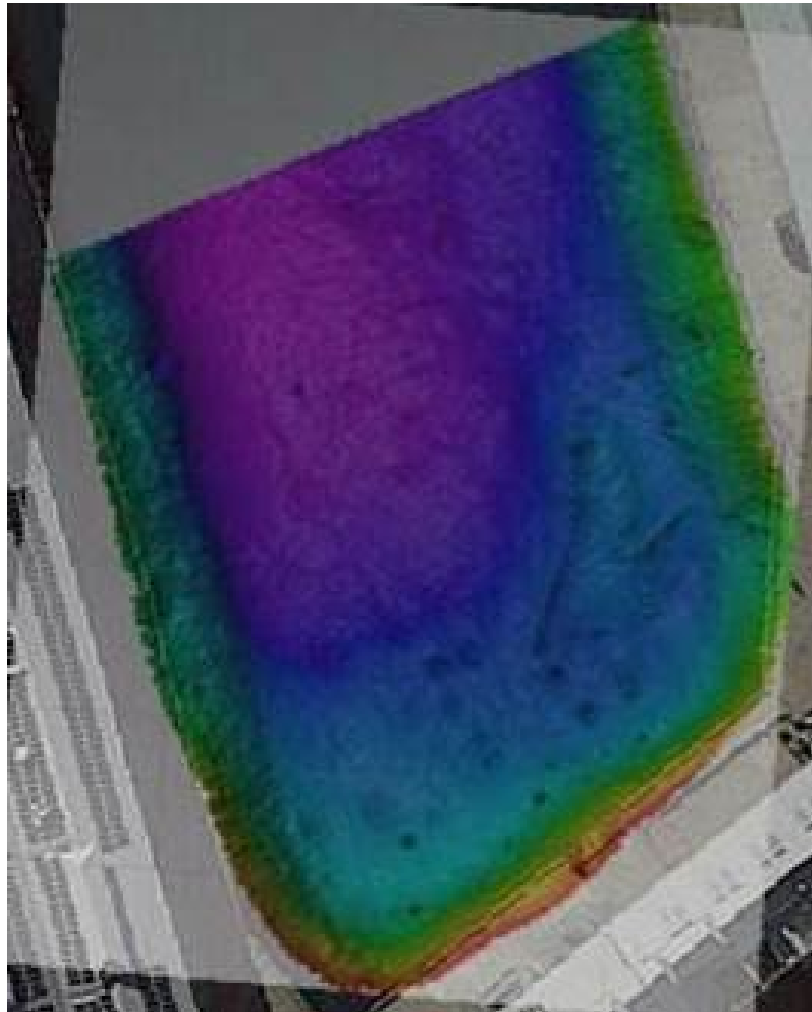
**Figure 15: Bathymetric data of the seabed between Pier 2/3 and Wharf 4/5. This information is provided courtesy of the Port Authority of New South Wales. Copyright is owned by Port Authority of New South Wales.**

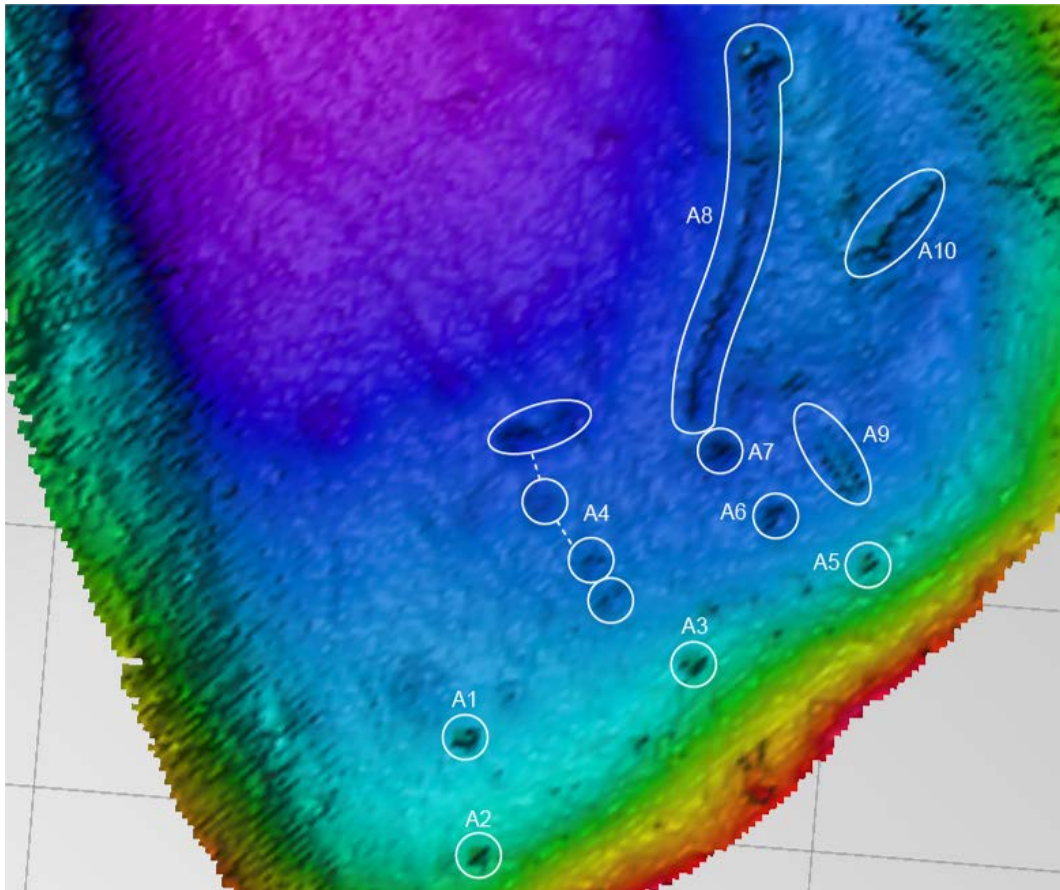
A number of anomalies are visible in the bathymetric data including a number of round features, one long (approximately 30 m long) gouge in the seabed, a shorter (4.7 m long) straight feature and areas of irregular seabed or possible debris (Figure 16 and Table 1). These anomalies may be evidence of cultural material or simply disturbances of the seabed by animals or vessels.

**Figure 16: Bathymetric data annotated with anomalies.**

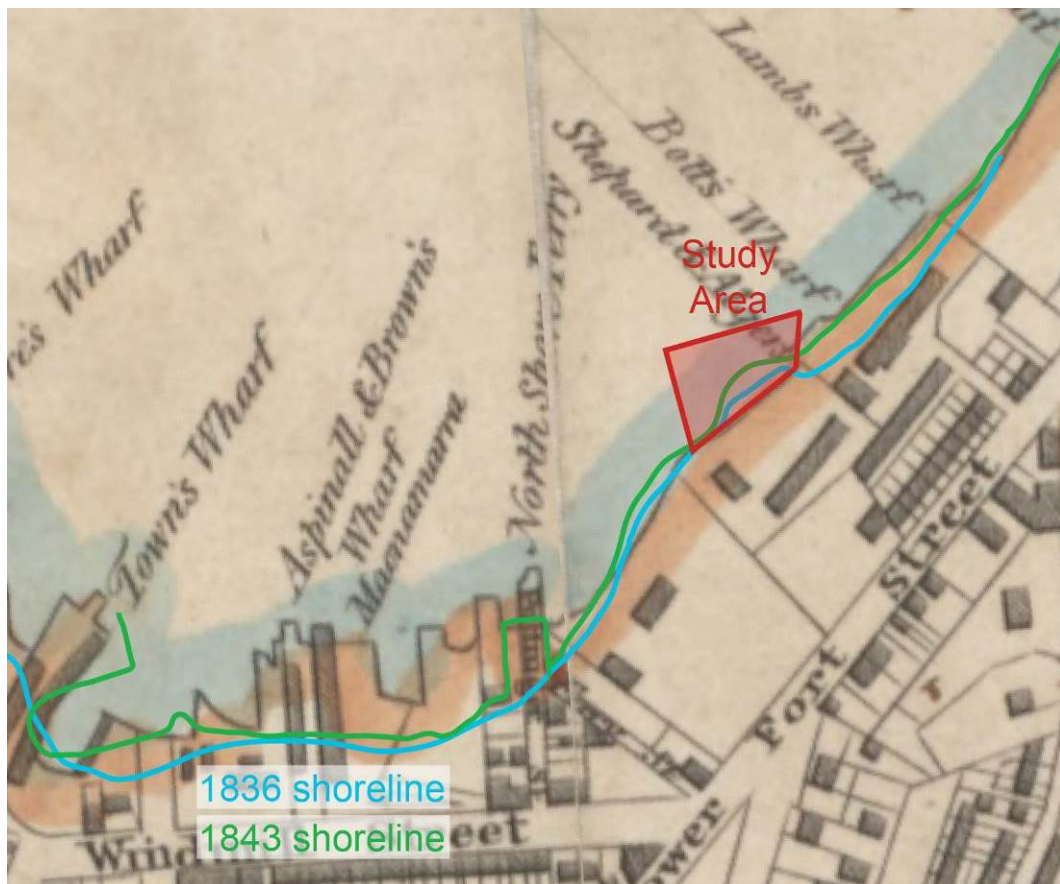
**Figure 19: Study area and the 1836 and 1843 shorelines (above) in relation to the 1854 shoreline of Walsh Bay (Figure 8).** Note that in 1854 the shoreline runs along the southern edge of the study area.

The study area overlaps what has been the edge of the coastline of Walsh Bay since the first structures in 1836. Pitman's Wharf first appears in the map from 1836 as a short but wide projection of the coast which sits entirely within the study area. This wharf is still present in the same location in the 1880 plan, although it changes owners a number of times before being bought and named by Alger's. By this time, it projects further into the harbour possibly indicating that the wharf had been re-built or lengthened in the years between (Figure 18 to Figure 21).

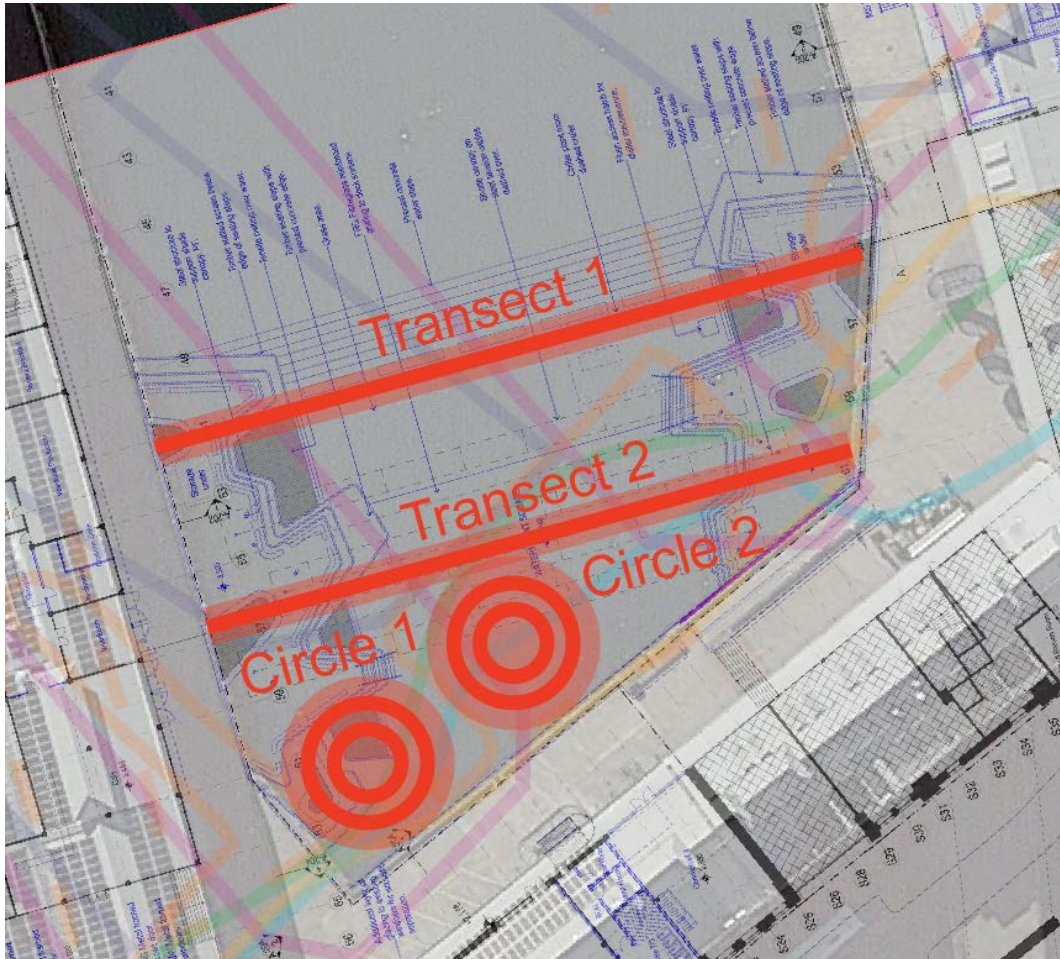
The locations of these transects were positioned within the footprint of the proposed development to cover bathymetric anomalies and the locations of previous wharfs. Video footage was used to record these transects as well as observations communicated to those on board who compiled written notes.

**Figure 23: Locations of transects and circle searches on an aerial of the study area, with previous coastlines (see Figure 22) and the proposed development area faintly shown in the background (Base image: Google Earth).**

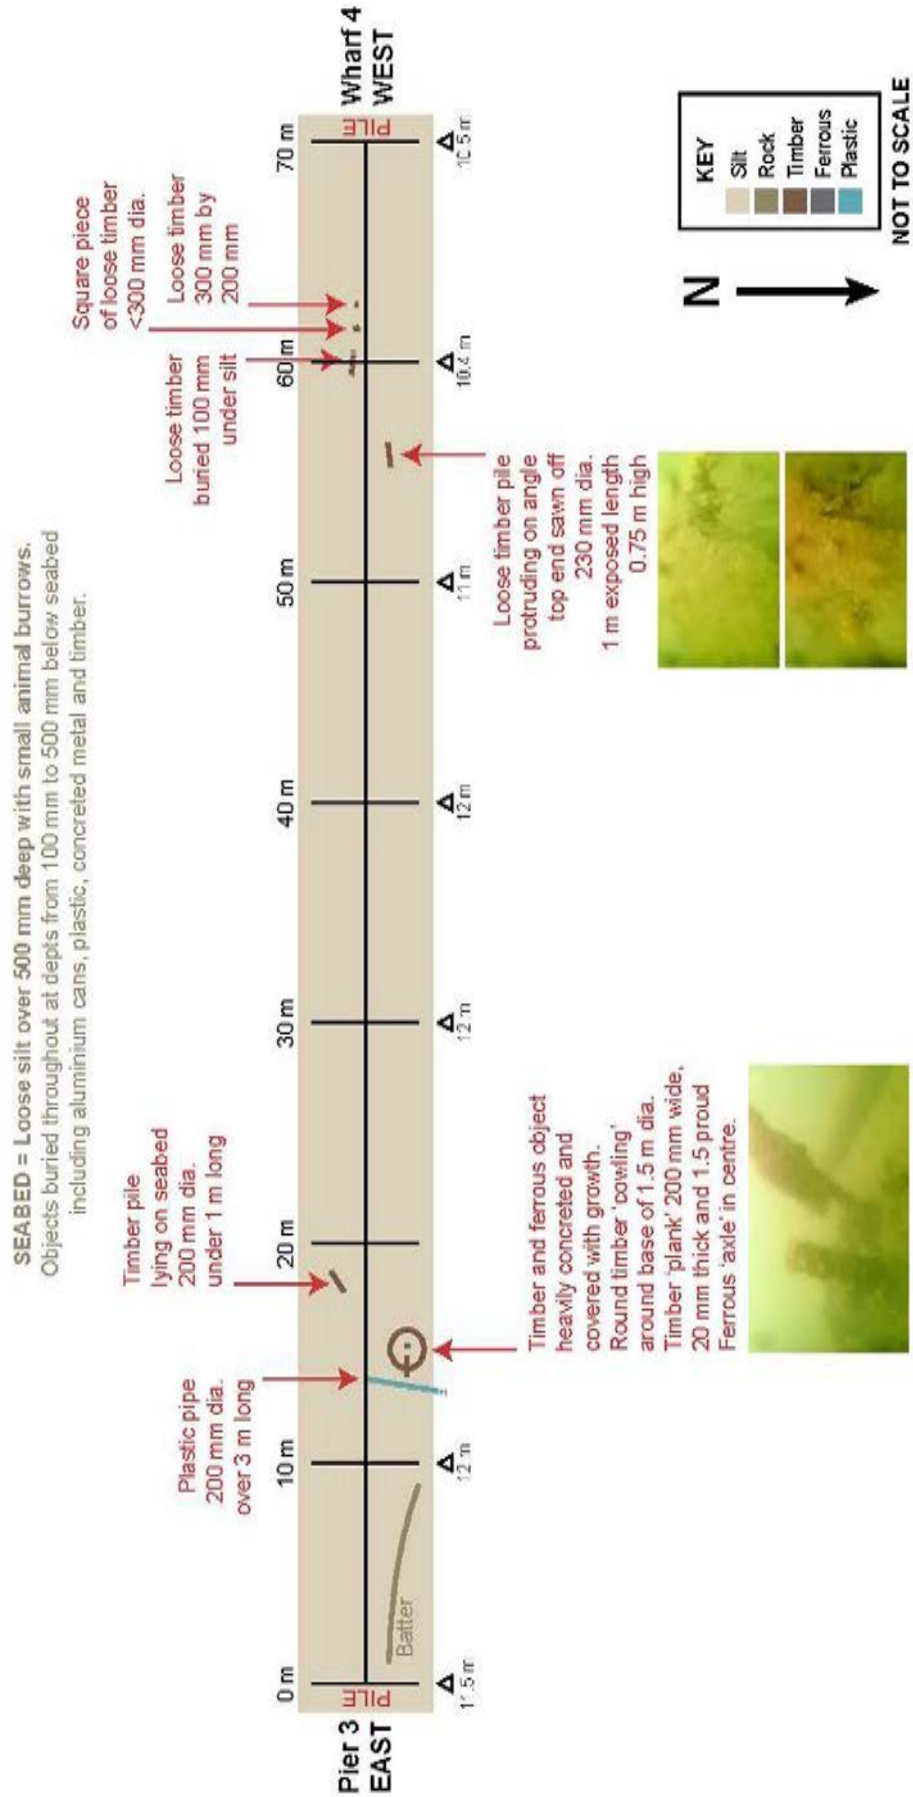
During the transect, the diver probed into the sediment with a 0.5 m range pole and/or his hand to test the depth of the loose silt and for any resistance from different sediment or buried objects. It was observed that almost 50% of these probes resulted in hitting buried items. Through touch he was able to identify glass bottles, aluminium cans and plastic items amongst the buried objects.

Features encountered along the transect included timber pieces: a loose or broken off timber pile of 200 mm diameter, another timber pile of 250 mm diameter and 750 mm exposed length with a bolt through it, a piece of loose buried timber and another two pieces of 300 mm by 200 mm timbers protruding at an angle (Figure 24). Despite these multiple timber targets, the condition of these finds indicated that they were relatively recent discards, likely present for under 50 years. A long piece of flexible plastic pipe was also identified running perpendicular to the transect line and of indeterminate length.

Figure 24: Digitised survey findings of Transect 1.

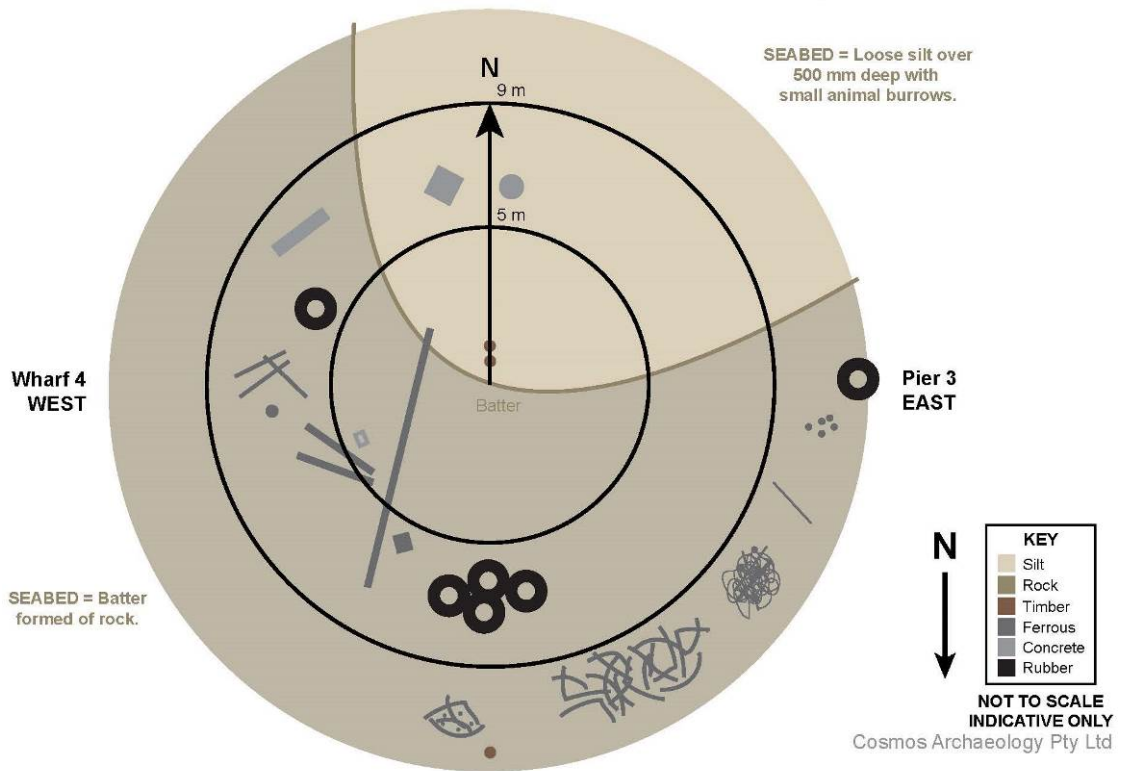
While at the centre point the diver noted a loose timber pile, approximately 160 mm above of the seabed and 120 mm in diameter, 1 m to the north of the centre point. Another pile was identified 1.4 m to the north, 540 mm proud with a width tapering from 240 mm at the top to 200 mm at the base, leaning on an angle in the seabed (Figure 26).

Beginning from the southern extremity, the diver identified four tractor tyres on the seabed 7 m from the centre point. He also noted a yellow-painted ferrous object, a 6 m long rolled steel joist (RSJ) beam, two v-shaped beams and a besser block.

Towards the west was a heavily corroded ferrous pile, tapering from 180 mm diameter to 300 mm diameter and exposed for a length of 180 mm. There was also a ferrous structure of angle irons with slight marine growth. To the north-west was a tyre, 1 m in diameter, and a slab of concrete with the exposed portion measuring 2.5 m long and 450 mm wide, sitting 800 mm proud of the seabed. The batter leading up to the piles of the apron linking Pier 3 and Wharf 4 was also identified to the north-west. Towards the north were two mooring blocks, one 1x1 m square with 600 mm above the seabed and the other of a flat topped cone shape, 600 mm at its widest, 150 mm at its narrowest and 800 mm proud of the seabed.

Nine metres to the east of the centre point was a tractor tyre, a collection of round objects that were possibly paint tins, and a metal T-shaped item measuring 2 m long covered in marine growth. Heading towards the south was a mound of metal and cable, likely flexible steel wire rope (FSWR), covering a 1.5 m by 2 m area ranging in height above the seabed of between 100 mm and 300 mm. There was also a clump of twisted ferrous items covering an area of 3.5-4 m long and 2 m wide. The batter was noted to have ferrous debris including a lattice like object.

Figure 26. Digitised survey findings of Circle Search 1.

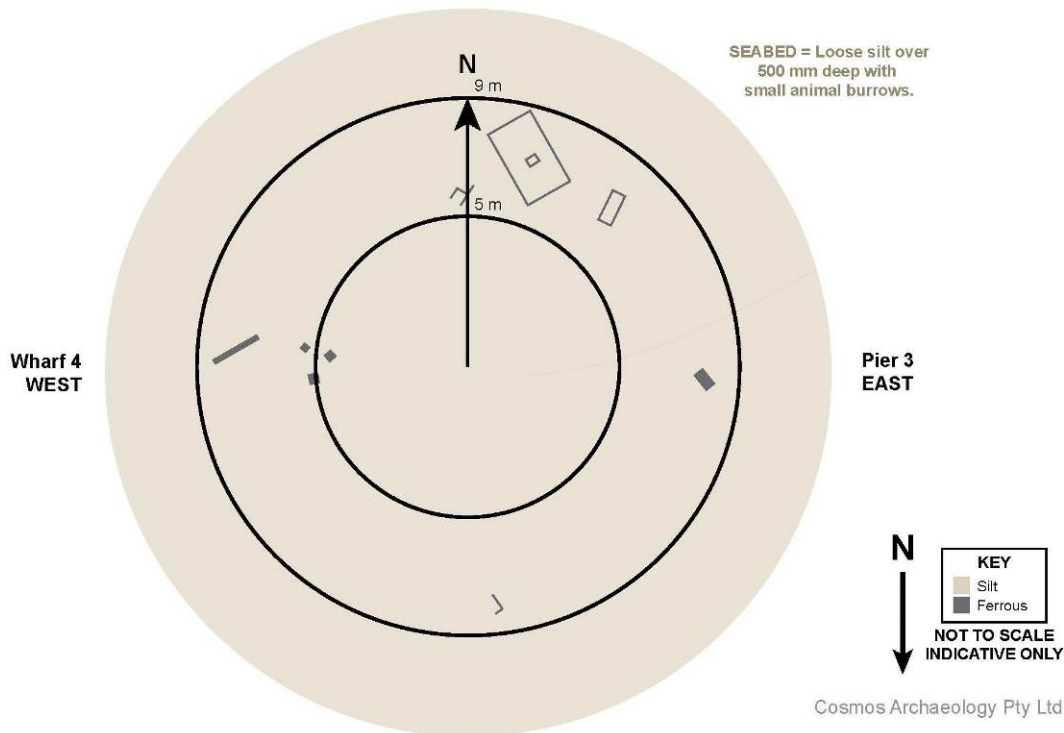
**Figure 27: Digitised survey findings of Circle Search 2.**

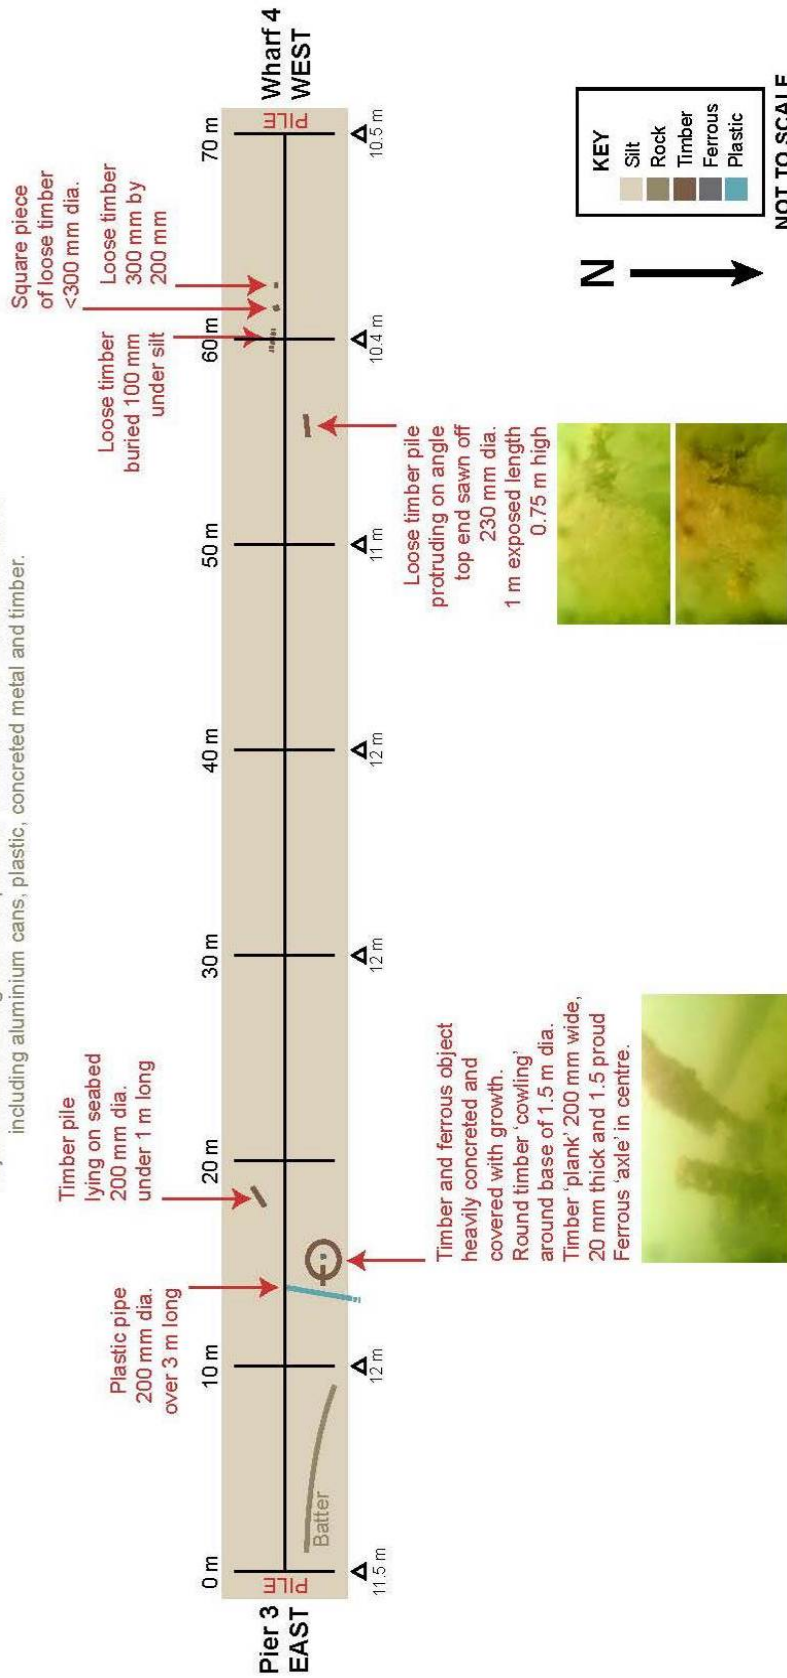
**SEABED** = Loose silt over 500 mm deep with small animal burrows.  
 Objects buried throughout at depths from 100 mm to 500 mm below seabed including aluminium cans, plastic, concreted metal and timber.

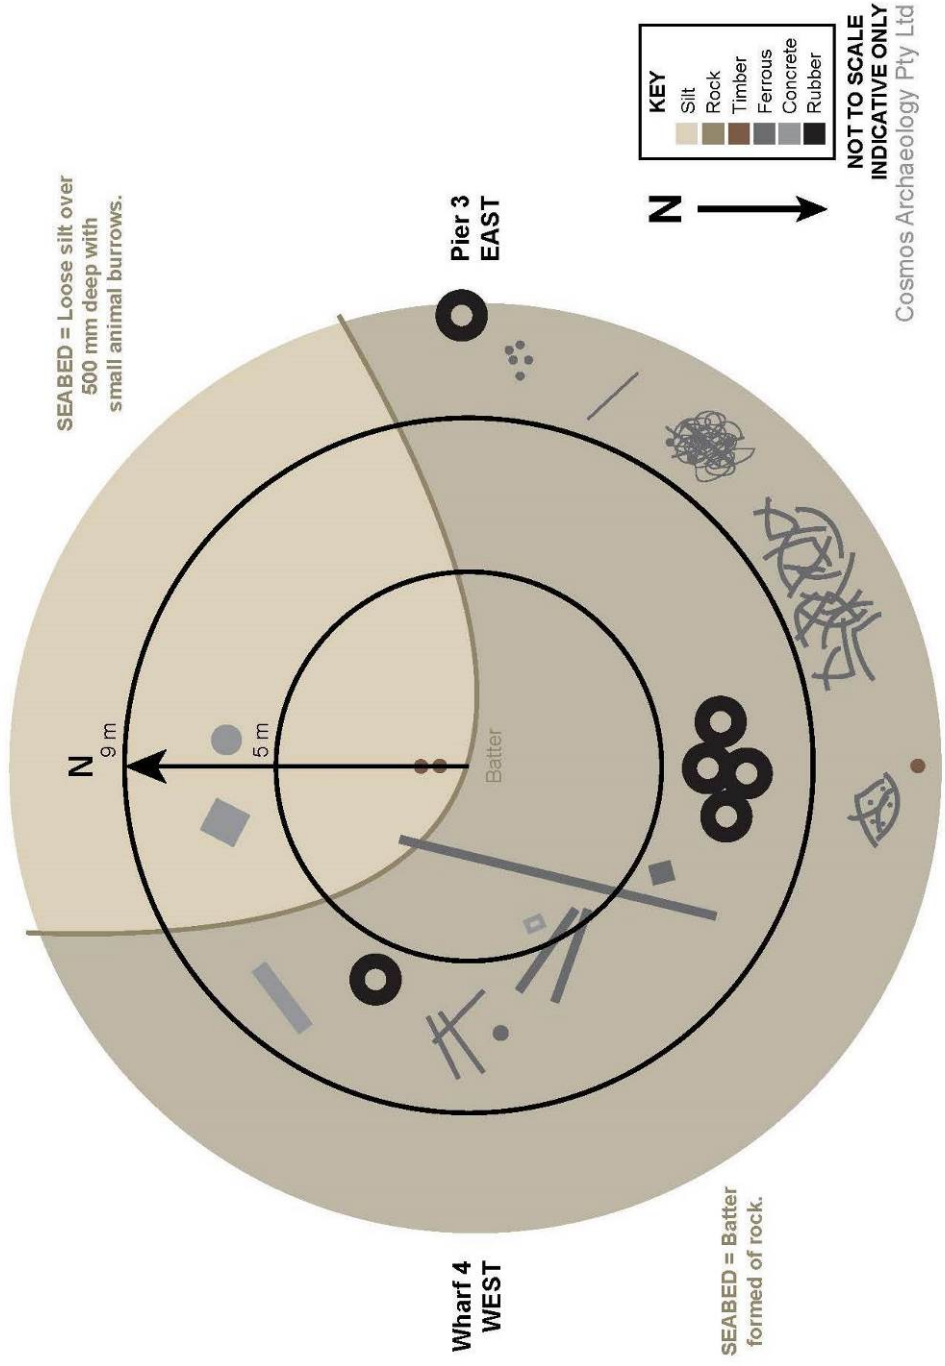
SEABED = Loose silt over  
 500 mm deep with  
 small animal burrows.
