# Interpretation Strategy for Movable Heritage Items

## Pier 2/3 Walsh Bay

Prepared for  
**Tonkin Zulaikha Greer**

November 2016

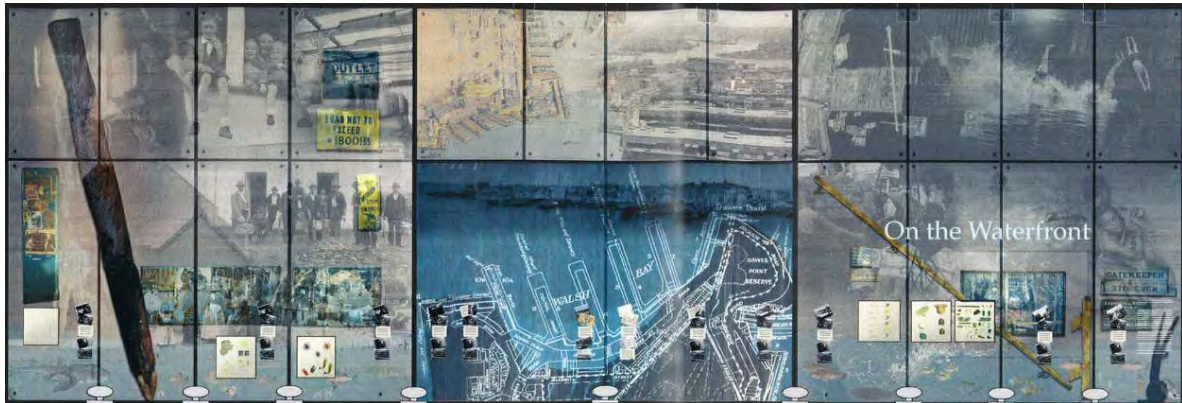
**Figure 2** Interpretation wall installed in the breezeway Wharf 2/3.

Has to be noted that an interpretation wall is installed in the breezeway of Wharf 2/3. This is a museology wall which describes the Walsh Bay Precinct Interpretation Center/Node. This area is not part of the WBAP. Any alteration or addition will require an Integrated Development Approval. The display contains a number of artefacts from the various archaeological digs at Pottinger Street and Town Place.

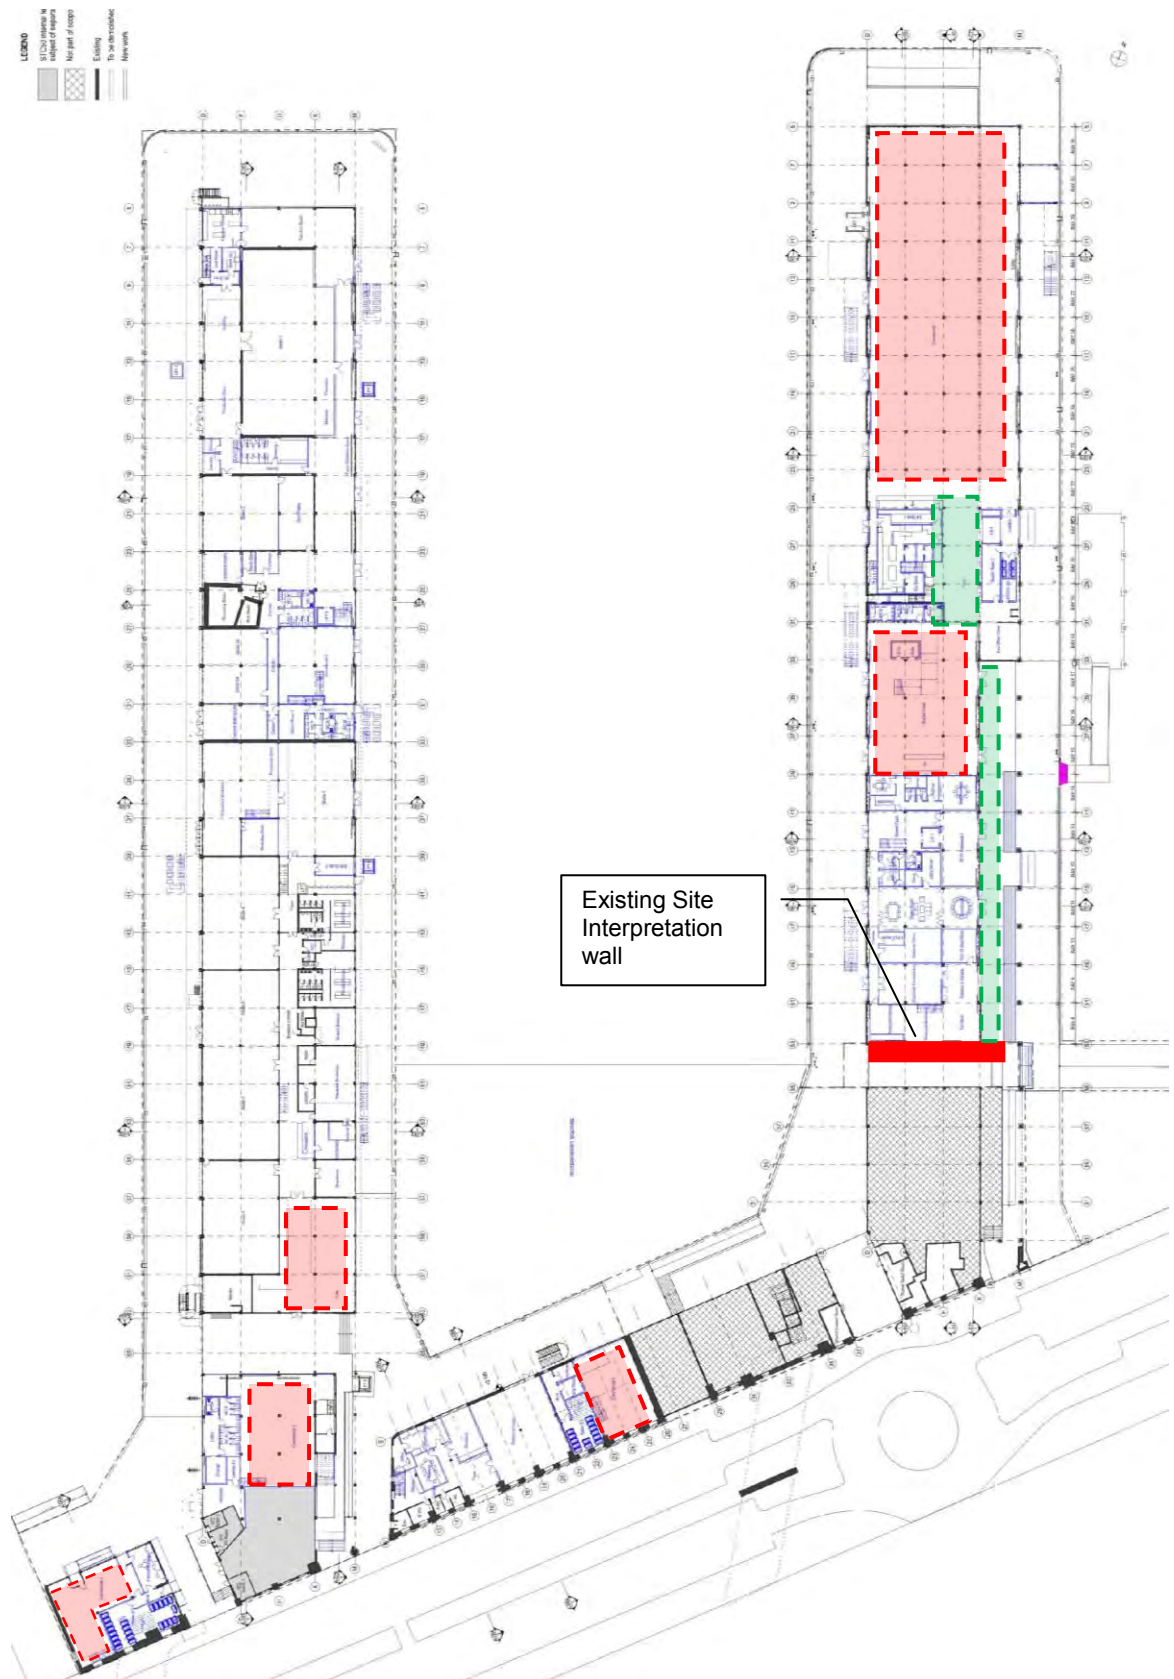
**Figure 3:** Pier 2/3 & 4/5 Ground Level. Highlighted in red suggested locations for interpretation static elements. Highlighted in green suggested locations for interpretation panels, text and historic photographs.

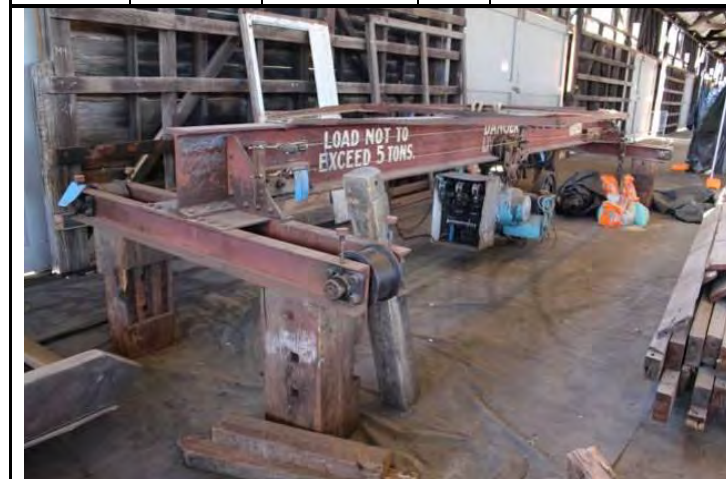
| Material | Condition (G, F, P) | Grade of Signif. | Tag No. | Description | Interpretation Strategy |
|---|---|---|---|---|---|
| Metal<br>Wood | F | Exceptional | 102 | Originally installed in the shored for Wharf 8/9, which was completed in 1912. This wharf was exclusively used throughout its operating life for the exporting of wool. It was identified as being significant at a regional level as an intact example for an electric overhead travelling crane which demonstrates the size and level of activity of the shipping trade carried out at these wharves. | Should be retained, reinstated, and interpreted at Walsh Bay Pier 2/3. |

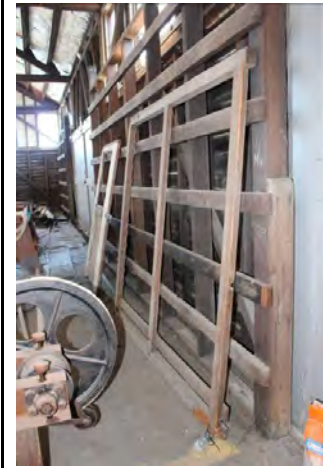
**Item No: 02**                      **Item/Fabric Name: Wooden frame**

| Material | Condition (G, F, P) | Grade of Signif. | Tag No. | Description | Interpretation Strategy |
|---|---|---|---|---|---|
| Wood | F | Low | | Wooden frame | A representative example should be stored as part of the Walsh Bay Moveable Heritage Collection - (offsite). |

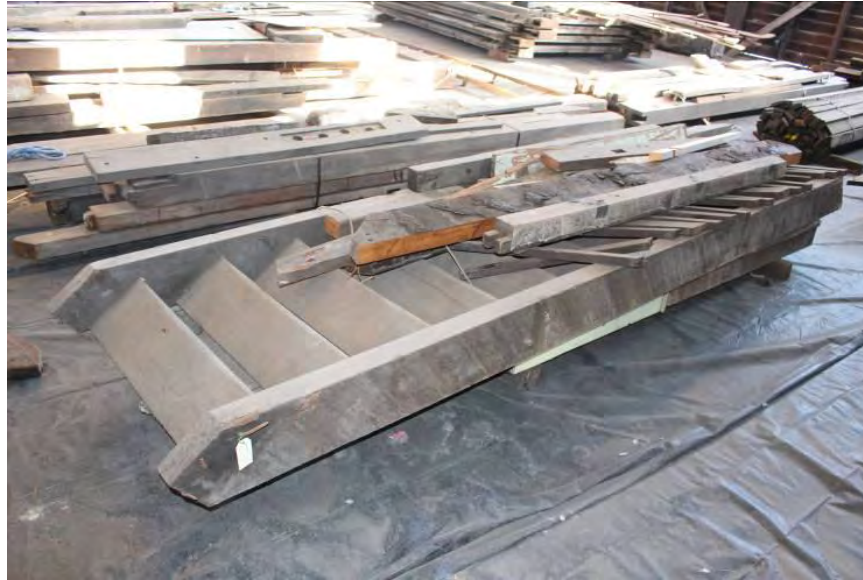
**Item No: 05**

| Material | Condition (G, F, P) | Grade of Signif. | Tag No. | Description | Interpretation Strategy |
|---|---|---|---|---|---|
| Wood<br>Metal | P | Low | 93 | Wooden planks and metal round poles | A representative example should be stored as part of the Walsh Bay Moveable Heritage Collection - (offsite). |

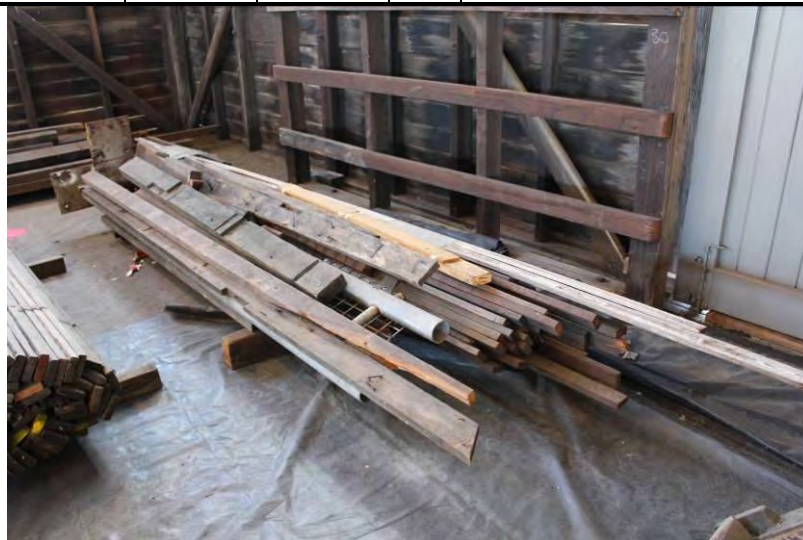
**Item No:** 06      **Item/Fabric Name:** Floor boards

| Material | Condition (G, F, P) | Grade of Signif. | Tag No. | Description | Interpretation Strategy |
|---|---|---|---|---|---|
| Wood | F | Low | 94 | Floor boards | A representative example should be stored as part of the Walsh Bay Moveable Heritage Collection - (offsite). |

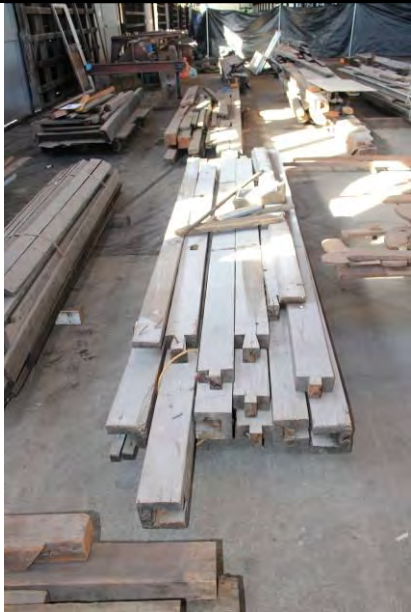
**Item No:** 07      **Item/Fabric Name:** Wooden planks with dovetail halving joints

| Material | Condition (G, F, P) | Grade of Signif. | Tag No. | Description | Interpretation Strategy |
|---|---|---|---|---|---|
| Wood | F | Low | | Wooden planks with dovetail halving joints | A representative example should be stored as part of the Walsh Bay Moveable Heritage Collection - (offsite). |

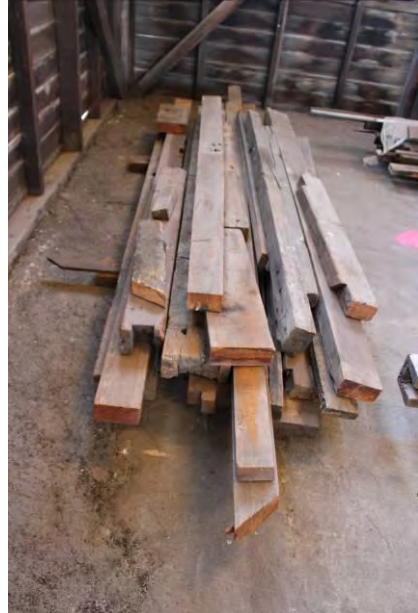
**Item No:** 08

| Material | Condition (G, F, P) | Grade of Signif. | Tag No. | Description | Interpretation Strategy |
|---|---|---|---|---|---|
| Wood | P | Low | | Wooden planks with mortise joints | A representative example should be stored as part of the Walsh Bay Moveable Heritage Collection - (offsite). |

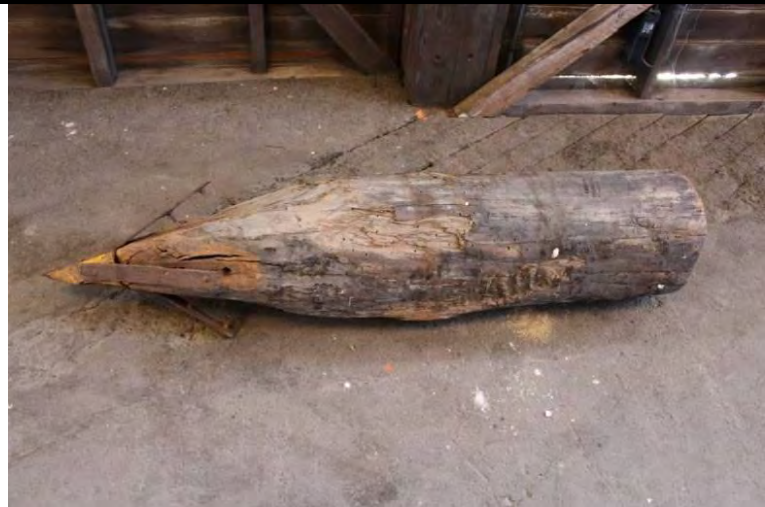
| Material | Condition (G, F, P) | Grade of Signif. | Tag No. | Description | Interpretation Strategy |
|---|---|---|---|---|---|
| Wood | P | Moderate | 100 | Wooden pile fragment with a metal head | Consider for interpretation and retain as part of a collection of Walsh Bay movable Heritage. |

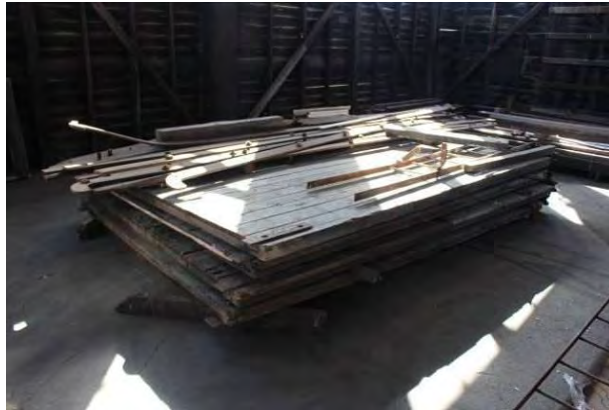
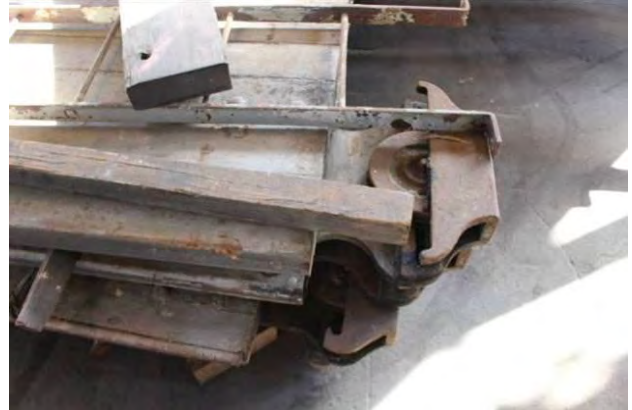
| Material | Condition (G, F, P) | Grade of Signif. | Tag No. | Description | Interpretation Strategy |
|---|---|---|---|---|---|
| Wood<br>Metal | F | Low | 104 | Wooden doors with reinforcement straps | A representative example should be stored as part of the Walsh Bay Moveable Heritage Collection - (offsite). |

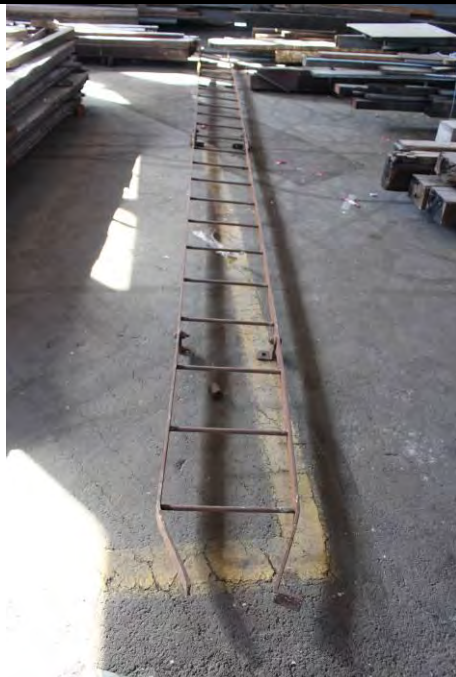
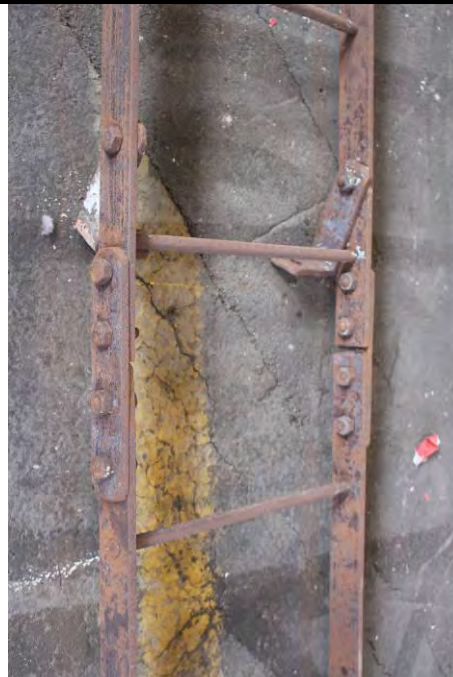
| Material | Condition (G, F, P) | Grade of Signif. | Tag No. | Description | Interpretation Strategy |
|---|---|---|---|---|---|
| Metal | F | Low | 108 | Steel ladder | A representative example should be stored as part of the Walsh Bay Moveable Heritage Collection - (offsite). |

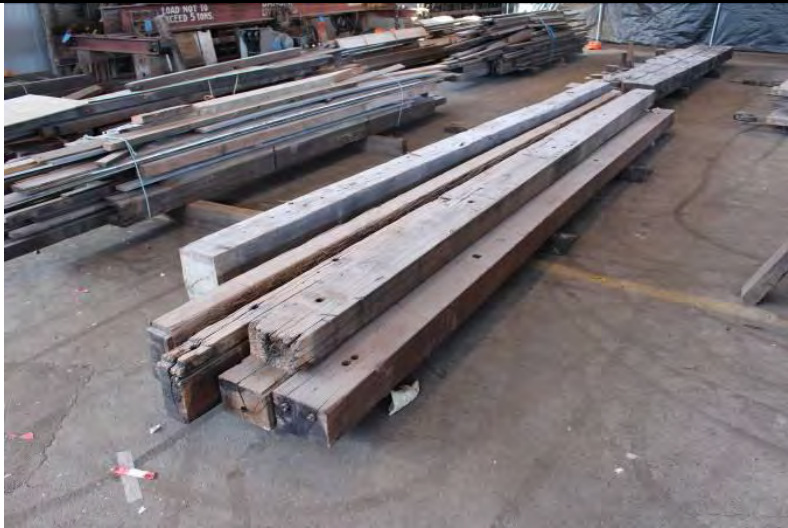
| Material | Condition (G, F, P) | Grade of Signif. | Tag No. | Description | Interpretation Strategy |
|---|---|---|---|---|---|
| Wood | P | Low | | Overhead rail posts | A representative example should be stored as part of the Walsh Bay Moveable Heritage Collection - (offsite). |

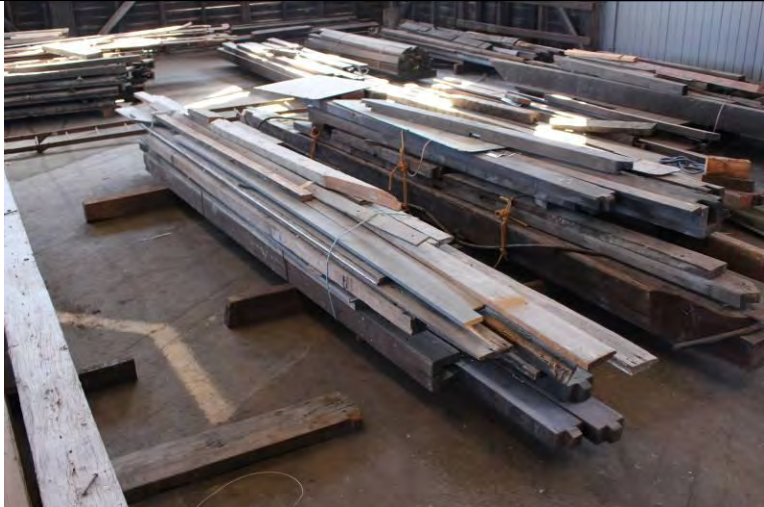
| Material | Condition (G, F, P) | Grade of Signif. | Tag No. | Description | Interpretation Strategy |
|---|---|---|---|---|---|
| Wood | P | Low | | Wooden planks with mortise joints | A representative example should be stored as part of the Walsh Bay Moveable Heritage Collection - (offsite). |

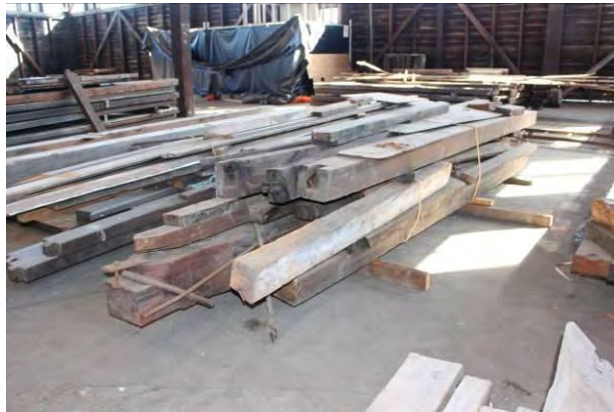
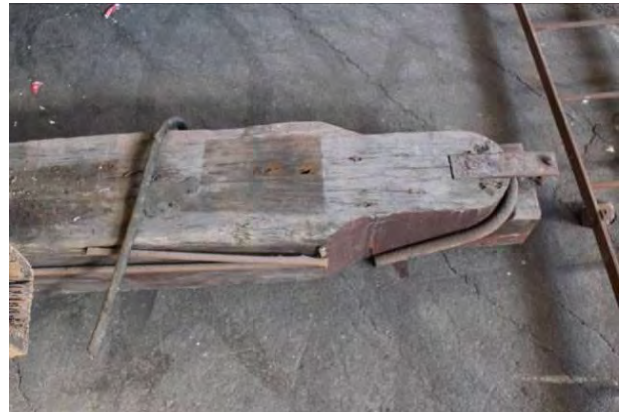
| Material | Condition (G, F, P) | Grade of Signif. | Tag No. | Description | Interpretation Strategy |
|---|---|---|---|---|---|
| Wood<br>Metal | P | Low | 113 | Wooden planks and posts | A representative example should be stored as part of the Walsh Bay Moveable Heritage Collection - (offsite). |

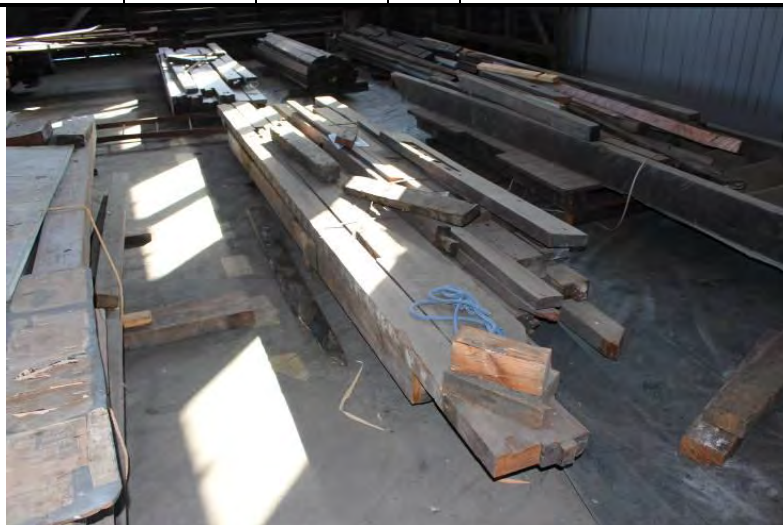
**Item No: 15**                      **Item/Fabric Name:** Wooden planks

| Material | Condition (G, F, P) | Grade of Signif. | Tag No. | Description | Interpretation Strategy |
|---|---|---|---|---|---|
| Wood | P | Low | | Wooden planks | A representative example should be stored as part of the Walsh Bay Moveable Heritage Collection - (offsite). |

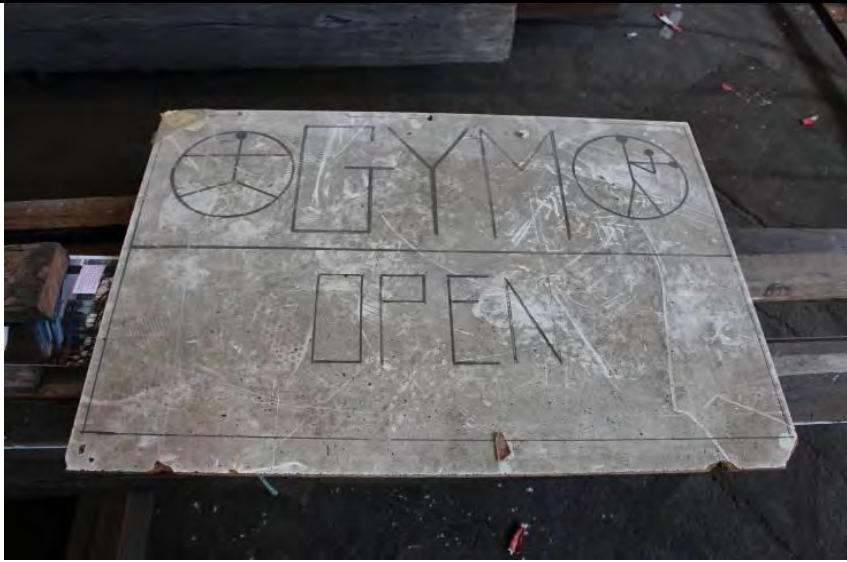
**Item No: 16**

| Material | Condition (G, F, P) | Grade of Signif. | Tag No. | Description | Interpretation Strategy |
|---|---|---|---|---|---|
| Plywood | F | Low | 120 | Wooden gym sign<br>"Gym open" | A representative example should be stored as part of the Walsh Bay Moveable Heritage Collection - (offsite). |

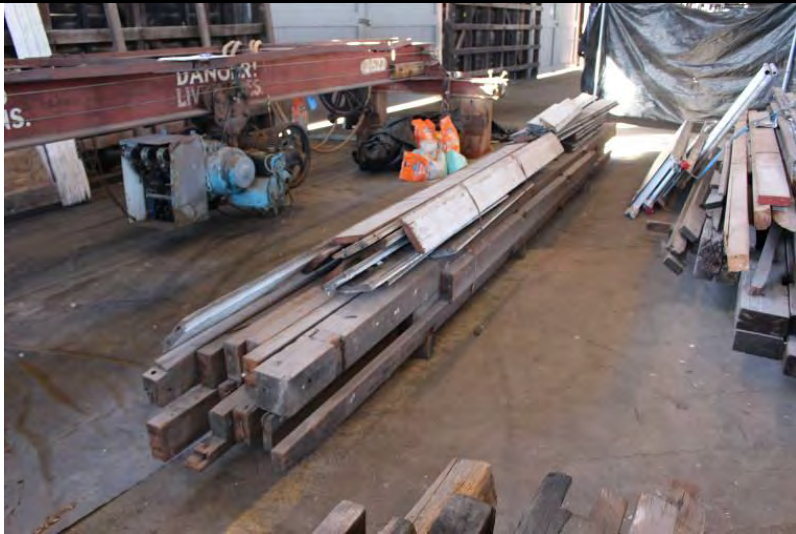
**Item No: 17**

| Material | Condition (G, F, P) | Grade of Signif. | Tag No. | Description | Interpretation Strategy |
|---|---|---|---|---|---|
| Wood | F | Low | | Wooden planks and posts | A representative example should be stored as part of the Walsh Bay Moveable Heritage Collection - (offsite). |

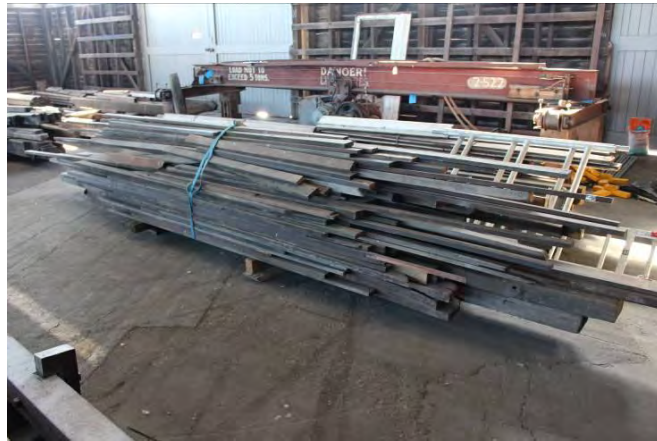
**Item No: 18** **Item/Fabric Name: Timber planks**

| Material | Condition (G, F, P) | Grade of Signif. | Tag No. | Description | Interpretation Strategy |
|---|---|---|---|---|---|
| Wood | F | Low | | Timber planks | A representative example should be stored as part of the Walsh Bay Moveable Heritage Collection - (offsite). |

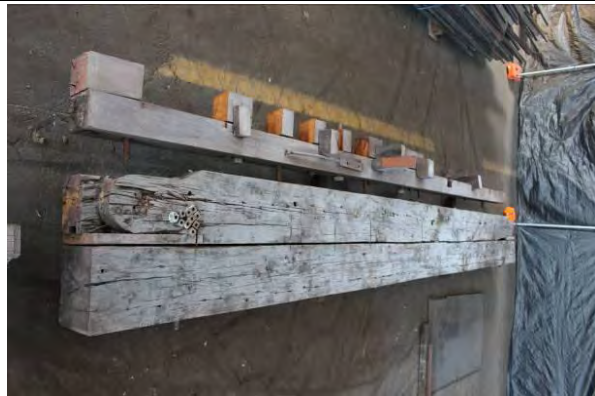
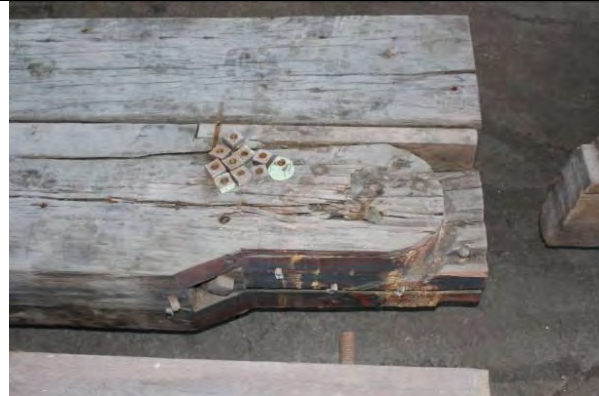
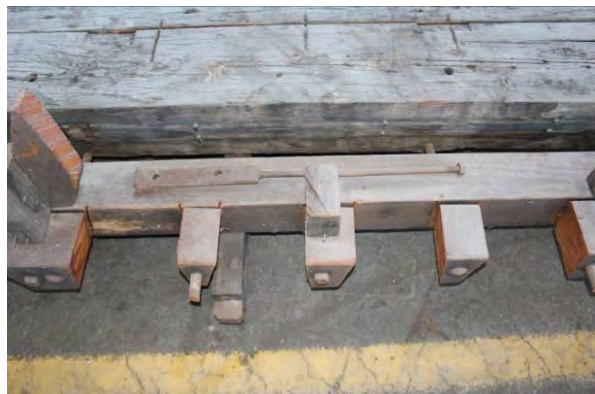
**Item No: 19** **Item/Fabric Name: Wooden element**

| Material | Condition (G, F, P) | Grade of Signif. | Tag No. | Description | Interpretation Strategy |
|---|---|---|---|---|---|
| Wood<br>Metal | P | Low | | Wooden element | A representative example should be stored as part of the Walsh Bay Moveable Heritage Collection - (offsite). |

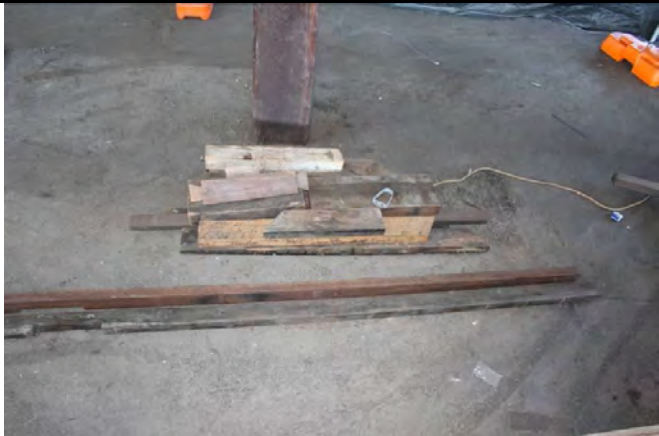
**Item No: 20**                      **Item/Fabric Name: Timber pieces**

| Material | Condition (G, F, P) | Grade of Signif. | Tag No. | Description | Interpretation Strategy |
|---|---|---|---|---|---|
| Wood | P | Low | | Timber pieces | Nil. No interpretive use. |

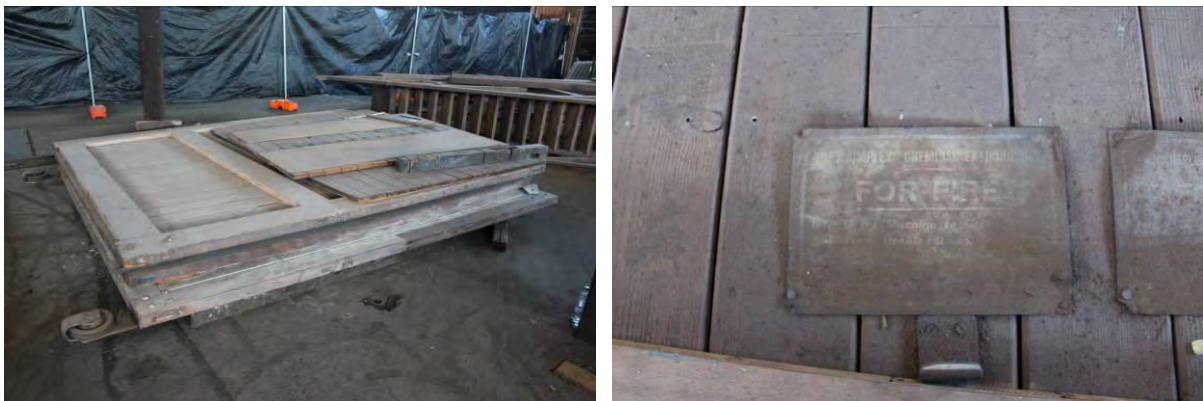
**Item No: 21**                      **Item/Fabric Name: Wooden cargo doors**

| Material | Condition (G, F, P) | Grade of Signif. | Tag No. | Description | Interpretation Strategy |
|---|---|---|---|---|---|
| Wood<br>Metal | F | Low | | Wooden cargo doors | A representative example should be stored as part of the Walsh Bay Moveable Heritage Collection - (offsite). |

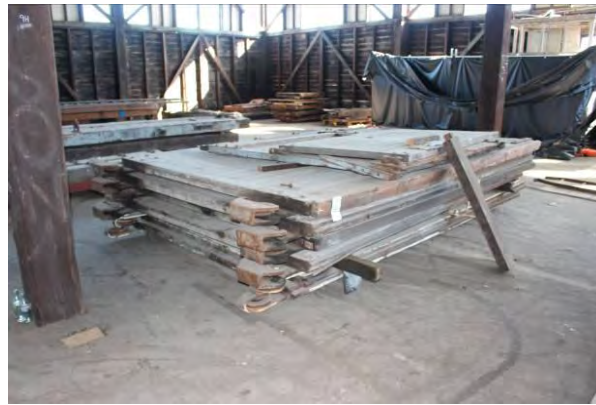
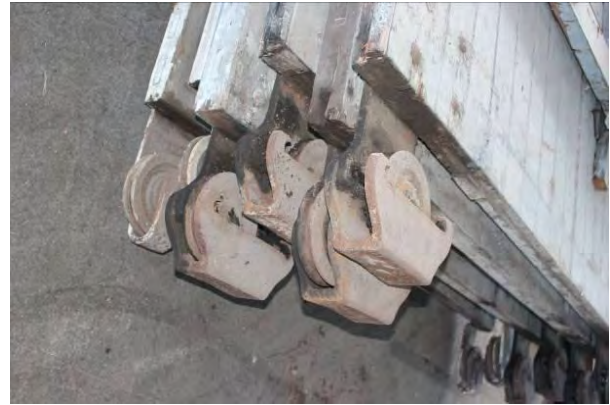
**Item No: 22**

| Material | Condition (G, F, P) | Grade of Signif. | Tag No. | Description | Interpretation Strategy |
|---|---|---|---|---|---|
| Wood<br>Metal | F | Low | | 4 wooden cargo doors from pier 6&7 | A representative example should be stored as part of the Walsh Bay Moveable Heritage Collection - (offsite). |

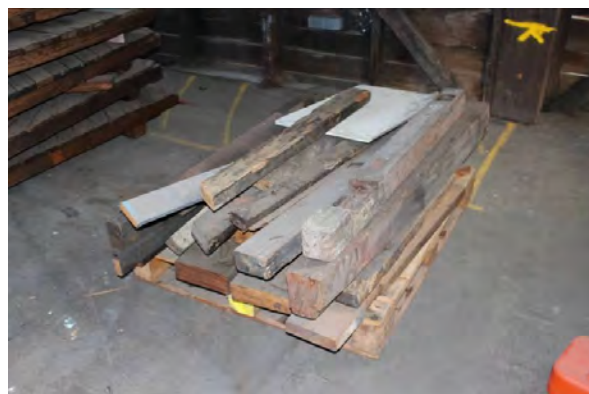
**Item No: 23**

| Material | Condition (G, F, P) | Grade of Signif. | Tag No. | Description | Interpretation Strategy |
|---|---|---|---|---|---|
| Wood | P | Low | 91 | Timber planks | A representative example should be stored as part of the Walsh Bay Moveable Heritage Collection - (offsite). |

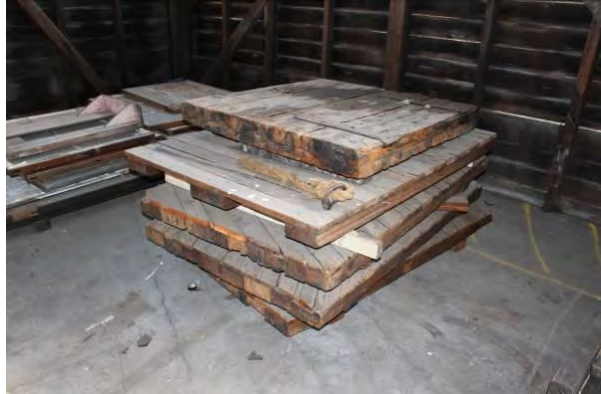
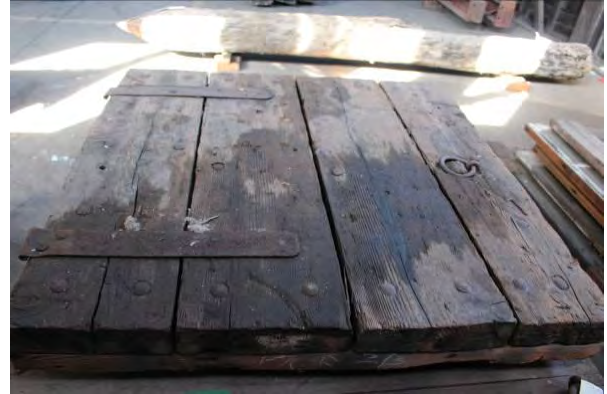
**Item No: 24**                      **Item/Fabric Name: Trap doors**

| Material | Condition (G, F, P) | Grade of Signif. | Tag No. | Description | Interpretation Strategy |
|---|---|---|---|---|---|
| Wood<br>Metal | F | Low | 105 | Timber trap doors | A representative example should be stored as part of the Walsh Bay Moveable Heritage Collection - (offsite). |

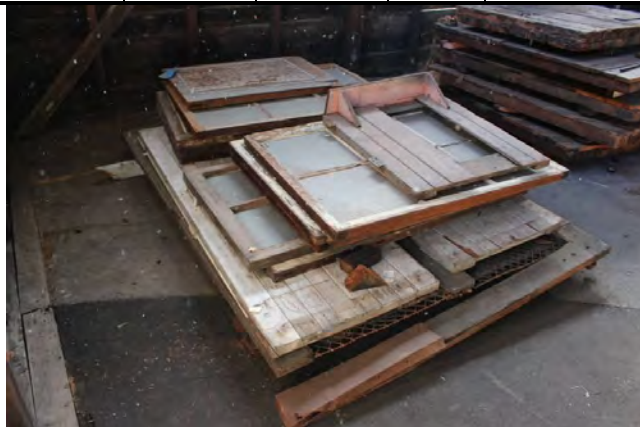
**Item No: 25**                      **Item/Fabric Name: Windows Pier 6/7**

| Material | Condition (G, F, P) | Grade of Signif. | Tag No. | Description | Interpretation Strategy |
|---|---|---|---|---|---|
| Wood<br>Metal<br>Glass | P | Low | 110-<br>111-<br>115 | Timber framed glass windows | A representative example should be stored as part of the Walsh Bay Moveable Heritage Collection - (offsite). |

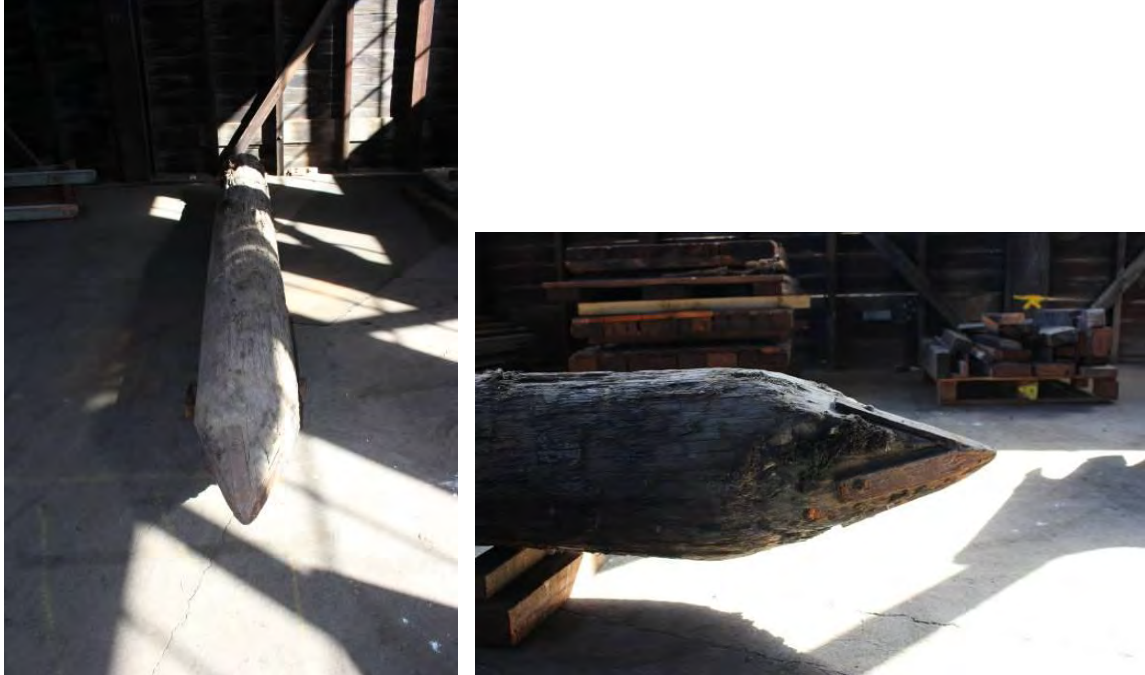
| Material | Condition (G, F, P) | Grade of Signif. | Tag No. | Description | Interpretation Strategy |
|---|---|---|---|---|---|
| Wood<br>Metal | F | Moderate | | Wooden pile with steel head | Consider for interpretation and retain as part of a collection of Walsh Bay movable Heritage. |

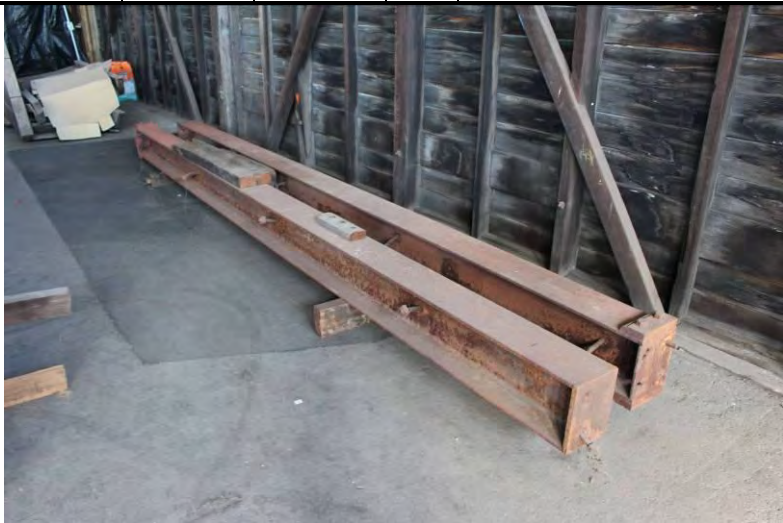
| Material | Condition (G, F, P) | Grade of Signif. | Tag No. | Description | Interpretation Strategy |
|---|---|---|---|---|---|
| Metal | F | Low | 114 | Metal beams | A representative example should be stored as part of the Walsh Bay Moveable Heritage Collection - (offsite). |

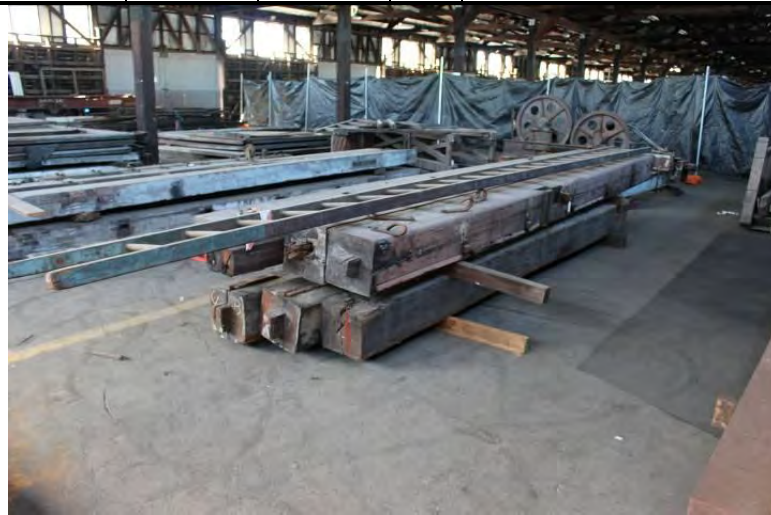
| Material | Condition (G, F, P) | Grade of Signif. | Tag No. | Description | Interpretation Strategy |
|---|---|---|---|---|---|
| Wood | F | Moderate | 119 | Timber columns with mortise joints | Consider for interpretation and retain as part of a collection of Walsh Bay movable Heritage. |

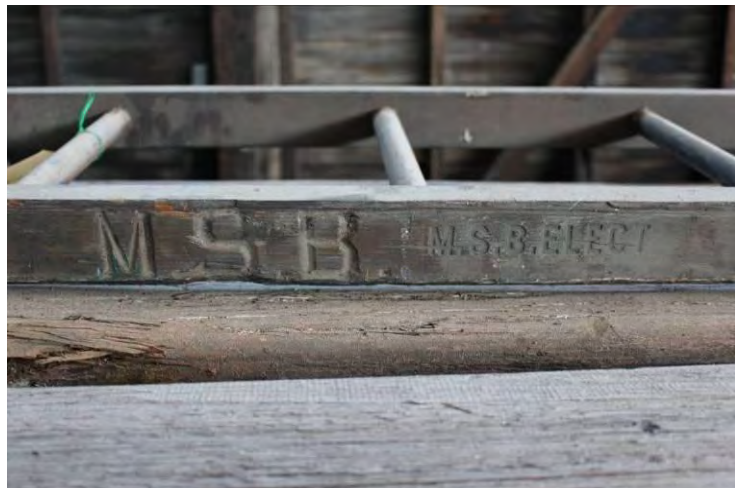
| Material | Condition (G, F, P) | Grade of Signif. | Tag No. | Description | Interpretation Strategy |
|---|---|---|---|---|---|
| Wood | F | Moderate | 116 | Timber ladder | Consider for interpretation and retain as part of a collection of Walsh Bay movable Heritage. |

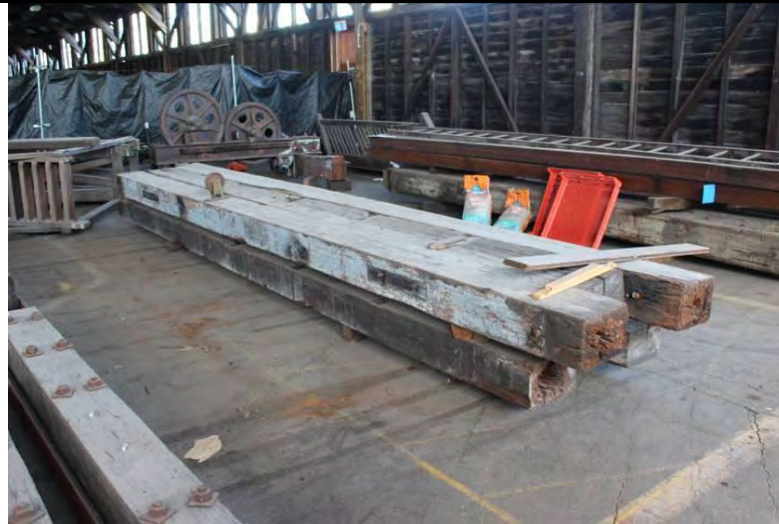
| Material | Condition (G, F, P) | Grade of Signif. | Tag No. | Description | Interpretation Strategy |
|---|---|---|---|---|---|
| Wood | P | Moderate | 119 | Timber posts | Consider for interpretation and retain as part of a collection of Walsh Bay movable Heritage. |

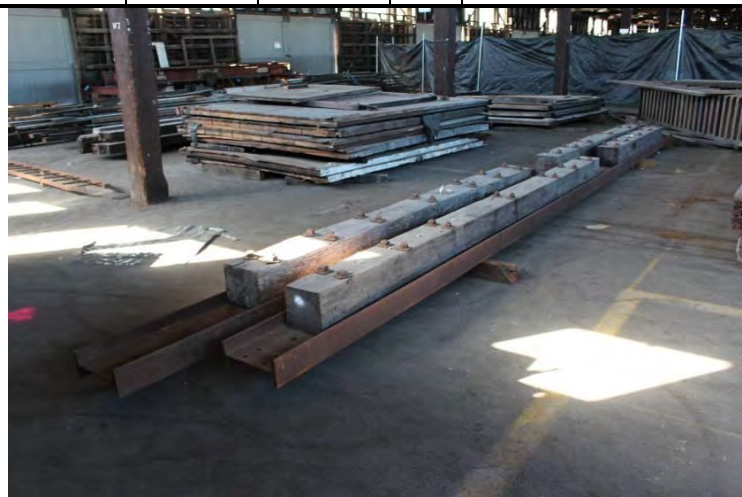
| Material | Condition (G, F, P) | Grade of Signif. | Tag No. | Description | Interpretation Strategy |
|---|---|---|---|---|---|
| Wood<br>Metal | F | Moderate | 117 | Under slung raw | Consider for interpretation and retain as part of a collection of Walsh Bay movable Heritage. |

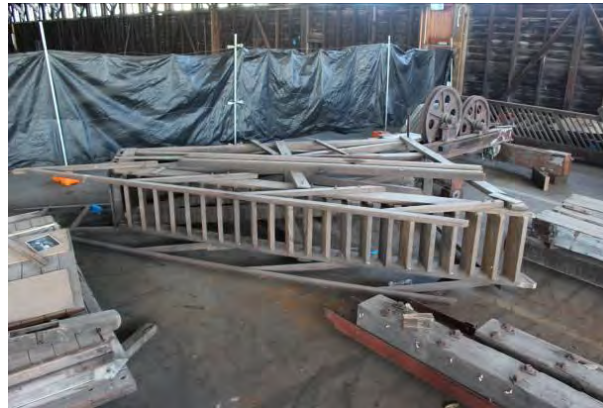
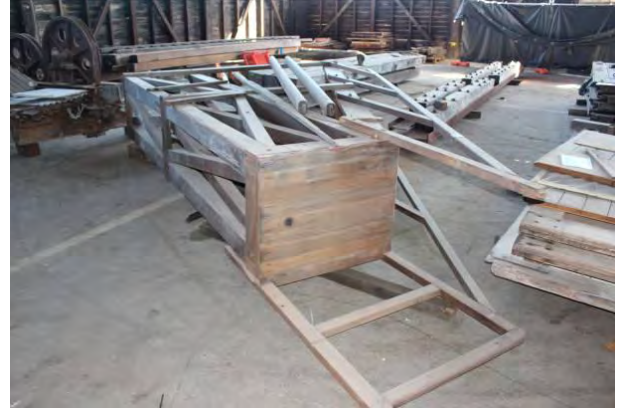
| Material | Condition (G, F, P) | Grade of Signif. | Tag No. | Description | Interpretation Strategy |
|---|---|---|---|---|---|
| Wood | F | High | 96 | Timber Stairs with landing | Should be retained, reinstated, and interpreted at Walsh Bay Pier 2/3. |

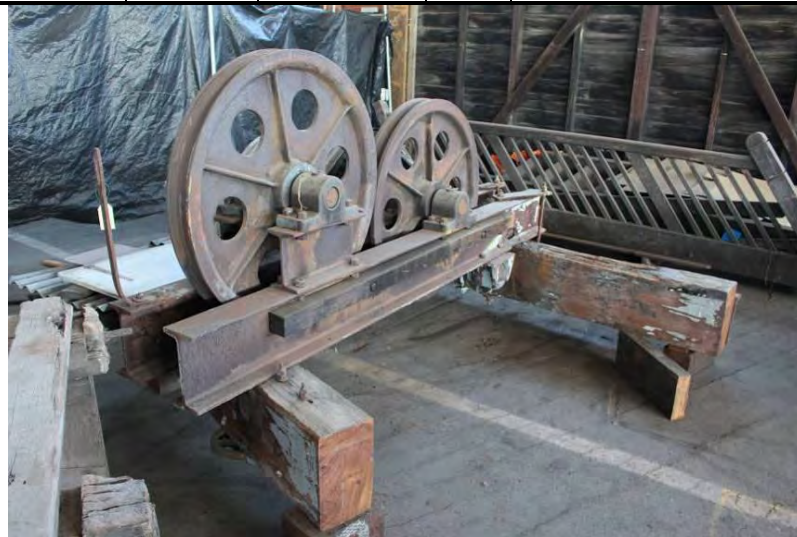
| Material | Condition (G, F, P) | Grade of Signif. | Tag No. | Description | Interpretation Strategy |
|---|---|---|---|---|---|
| Wood<br>Metal | F | Exceptional | 97 | Overhead sheaths for a good Hoist | Should be retained, reinstated, and interpreted at Walsh Bay Pier 2/3. |

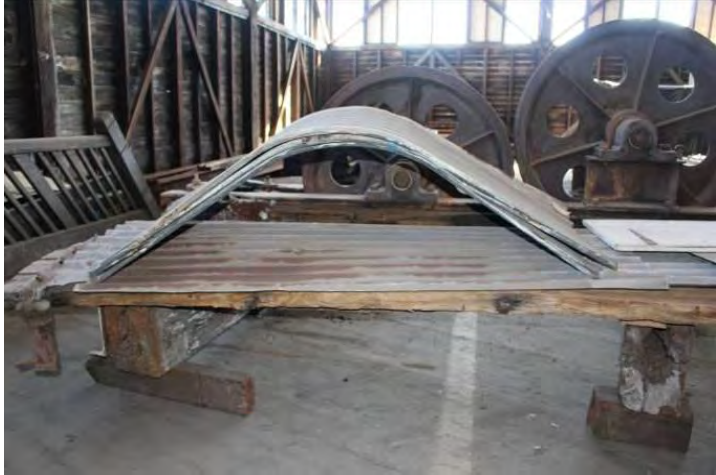
| Material | Condition (G, F, P) | Grade of Signif. | Tag No. | Description | Interpretation Strategy |
|---|---|---|---|---|---|
| Metal | F | Exceptional | 98 | Corrugated cast iron sheets | Should be retained, reinstated, and interpreted at Walsh Bay Pier 2/3. |

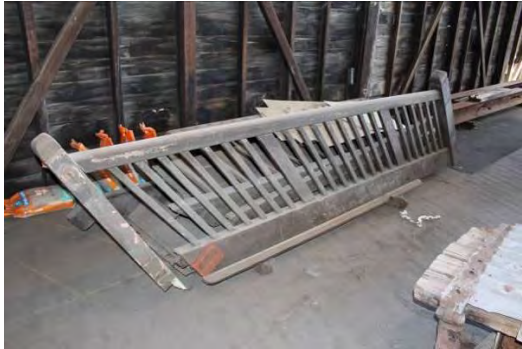
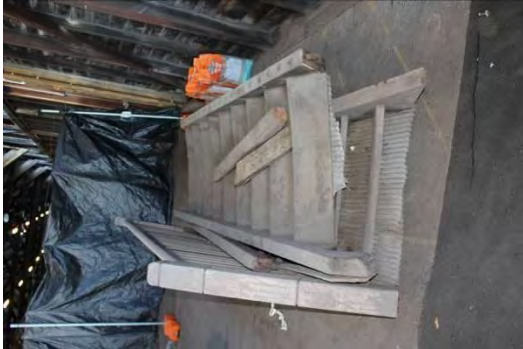
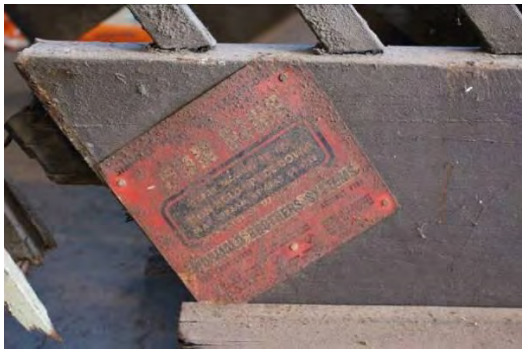
| Material | Condition (G, F, P) | Grade of Signif. | Tag No. | Description | Interpretation Strategy |
|---|---|---|---|---|---|
| Wood | P | Low | | Wooden stairs with handrail | A representative example should be stored as part of the Walsh Bay Moveable Heritage Collection - (offsite). |

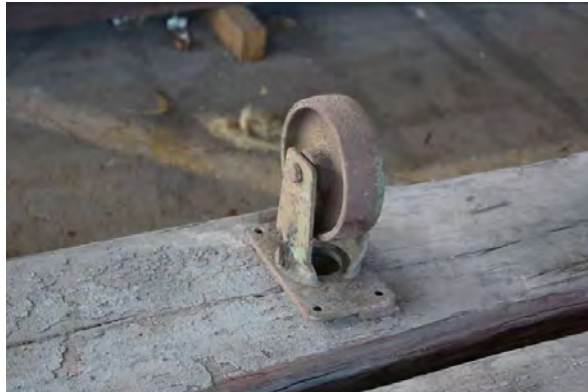
**Item No: 36**                      **Item/Fabric Name: Metal wheel**

| Material | Condition (G, F, P) | Grade of Signif. | Tag No. | Description | Interpretation Strategy |
|---|---|---|---|---|---|
| Metal | F | Low | | Metal wheel | A representative example should be stored as part of the Walsh Bay Moveable Heritage Collection - (offsite). |

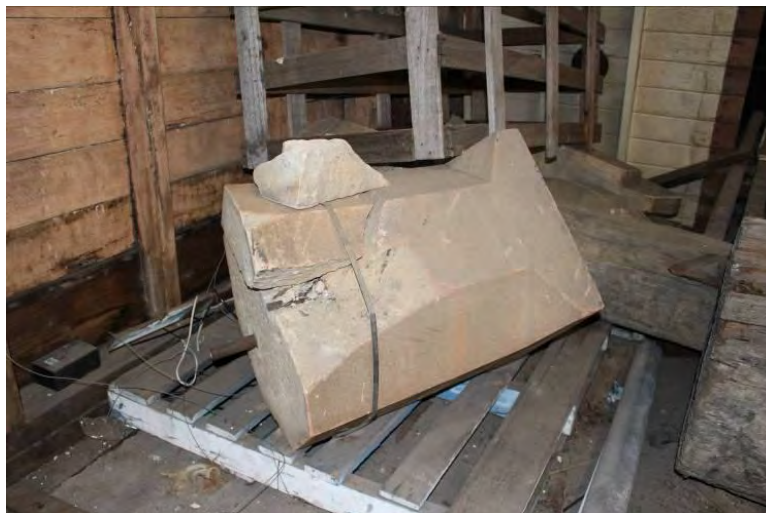
**Item No: 37**                      **Item/Fabric Name: Part of stone column**

| Material | Condition (G, F, P) | Grade of Signif. | Tag No. | Description | Interpretation Strategy |
|---|---|---|---|---|---|
| Stone<br>Metal | P | Low | 57-75 | Part of stone column | A representative example should be stored as part of the Walsh Bay Moveable Heritage Collection - (offsite). |

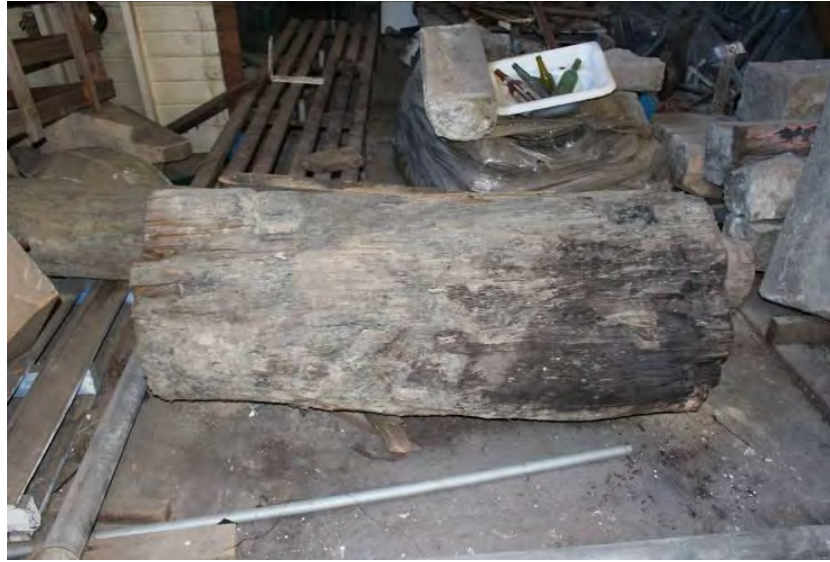
| Material | Condition (G, F, P) | Grade of Signif. | Tag No. | Description | Interpretation Strategy |
|---|---|---|---|---|---|
| Wood | P | Low | 50 | Part of wooden pole | A representative example should be stored as part of the Walsh Bay Moveable Heritage Collection - (offsite). |

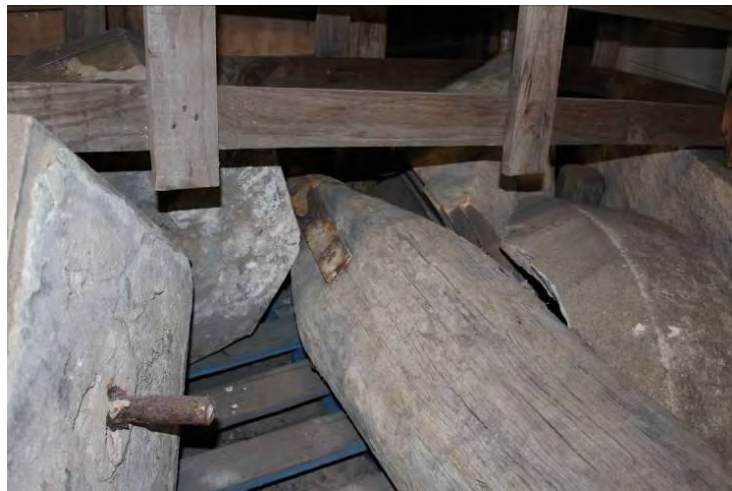
| Material | Condition (G, F, P) | Grade of Signif. | Tag No. | Description | Interpretation Strategy |
|---|---|---|---|---|---|
| Wood<br>Metal | F | Moderate | 50 | Wooden pole with metal head | Consider for interpretation and retain as part of a collection of Walsh Bay movable Heritage. |

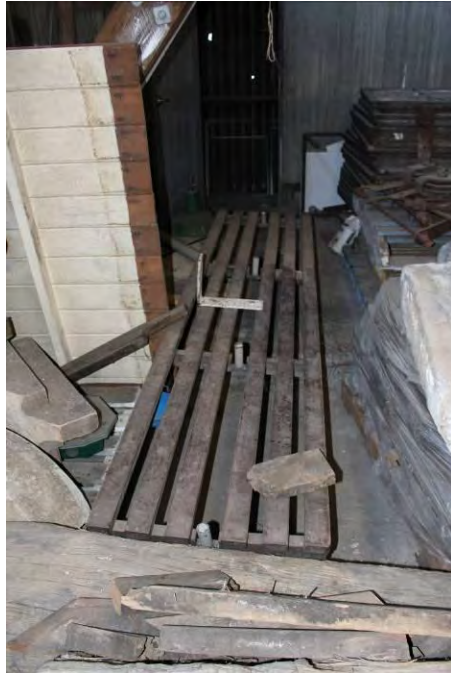
| Material | Condition (G, F, P) | Grade of Signif. | Tag No. | Description | Interpretation Strategy |
|---|---|---|---|---|---|
| Wood | F | Low | 70 | Timber benches | A representative example should be stored as part of the Walsh Bay Moveable Heritage Collection - (offsite). |

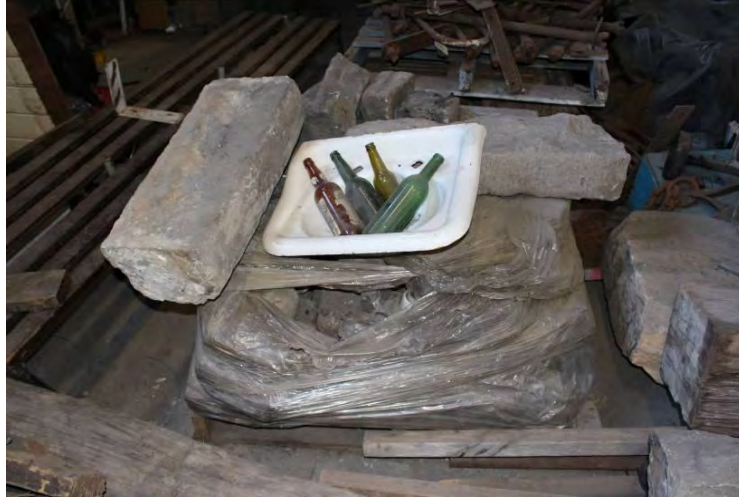
| Material | Condition (G, F, P) | Grade of Signif. | Tag No. | Description | Interpretation Strategy |
|---|---|---|---|---|---|
| Stone | F | Low | 80 | Pile of stones | A representative example should be stored as part of the Walsh Bay Moveable Heritage Collection - (offsite). |

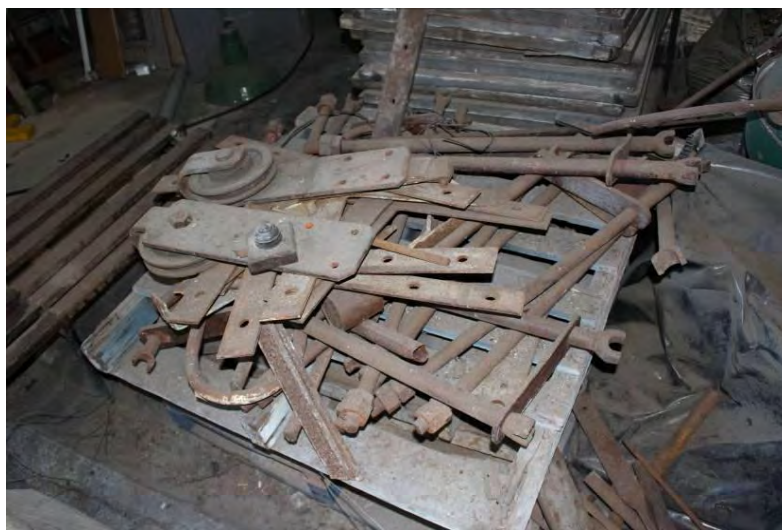
| Material | Condition (G, F, P) | Grade of Signif. | Tag No. | Description | Interpretation Strategy |
|---|---|---|---|---|---|
| Metal | F | Moderate | 47-82 | Components of Overhead Cranes | Consider for interpretation and retain as part of a collection of Walsh Bay movable Heritage. |
