# Interpretation Strategy for Movable Heritage Items

## Pier 2/3 Walsh Bay

Prepared for  
**Tonkin Zulaikha Greer**

November 2016

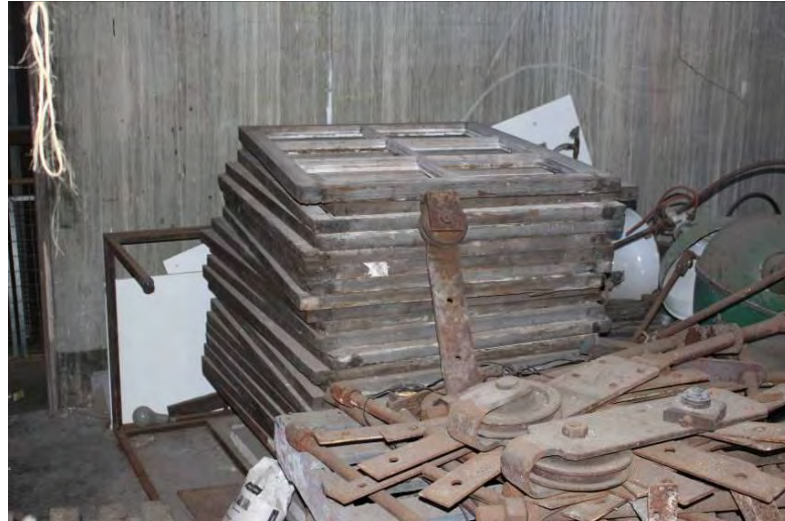
| Material | Condition (G, F, P) | Grade of Signif. | Tag No. | Description | Interpretation Strategy |
|---|---|---|---|---|---|
| Wood<br>Glass | F | Low | 38 | Timber windows | A representative example should be stored as part of the Walsh Bay Moveable Heritage Collection - (offsite). |

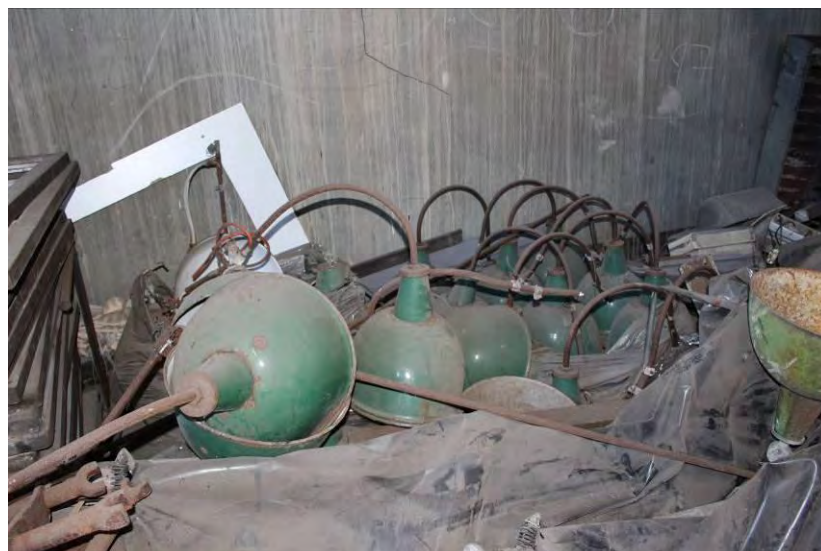
**Item No: 45**

| Material | Condition (G, F, P) | Grade of Signif. | Tag No. | Description | Interpretation Strategy |
|---|---|---|---|---|---|
| Metal | F | Low | 37-65 | Metal lamps | A representative example should be stored as part of the Walsh Bay Moveable Heritage Collection - (offsite). |

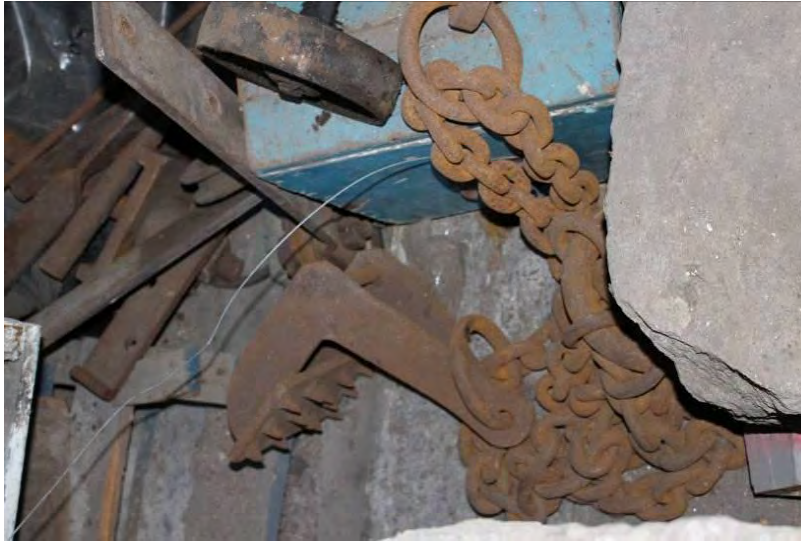
| Material | Condition (G, F, P) | Grade of Signif. | Tag No. | Description | Interpretation Strategy |
|---|---|---|---|---|---|
| Metal | F | Moderate | 85 | Metal chain with spike grid | Consider for interpretation and retain as part of a collection of Walsh Bay movable Heritage. |

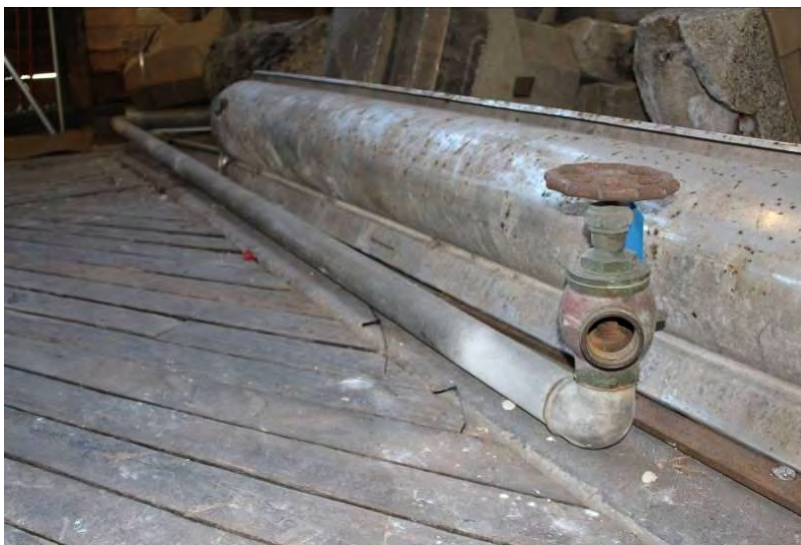
| Material | Condition (G, F, P) | Grade of Signif. | Tag No. | Description | Interpretation Strategy |
|---|---|---|---|---|---|
| Metal | F | Low | | Metal pipe with valve | A representative example should be stored as part of the Walsh Bay Moveable Heritage Collection - (offsite). |

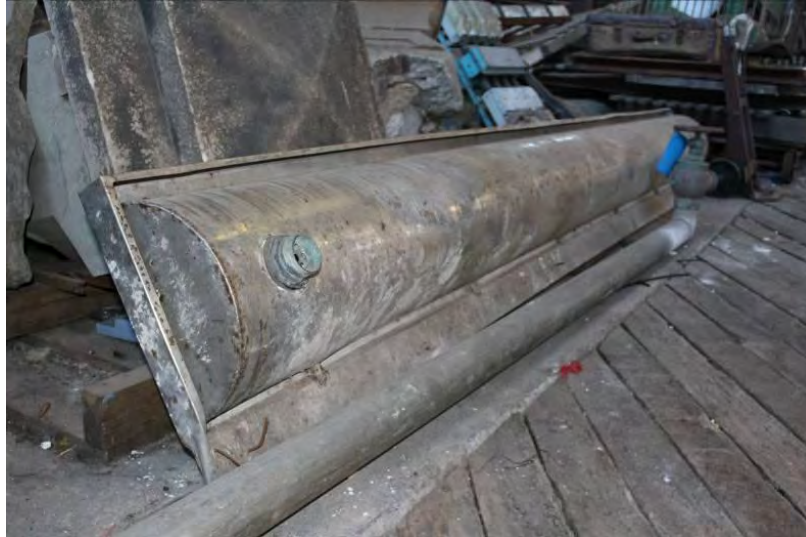
| Material | Condition (G, F, P) | Grade of Signif. | Tag No. | Description | Interpretation Strategy |
|---|---|---|---|---|---|
| Metal | P | Low | 81 | Metal urinal | A representative example should be stored as part of the Walsh Bay Moveable Heritage Collection - (offsite). |

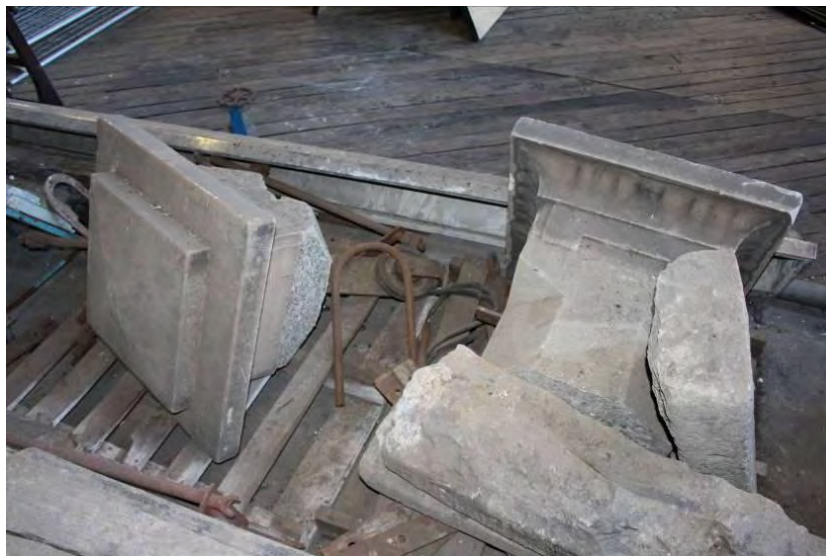
| Material | Condition (G, F, P) | Grade of Signif. | Tag No. | Description | Interpretation Strategy |
|---|---|---|---|---|---|
| Stone | F | Low | 57-75 | Parts of stone columns | A representative example should be stored as part of the Walsh Bay Moveable Heritage Collection - (offsite). |

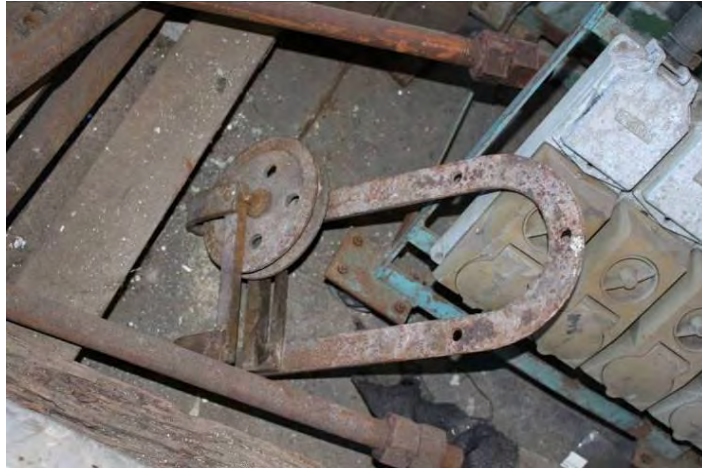
**Item No: 50**                      **Item/Fabric Name:** Metal element with wheel

| Material | Condition (G, F, P) | Grade of Signif. | Tag No. | Description | Interpretation Strategy |
|---|---|---|---|---|---|
| Metal | F | Low | | Metal element with wheel | A representative example should be stored as part of the Walsh Bay Moveable Heritage Collection - (offsite). |

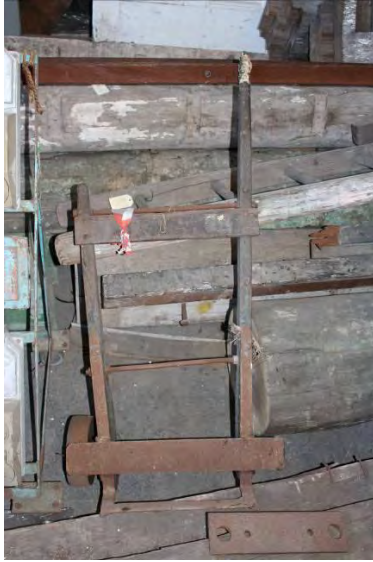
**Item No: 52**

**Item/Fabric Name:** Small trolley

| Material | Condition (G, F, P) | Grade of Signif. | Tag No. | Description | Interpretation Strategy |
|---|---|---|---|---|---|
| Wood<br>Metal | P | Moderate | 39 | Small trolley | Consider for interpretation and retain as part of a collection of Walsh Bay movable Heritage. |

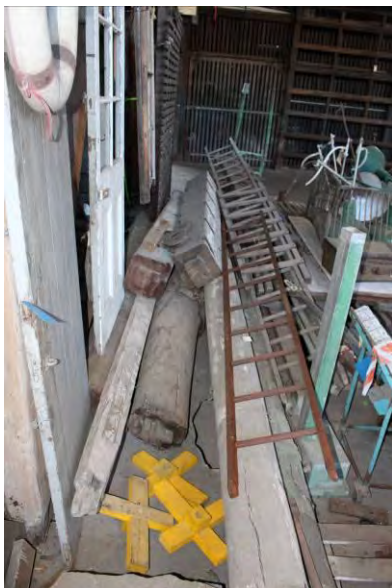
**Item No: 53**

**Item/Fabric Name:** 3 timber ladders and wooden posts with mortise joints

| Material | Condition (G, F, P) | Grade of Signif. | Tag No. | Description | Interpretation Strategy |
|---|---|---|---|---|---|
| Wood | F | Moderate | 43 | 3 timber ladders and wooden posts with mortise joints | Consider for interpretation and retain as part of a collection of Walsh Bay movable Heritage. |

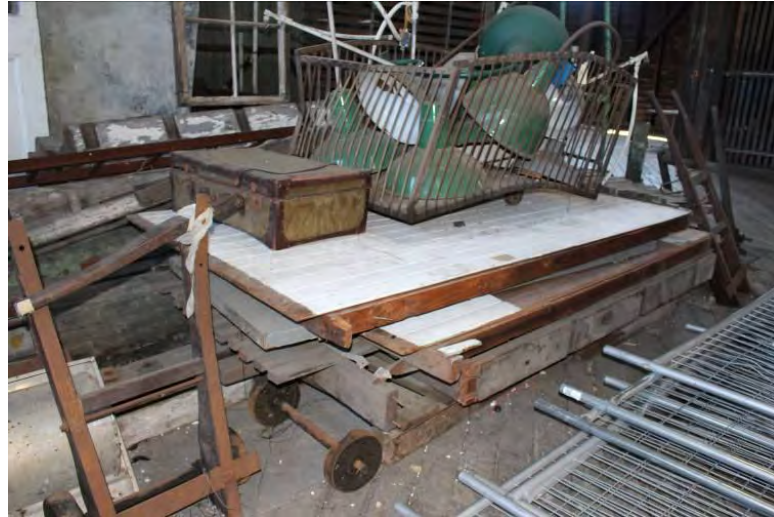
**Item No: 54**                      **Item/Fabric Name: Timber frames**

| Material | Condition (G, F, P) | Grade of Signif. | Tag No. | Description | Interpretation Strategy |
|---|---|---|---|---|---|
| Wood | P | Low | | Timber frames | A representative example should be stored as part of the Walsh Bay Moveable Heritage Collection - (offsite). |

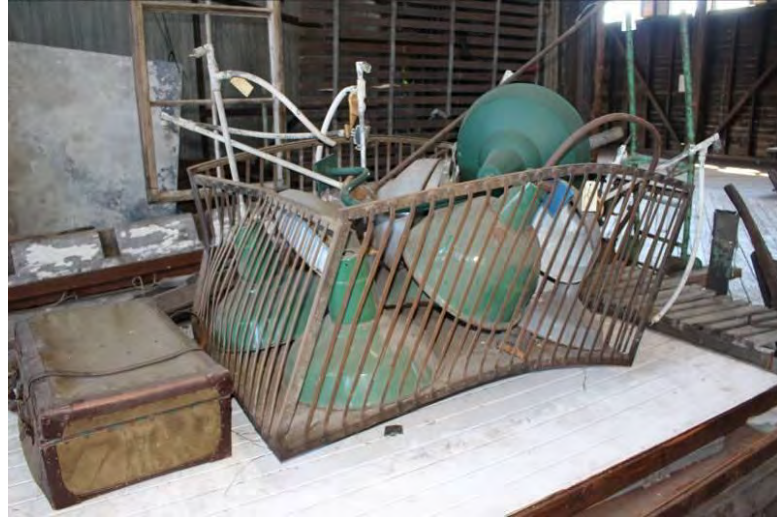
**Item No: 56**                      **Item/Fabric Name: Lamps in a metal box**

| Material | Condition (G, F, P) | Grade of Signif. | Tag No. | Description | Interpretation Strategy |
|---|---|---|---|---|---|
| Metal<br>Plastic | F | Low | 66-72 | Metal lamps for industrial lighting | A representative example should be stored as part of the Walsh Bay Moveable Heritage Collection - (offsite). |

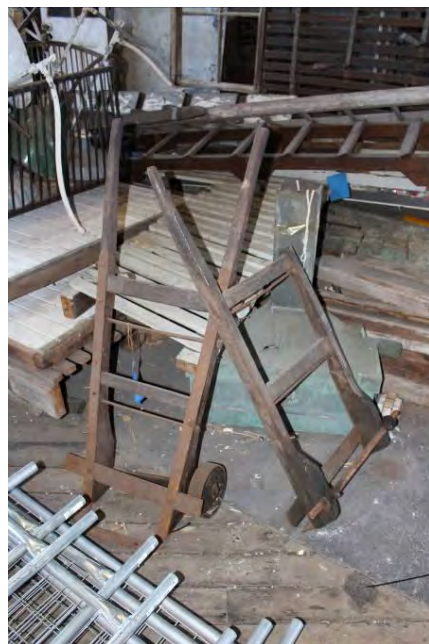
**Item No: 57**                      **Item/Fabric Name: Wooden trolleys**

| Material | Condition (G, F, P) | Grade of Signif. | Tag No. | Description | Interpretation Strategy |
|---|---|---|---|---|---|
| Wood<br>Metal | F | Moderate | 39 | Wooden trolleys | Consider for interpretation and retain as part of a collection of Walsh Bay movable Heritage. |

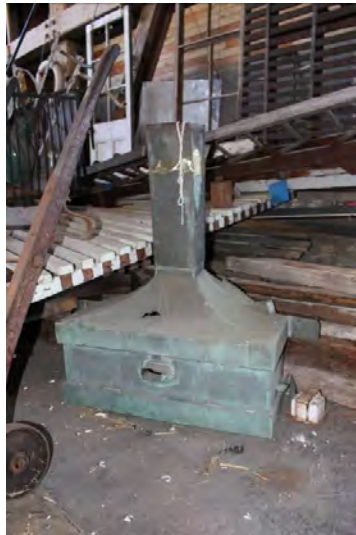
**Item No: 58**

**Item/Fabric Name:** Copper rain head

| Material | Condition (G, F, P) | Grade of Signif. | Tag No. | Description | Interpretation Strategy |
|---|---|---|---|---|---|
| Copper | F | Moderate | 42 | Copper rain head | Consider for interpretation and retain as part of a collection of Walsh Bay movable Heritage. |

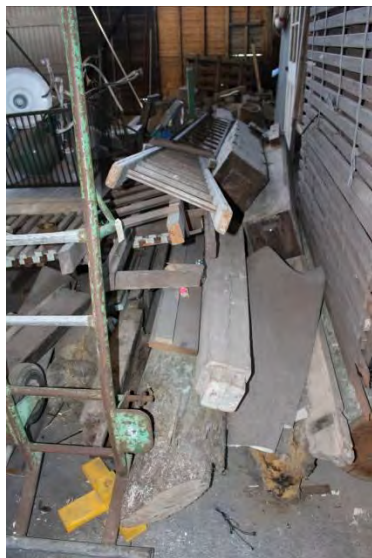
**Item No: 59**

**Item/Fabric Name:** Timber planks and posts

| Material | Condition (G, F, P) | Grade of Signif. | Tag No. | Description | Interpretation Strategy |
|---|---|---|---|---|---|
| Wood | P | Low | | Timber planks and posts | A representative example should be stored as part of the Walsh Bay Moveable Heritage Collection - (offsite). |

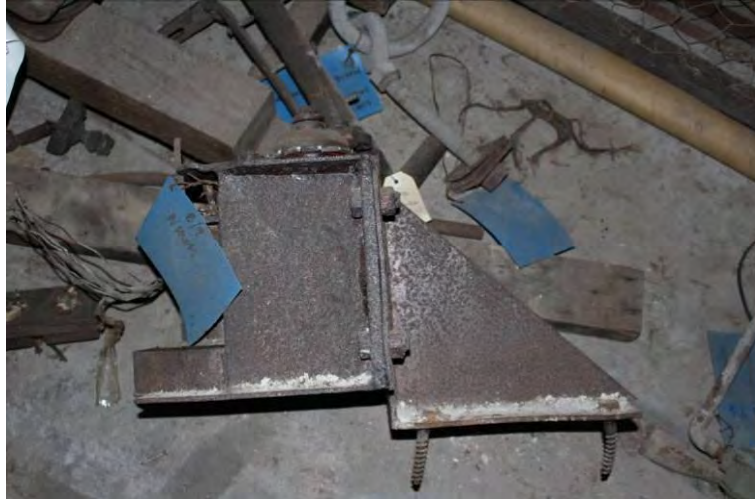
| Material | Condition (G, F, P) | Grade of Signif. | Tag No. | Description | Interpretation Strategy |
|---|---|---|---|---|---|
| Metal | F | Moderate | 47 | Overhead crane parts | Consider for interpretation and retain as part of a collection of Walsh Bay movable Heritage. |

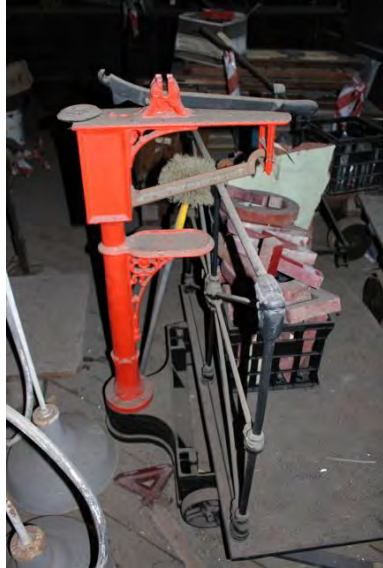
**Item No: 70**

**Item/Fabric Name: Scale**

| Material | Condition (G, F, P) | Grade of Signif. | Tag No. | Description | Interpretation Strategy |
|---|---|---|---|---|---|
| Metal | F | Moderate | 7 | Scale | Consider for interpretation and retain as part of a collection of Walsh Bay movable Heritage. |

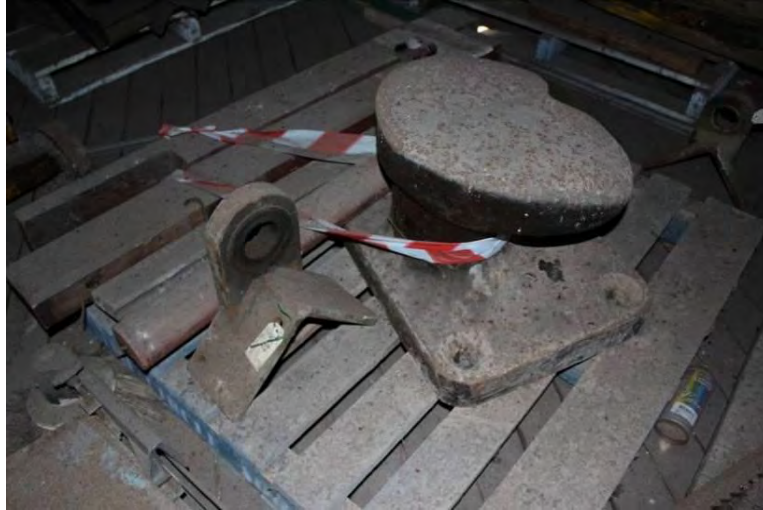
**Item No: 74**                      **Item/Fabric Name: Bollard**

| Material | Condition (G, F, P) | Grade of Signif. | Tag No. | Description | Interpretation Strategy |
|---|---|---|---|---|---|
| Metal | F | Moderate | 17 | Metal bollard | Consider for interpretation and retain as part of a collection of Walsh Bay movable Heritage. |

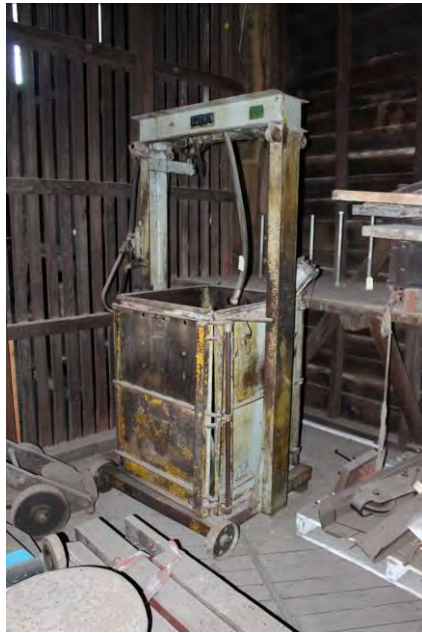
**Item No: 76**

**Item/Fabric Name:** Goliath Hydraulic Wool Press

| Material | Condition (G, F, P) | Grade of Signif. | Tag No. | Description | Interpretation Strategy |
|---|---|---|---|---|---|
| Metal | P | Moderate | 16 | Most likely dates from 1930s-1950s | Consider for interpretation and retain as part of a collection of Walsh Bay movable Heritage. |

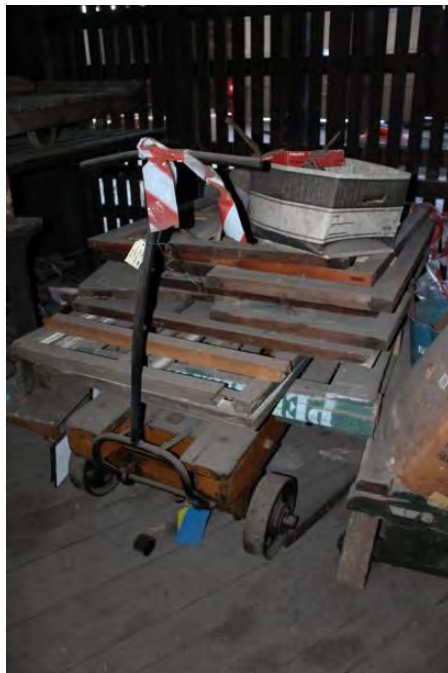
**Item No:** 81

**Item/Fabric Name:** Heavy weight 4 wheel trolley

| Material | Condition (G, F, P) | Grade of Signif. | Tag No. | Description | Interpretation Strategy |
|---|---|---|---|---|---|
| Metal | F | Moderate | 9 | Heavy weight 4 wheel trolley | Consider for interpretation and retain as part of a collection of Walsh Bay movable Heritage. |

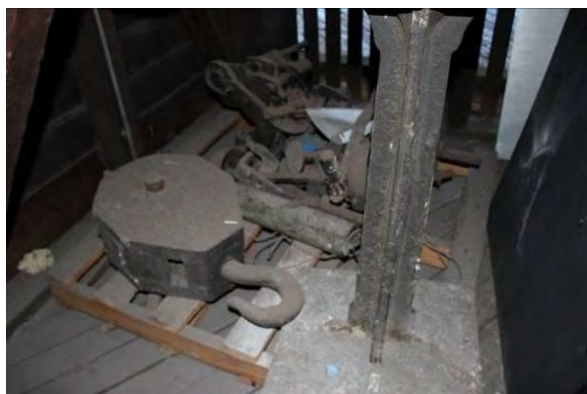
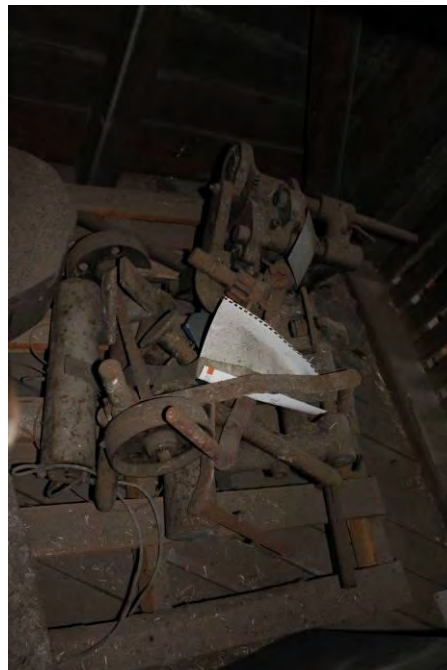
**Item No: 83**

**Item/Fabric Name:** Jib crane components

| Material | Condition (G, F, P) | Grade of Signif. | Tag No. | Description | Interpretation Strategy |
|---|---|---|---|---|---|
| Metal | F | High | 19 | Components located together on timber pallets | Should be retained, reinstated, and interpreted at Walsh Bay Pier 2/3. |

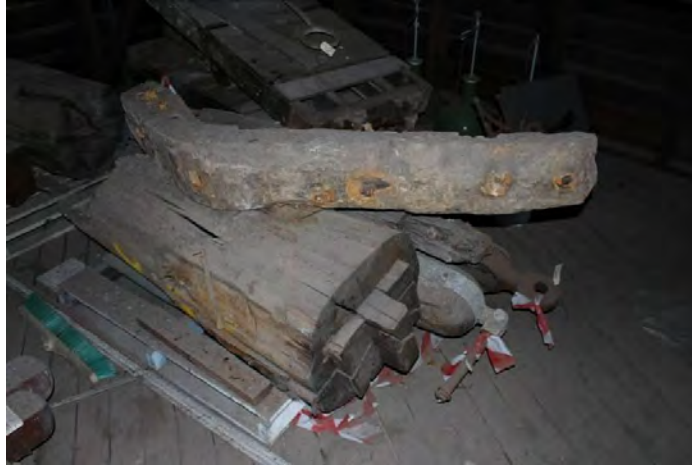
**Item No: 84**

**Item/Fabric Name: Cat Head Beam**

| Material | Condition (G, F, P) | Grade of Signif. | Tag No. | Description | Interpretation Strategy |
|---|---|---|---|---|---|
| Wood | P | High | 21 | Sheave holes | Should be retained, reinstated, and interpreted at Walsh Bay Pier 2/3. |

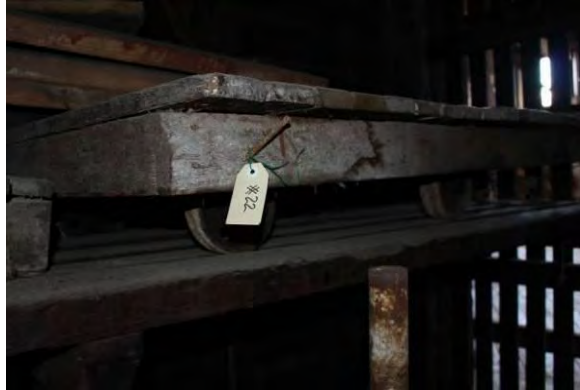
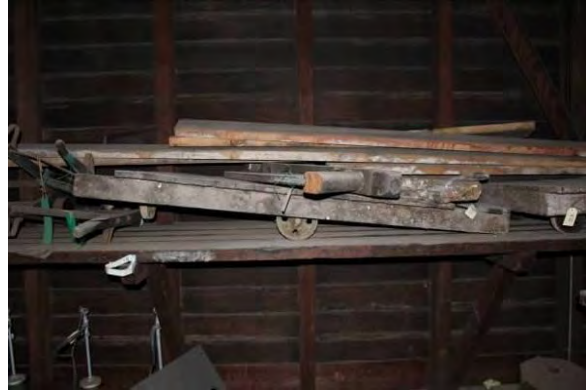
**Item No: 88**

**Item/Fabric Name:** Wheeled wooden flat trolleys

| Material | Condition (G, F, P) | Grade of Signif. | Tag No. | Description | Interpretation Strategy |
|---|---|---|---|---|---|
| Wood<br>Metal | F | Moderate | 22 | Wheeled wooden flat trolleys | Consider for interpretation and retain as part of a collection of Walsh Bay movable Heritage. |

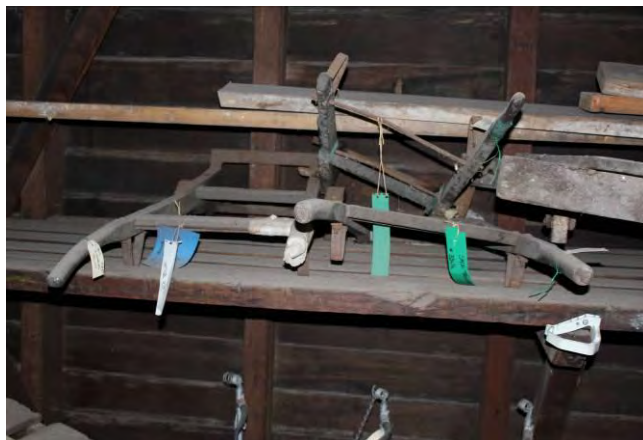
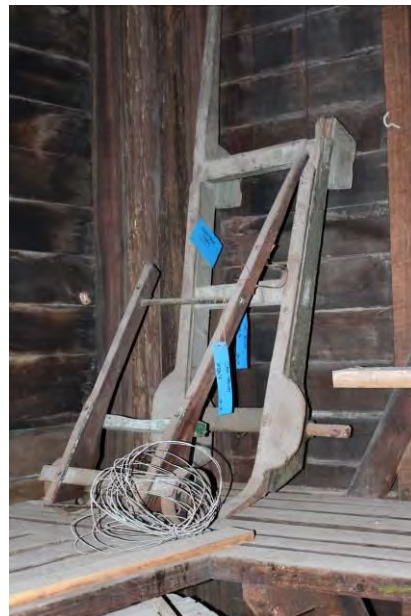
**Item No: 89**

**Item/Fabric Name:** 5 wooden trolleys

| Material | Condition (G, F, P) | Grade of Signif. | Tag No. | Description | Interpretation Strategy |
|---|---|---|---|---|---|
| Wood<br>Metal | F | Moderate | 12 | 5 wooden trolleys | Consider for interpretation and retain as part of a collection of Walsh Bay movable Heritage. |

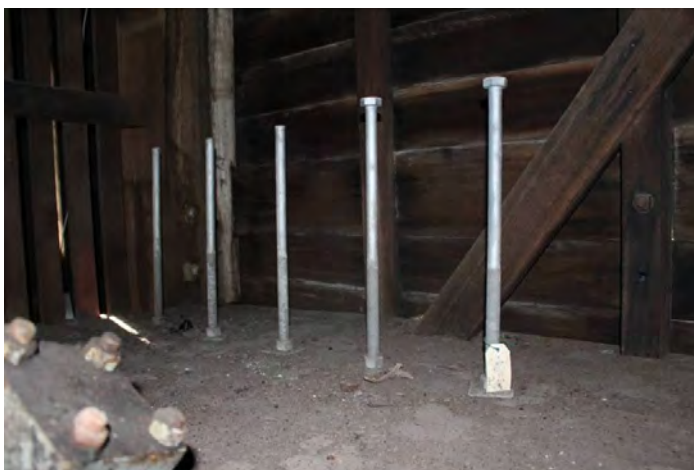
**Item No:** 92

**Item/Fabric Name:** Wooden pile iron casing

| Material | Condition (G, F, P) | Grade of Signif. | Tag No. | Description | Interpretation Strategy |
|---|---|---|---|---|---|
| Wood<br>Metal | P | Moderate | 6 | Wooden pile iron casing | Consider for interpretation and retain as part of a collection of Walsh Bay movable Heritage. |

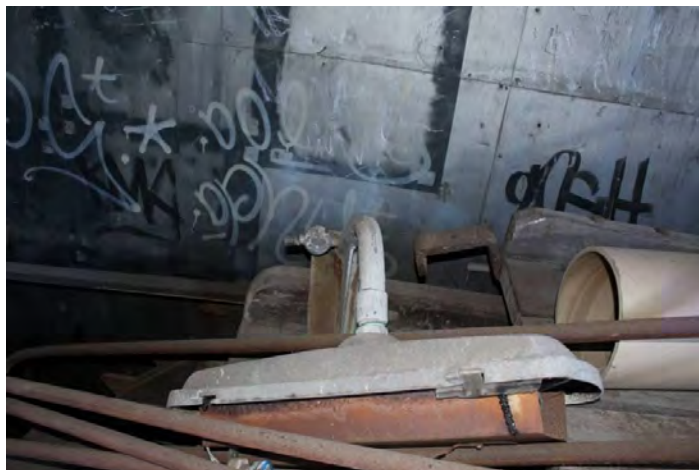
**Item No:** 100

**Item/Fabric Name:** Wooden panels

| Material | Condition (G, F, P) | Grade of Signif. | Tag No. | Description | Interpretation Strategy |
|---|---|---|---|---|---|
| Wood | F | Low | 1 | Wooden panels | A representative example should be stored as part of the Walsh Bay Moveable Heritage Collection - (offsite). |

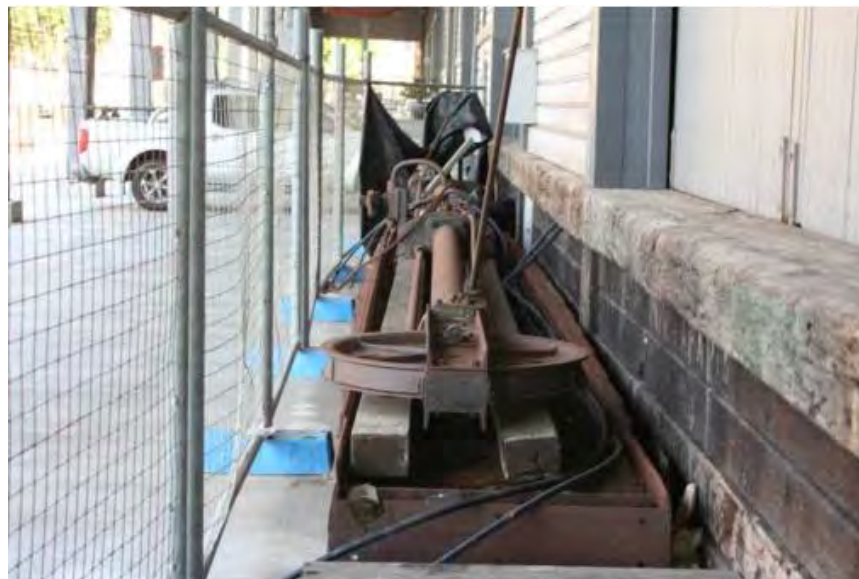
Photo from GML report. Today the item is kept inside a box.
