WBAP Heritage Impact Statement

PART 2

3.4 Marine and Land Archaeology

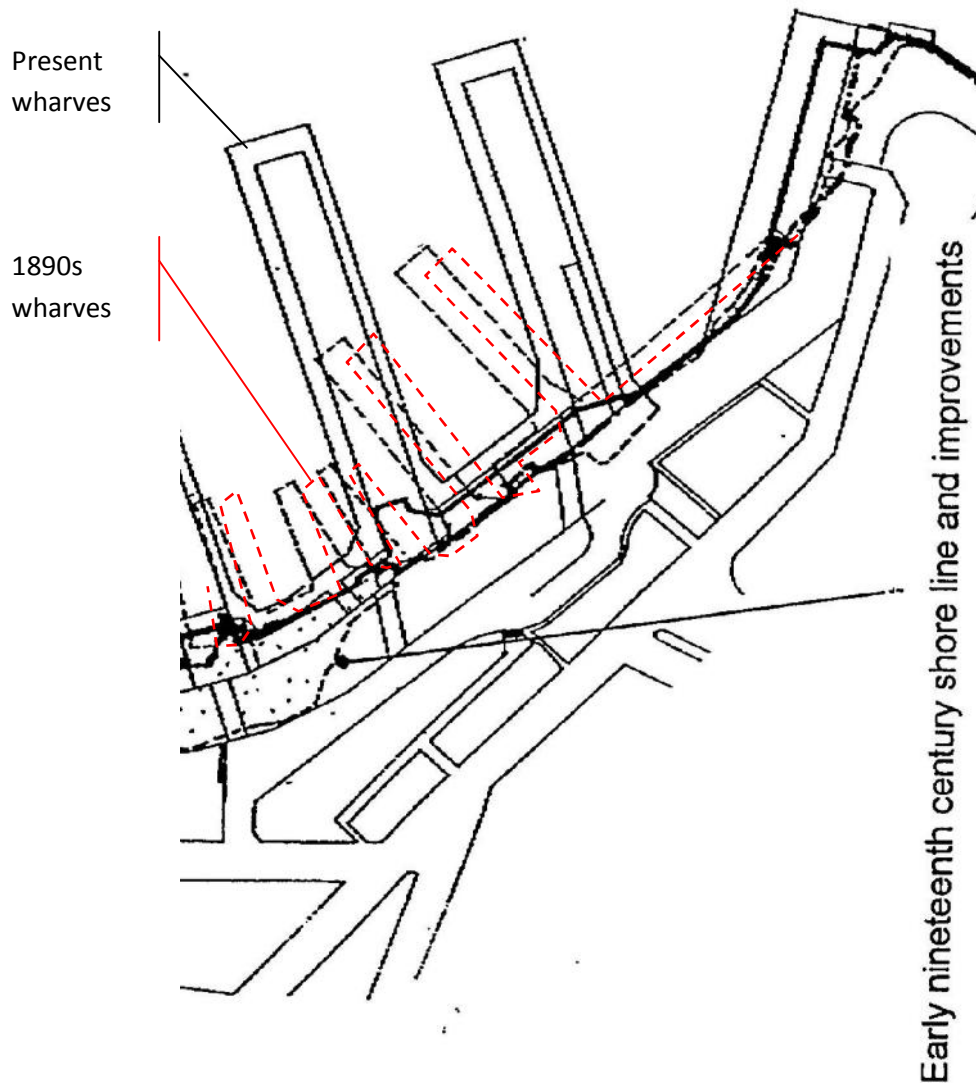
Figure 46: Overlay showing the relationship of the current wharves to the later nineteenth century wharves and shore, the early nineteenth century developments and the Sydney Harbour Trust wall. From *Archaeological Assessment Wharves 6/7 & 8/9 Walsh Bay*, by Wendy Thorp, 1997.

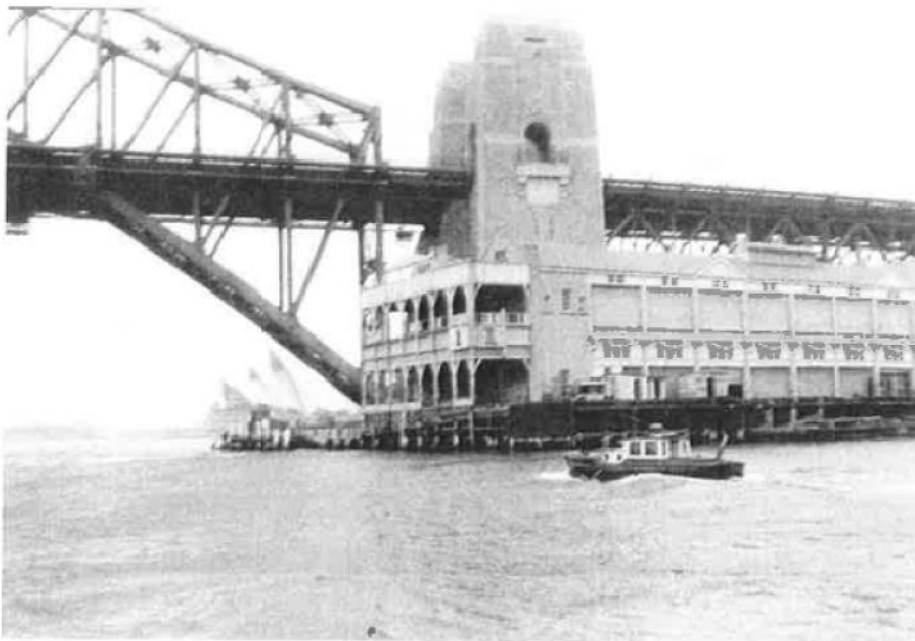
WALSH BAY 1: Prior to the redevelopment of this building as a market building, it was painted a light grey with contrasts in white. All of these wharf buildings were similarly coloured. The verandahs on the north end of Pier One, prior to the construction of the Harbour Bridge, would have had an uninterrupted view up and down the Harbour.

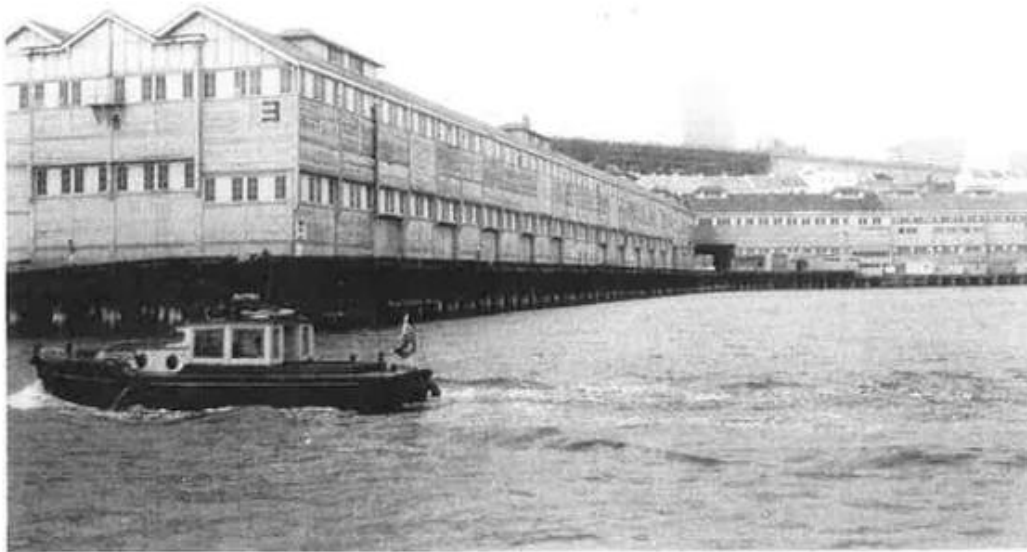
WALSH BAY 3: The lack of access to the upper floor on this wharf indicates the functional division of the wharf shed - the upper floor serviced Wharf No 2 whilst the lower floor serviced Wharf No 3.

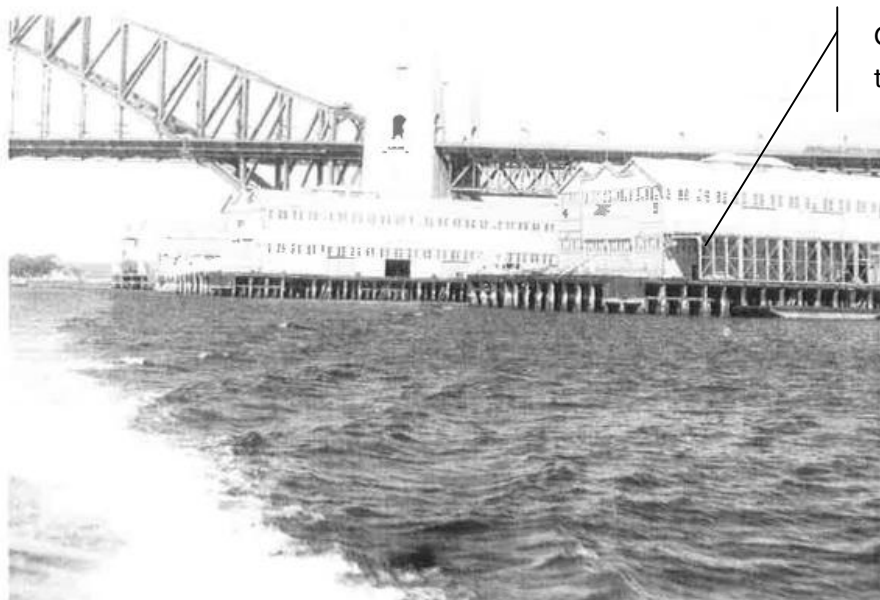
Gantry to the end of the Pier 4/5.

WALSH BAY 2/3 and 4/5: Dwarfed by the Sydney Harbour Bridge, the similarities between wharves 2/3 and 4/5 are apparent. The travelling gantries on Wharf 5 have all been parked together on the harbour end of the wharf. (1983)
