### 5.7 Wharf 4/5

CULTURAL RESOURCES MANAGEMENT  
for  
CLIVE LUCAS STAPLETON AND PARTNERS

The study site comprises Wharf 2/3 and Wharf 4/5 in Walsh Bay and includes the associated shore-sheds and waterway between the Pier and Wharf. The study site is located on Sydney Harbour and forms part of the Walsh Bay Wharves Precinct Conservation Area. The Conservation Area is adjacent to the Millers Point and Dawes Point Village Precinct and The Rocks Conservation Area.

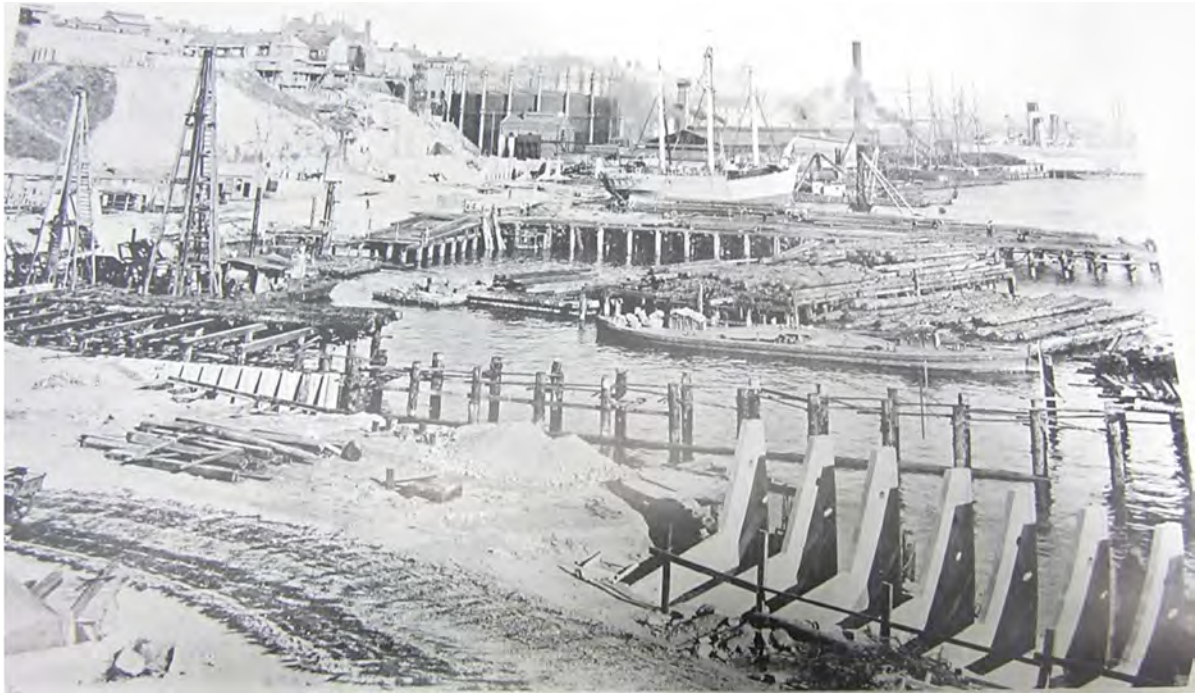
Excavation of the foreshore for the new road, here a view of these works and the construction of new wharves on the western side of Darling Harbour near the Gas Works in 1909 (Source: SHT Annual Report 1909)

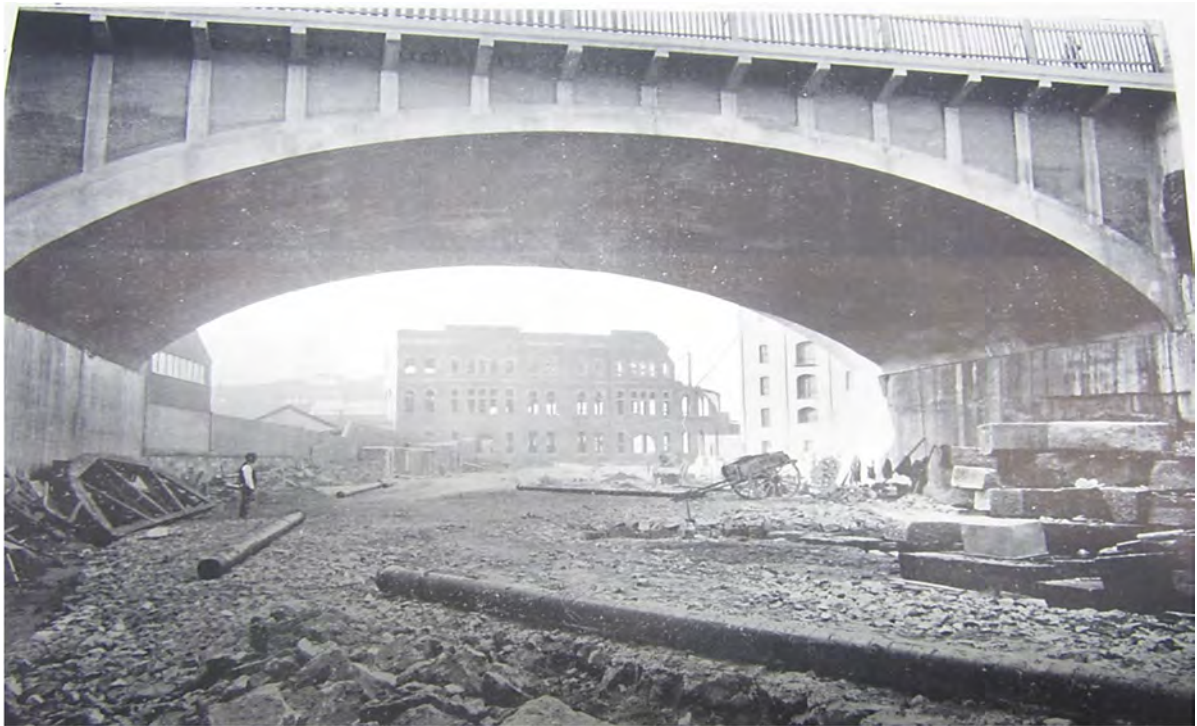
View west along Hickson Road showing the new bridge that spanned what was described as “deep rock cutting” through Millers Point. Wharf 8/9 is in the background and in the foreground can be seen some of the sandstone that has been extracted as dimension stone (Source: SHT Annual Report 1913)

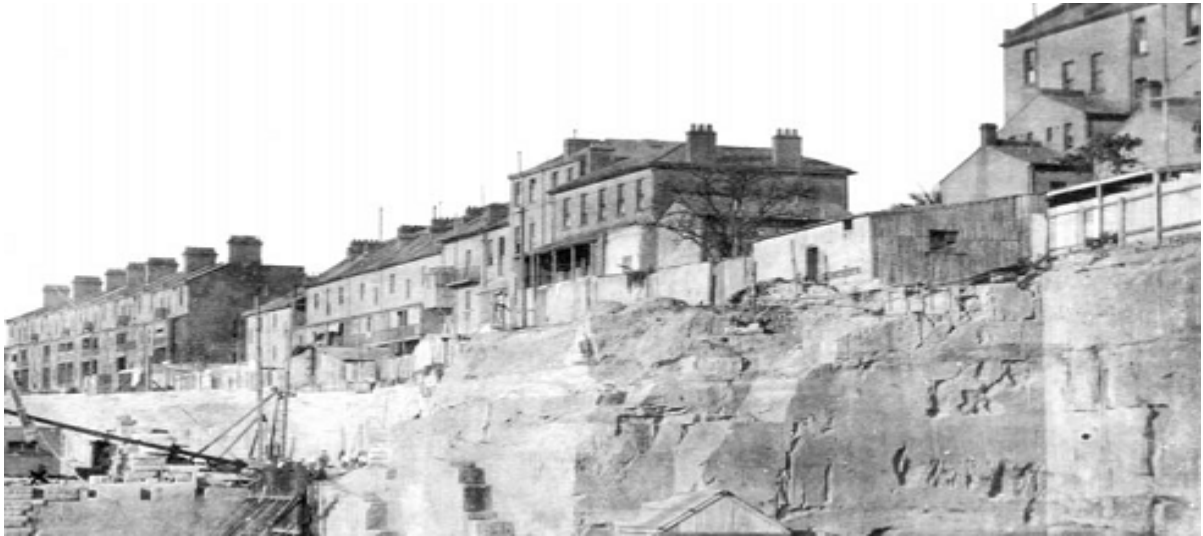
The extent of excavation of the existing landform required to create the new streets of Hickson Road and New Pottinger Street is demonstrated in this image (Source: GPO collection reproduced in Fitzgerald and Keating (1991), *Millers Point the Urban Village*)

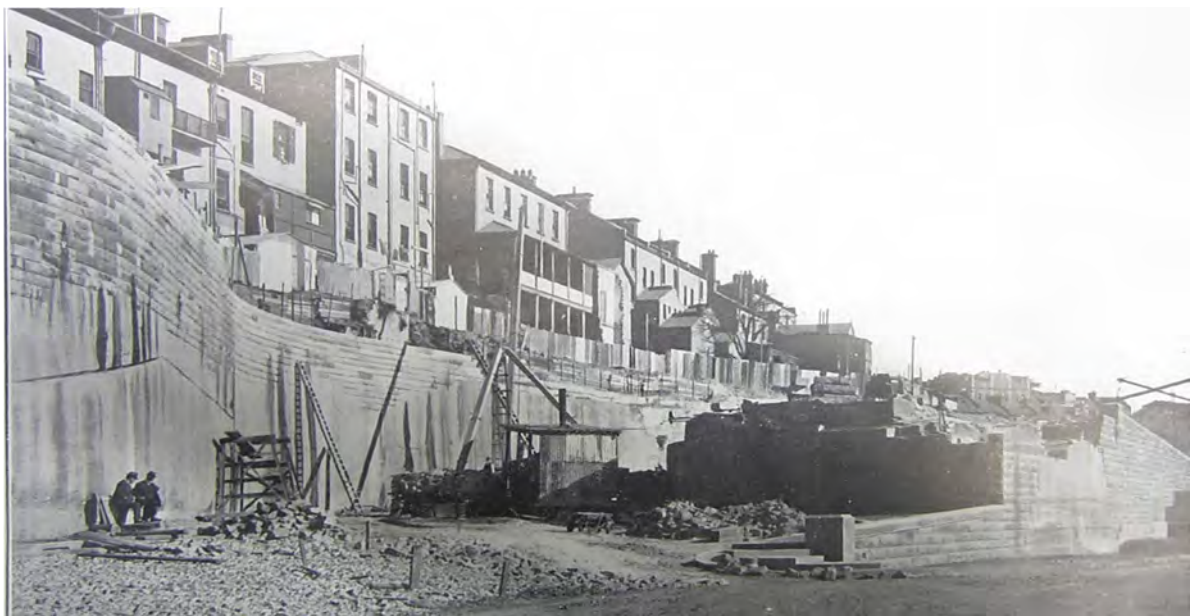
The junction of New Pottinger Street and Hickson Road in the course of construction in 1916 (Source: SHT Annual report 1916)

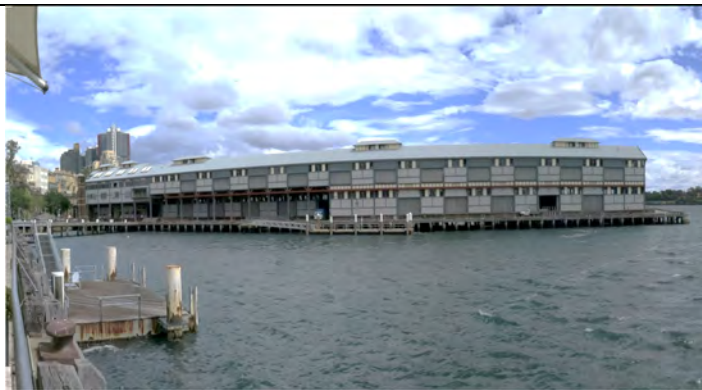
**Pier 2/3:** a Federation style, two level wharf structure constructed between 1913 and 1922. It consists of a timber framed post and beam construction with a regular grid layout. It is clad in weatherboards, has a double-pitched roof and roof lantern. It has concrete aprons that wrap around the eastern western and northern sides. The shore-sheds have a brick facade

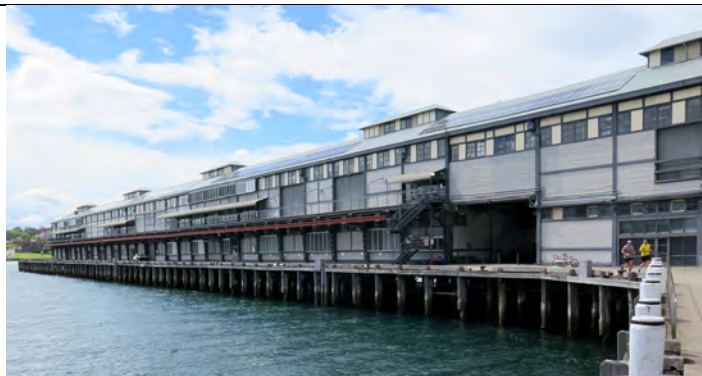
**Wharf 4/5:** a Federation style, two-level wharf structure similar in construction to Pier 2/3 and also constructed in the years 1913-1922. It has been altered in the 1980s to accommodate performance spaces. It has a brick façade to Hickson Road

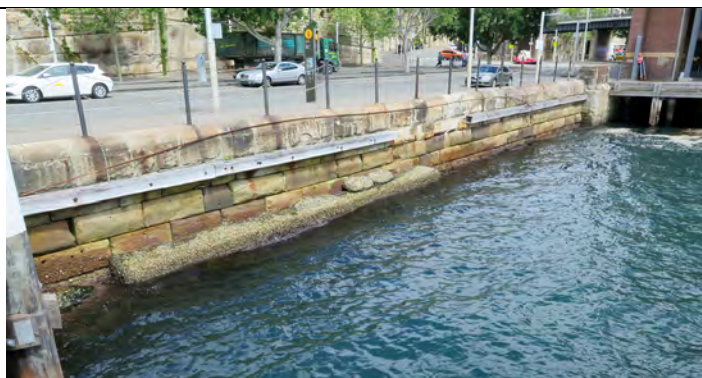
*Sea wall east of Pier 2/3*

The sea wall between the two wharves and behind them constructed from dressed sandstone constructed between 1918-1919

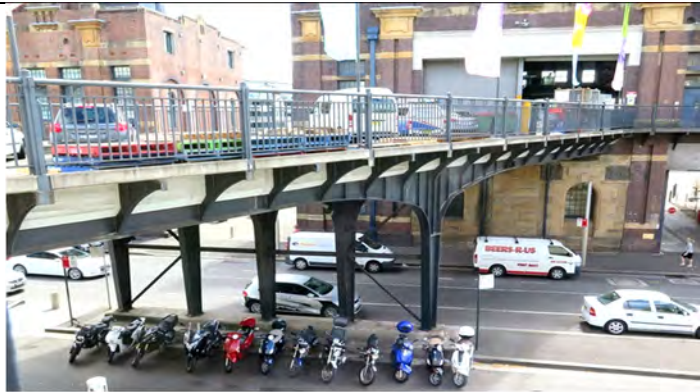
*Bridge to Wharf 4/5*

The original timber bridges between the upper storeys of the piers and Pottinger Street have been replaced with steel bridges set on concrete plinths or steel piers in c. 1940

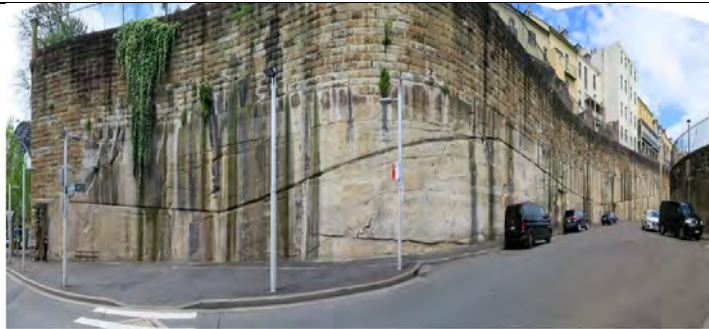
*Quarried sandstone bedrock at the junction of Hickson Road and New Pottinger Street*

The extent to which the bedrock has been quarried to provide for the construction of Hickson Road may be seen at the base of the retaining wall on the southern side of that road and in Pottinger Street

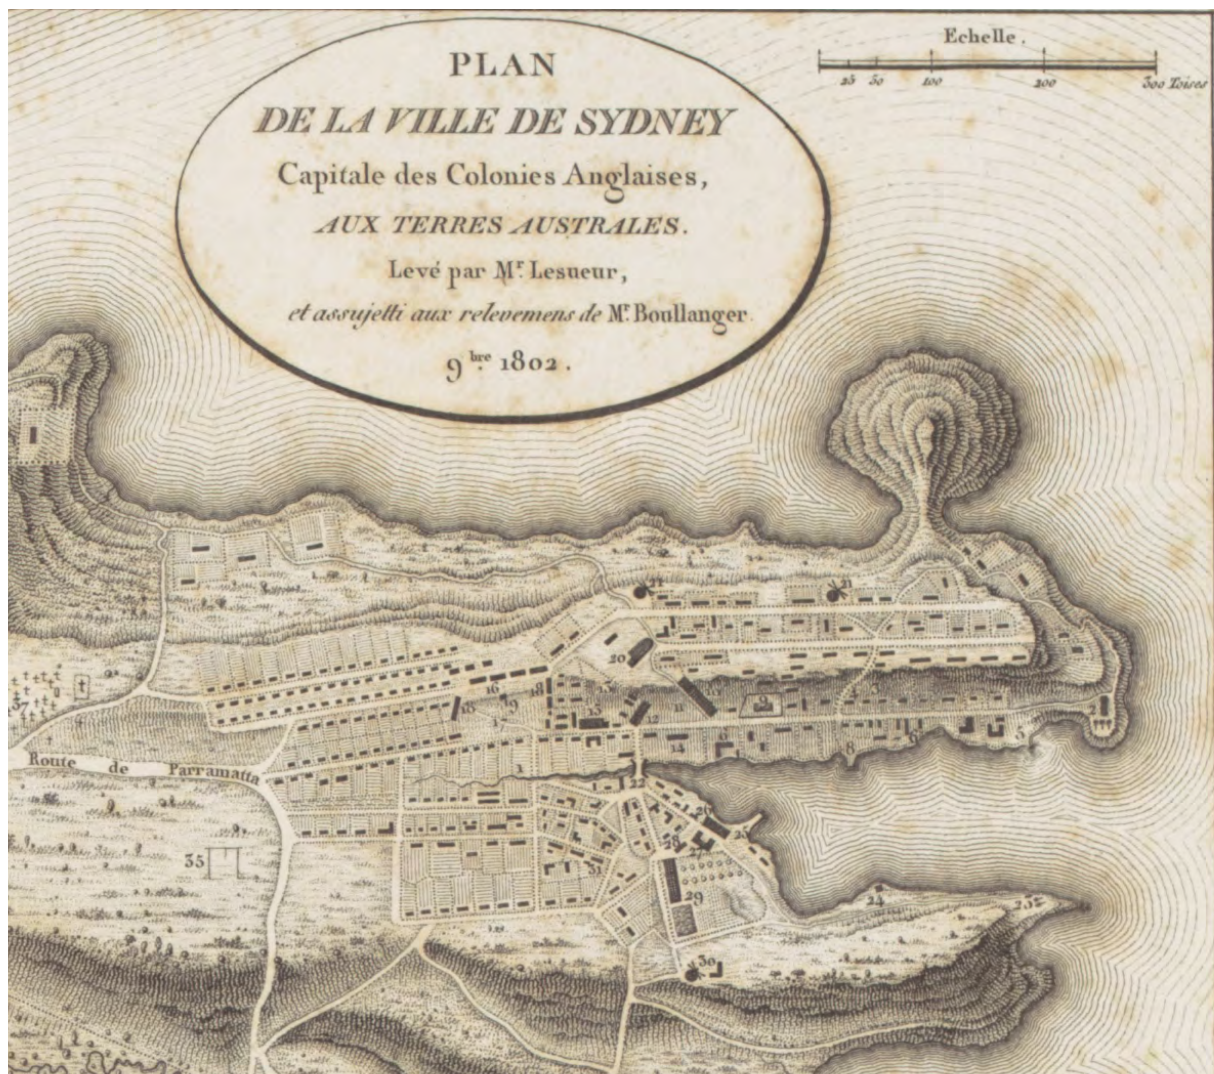
Figure 3 Detail of Milbert, Cloquet and Walker's 1802 Plan de la Ville de Sydney showing the steep rocky headlands of Millers Point and Walsh Bay. (Source: NLA <http://trove.nla.gov.au/version/209669543>)

Prior to European settlement, reclamation and construction along Walsh Bay, the study area consisted of a steep, rocky sandstone headland overlooking the deep waters of Sydney Harbour. Early plans of the town of Sydney indicate that this area comprised of steep sided cliffs leading down to a narrow rocky foreshore (Figure 3 and Figure 4).

During the earliest years of the NSW colony the steep, rocky terrain of Walsh Bay and Millers Point discouraged extensive development along the foreshore in these locations. Milbert, Cloquet and Walker's 1802 plan of the town of Sydney shows only a few structures along the foreshore with much more dense development occurring along the Observatory Hill ridgeline (Figure 3). Some early uses of the foreshore include anchorage for whaling vessels and a battery at Dawes Point to the east.<sup>19</sup>

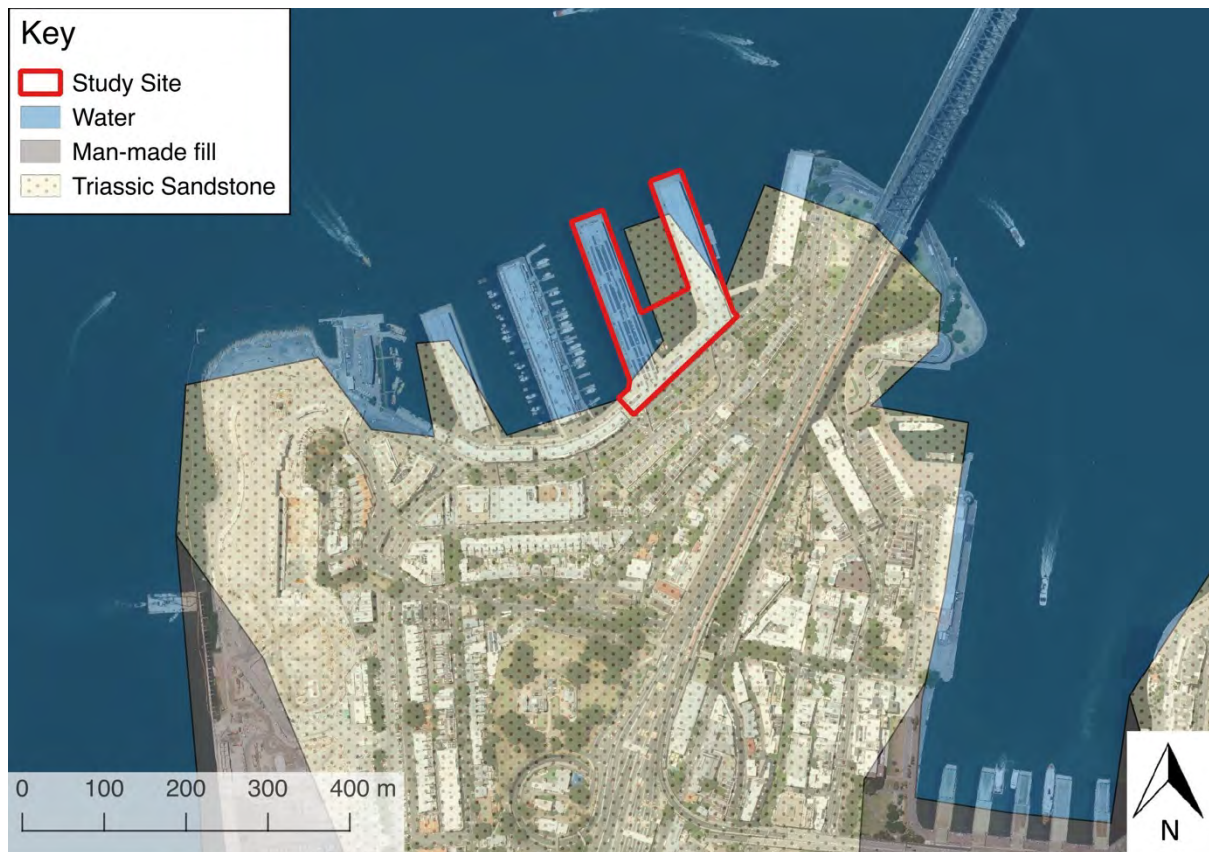
Figure 4 Map of the local underlying geology of the study site. (Source: NSW Geological Survey with CRM additions)

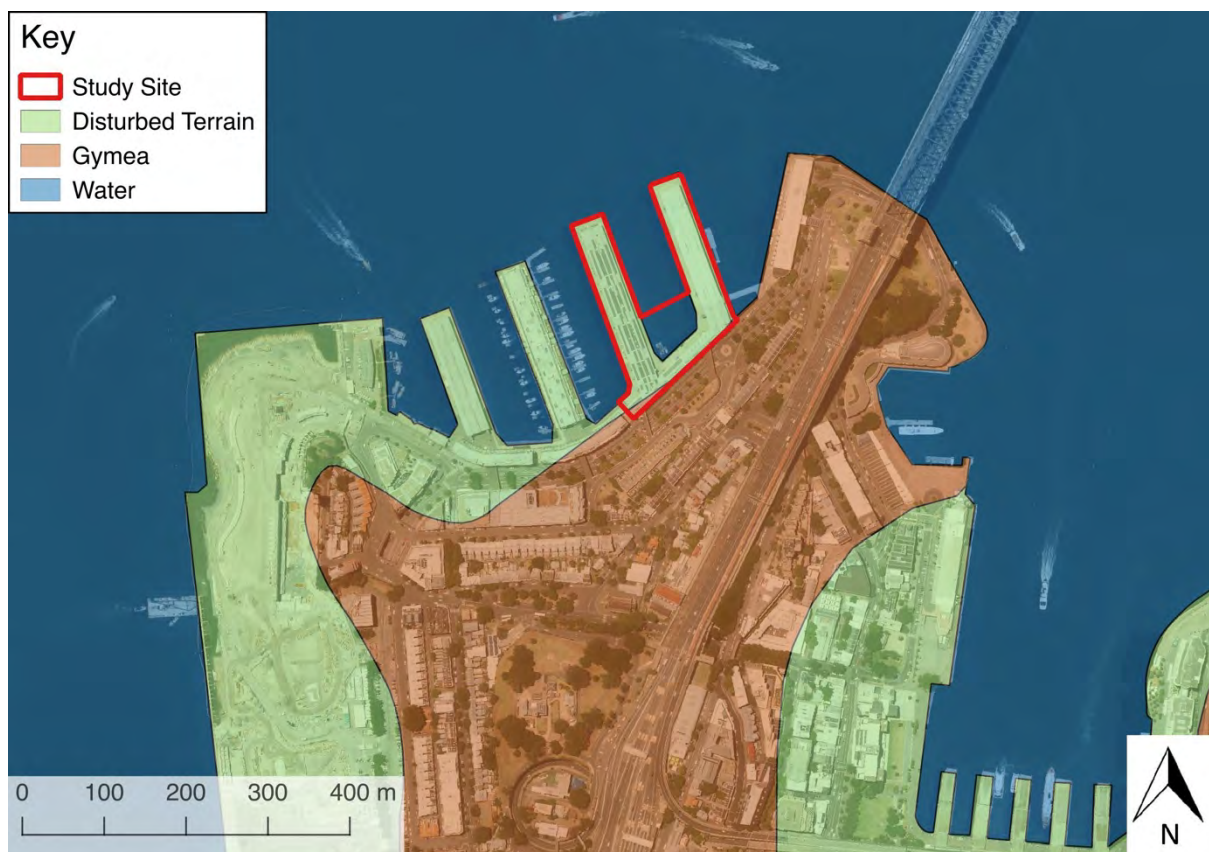
Figure 5 Map of the soil landscapes in the vicinity of the study site. (Source: Soil Landscapes of the Sydney 1:100,000 Sheet, NSW Department of Environment, Climate Change and Water with CRM additions)

The Sydney soil landscape 1:100 000 sheet indicates that the area in the vicinity of the study site is overlain with Gympsea soils (Figure 5). These shallow, loose, sandy soils are formed by the weathering of the underlying sandstone bedrock and are highly prone to erosion.<sup>2</sup> The original natural foreshore is likely to have been rocky with small pockets of sandy beach deposits.

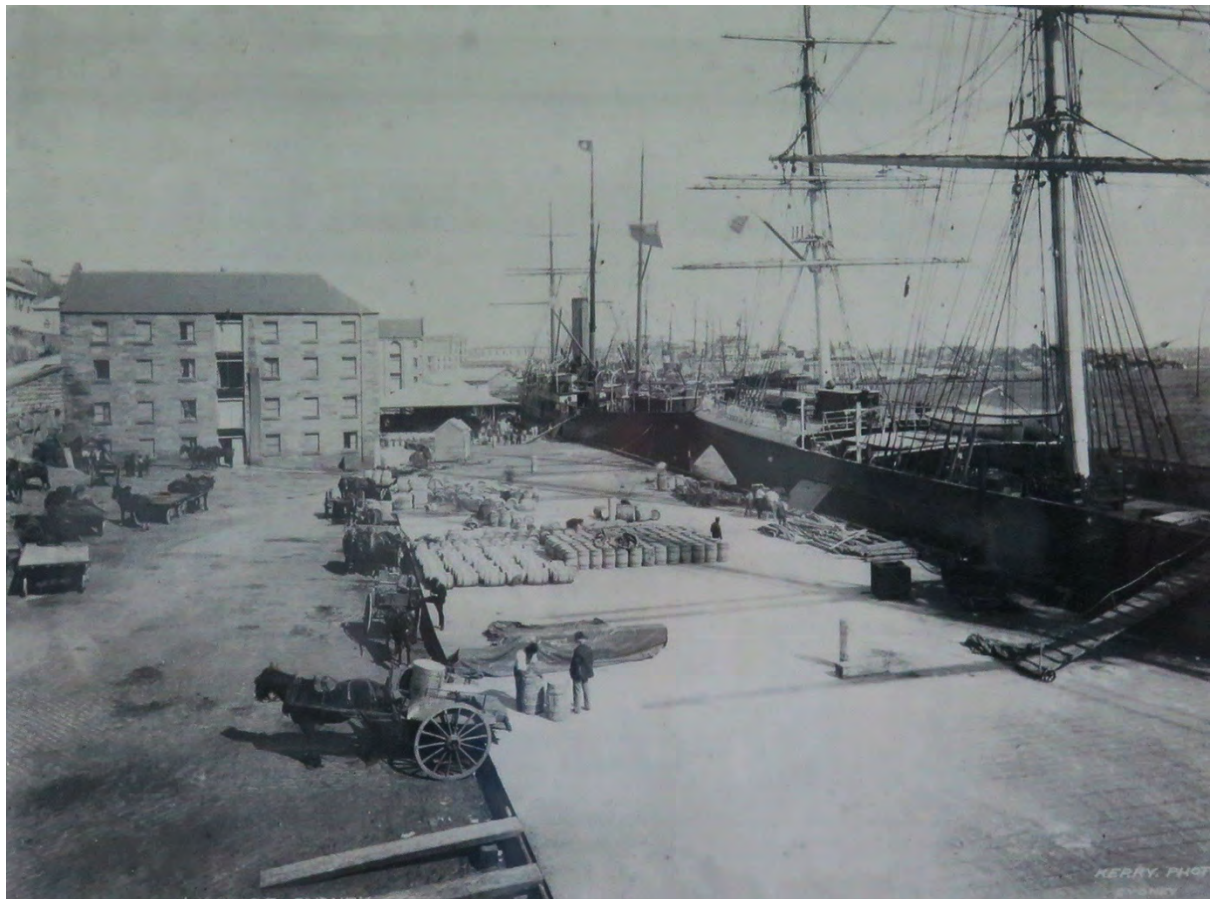
Figure 12 Padbury's Wharf c. 1873 showing the long-side wharves, sea wall and levelled foreshore of Walsh Bay. (Source: Pier 2/3 heritage interpretation panels, 2016).

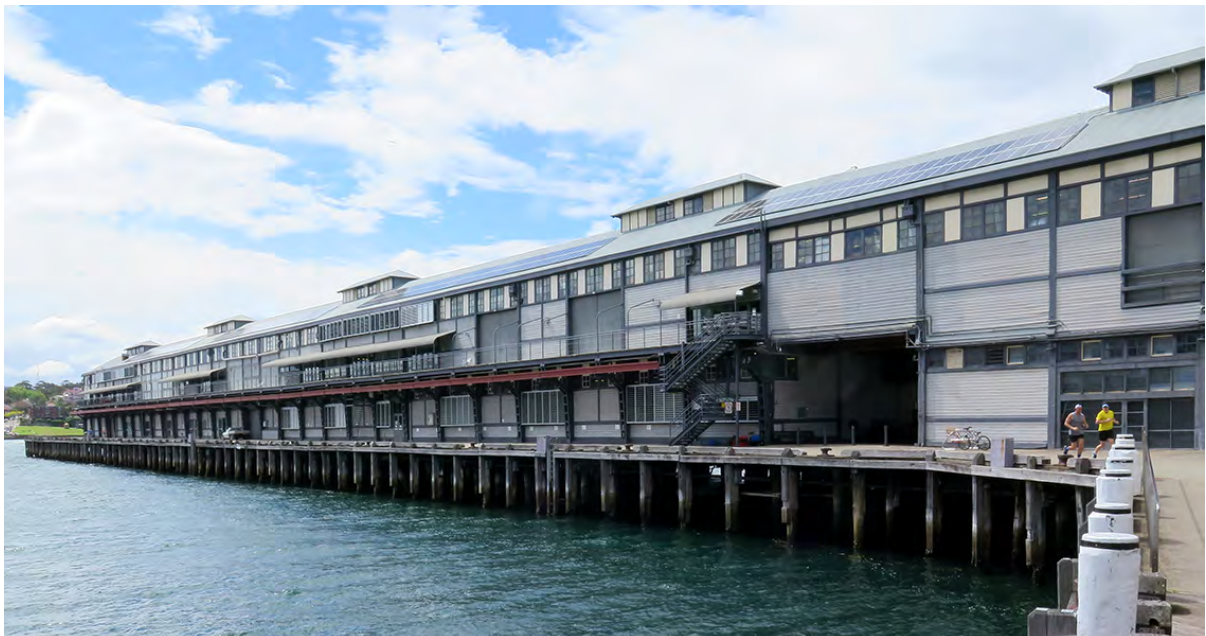
Figure 15 Western side of Wharf 4/5. (Source: CRM 2016)

- Pier 2/3 and Wharf 4/5 are constructed on a series of timber piles and comprise of a two storey warehouse structures (Figure 15 to Figure 18).
- The current sea wall comprises a dressed sandstone wall running below the wharves (Figure 19).
- The quarried sandstone bedrock can be seen on the south side of Hickson Road and Pottinger Street (Figure 20).
- The undulating surface of the former natural topography can be seen in the undulating levels of the sandstone retaining wall which has been constructed on top of the bedrock cliff face (Figure 20).
- The original timber bridges between the upper storeys of the piers and Pottinger Street have been replaced with steel bridges set on concrete plinths or steel piers (Figure 22).
- A number of underground services have been installed below the current footpaths including sewerage, stormwater and telecommunications.

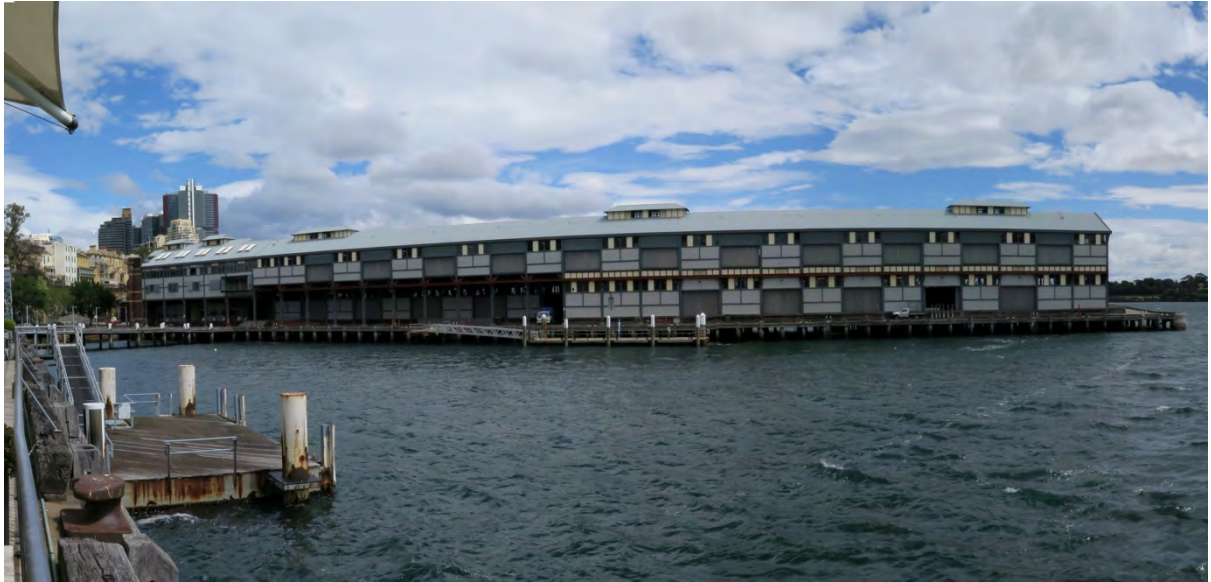
Figure 16 Eastern side of Pier 2/3. (Source: CRM 2016)

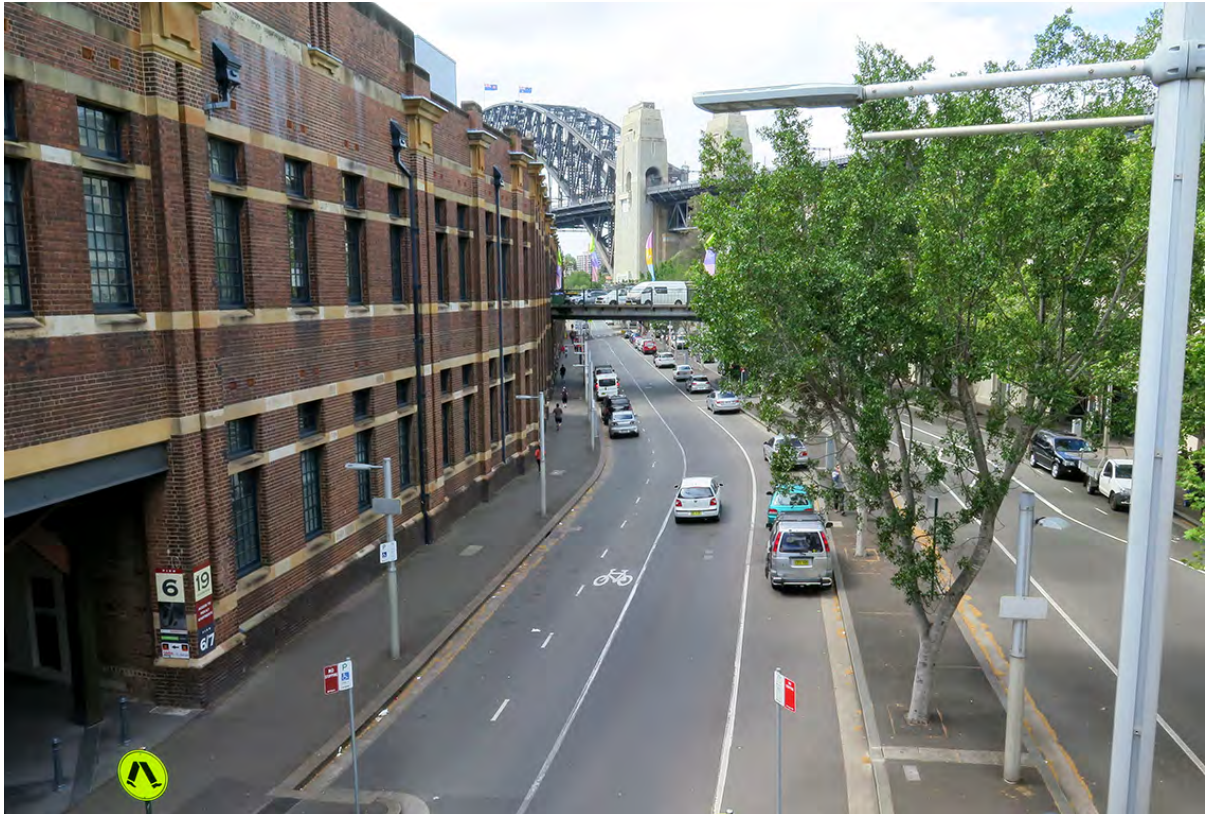
Figure 21 View east along Hickson Road. (Source: CRM 2016)

Inspection of the study site confirms the historical evidence for quarrying the sandstone headland and levelling of the Walsh Bay foreshore. This is evident at the base of the retaining wall on Hickson Road

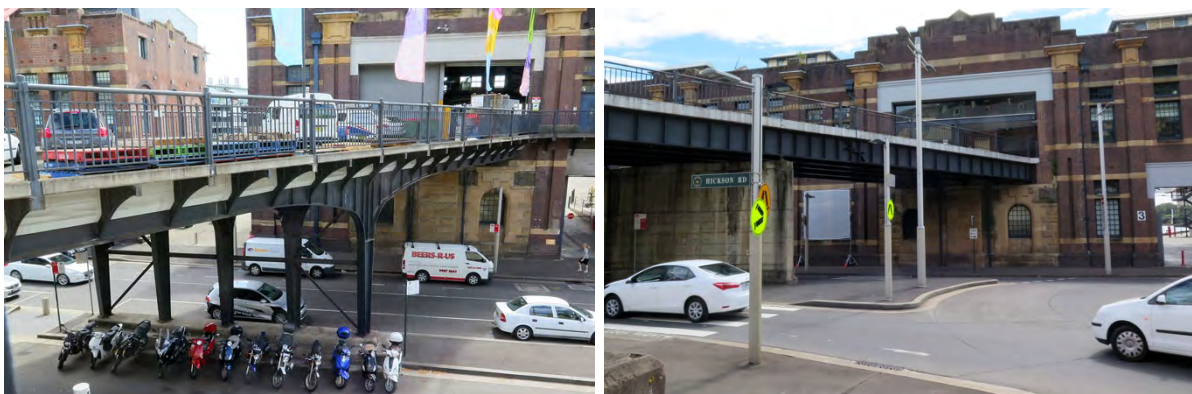
Figure 22 Bridges from Pottinger Street to Wharf 4/5 (L) and Pier 2/3 (R). (Source: CRM 2016)

Construction of the new finger wharves was completed between 1909 and 1922. The new wharves were larger and could be serviced on two levels, taking advantage of the topography by using a series of timber bridges from Lower Fort Street. These bridges have since been upgraded but remain in use today.
