Project 72744.04  
3 July 2015  
GSY:dh

## **Earthworks Report for Southlands Industrial Park, Stage 2 Southlands Industrial Park, Banksmeadow**

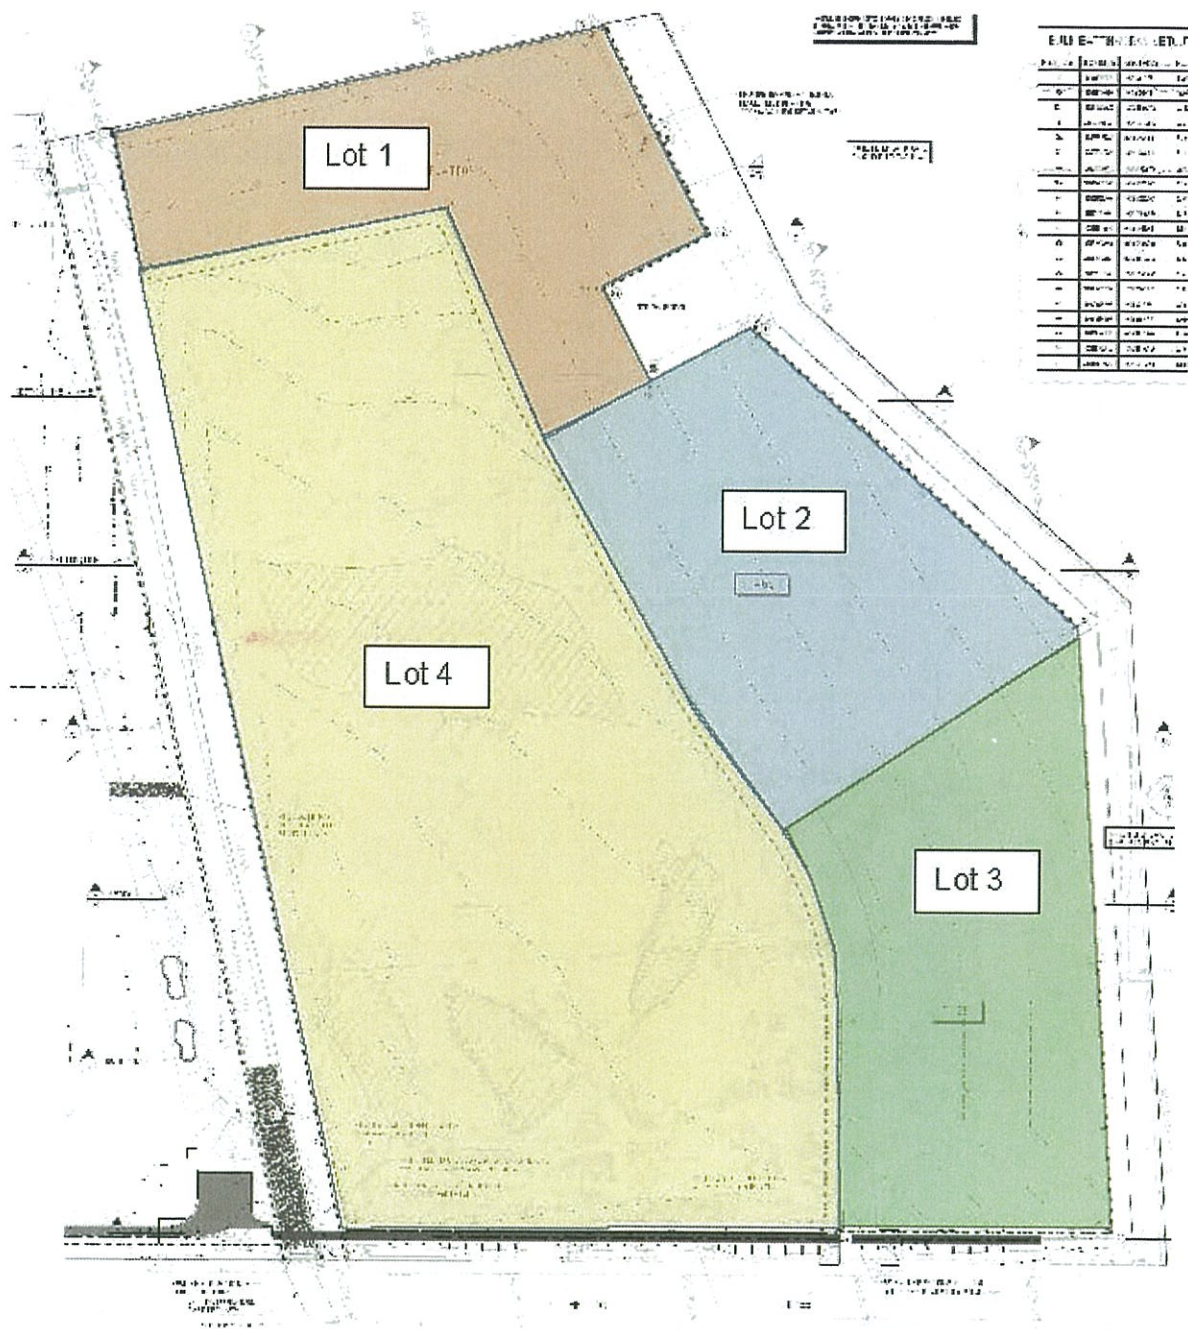
For earthworks purposes, the earthworks contractor, Enviropacific, divided the site into four areas, which were nominally called Lots 1 to 4 and the works were generally carried out on in stages. Earthworks was generally restricted to Lots 1, 2 and 3 with little earthworks carried out on Lot 4, which was the biggest lot. See attached plan for site drawing.
