**SPECIALIST ADVICE TO  
RTL INVESTMENTS 2 PTY LTD AS TRUSTEE FOR  
RTL MARRICKVILLE PROPERTY TRUST ('RTL CO.')**  
**ON  
GEOTECHNICAL INVESTIGATION**

**FOR  
PROPOSED MIXED USE DEVELOPMENT**

**AT  
FARR STREET, MITCHELL STREET, VICTORIA ROAD,  
& SYDENHAM ROAD, MARRICKVILLE, NSW**

Ref: 36478YCrpt2rev1

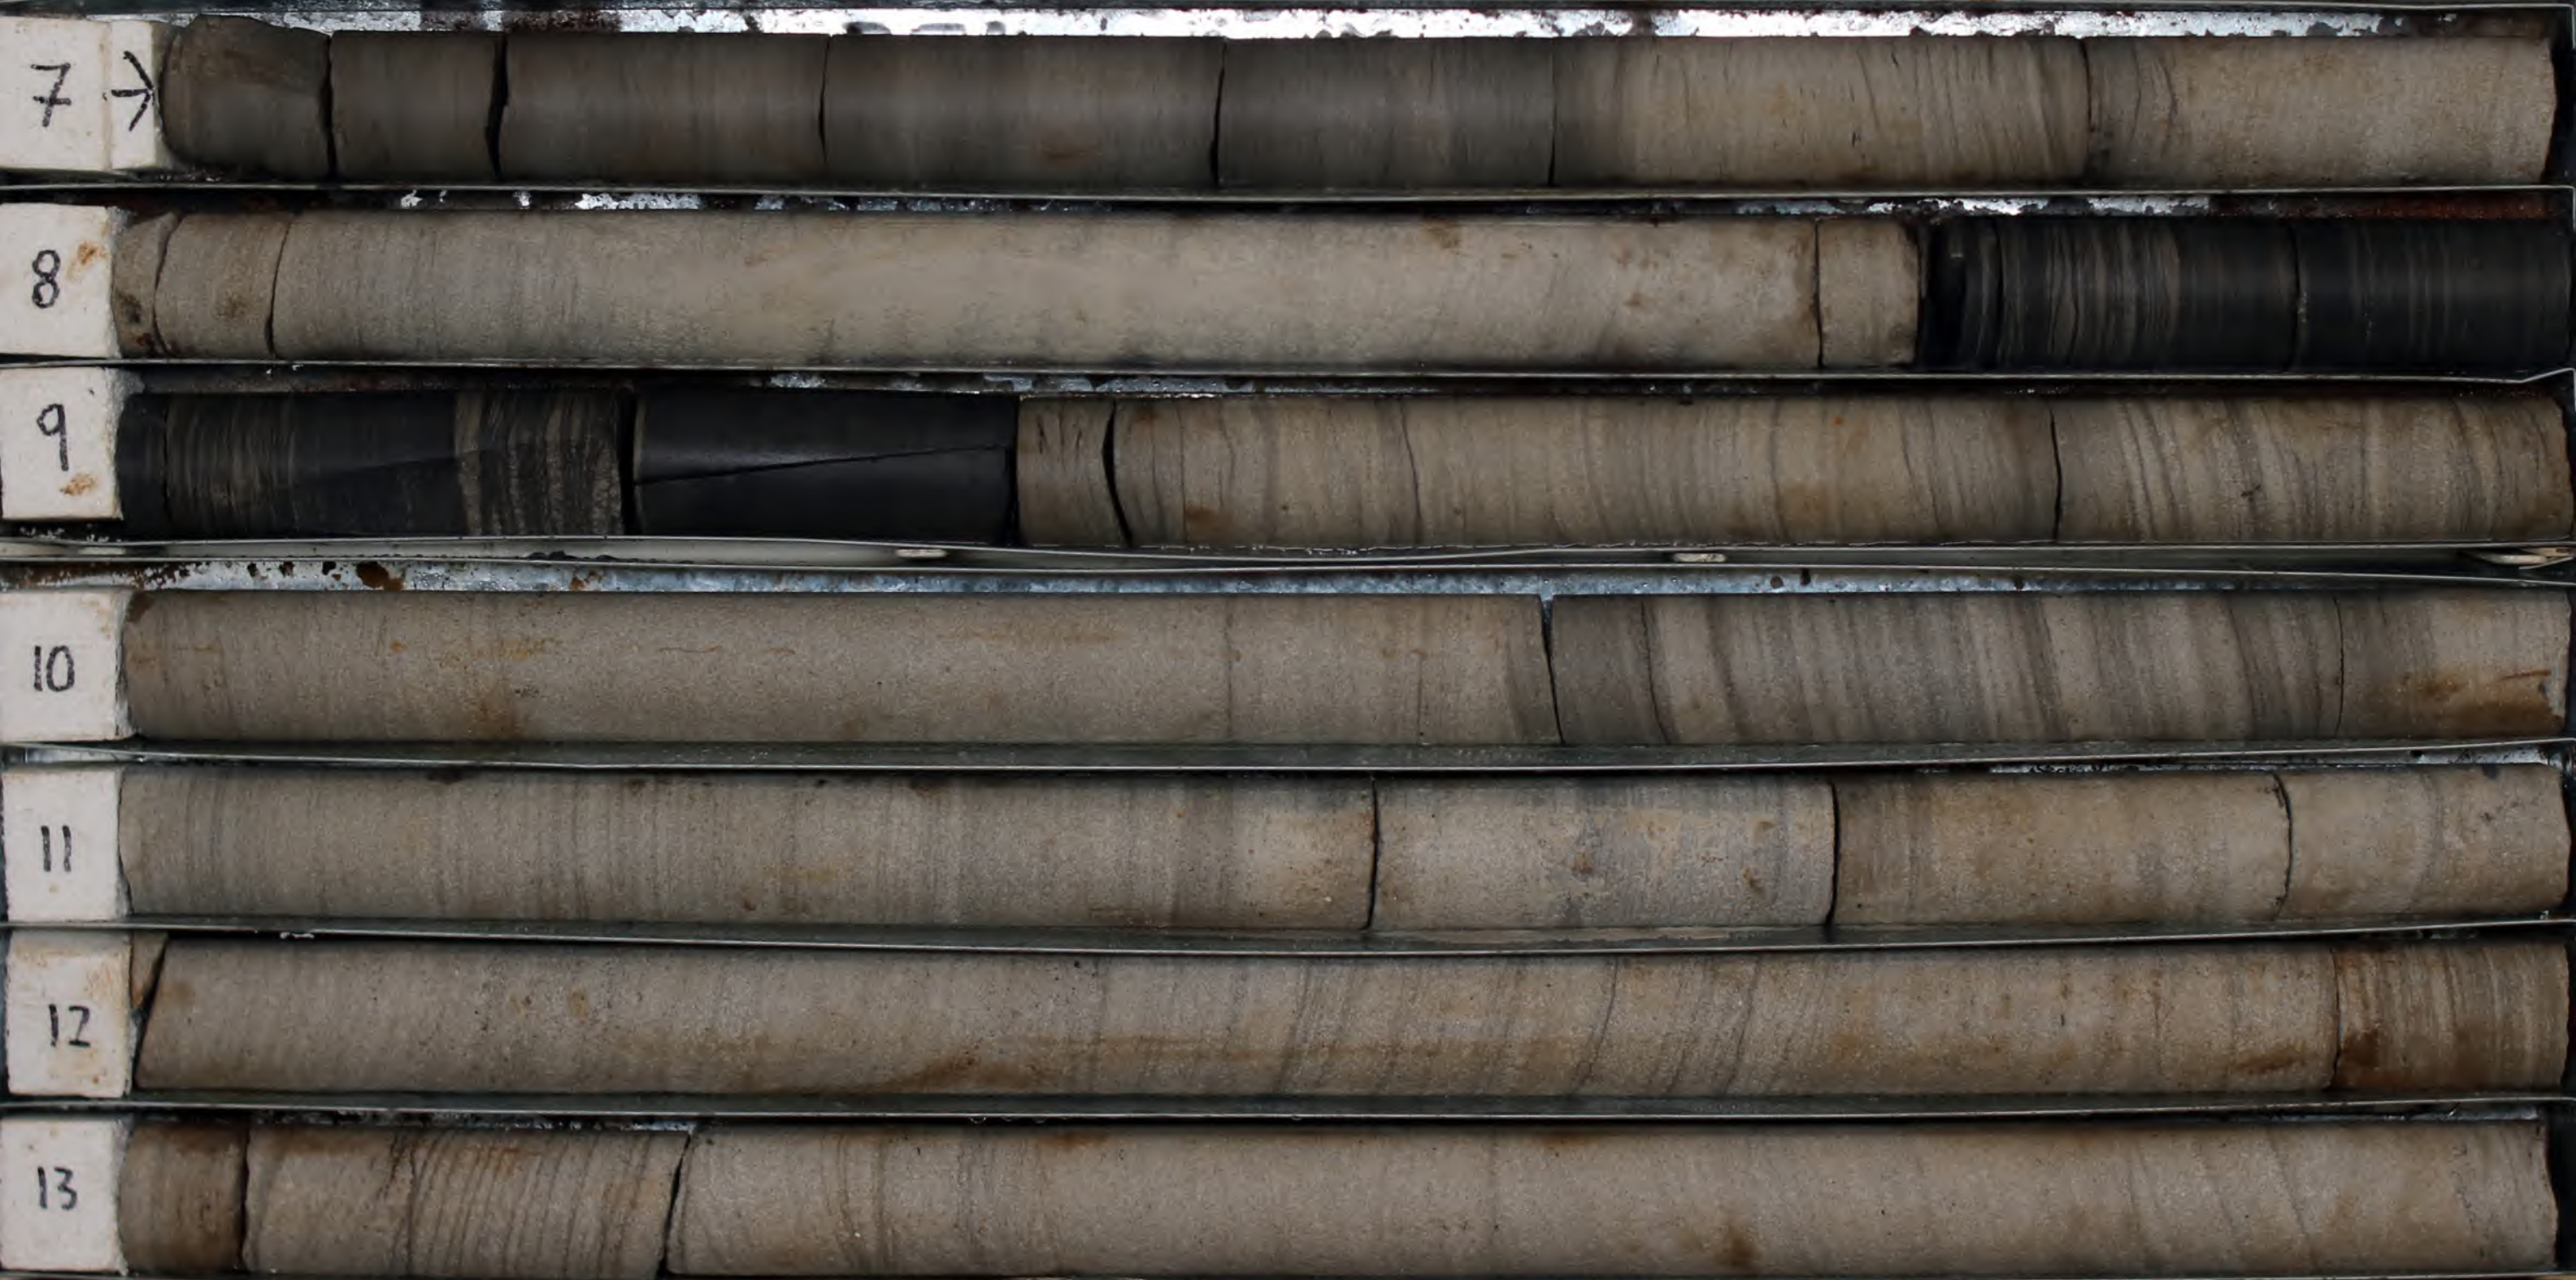
Job No: 36478YC  
Borehole No: BH201  
Depth: 7.02m to 14.00m

36478YC BH201 START CORING AT 7.02m

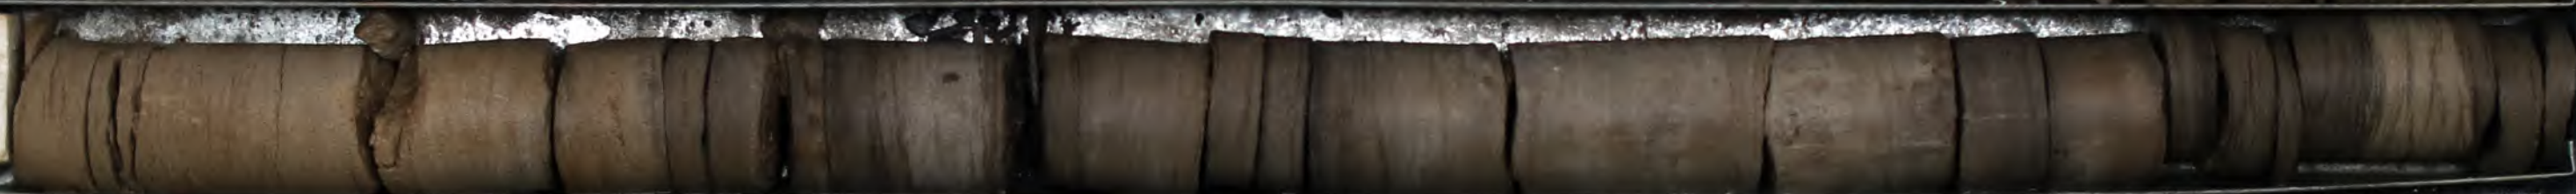
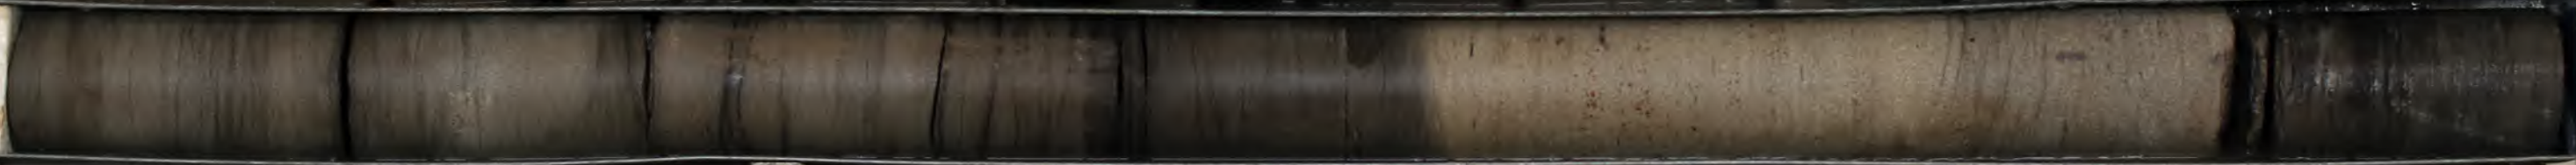
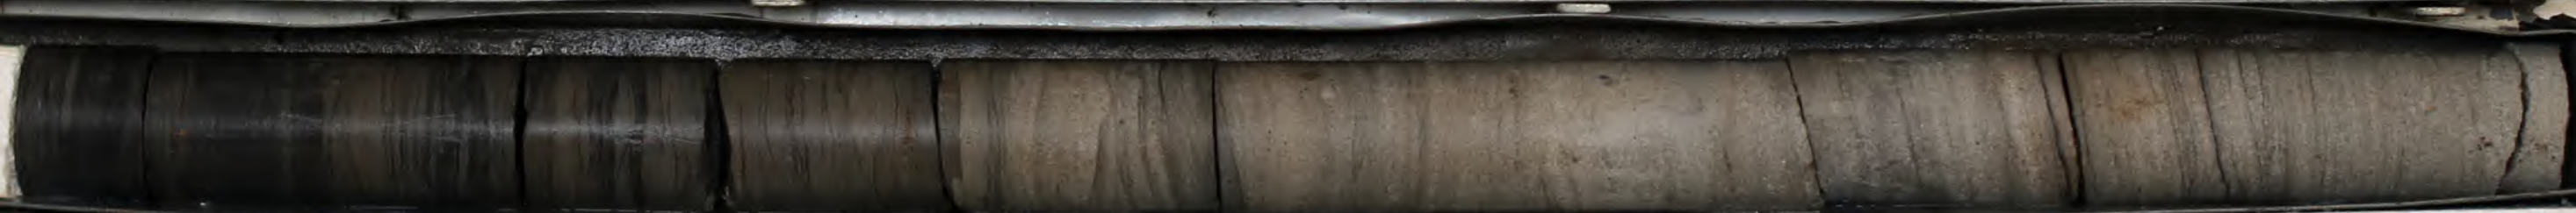
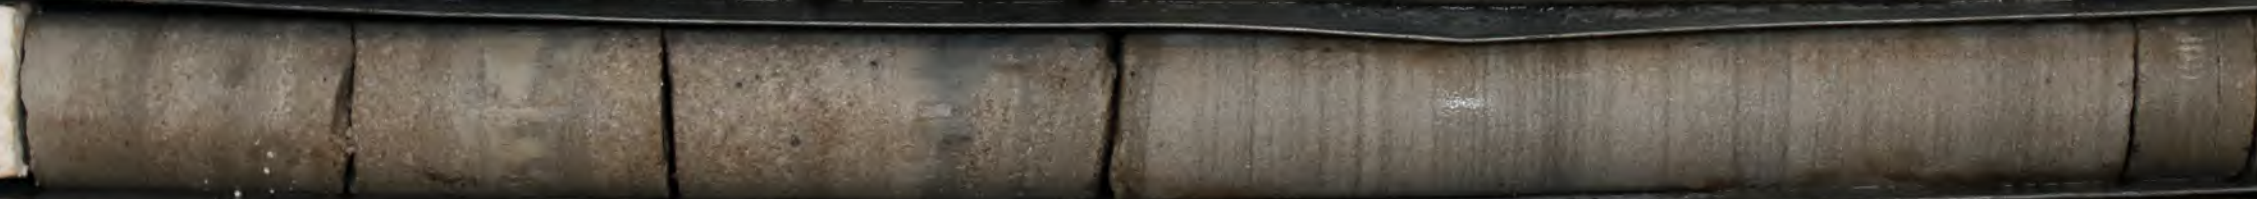
Job No: 36478YC  
Borehole No: BH205  
Depth: 5.82m to 9.77m

36478YC BH205 START CORING AT: 5.82m

EOH AT 9.77m

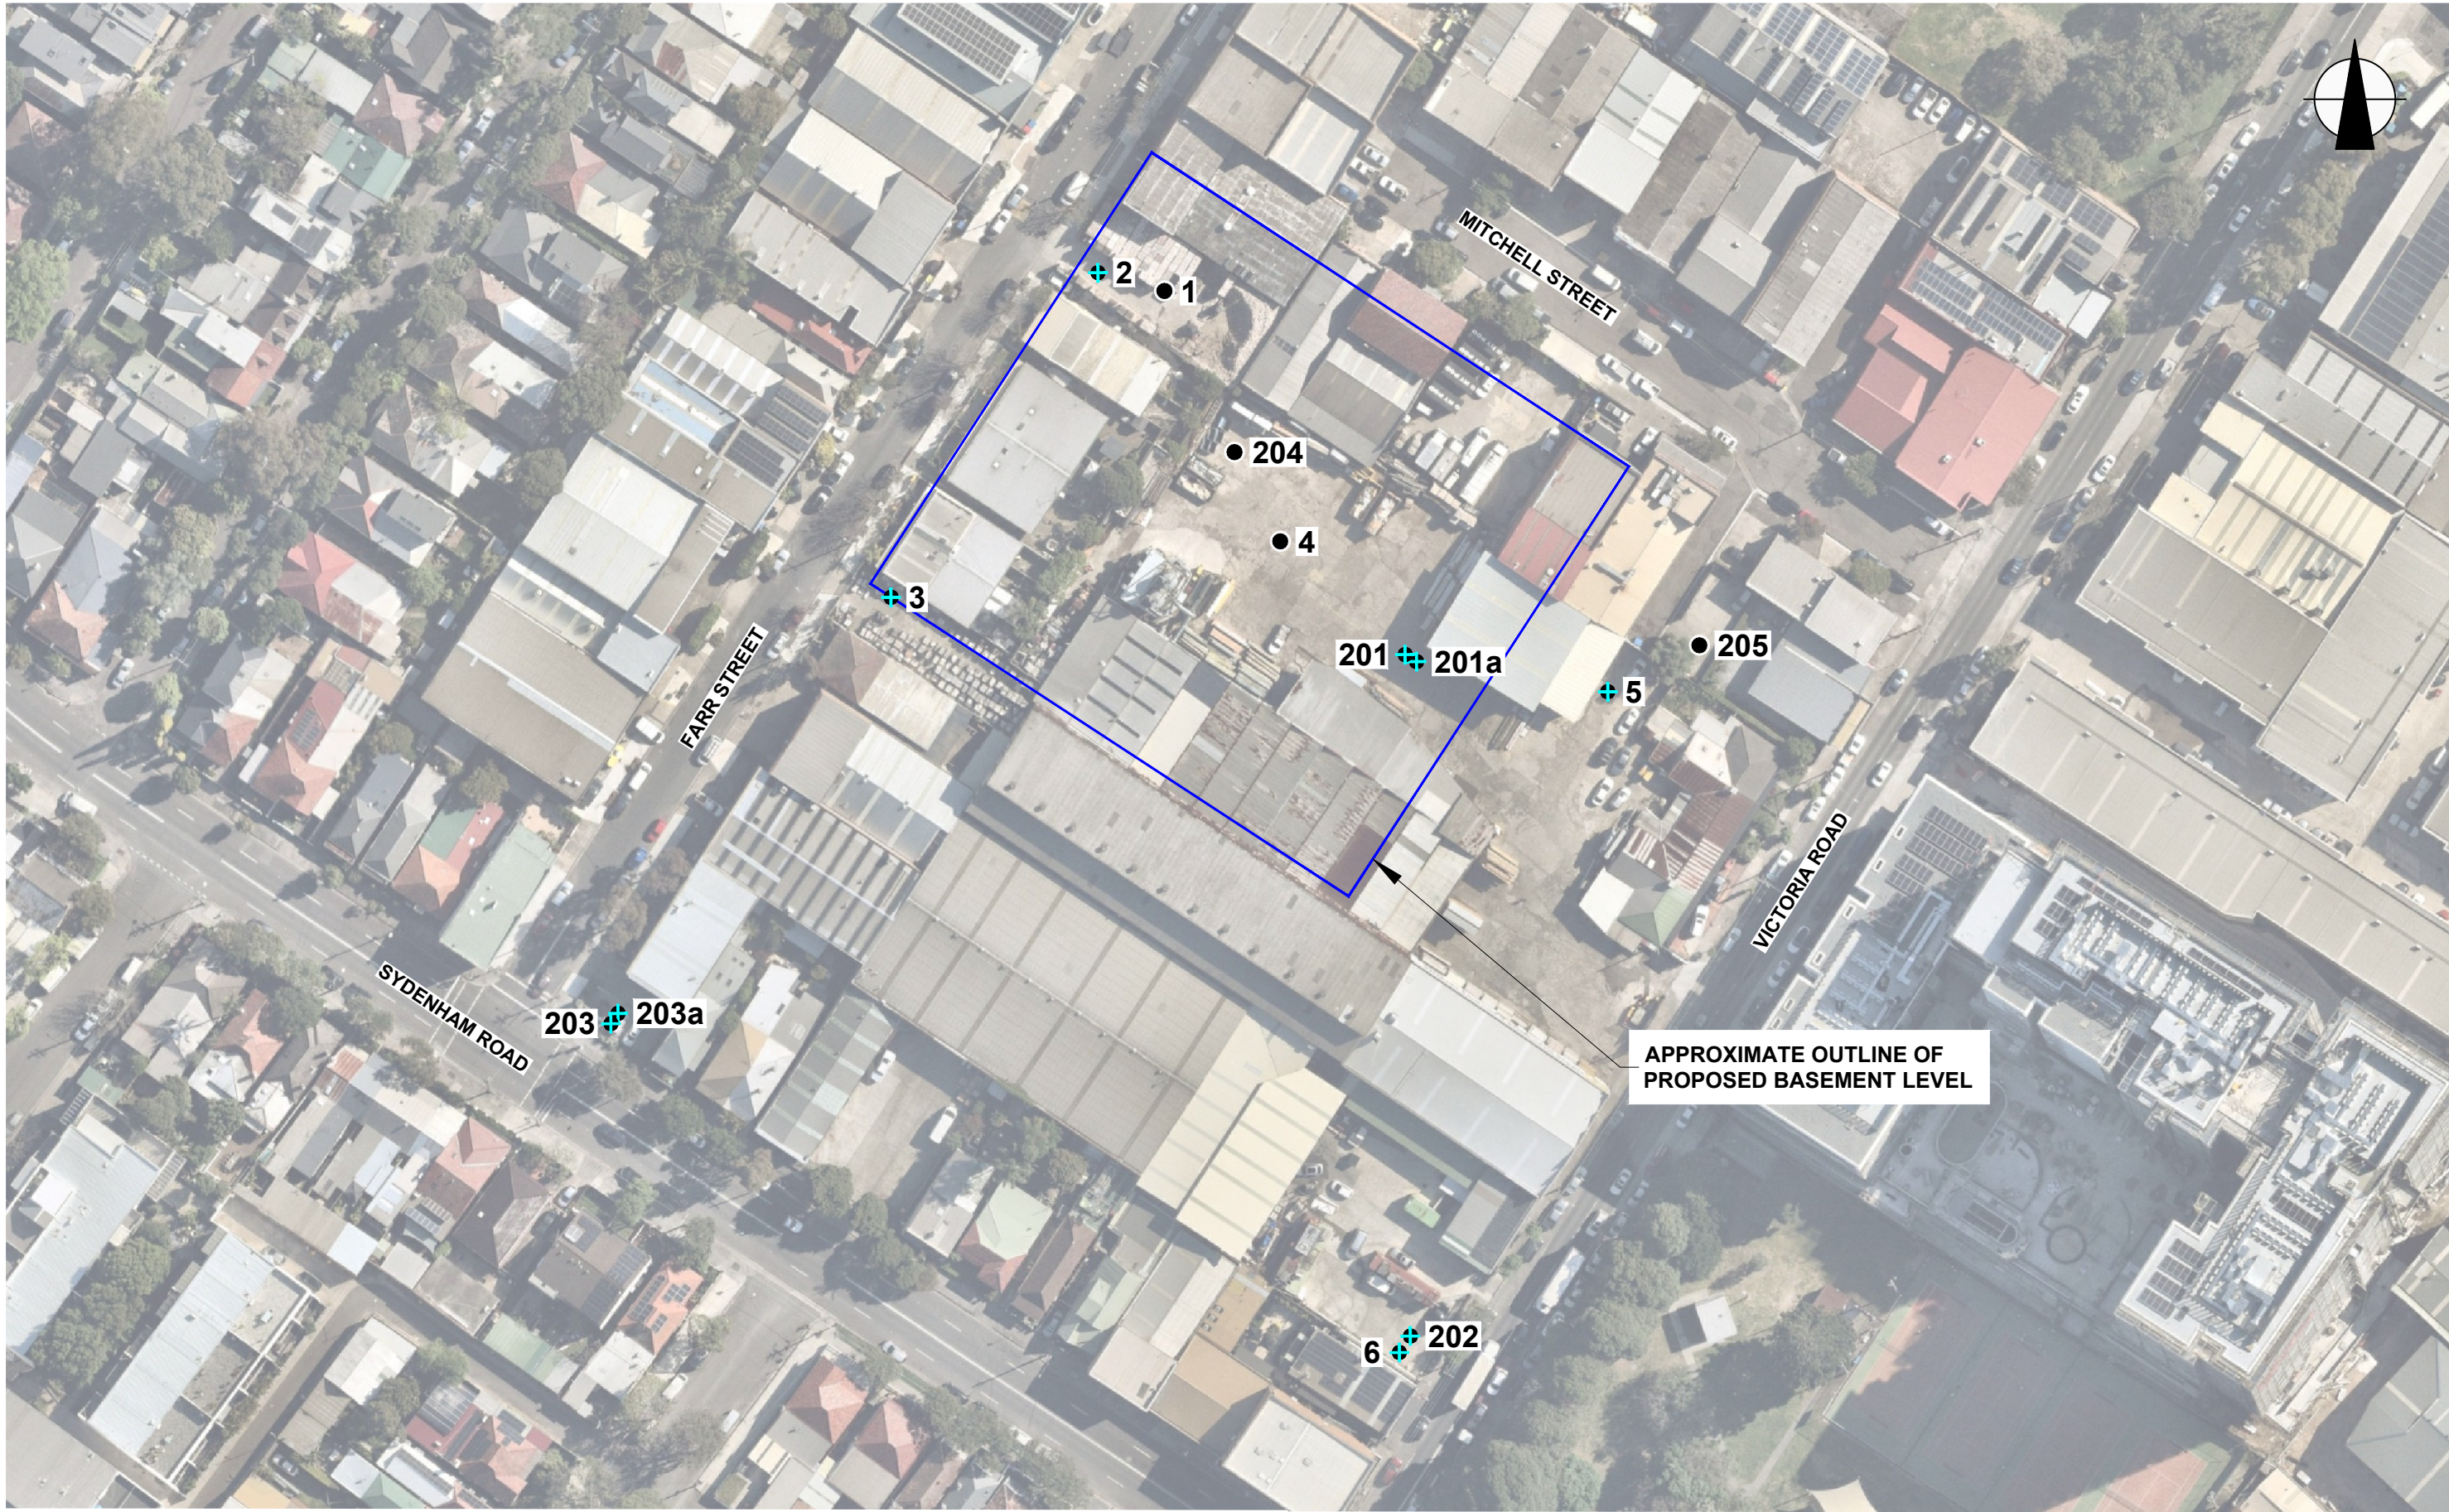
LEGEND

- BOREHOLE
- ✚ BOREHOLE AND GROUNDWATER MONITORING
