Oakdale East Estate
SSD-37486043

Biodiversity Development Assessment
Report

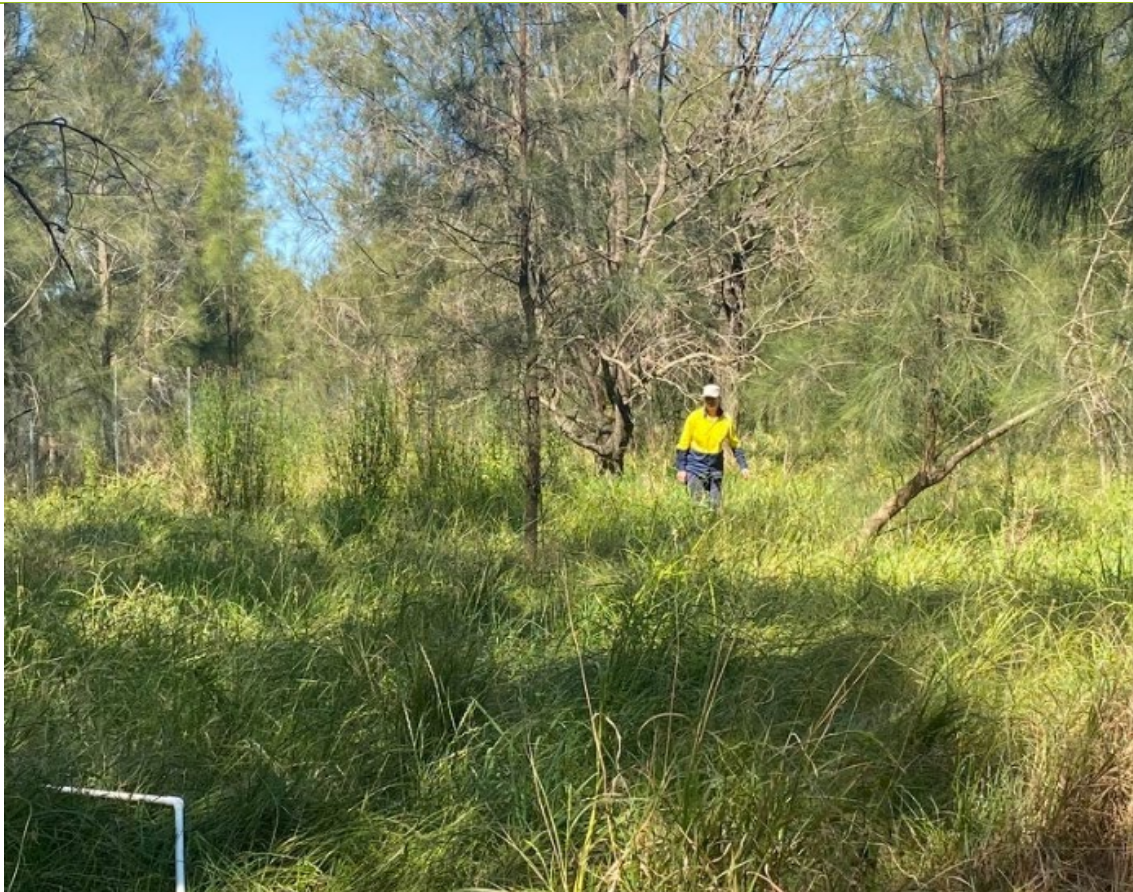
Photo 10. PCT 1800 Zone 1 (poor condition) - location of plot / transect data collection

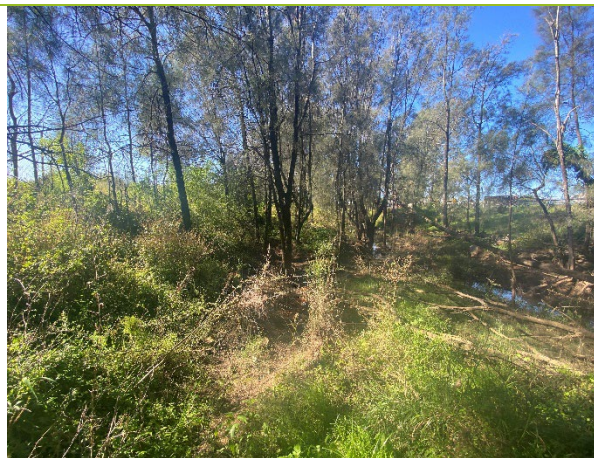
Photo 11. PCT 1800 Zone 1 (low-moderate condition) - location of plot / transect data collection

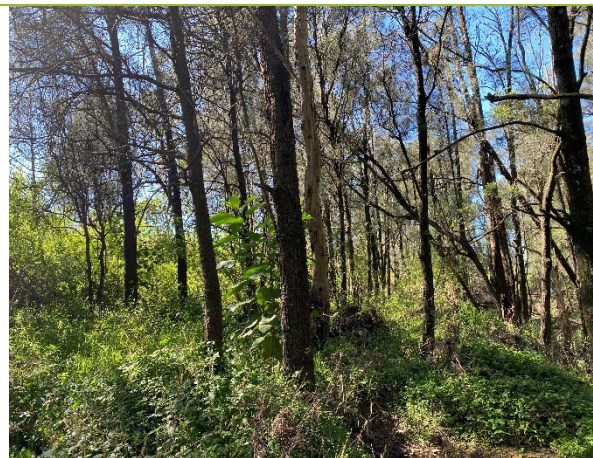
Photo 12. PCT 1800 Zone 1 (low-moderate condition) - location of plot / transect data collection

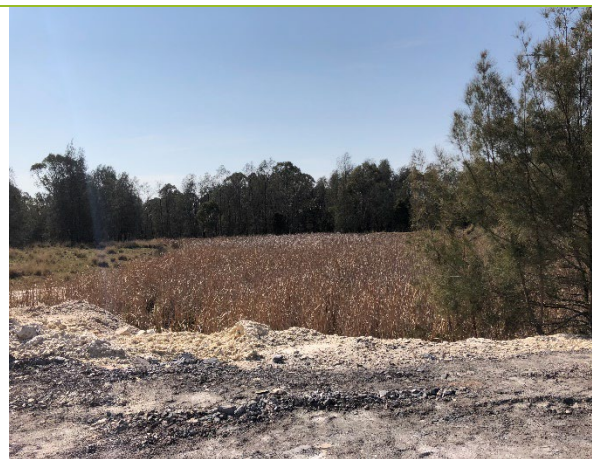
Photo 13. PCT 1071 location of plot data`

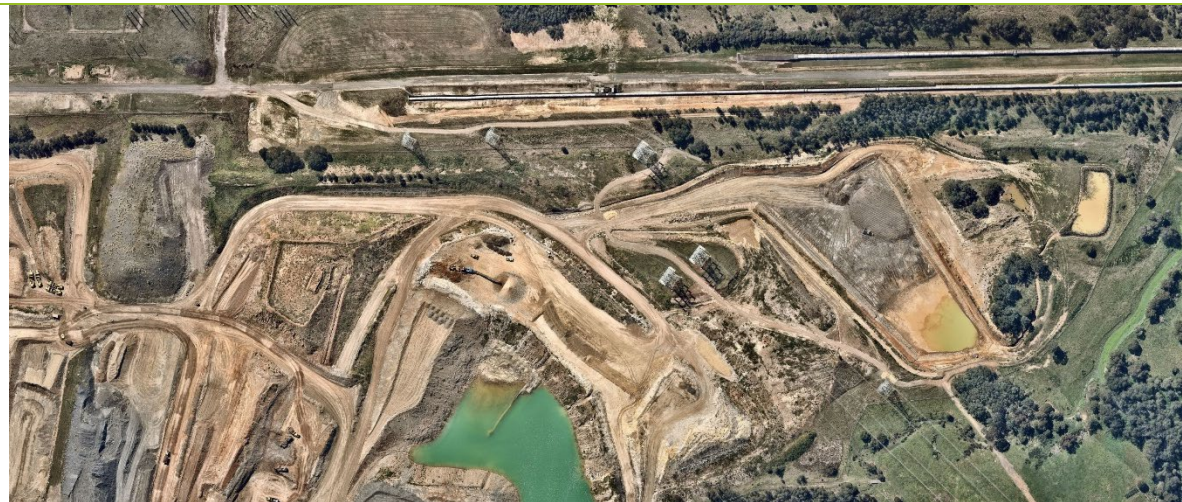
Photo 21. Aerial photograph (October 2020)

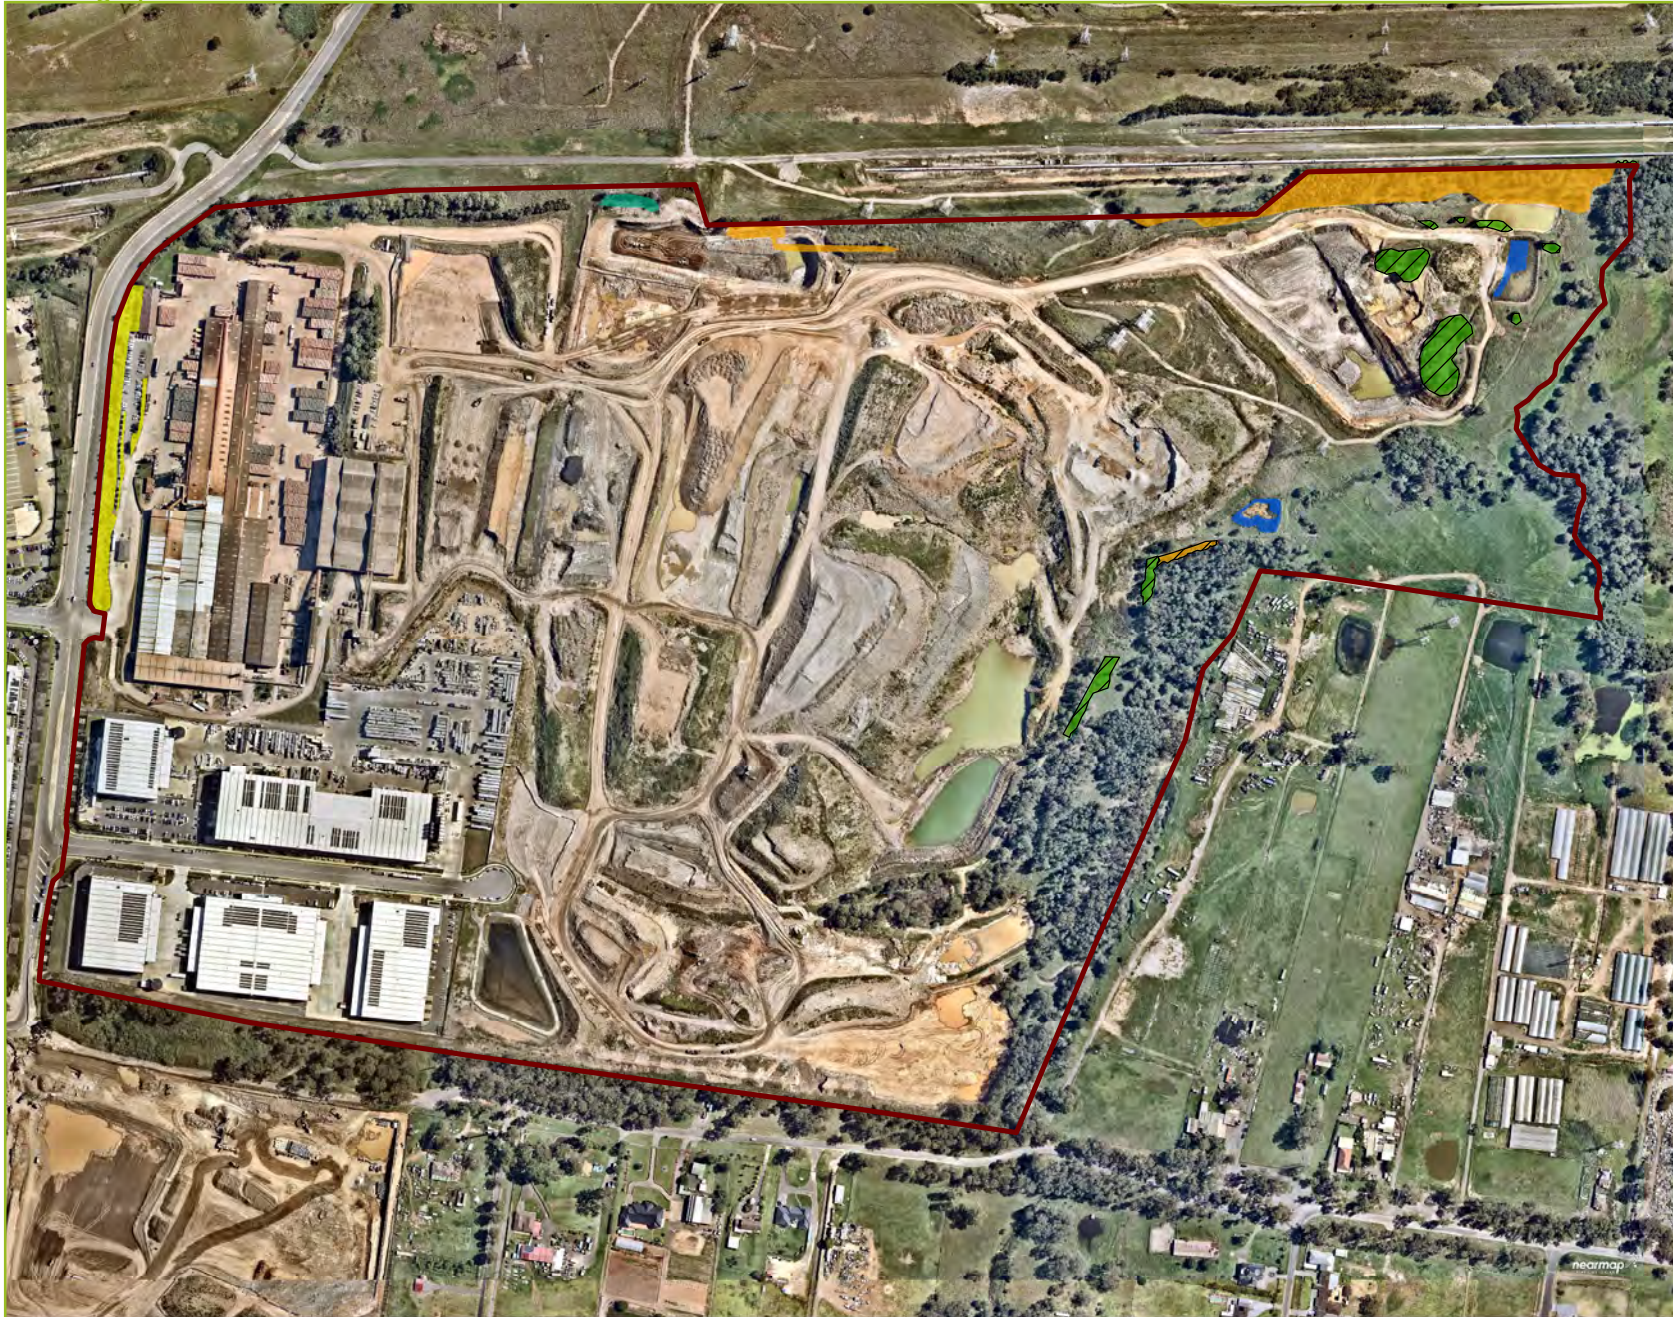
Oakdale East Estate SSD-37486043

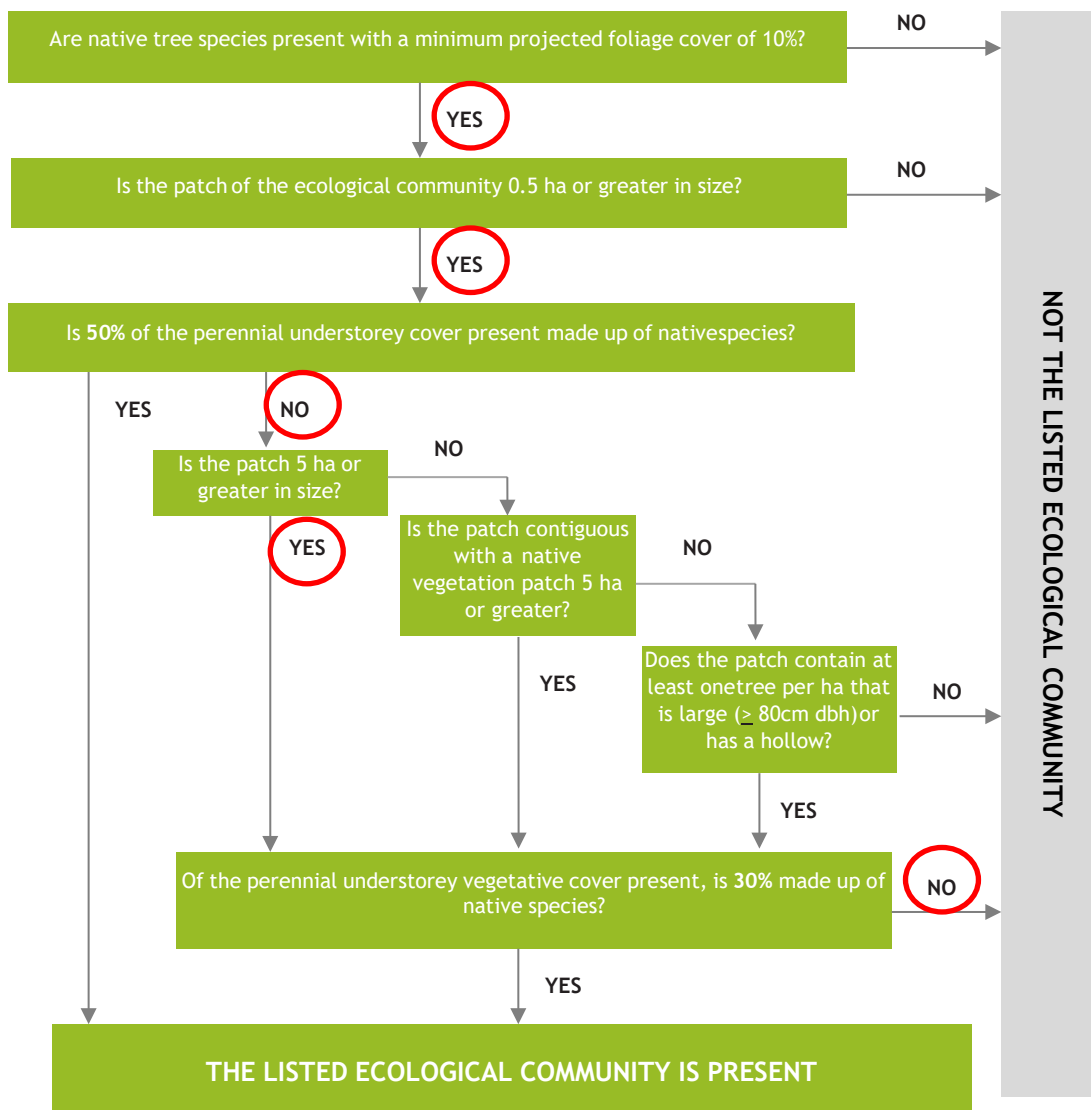
Figure 5-1. CPW diagnostic features and condition thresholds (adapted from DAWE guidelines, 2010)

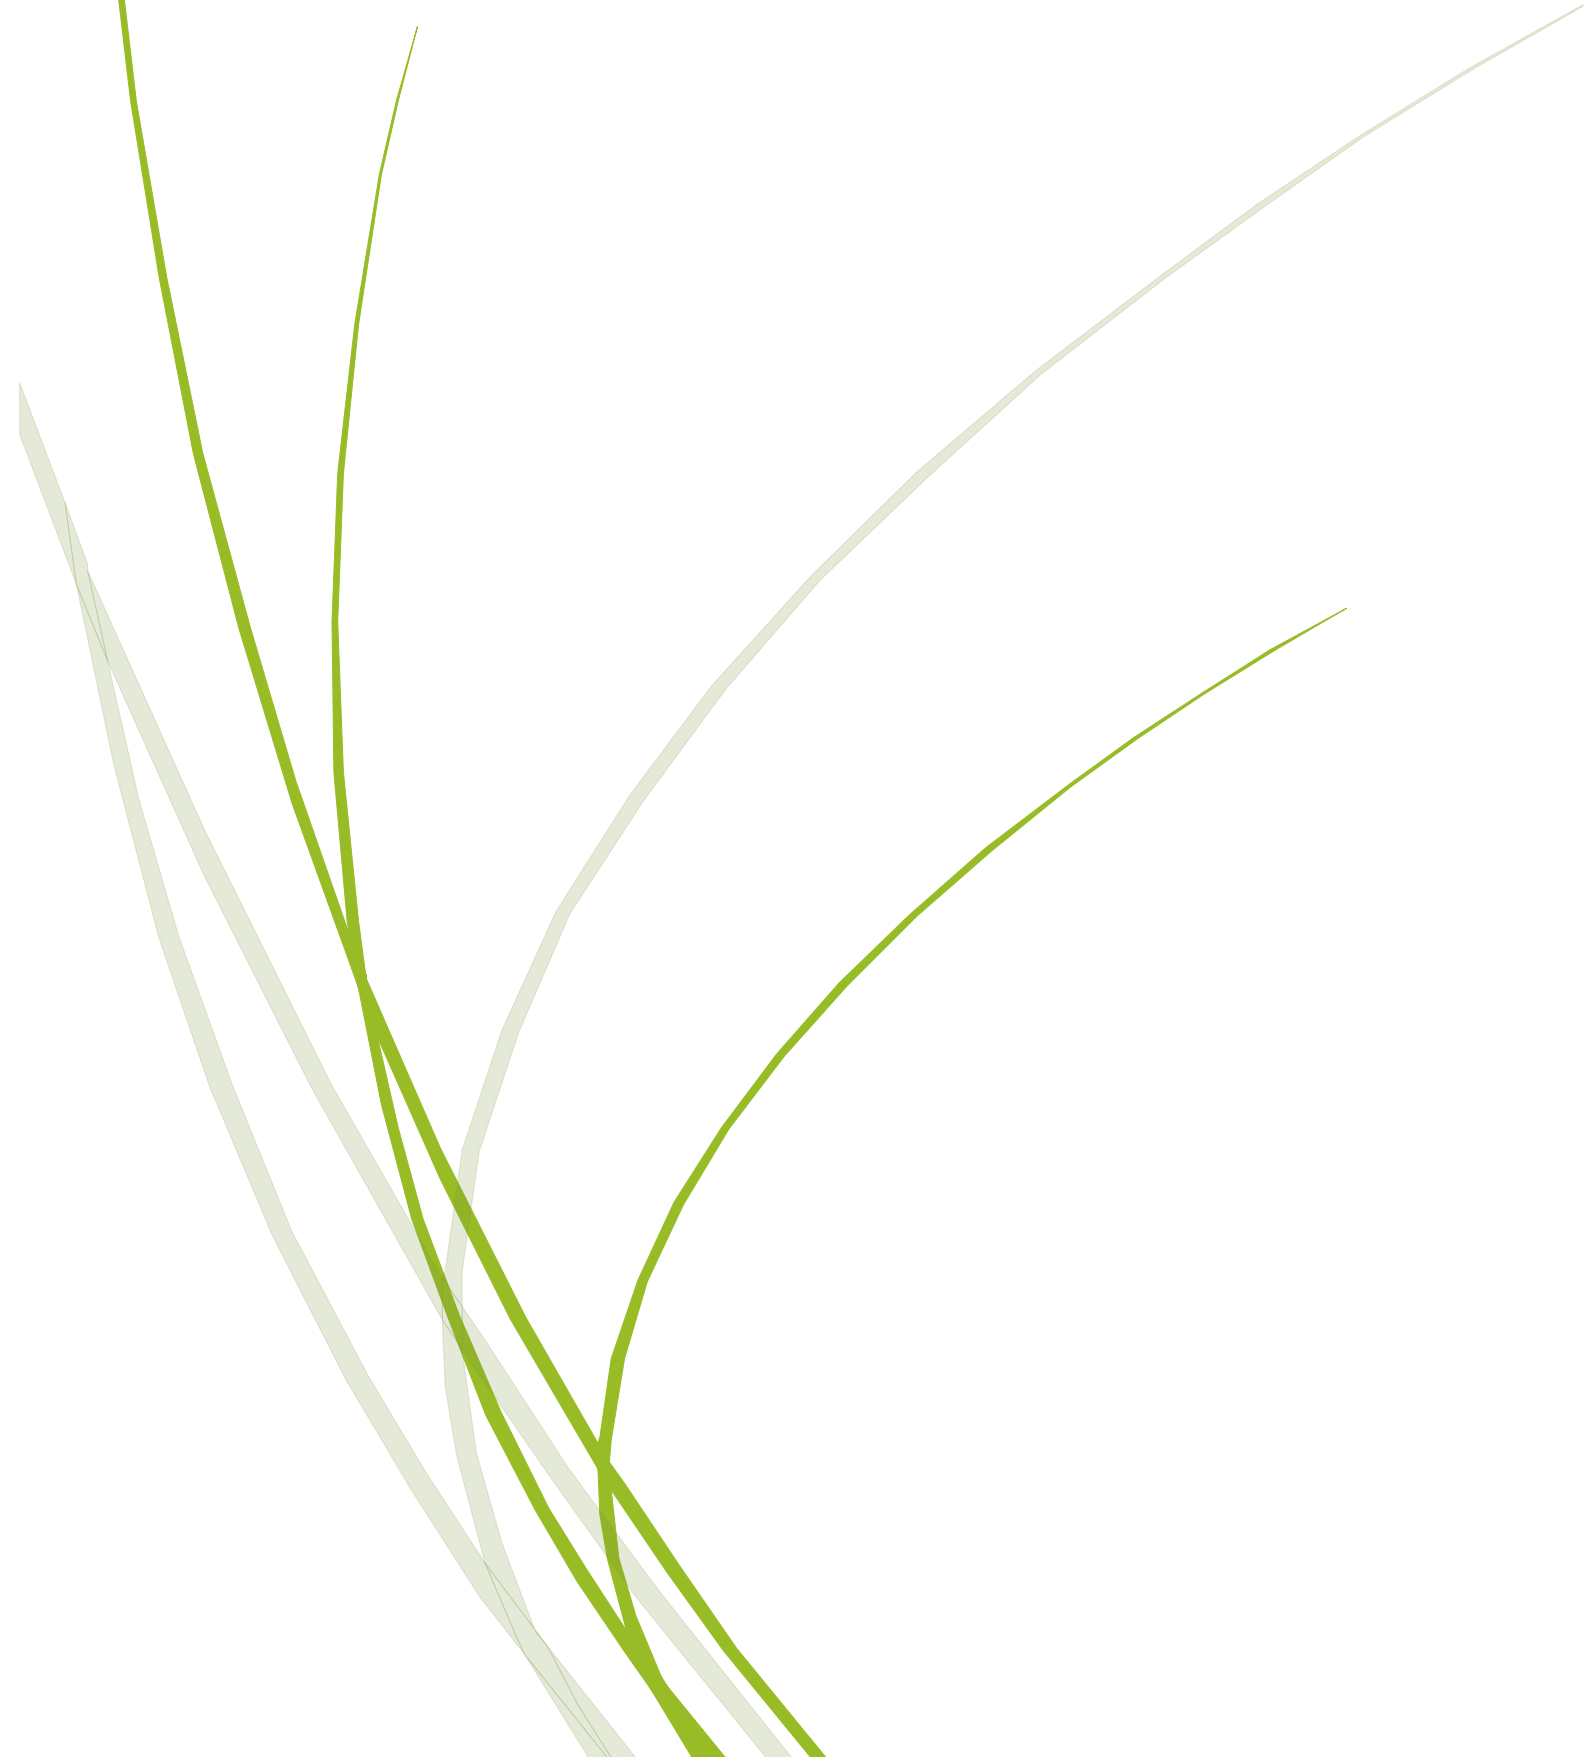
Appendix B. BAM summary reports

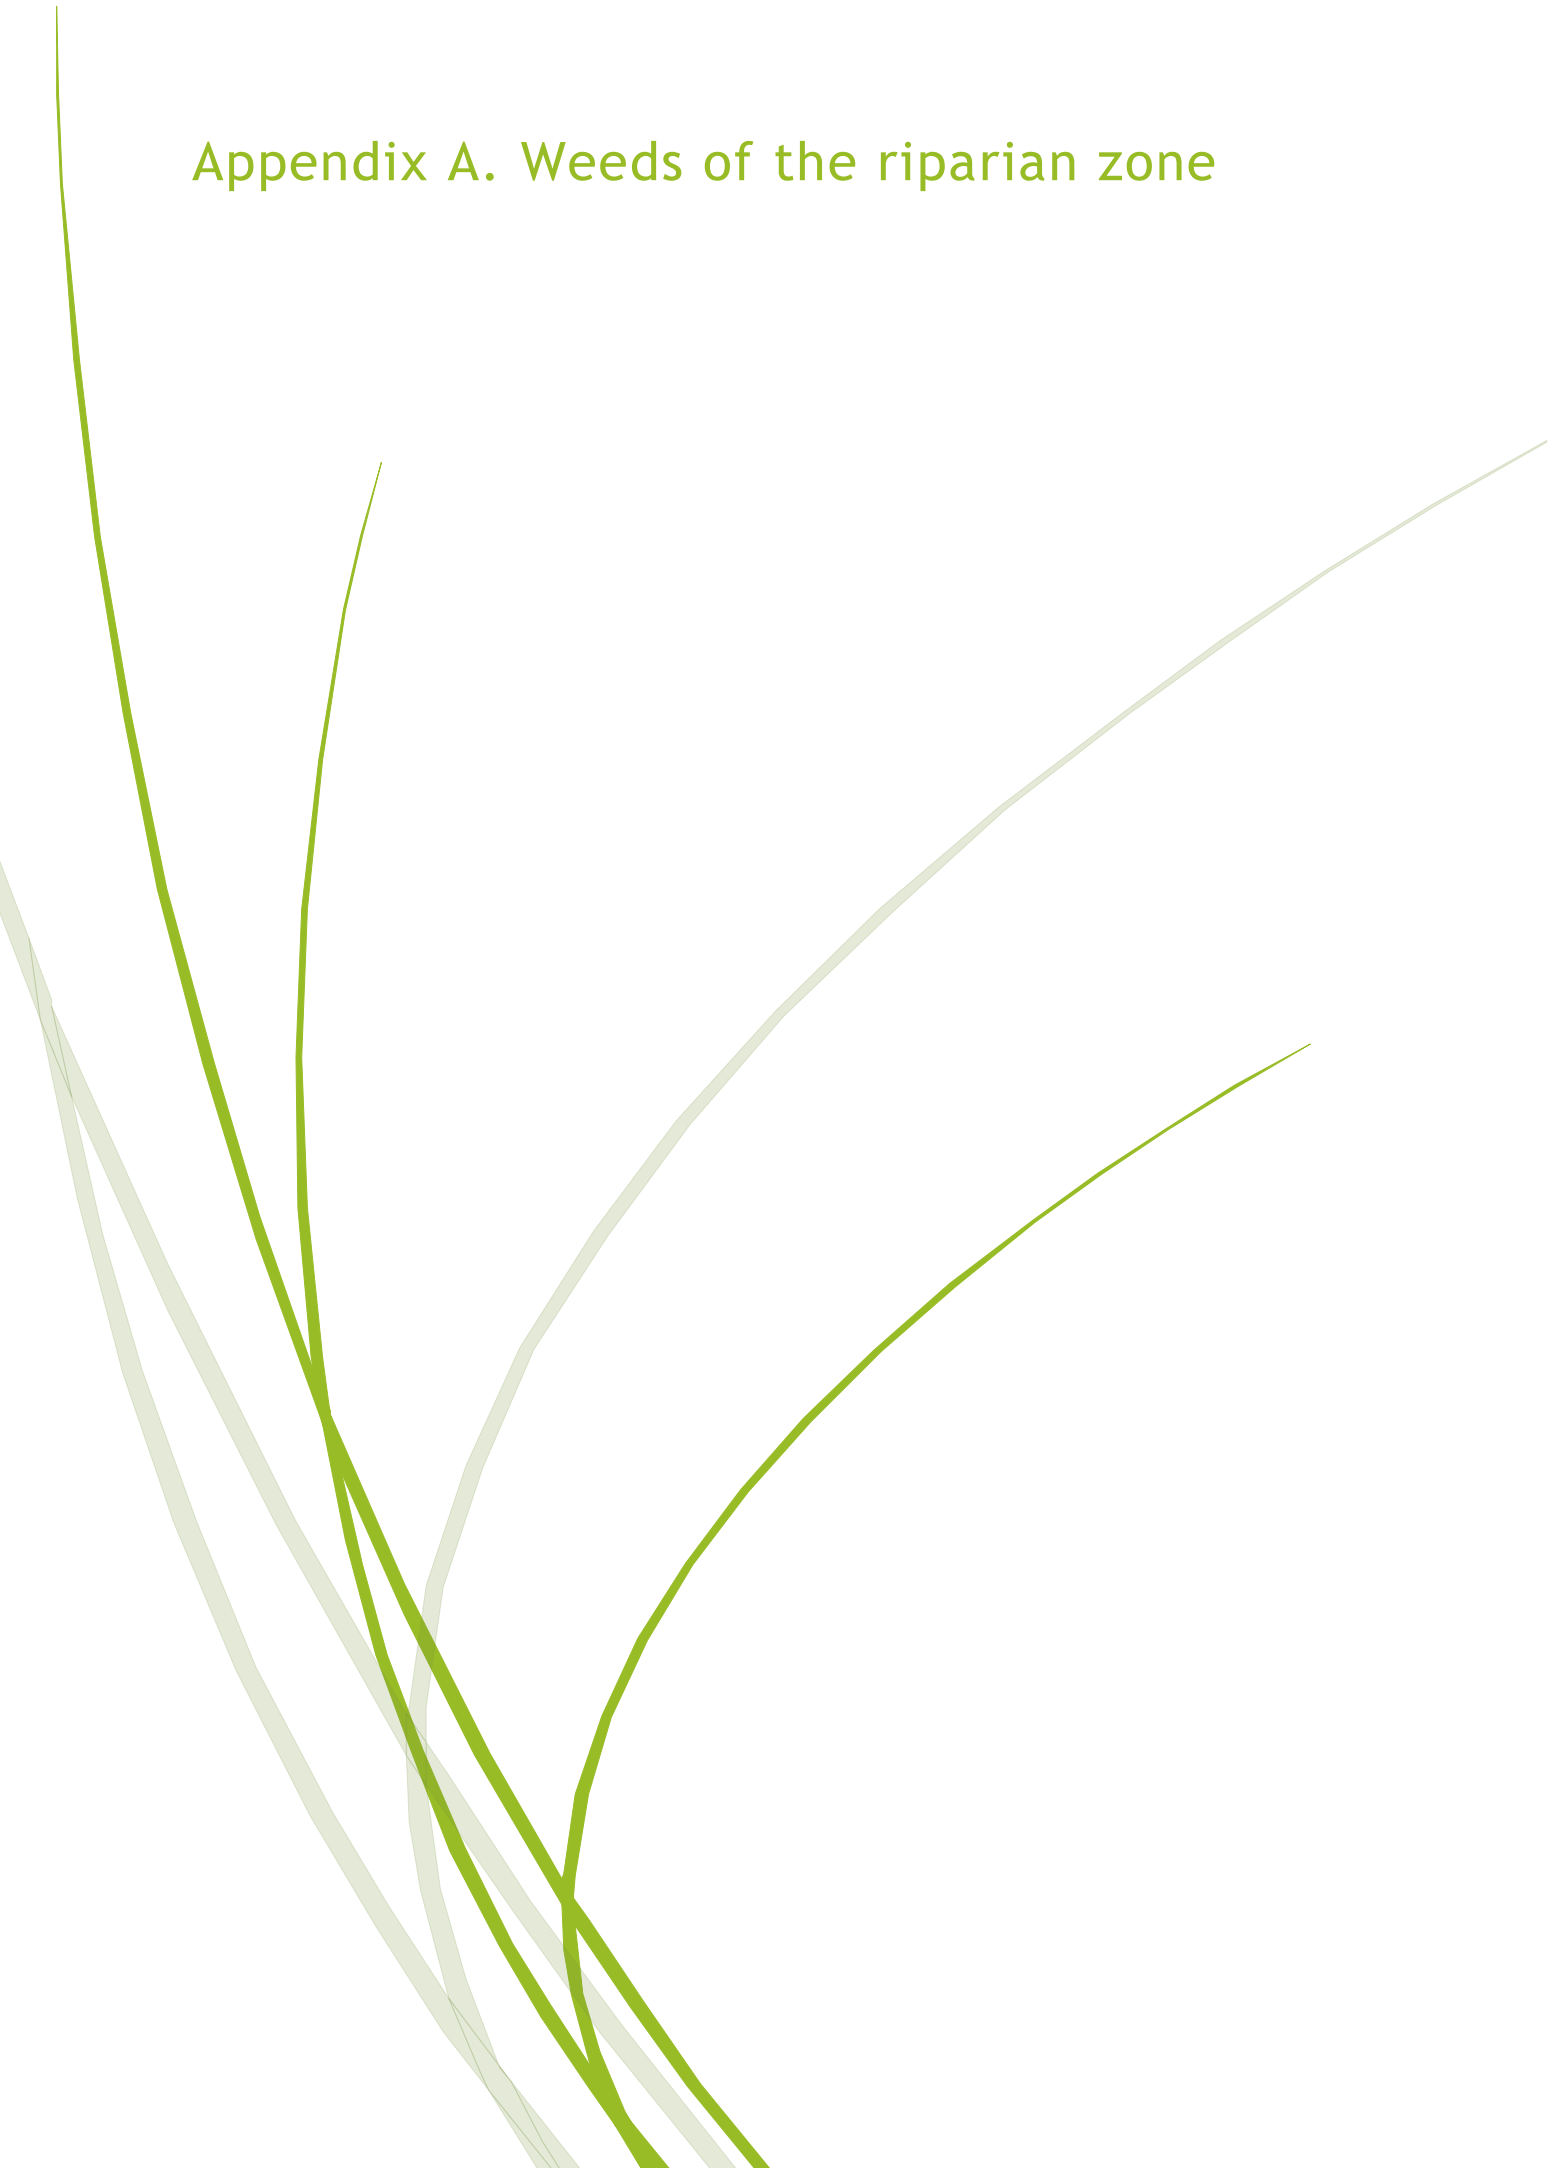
Appendix A. Weeds of the riparian zone
