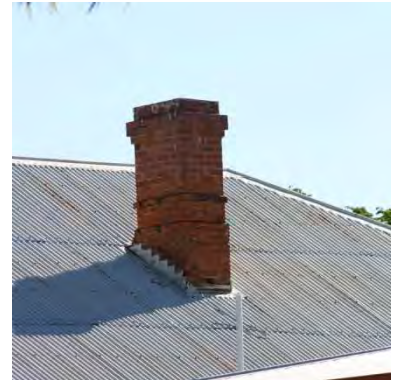
**Figure 63** 1868 building exterior showing original chimney

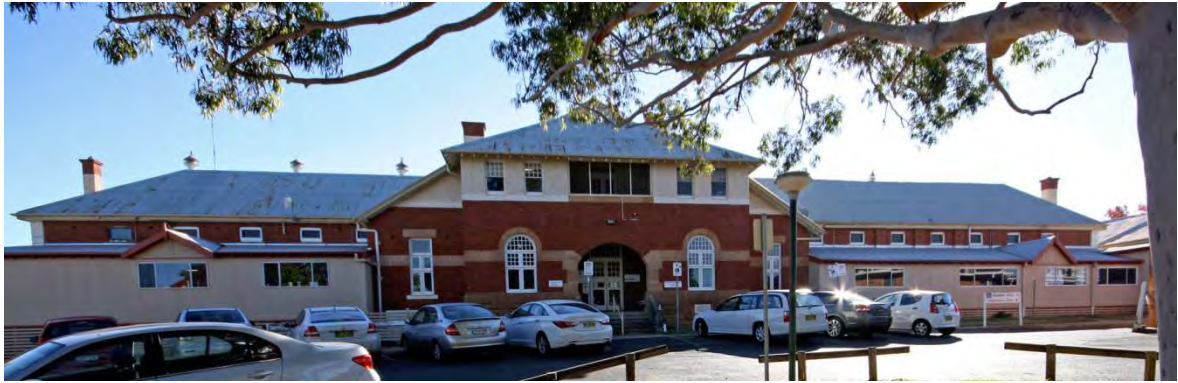
**Figure 70** Completed hospital building with 1887, 1907 and 1913 wings. Intrusive infill to verandah greatly reduces the aesthetic impact of the building.

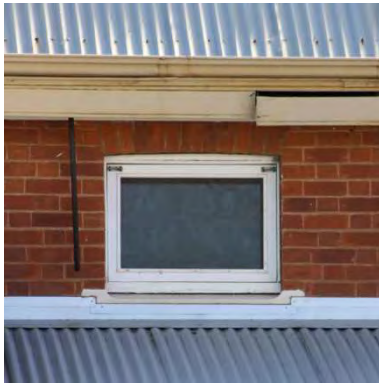
**Figure 80** 1887/1907 building exterior showing highlight ventilation window – note Flemish bond to brickwork

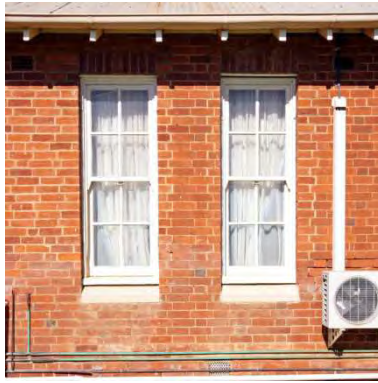
**Figure 105** c1890 additions exterior north face showing 1926 windows cut into wall. The discoloured mortar shows where bricks were removed. Wells' drawings show these as 12 pane d/h

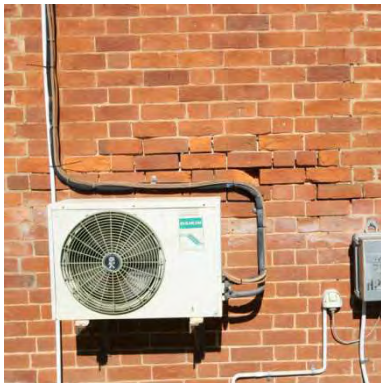
**Figure 107** c1890 external wall where the soft bricks are being seriously damaged by air conditioning unit – the units need to be removed

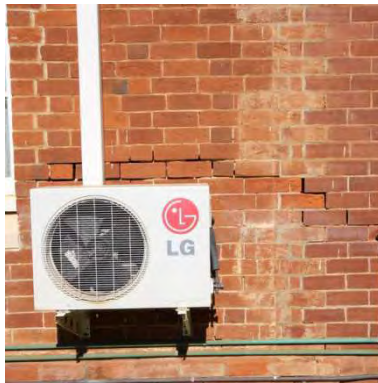
**Figure 108** c1890 external wall at junction with 1926 addition where the stronger bricks are not suffering as greatly.

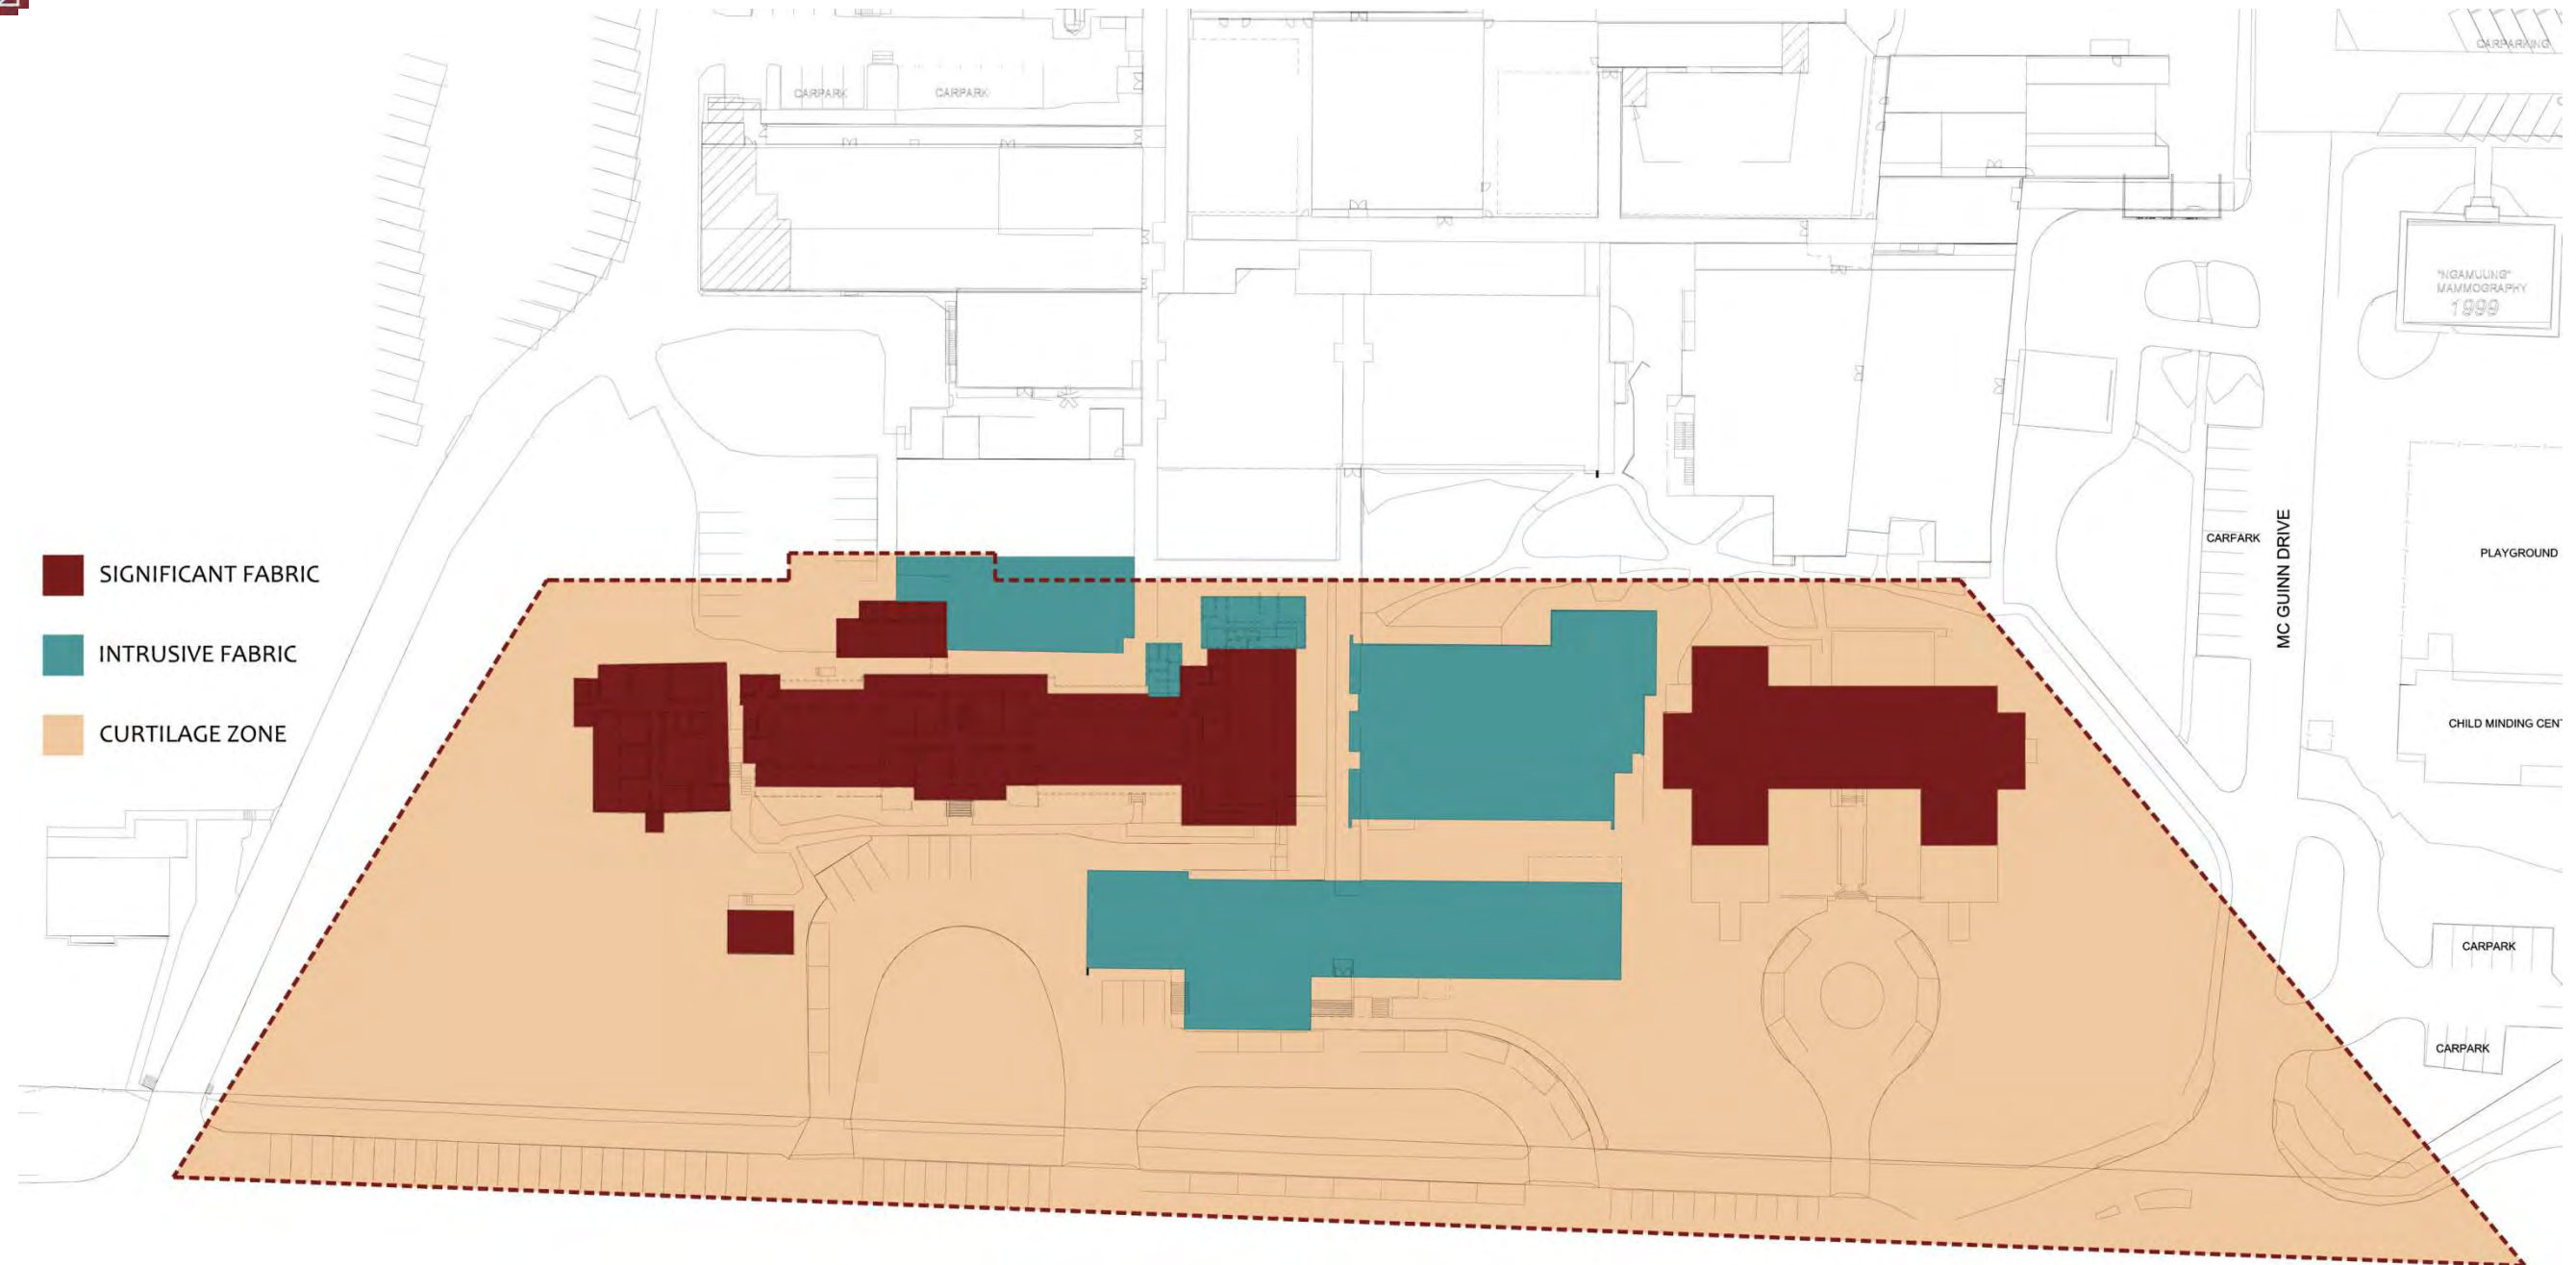
**Figure 138** Curtilage diagram establishes the heritage precinct and defines the significant and intrusive items – Adaptive Architects Pty Ltd 2016

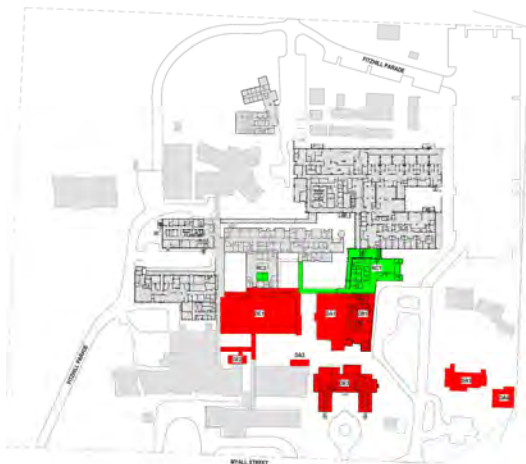
**Figure 145** The full extent of demolition over the course of the complete works. The only building of heritage value is the 1936 former Nurses' Building (George Hatch) - Rice Daubney 2016

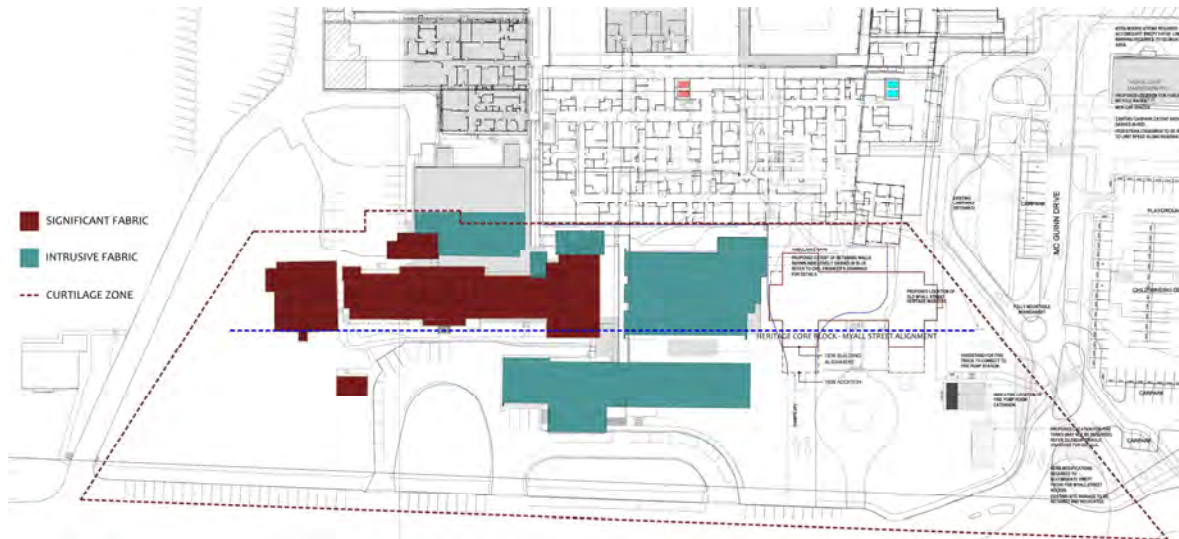
**Figure 148 Detailed Ground Plan overlaid with curtilage zone** – The new clinical building to the immediate north of the curtilage zone brings the central functions of the hospital into close proximity with the heritage core buildings, which will ensure they continue to be used and preserved. The demolition of the 1936 Nurses' Building leaves a large gap at the right side of the heritage curtilage area. The Myall Street frontage remains historically important and any new development should use the heritage policies prepared in 2014 for this area. – *Rice Daubney 2016 with Adaptive Architects overlay*

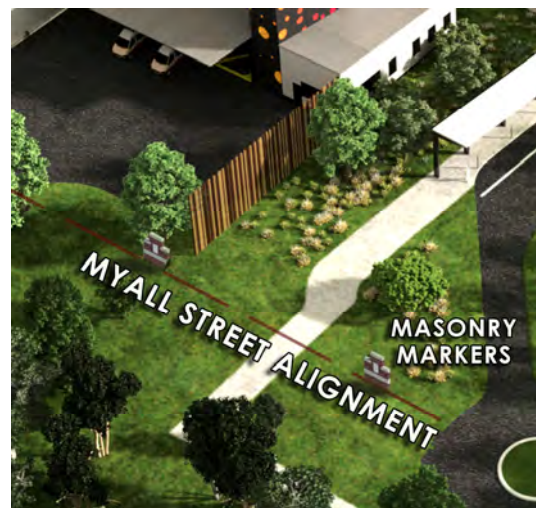
**Figure 150** Two brick and rendered markers sit in the landscaped forecourt and interpret the Myall Street alignment of the heritage precinct (cf Fig 139). - Rice Daubney 2016, overlaid with notes

- As noted above, the proposed banded brick and render markers in the landscaped forecourt will physically interpret the Myall Street setback alignment and the consistent address toward the public realm of Myall Street.
