Principal Healthcare Finance Pty Limited

Opal Residential Aged Care Facility, Bayview

Geotechnical Investigation Report

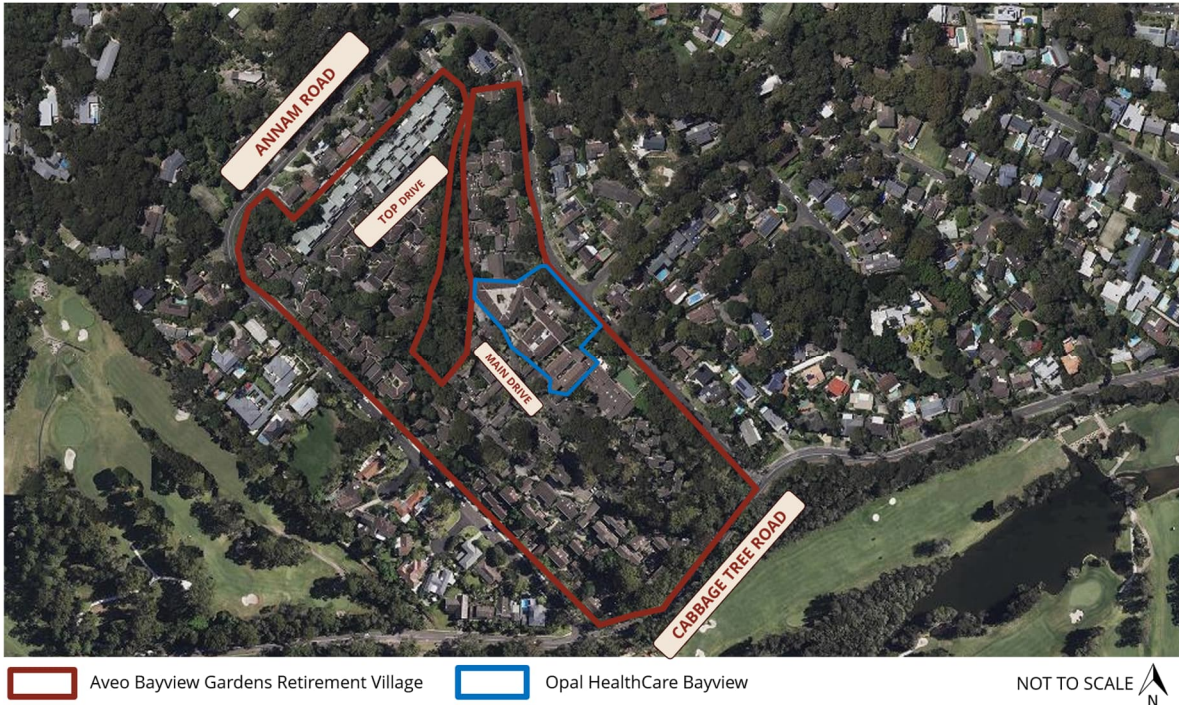
Figure 1.1 Context of site within the broader Aveo site

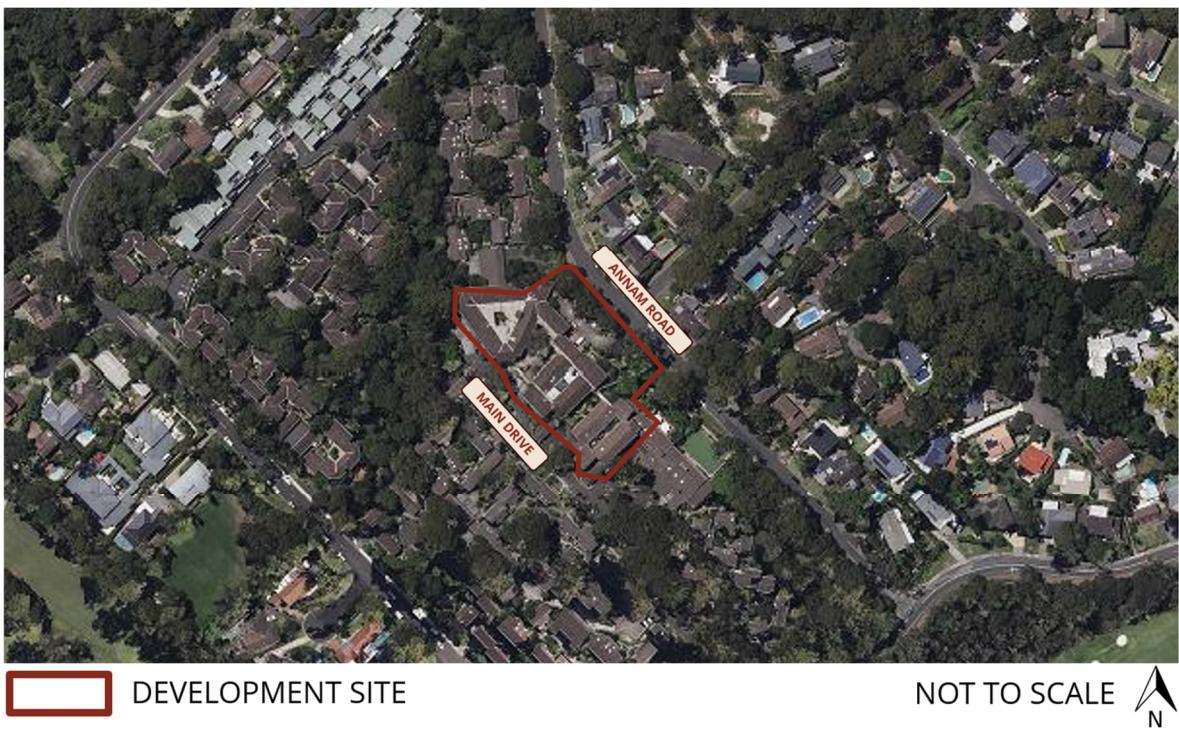
Figure 1.2 Development site

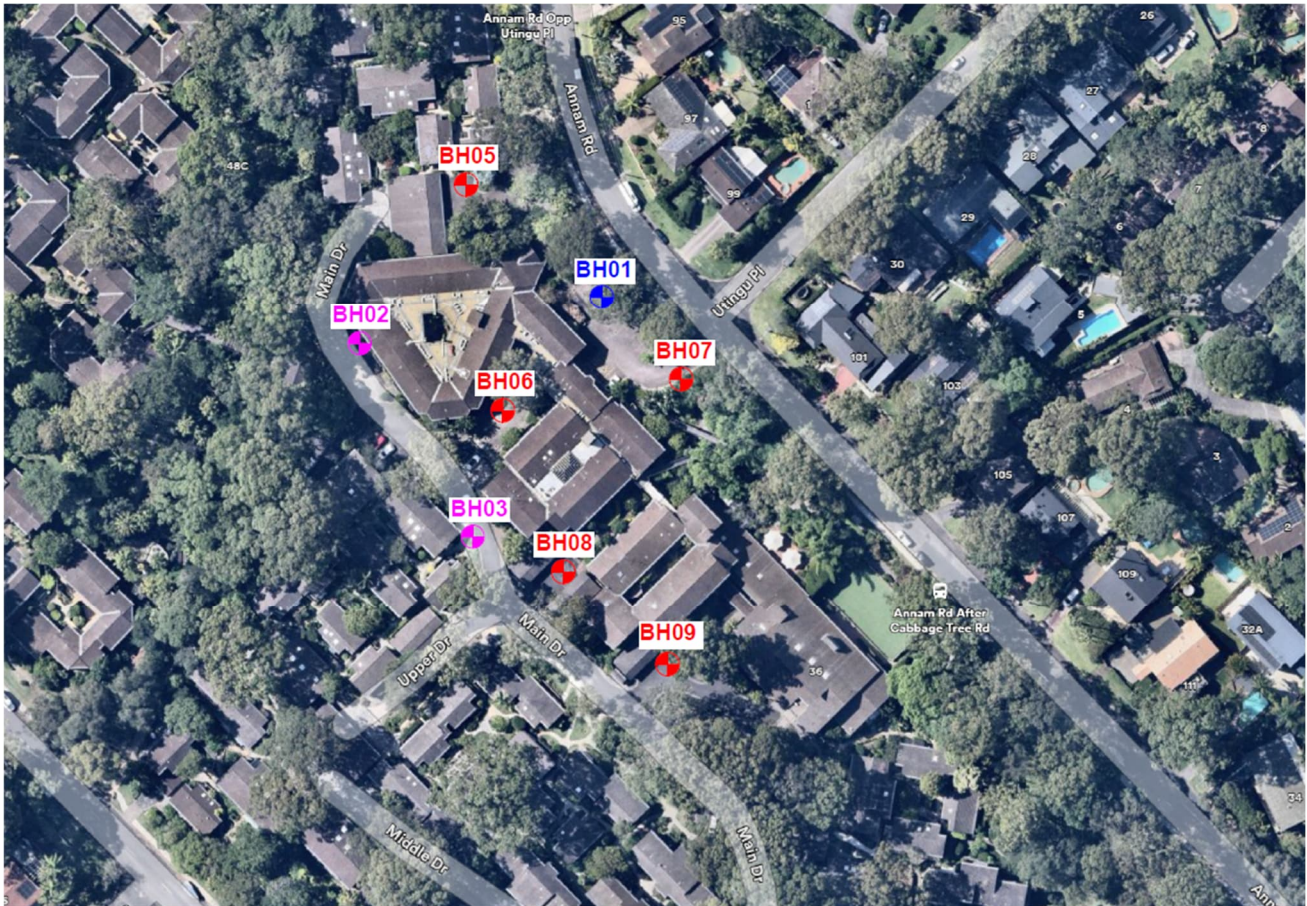
Figure 3.2 Test location plan at Opal Bayview RACF site
