## **GEOTECHNICAL INVESTIGATION**

**2-4 BURLEIGH STREET & 20-24 RAILWAY  
PARADE, BURWOOD**

**REPORT GG11730.002  
28 JANUARY 2025**

# **Geotechnical Investigation for a proposed mixed-use development at 2-4 Burleigh Street and 20-24 Railway Parade, Burwood**

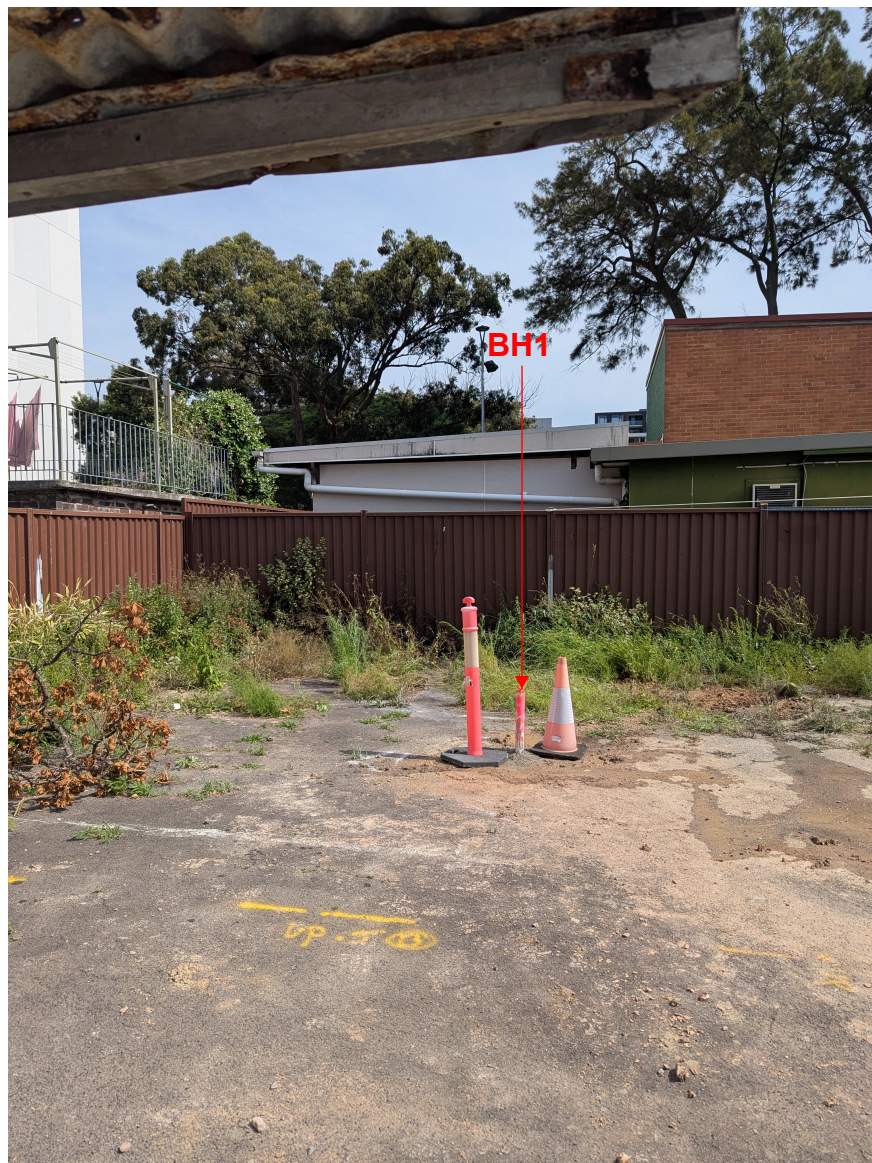
Location of BH1

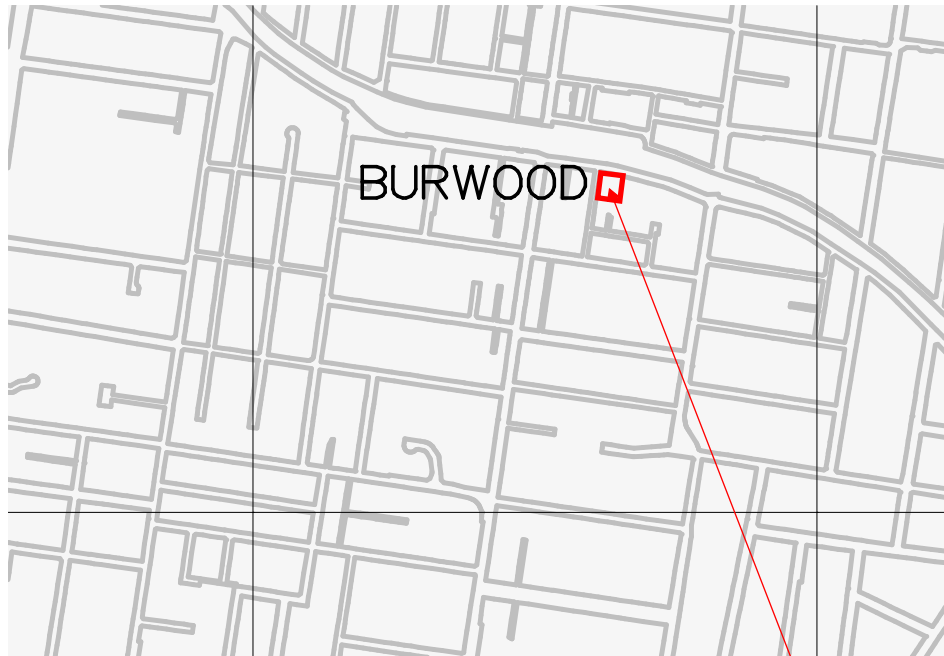
Botany Bay Acid Sulfate Soils Risk Map

Reference to the Botany Bay ASS Risk Map indicates the property is within an area where there are no known occurrences of ASS. It should be noted that maps are a guide only.

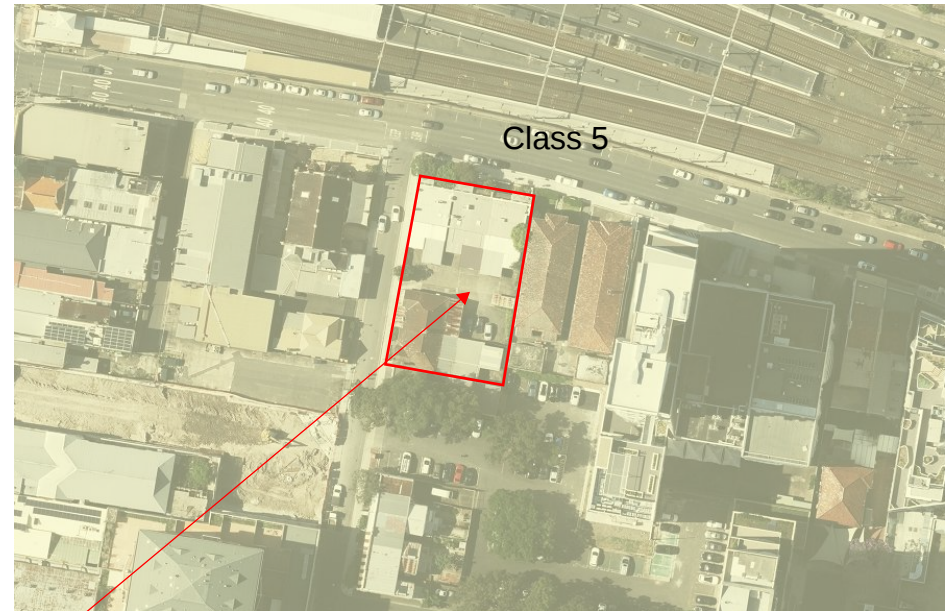
Acid Sulfate Soils Classification Mapping (Source ePlanning Spatial Viewer)

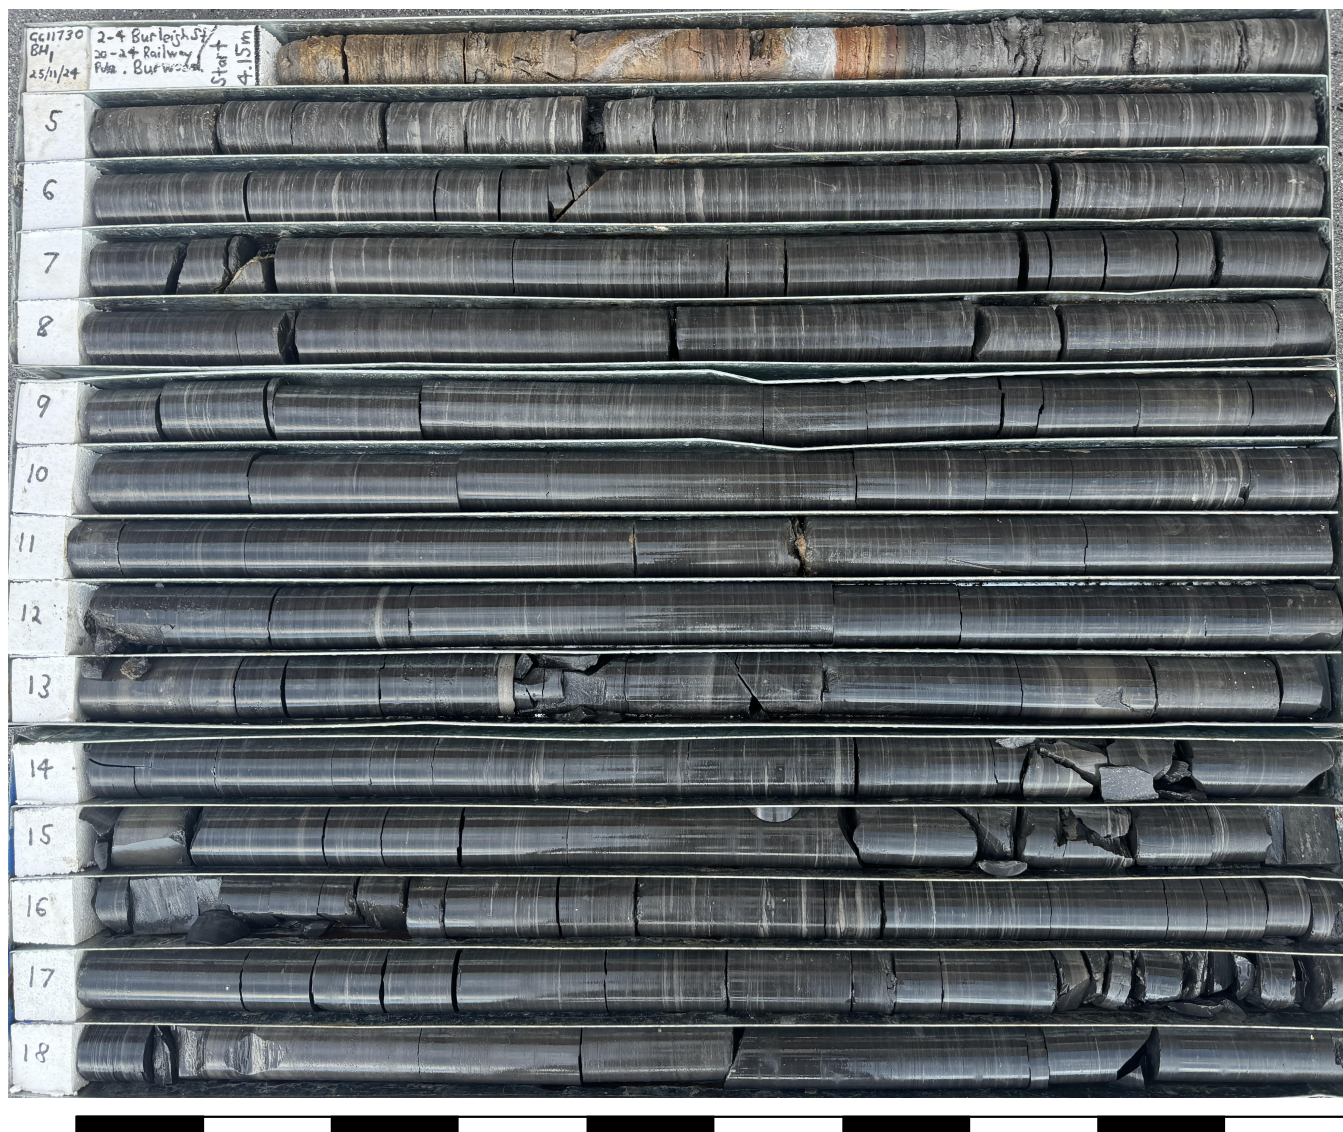
Geotechnical Investigation  
2-4 Burleigh Street and 20-24 Railway  
Parade, Burwood  
**CORE PHOTO - BH1**
