**Ballina High School Redevelopment**

**Burnet Street Ballina NSW**

**Geotechnical Report**

Report No. RGS30738.1 - AB

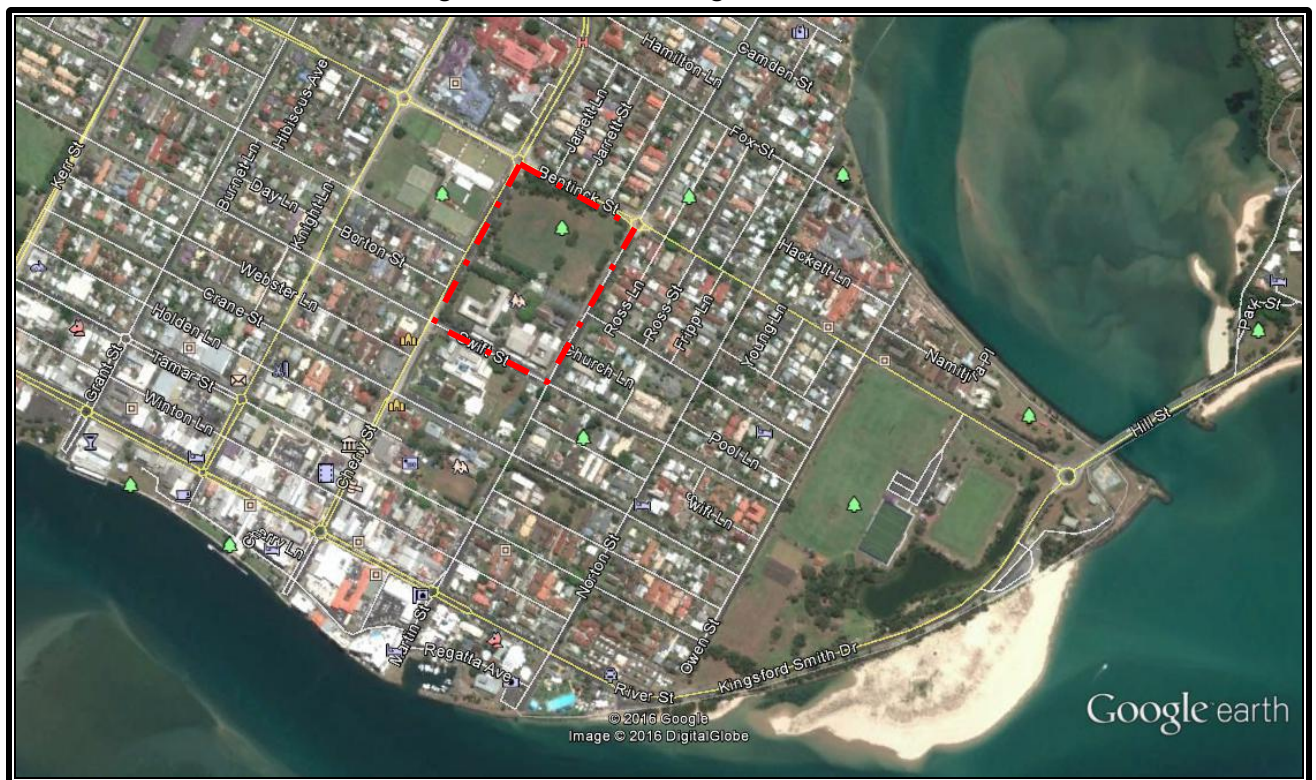
**Diagram 1: Site Setting and Features**

The site is located in Ballina CBD on a flat low lying estuarine spit associated with the Richmond River which lies approximately 600m to 700m to the north and south. The Google earth image below illustrates the site setting and features.

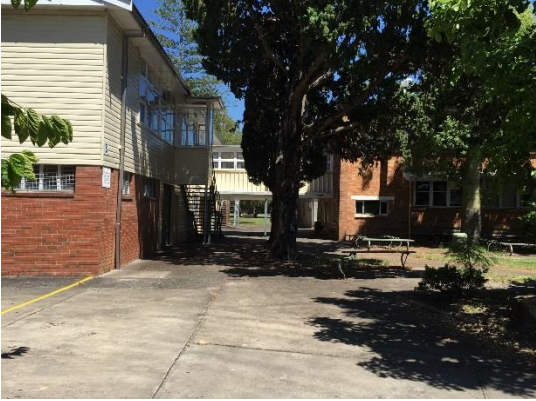
| <p>1. Older style two storey buildings with lower level masonry and upper level timber.</p> | <p>2. Two storey full masonry with concrete floor slabs and reinforced concrete frames.</p> |

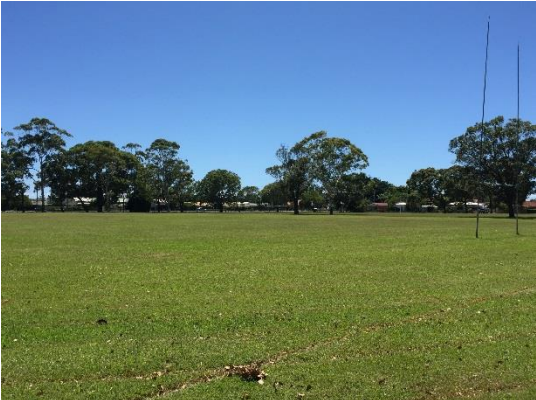
| <p>3. Playing field to the north of the school buildings.</p> | <p>4. Crack in brickwork, appears superficial and not related to potential ground issues.</p> |

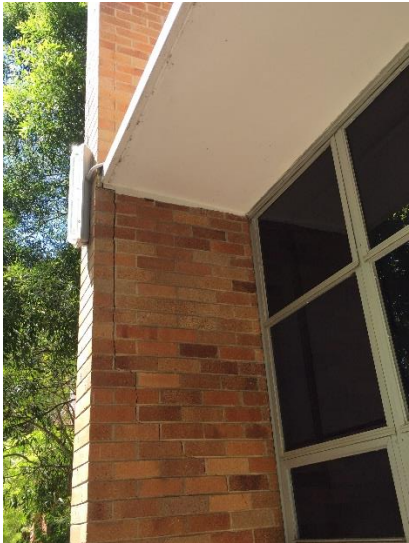
Generally the buildings are in good external condition with no apparent signs of damage that could be attributed to ground related issues. Cracks in one of the north facing walls of one of the
