**Ballina High School Redevelopment**

**Phase 1 Site Contamination Assessment Report**

Report No. RGS306738.1 – AC

25 February 2016

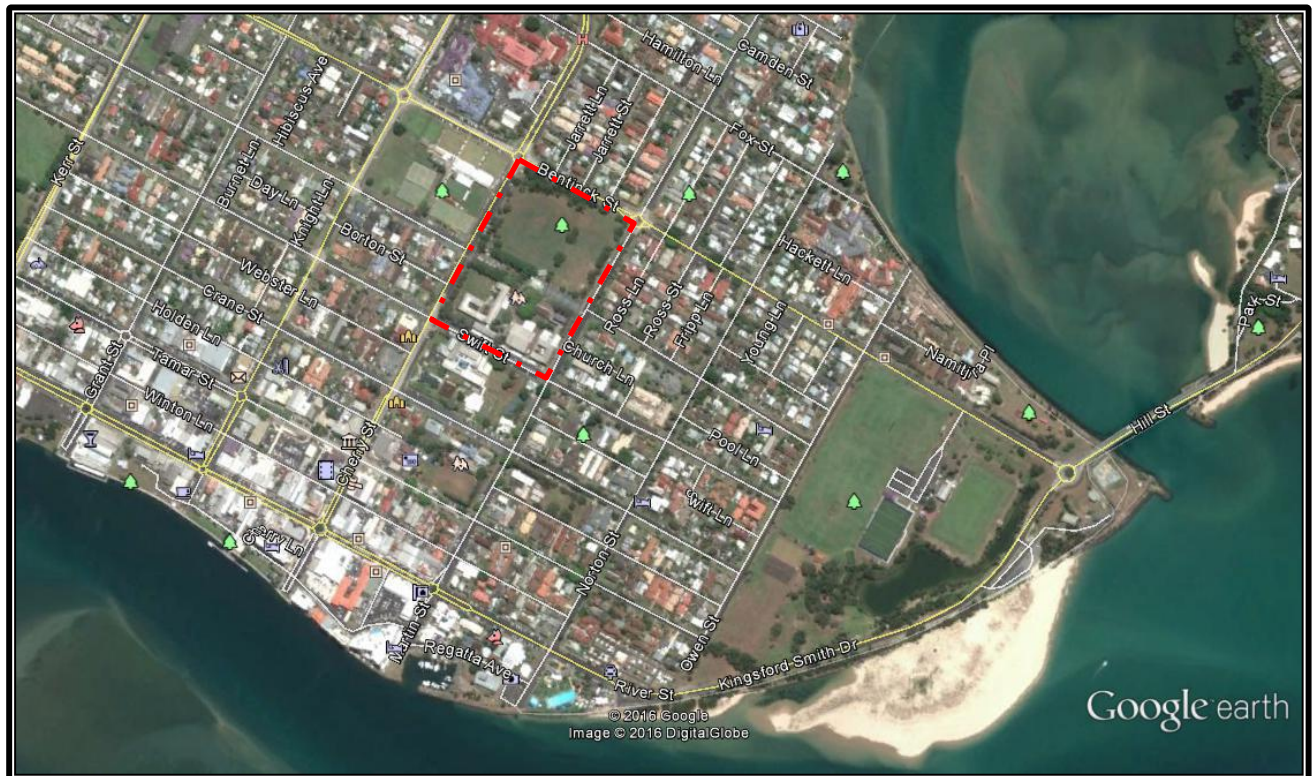
**Diagram 1 Site Setting and Features**

The site is located in Ballina CBD on a flat low lying estuarine spit associated with the Richmond River which lies approximately 600m to 700m to the north and south. The Google earth image below illustrates the site setting and features.

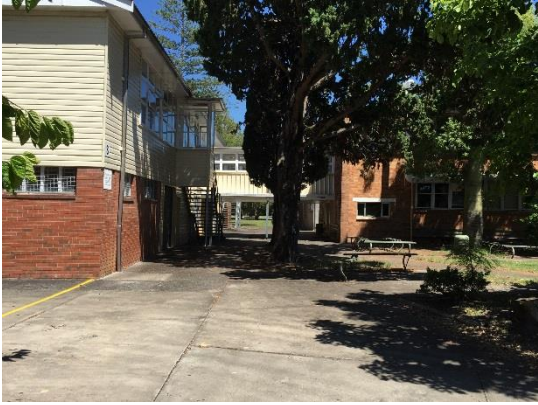
| <p>1. Older style two storey buildings with lower level masonry and upper level timber.</p> | <p>2. Two storey full masonry with concrete floor slabs and reinforced concrete frames.</p> |

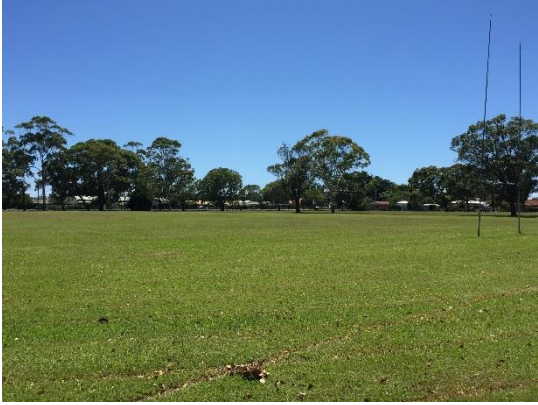
| <p>3. Playing field to the north of the school buildings.</p> | <p>4. Looking east along the old alignment of Burnet Street. Now occupied by carpark, buildings and concrete playing courts.</p> |

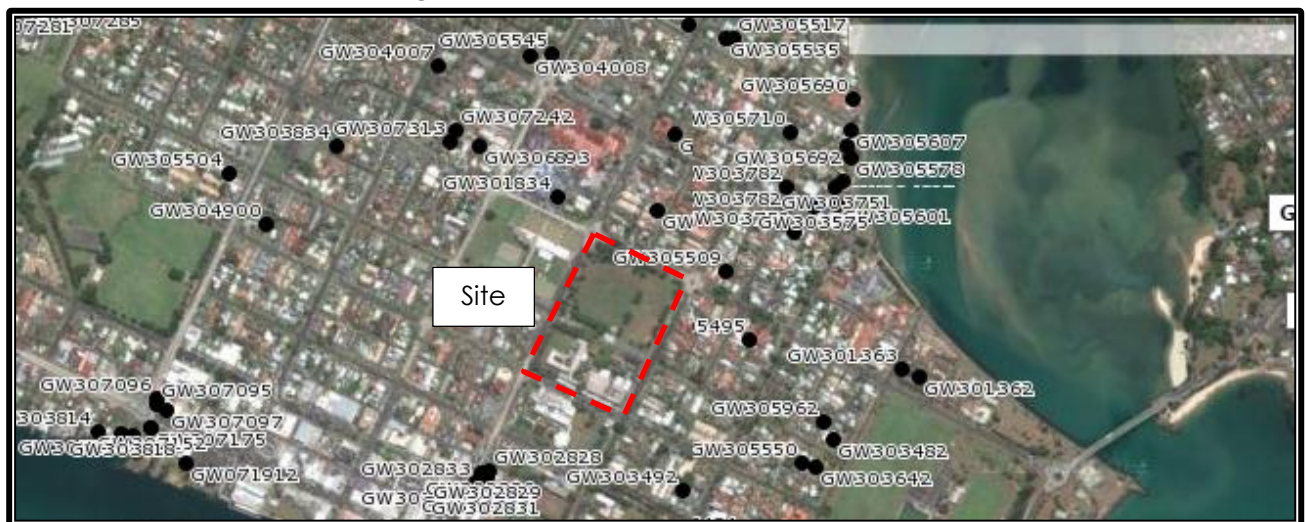
**Diagram 2 Groundwater Bore locations**

A groundwater bore search on the NSW Water Information website, <http://waterinfo.nsw.gov.au/gw/> indicates there are a number of licensed groundwater bores nearby as illustrated in Diagram 2 below.

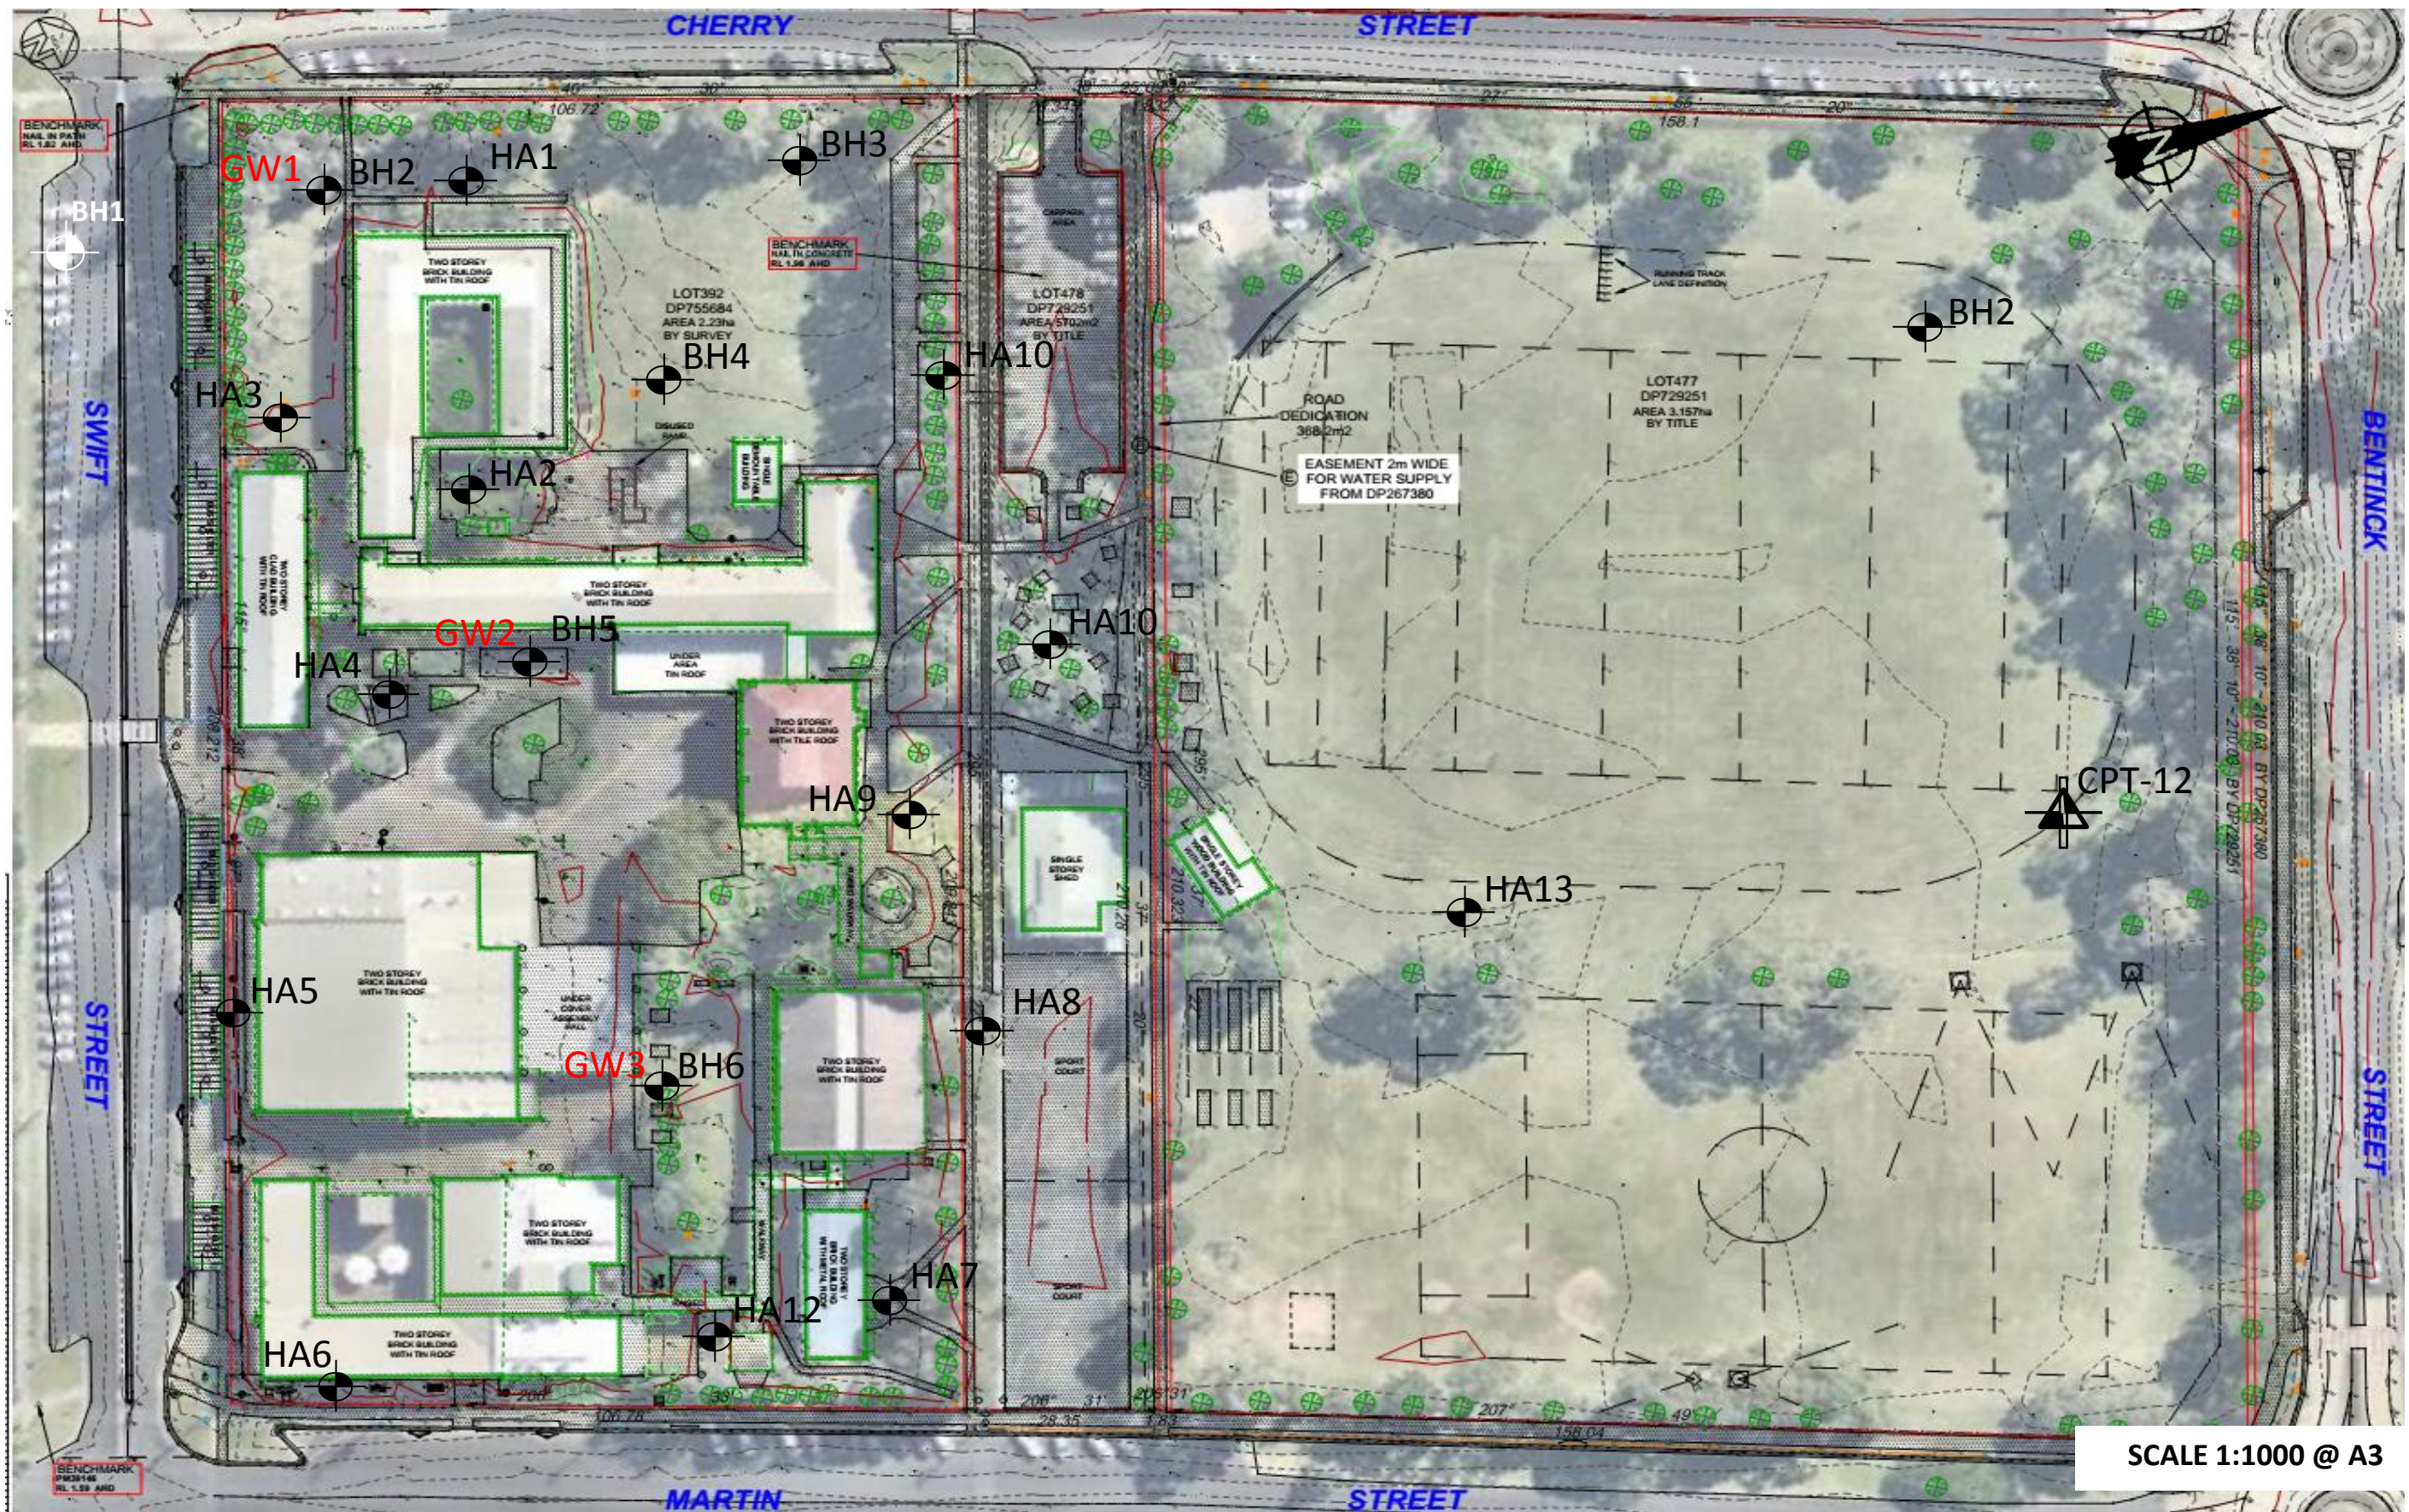
Figure 1      Site Plan

In consideration of the site conditions and assessed areas of environmental concern a sampling plan was prepared with the aim of targeting these areas of concern. Thirteen soil samples were collected for analysis. Approximate sampling locations are shown on Figure 1. A summary of the soils present at the sampled locations is presented below in Table 4.
