## Geotechnical Investigation

135 Badgerys Creek Road, Bradfield NSW

E26733.G03\_Rev0  
25 September 2025

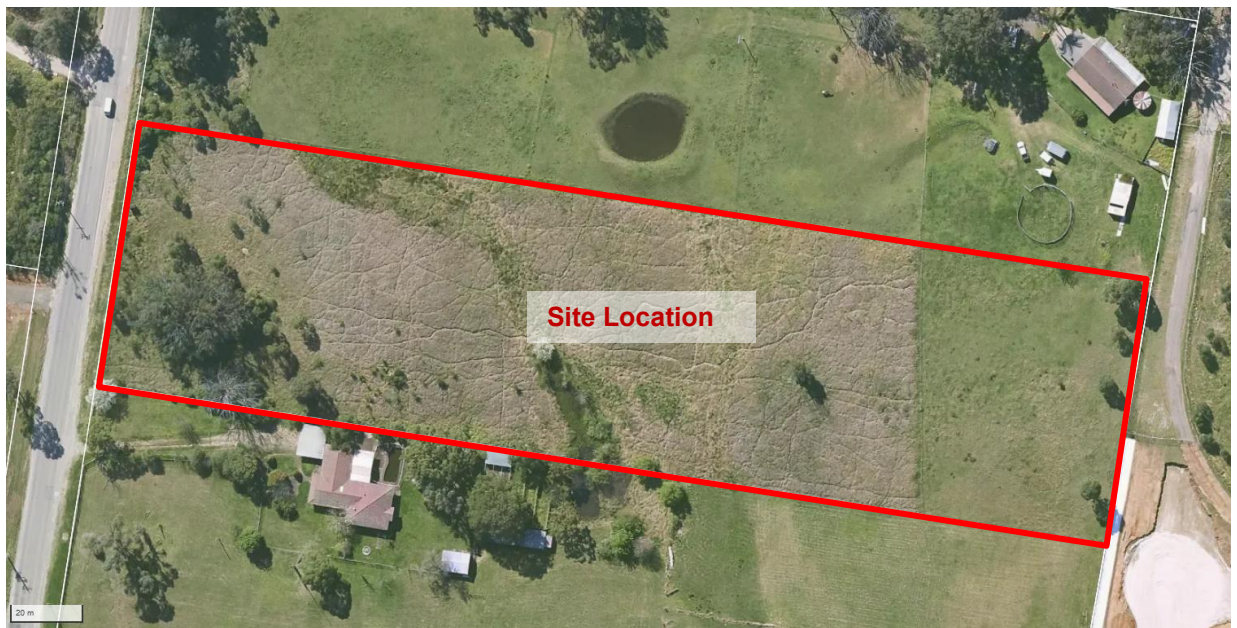
**Plate 1** Satellite image of the site (Metro Maps, image dated 3 September 2024)

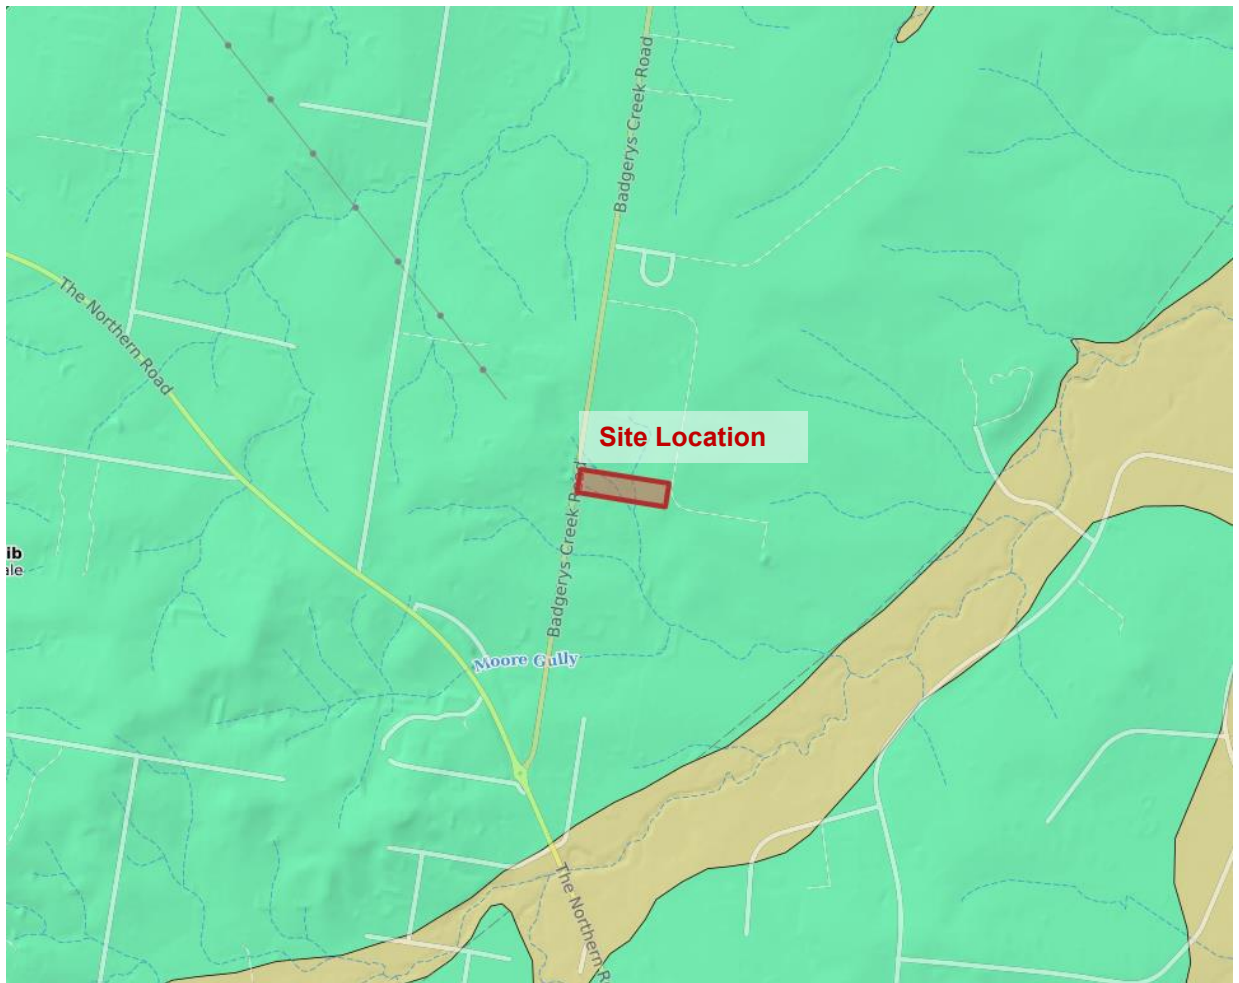
**Plate 2** Excerpt of regional geological map showing location of site

While the dyke is not expected to intersect the site, they are typically associated with additional jointing within the host rock (siltstone bedrock) which can lead to poorer rock quality than otherwise expected in the vicinity of the dyke intrusion. The degree of fracturing observed in BH1M and BH2M, not present in the other boreholes, may potentially be associated with a nearby geological feature such as a dyke.

As indicated in the degree of fracturing observed in boreholes BH1M and BH2M on the western side of the site and the associated high permeability values within these boreholes, the dyke or vein as mapped in the regional geology may affect the site.

Extrapolating the alignment of the geotechnical feature indicates it may intersect the south-west corner of the site. Where dykes or host rock affect by geological intrusive features is encountered, the stability of the excavation will be negatively affected and additional shoring measures such as closely spaced contiguous pile walls may be required. Foundations or piles may need to be placed outside the zone of influence and or bridge the dyke depending on the required load capacity.

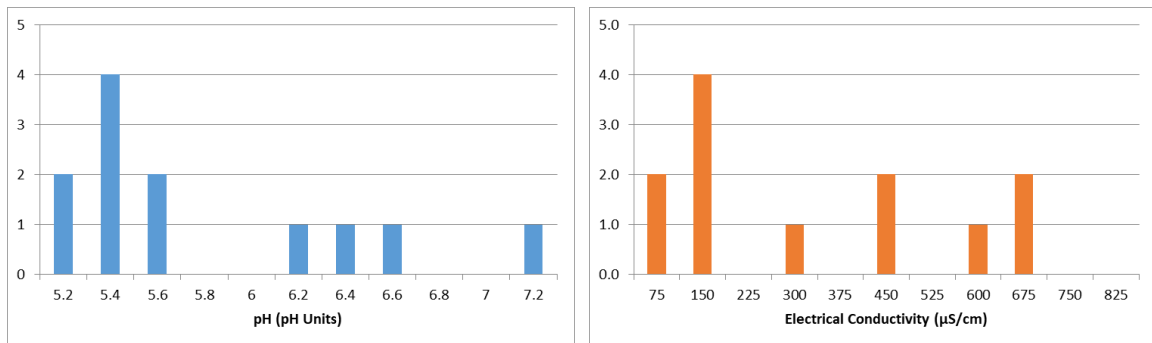
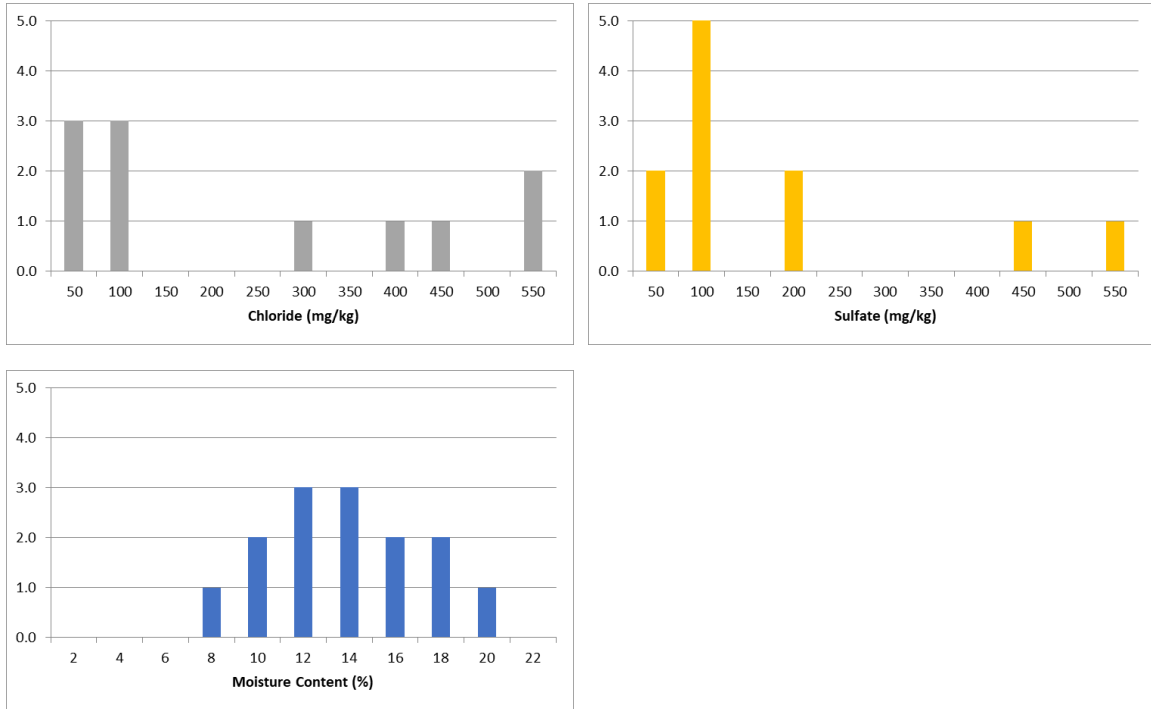
**Plate 3 Plots of Soil Aggressivity Test Results**

The Atterberg Limits result on the selected Topsoil sample indicates it to be of high plasticity (CH). The Atterberg Limits result on the selected Residual Soil samples indicates it to be of medium to high plasticity (CI-CH). Using the Atterberg Limits and Linear Shrinkage results, the tested Residual Soil samples were assessed to have moderate to high shrink-swell potential.

The assessment indicated low permeability soil was present above the groundwater table. In accordance with Tables 6.4.2(C) and 6.5.2(C) of AS 2159:2009 ‘Piling – Design and Installation’, the results of the pH, chloride and sulfate content, and electrical conductivity of the soil provided the following exposure classifications:

- Exposure Condition B;
- ‘Mild’ for buried concrete structural elements; and
- ‘Mild’ for buried steel structural elements.

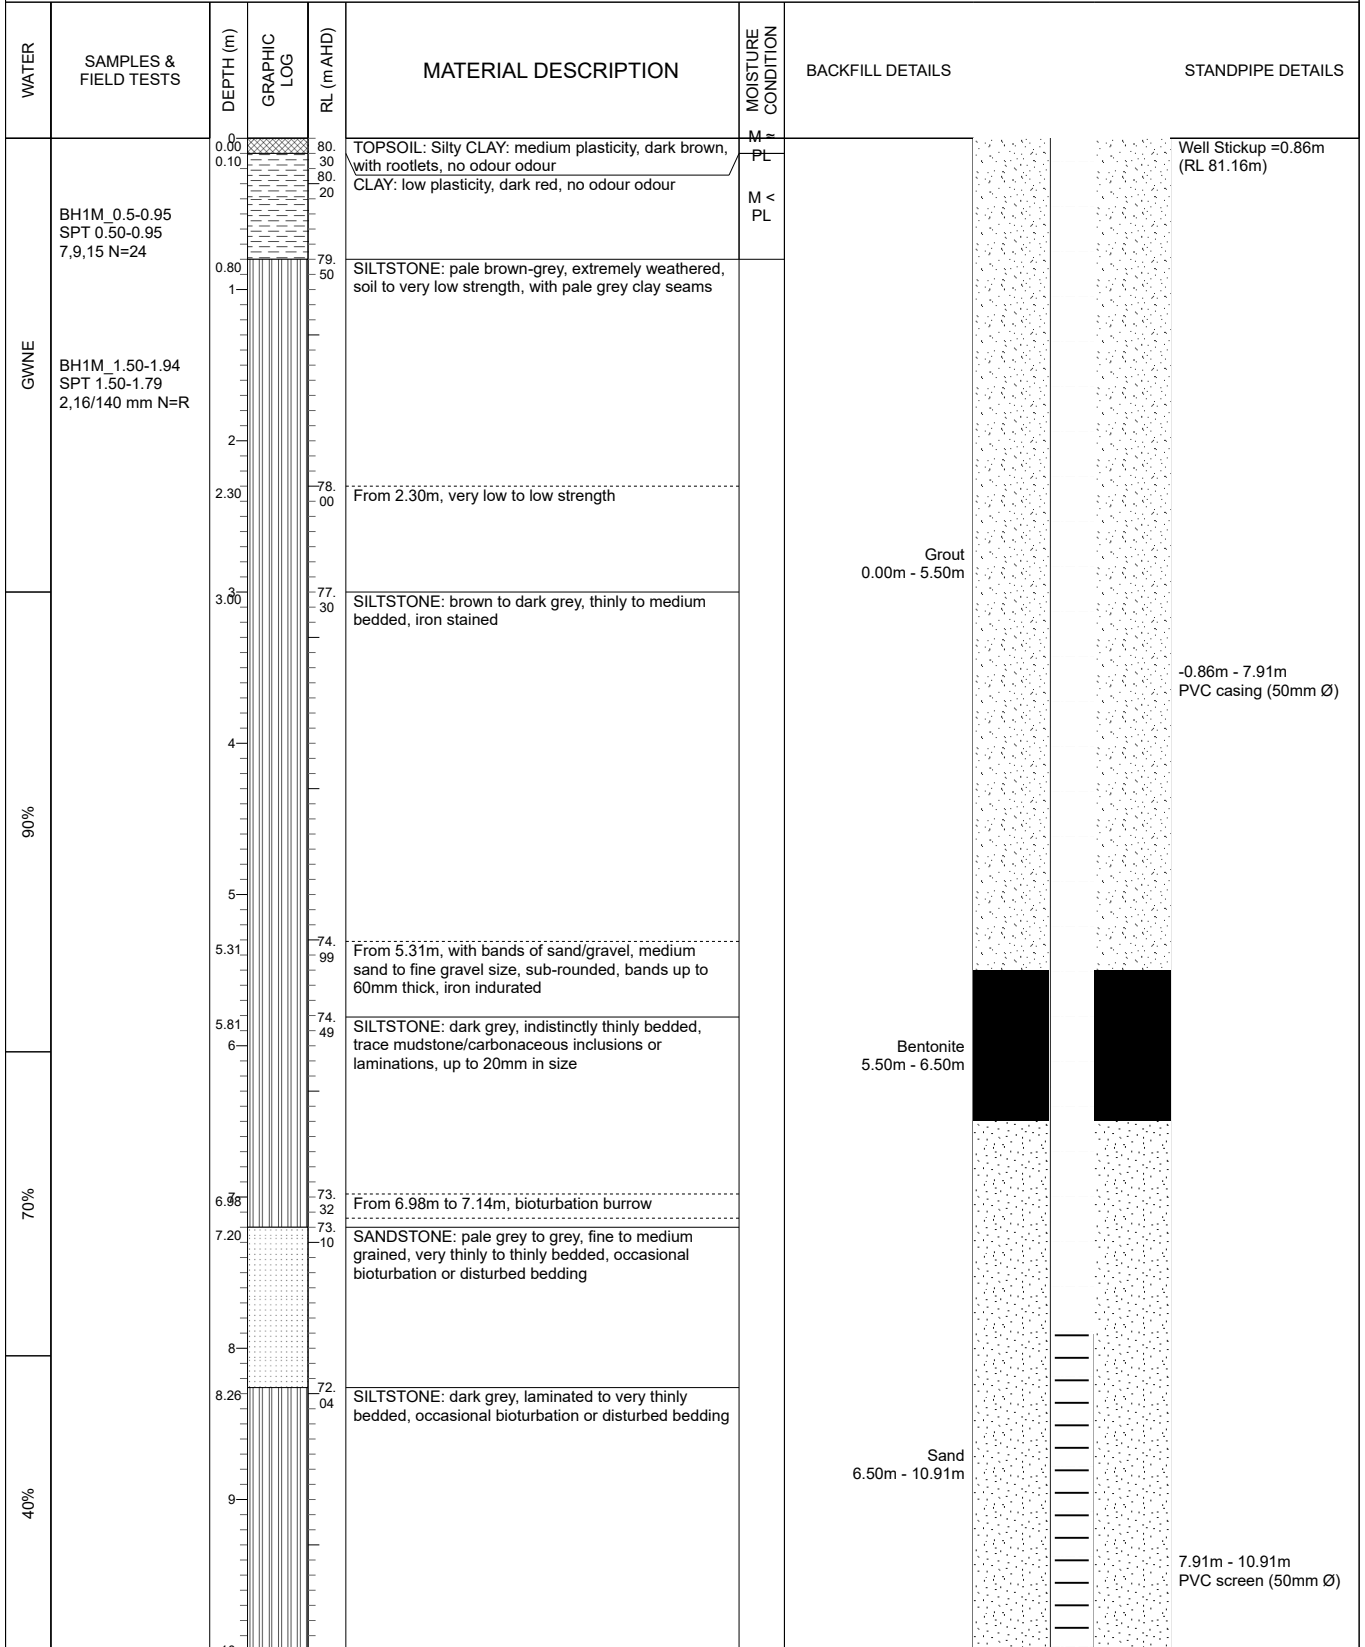
BH ID: BH1M

<b>Location</b>	135 Badgerys Creek Road, Bradfield NSW	<b>Started</b>	23 April 2025
<b>Client</b>	Creative Vision	<b>Completed</b>	23 April 2025
<b>Job No.</b>	E26733.G03	<b>Logged By</b>	GB <b>Date</b> 23 April 2025
<b>Sheets</b>	1 of 2	<b>Review By</b>	JB <b>Date</b> 23 June 2025
<b>Drilling Contractor</b>	Geosense Drilling Engineers	<b>Surface RL</b>	≈80.30 m (AHD)
		<b>Northing</b>	6244091.0000 (MGA 2020 Zone 56)
<b>Plant</b>	Comacchio Geo 205	<b>Inclination</b>	90°
		<b>Easting</b>	290122.0000 (MGA 2020 Zone 56)

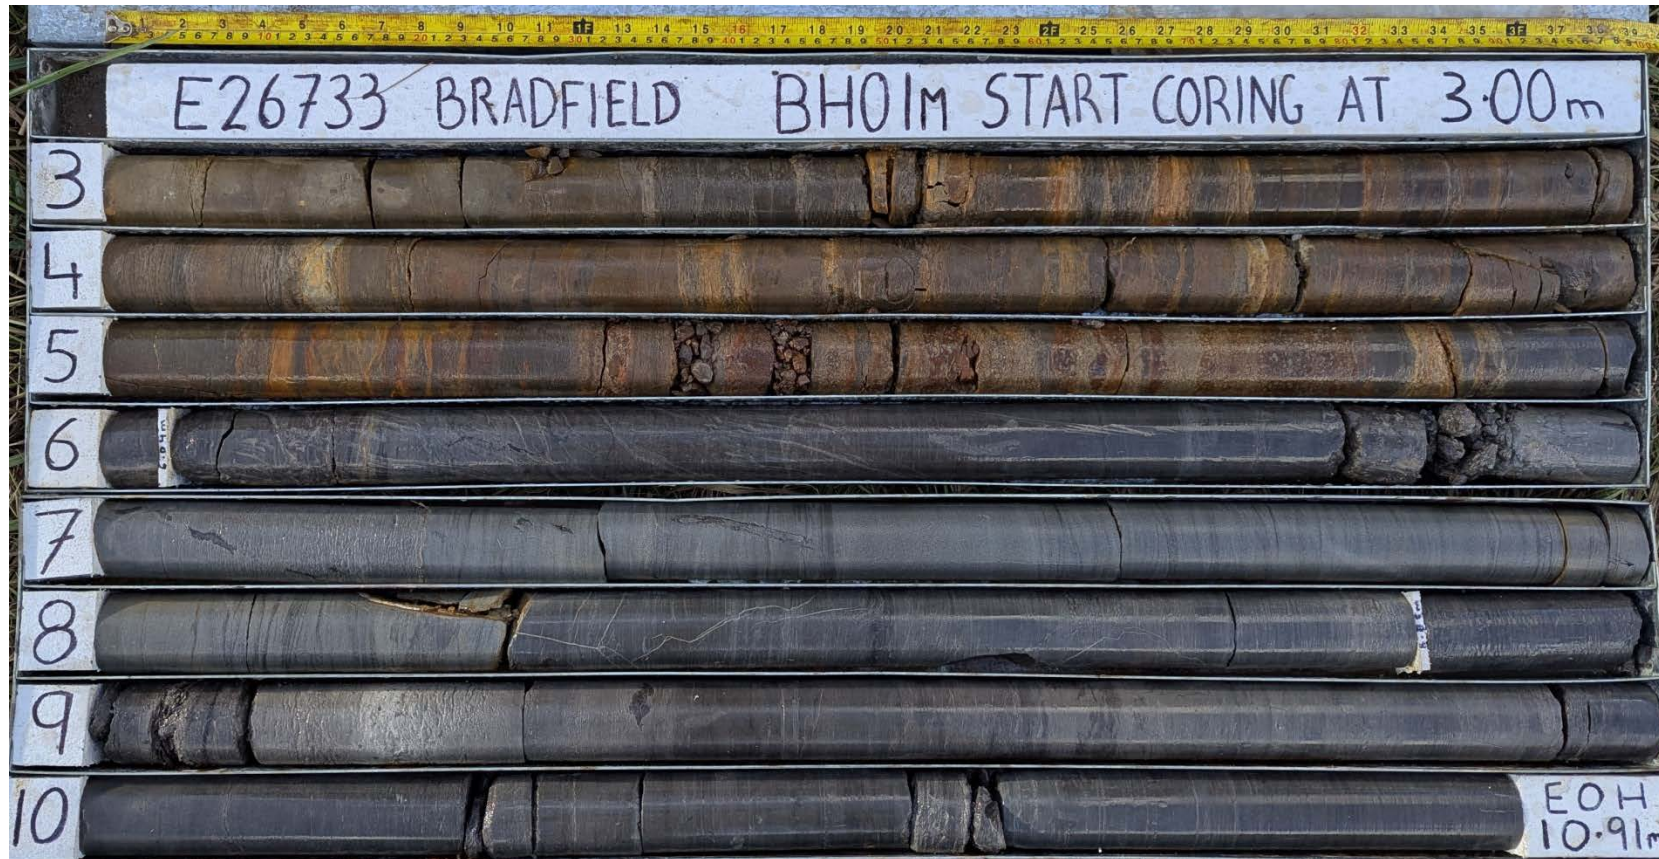
# CORE PHOTOGRAPH OF BOREHOLE: BH1M

<b>Project</b>	Proposed Mixed-use Development	<b>East</b>	290122	<b>Depth Range</b>	3.00m to 10.91m BEGL	
<b>Location</b>	135 Badgerys Creek Road, Bradfield NSW	<b>North</b>	6244091	<b>Contractor</b>	Geosense Drilling Engineers Pty Ltd	
<b>Position</b>	See Figure 2	<b>Surface RL</b>	≈ 80.3m	<b>Drill Rig</b>	Comacchio GEO 205	
<b>Job No.</b>	E26733.G03	<b>Inclination</b>	-90°	<b>Logged</b>	GB	<b>Date</b> 23 / 04 / 2025
<b>Client</b>	Creative Vision	<b>Box</b>	1-2 of 2	<b>Checked</b>	JB	<b>Date</b> 23 / 06 / 2025

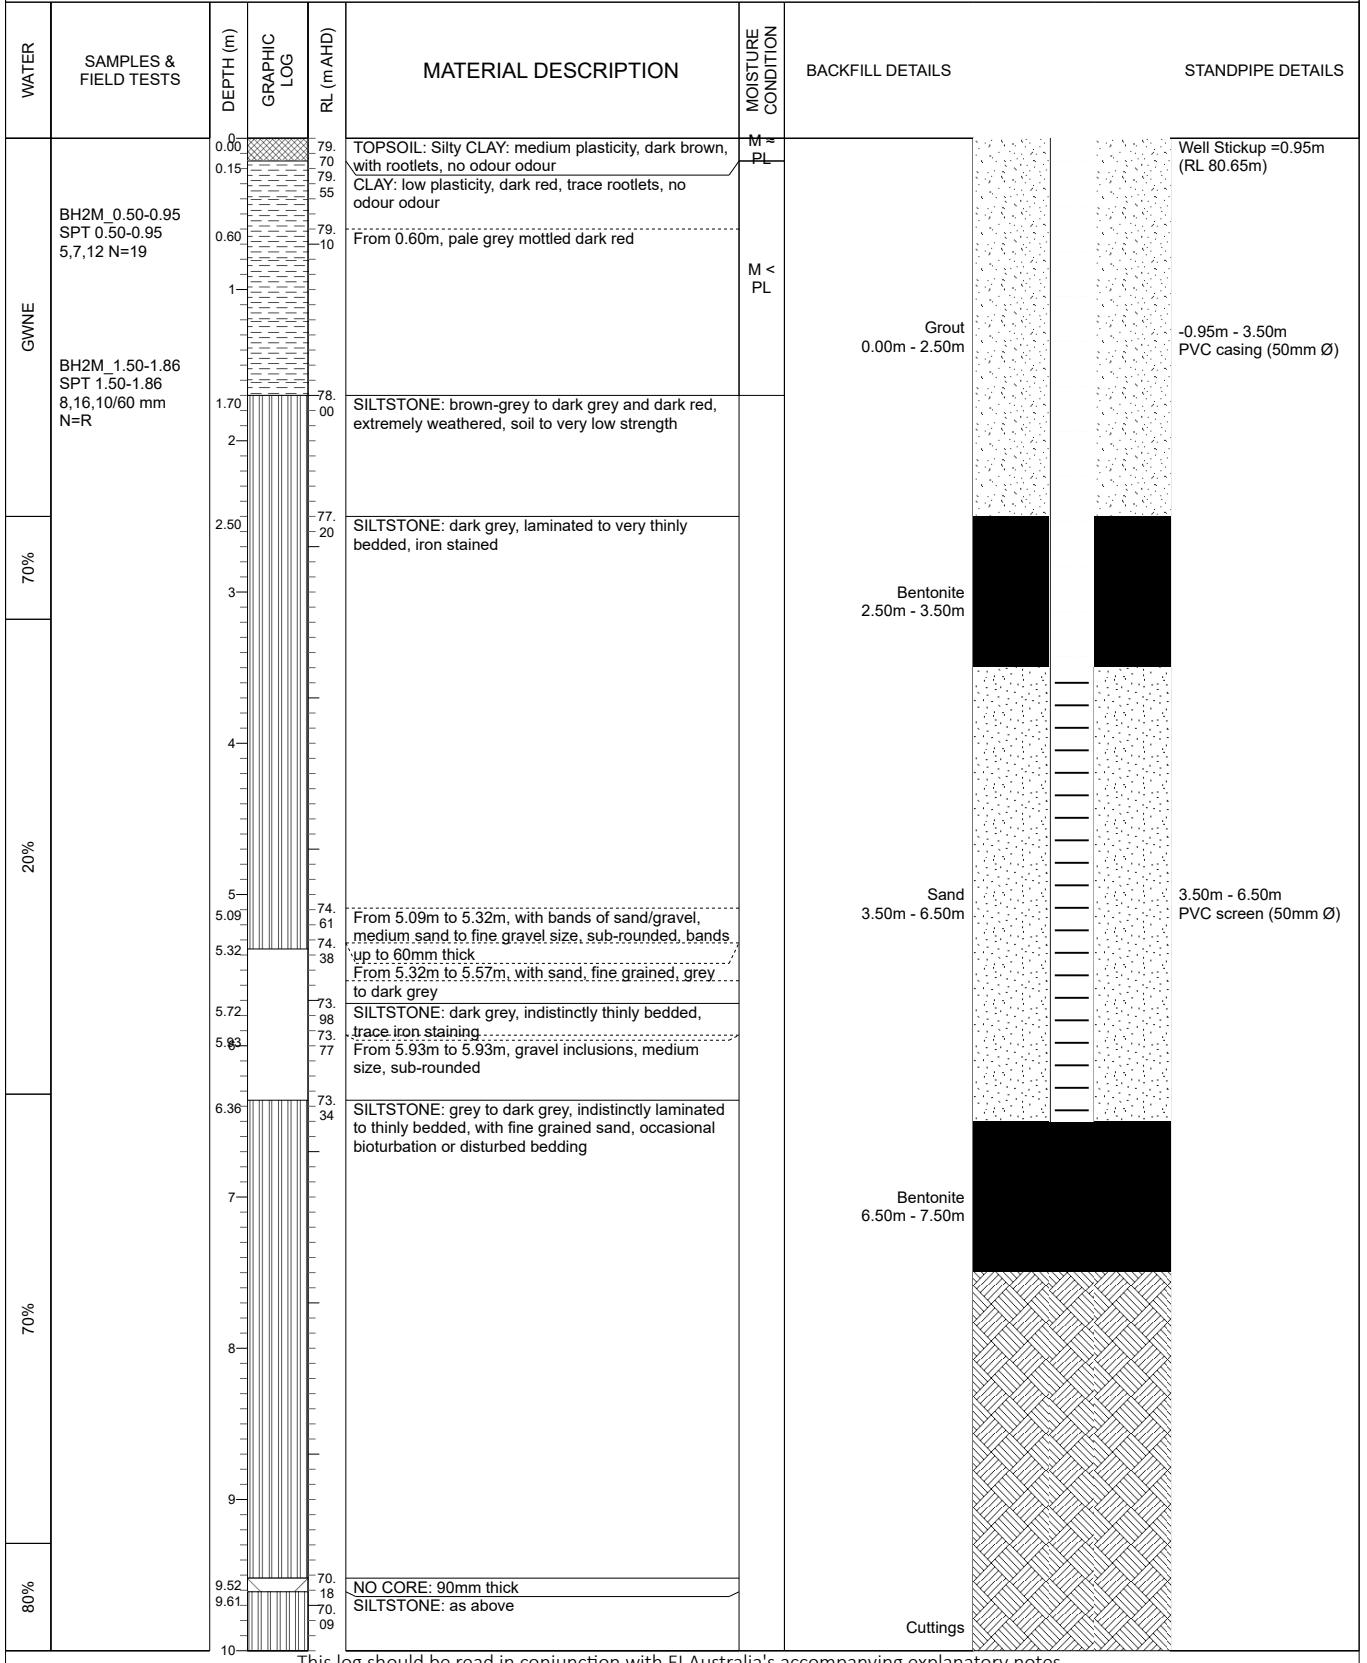
BH ID: BH2M

<b>Location</b>	135 Badgerys Creek Road, Bradfield NSW	<b>Started</b>	23 April 2025
<b>Client</b>	Creative Vision	<b>Completed</b>	24 April 2025
<b>Job No.</b>	E26733.G03	<b>Logged By</b>	GB <b>Date</b> 24 April 2025
<b>Sheets</b>	1 of 2	<b>Review By</b>	JB <b>Date</b> 23 June 2025
<b>Drilling Contractor</b>	Geosense Drilling Engineers	<b>Surface RL</b>	≈79.70 m (AHD)
<b>Plant</b>	Comacchio Geo 205	<b>Inclination</b>	90°
		<b>Northing</b>	6244031.0000 (MGA 2020 Zone 56)
		<b>Easting</b>	290135.0000 (MGA 2020 Zone 56)

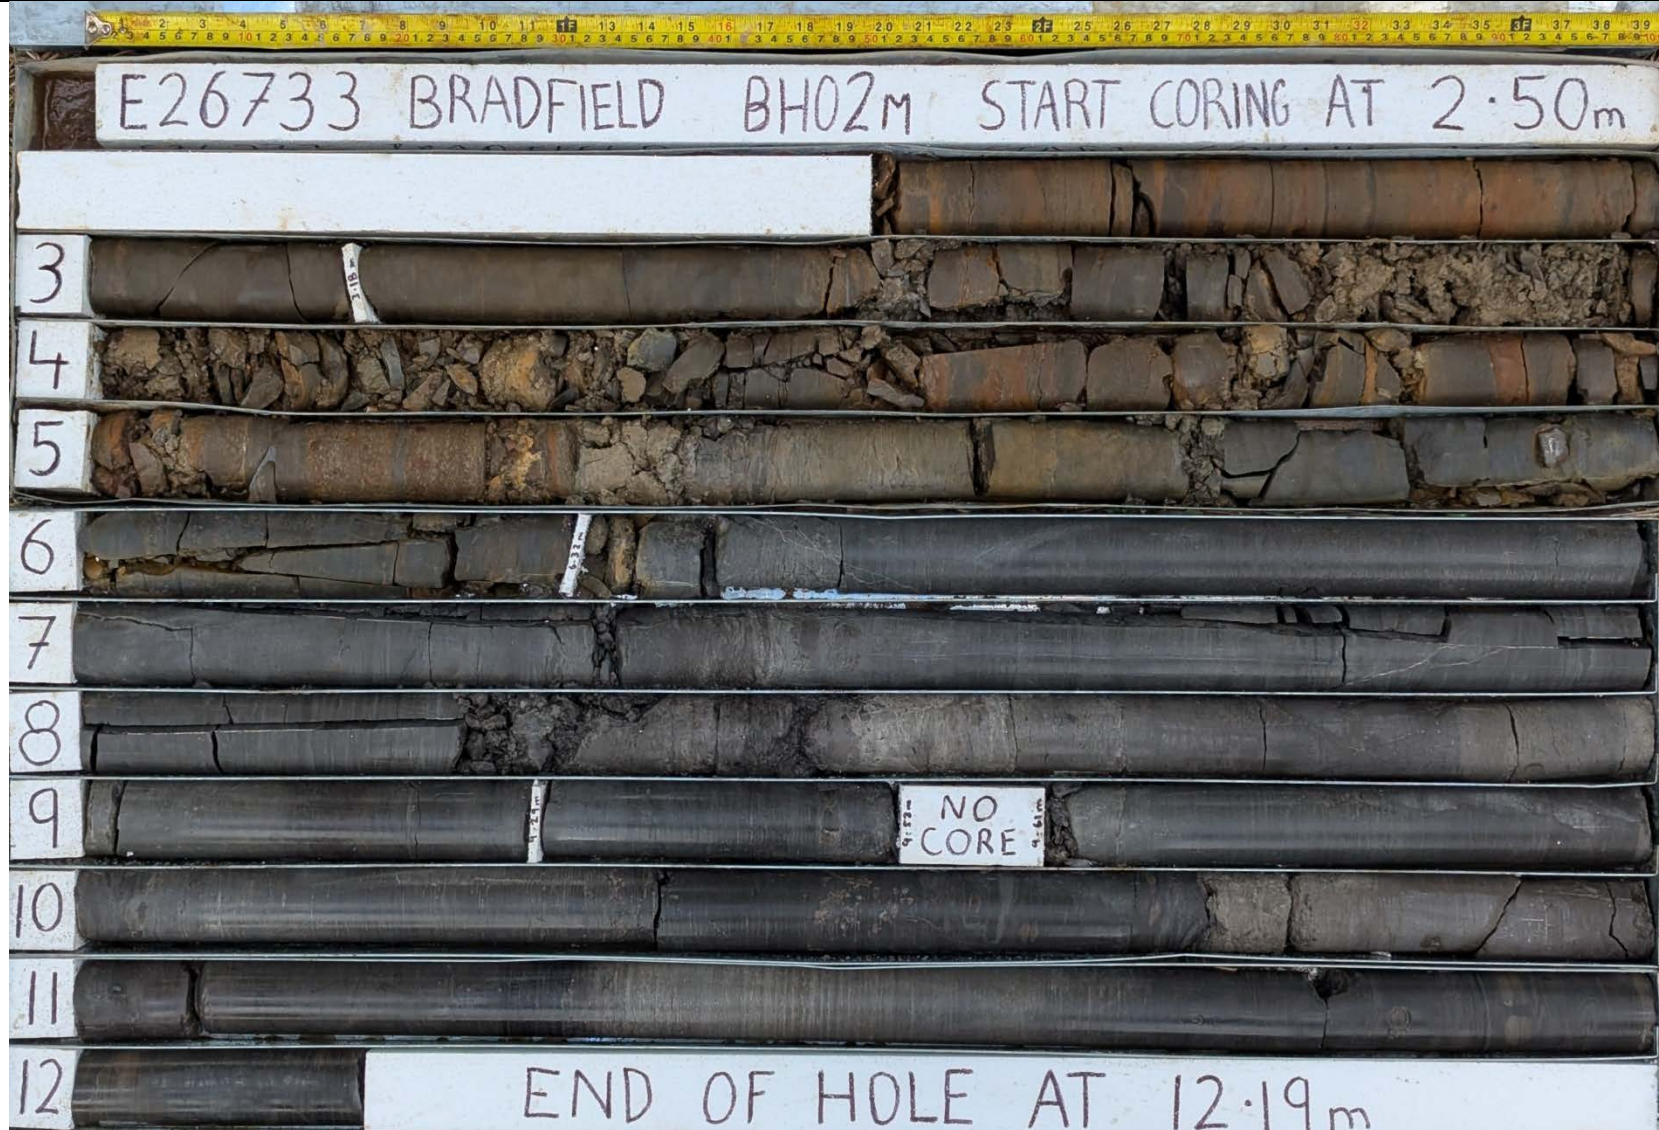
<b>Project</b>	Proposed Mixed-use Development	<b>East</b>	290135	<b>Depth Range</b>	2.5m to 12.19m BEGL
<b>Location</b>	135 Badgerys Creek Road, Bradfield NSW	<b>North</b>	6244031	<b>Contractor</b>	Geosense Drilling Engineers Pty Ltd
<b>Position</b>	See Figure 2	<b>Surface RL</b>	≈ 79.7m	<b>Drill Rig</b>	Comacchio GEO 205
<b>Job No.</b>	E26733.G03	<b>Inclination</b>	-90°	<b>Logged</b>	GB <b>Date</b> 24 / 04 / 2025
<b>Client</b>	Creative Vision	<b>Box</b>	1-3 of 3	<b>Checked</b>	JB <b>Date</b> 23 / 06 / 2025

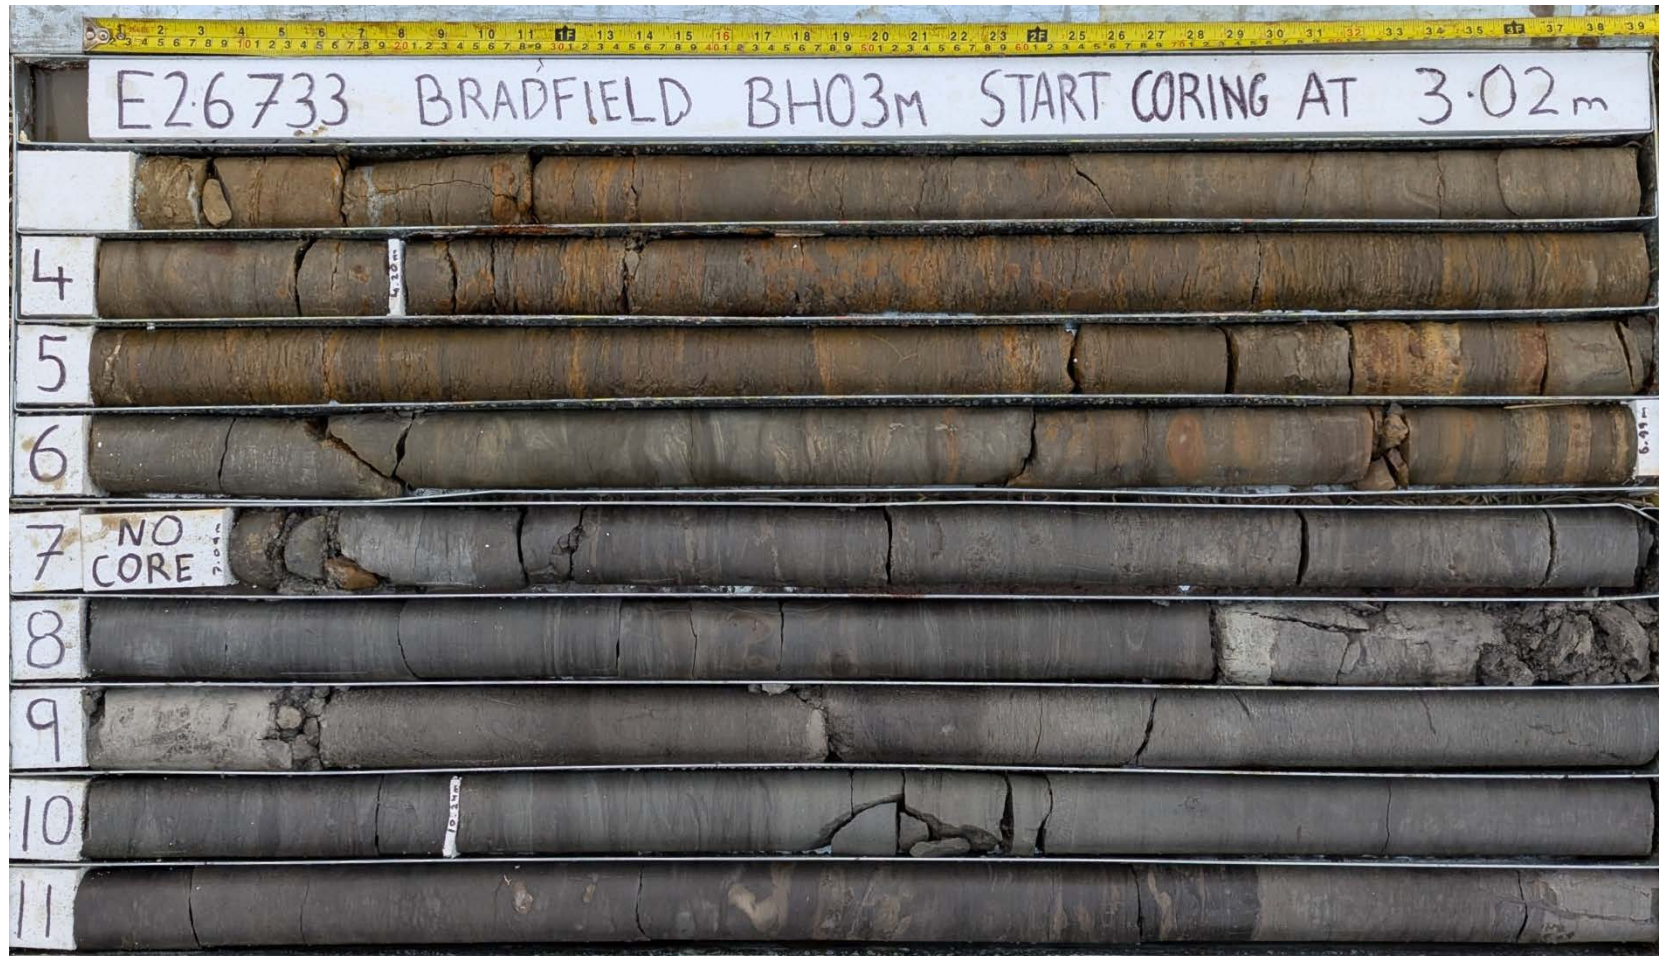
<b>Project</b>	Proposed Mixed-use Development	<b>East</b>	290213	<b>Depth Range</b>	3.02m to 12.00m BEGL	
<b>Location</b>	135 Badgerys Creek Road, Bradfield NSW	<b>North</b>	6244042	<b>Contractor</b>	Geosense Drilling Engineers Pty Ltd	
<b>Position</b>	See Figure 2	<b>Surface RL</b>	≈ 76.8m	<b>Drill Rig</b>	Comacchio GEO 205	
<b>Job No.</b>	E26733.G03	<b>Inclination</b>	-90°	<b>Logged</b>	GB	<b>Date</b> 28 / 04 / 2025
<b>Client</b>	Creative Vision	<b>Box</b>	1-2 of 4	<b>Checked</b>	JB	<b>Date</b> 23 / 06 / 2025

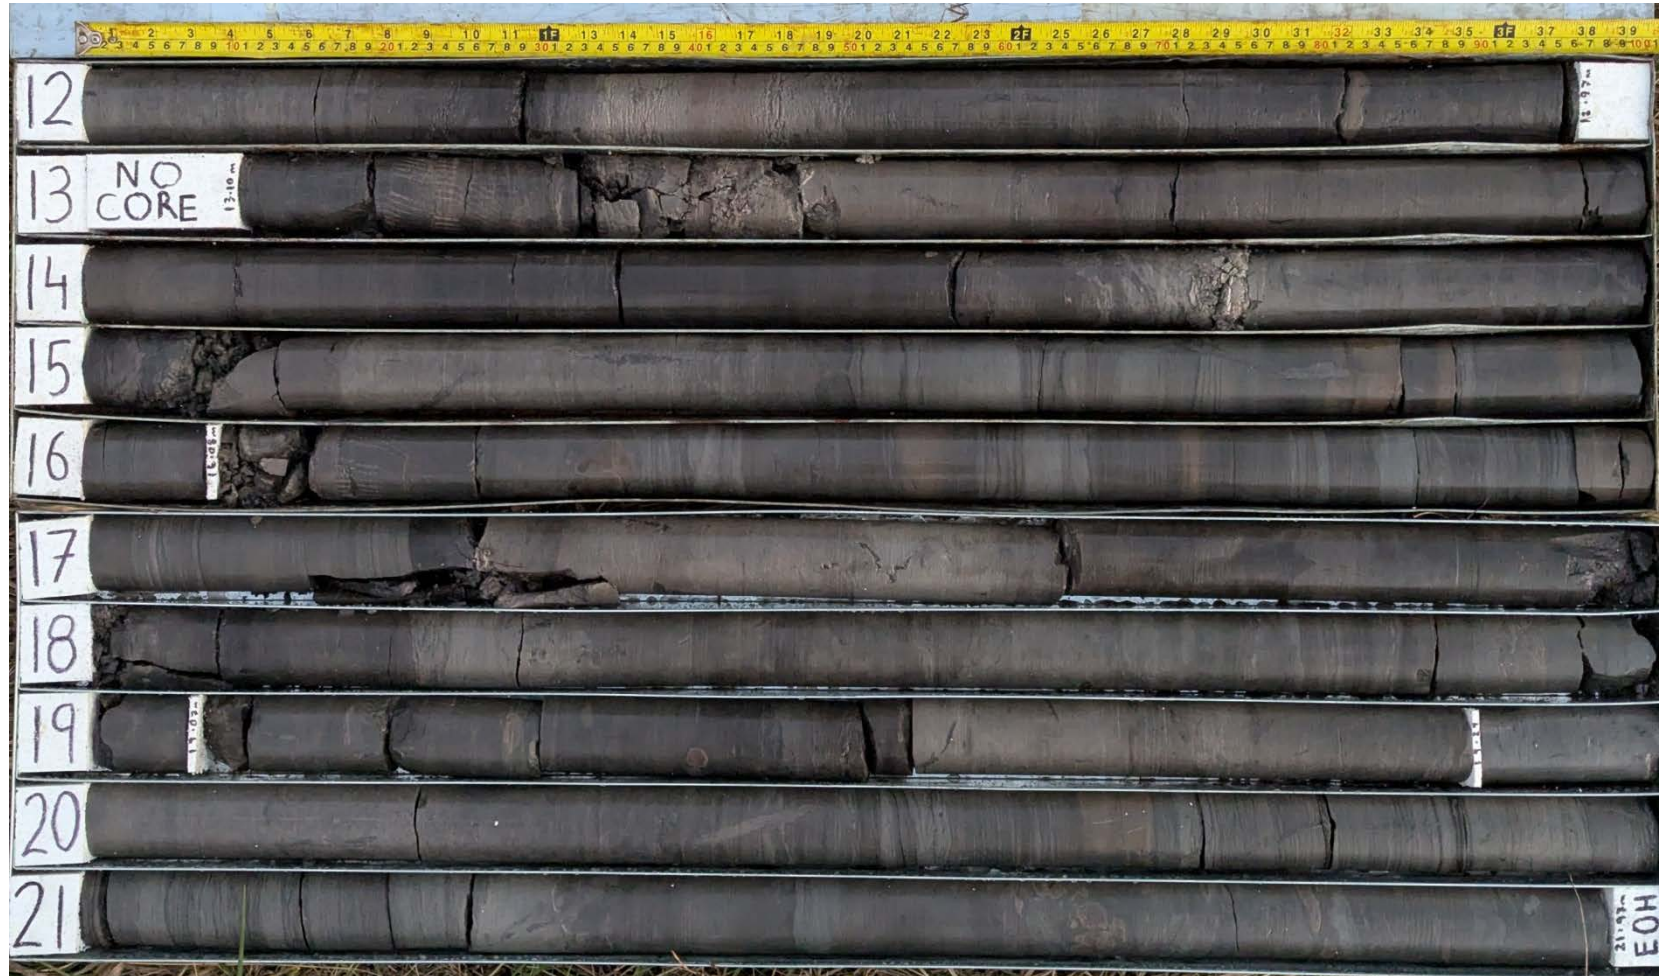
<b>Project</b>	Proposed Mixed-use Development	<b>East</b>	290213	<b>Depth Range</b>	12.00m to 21.97m BEGL
<b>Location</b>	135 Badgerys Creek Road, Bradfield NSW	<b>North</b>	6244042	<b>Contractor</b>	Geosense Drilling Engineers Pty Ltd
<b>Position</b>	See Figure 2	<b>Surface RL</b>	≈ 76.8m	<b>Drill Rig</b>	Comacchio GEO 205
<b>Job No.</b>	E26733.G03	<b>Inclination</b>	-90°	<b>Logged</b>	GB <b>Date</b> 28 / 04 / 2025
<b>Client</b>	Creative Vision	<b>Box</b>	3-4 of 4	<b>Checked</b>	JB <b>Date</b> 23 / 06 / 2025

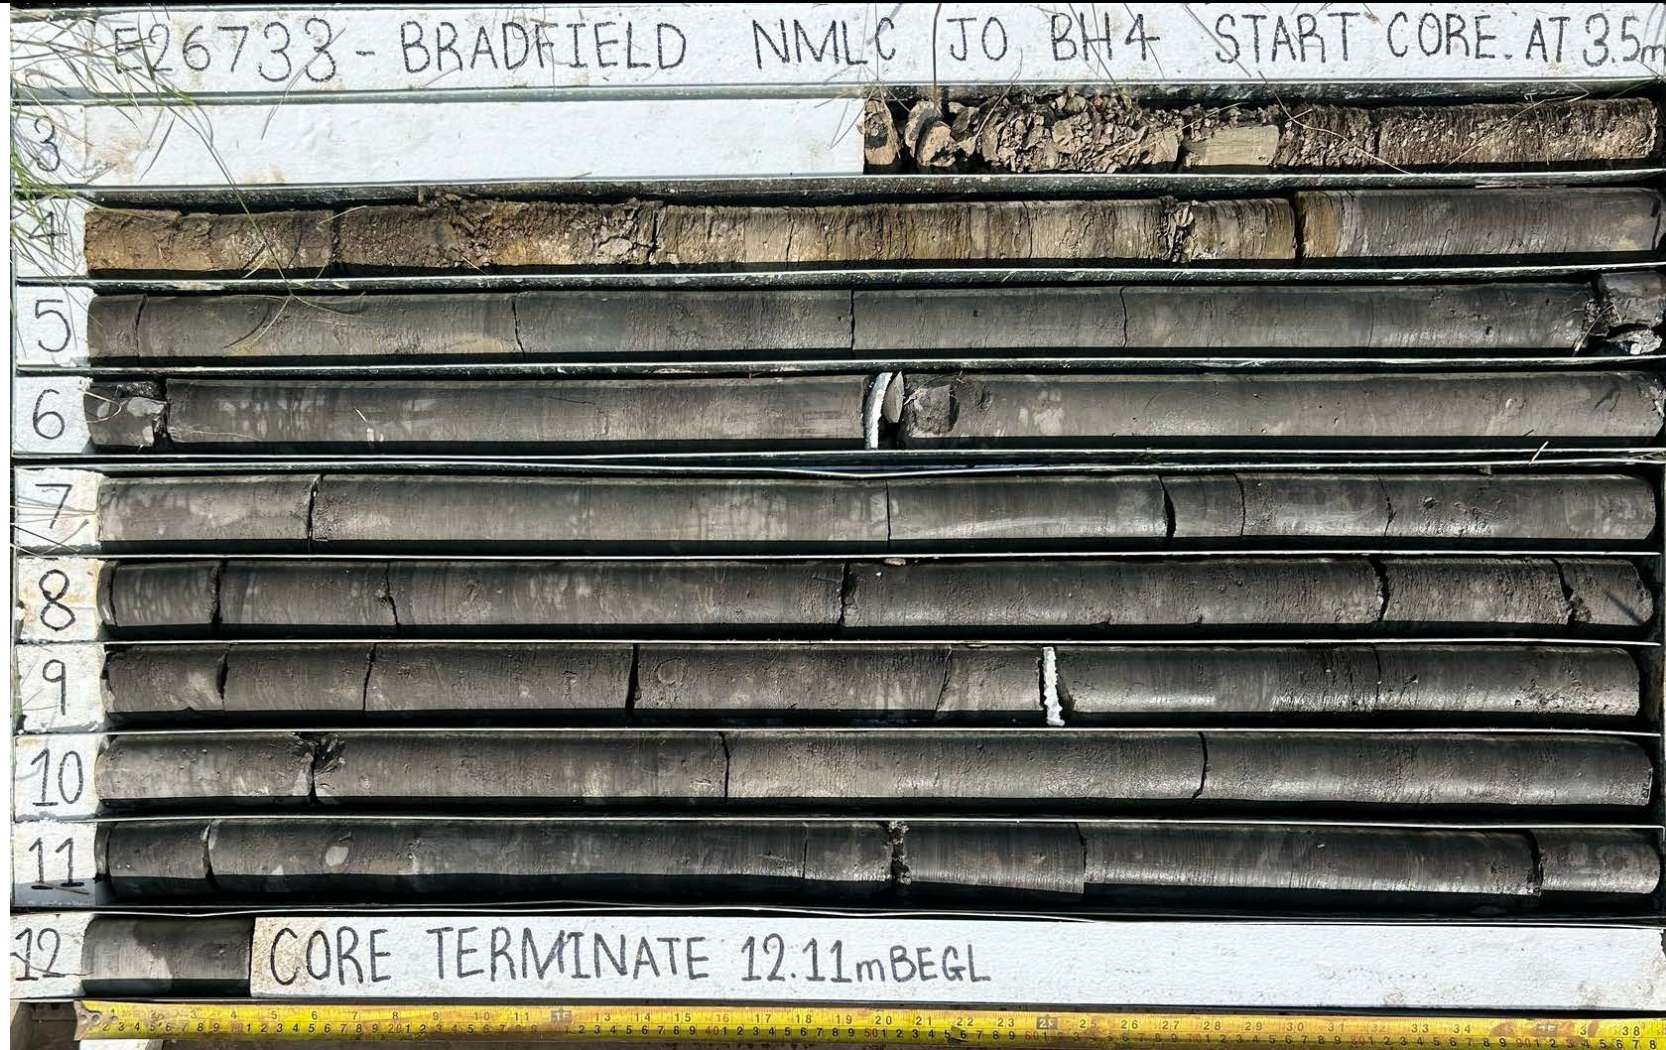
<b>Project</b>	Proposed Mixed-use Development	<b>East</b>	290287	<b>Depth Range</b>	3.5m to 12.11m BEGL
<b>Location</b>	135 Badgerys Creek Road, Bradfield NSW	<b>North</b>	6244062	<b>Contractor</b>	Geosense Drilling Engineers Pty Ltd
<b>Position</b>	See Figure 2	<b>Surface RL</b>	≈ 77.1m	<b>Drill Rig</b>	Comacchio GEO 205
<b>Job No.</b>	E26733.G03	<b>Inclination</b>	-90°	<b>Logged</b>	JO <b>Date</b> 29 / 04 / 2025
<b>Client</b>	Creative Vision	<b>Box</b>	1-3 of 3	<b>Checked</b>	JB <b>Date</b> 23 / 06 / 2025

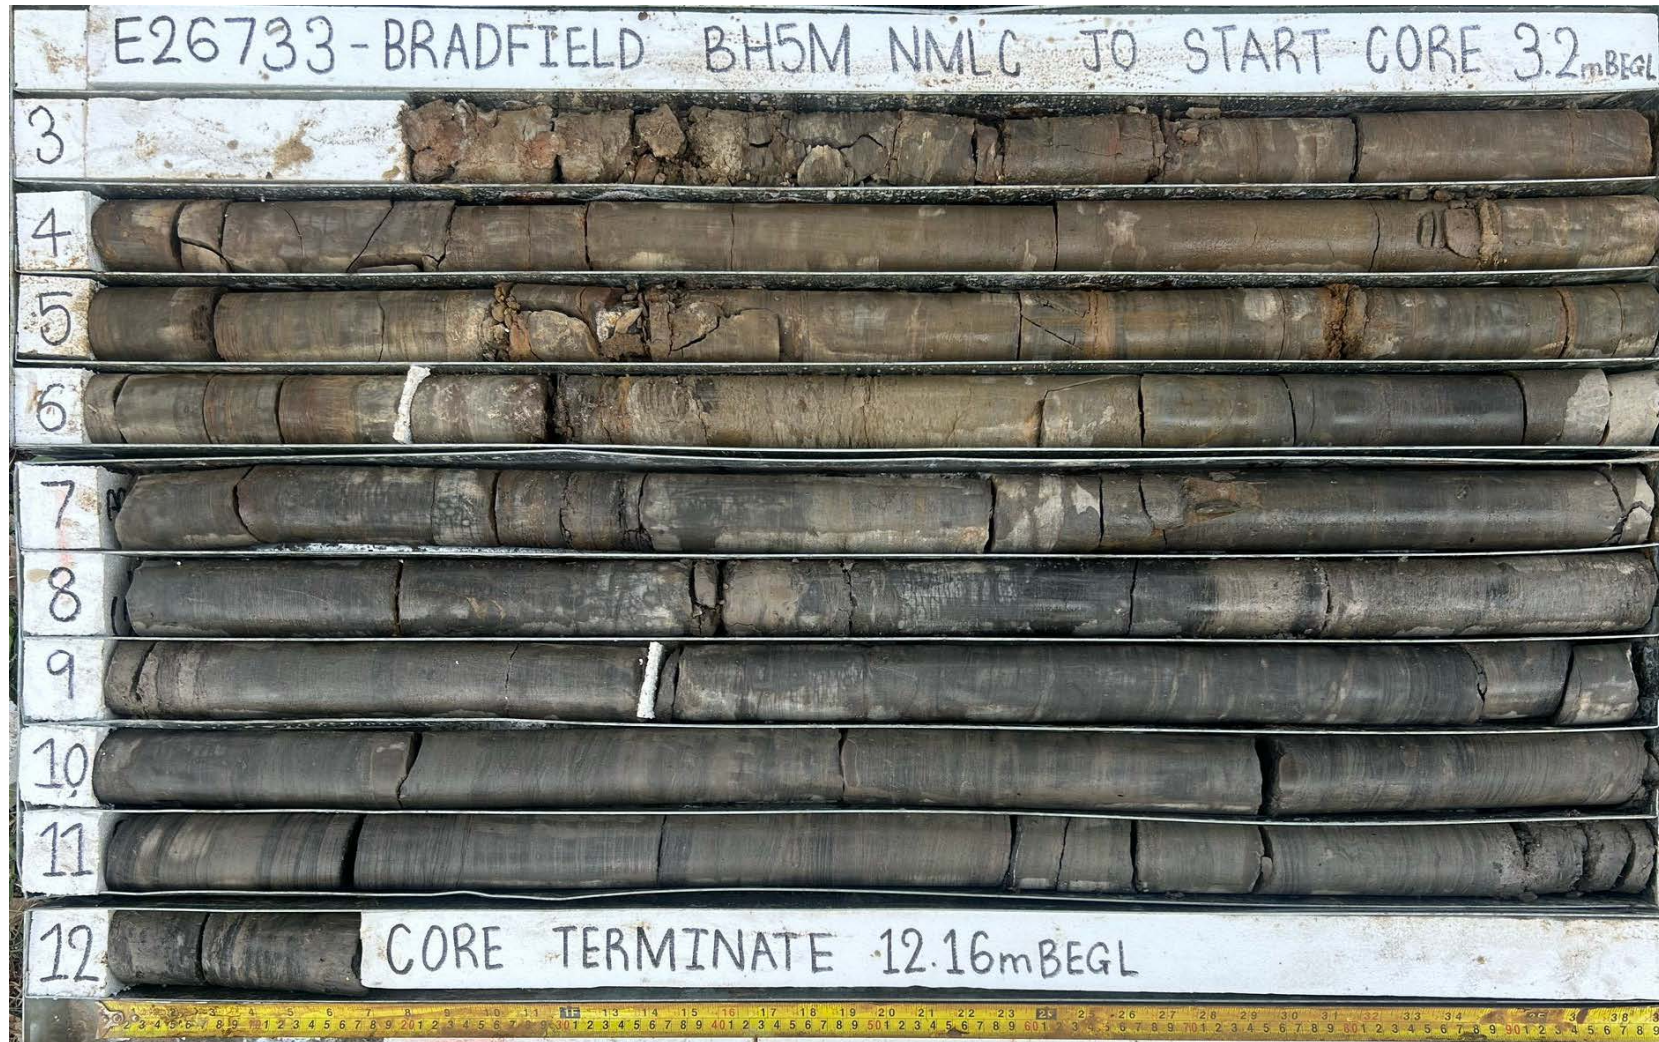
# CORE PHOTOGRAPH OF BOREHOLE: BH5M

<b>Project</b>	Proposed Mixed-use Development	<b>East</b>	290372	<b>Depth Range</b>	3.2m to 12.16m BEGL
<b>Location</b>	135 Badgerys Creek Road, Bradfield NSW	<b>North</b>	6244051	<b>Contractor</b>	Geosense Drilling Engineers Pty Ltd
<b>Position</b>	See Figure 2	<b>Surface RL</b>	≈ 80.7m	<b>Drill Rig</b>	Comacchio GEO 205
<b>Job No.</b>	E26733.G03	<b>Inclination</b>	-90°	<b>Logged</b>	JO <b>Date</b> 30 / 04 / 2025
<b>Client</b>	Creative Vision	<b>Box</b>	1-3 of 3	<b>Checked</b>	JB <b>Date</b> 23 / 06 / 2025

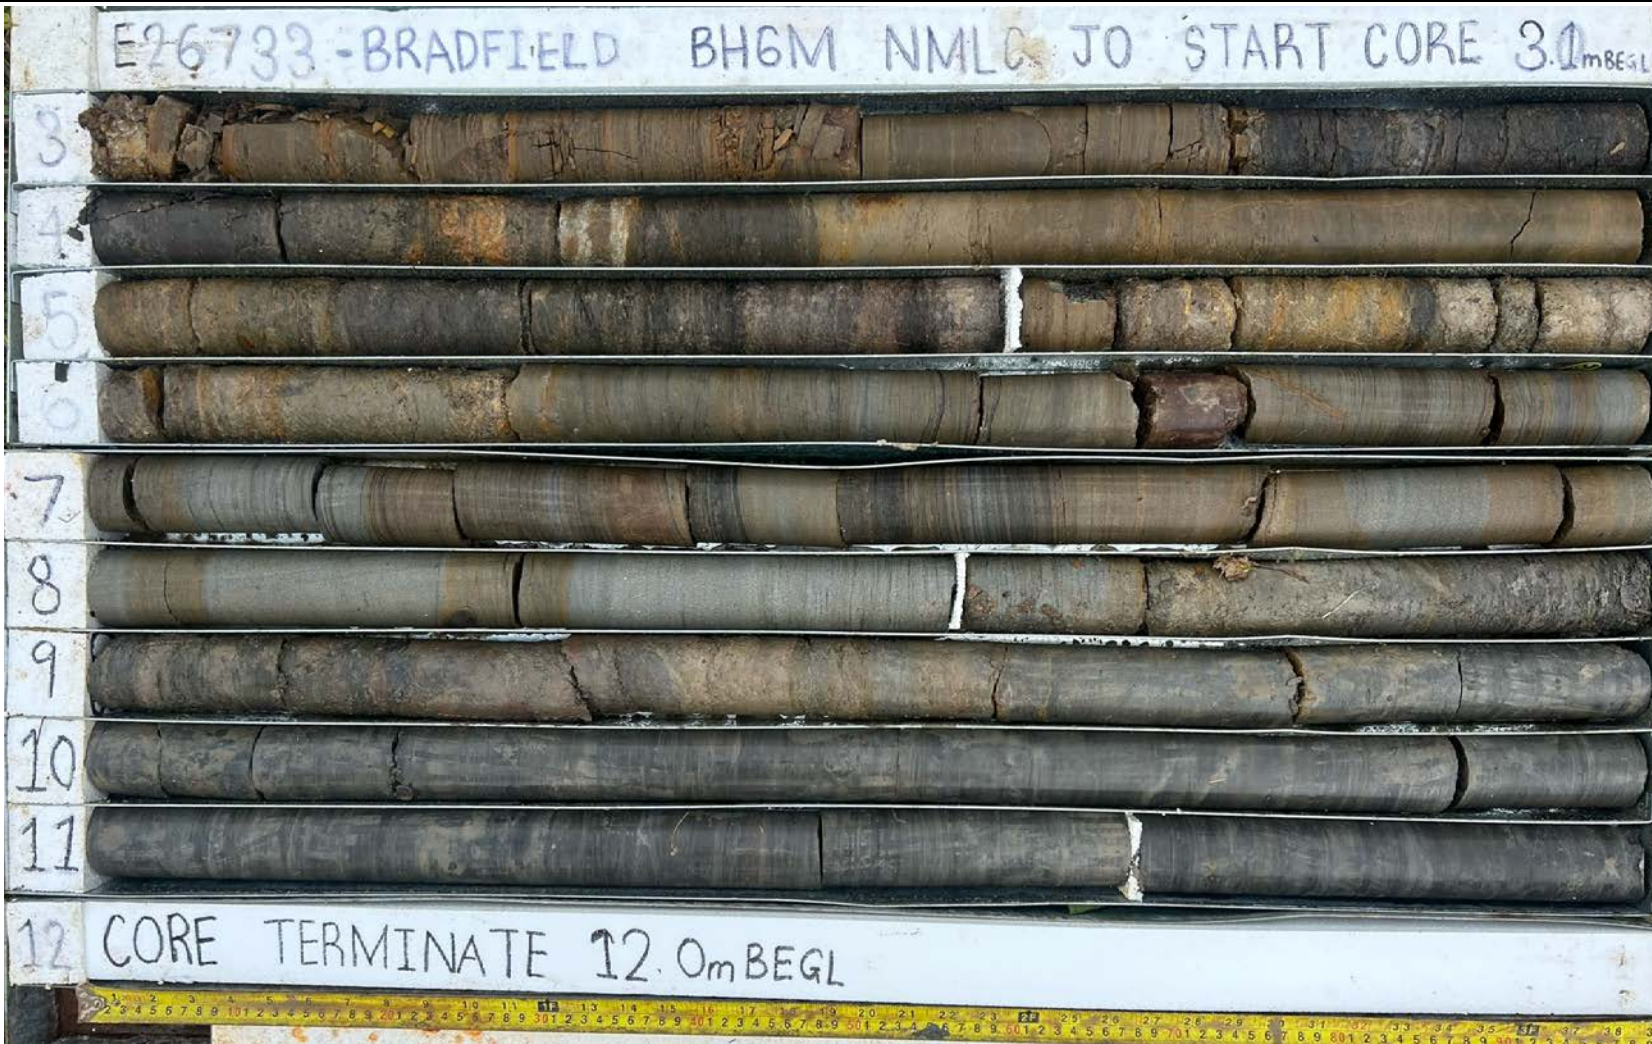
# CORE PHOTOGRAPH OF BOREHOLE: BH6M

<b>Project</b>	Proposed Mixed-use Development	<b>East</b>	290363	<b>Depth Range</b>	3.0m to 12.0m BEGL	
<b>Location</b>	135 Badgerys Creek Road, Bradfield NSW	<b>North</b>	6243994	<b>Contractor</b>	Geosense Drilling Engineers Pty Ltd	
<b>Position</b>	See Figure 2	<b>Surface RL</b>	≈ 78.7m	<b>Drill Rig</b>	Comacchio GEO 205	
<b>Job No.</b>	E26733.G03	<b>Inclination</b>	-90°	<b>Logged</b>	JO	<b>Date</b> 30 / 04 / 2025
<b>Client</b>	Creative Vision	<b>Box</b>	1-2 of 2	<b>Checked</b>	JB	<b>Date</b> 23 / 06 / 2025

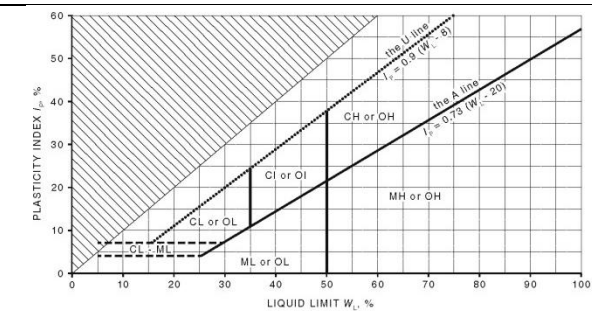
### PLASTICITY PROPERTIES

OL	Organic silts and organic silty clays of low plasticity, low to medium dry strength.
	MH	Inorganic silts of high plasticity, high to very high dry strength.
	CH	Inorganic clays of high plasticity, high to very high dry strength.
<b>OH</b> Liquid Limit > 50%	OH	Organic clays of medium to high plasticity, medium to high dry strength.
	PT	Peat muck and other highly organic soils.
Highly Organic soil
