Arboricultural Development Assessment Report

22 Hospital Road
Bulli NSW 2516
April 2017
FINAL

Prepared for: Health Infrastructure
c/o Johnstaff
Level 12, 70 Pitt St,
Sydney NSW 2000

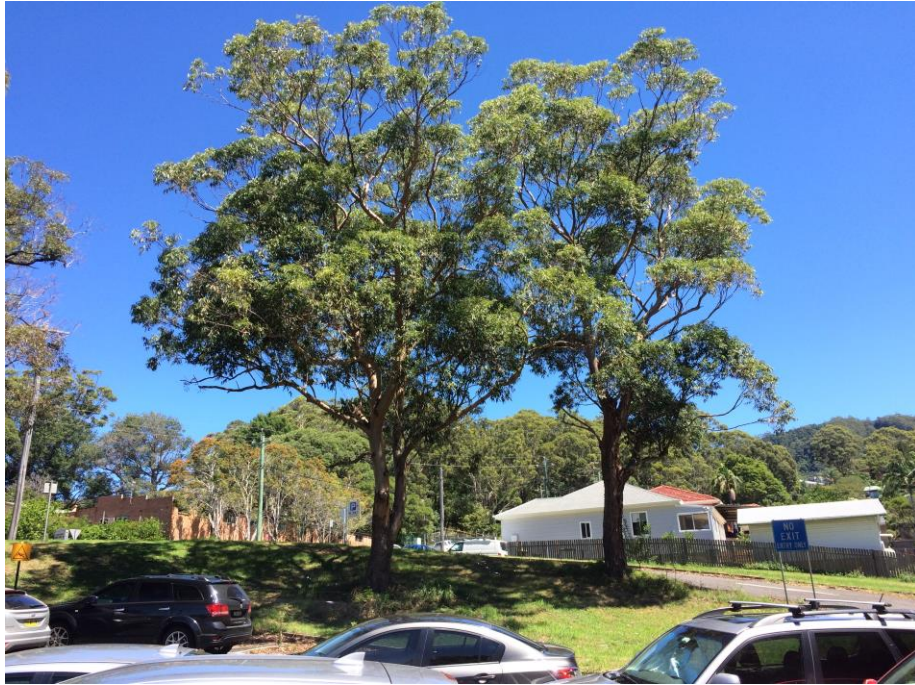
3.4 Tree 1 has a large vertical cavity and fruiting body growing within in it (Plate 1). Fruiting bodies are associated with decay pathogens and generally the decay is at its worst in the location of the fruiting body. Decay affects the strength of wood, only becoming worse with time and making the affected area prone to failure. This tree is structurally dangerous and, as a result, has a short SULE. Tree 2 is in good health and condition. Tree 4 is a large mature Grey iron bark (*Eucalyptus paniculata*) in good health and condition (Plate 2). It consists of three (3) main stems. It is quite a large prominent tree that can be seen from the streetscape. It provides visual amenity to the streetscape. If possible, this tree should be retained.

Plate 1: Trees 1 (Right) and 2 (Left). Tree 1 is recommended for removal. P. Vezgoff.

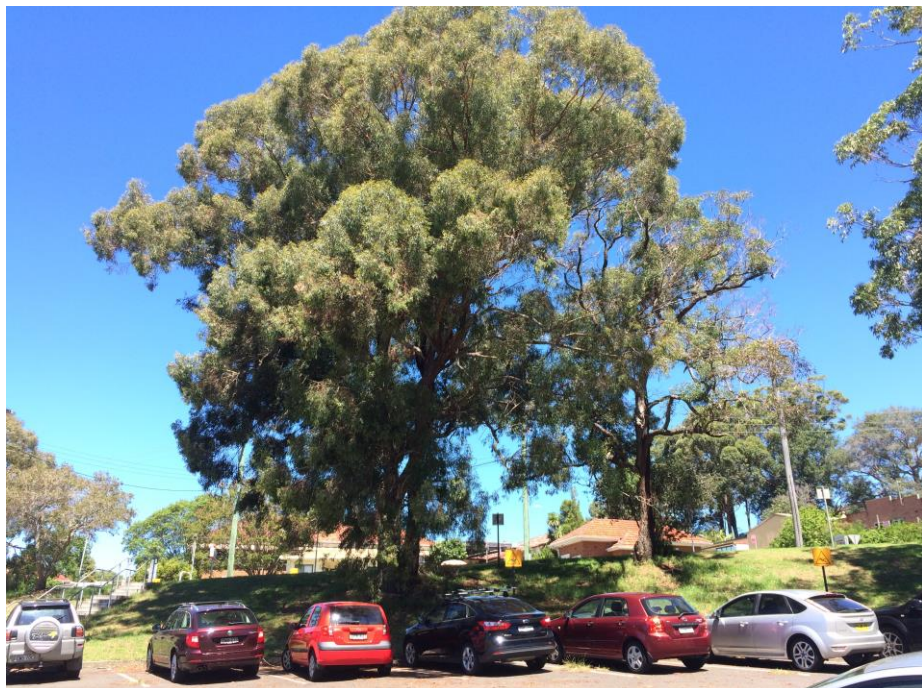
Plate 2: Trees 3 (right) and Tree 4 (left). P. Vezgoff.

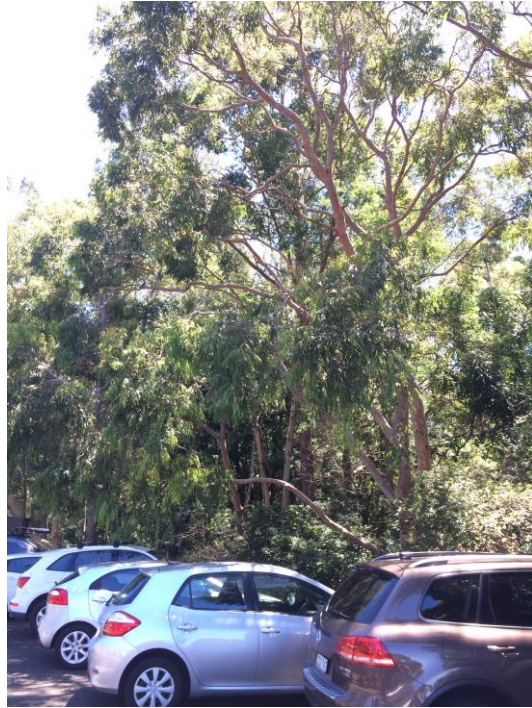
- 3.6** Trees 11-19 are all semi mature, but large, Hill's weeping fig (*Ficus microcarpa* var. *Hillii*). These trees are all in fair health and condition (Plate 3). They have broad domed canopies with low arching branches, which is normal for their growing type. Tree 11 is an individual specimen growing near the car park exit on Hospital Road (Plate 8). Trees 12-19 have been planted as a screening hedge in one row near the northern site boundary.

Plate 3: Trees 18-25 in the north western corner. P. Vezgoff.

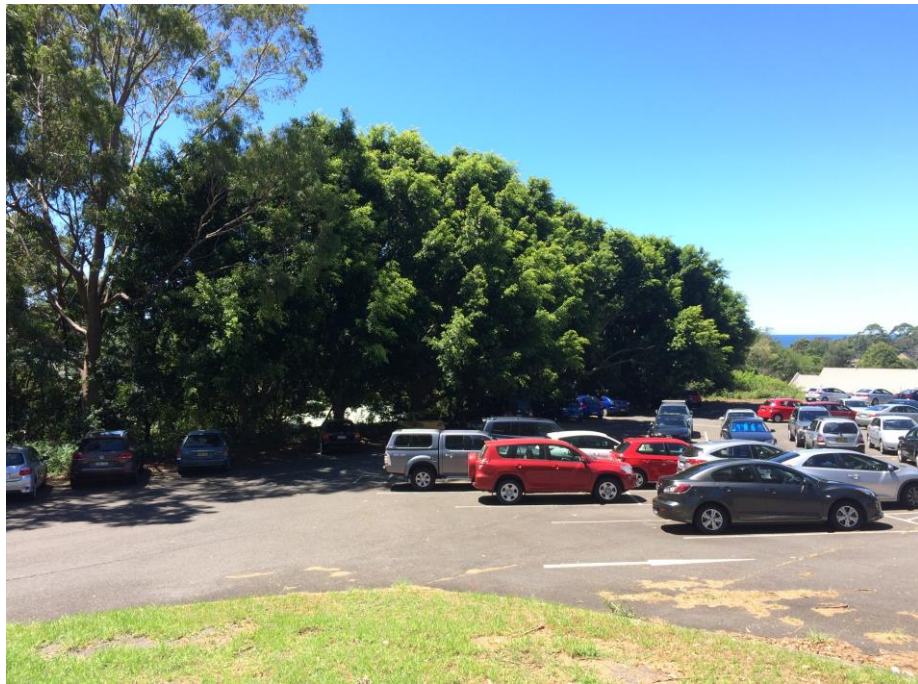
Plate 4: Trees 12-19 being a dominant planting on the site. P. Vezgoff.

- 4.5** Reduction pruning should occur to Trees 13, 14, 17-19 to reduce weight on the northern lateral stems and also encourage a finer development of branches rather than the long stems that are currently developing.

Branches on the northern portion of the canopies should be reduced by 20% in length. These branches should be reduced back so as to maintain the canopy of the tree (ie, no lopping or 'flat topping'). Pruning points should be no greater than 150mm in diameter. This pruning is known as reduction pruning and can be read about in more detail in the Australian Standard for the Pruning of Amenity Trees (AS 4373) 2007.

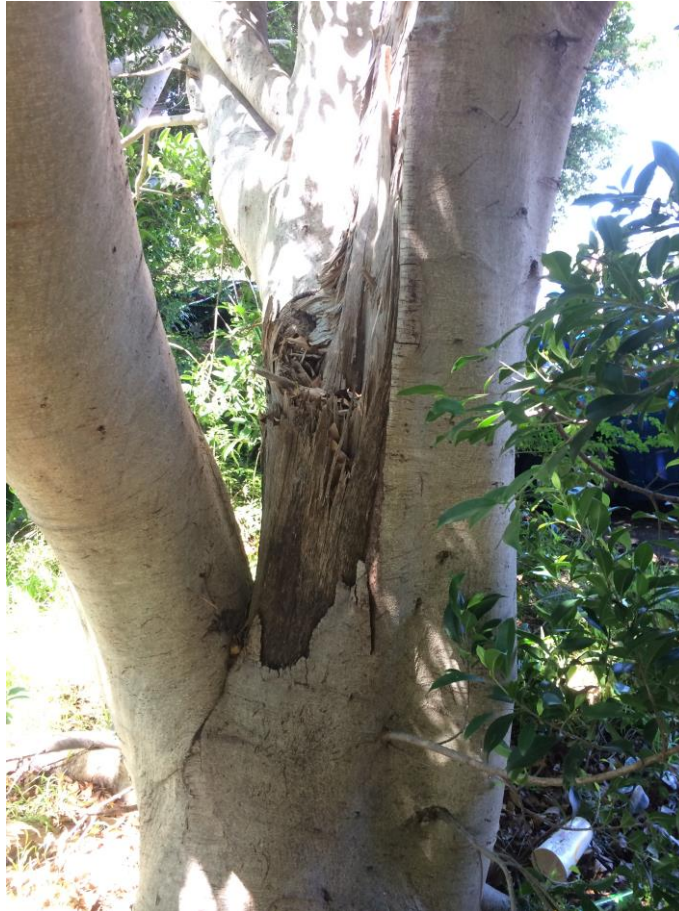
- 3.8** Since my initial inspection back in 2015, these trees have had some branch and stem failures such as on Trees 15 and 16 (Plates 5 and 6). Two (2) of these failures have occurred at the basal area (Plate 6) where further failure is possible. It should be remembered that branch failure is not unusual for any tree, it is a natural process. I have allocated these trees a SULE rating of 15-40 years provided weight reduction pruning occurs. The weight reduction pruning will provide a reduction in risk for the next 10-15 years. The weight reduction will reduce tension and compression forces on the main branch unions but also reduce the length of branch to an extent that should it fail it will not fall entirely onto private property. Due to the potential size these trees can grow to, they will require reduction pruning approximately every 5 years.

Plate 5: Old stem failure on Tree 16. P. Vezgoff.

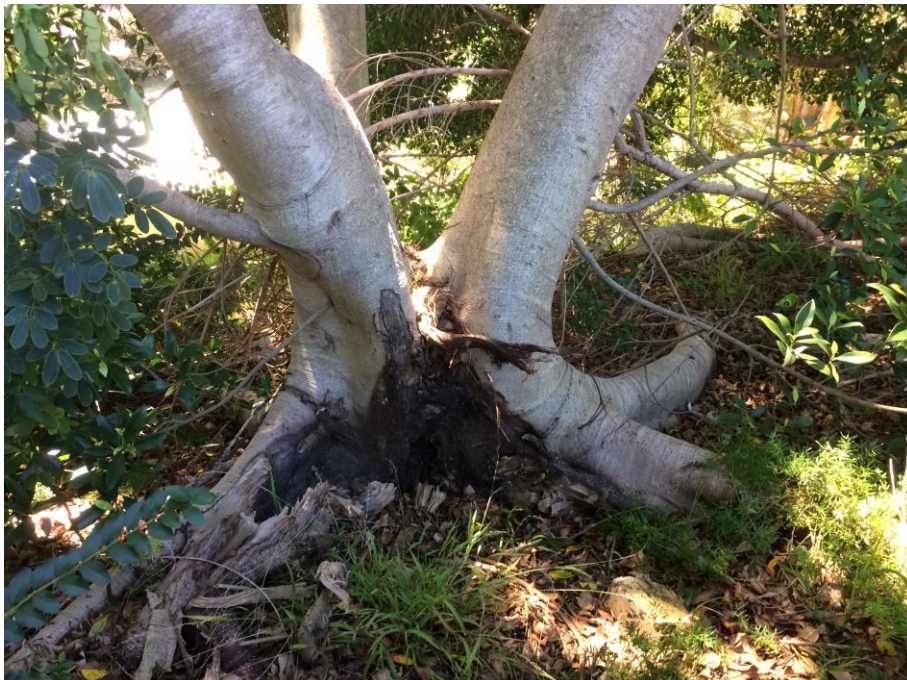
Plate 6: Tree 15 basal failure. P. Vezgoff.

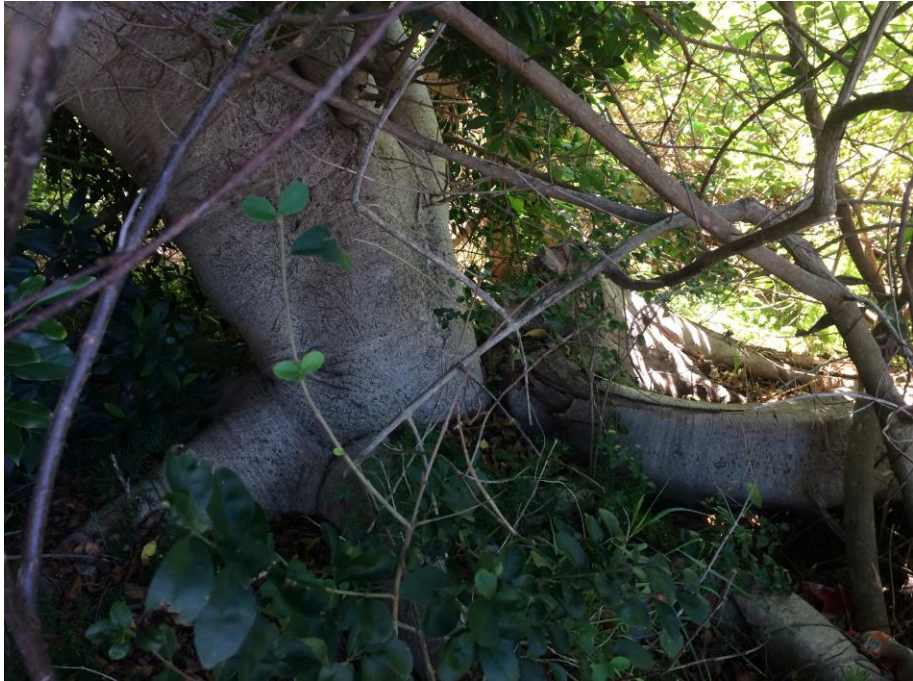
Plate 7: Tree 12. P. Vezgoff.

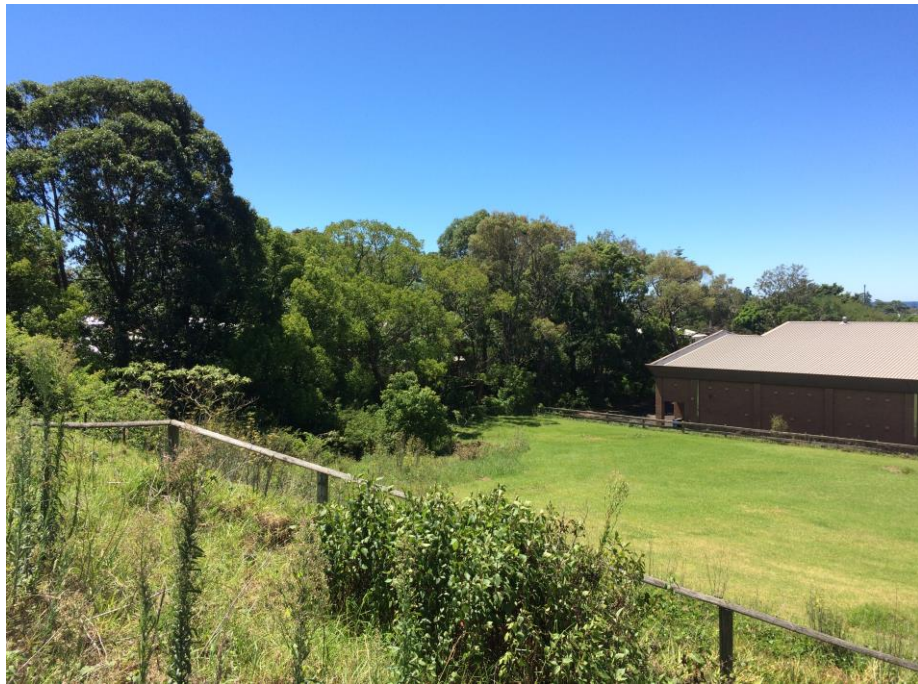
Plate 9: Trees located in the north eastern corner. P. Vezgoff.

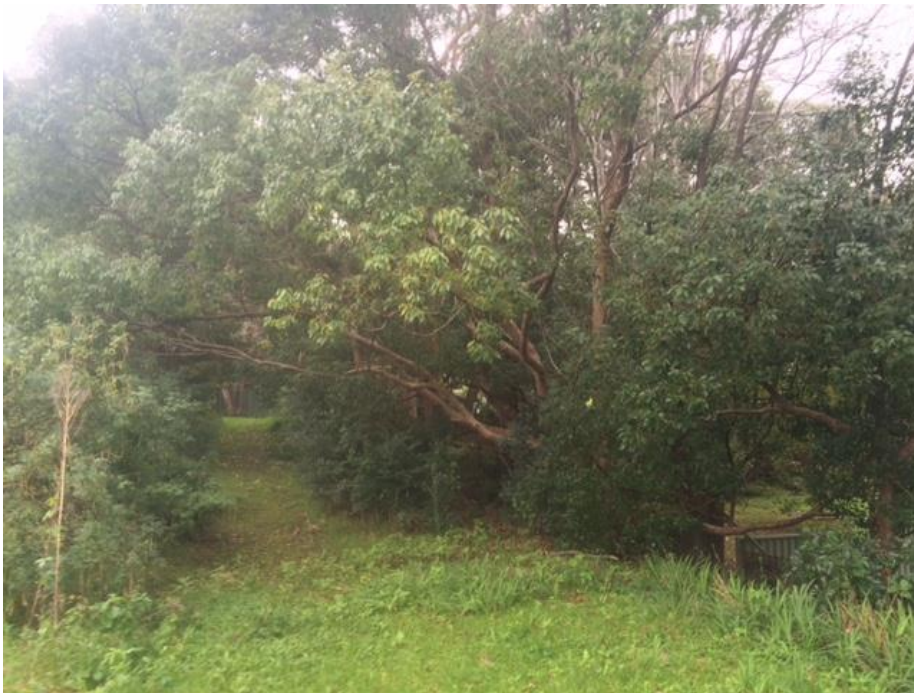
Plate 10: Image showing Trees 36-41. P.Vezgoff

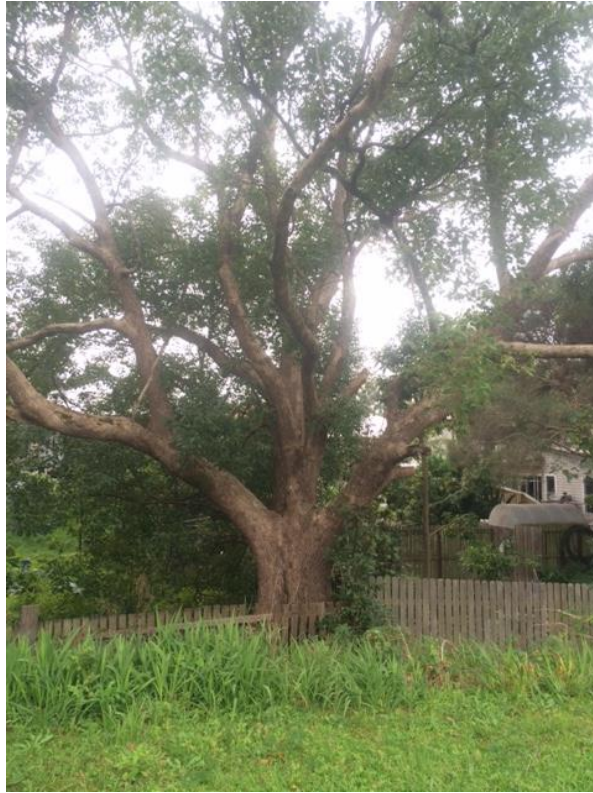
Plate 11: Image showing Tree 43 on the adjoining property to the north. P.Vezgoff

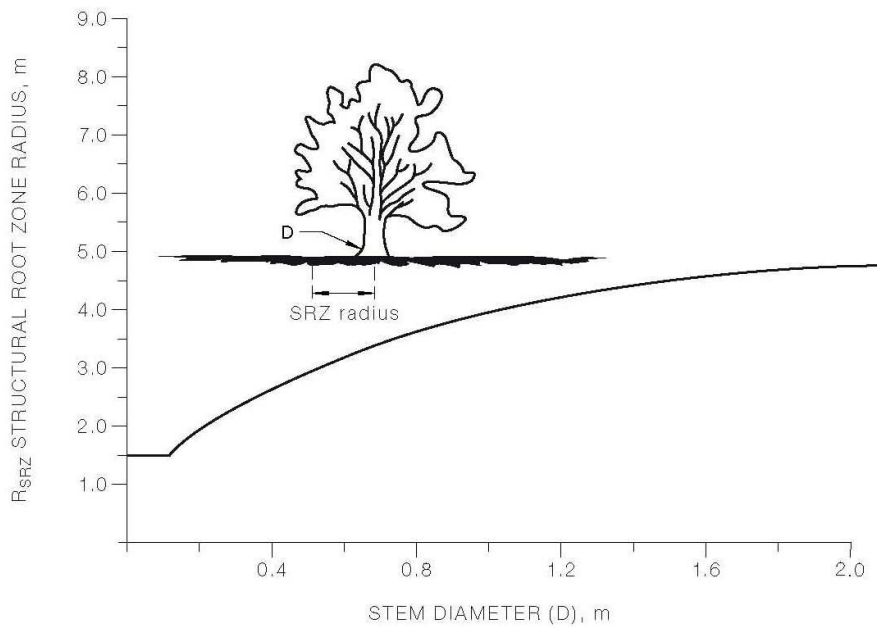
NOTE: The SRZ for trees with trunk diameters less than 0.15m will be 1.5m (see Figure 1).

The curve can be expressed by the following formula:
 $R_{SRZ} = (D \times 50)^{0.42} \times 0.64$

FIGURE 1 - STRUCTURAL ROOT ZONE

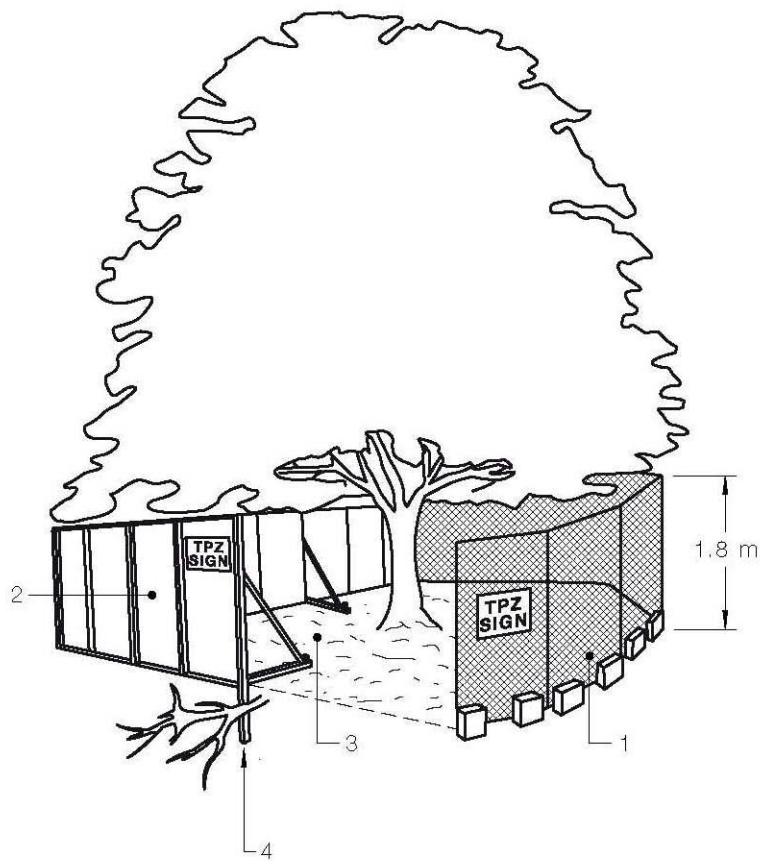
Tree protection fencing
specifications

- 1 Chain wire mesh panels with shade cloth (if required) attached, held in place with concrete feet.
- 2 Alternative plywood or wooden paling fence panels. This fencing material also prevents building materials or soil entering the TPZ.
- 3 Mulch installation across surface of TPZ (at the discretion of the project arborist). No excavation, construction activity, grade changes, surface treatment or storage of materials of any kind is permitted within the TPZ.
- 4 Bracing is permissible within the TPZ. Installation of supports should avoid damaging roots.

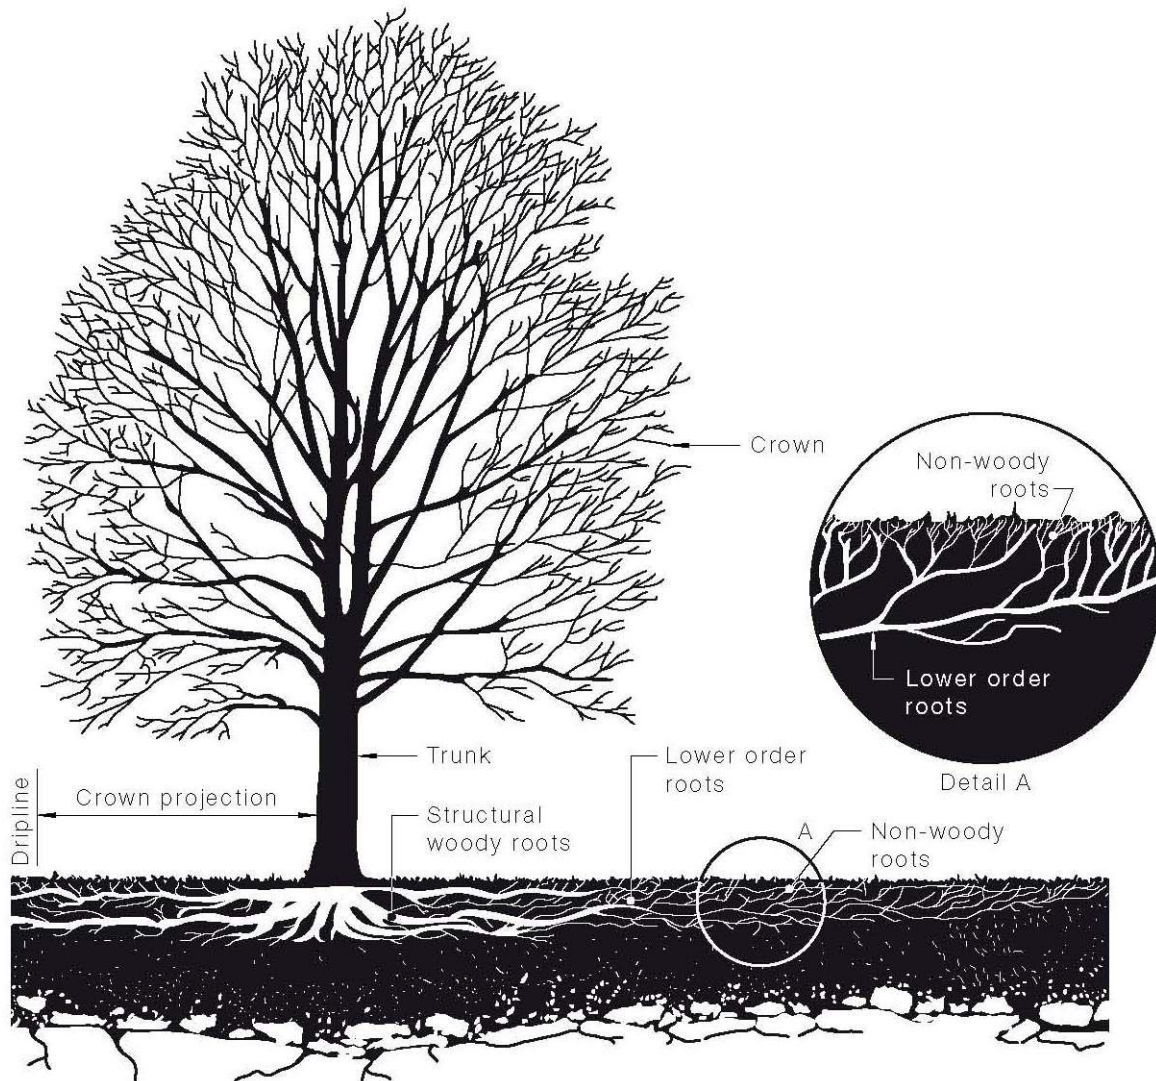
Figure 2: Structure of a tree in a normal growing environment (AS 4970, 2009.).
