AQUALAND PRESTIGE 2 PTY LTD

Geotechnical Investigation

Site B, 2-16 Pockley Avenue, Roseville NSW

E26491.G03_Rev2
16 April 2025

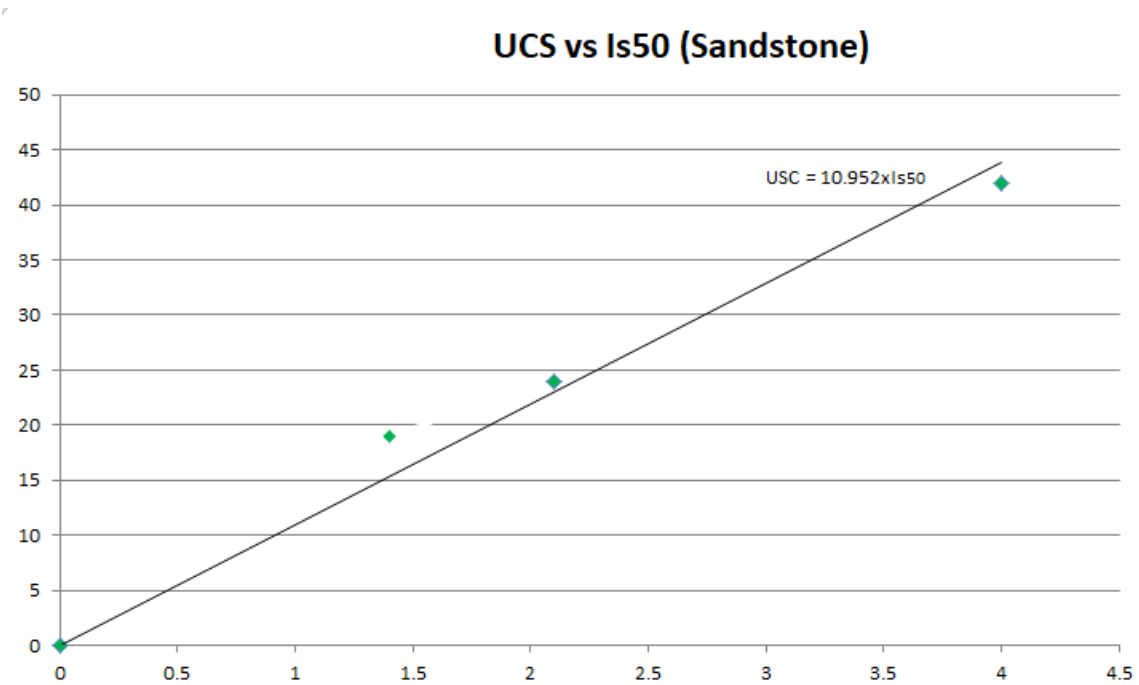
Plate 4 Correlation of UCS vs I_{s50}

A plot correlating the UCS test results with the neighbouring point load test results on the same rock are presented in **Plate 4**.

As presented in **Plate 4** above, the correlation of UCS value to the point load strength index for sandstone at the site is $UCS = 10.95 \times I_{s50}$. The approximate UCS of Unit 4b (Class III Sandstone), estimated from this correlation with the point load strength index test results, varied from 7 MPa to 60 MPa. It should be noted that the strength of Unit 4b varied with depth. Material within unit 4b has been classified as Class III sandstone, governed by defect spacing.

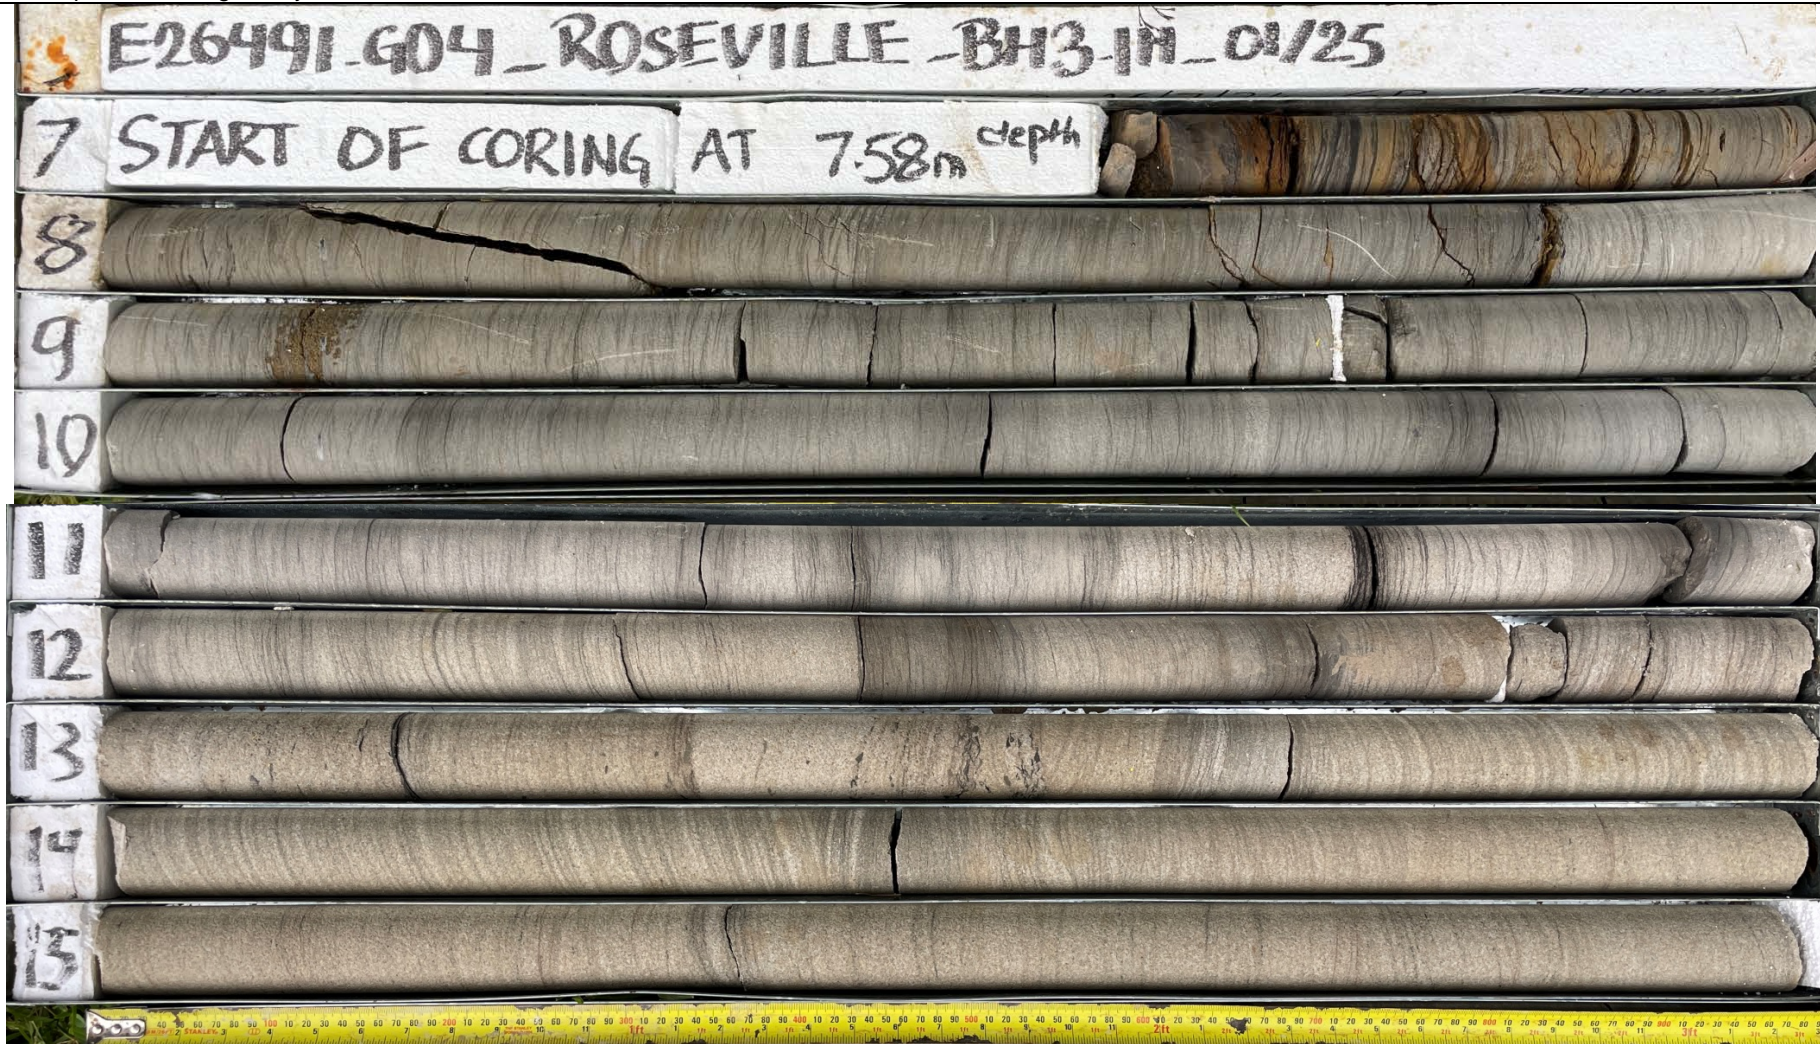
CORE PHOTOGRAPH OF BOREHOLE: BH3.1M

| Project | Proposed Development | East | 331134.3520 (MGA 2020 Zone 56) | Depth Range | 7.58m to 24.2m |

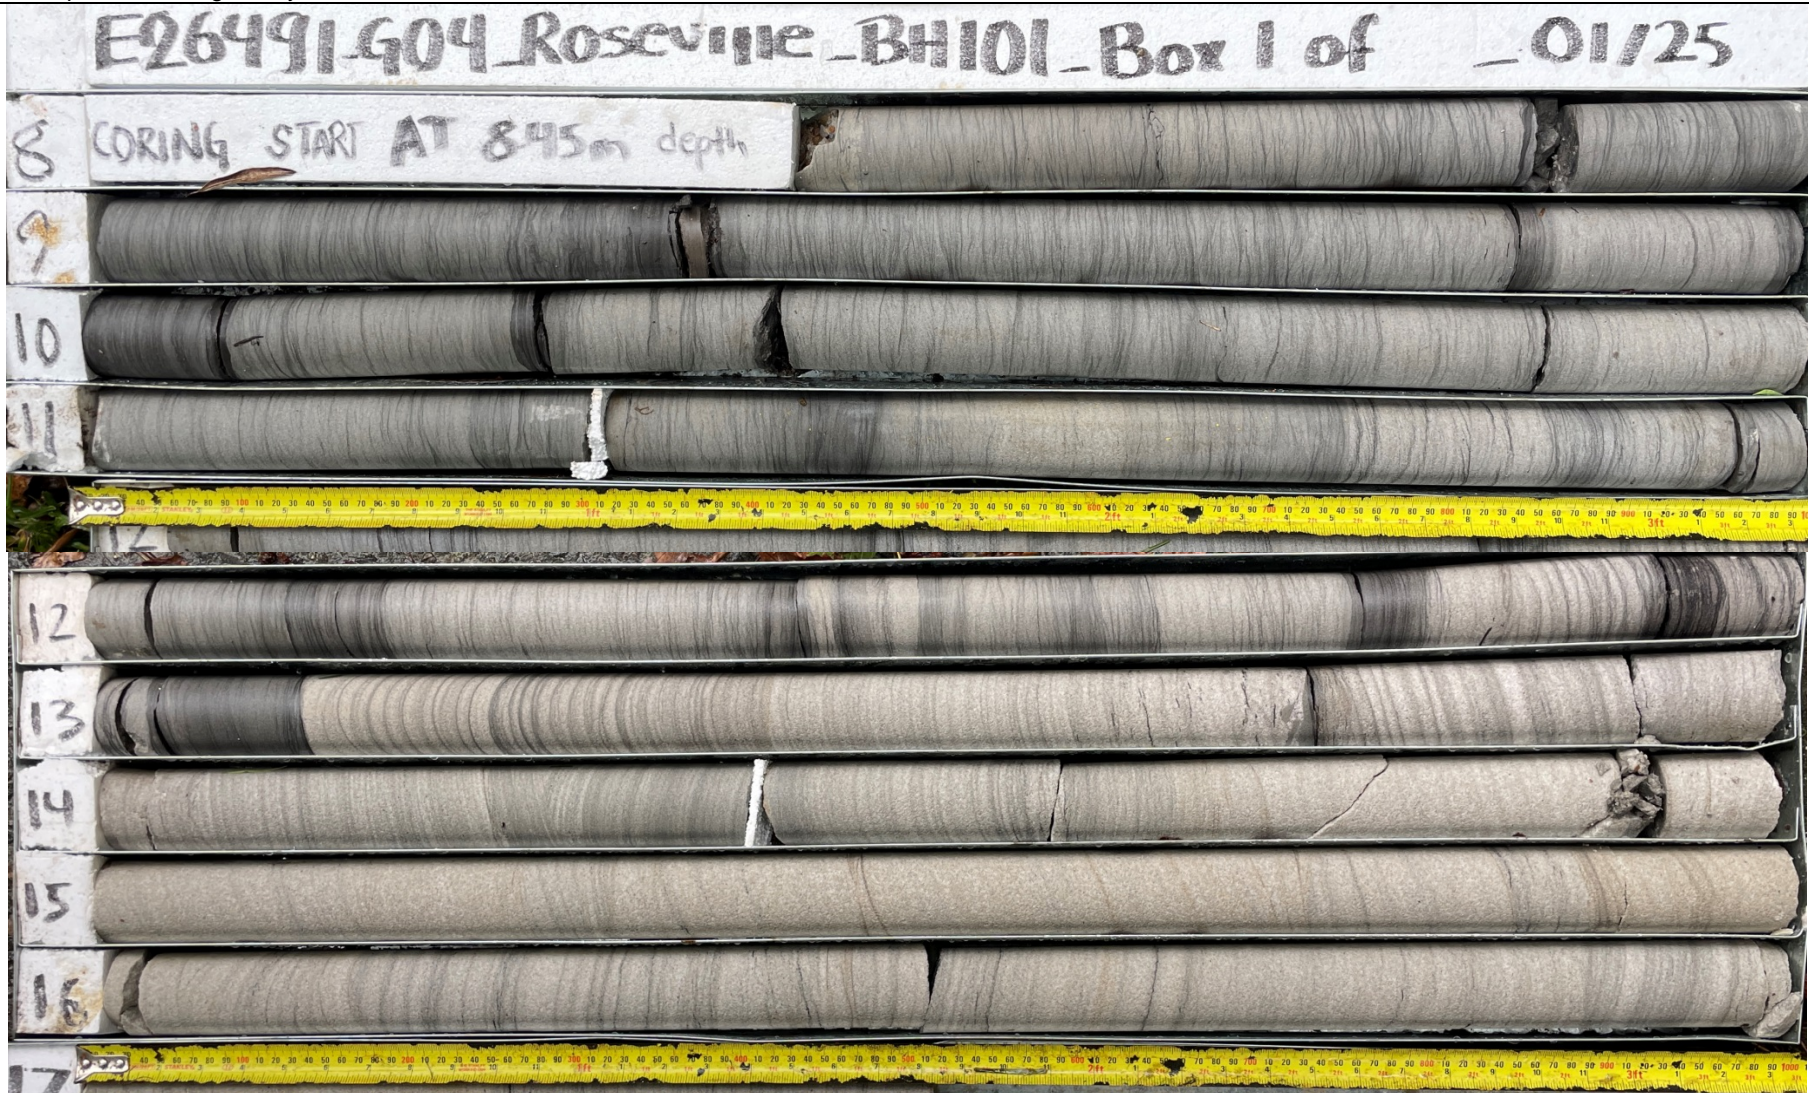
CORE PHOTOGRAPH OF BOREHOLE: BH101

| Project | Proposed Development | East | 331128.9804 (MGA 2020 Zone 56) | Depth Range | 8.45m to 22.0m | |

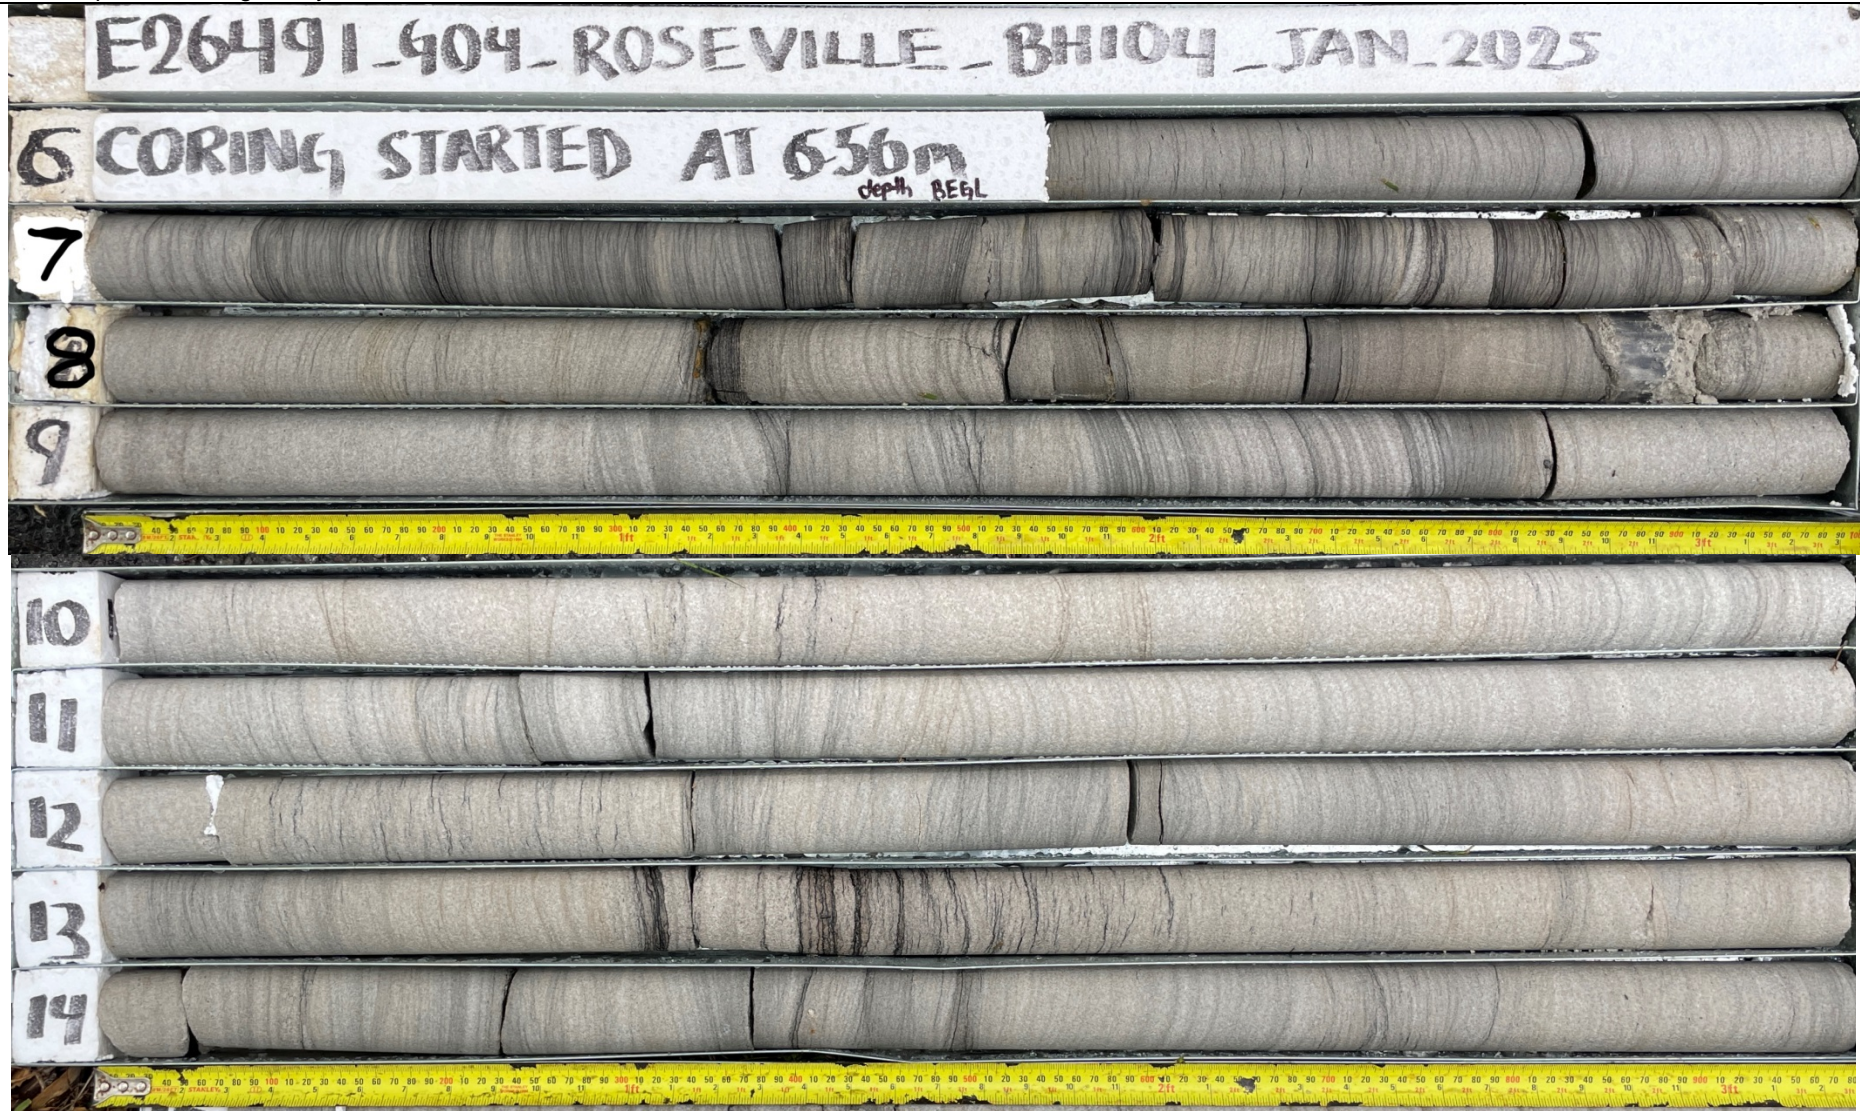
CORE PHOTOGRAPH OF BOREHOLE: BH102

| Project | Proposed Development | East | 331076.9665 (MGA 2020 Zone 56) | Depth Range | 6.56m to 19.37m | |
