AQUALAND PRESTIGE 2 PTY LTD

Geotechnical Investigation

Site B, 2-16 Pockley Avenue, Roseville NSW

E26491.G03_Rev3
30 September 2025

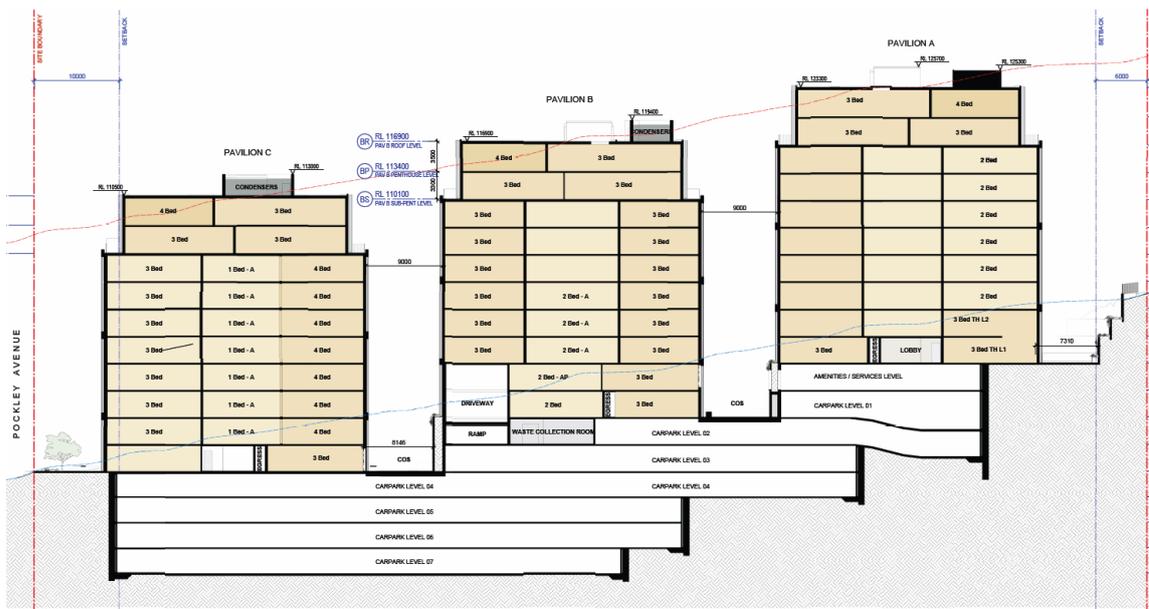
Plate 1 Extract of site section (source: Woods Bagot, Proj. 122021, Dwg. DA-AR-B-32-101, Rev. B, 9 April 2025)

It is understood that the lowest basement level will have a Finished Floor Level (FFL) of RL 90.8m AHD at the north-eastern site boundary and RL 66.0m AHD at the south-western site boundary. It is expected that the basement excavation will have a Bulk Excavation Level (BEL) will exist approximately 300 mm below the FFL, accounting for the slab and drainage layer. To reach BEL, EI expects a maximum excavation depth of 23 m. Locally deeper excavations may be required for footings, lift overrun pits, crane pads, and service trenches.

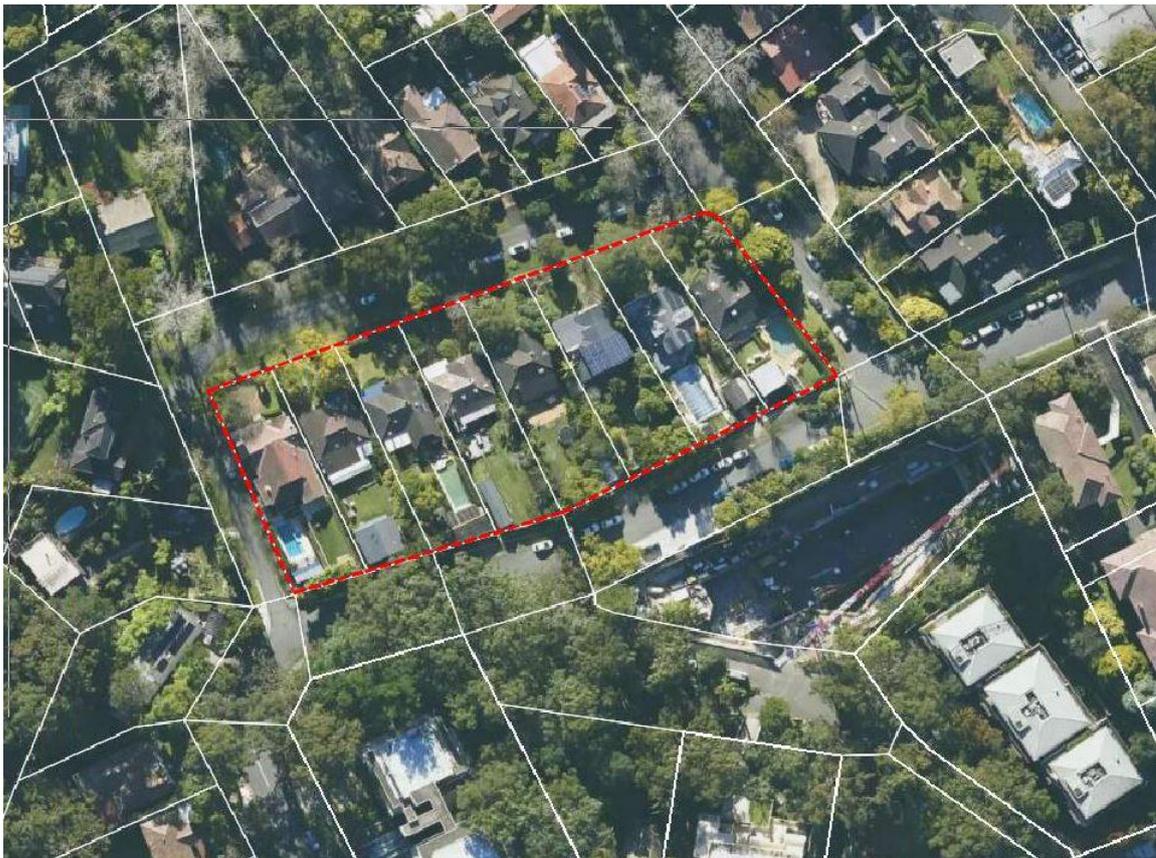
Plate 2 Aerial photograph of the site (source: Metro Map, accessed on 5 September 2024)

Information	Detail
Street Address	2-16 Pockley Avenue, Roseville NSW
Lot and Deposited Plan (DP) Identification	Lot 11 to18 in DP 8261
Brief Site Description	At the time of our investigation, the site was occupied by one to two–storey residential dwellings. The remaining areas of the site are occupied by grass, plants and trees scattered across.
Site Area	The site area is approximately 6589m ² (based on the provided information from SIX Maps accessed on 5 September 2024).

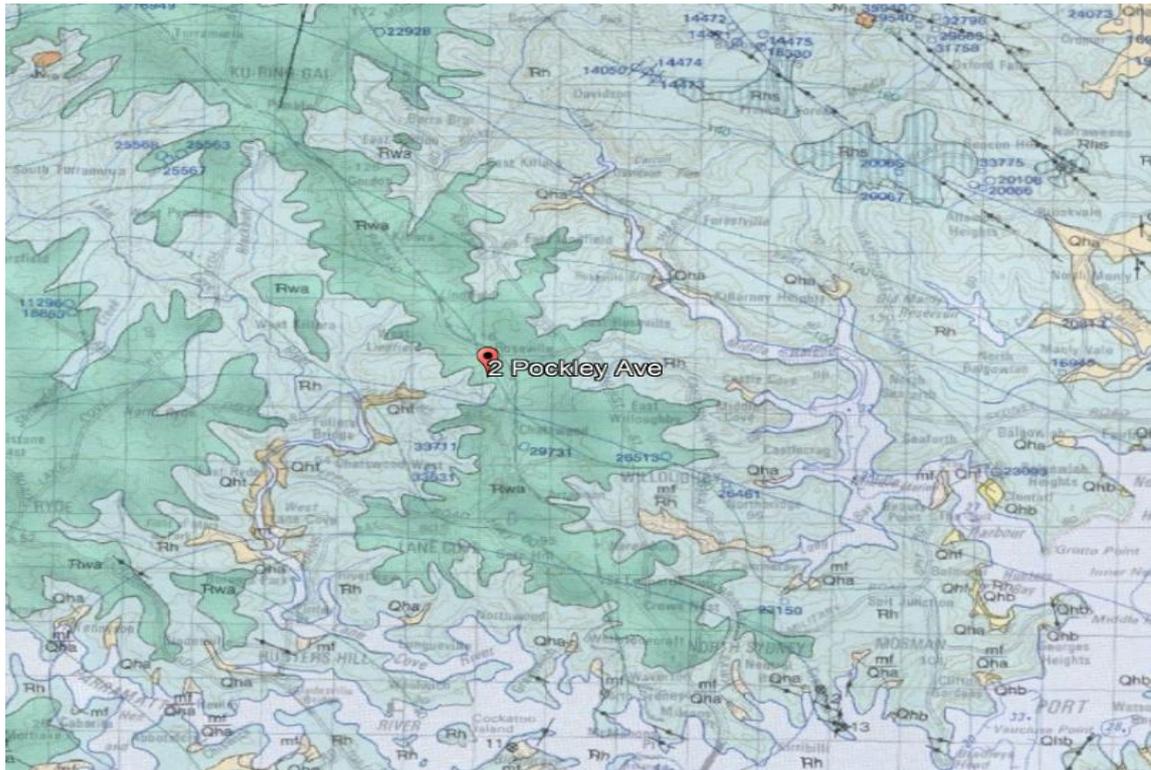
Plate 3 Excerpt of geological map showing location of site.

Attribute	Description
Topography	The site moderately dips from eastern site boundary towards the western site boundary towards Blue Gum Creek.
Regional Geology	Information on regional sub-surface conditions, referenced from the Department of Minerals and Energy Geological Map Sydney 1:100,000 Geological Series Sheet 9130 (DMR 1983) indicates the site to be underlain by Ashfield Shale (Rwa), as shown in Plate 3 . Ashfield Shale (Rwa) typically consists of black to dark grey shale and laminite.

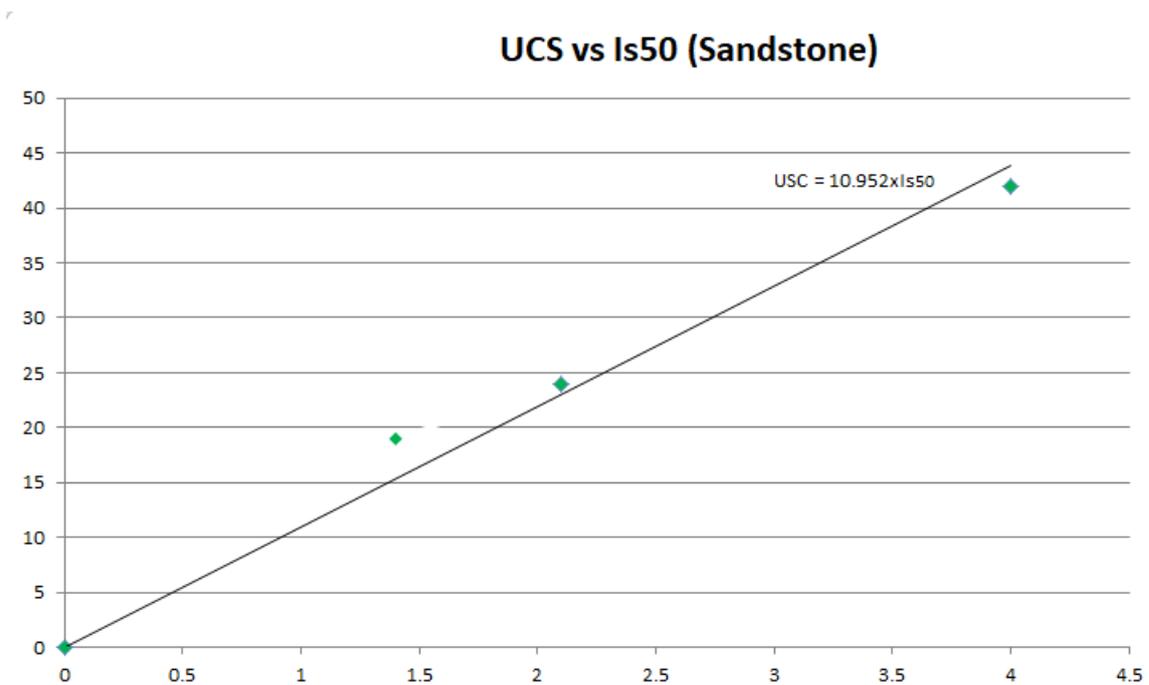
Plate 4 Correlation of UCS vs I_{s50}

A plot correlating the UCS test results with the neighbouring point load test results on the same rock are presented in **Plate 4**.

As presented in **Plate 4** above, the correlation of UCS value to the point load strength index for sandstone at the site is $UCS = 10.95 \times I_{s50}$. The approximate UCS of Unit 4b (Class III Sandstone), estimated from this correlation with the point load strength index test results, varied from 7 MPa to 60 MPa. It should be noted that the strength of Unit 4b varied with depth. Material within unit 4b has been classified as Class III sandstone, governed by defect spacing.

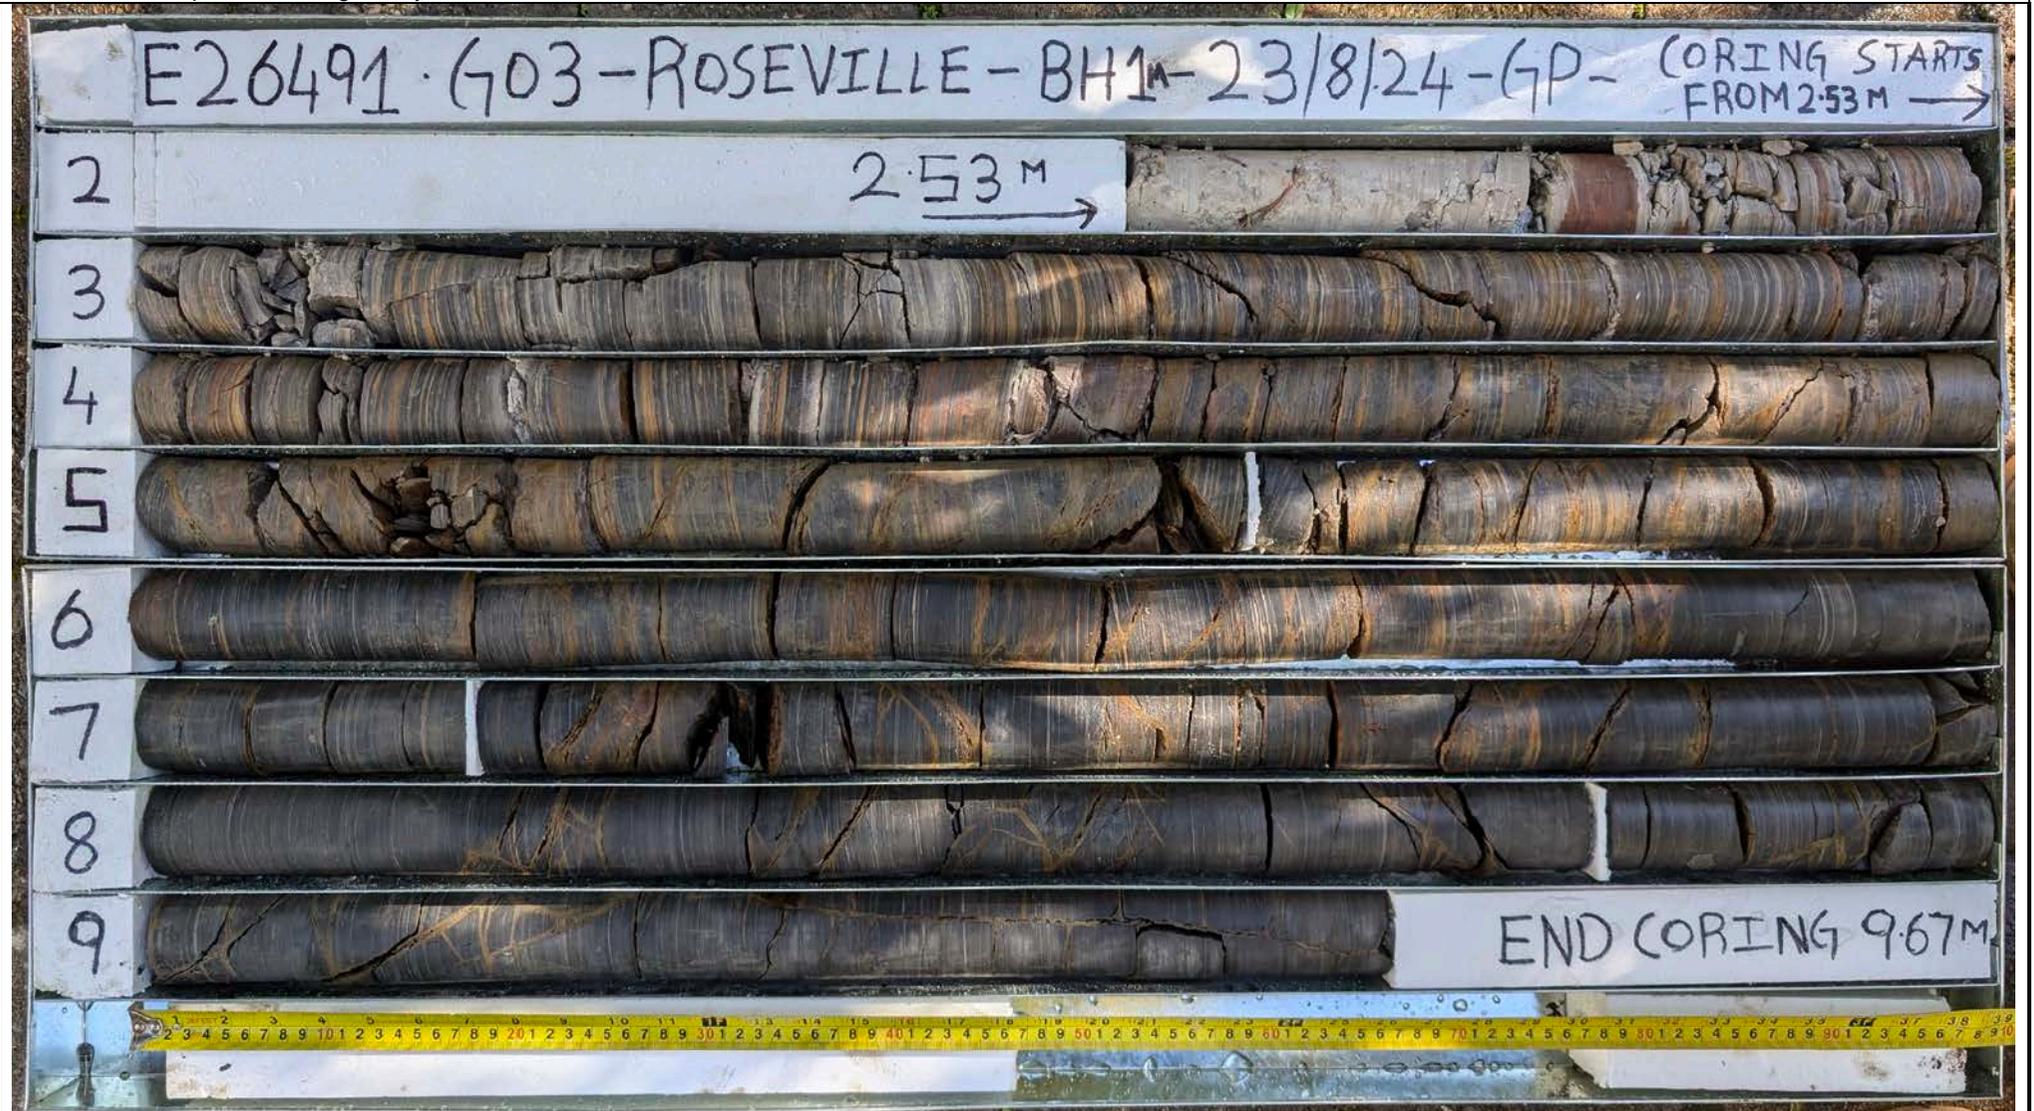
CORE PHOTOGRAPH OF BOREHOLE: BH1M

Project	Proposed Development	East	331179.6865 (MGA 2020 Zone 56)	Depth Range	2.53m to 9.67m
Location	Site B, 2 – 16 Pockley Street, Roseville	North	6260054.9201 (MGA 2020 Zone 56)	Contractor	Tight Site Pty Ltd
Position	See Figure 2	Surface RL	94.80	Drill Rig	Hand Portable
Job No.	E26491.G03	Inclination	90°	Logged	GP Date 23/8/24
Client	Aqualand Prestige 2 Pty Ltd	Box	1&2 of 2	Checked	AC Date 5/9/24

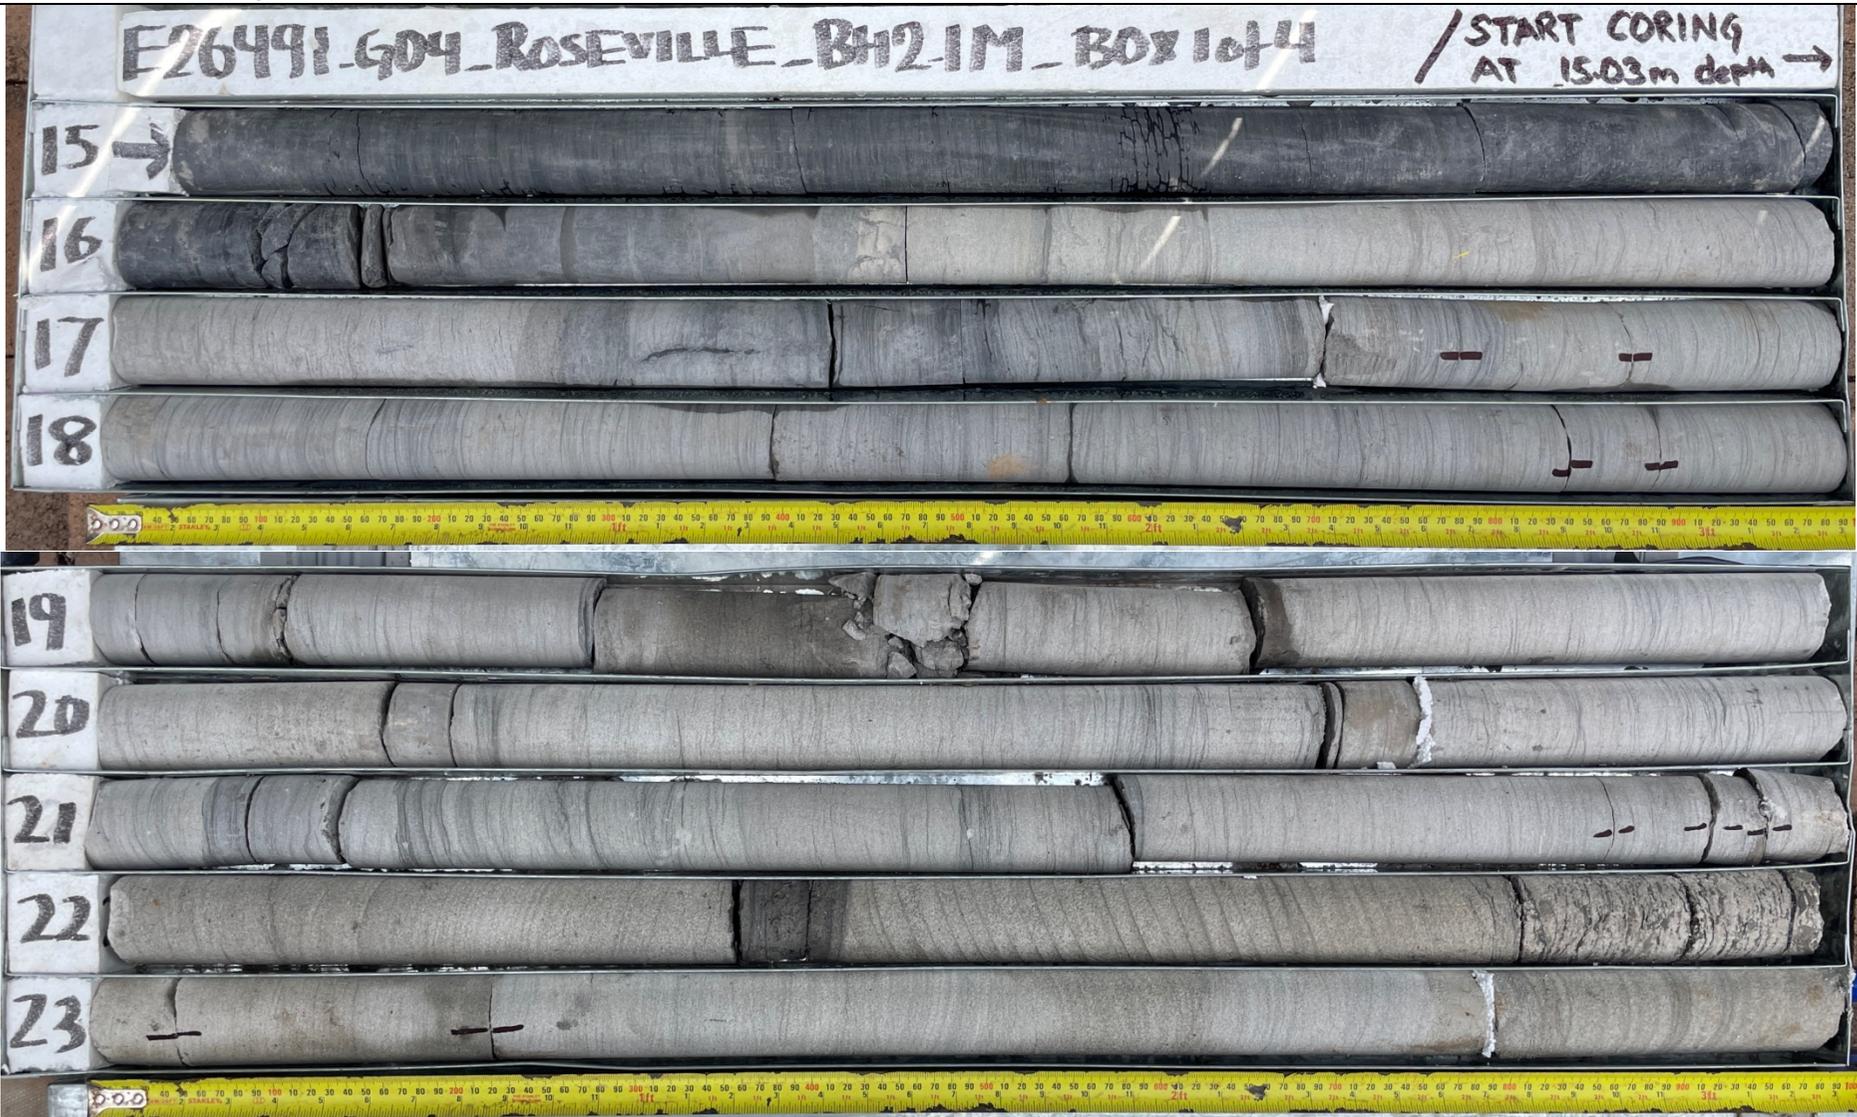
CORE PHOTOGRAPH OF BOREHOLE: BH2.1M

Project	Proposed Development	East	331192.4370 (MGA 2020 Zone 56)	Depth Range	15.03 to 30.05m
Location	Site B, 2 – 16 Pockley Street, Roseville	North	6260034.7860 (MGA 2020 Zone 56)	Contractor	Geosense Drilling Engineers
Position	See Figure 2	Surface RL	98.10	Drill Rig	Comacchio Geo 205
Job No.	E26491.G03	Inclination	90°	Logged	PS Date 13/01/2025
Client	Aqualand Prestige 2 Pty Ltd	Box	1 of 2	Checked	JB Date 06/03/25

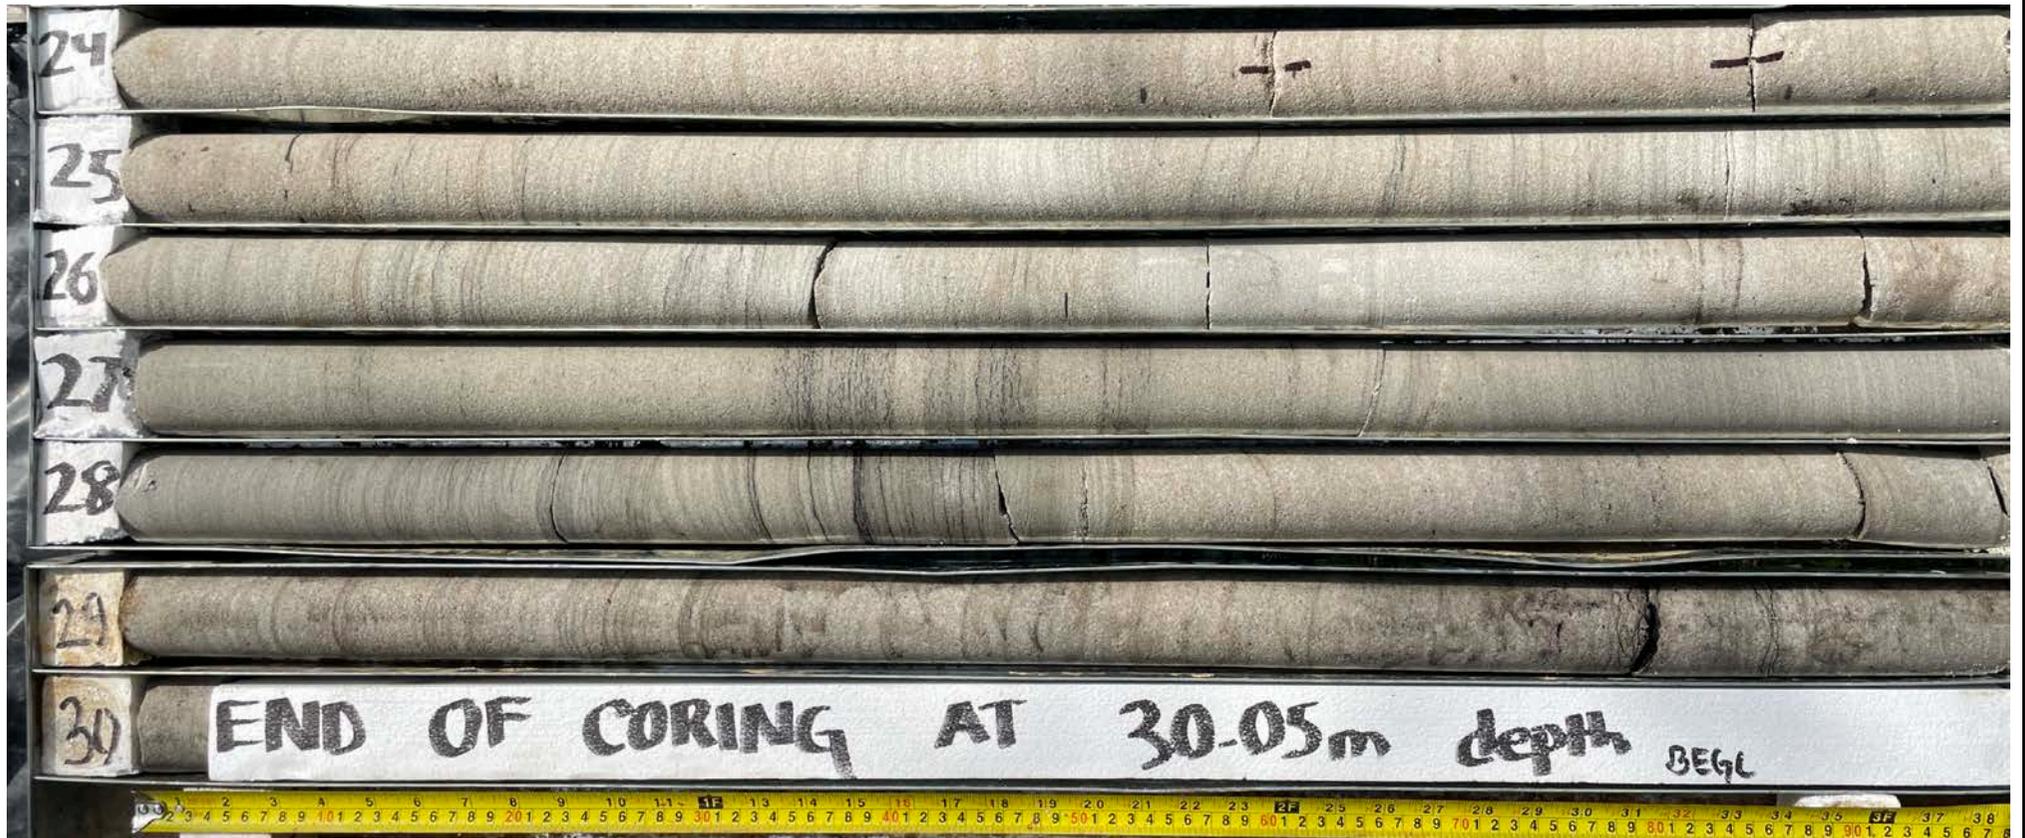
CORE PHOTOGRAPH OF BOREHOLE: BH2.1M

Project	Proposed Development	East	331192.4370 (MGA 2020 Zone 56)	Depth Range	15.03 to 30.05m
Location	Site B, 2 – 16 Pockley Street, Roseville	North	6260034.7860 (MGA 2020 Zone 56)	Contractor	Geosense Drilling Engineers
Position	See Figure 2	Surface RL	98.10	Drill Rig	Comacchio Geo 205
Job No.	E26491.G03	Inclination	90°	Logged	PS Date 13/01/2025
Client	Aqualand Prestige 2 Pty Ltd	Box	2 of 2	Checked	JB Date 06/03/25

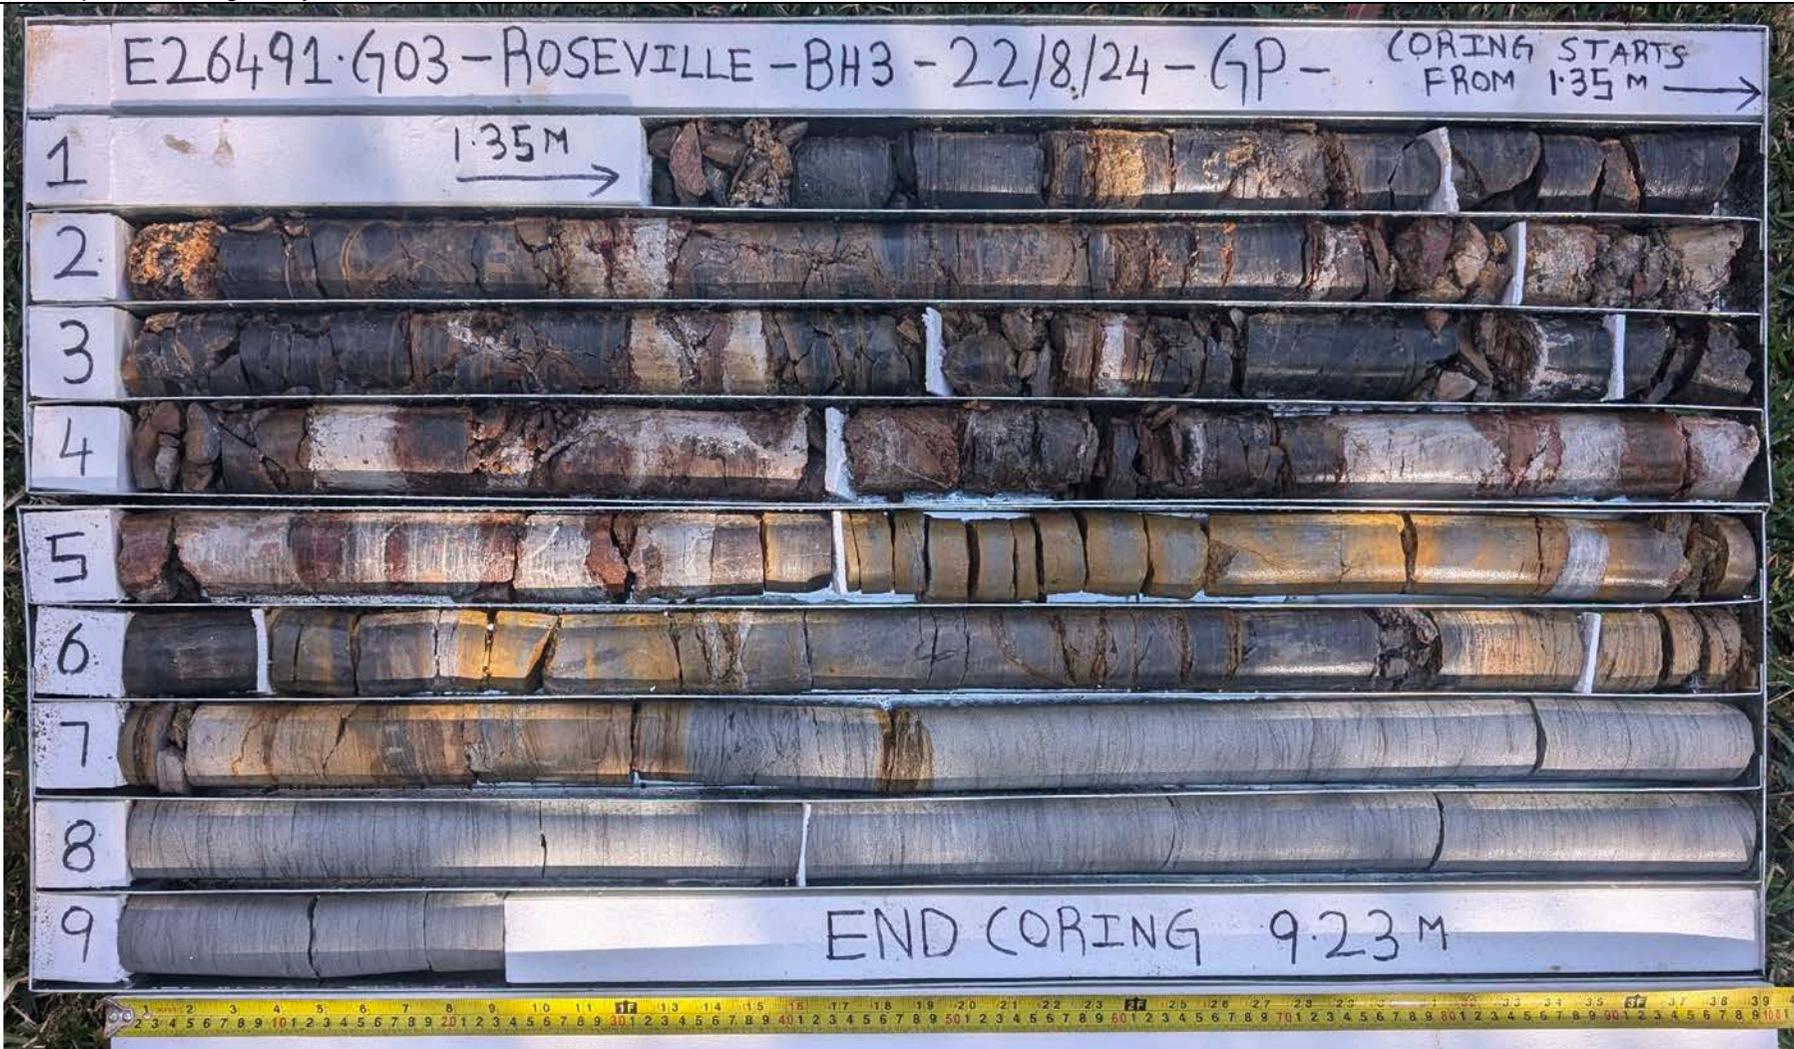
CORE PHOTOGRAPH OF BOREHOLE: BH3

Project	Proposed Development	East	331132.6459(MGA 2020 Zone 56)	Depth Range	1.35m to 9.23m
Location	Site B, 2 – 16 Pockley Street, Roseville	North	6260002.914(MGA 2020 Zone 56)	Contractor	Tight Site Pty Ltd
Position	See Figure 2	Surface RL	86.60	Drill Rig	Hand Portable
Job No.	E26491.G03	Inclination	90°	Logged	GP Date 22/8/24
Client	Aqualand Prestige 2 Pty Ltd	Box	1&2 of 2	Checked	AC Date 5/9/24

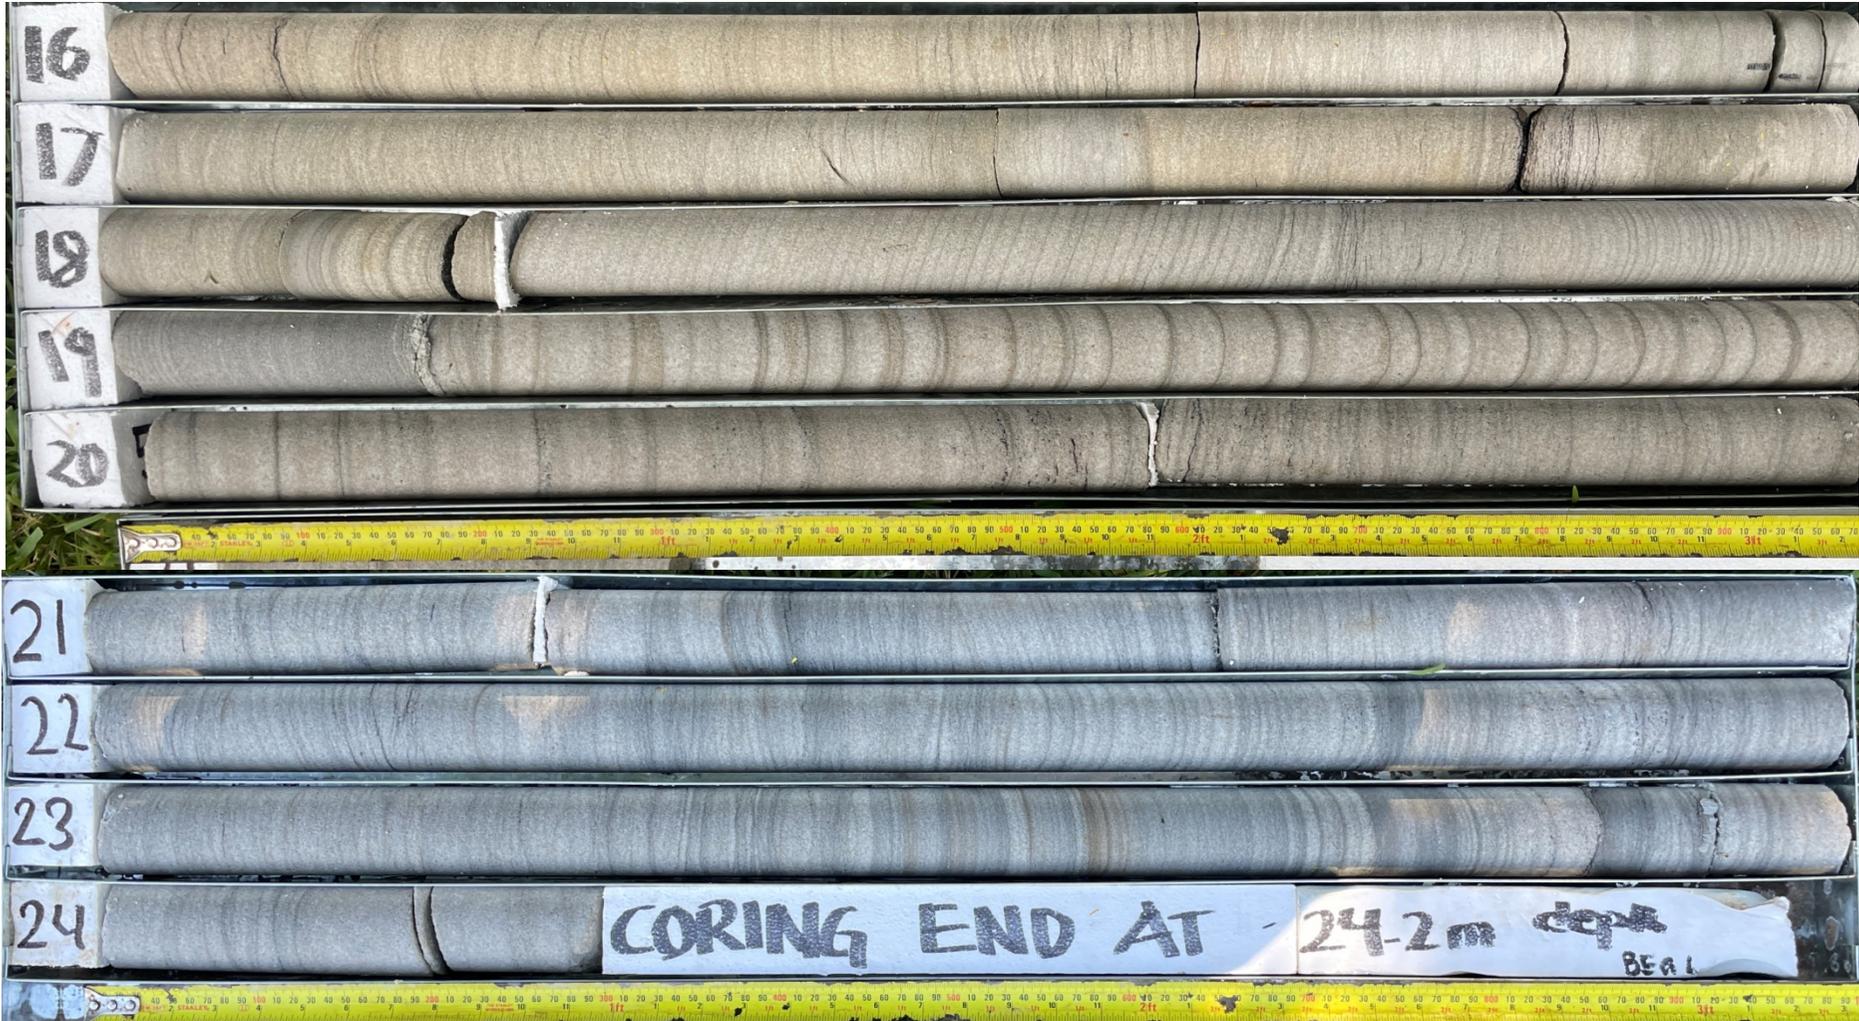
CORE PHOTOGRAPH OF BOREHOLE: BH3.1M

Project	Proposed Development	East	331134.3520 (MGA 2020 Zone 56)	Depth Range	7.58m to 24.2m
Location	Site B, 2 – 16 Pockley Street, Roseville	North	6260009.320 (MGA 2020 Zone 56)	Contractor	Geosense Drilling Engineers
Position	See Figure 2	Surface RL	86.60	Drill Rig	Comacchio Geo 205
Job No.	E26491.G03	Inclination	90°	Logged	PS Date 14/01/25
Client	Aqualand Prestige 2 Pty Ltd	Box	2 of 2	Checked	JB Date 06/03/25

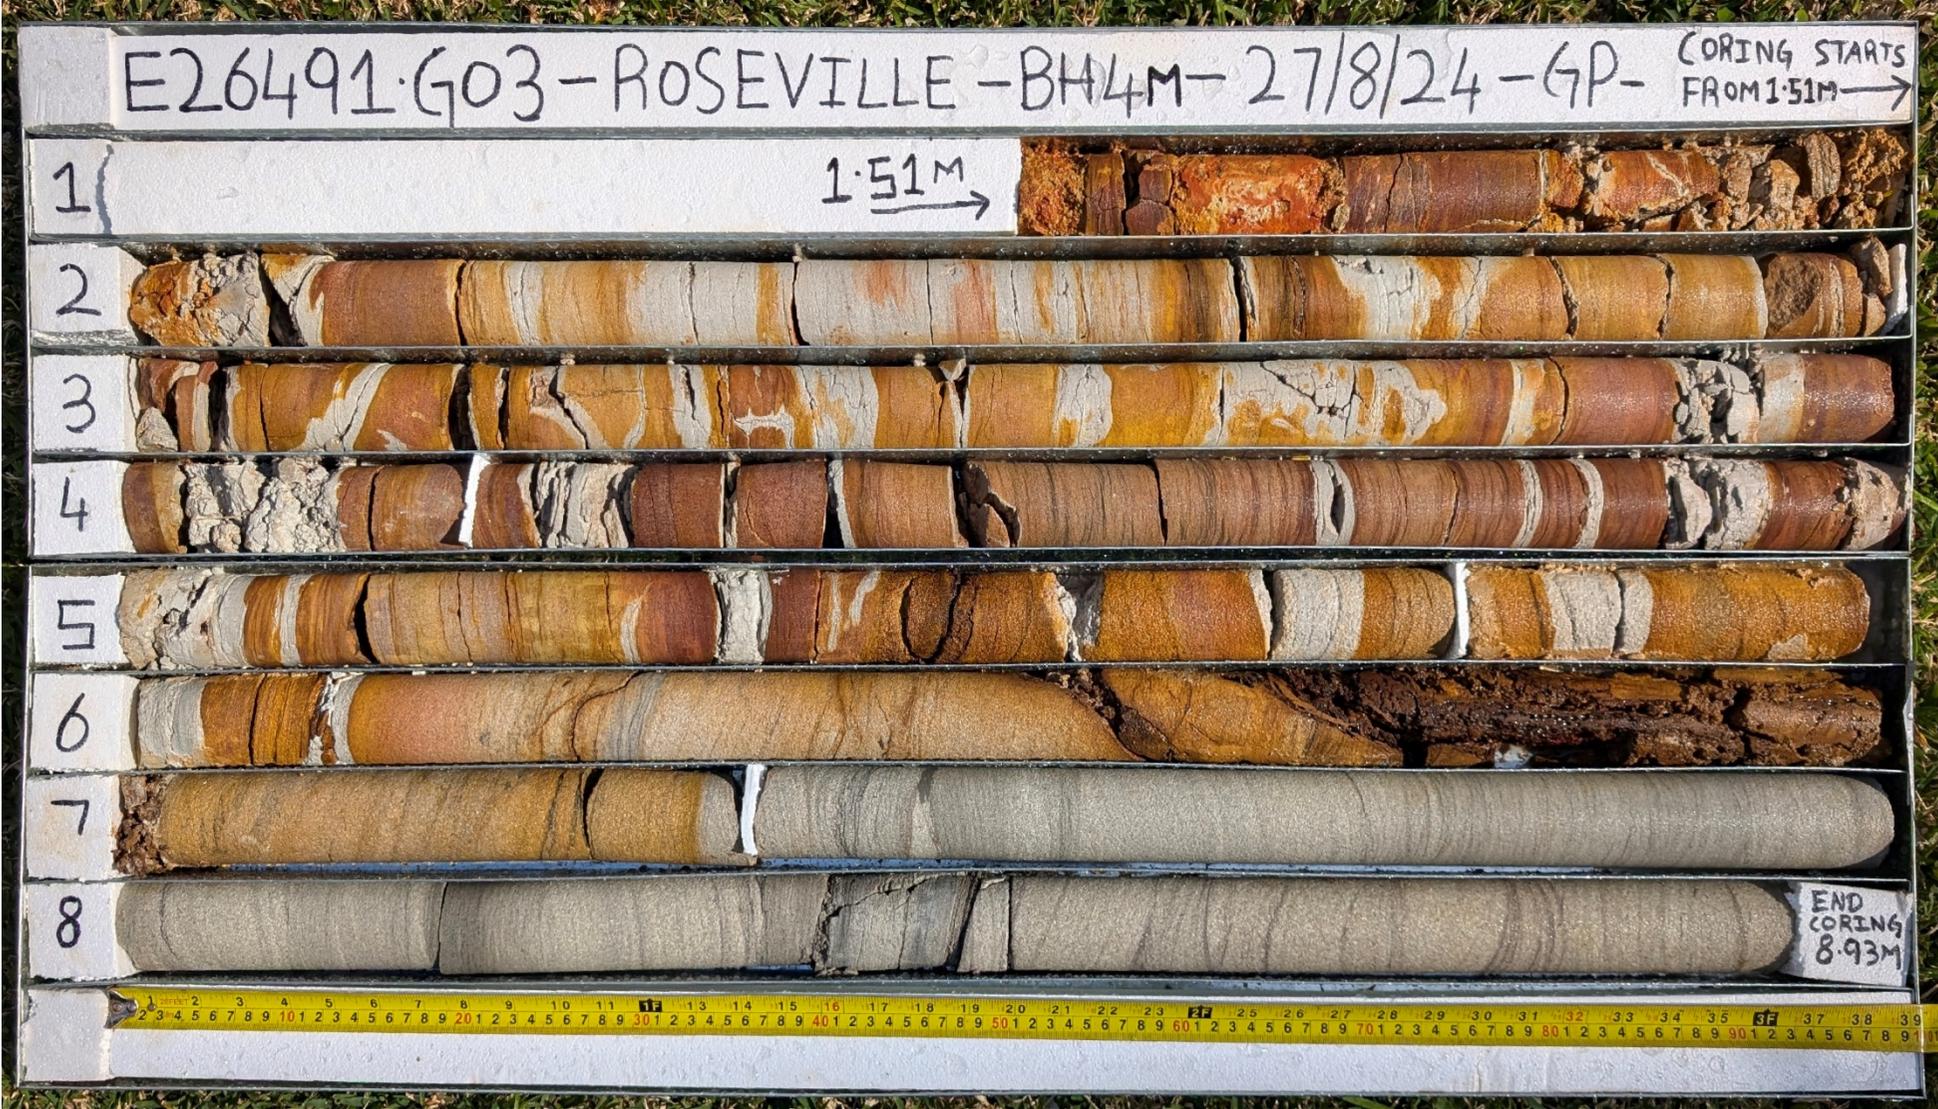
CORE PHOTOGRAPH OF BOREHOLE: BH4M

Project	Proposed Development	East	331098.3968 (MGA 2020 Zone 56)	Depth Range	1.51m to 8.93m
Location	Site B, 2 – 16 Pockley Street, Roseville	North	6259991.7256 (MGA 2020 Zone 56)	Contractor	Tight Site Pty Ltd
Position	See Figure 2	Surface RL	80.25	Drill Rig	Hand Portable
Job No.	E26491.G03	Inclination	90°	Logged	GP Date 27/8/24
Client	Aqualand Prestige 2 Pty Ltd	Box	1&2 of 2	Checked	AC Date 5/9/24

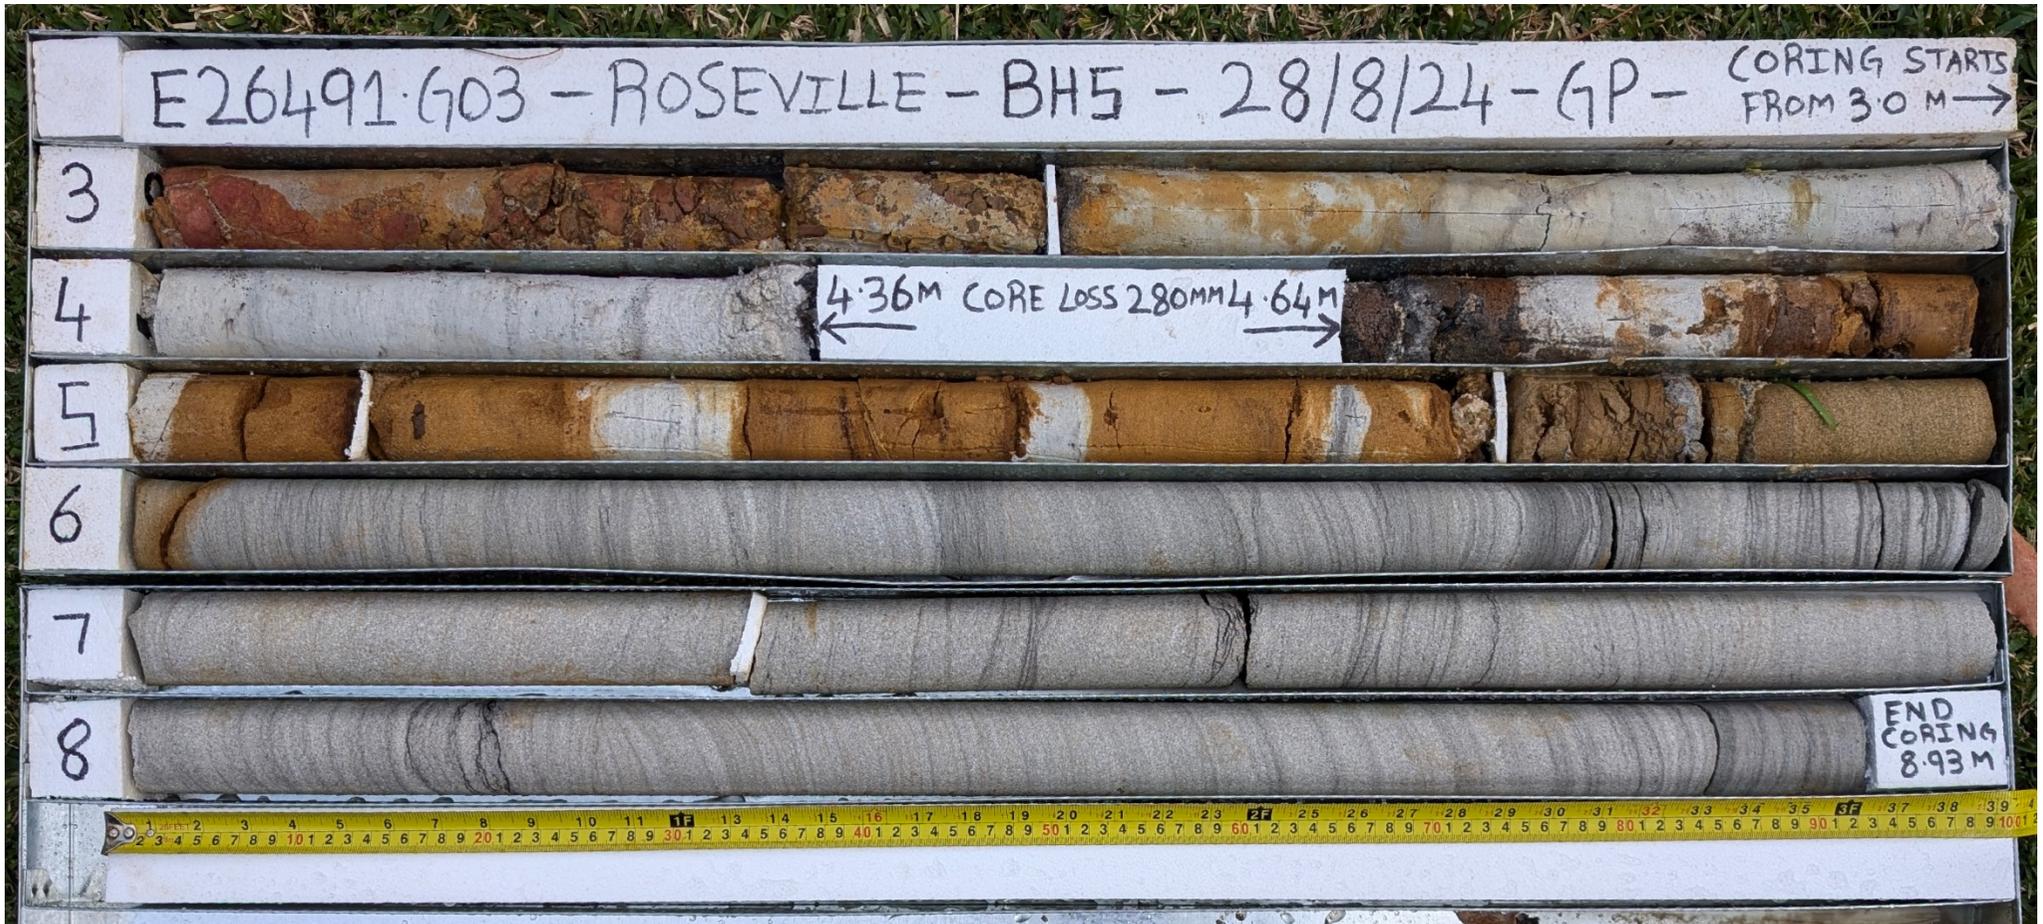
CORE PHOTOGRAPH OF BOREHOLE: BH5

Project	Proposed Development	East	331067.6230 (MGA 2020 Zone 56)	Depth Range	3.0m to 8.93m
Location	Site B, 2 – 16 Pockley Street, Roseville	North	6260031.6290 (MGA 2020 Zone 56)	Contractor	Tight Site Pty Ltd
Position	See Figure 2	Surface RL	78.2	Drill Rig	Hand Portable
Job No.	E26491.G03	Inclination	90°	Logged	GP Date 27/8/24
Client	Aqualand Prestige 2 Pty Ltd	Box	1 of 1	Checked	AC Date 5/9/24

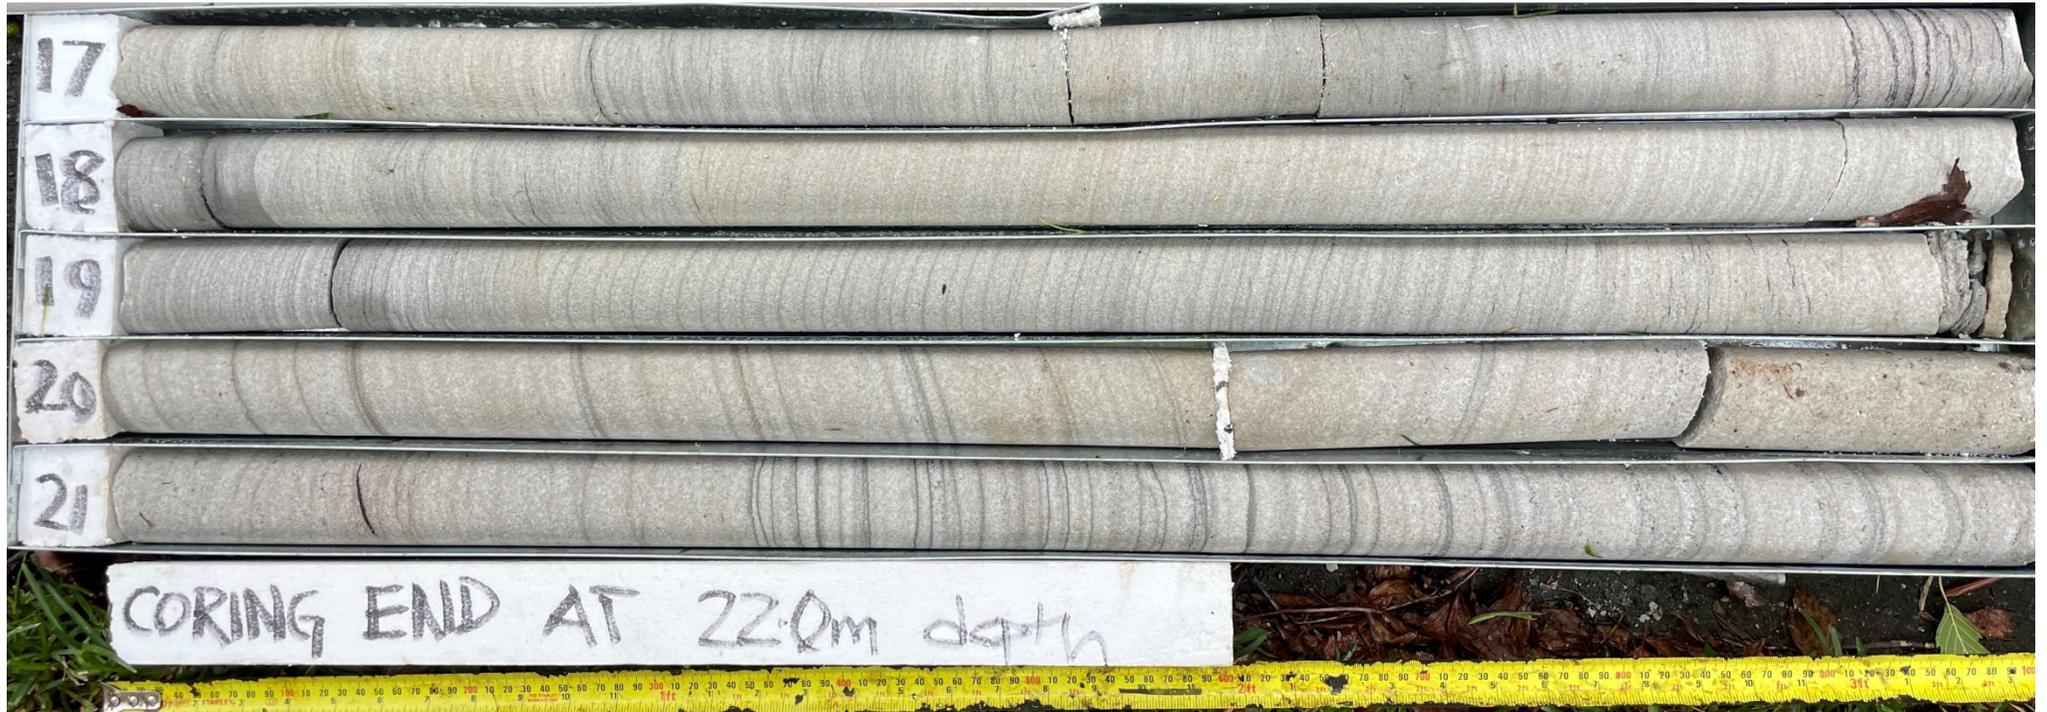
CORE PHOTOGRAPH OF BOREHOLE: BH101

Project	Proposed Development	East	331128.9804 (MGA 2020 Zone 56)	Depth Range	8.45m to 22.0m
Location	Site B, 2 – 16 Pockley Street, Roseville	North	6260046.7119 (MGA 2020 Zone 56)	Contractor	Geosense Drilling Engineers
Position	See Figure 2	Surface RL	86.60	Drill Rig	Comacchio Geo 205
Job No.	E26491.G03	Inclination	90°	Logged	PS Date 17/01/25
Client	Aqualand Prestige 2 Pty Ltd	Box	2 of 2	Checked	JB Date 06/03/25

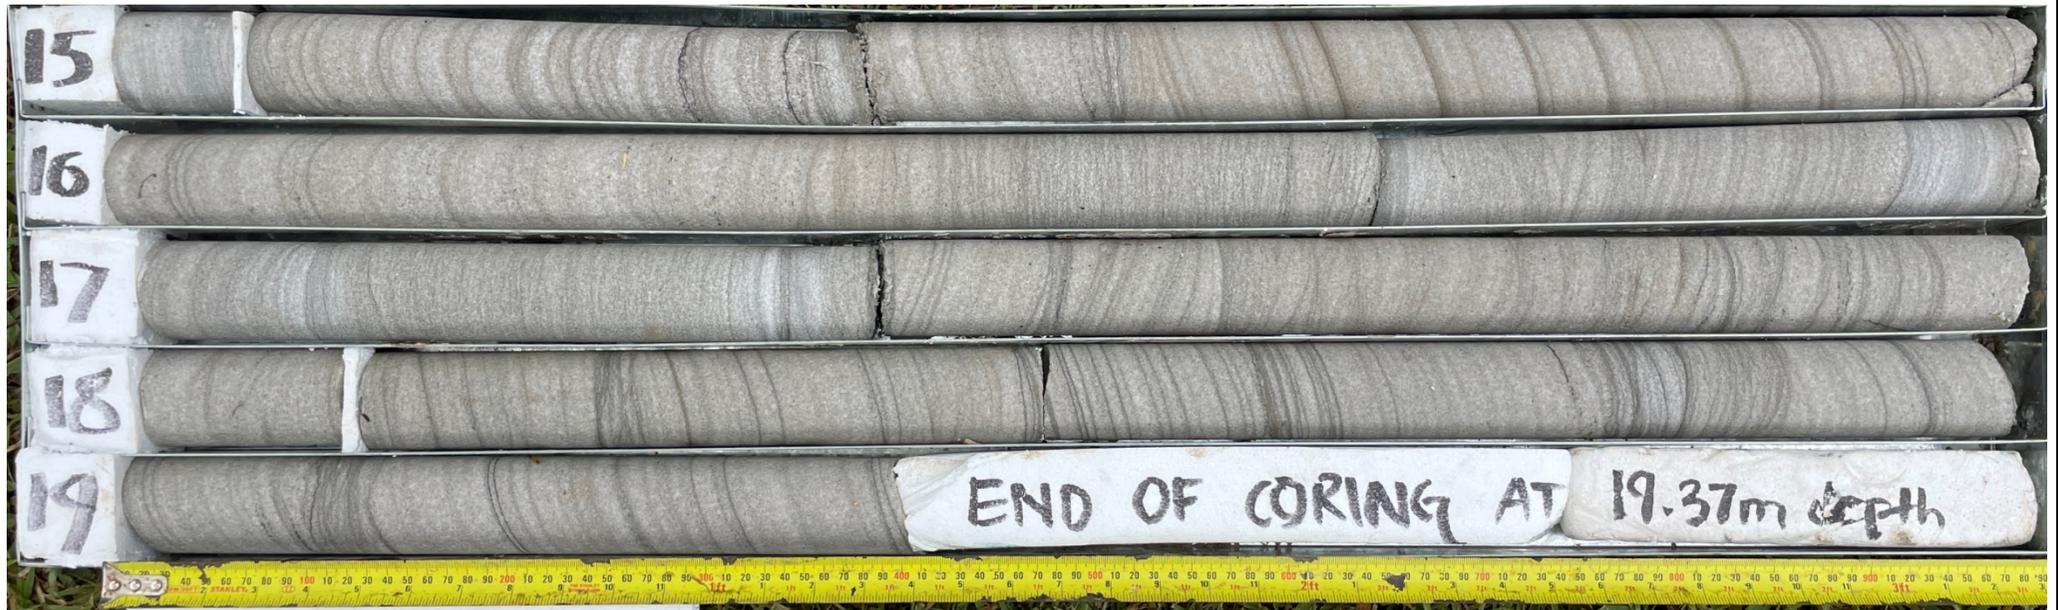
CORE PHOTOGRAPH OF BOREHOLE: BH102

Project	Proposed Development	East	331076.9665 (MGA 2020 Zone 56)	Depth Range	6.56m to 19.37m	
Location	Site B, 2 – 16 Pockley Street, Roseville	North	6260040.1776 (MGA 2020 Zone 56)	Contractor	Geosense Drilling Engineers	
Position	See Figure 2	Surface RL	80.80	Drill Rig	Comacchio Geo 205	
Job No.	E26491.G03	Inclination	90°	Logged	PS	Date 10/01/25
Client	Aqualand Prestige 2 Pty Ltd	Box	2 of 2	Checked	JB	Date 06/03/25
