## ALTON PROPERTY GROUP PTY LTD

## Geotechnical Investigation

93-107 Cecil Avenue & 9-10 Roger Avenue, Castle Hill, NSW

Report No: E26536.G03\_Rev1

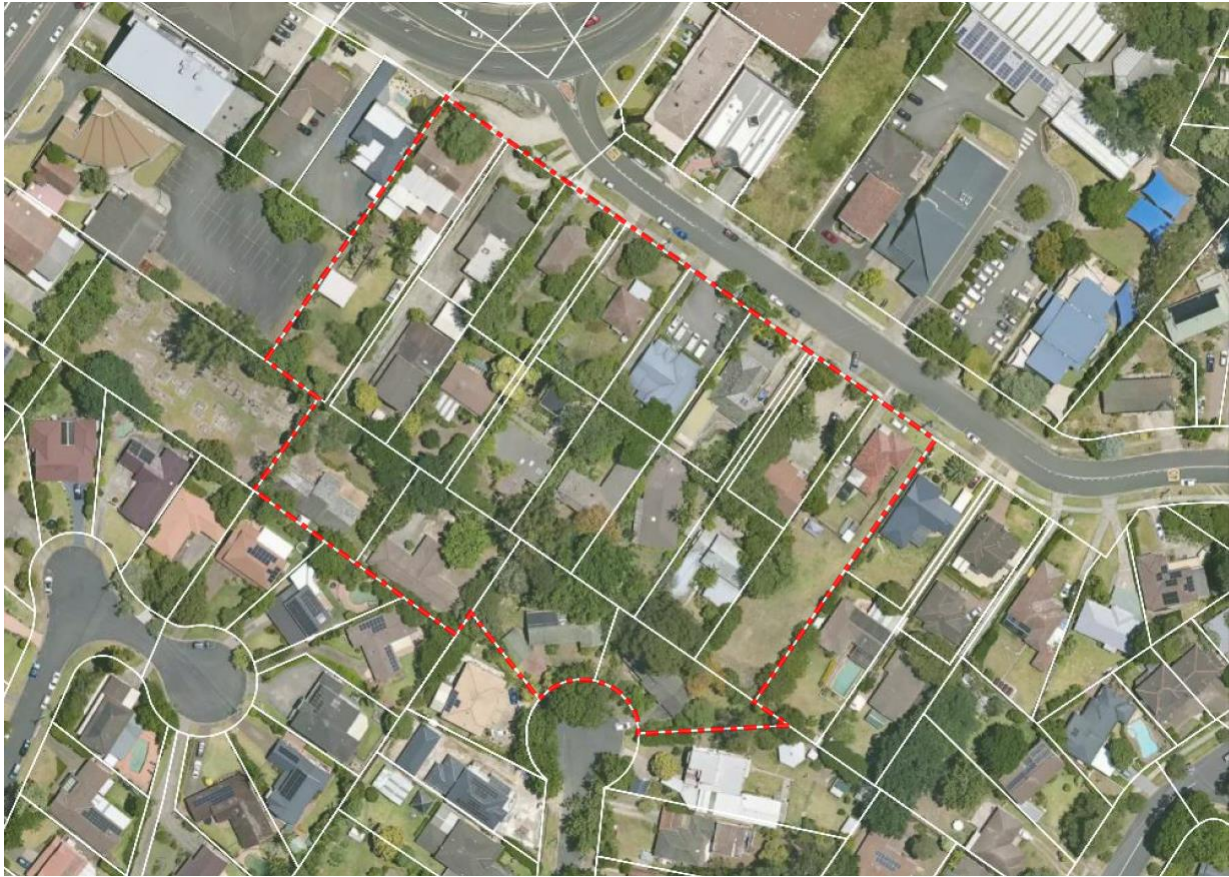
**Plate 1** Satellite image of the site (MetroMap, image dated 28 January 2026)

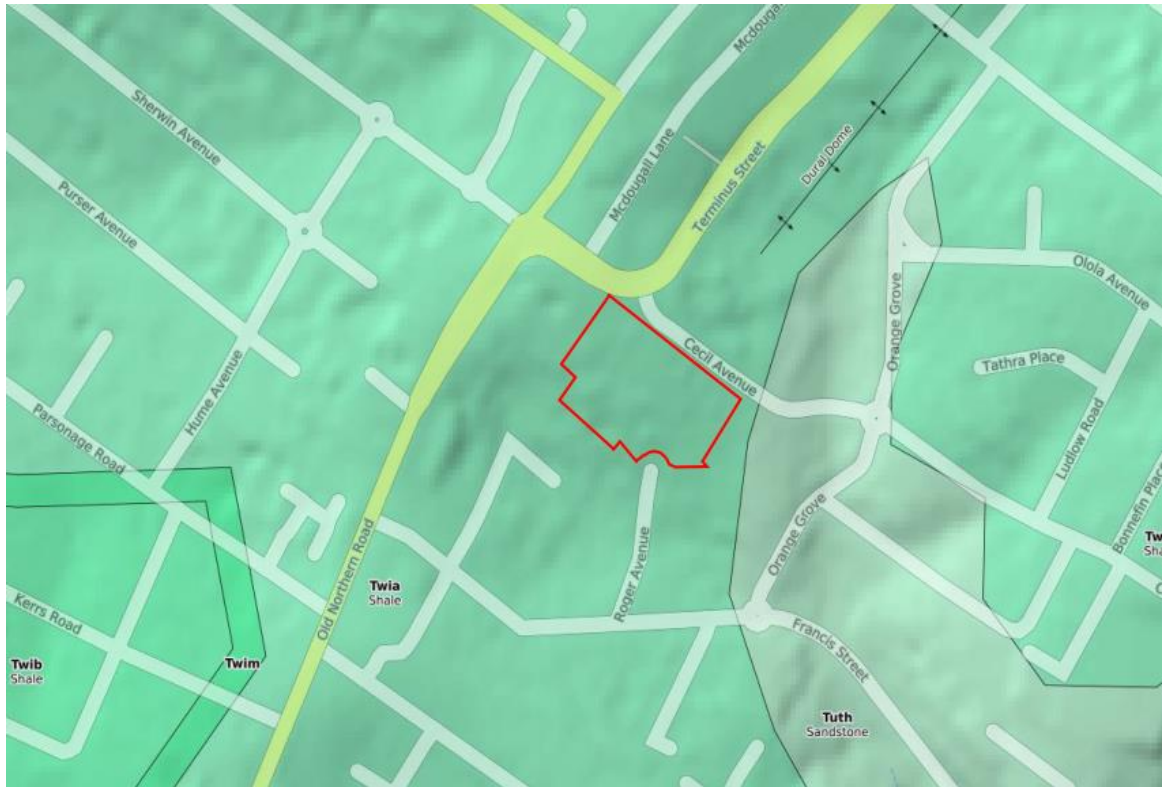
**Plate 2** Excerpt of geological map showing location of site.

<b>Regional Geology</b>	Information on regional sub-surface conditions, referenced from the NSW Seamless Geology dataset (Colquhoun et al., 2024, corresponding to the Sydney 1:100,000 Geological Series Sheet) indicates the site to be underlain by Ashfield Shale (Twia) Black to light grey shale and laminite.
<b>Acid Sulfate Soil (ASS) Risk</b> <i>(Source: eSPADE)</i>	<p>The NSW Government Department of Planning, Industry, and Environment <i>eSPADE</i> v2.2 website indicates that the site is also situated in an area of <i>No Known Occurrence</i>.</p> <p>Given the information above, the potential presence of ASS on the site can be considered to be low. Further assessments on ASS presence were deemed unwarranted.</p>
<b>Salinity</b> <i>(Source: SEED Map)</i>	<p>Reference to the Salinity Potential Western Sydney map through SEED Map indicates the site is located in an area of 'Moderate'.</p> <p><b>Note:</b> For sites subject to The Hills DCP 2012 Part B Section 7 – Industrial, areas mapped with having a potential salinity occurrence, will require site investigations to assess the actual salinity potential, and the collation of a saline soil management plan (SSMP).</p> <p>The site is not subject to DCP2012 Part B section 7 (see <b>Table 2-1</b>), and it is understood that proposed development is currently under planning stage, saline soils investigations and the collation of a SSMP have not been carried out as part of this GI.</p>

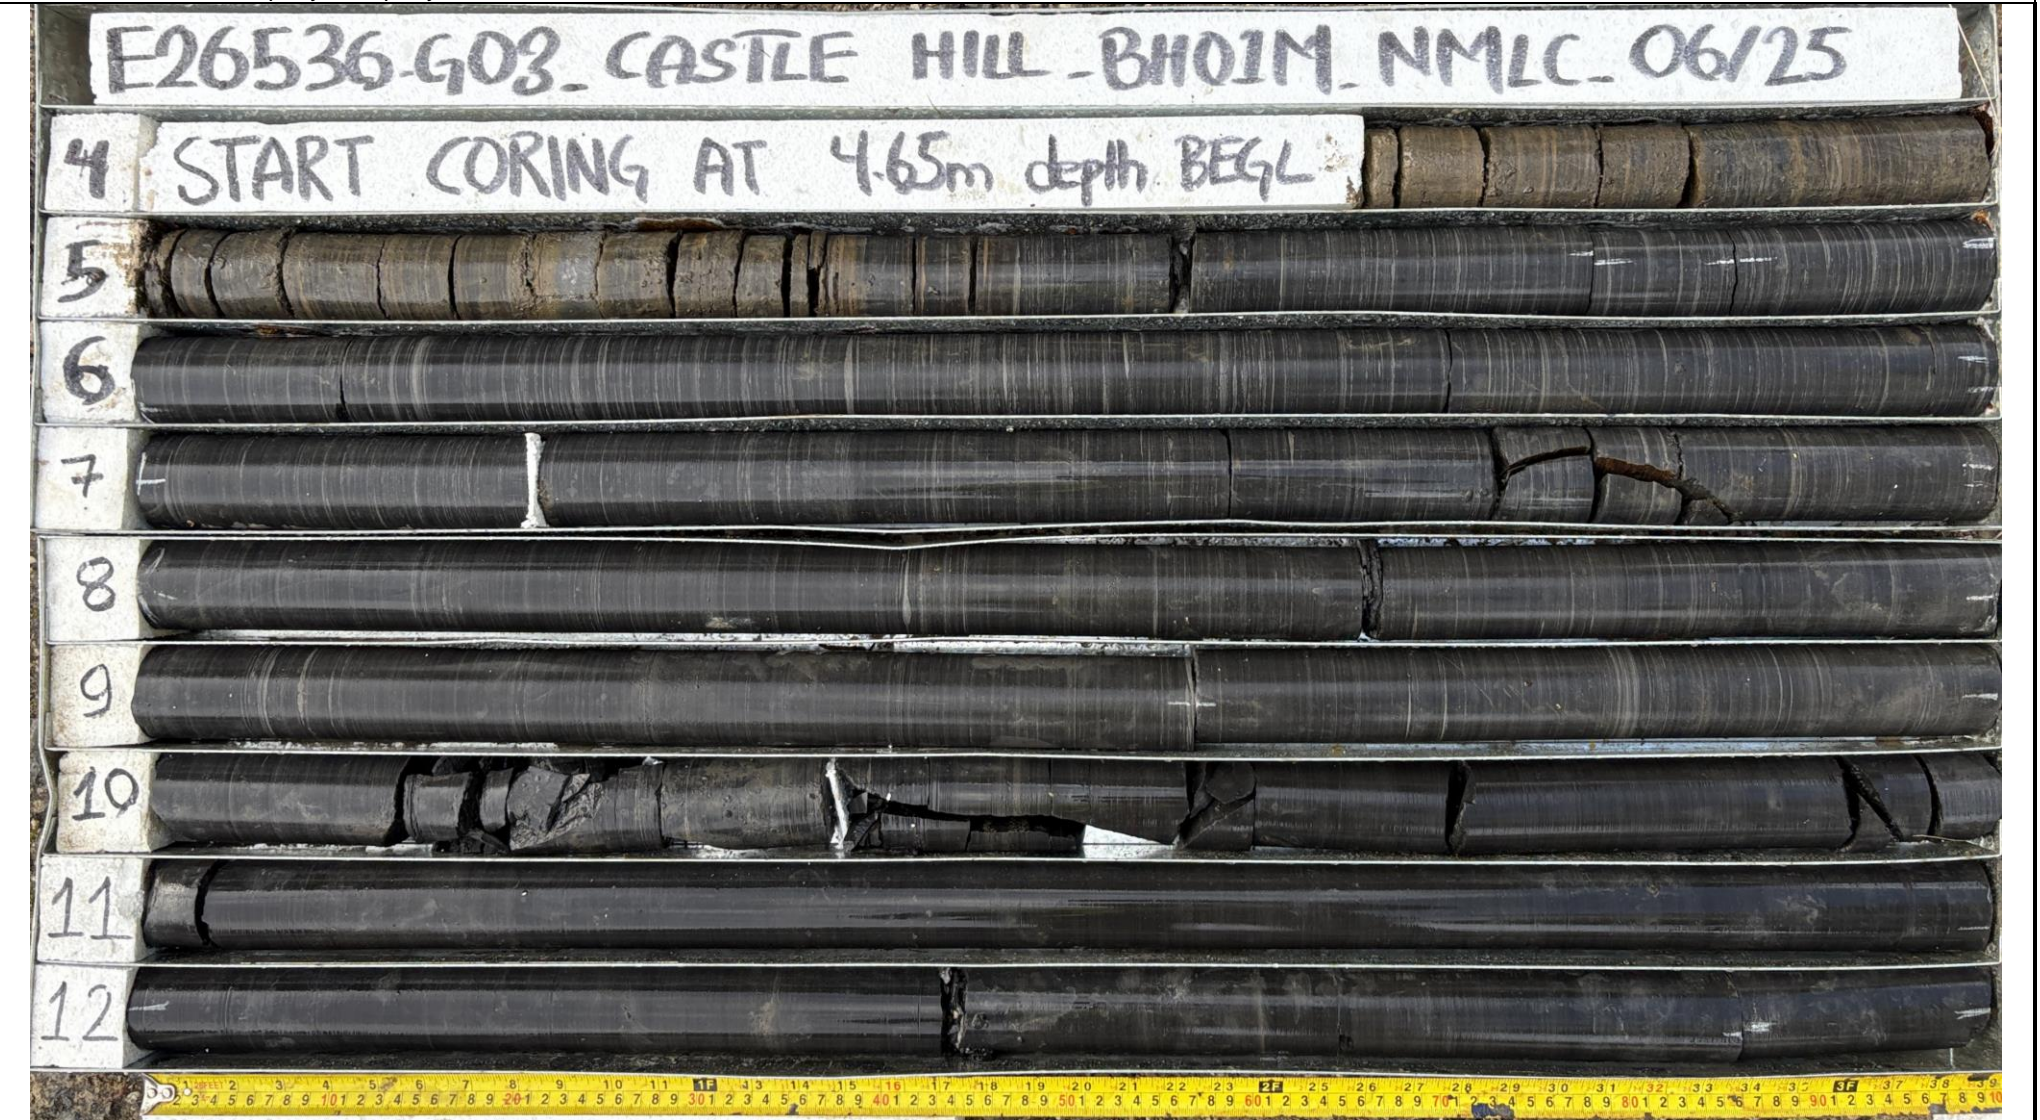
# CORE PHOTOGRAPH OF BOREHOLE: BH01M

<b>Project</b>	Proposed Development	<b>East</b>	315105.13	<b>Depth Range</b>	4.65m to 22.44m	
<b>Location</b>	93-107 Cecil Avenue & 9-10 Roger Avenue, Castle Hill, NSW	<b>North</b>	6265367.78	<b>Contractor</b>	Geosense Drilling Engineers Pty Ltd	
<b>Position</b>	See Figure 2	<b>Surface RL</b>	≈130.80 m (AHD)	<b>Drill Rig</b>	Comacchio Geo 205	
<b>Job No.</b>	E26536.G03	<b>Inclination</b>	90°	<b>Logged</b>	PS	<b>Date</b> 17/06/2025
<b>Client</b>	Alton Property Group Pty Ltd	<b>Box</b>	1 & 2 of 4	<b>Checked</b>	GP	<b>Date</b> 08/08/2025

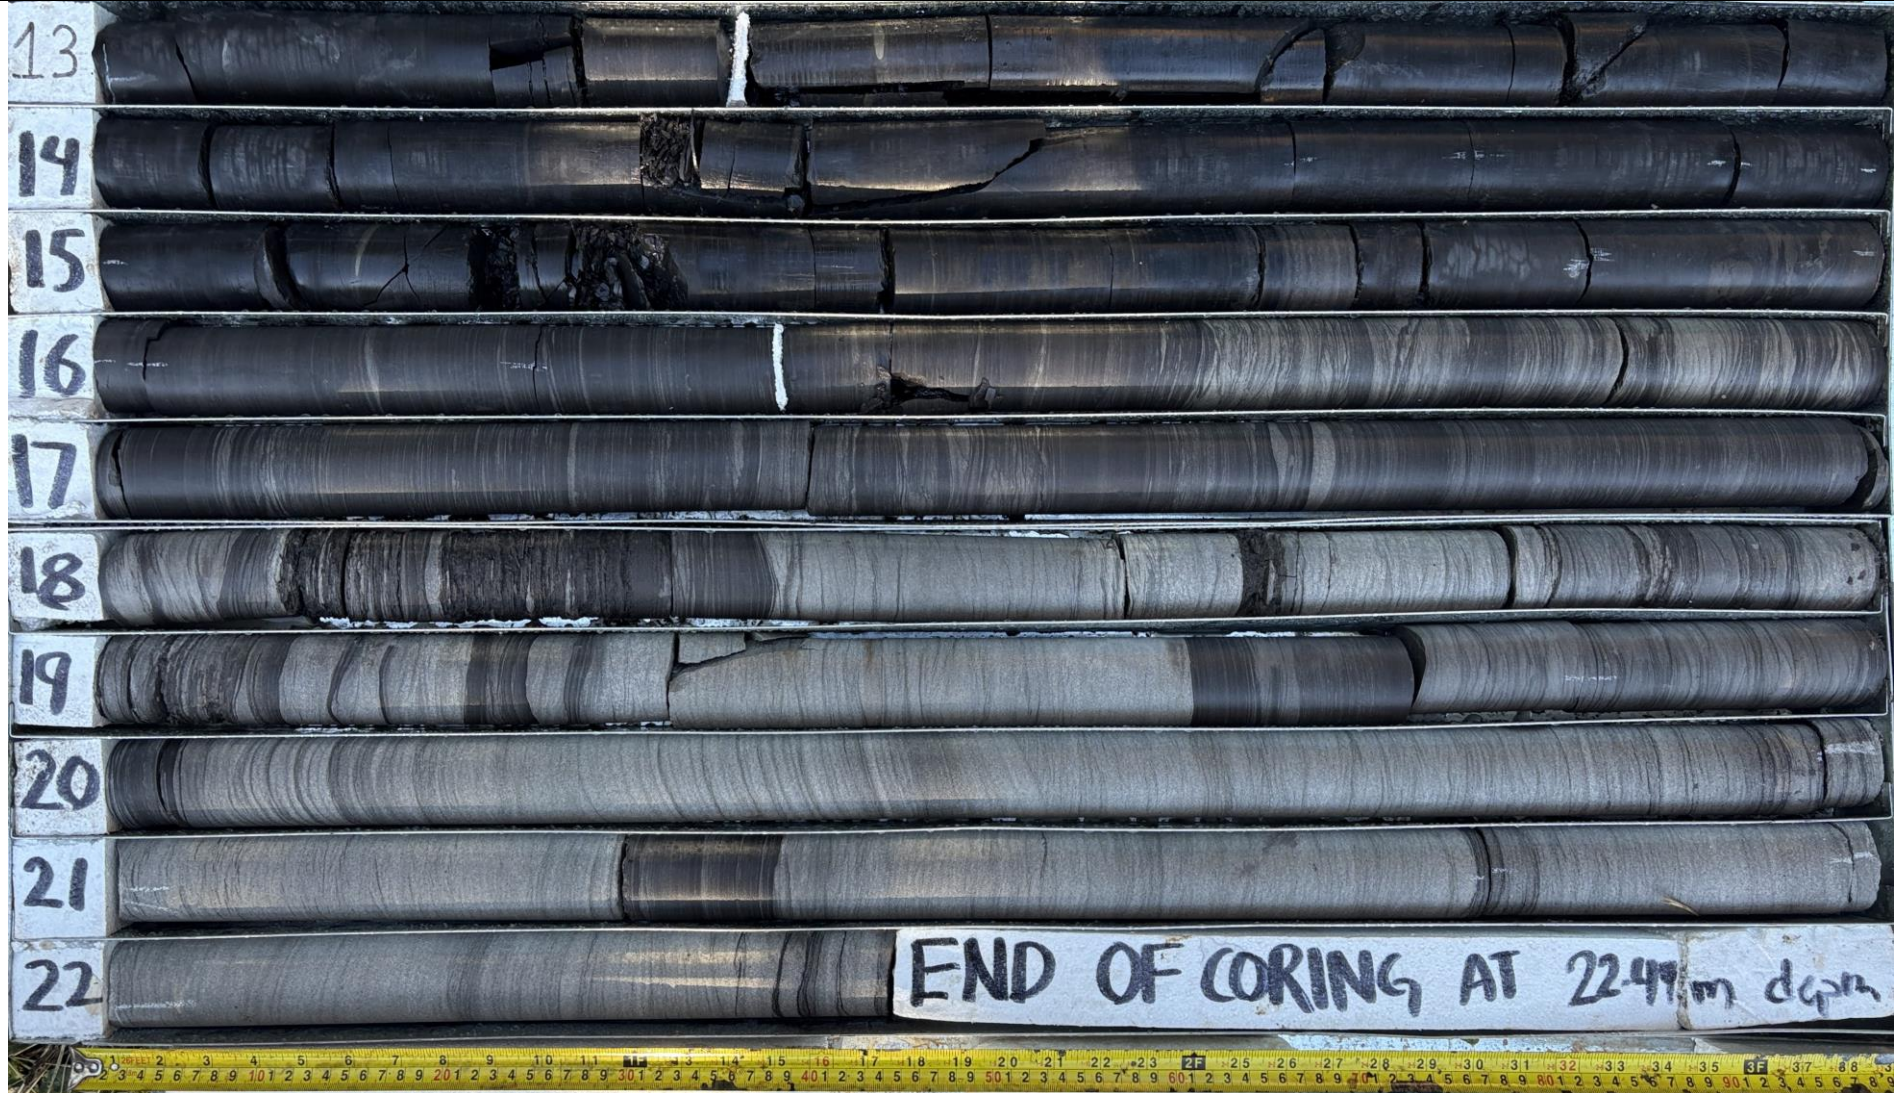
# CORE PHOTOGRAPH OF BOREHOLE: BH01M

<b>Project</b>	Proposed Development	<b>East</b>	315105.13	<b>Depth Range</b>	4.65m to 22.44m
<b>Location</b>	93-107 Cecil Avenue & 9-10 Roger Avenue, Castle Hill, NSW	<b>North</b>	6265367.78	<b>Contractor</b>	Geosense Drilling Engineers Pty Ltd
<b>Position</b>	See Figure 2	<b>Surface RL</b>	≈130.80 m (AHD)	<b>Drill Rig</b>	Comacchio Geo 205
<b>Job No.</b>	E26536.G03	<b>Inclination</b>	90°	<b>Logged</b>	PS <b>Date</b> 17/06/2025
<b>Client</b>	Alton Property Group Pty Ltd	<b>Box</b>	3 & 4 of 4	<b>Checked</b>	GP <b>Date</b> 08/08/2025

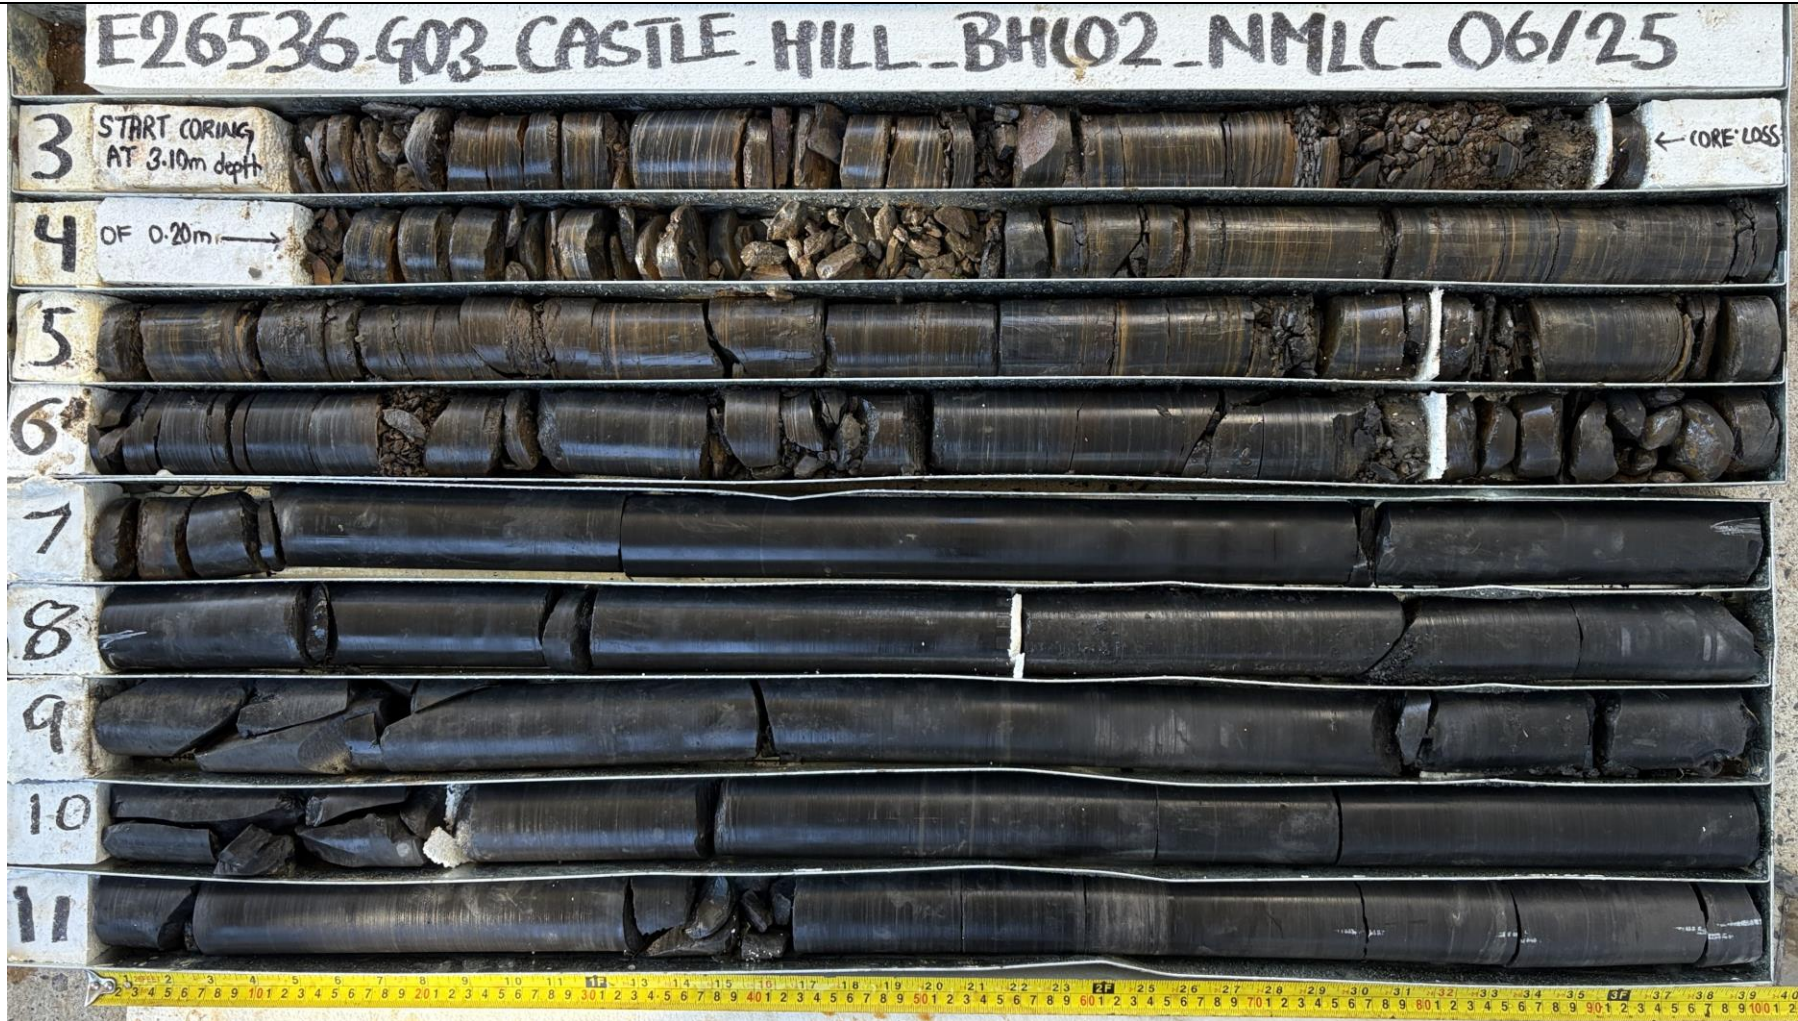
<b>Project</b>	Proposed Development	<b>East</b>	315147.06	<b>Depth Range</b>	3.10m to 20.6m
<b>Location</b>	93-107 Cecil Avenue & 9-10 Roger Avenue, Castle Hill, NSW	<b>North</b>	6265342.26	<b>Contractor</b>	Geosense Drilling Engineers Pty Ltd
<b>Position</b>	See Figure 2	<b>Surface RL</b>	≈127.50 m (AHD)	<b>Drill Rig</b>	Comacchio Geo 205
<b>Job No.</b>	E26536.G03	<b>Inclination</b>	90°	<b>Logged</b>	PS <b>Date</b> 11/06/2025
<b>Client</b>	Alton Property Group Pty Ltd	<b>Box</b>	1 & 2 of 4	<b>Checked</b>	GP <b>Date</b> 08/08/2025

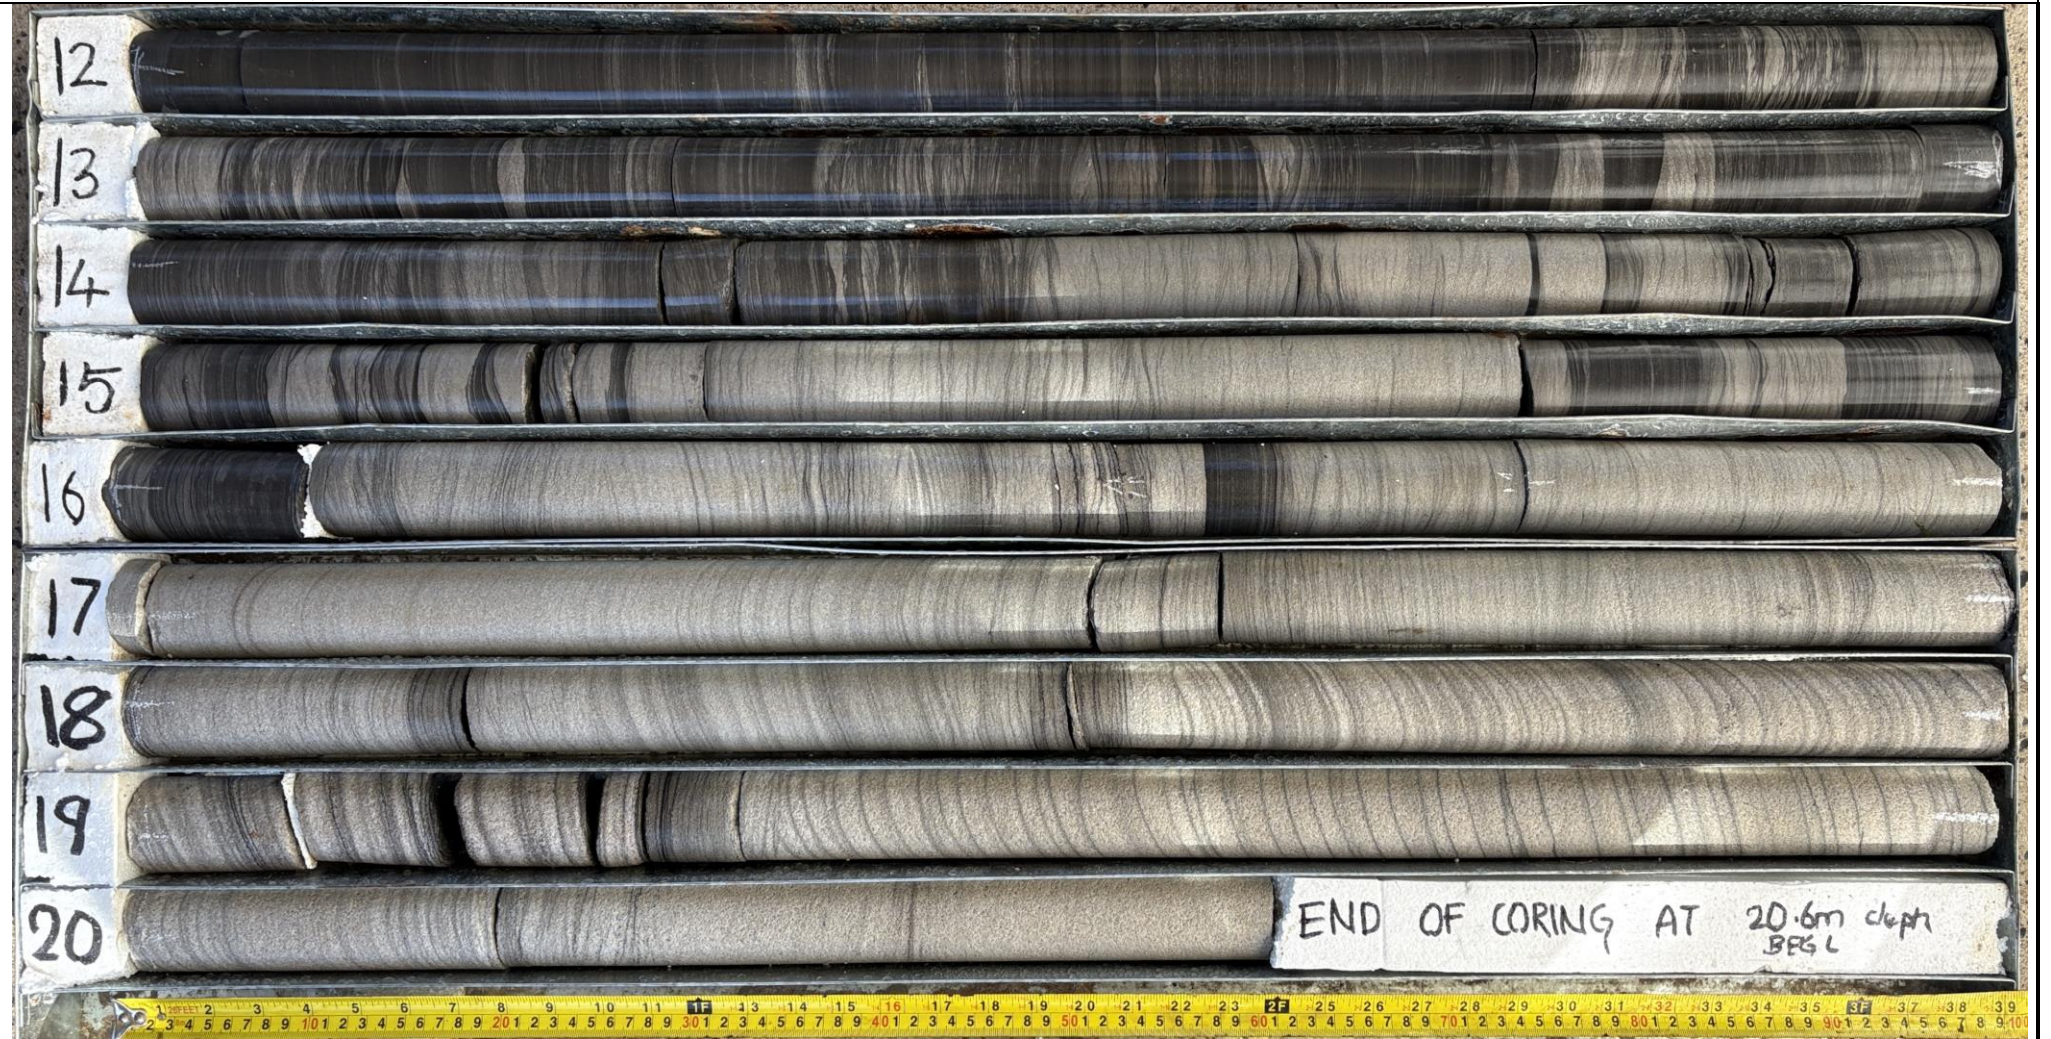
# CORE PHOTOGRAPH OF BOREHOLE: BH02

<b>Project</b>	Proposed Development	<b>East</b>	315147.06	<b>Depth Range</b>	3.10m to 20.6m	
<b>Location</b>	93-107 Cecil Avenue & 9-10 Roger Avenue, Castle Hill, NSW	<b>North</b>	6265342.26	<b>Contractor</b>	Geosense Drilling Engineers Pty Ltd	
<b>Position</b>	See Figure 2	<b>Surface RL</b>	≈127.50 m (AHD)	<b>Drill Rig</b>	Comacchio Geo 205	
<b>Job No.</b>	E26536.G03	<b>Inclination</b>	90°	<b>Logged</b>	PS	<b>Date</b> 11/06/2025
<b>Client</b>	Alton Property Group Pty Ltd	<b>Box</b>	3 & 4 of 4	<b>Checked</b>	GP	<b>Date</b> 08/08/2025

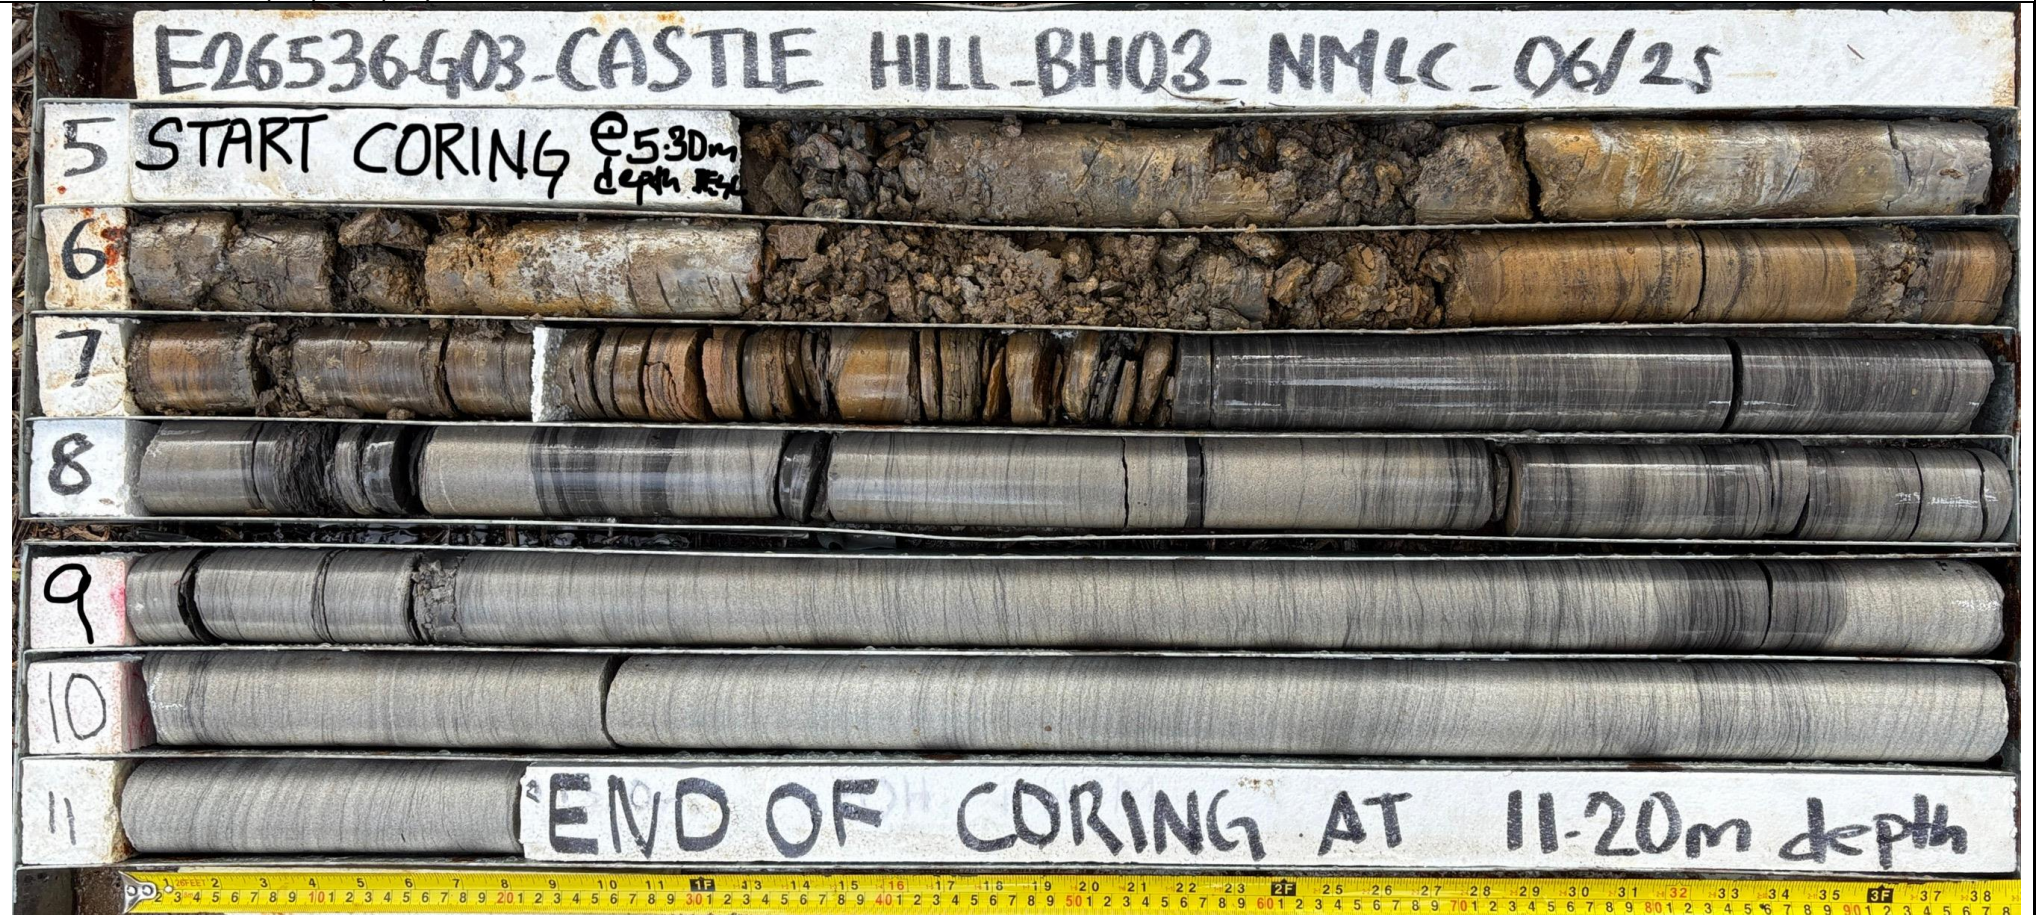
# CORE PHOTOGRAPH OF BOREHOLE: BH03M

<b>Project</b>	Proposed Development	<b>East</b>	315195.03	<b>Depth Range</b>	5.30m to 11.20m	
<b>Location</b>	93-107 Cecil Avenue & 9-10 Roger Avenue, Castle Hill, NSW	<b>North</b>	6265307.38	<b>Contractor</b>	Geosense Drilling Engineers Pty Ltd	
<b>Position</b>	See Figure 2	<b>Surface RL</b>	≈122.60 m (AHD)	<b>Drill Rig</b>	Comacchio Geo 205	
<b>Job No.</b>	E26536.G03	<b>Inclination</b>	90°	<b>Logged</b>	PS	<b>Date</b> 12/06/2025
<b>Client</b>	Alton Property Group Pty Ltd	<b>Box</b>	1 & 2 of 2	<b>Checked</b>	GP	<b>Date</b> 08/08/2025

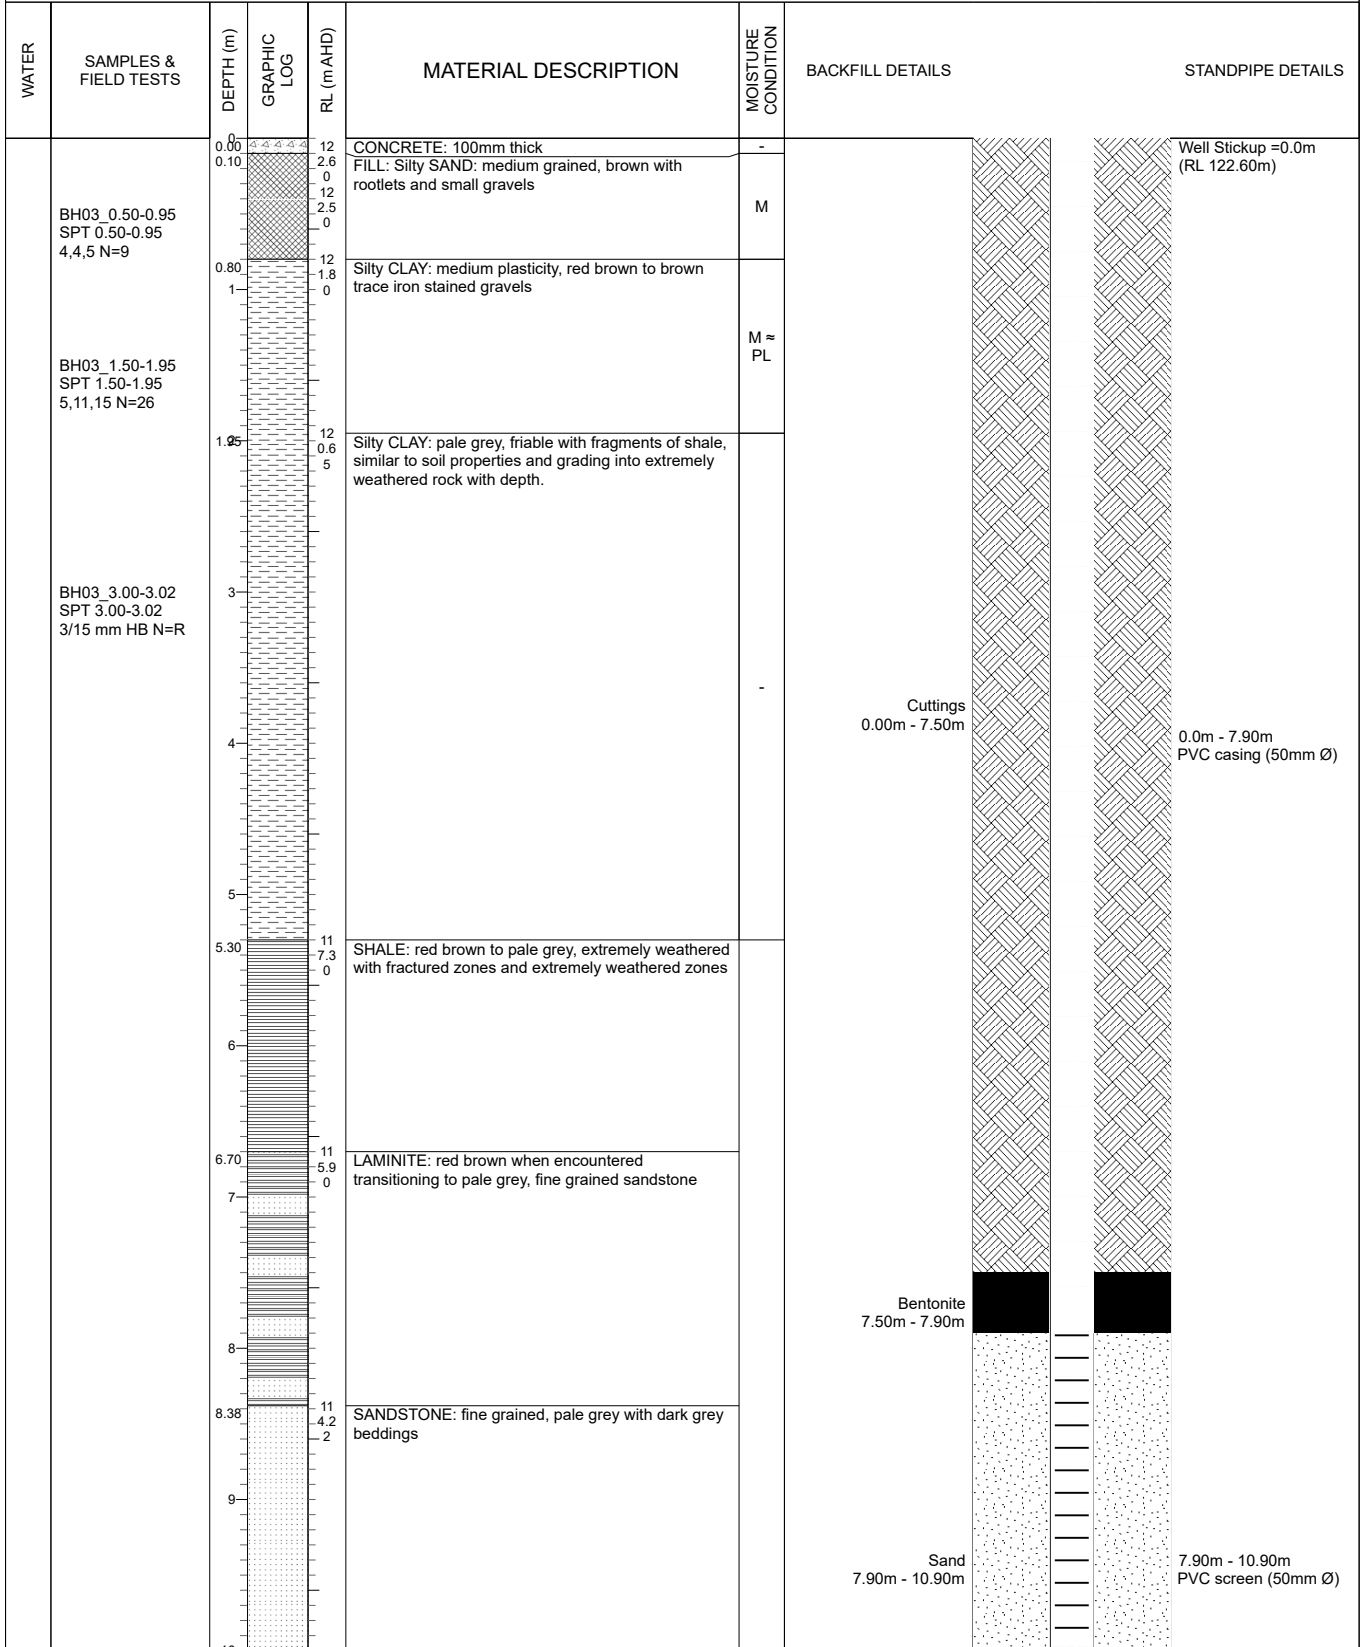
BH ID: BH03M

<b>Location</b>	93-107 Cecil Avenue & 9-10 Roger Avenue, Castle Hill, NSW	<b>Started</b>	12 June 2025
<b>Client</b>	Alton Property Group Pty Ltd	<b>Completed</b>	12 June 2025
<b>Job No.</b>	E26536.G03	<b>Logged By</b>	PS <b>Date</b> 12 June 2025
<b>Sheets</b>	1 of 2	<b>Review By</b>	GB <b>Date</b> 24 July 2025
<b>Drilling Contractor</b>	Geosense Drilling Engineers	<b>Surface RL</b>	≈122.60 m (AHD) <b>Northing</b> 6265307.4 (MGA 2020 Zone 56)
<b>Plant</b>	Comacchio Geo 205	<b>Inclination</b>	90° <b>Easting</b> 315195.0 (MGA 2020 Zone 56)

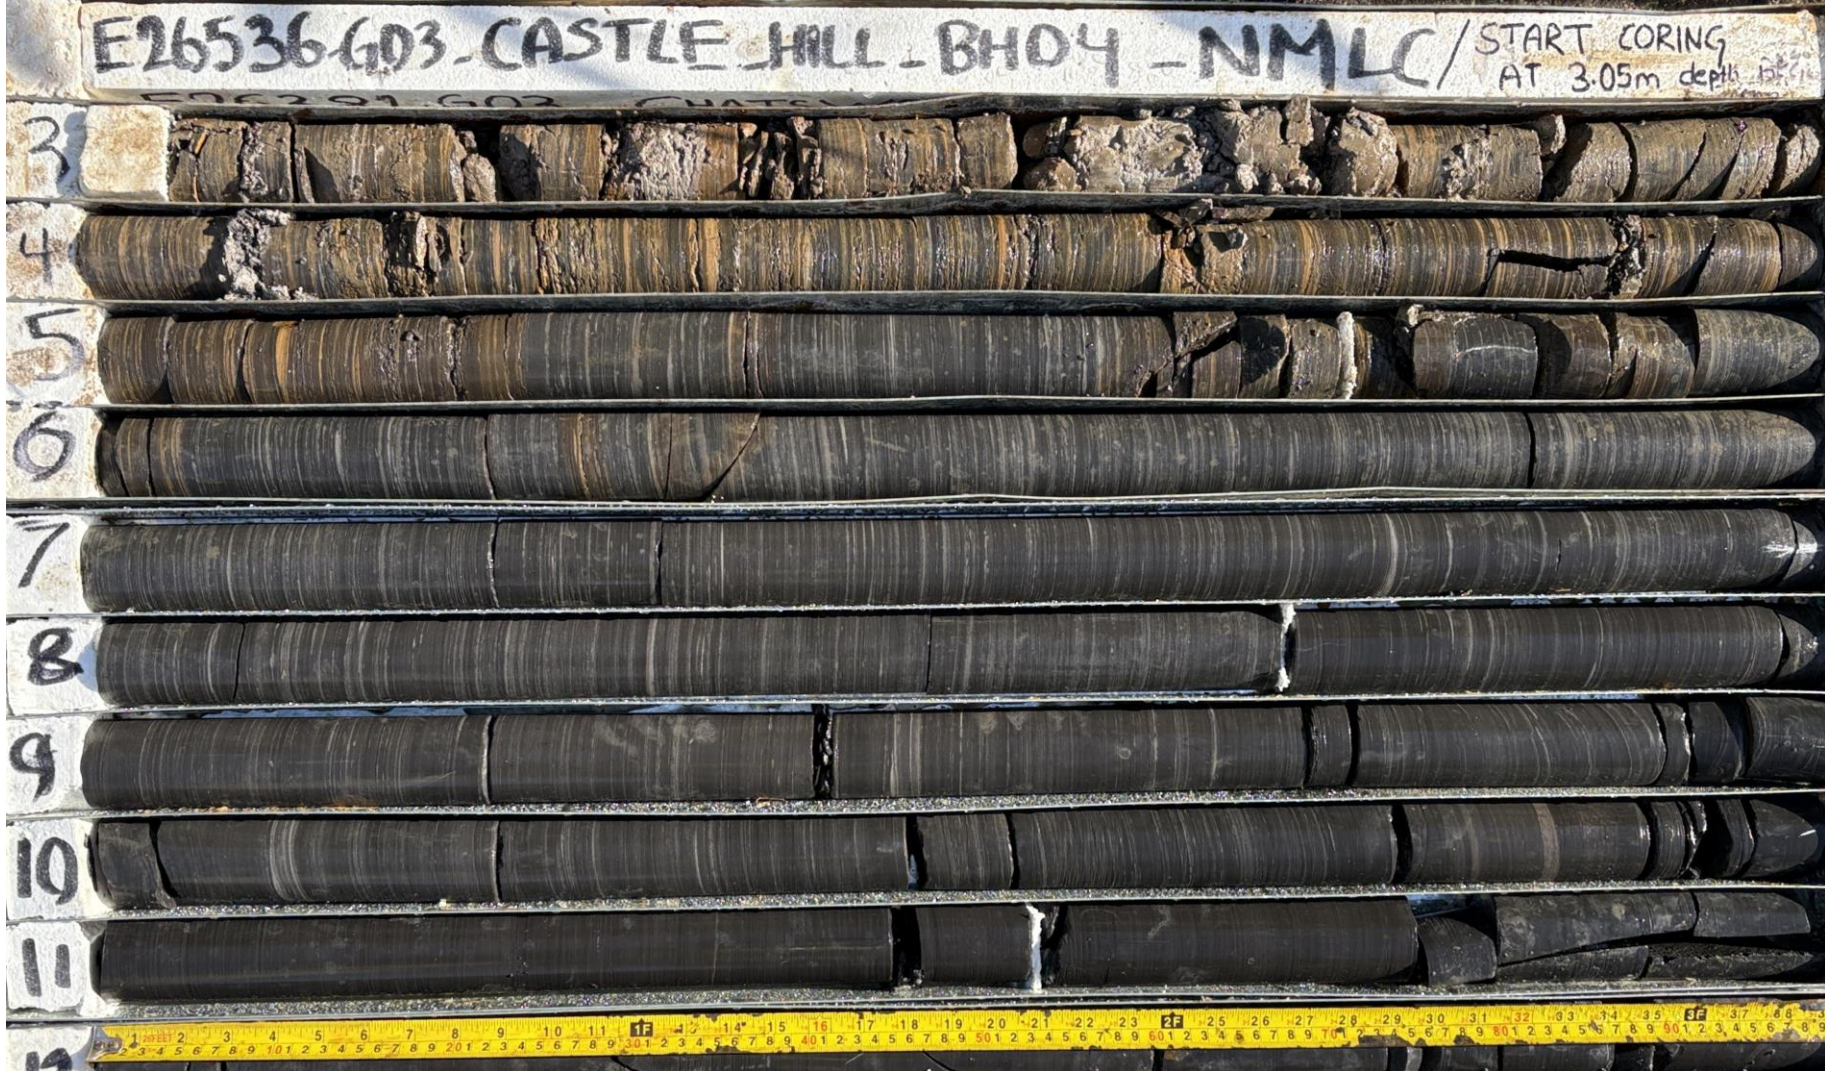
# CORE PHOTOGRAPH OF BOREHOLE: BH04

<b>Project</b>	Proposed Development	<b>East</b>	315073.37	<b>Depth Range</b>	3.05m to 20.55m	
<b>Location</b>	93-107 Cecil Avenue & 9-10 Roger Avenue, Castle Hill, NSW	<b>North</b>	6265329.98	<b>Contractor</b>	Geosense Drilling Engineers Pty Ltd	
<b>Position</b>	See Figure 2	<b>Surface RL</b>	≈128.50 m (AHD)	<b>Drill Rig</b>	Comacchio Geo 205	
<b>Job No.</b>	E26536.G03	<b>Inclination</b>	90°	<b>Logged</b>	PS	<b>Date</b> 18/06/2025
<b>Client</b>	Alton Property Group Pty Ltd	<b>Box</b>	1 & 2 of 4	<b>Checked</b>	GP	<b>Date</b> 08/08/2025

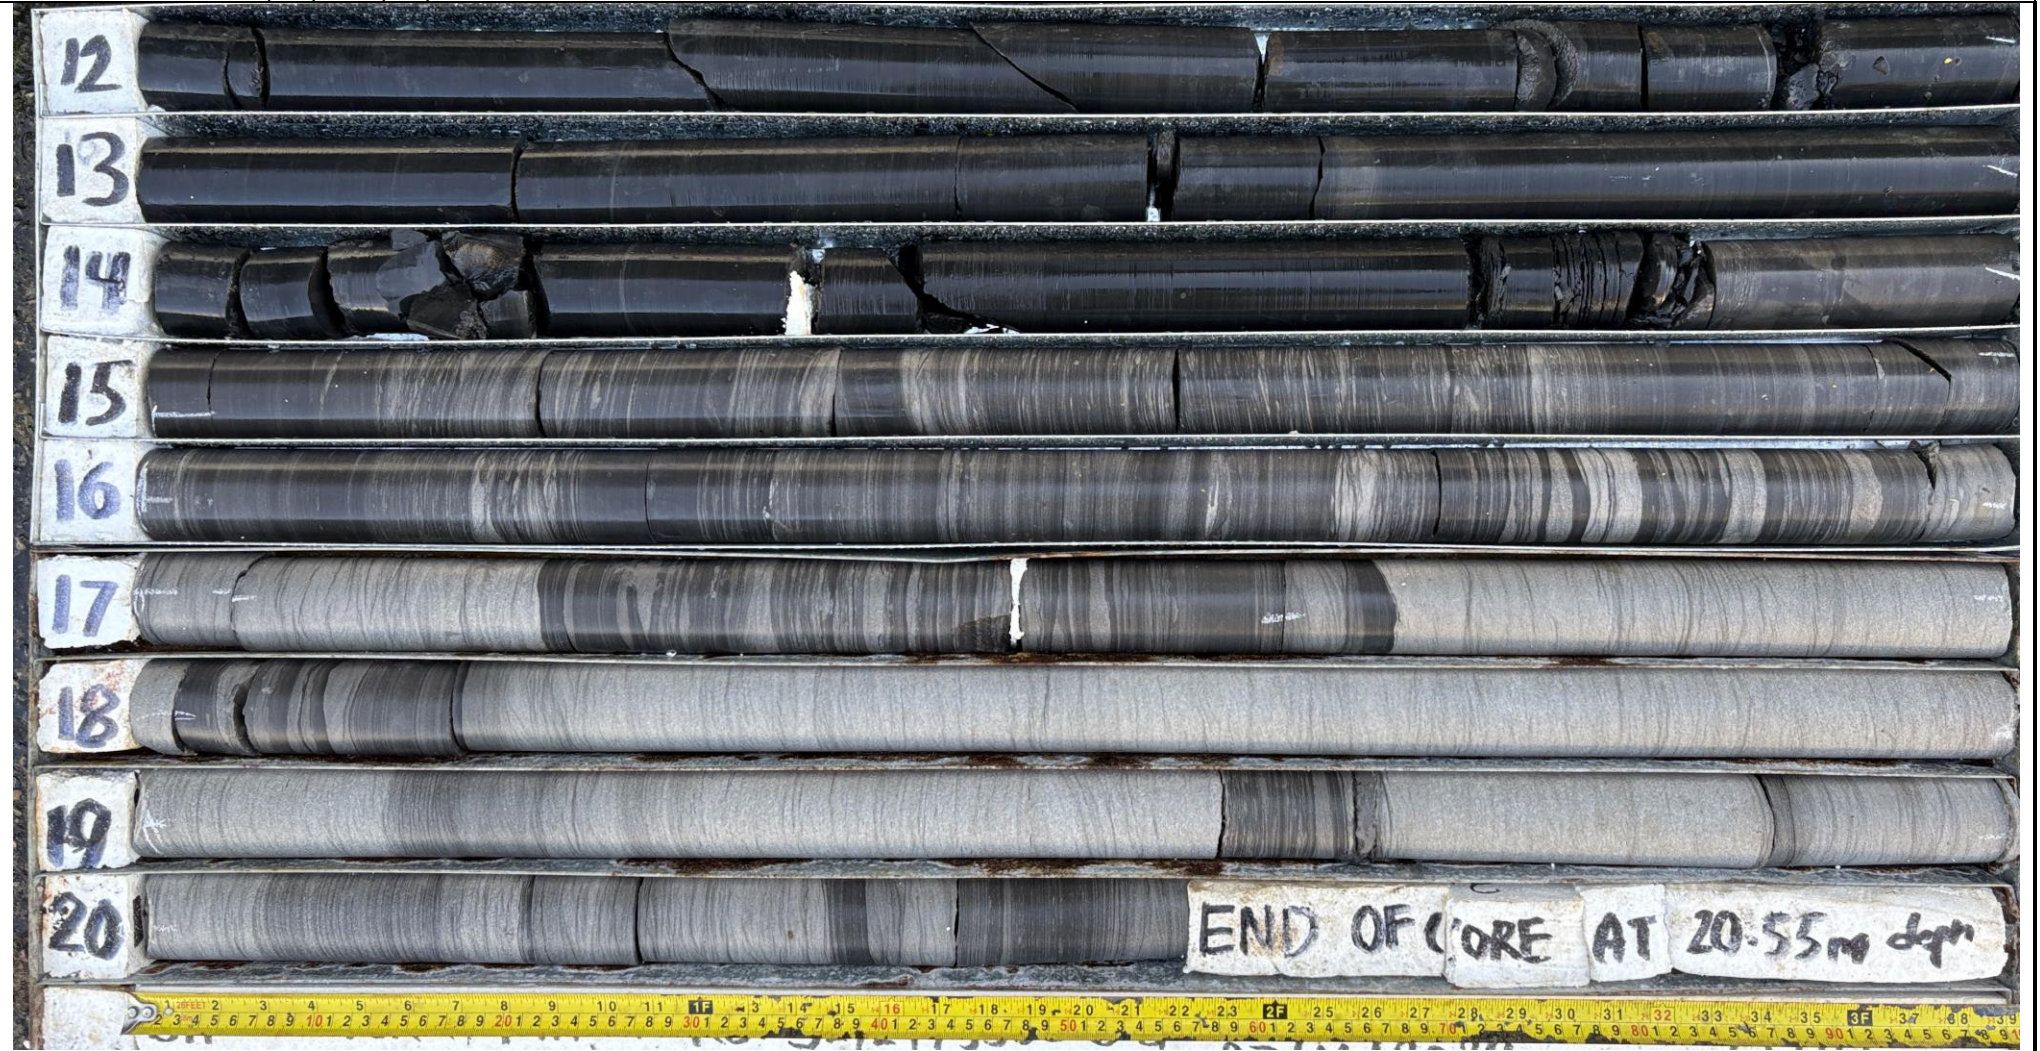
<b>Project</b>	Proposed Development	<b>East</b>	315073.37	<b>Depth Range</b>	3.05m to 20.55m	
<b>Location</b>	93-107 Cecil Avenue & 9-10 Roger Avenue, Castle Hill, NSW	<b>North</b>	6265329.98	<b>Contractor</b>	Geosense Drilling Engineers Pty Ltd	
<b>Position</b>	See Figure 2	<b>Surface RL</b>	≈128.50 m (AHD)	<b>Drill Rig</b>	Comacchio Geo 205	
<b>Job No.</b>	E26536.G03	<b>Inclination</b>	90°	<b>Logged</b>	PS	<b>Date</b> 18/06/2025
<b>Client</b>	Alton Property Group Pty Ltd	<b>Box</b>	3 & 4 of 4	<b>Checked</b>	GP	<b>Date</b> 08/08/2025

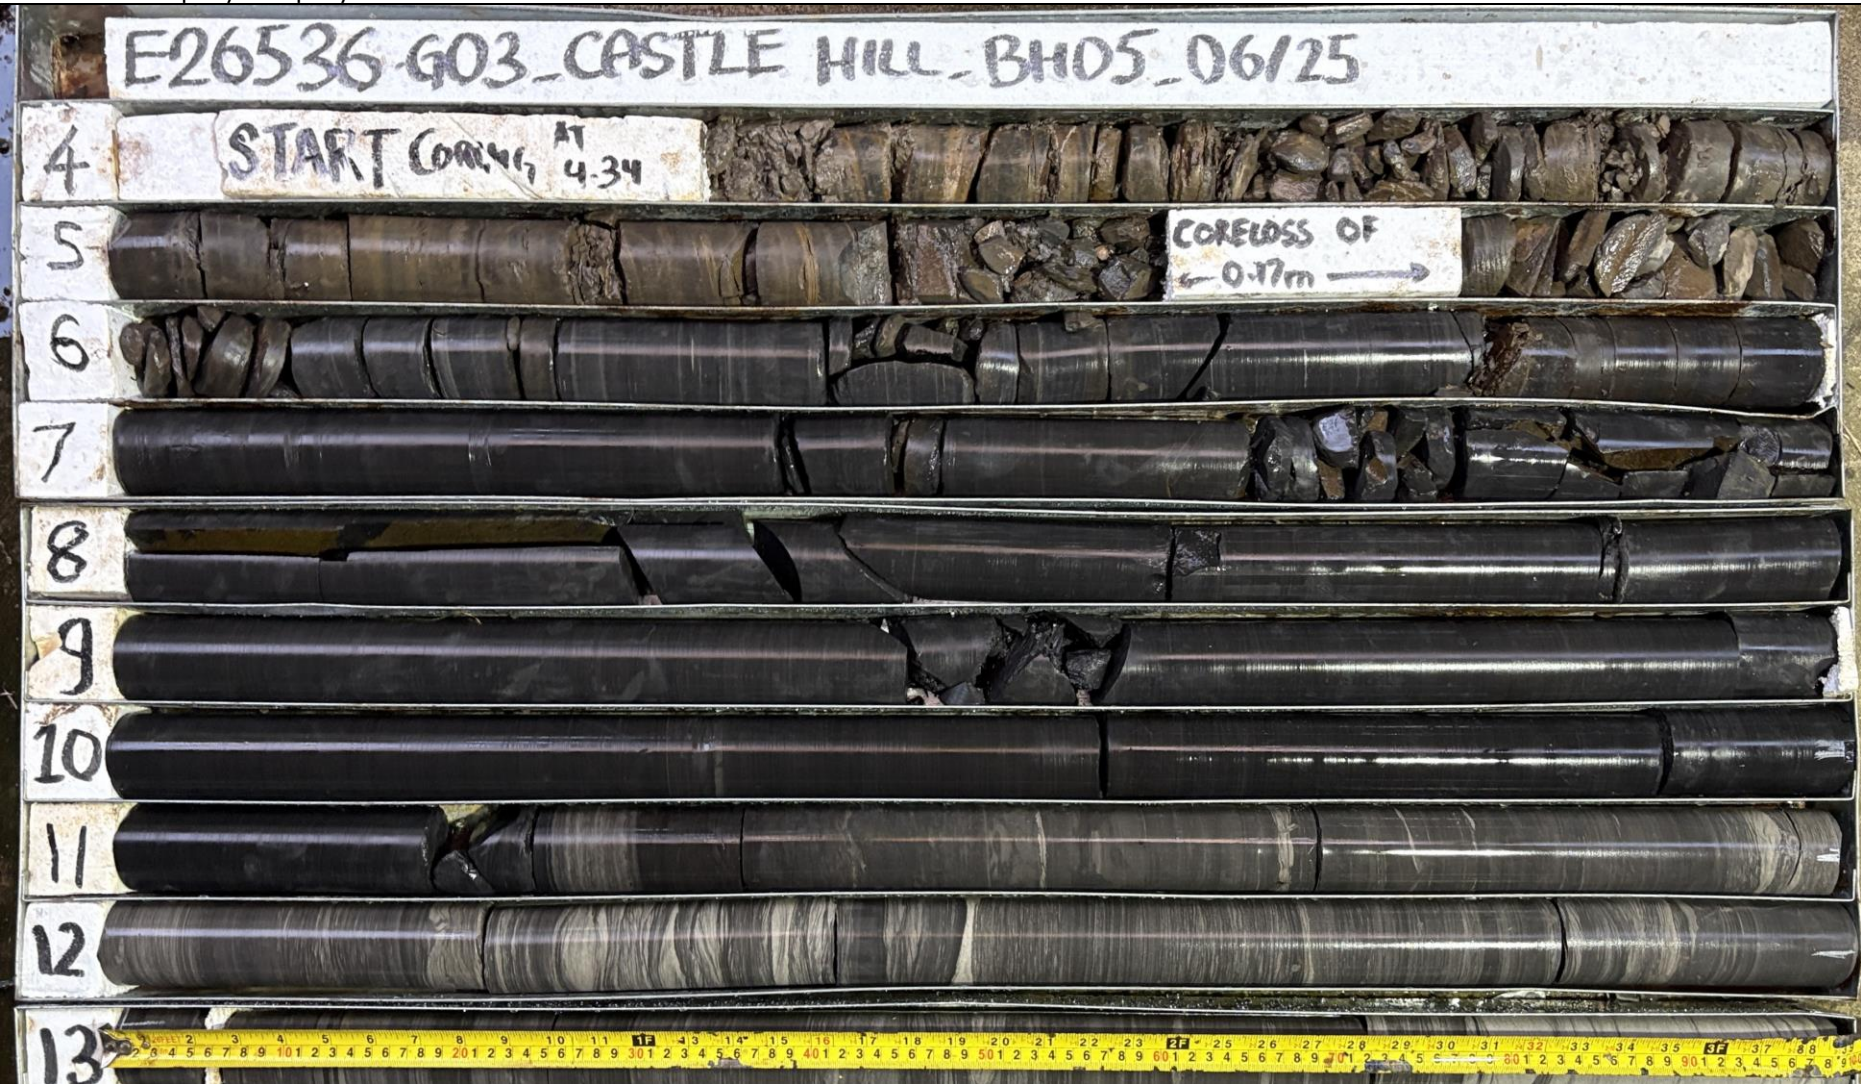
# CORE PHOTOGRAPH OF BOREHOLE: BH05

<b>Project</b>	Proposed Development	<b>East</b>	315125.04	<b>Depth Range</b>	4.34m to 18.30m
<b>Location</b>	93-107 Cecil Avenue & 9-10 Roger Avenue, Castle Hill, NSW	<b>North</b>	6265311.03	<b>Contractor</b>	Geosense Drilling Engineers Pty Ltd
<b>Position</b>	See Figure 2	<b>Surface RL</b>	≈126.20 m (AHD)	<b>Drill Rig</b>	Comacchio Geo 205
<b>Job No.</b>	E26536.G03	<b>Inclination</b>	90°	<b>Logged</b>	PS <b>Date</b> 16/06/2025
<b>Client</b>	Alton Property Group Pty Ltd	<b>Box</b>	1 & 2 of 4	<b>Checked</b>	GP <b>Date</b> 08/08/2025
