## ALTON PROPERTY GROUP PTY LTD

## Geotechnical Investigation

93-107 Cecil Avenue & 9-10 Roger Avenue, Castle Hill, NSW

Report No: E26536.G03\_Rev1

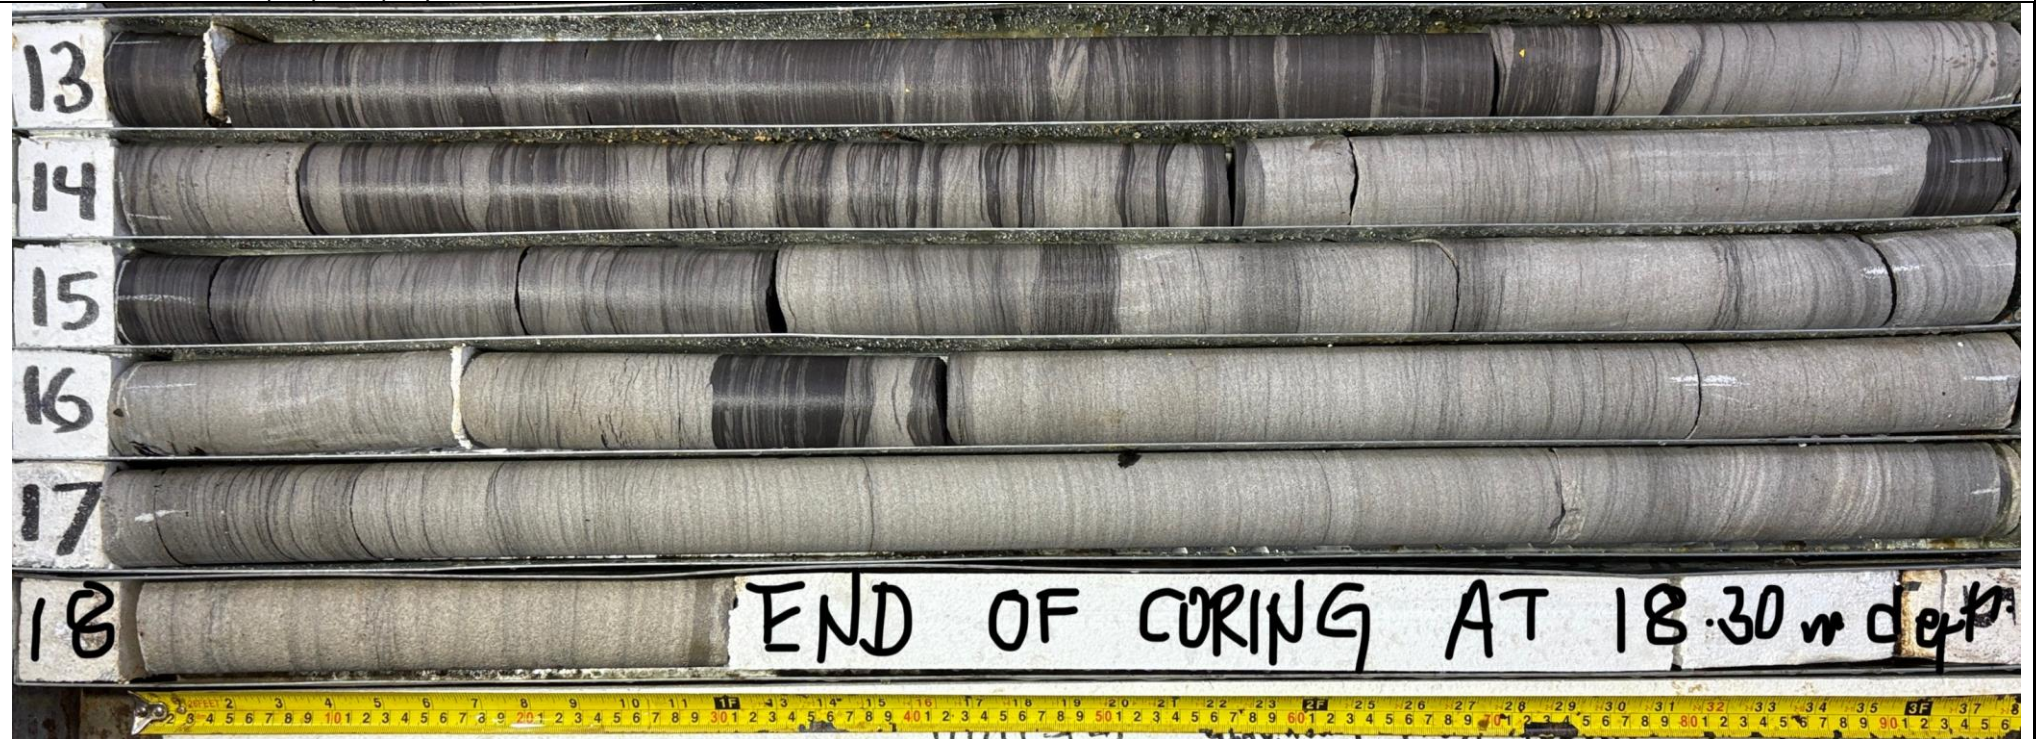
# CORE PHOTOGRAPH OF BOREHOLE: BH05

<b>Project</b>	Proposed Development	<b>East</b>	315125.04	<b>Depth Range</b>	4.34m to 18.30m	
<b>Location</b>	93-107 Cecil Avenue & 9-10 Roger Avenue, Castle Hill, NSW	<b>North</b>	6265311.03	<b>Contractor</b>	Geosense Drilling Engineers Pty Ltd	
<b>Position</b>	See Figure 2	<b>Surface RL</b>	≈126.20 m (AHD)	<b>Drill Rig</b>	Comacchio Geo 205	
<b>Job No.</b>	E26536.G03	<b>Inclination</b>	90°	<b>Logged</b>	PS	<b>Date</b> 16/06/2025
<b>Client</b>	Alton Property Group Pty Ltd	<b>Box</b>	3 & 4 of 4	<b>Checked</b>	GP	<b>Date</b> 08/08/2025

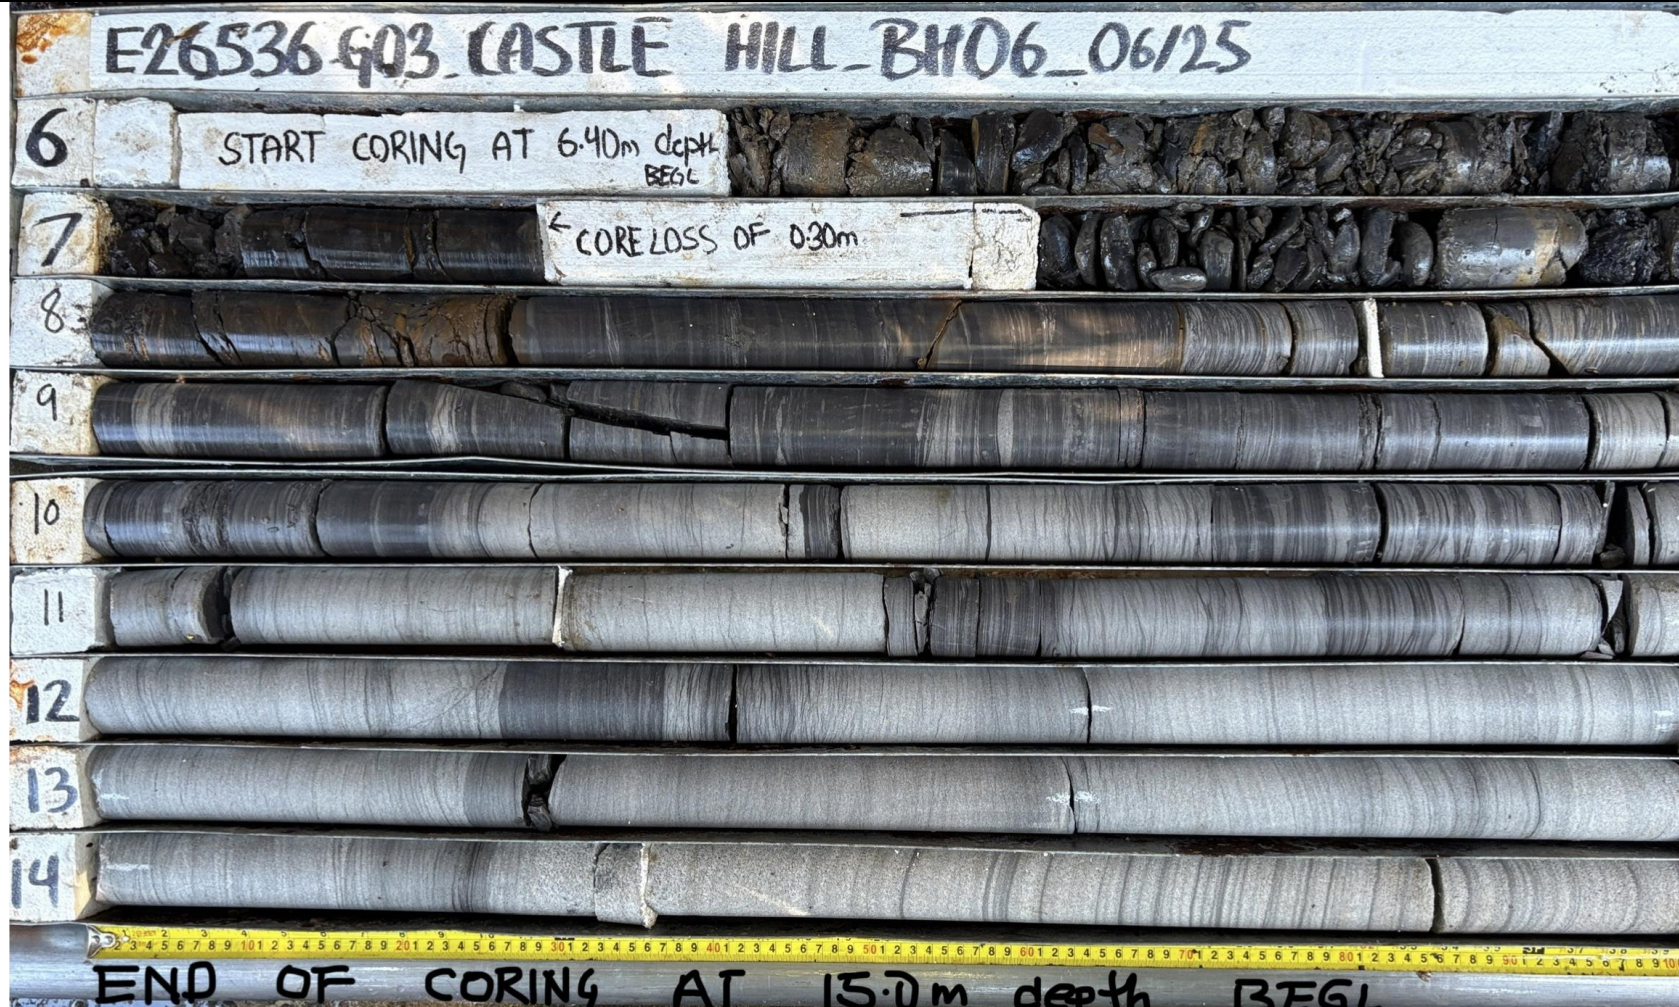
<b>Project</b>	Proposed Development	<b>East</b>	315166.65	<b>Depth Range</b>	6.40m to 15.0m
<b>Location</b>	93-107 Cecil Avenue & 9-10 Roger Avenue, Castle Hill, NSW	<b>North</b>	6265299.97	<b>Contractor</b>	Geosense Drilling Engineers Pty Ltd
<b>Position</b>	See Figure 2	<b>Surface RL</b>	≈123.00 m (AHD)	<b>Drill Rig</b>	Comacchio Geo 205
<b>Job No.</b>	E26536.G03	<b>Inclination</b>	90°	<b>Logged</b>	PS <b>Date</b> 13/06/2025
<b>Client</b>	Alton Property Group Pty Ltd	<b>Box</b>	1 & 2 of 2	<b>Checked</b>	GP <b>Date</b> 08/08/2025

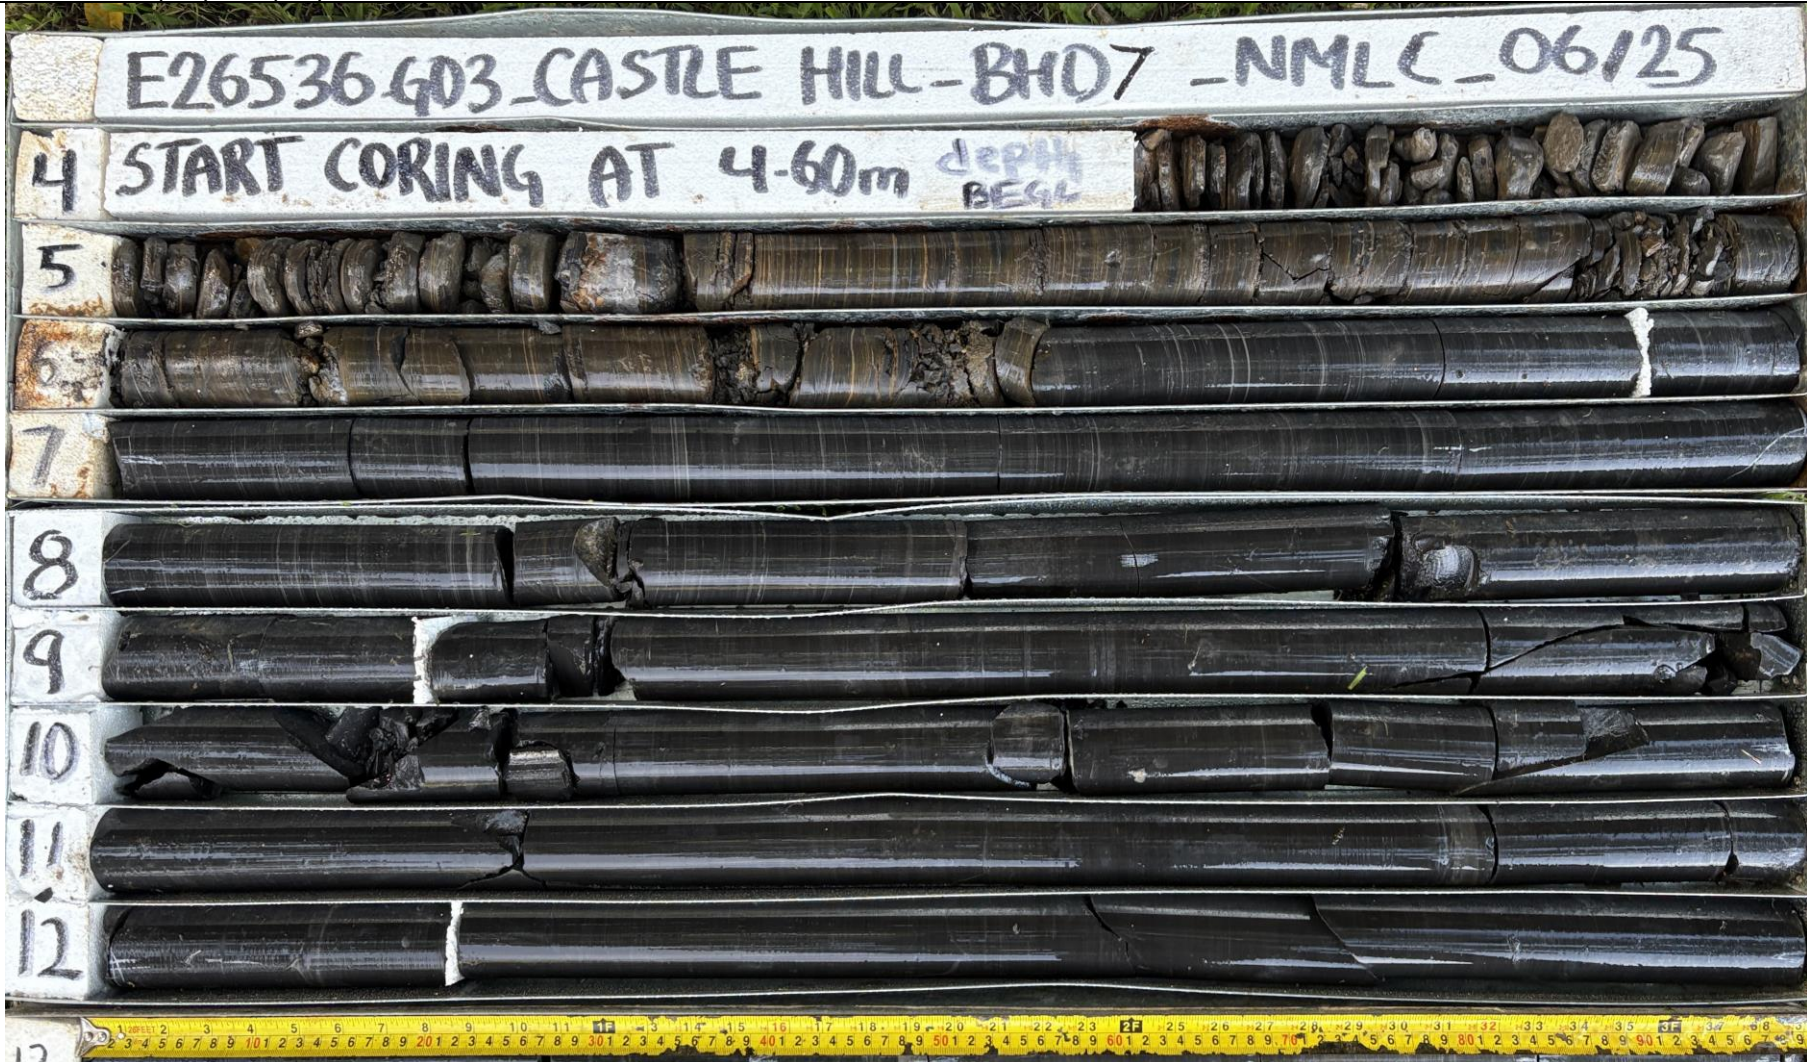
<b>Project</b>	Proposed Development	<b>East</b>	315049.06	<b>Depth Range</b>	4.60m to 18.30m	
<b>Location</b>	93-107 Cecil Avenue & 9-10 Roger Avenue, Castle Hill, NSW	<b>North</b>	6265299.25	<b>Contractor</b>	Geosense Drilling Engineers Pty Ltd	
<b>Position</b>	See Figure 2	<b>Surface RL</b>	≈125.50 m (AHD)	<b>Drill Rig</b>	Comacchio Geo 205	
<b>Job No.</b>	E26536.G03	<b>Inclination</b>	90°	<b>Logged</b>	PS	<b>Date</b> 18/06/2025
<b>Client</b>	Alton Property Group Pty Ltd	<b>Box</b>	1 & 2 of 4	<b>Checked</b>	GP	<b>Date</b> 08/08/2025

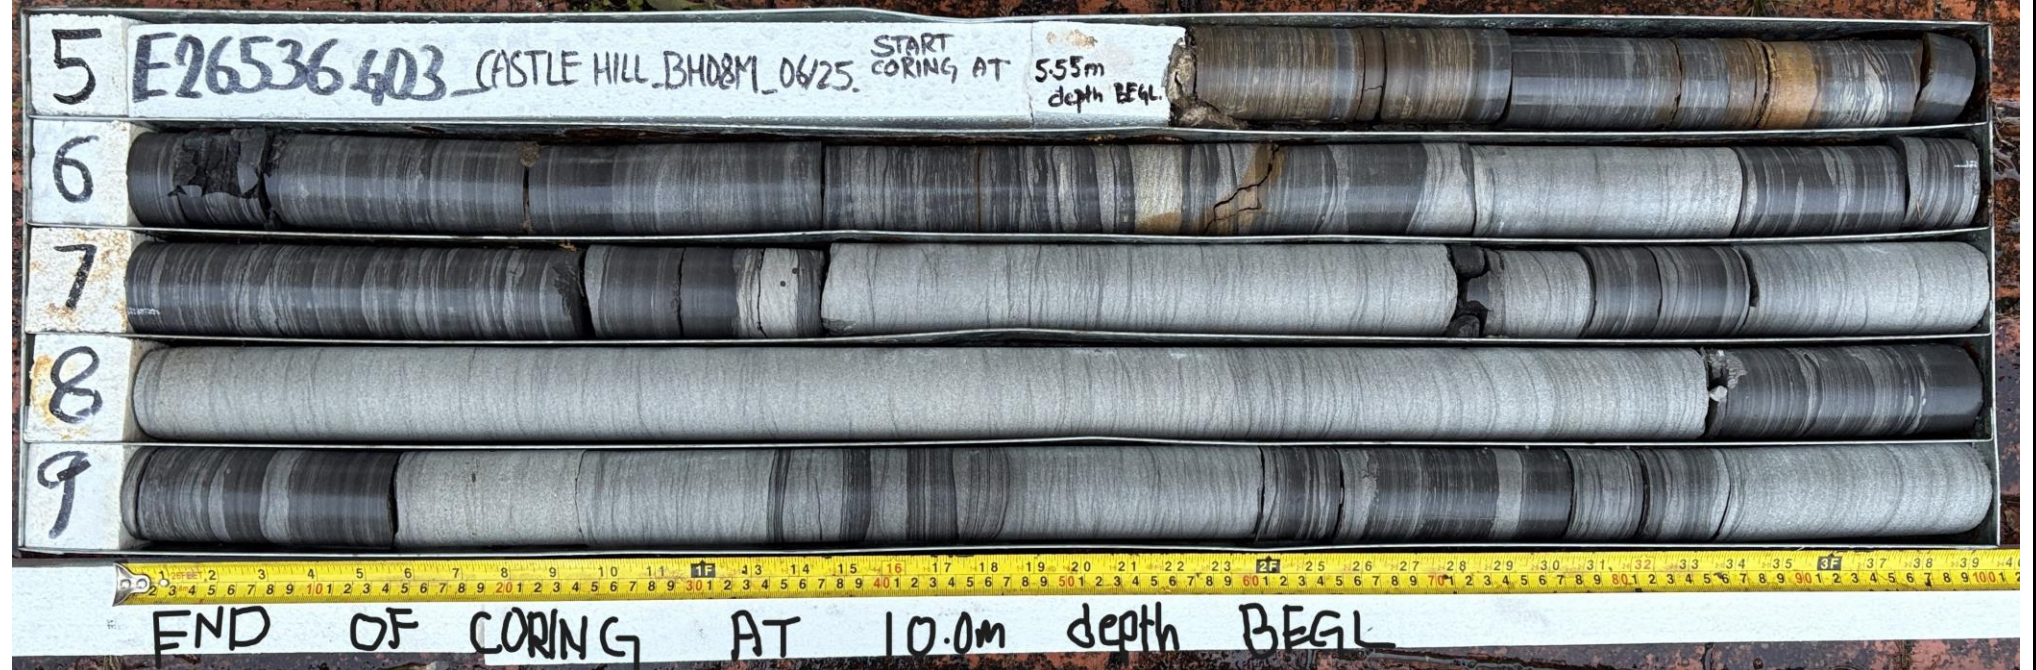
# CORE PHOTOGRAPH OF BOREHOLE: BH08M

<b>Project</b>	Proposed Development	<b>East</b>	315115.79	<b>Depth Range</b>	5.55m to 10.0m	
<b>Location</b>	93-107 Cecil Avenue & 9-10 Roger Avenue, Castle Hill, NSW	<b>North</b>	6265228.01	<b>Contractor</b>	Geosense Drilling Engineers Pty Ltd	
<b>Position</b>	See Figure 2	<b>Surface RL</b>	≈117.50 m (AHD)	<b>Drill Rig</b>	Comacchio Geo 205	
<b>Job No.</b>	E26536.G03	<b>Inclination</b>	90°	<b>Logged</b>	PS	<b>Date</b> 16/06/2025
<b>Client</b>	Alton Property Group Pty Ltd	<b>Box</b>	1 of 1	<b>Checked</b>	GP	<b>Date</b> 08/08/2025

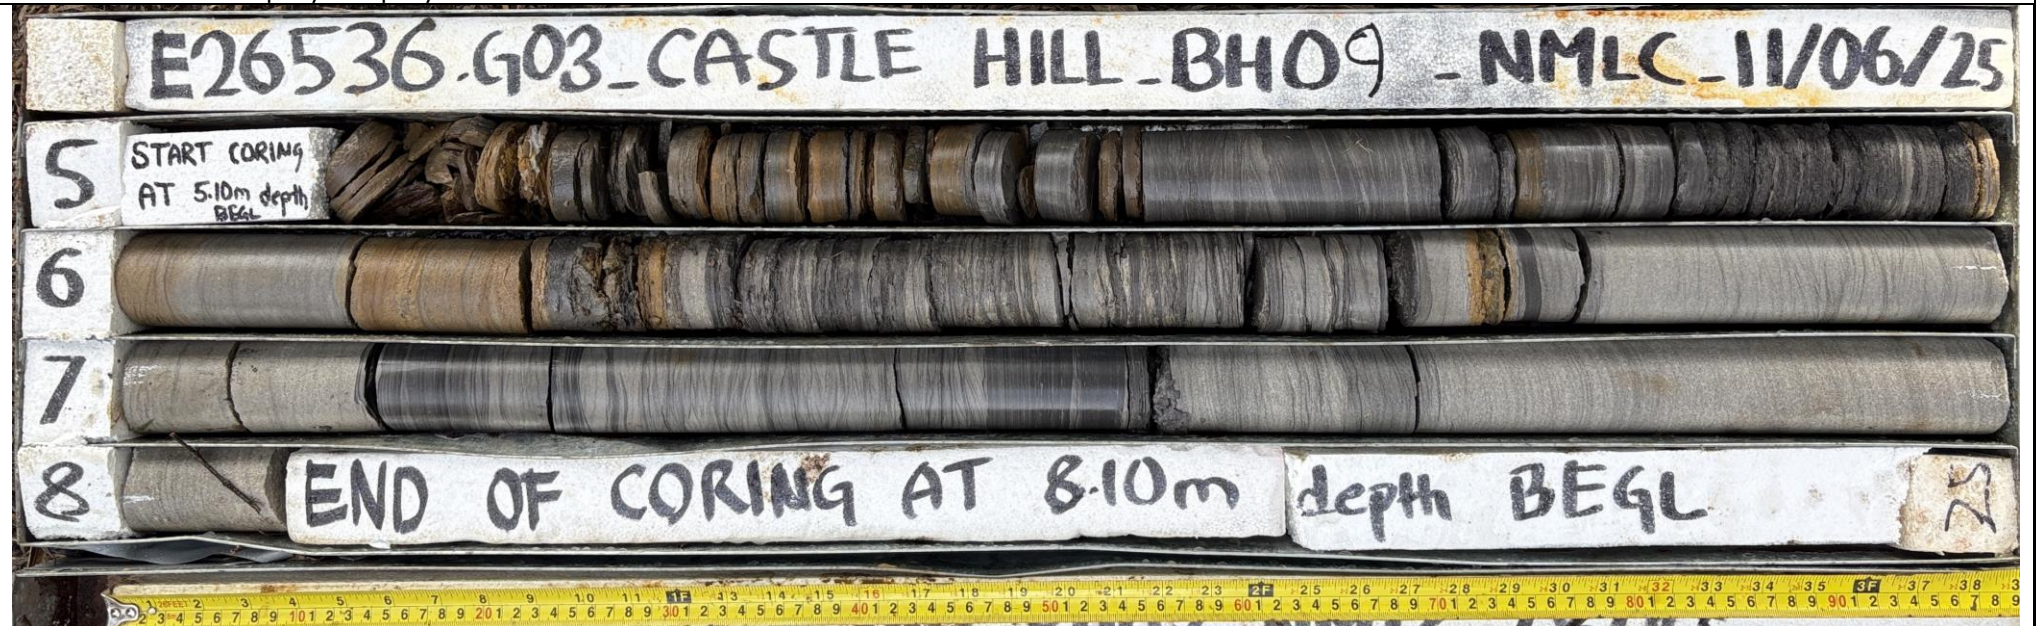
<b>Project</b>	Proposed Development	<b>East</b>	315160.45	<b>Depth Range</b>	5.10m to 8.10m	
<b>Location</b>	93-107 Cecil Avenue & 9-10 Roger Avenue, Castle Hill, NSW	<b>North</b>	6265237.85	<b>Contractor</b>	Geosense Drilling Engineers Pty Ltd	
<b>Position</b>	See Figure 2	<b>Surface RL</b>	≈118.00 m (AHD)	<b>Drill Rig</b>	Comacchio Geo 205	
<b>Job No.</b>	E26536.G03	<b>Inclination</b>	90°	<b>Logged</b>	PS	<b>Date</b> 11/06/2025
<b>Client</b>	Alton Property Group Pty Ltd	<b>Box</b>	1 of 1	<b>Checked</b>	GP	<b>Date</b> 08/08/2025
