93-107 Cecil Ave & 9-10 Roger Ave
CASTLE HILL NSW 2154

Arboriculture Impact Assessment (AIA)

Client: Alton Property Group

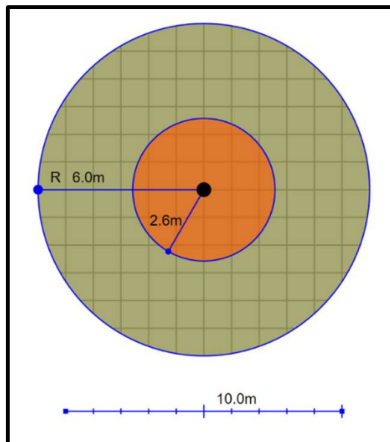
A specified area above and below ground and at a given distance from the trunk set aside for the protection of a tree's roots and crown to provide for the viability and stability of a tree to be retained where it is potentially subject to damage by development (AS4970-2009, 2009). The TPZ is calculated at $12 \times \text{DBH}$, where DBH is trunk diameter measured at 1.4m above the ground. The TPZ is the radius measured from the centre of the tree. For example:

TPZ - is the radius measured from the centre of the tree.

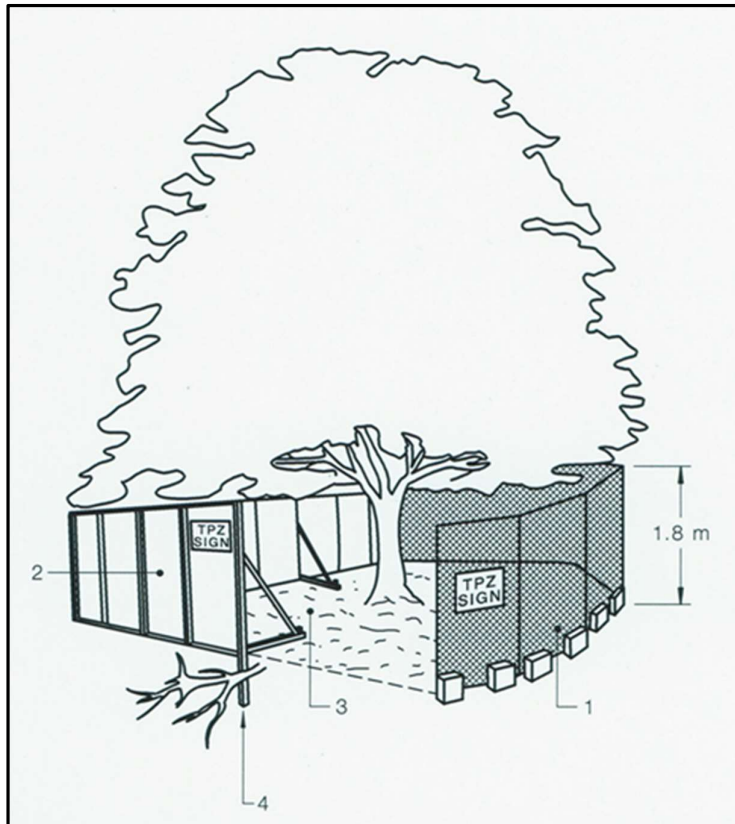
Where minimum requirements for the fencing are desirable, it should be a minimum of 1.2 - 1.5 metres in height, of chain mesh or like fence with 1.8 metre posts (e.g. treated pine) or like support every 3-4 metres and a top line of high visibility plastic hazard tape. The posts should be strong enough to sustain knocks from on-site excavation equipment. On large projects, with large numbers of trees, para-webbing may be used. However, the maintenance of this type of fencing must be enforced regularly. Para-webbing could also be used to isolate groups of trees at the fringe of the work zone to indicate that access is not permitted.

Tree Protection Zone Fencing

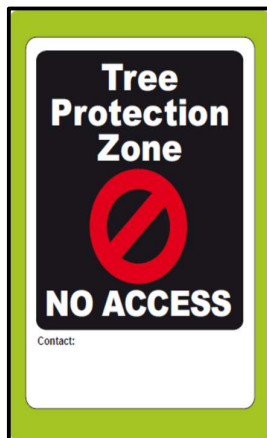
An additional recommendation would be to attach signs to the fencing indicating their purpose and the restrictions applying to the TPZ. Contact details could also be attached to assist persons/contractors seeking information on the TPZ - refer to figure 6.

Tree Protection signage
