## **Remediation Action Plan**

**Concept and Stage 1 - Redevelopment of  
Newington College Senior Campus**

**200-244 and 221-235 Stanmore Road,  
Stanmore NSW**

**Project 234875.01**

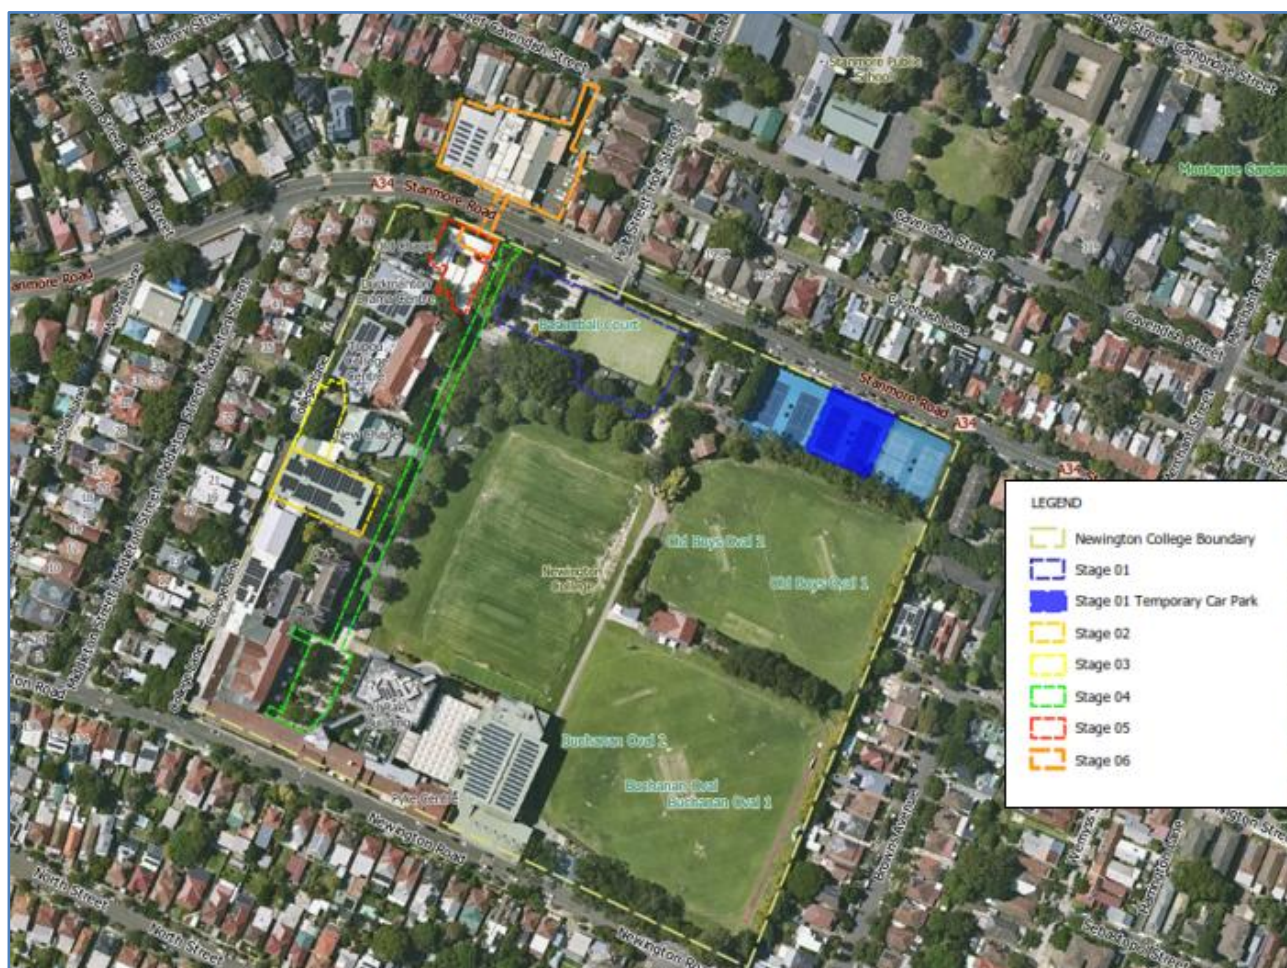
**Figure 2. Site (Stage 01 to Stage 06 that are subject to this RAP) location (refer to Drawing 1 for full legend)**

The boundary of each stage and the college is shown on Figure 2, and Drawing 1, Appendix A.

The boundary of the site (Stages 01 to 06) is shown on Drawing 1, Appendix A. It is noted that the RAP applies to the site only, and if any further areas within the Newington College Senior Campus are subject to works, the RAP will need to be revised.

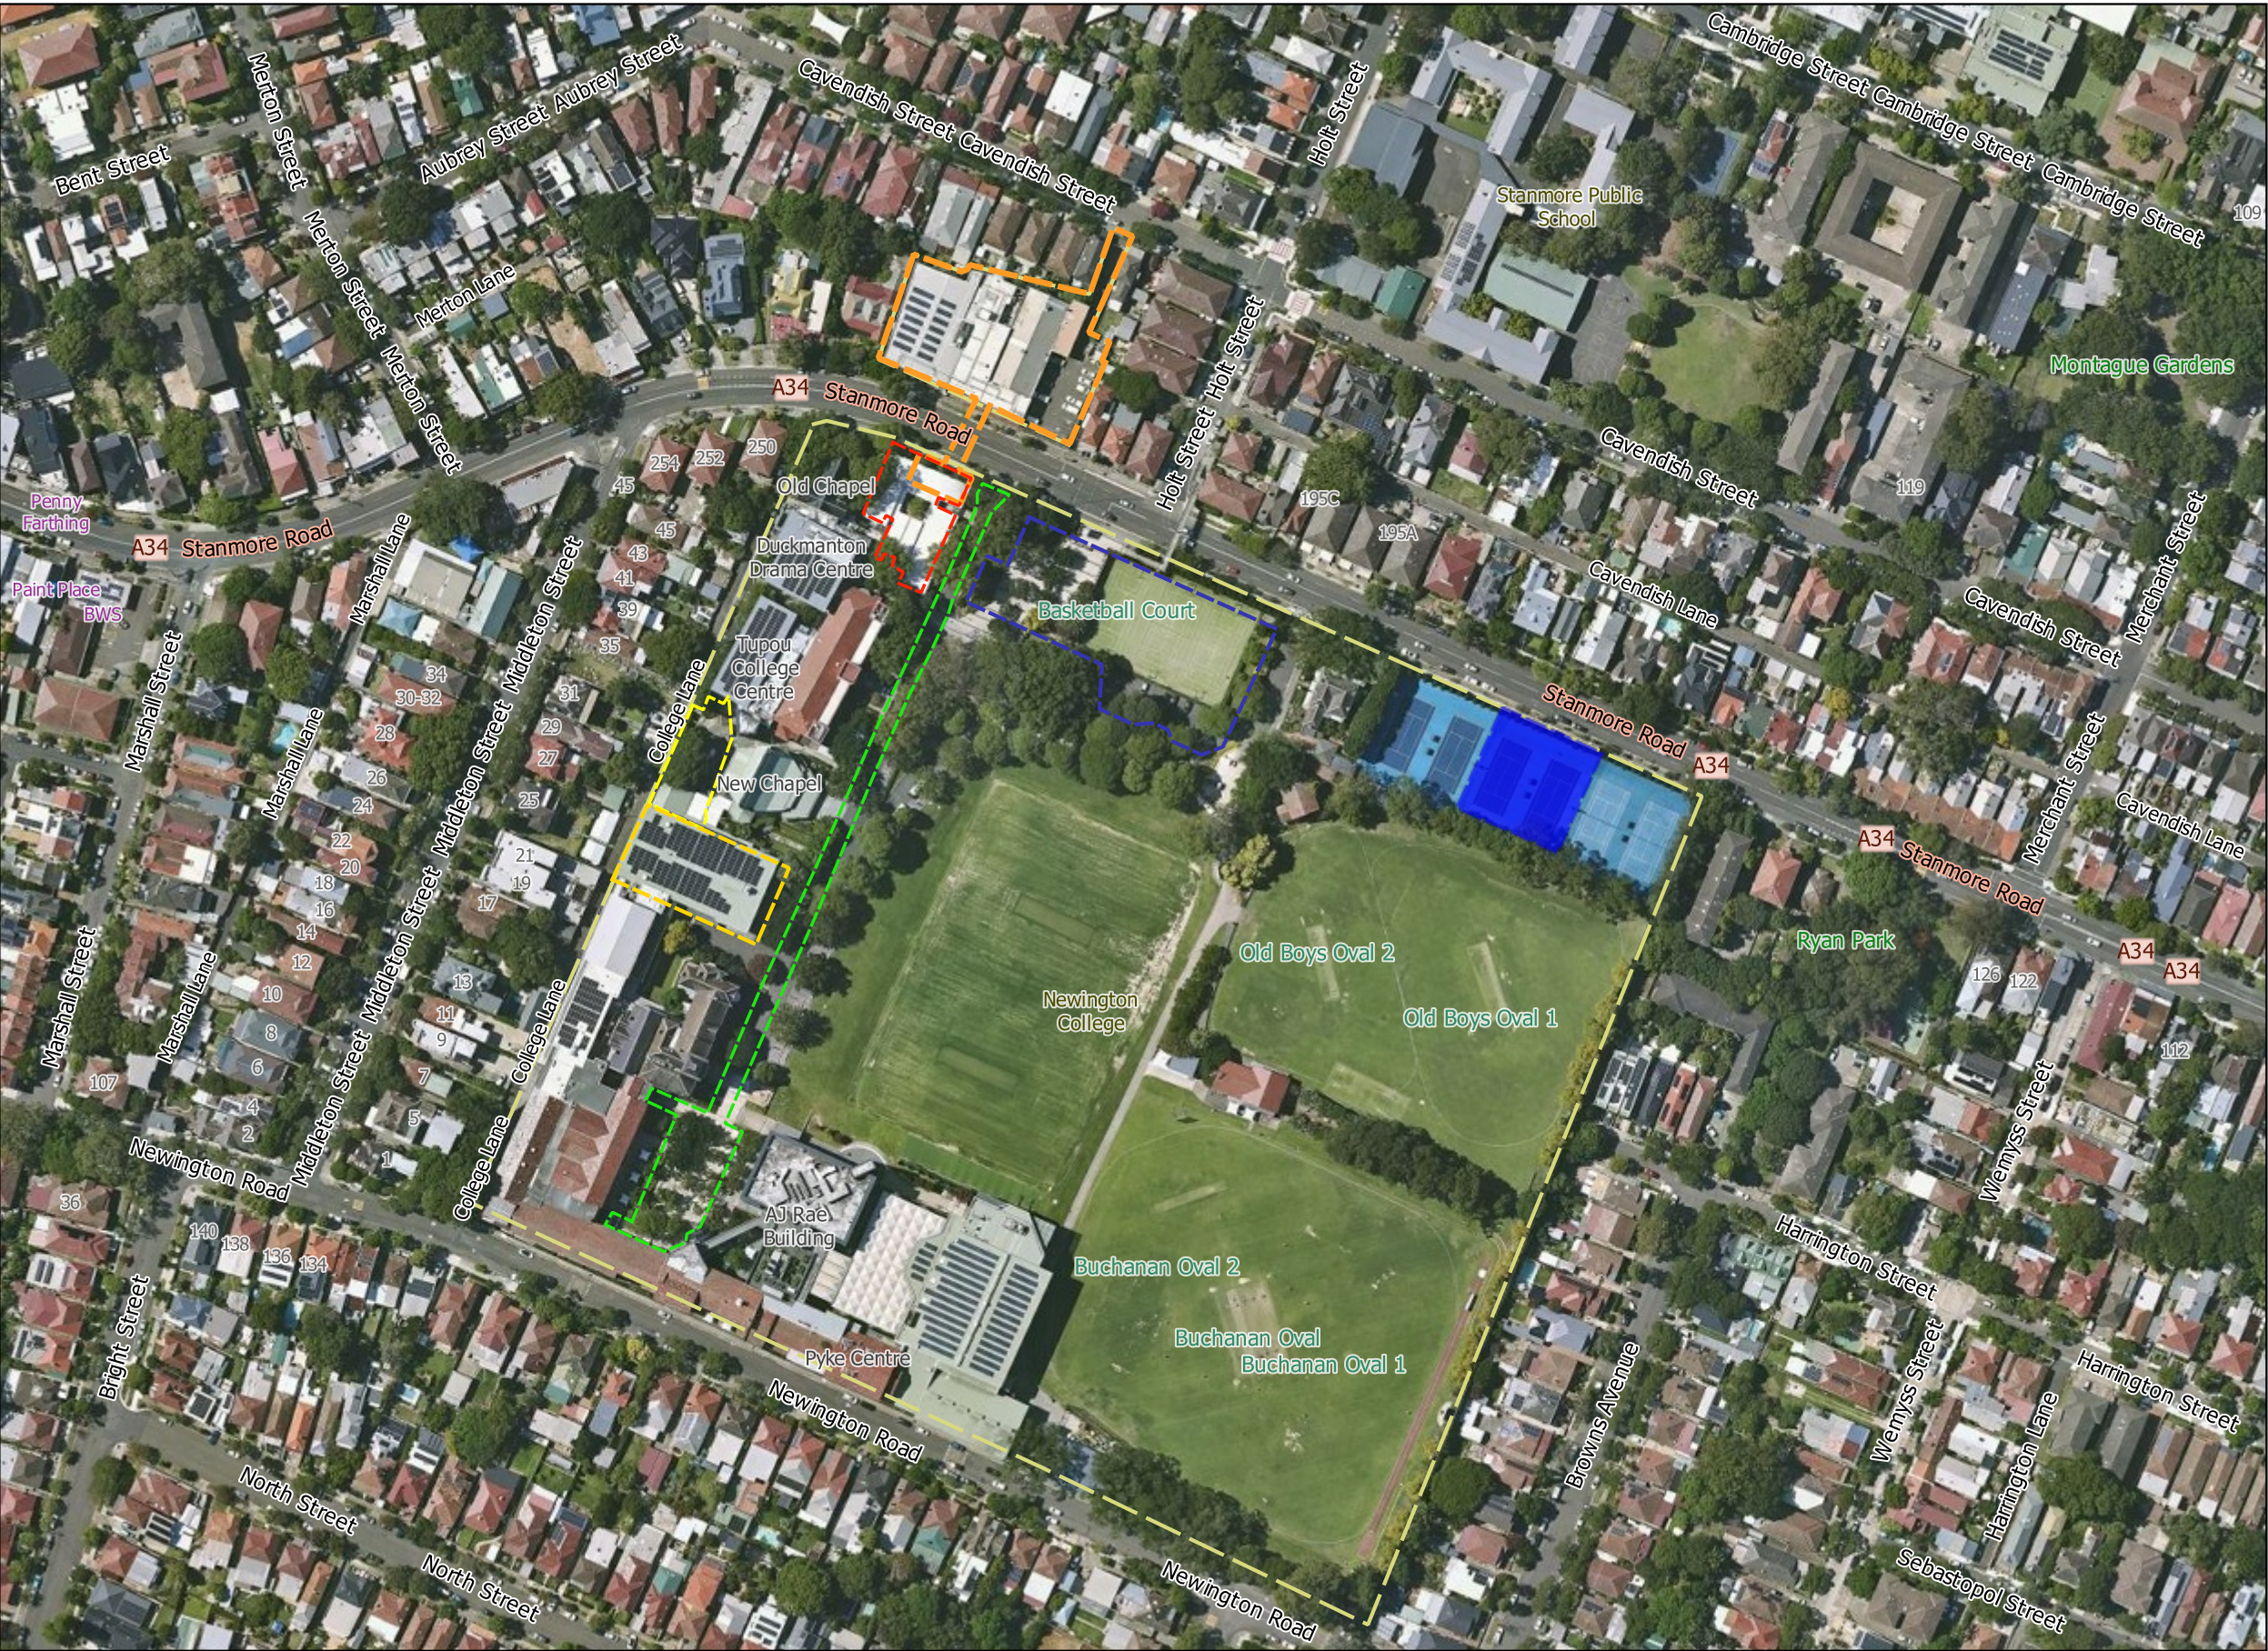
| DRAWING No: | 1 |

- LEGEND
- Newington College Boundary
  - Stage 01
  - Stage 01 Temporary Car Park
  - Stage 02
  - Stage 03
  - Stage 04
  - Stage 05
  - Stage 06

This report covers the concept proposal (Stage 01 to Stage 06 areas as shown on Drawing 1) and detailed stage 1 works associated with the proposed alterations and additions to Newington College. The proposed stages of the concept proposal are outlined below:

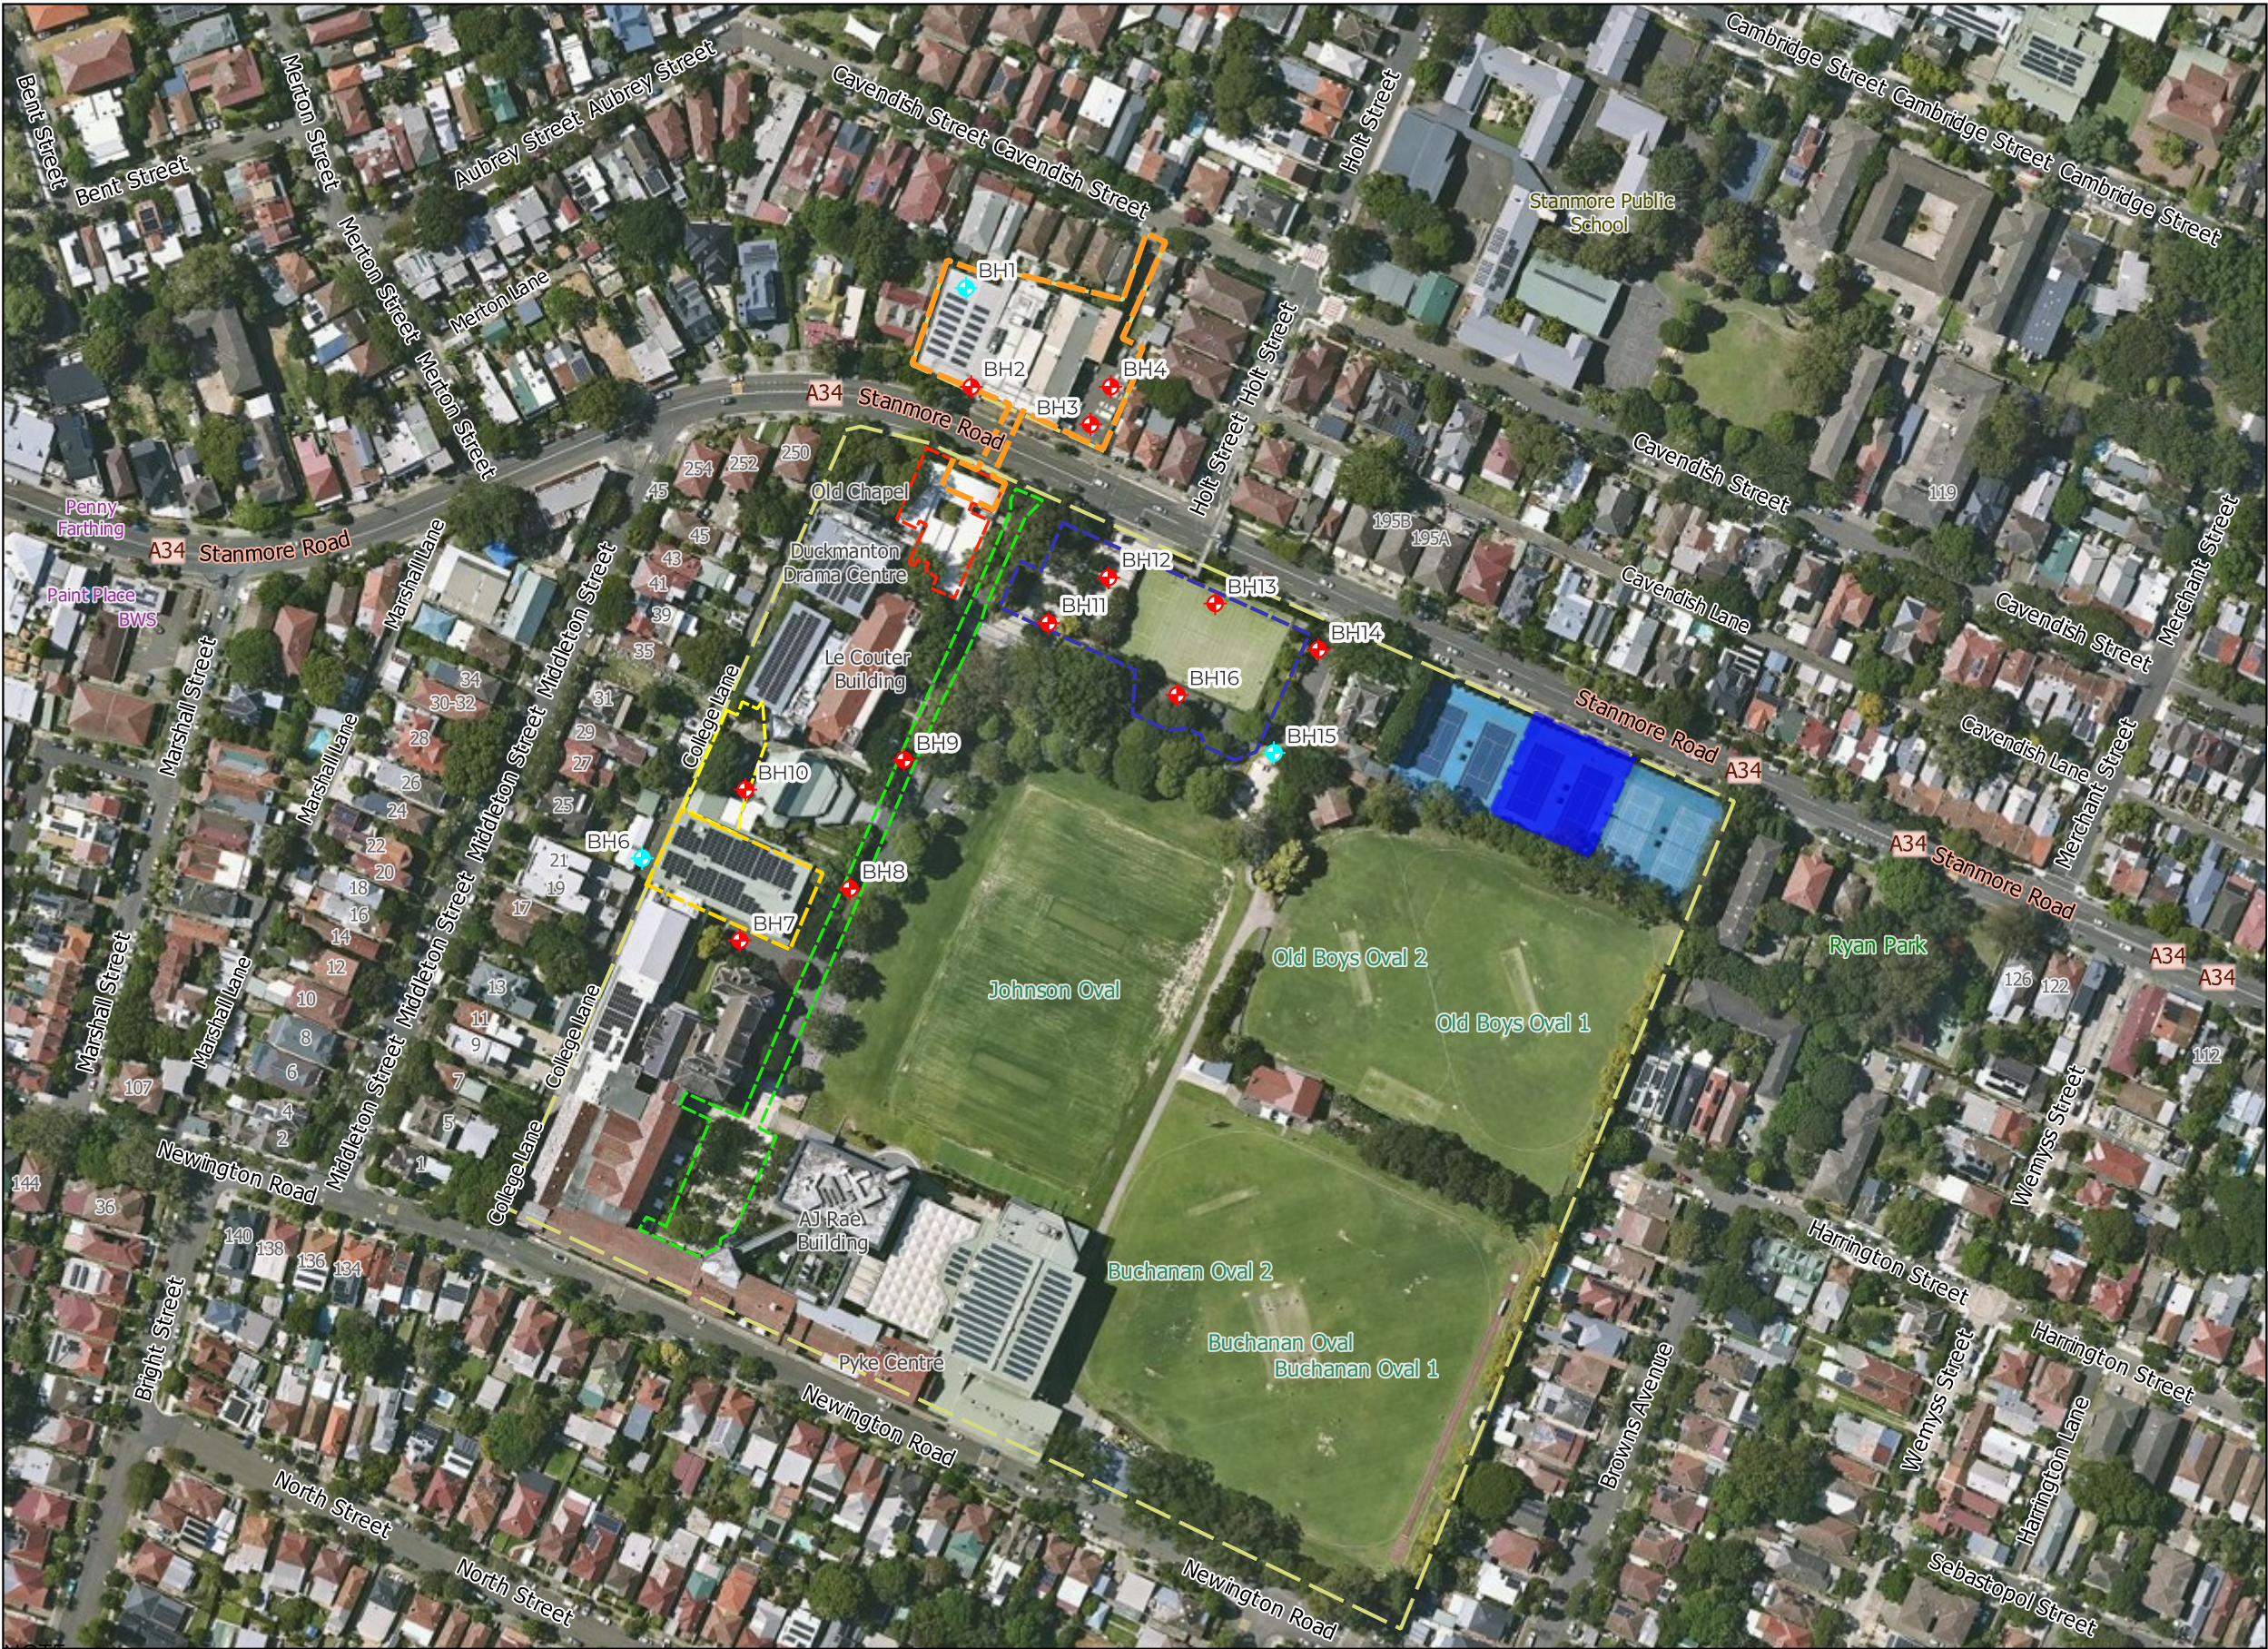
PROJECT: 234875.01  
DRAWING No: 2  
REVISION: 2

The boreholes drilled and sampled as part of the PSI, numbering BH1 to BH4, BH6 to BH15 are shown on Drawing 2, Appendix A. Fill depths recorded during the sampling ranged between 0.7 m and 2.3 m below ground level (bgl) for Stage 01 with depth increasing from east to west, between 0.5 m bgl and 0.9 m bgl for Stage 02 to 04, and between 0.23 m and 2.8 m bgl for Stage 06 with generally shallow fill in the at grade car park area in the west and deeper fill area in the east. Asbestos containing material (ACM) was observed in BH1/0.15-0.25. Building debris, which can be indicative of asbestos contamination, was observed in a number of boreholes, including at least one borehole at each stage, with a larger quantity of building debris observed in fill in the east of Stage 06. Borehole logs are included in Appendix C.

- LEGEND
- Newington College Boundary
  - Stage 01
  - Stage 1 Temporary Car Park
  - Stage 02
  - Stage 03
  - Stage 04
  - Stage 05
  - Stage 06
- Test Location
- Borehole Location
  - Borehole / Groundwater Well
