## **Report on Geotechnical Investigation**

### **Newington Masterplan**

**200-244 and 221-235 Stanmore Road,  
Stanmore NSW**

**Project 234875.00**

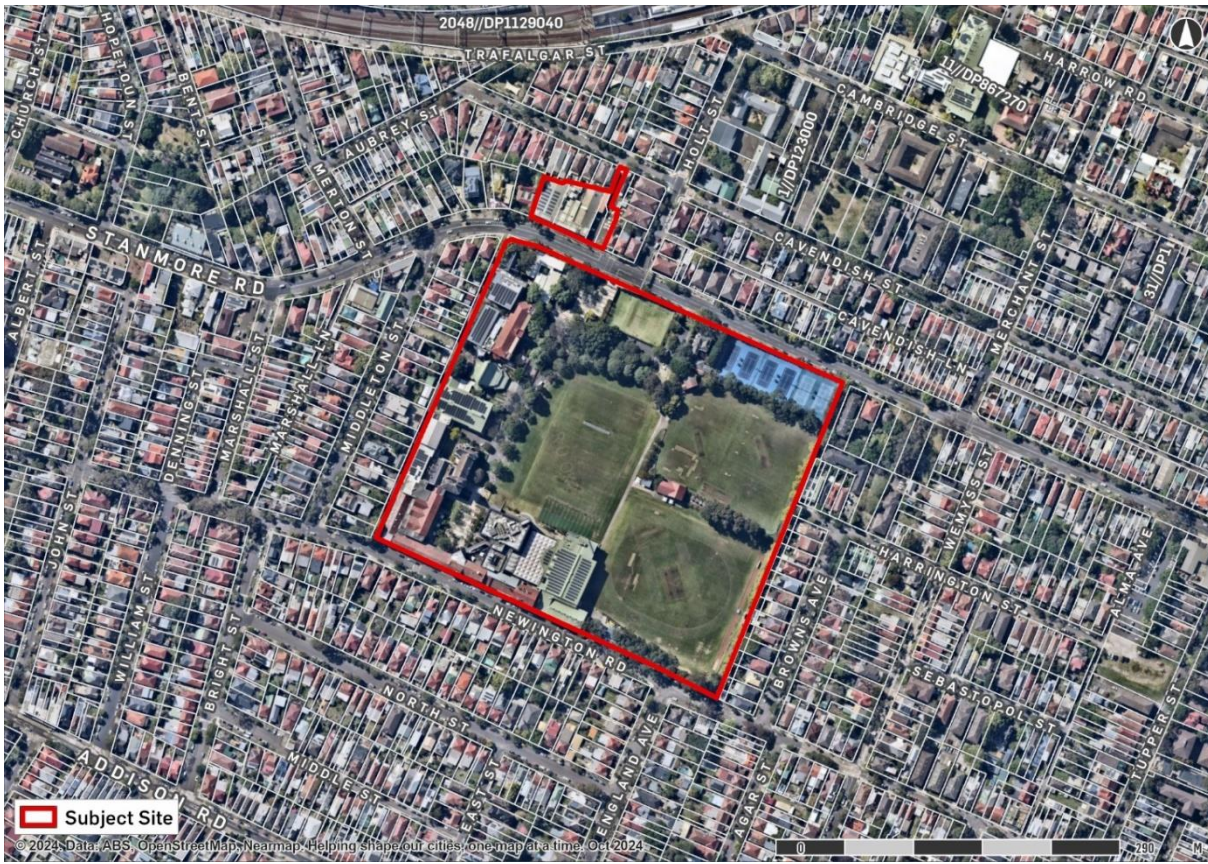
The site is identified in the figure overleaf.

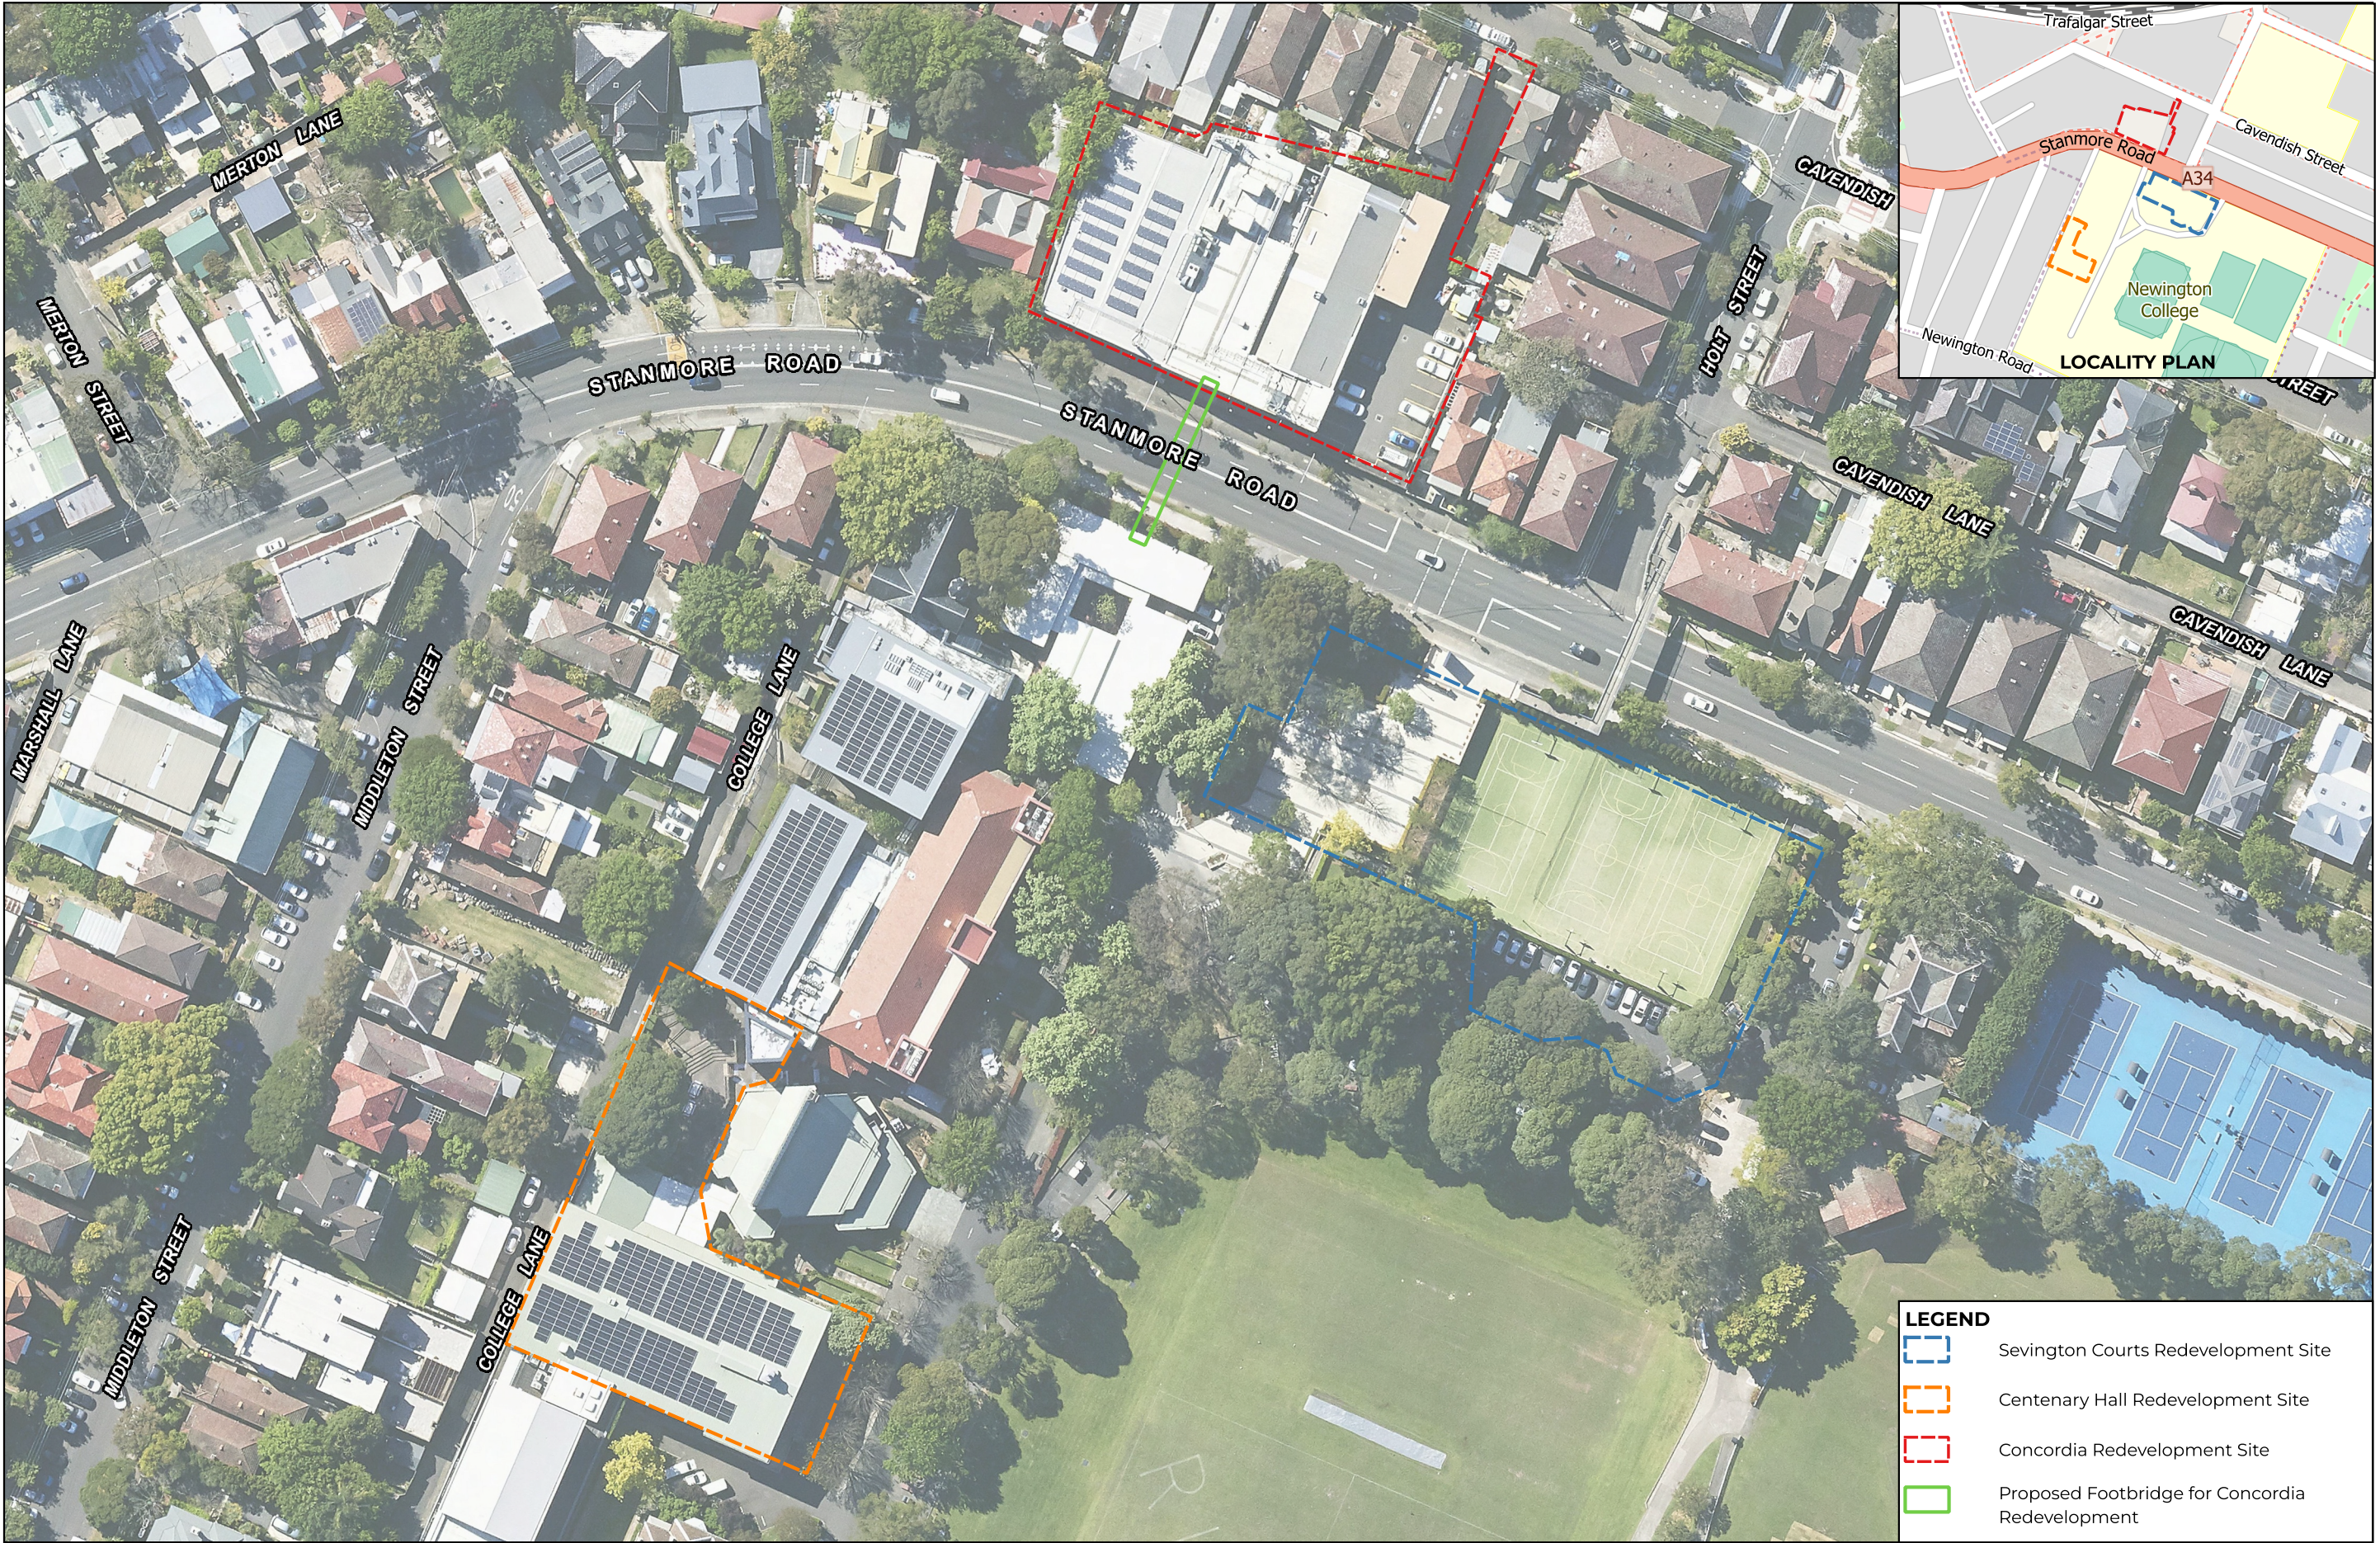
| DRAWING NO: | 1 |

Sevington Courts Redevelopment Site

An overview of the three sites to which this report pertains is shown on Drawing 1 in Appendix B. The sites are individually shown in Drawings 2 to 4. It is noted the sites are referred to hereon in this report as the “Concordia”, “Sevington”, and “Centenary Hall” sites.

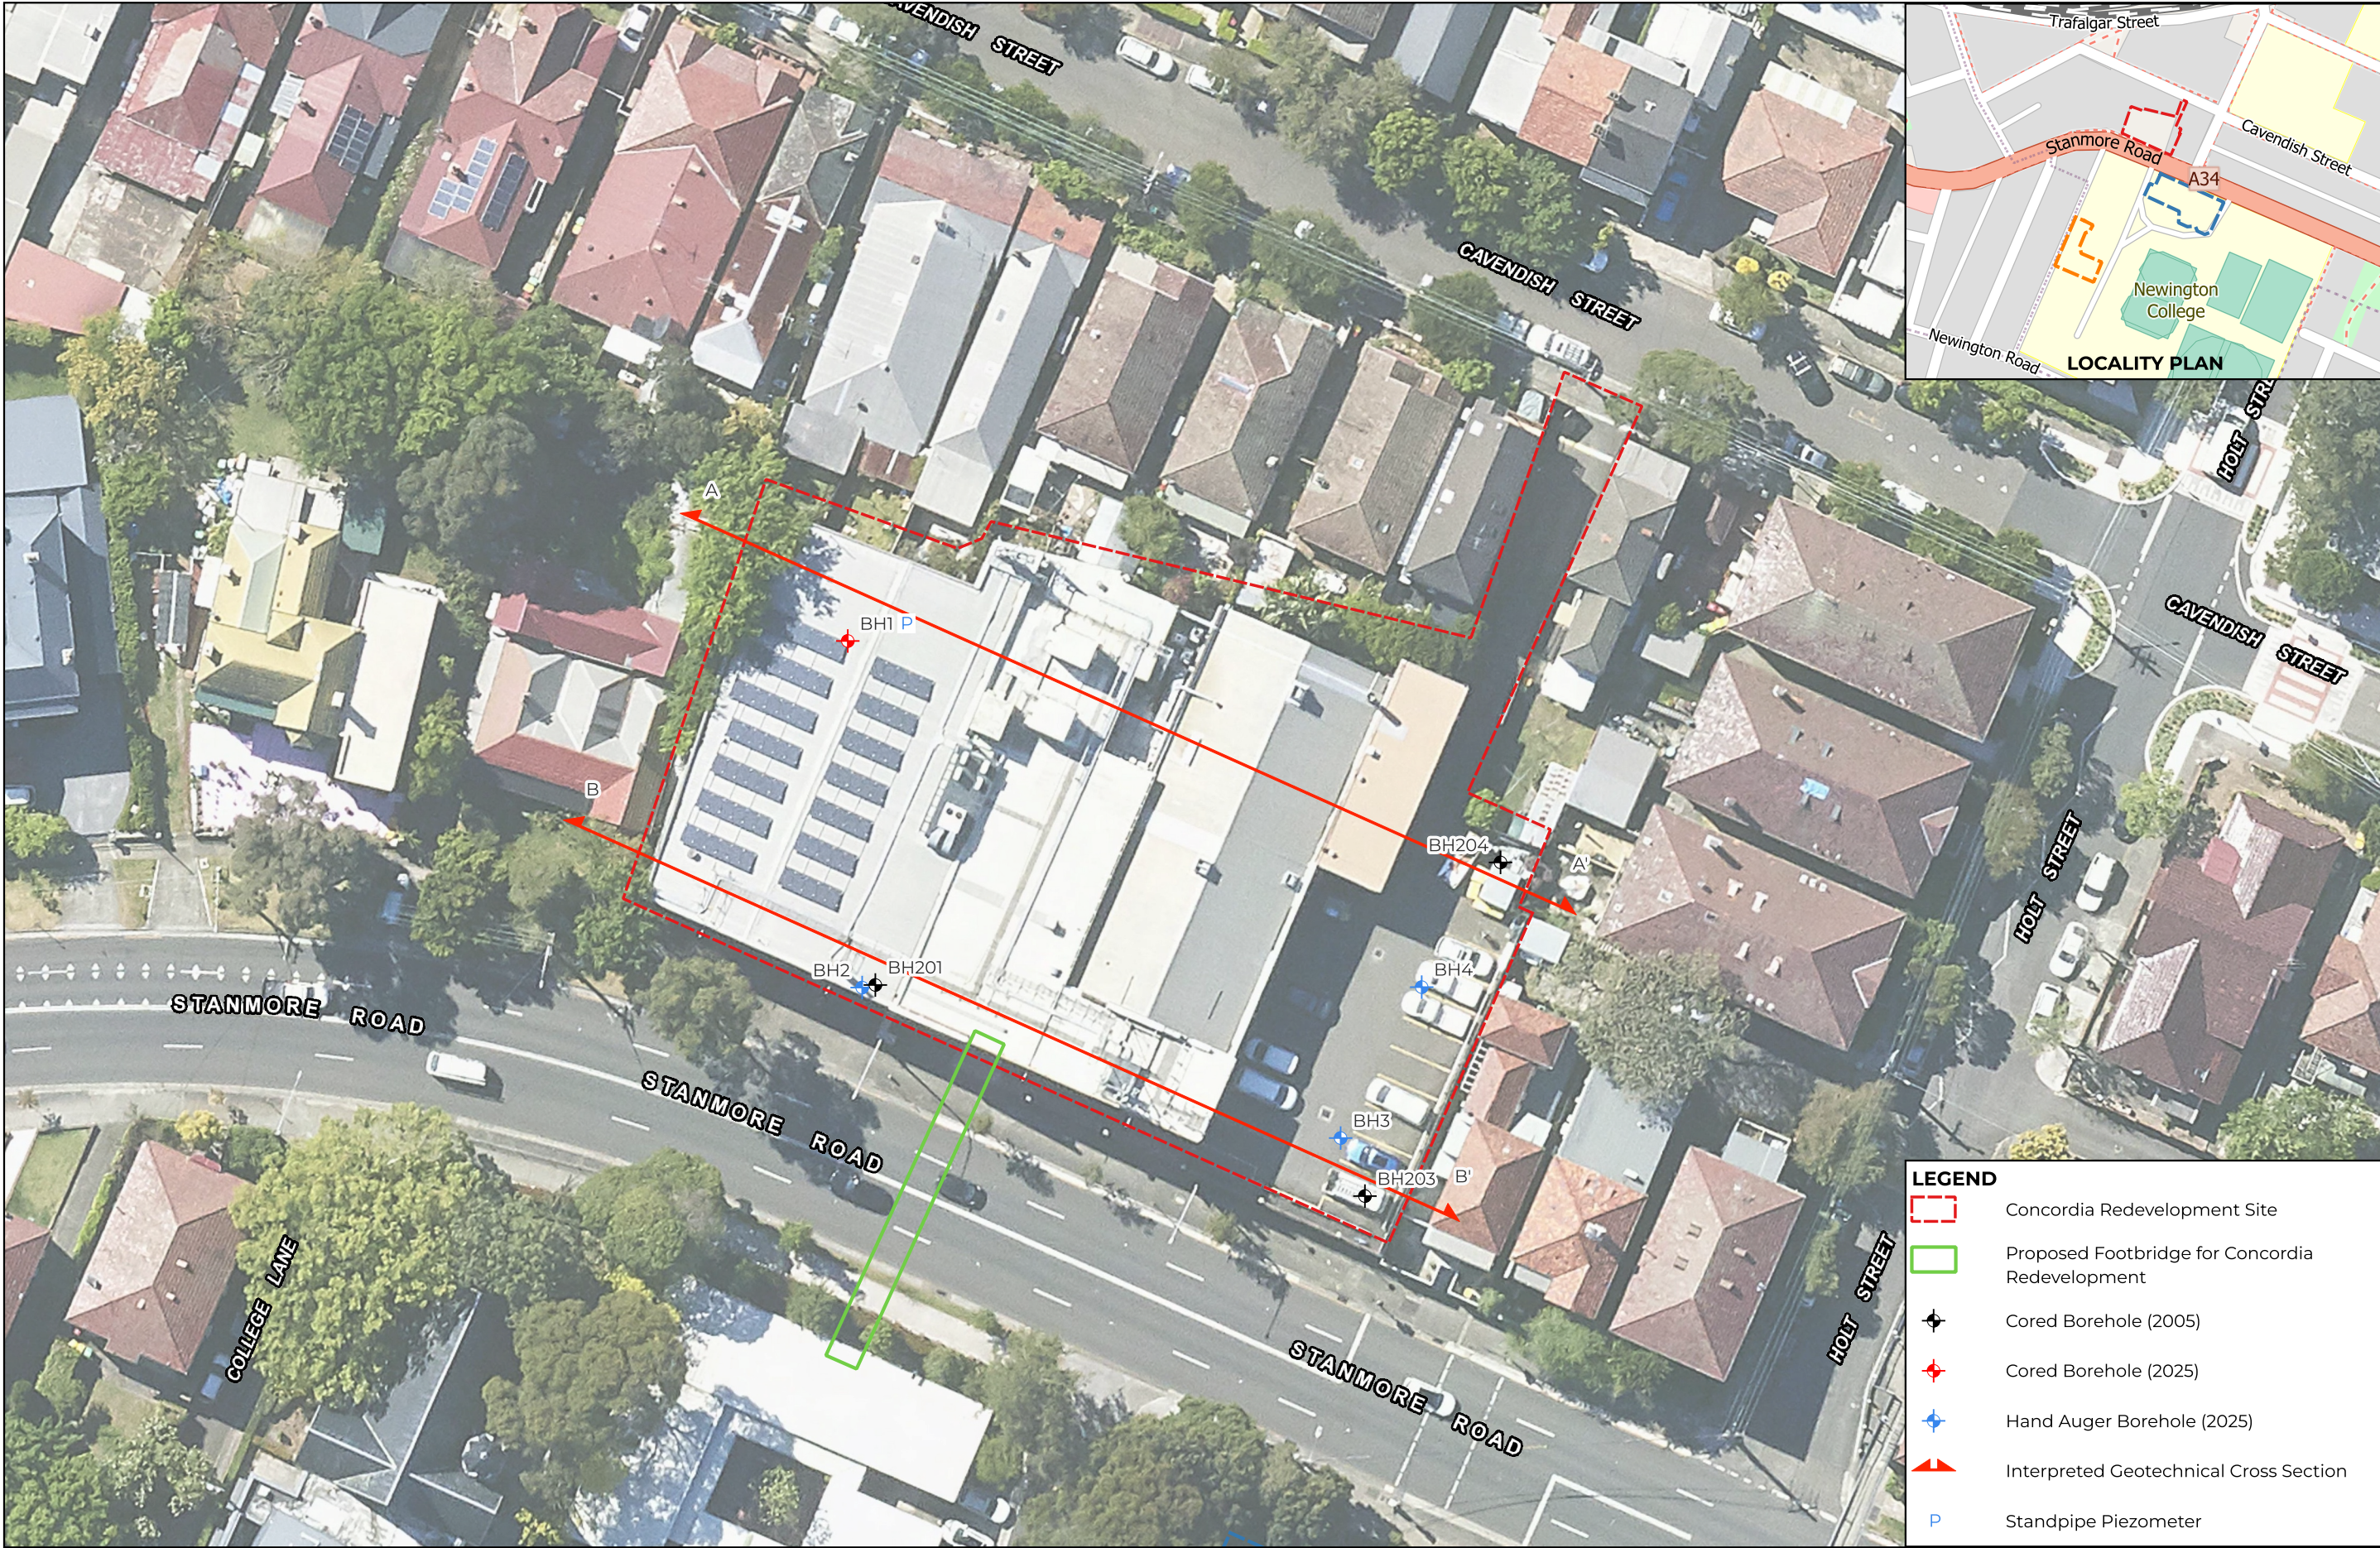
DRAWING NO:  
**2**

- LEGEND**
- Concordia Redevelopment Site
  - Proposed Footbridge for Concordia Redevelopment
  - Cored Borehole (2005)
  - Cored Borehole (2025)
  - Hand Auger Borehole (2025)
  - Interpreted Geotechnical Cross Section
  - Standpipe Piezometer

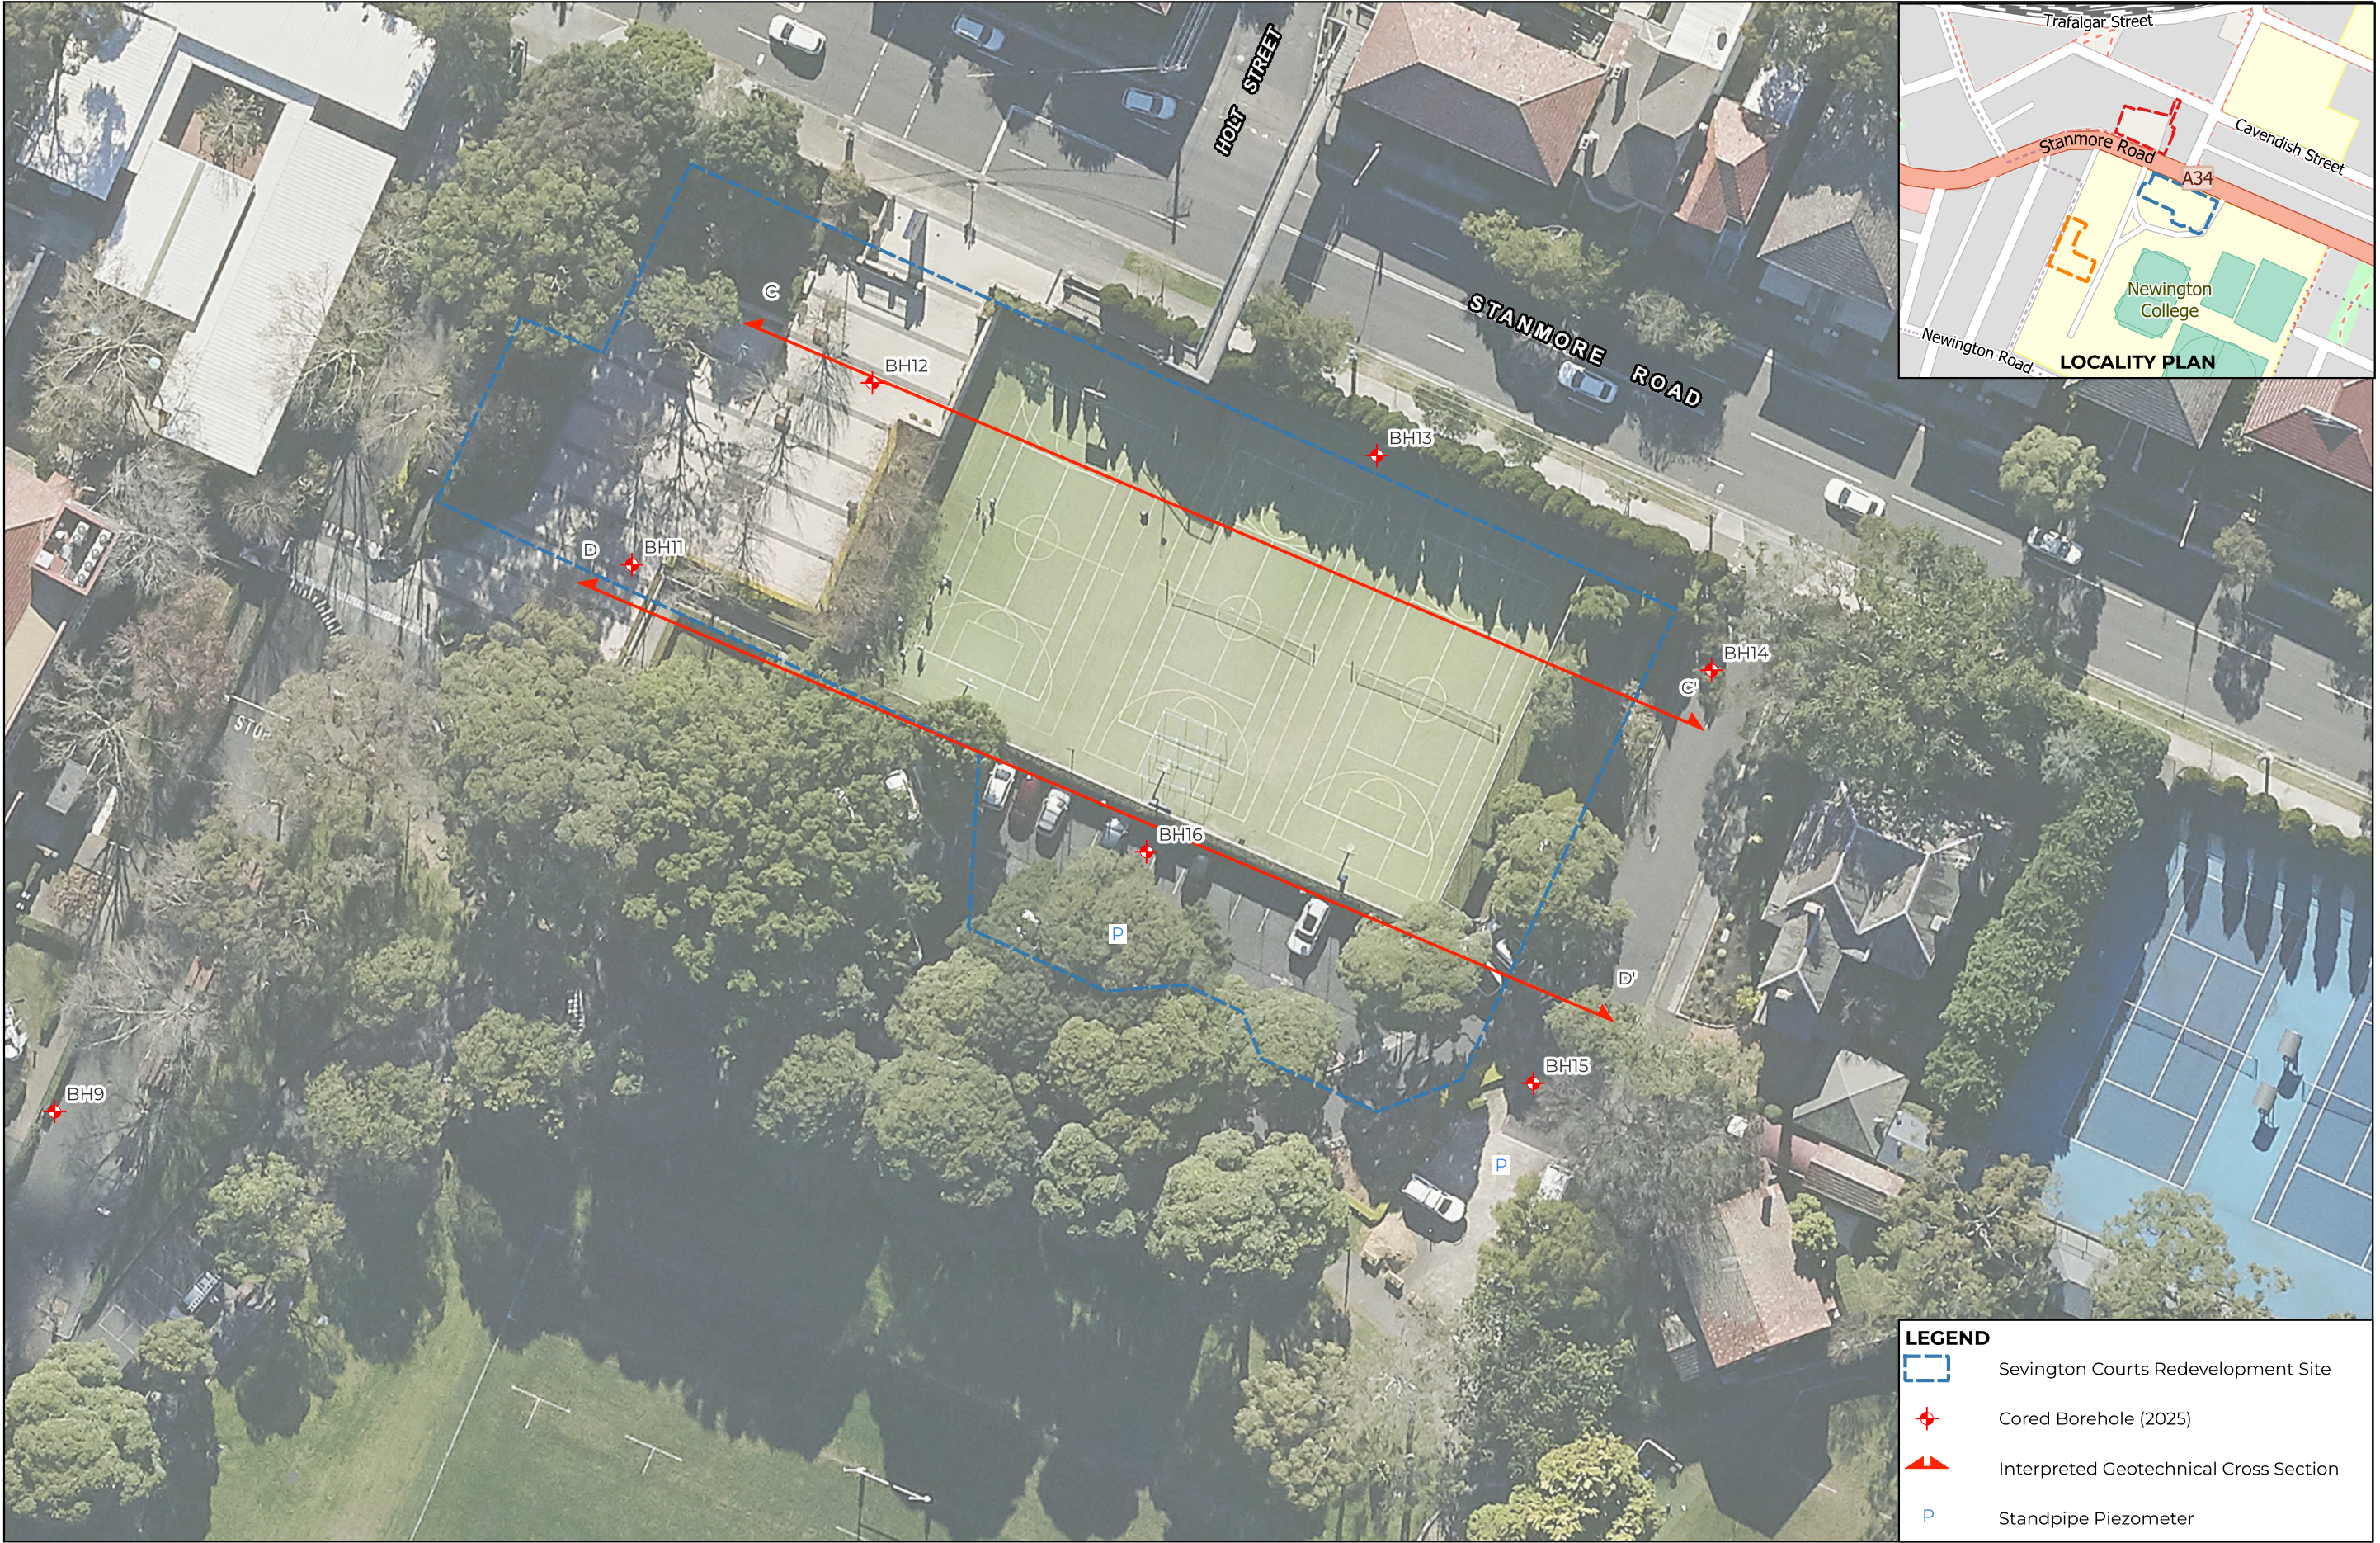
- Sevington Courts Redevelopment Site
- Cored Borehole (2025)
- Interpreted Geotechnical Cross Section
- Standpipe Piezometer

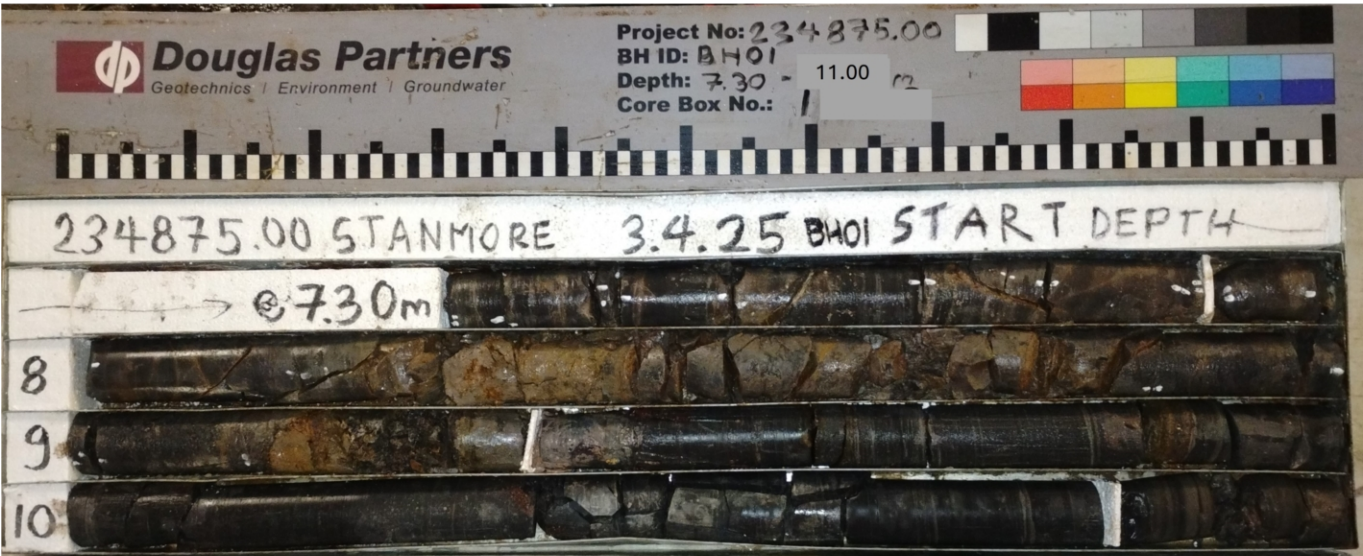
7.30-11.00 m depth

11.00-11.73 m depth

Details of the subsurface conditions encountered are presented in the borehole logs in Appendix C, with colour photographs of the recovered rock cores. Notes defining classification methods and descriptive terms used in preparation of the logs are included in Appendix A.

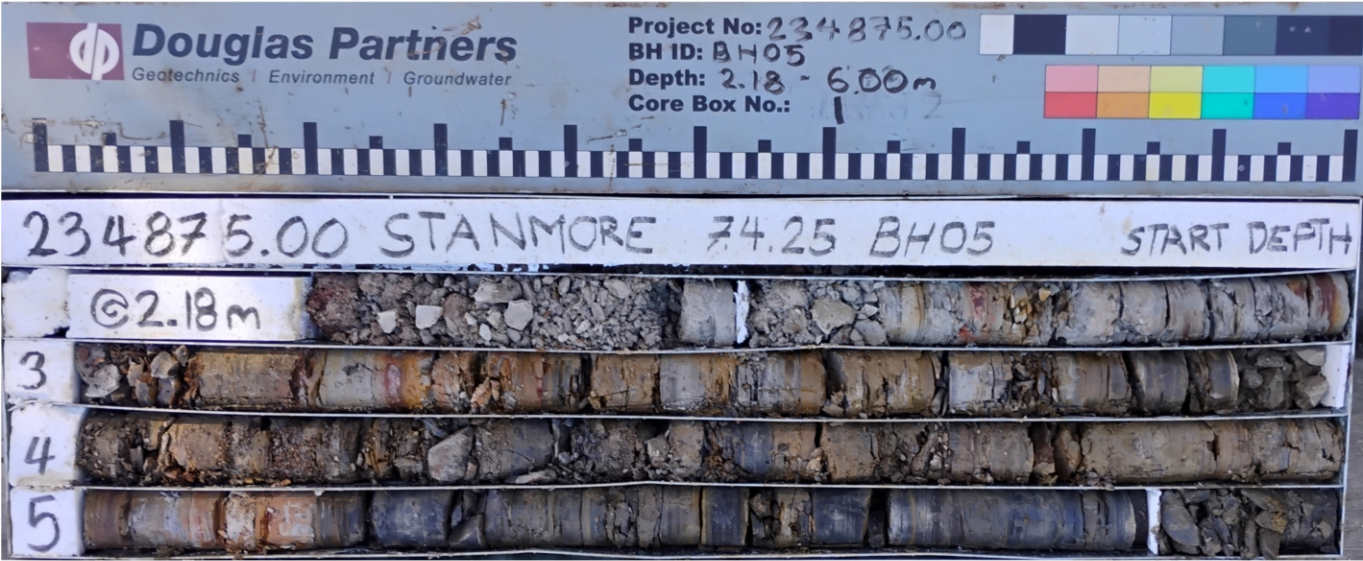
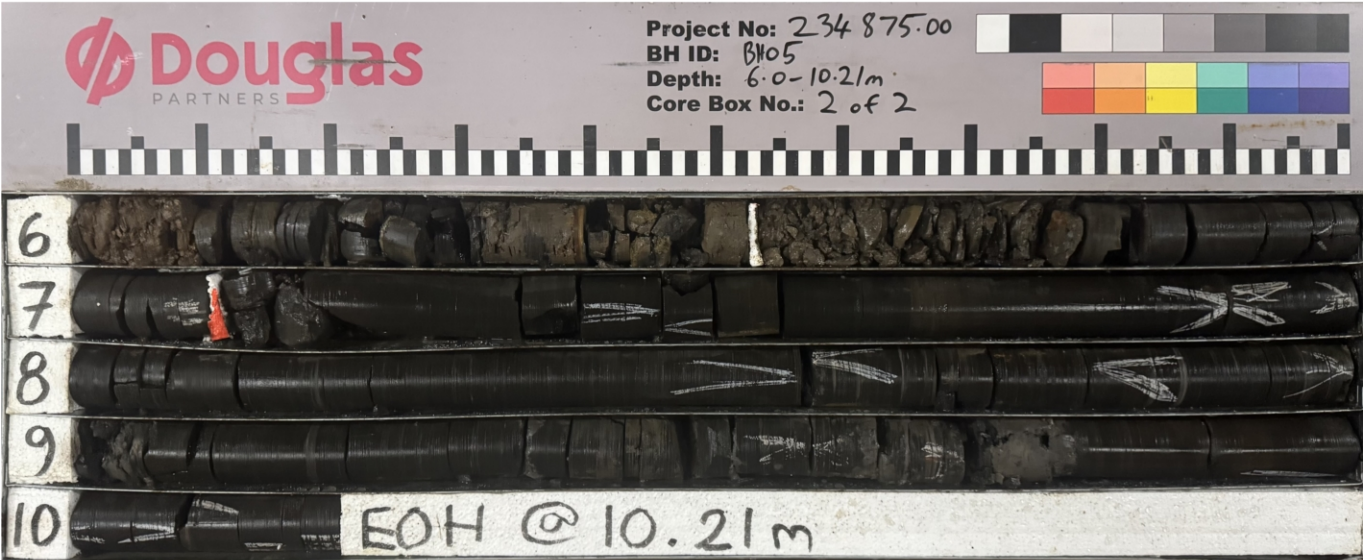
2.18-6.00 m depth

6.00-10.21 m depth

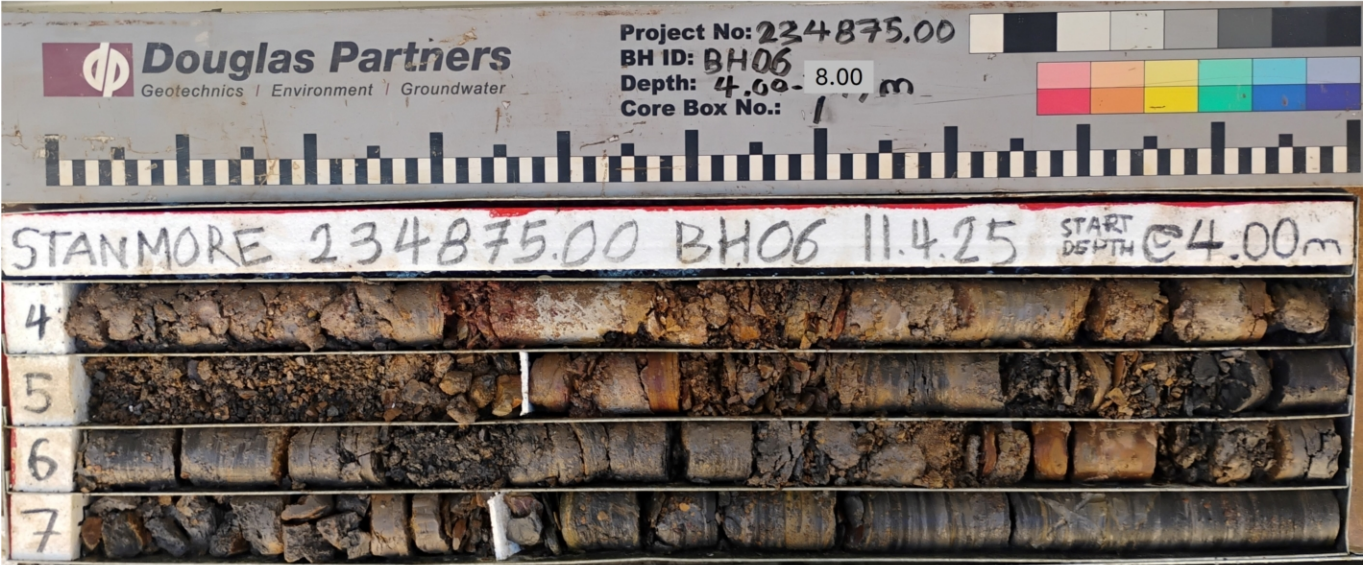
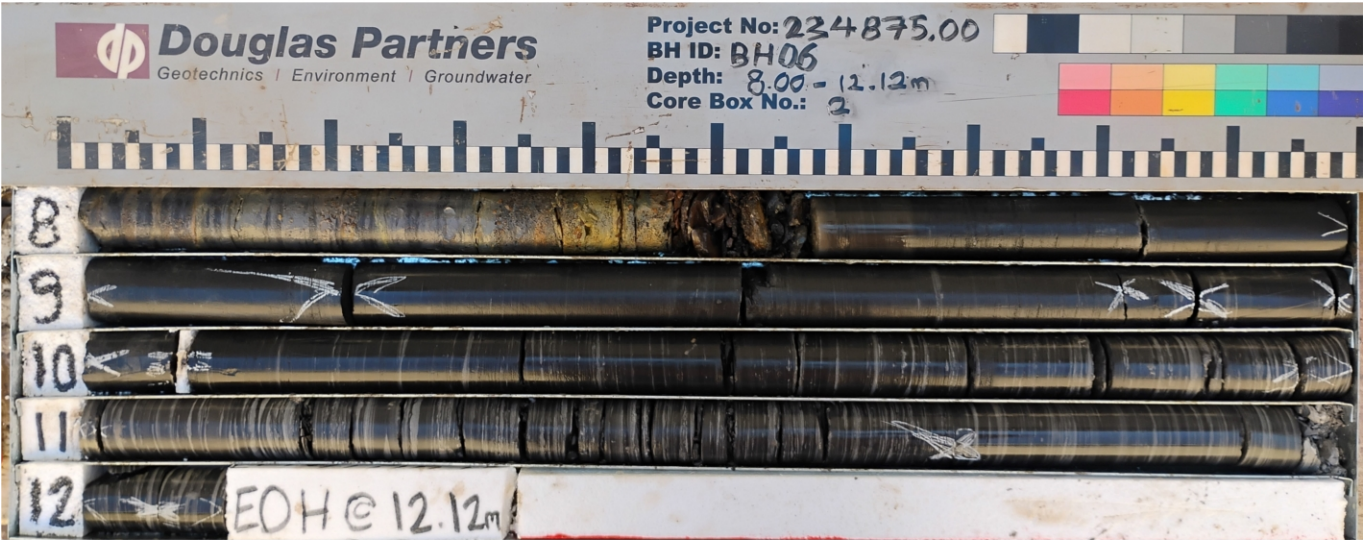
4.00-8.00 m depth

8.00-12.12 m depth

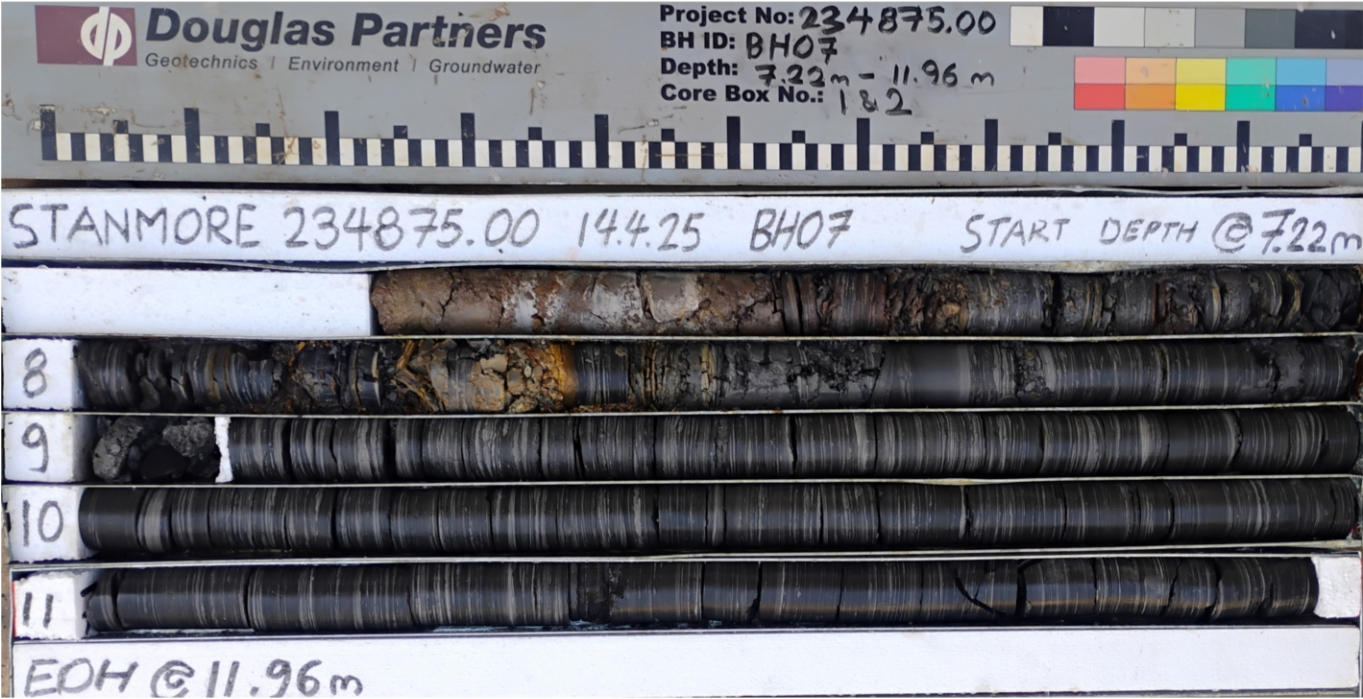
7.22-11.96 m depth

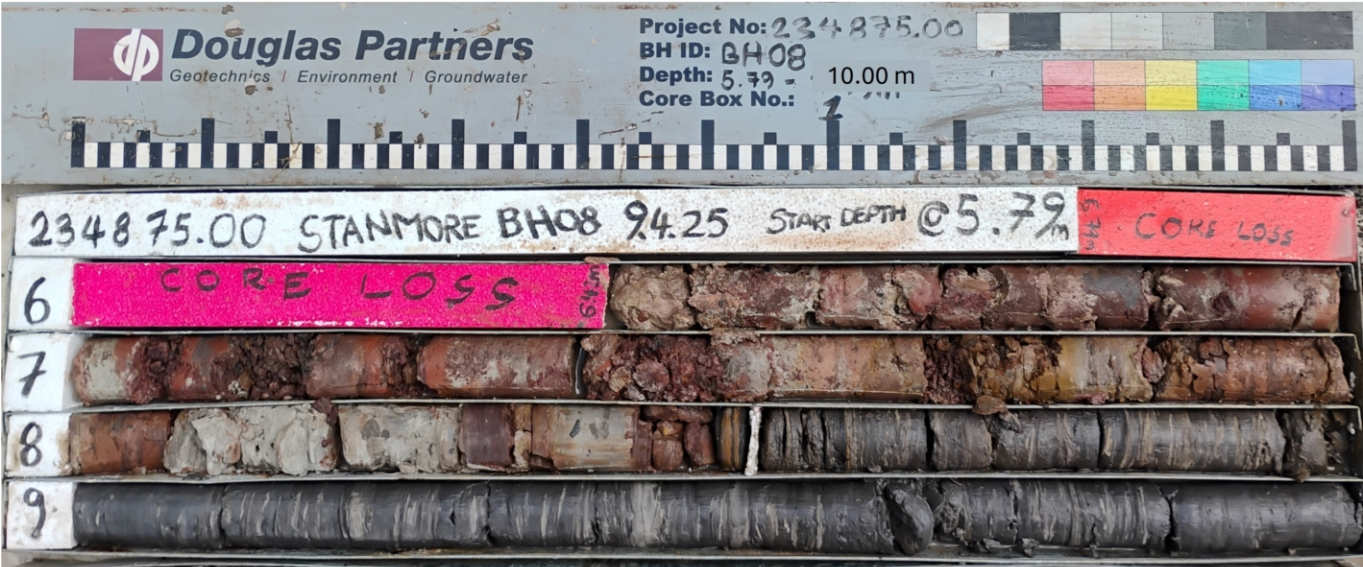
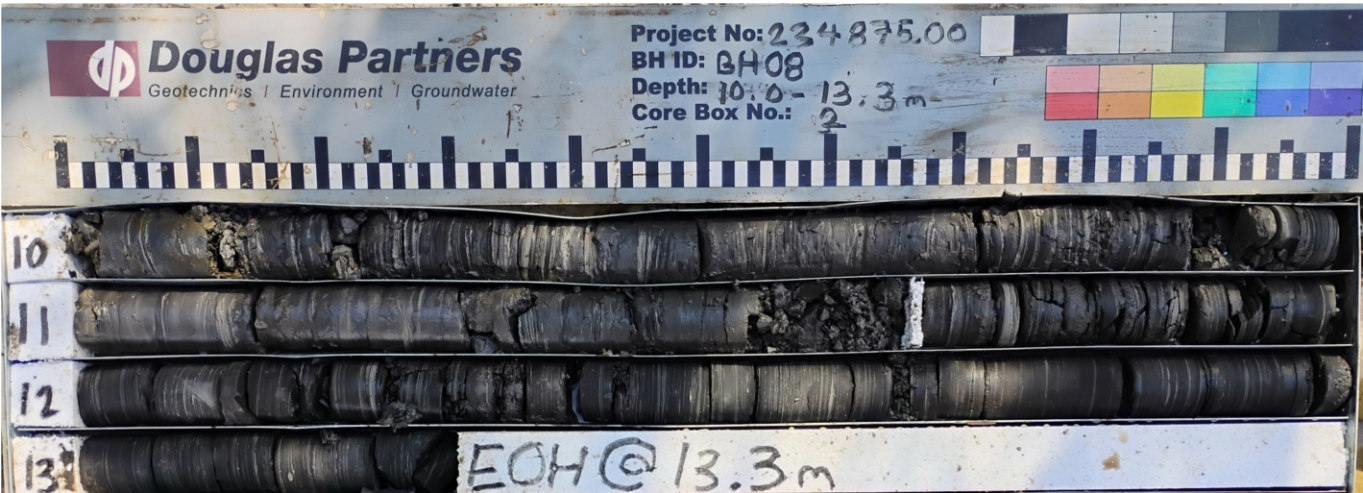
5.79-10.00 m depth

10.00-13.30 m depth

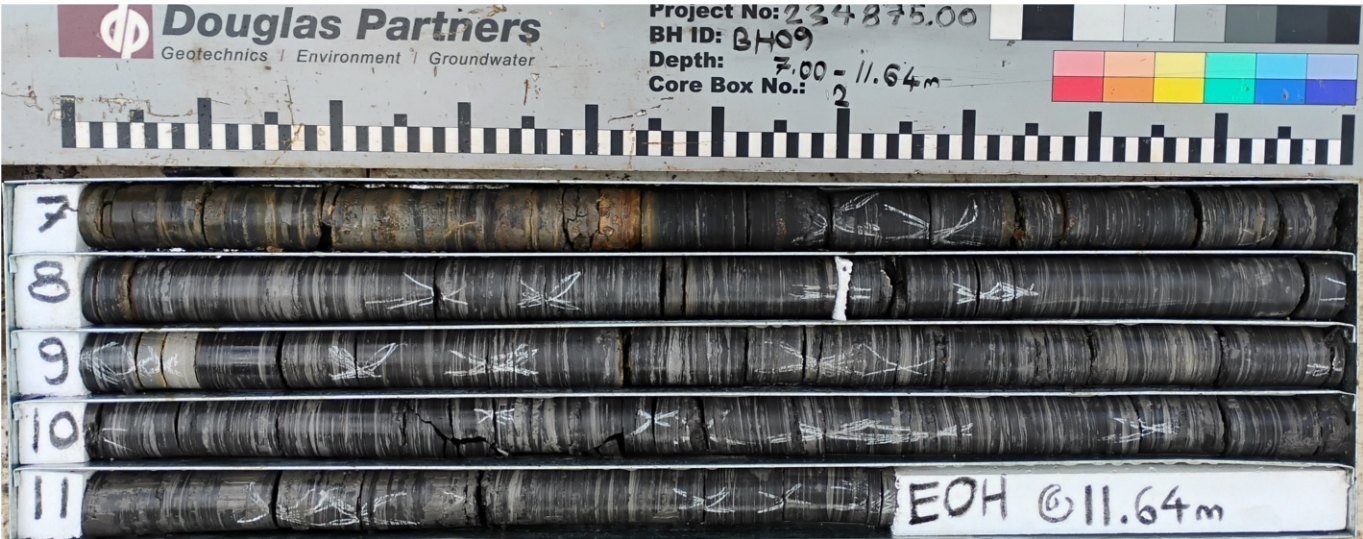
2.95-7.00 m depth

7.00-11.64 m depth

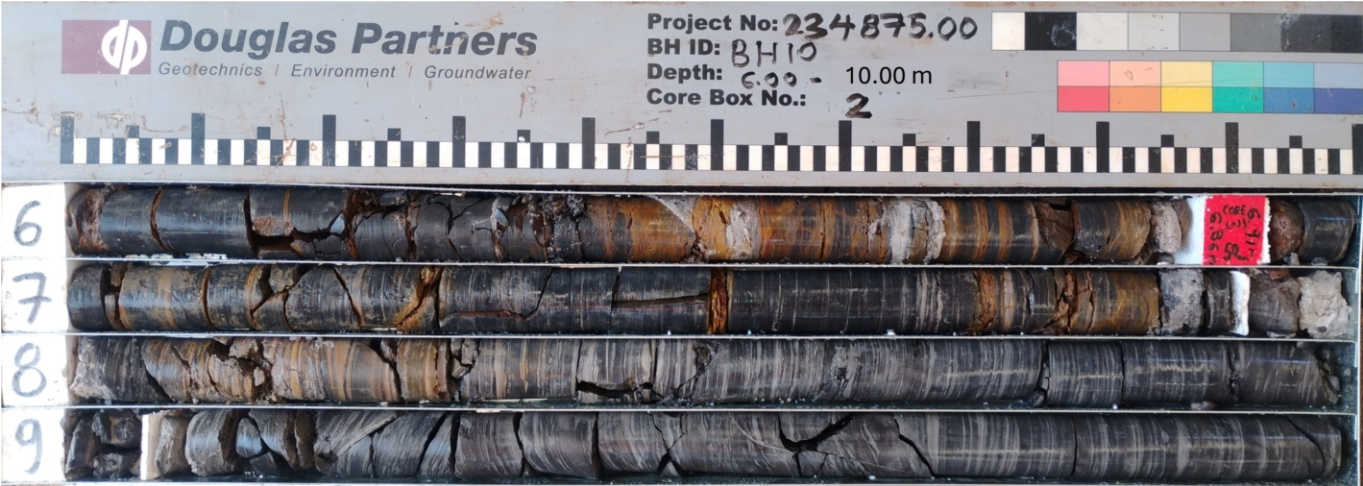
2.12-6.00 m depth

6.00-10.00 m depth

10.00-11.64 m depth

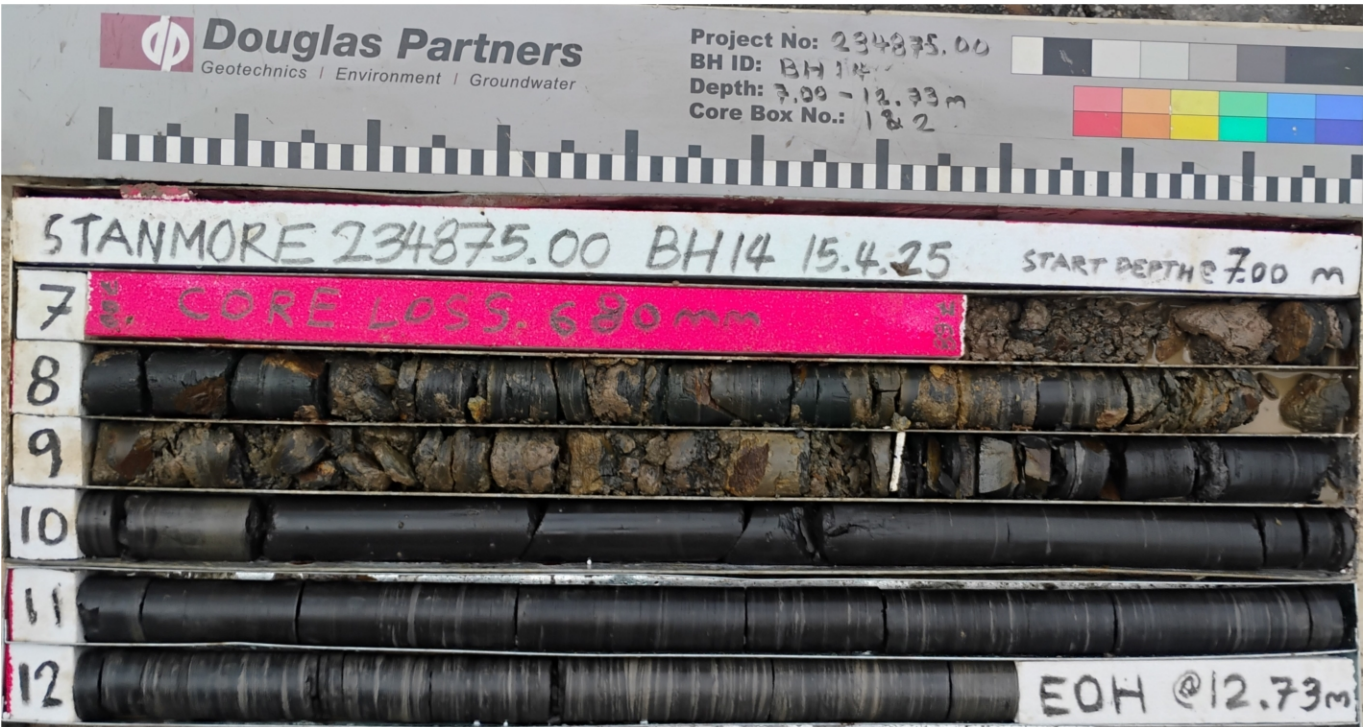
7.00-12.73 m depth

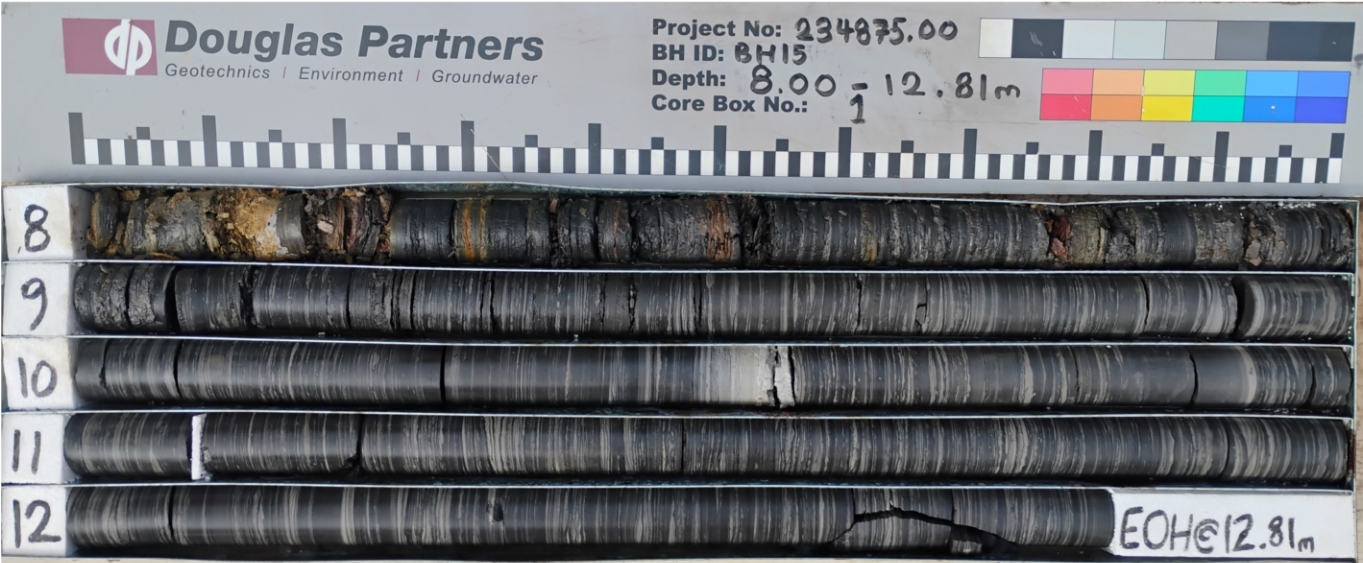
8.00-12.81 m depth

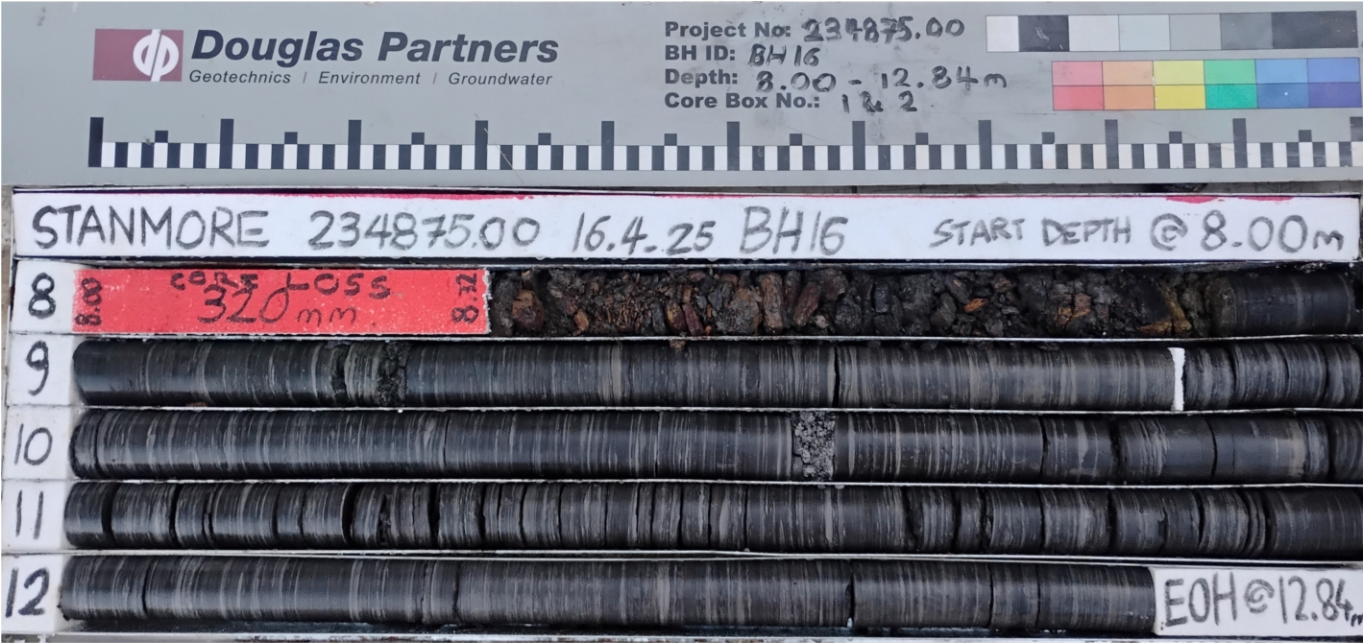
8.00-12.84 m depth
